WATER LICENCE INSPECTION FORM

Licensee MMG Resources INC.	Licensee Representative Greg Martin
Licence No. / Expiry 2BE-HIG2328	Representative's Title
Land / Other Authorizations N2024C0021	Land / Other Authorizations
Date of Inspection 31/07/2024	Inspector Isaiah James Bolt
Activities Inspected <input checked="" type="checkbox"/> Camp <input type="checkbox"/> Drilling <input type="checkbox"/> Mining <input type="checkbox"/> Construction <input checked="" type="checkbox"/> Reclamation <input checked="" type="checkbox"/> Fuel Storage <input type="checkbox"/> Roads/Hauling <input type="checkbox"/> Other: <input checked="" type="checkbox"/> Other: Care & Maintenance

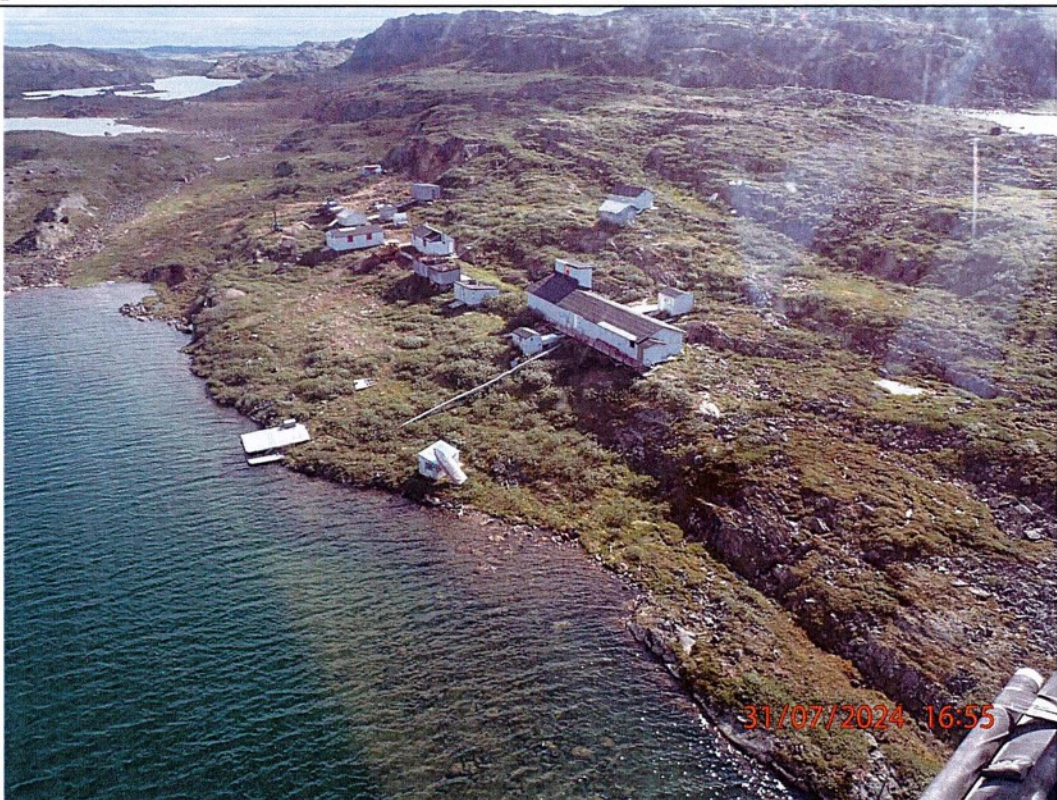
Photo 1

High Lake camp Aerial Looking south.

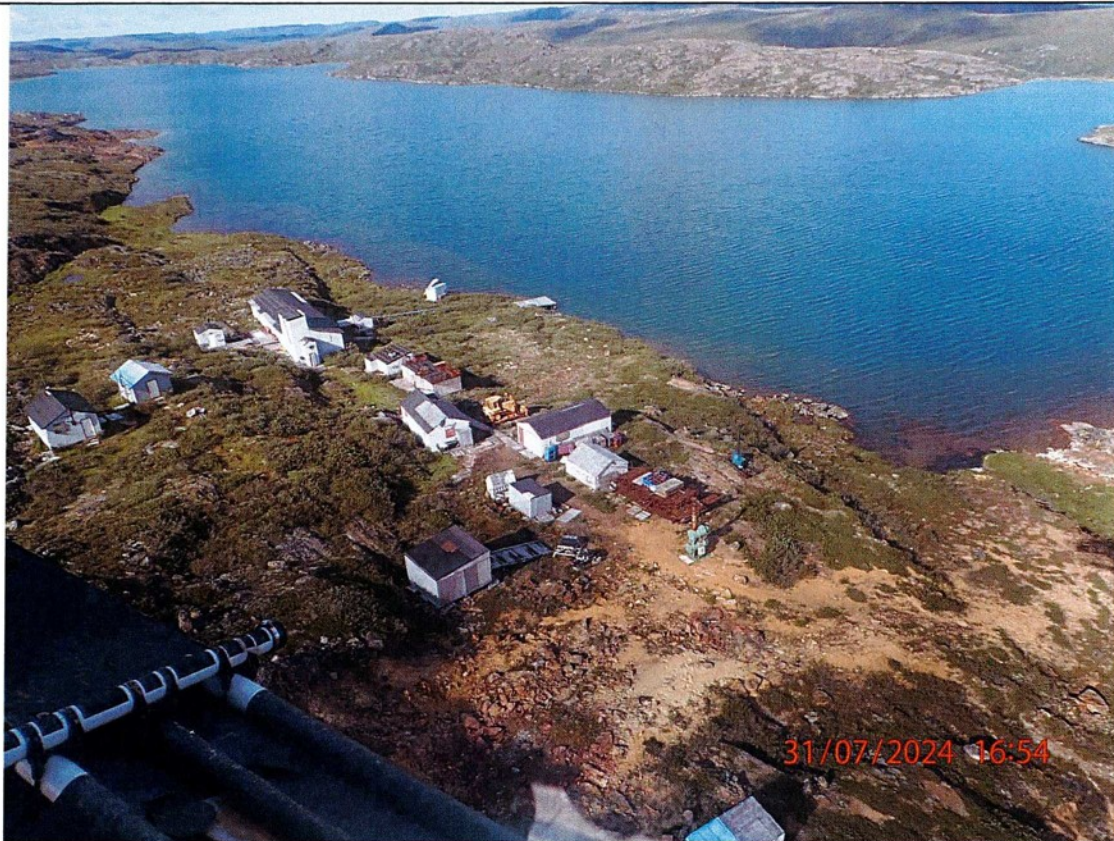
Photo 2

High Lake Looking North

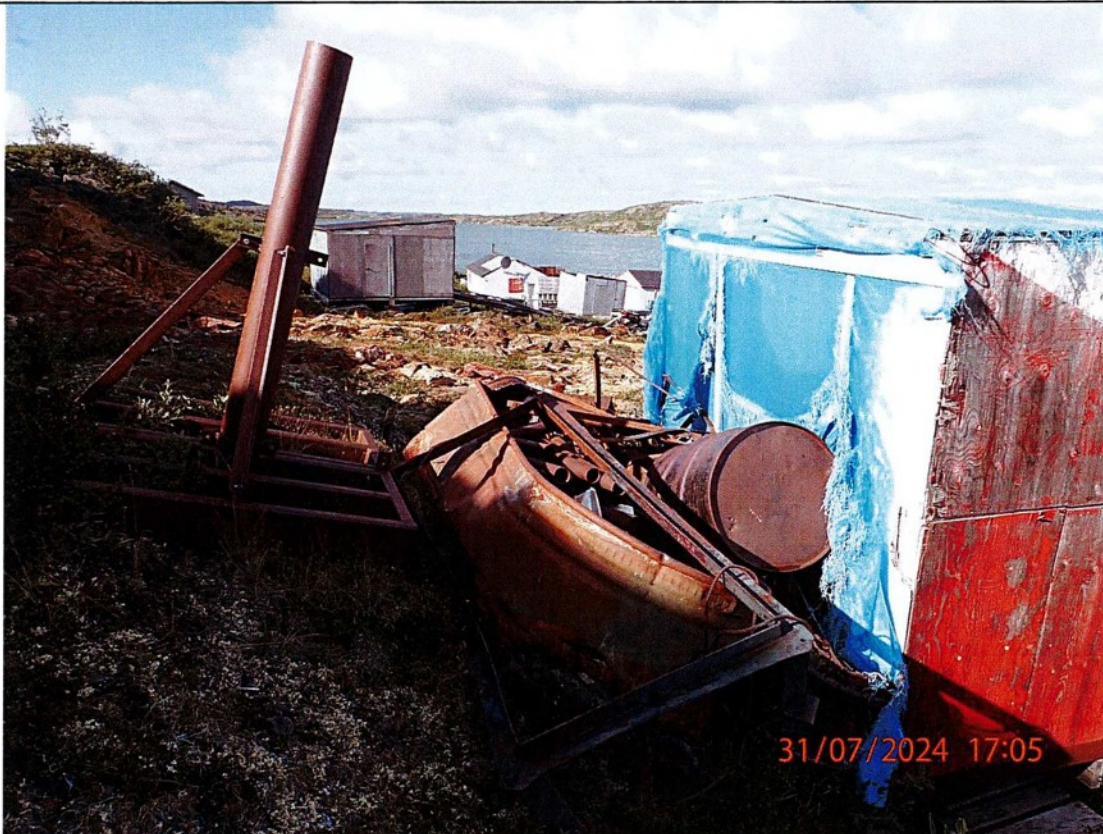
Photo 3

SECTION 2	<input checked="" type="checkbox"/> Comments	<input type="checkbox"/> Non-Compliance with Act or Licence	<input type="checkbox"/> Action Required
<p>-Scrap metal on site. -Fuel containers out of secondary containment</p>

Part I Item 3 of the Issued water license states: "The Licensee shall carry out progressive reclamation of any components of the project no longer required for the Licensee's operations."

Scrap metal and parts

All scrap metal shall be removed from site including any garbage, discarded barrels or debris. All fuel must be stored in secondary containment. All building doors, windows and walls must be repaired and closed to prevent access from wildlife. All drill rods shall be cut to grade, capped and scrap metal rod removed from site. The metal dish should be stored in camp for removal from site or stored in camp for future use. A detailed plan and timeline to achieve the actions required shall be submitted to me at james.bolt@rcaanc-cirnac.gc.ca by December 20 2024. Actions required should be planned for completion prior to July 31 2025.

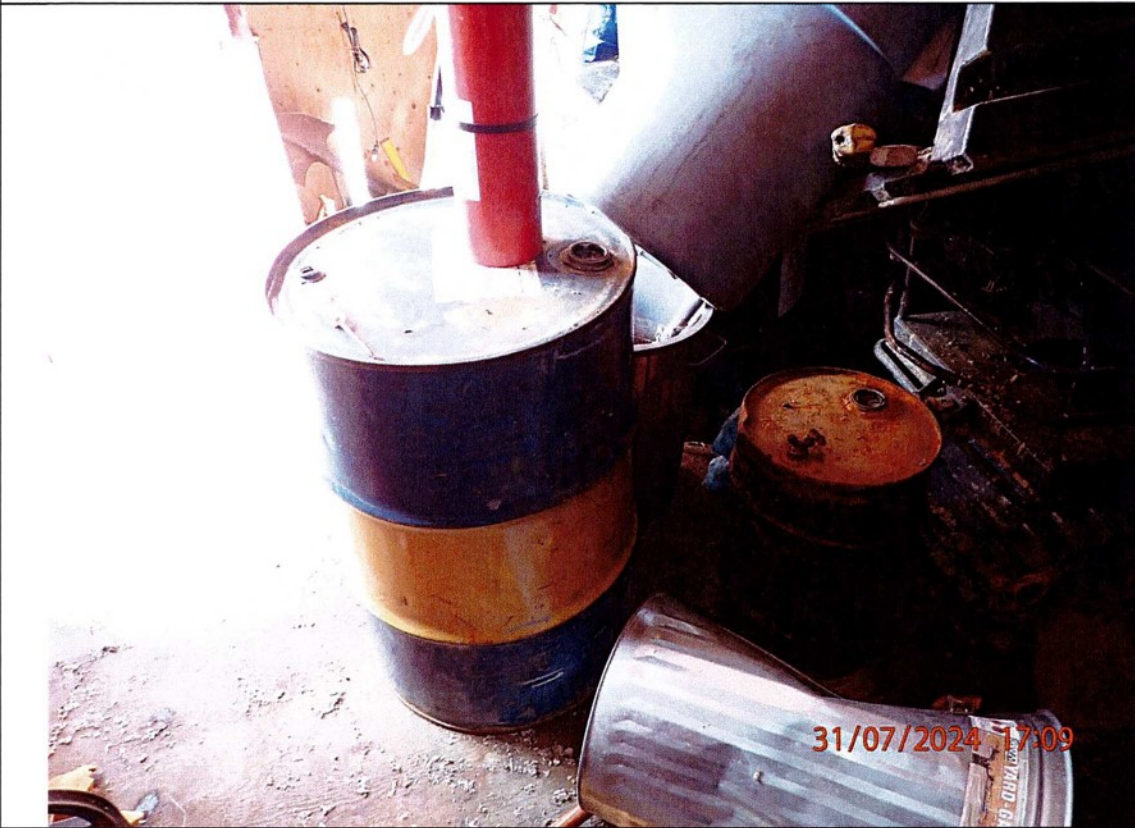
Photo Log
Photo 4

3.0 Site Descriptions of the Spill Contingency Plan states: "A plastic spill container will be placed below each drum and absorbent matting will be fixed around each Bung/fuel supply assembly"

2 fuel containers out of secondary containment inside the mechanic shop.

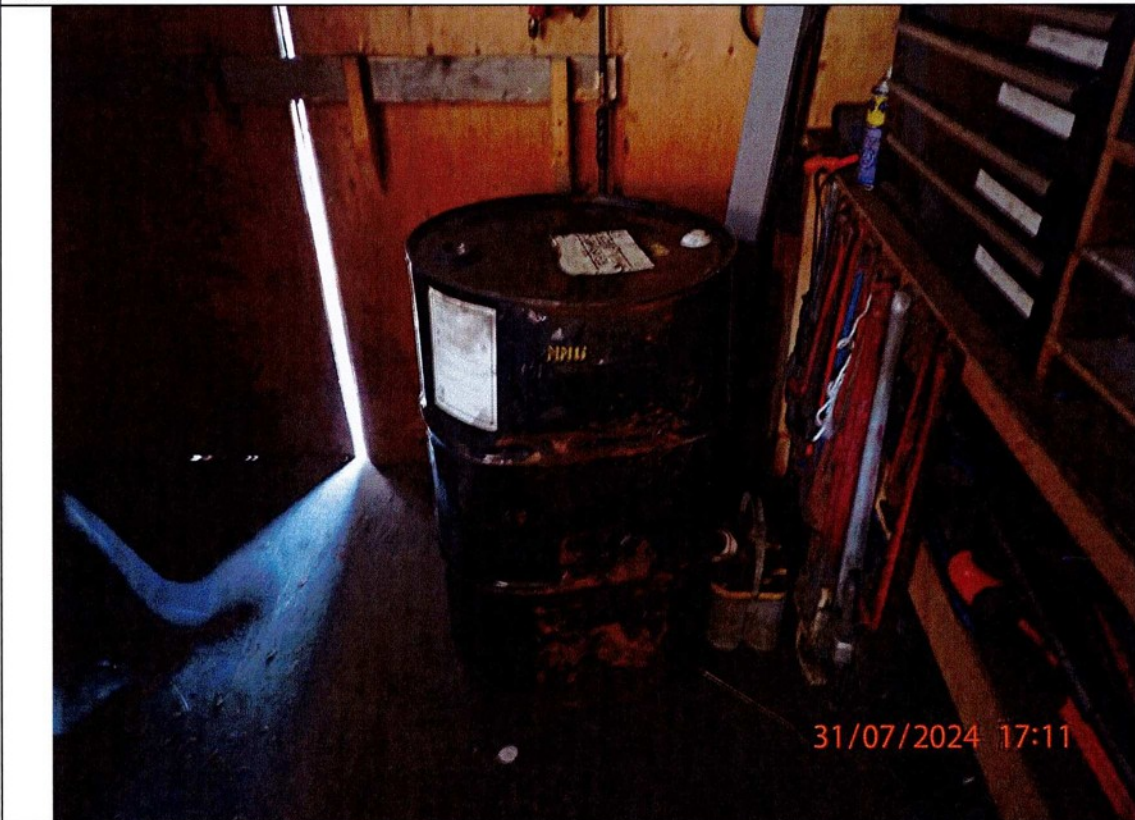
Photo Log
Photo 5

1 fuel drum outside of containment inside the mechanic shop

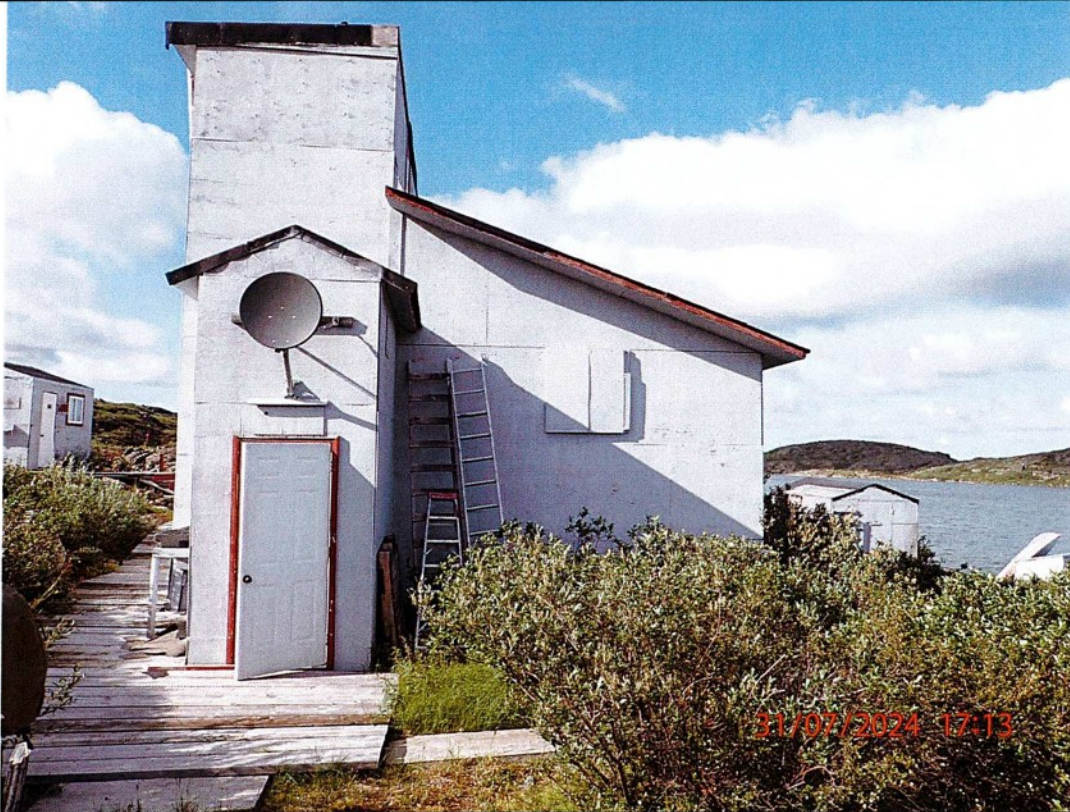
Photo 6

Main building with door open.

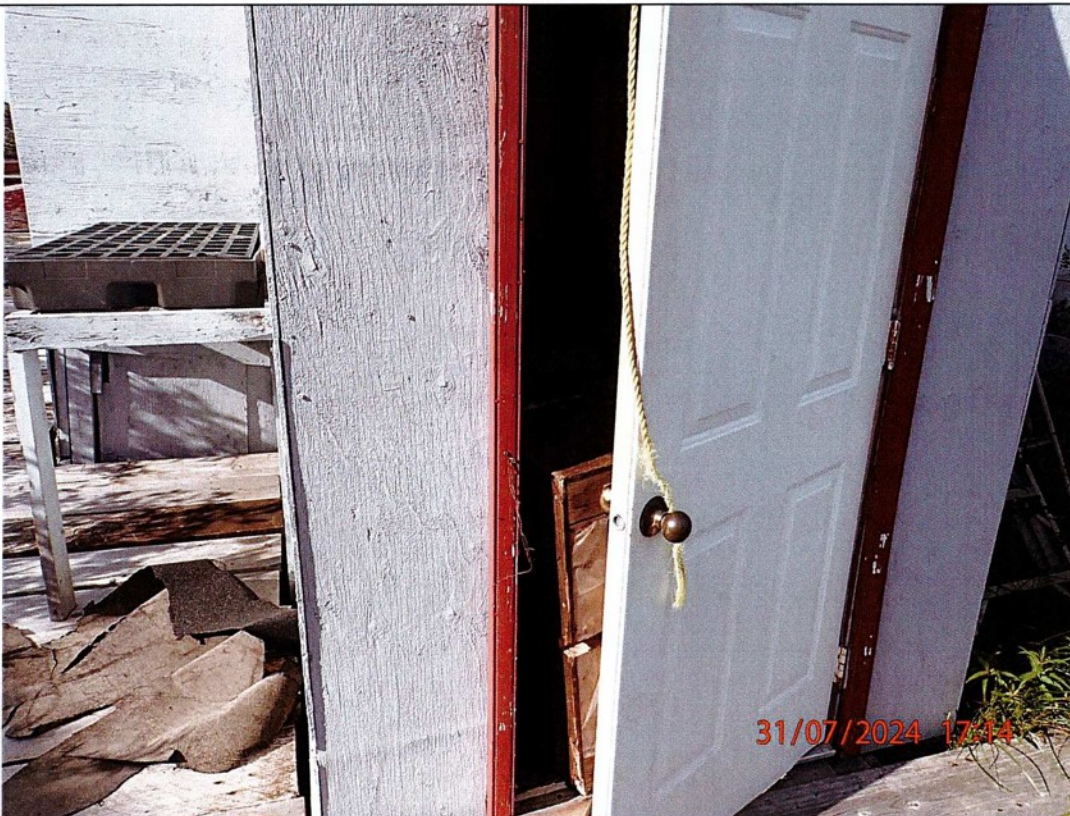
Photo 7

Roofing material outside main building, image shows box in door way. Bear sign is apparent in the building.

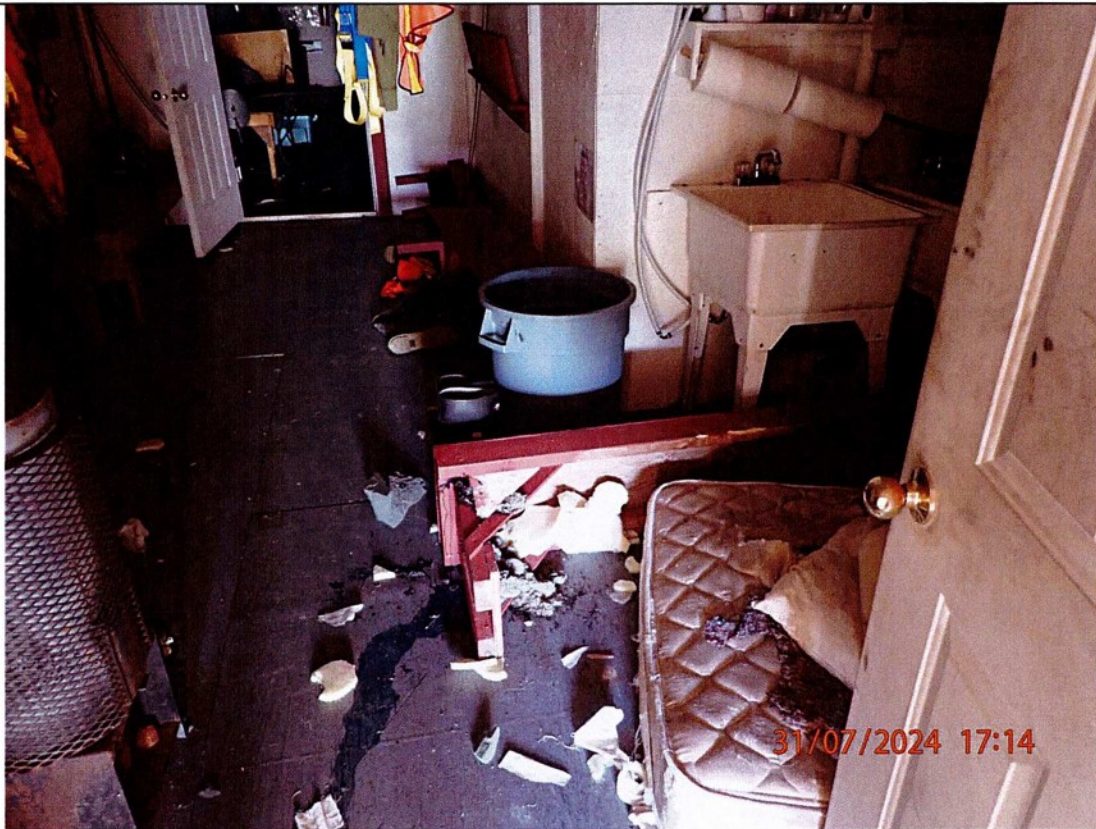
Photo Log
Photo 8

Inside the main building entrance, bear scat is observed on the bench and floor.

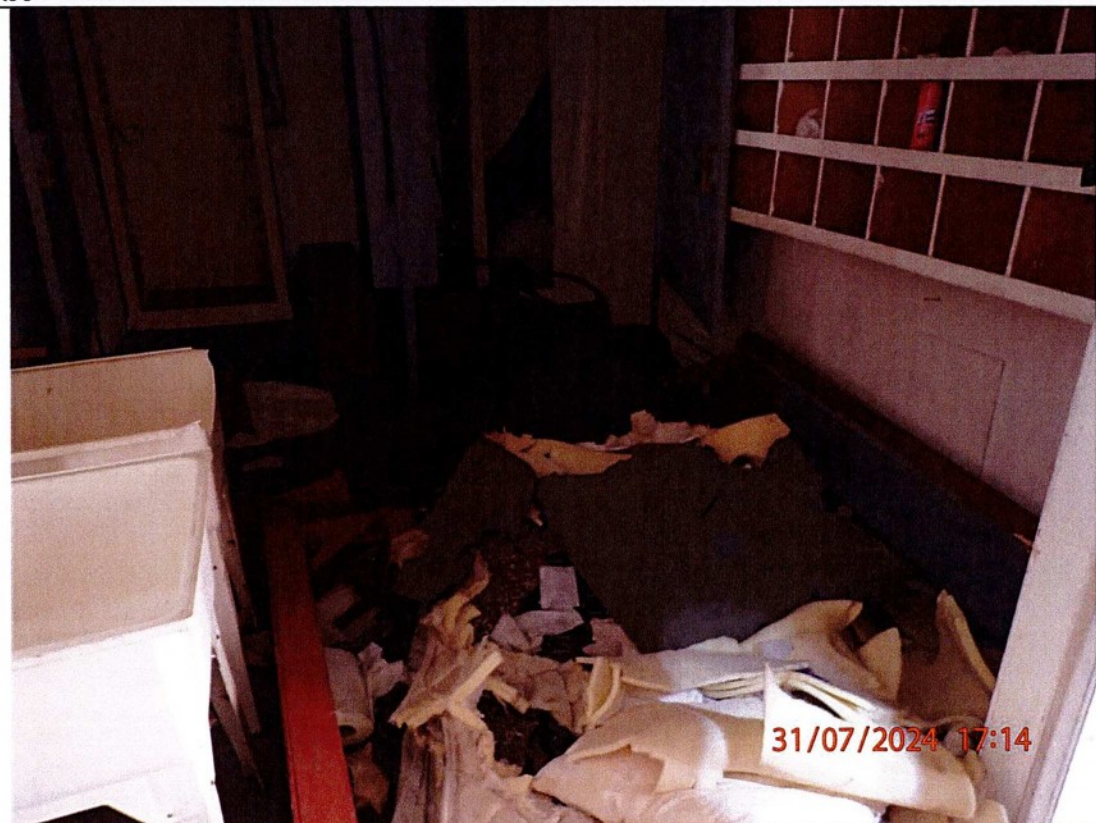
Photo Log
Photo 9

Inside the main building entrance, mess caused by a bear

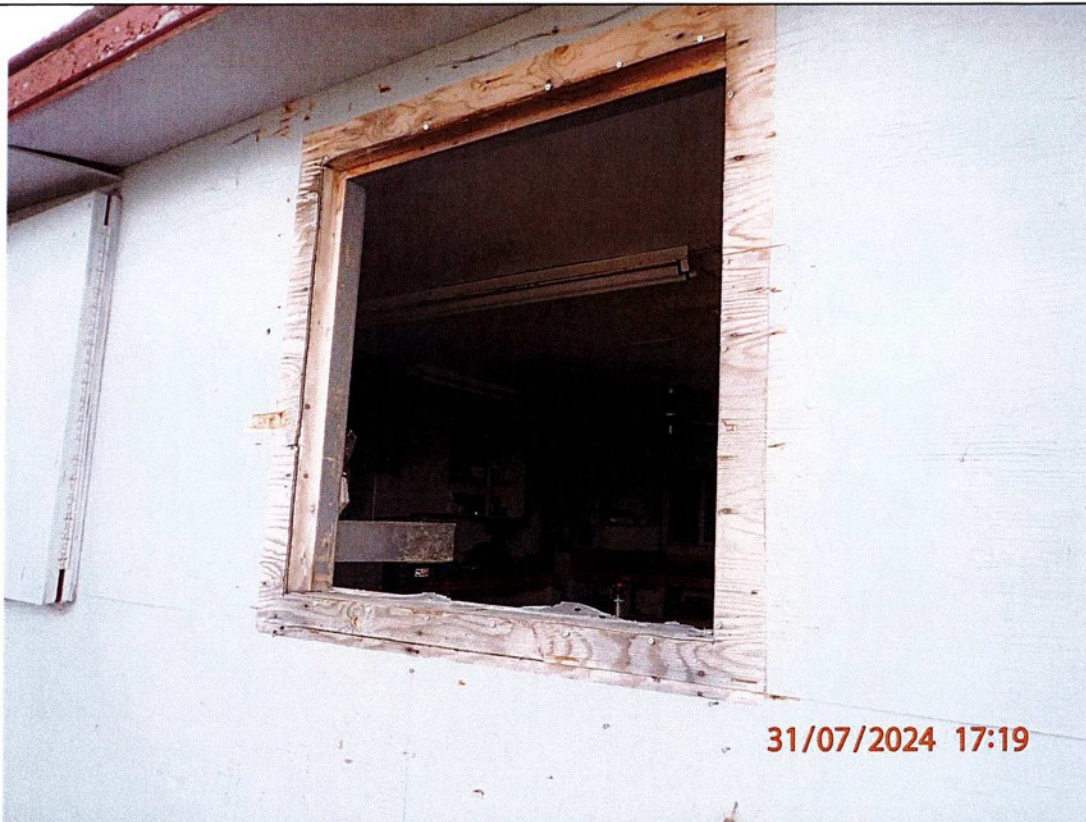
Photo 10

Main building kitchen window open, the plywood was observed on the ground.

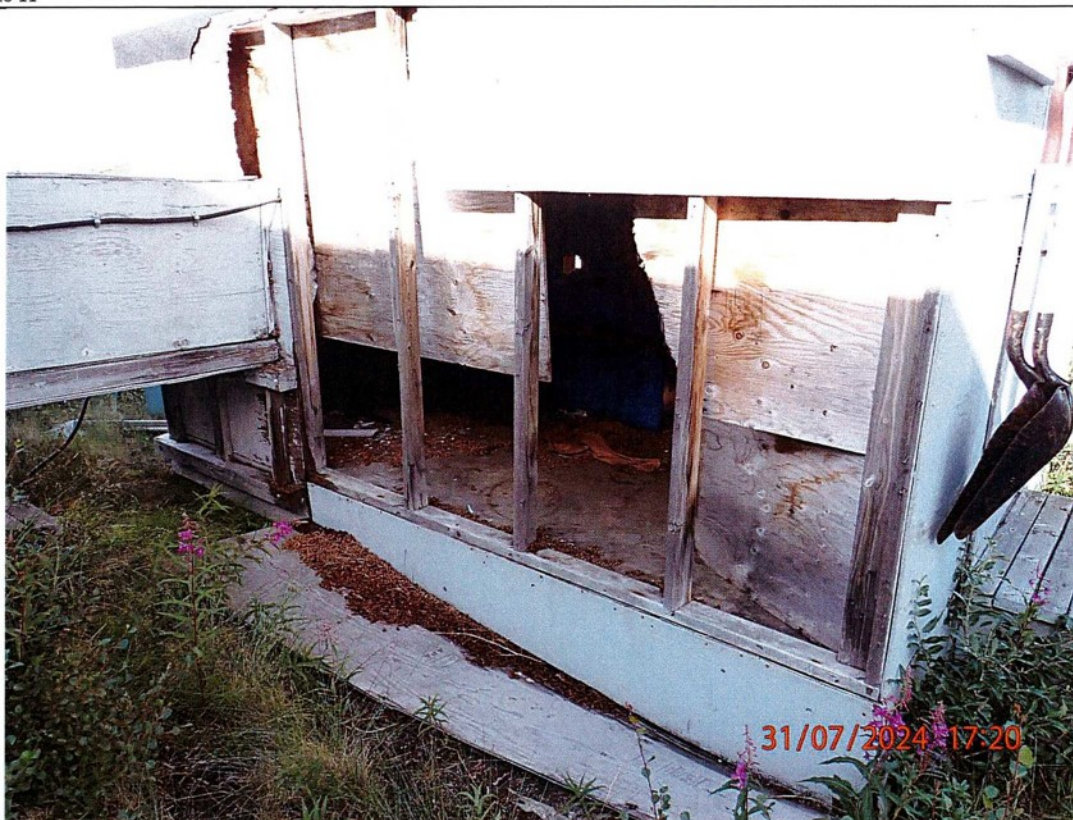
Photo 11

Small shack beside main building shown with an open side wall and ptarmigan droppings inside.

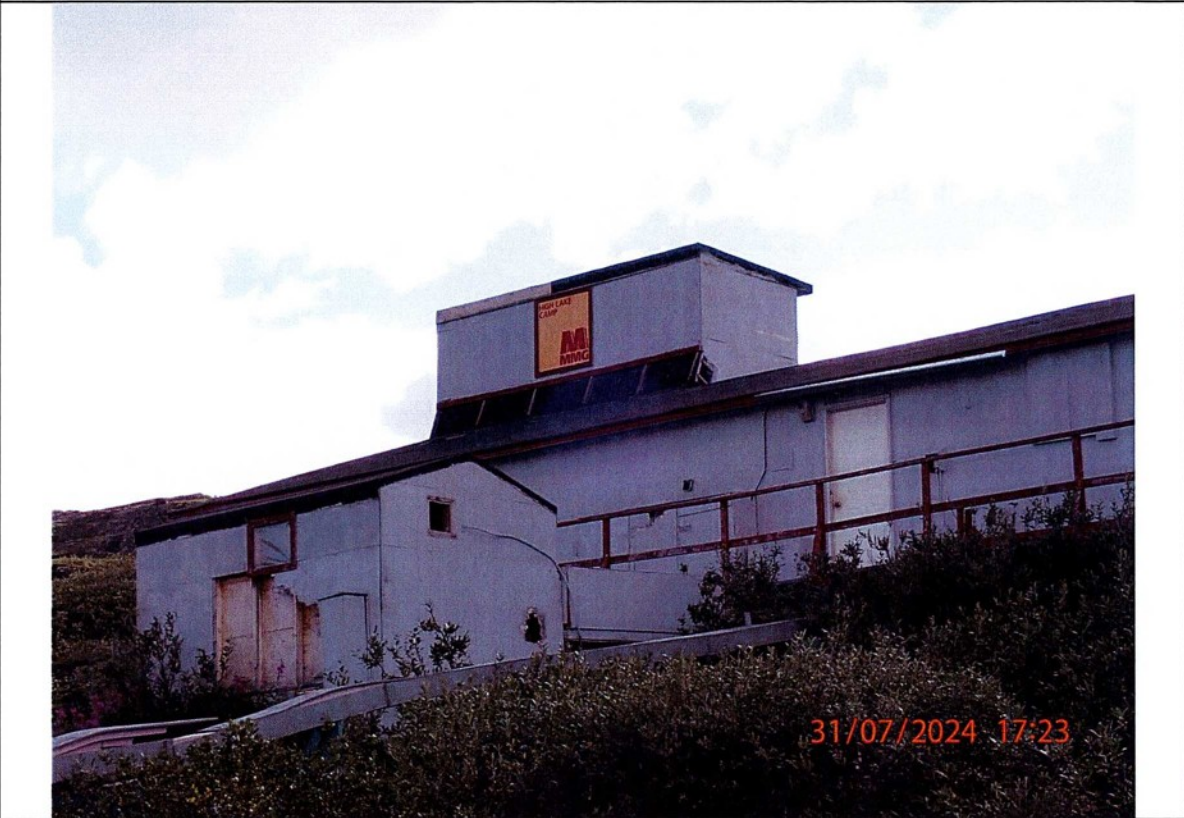
Photo Log
Photo 12

Another view of the shack beside the main building, Plywood from the wall is missing, an open window and a hole in the back wall is shown.

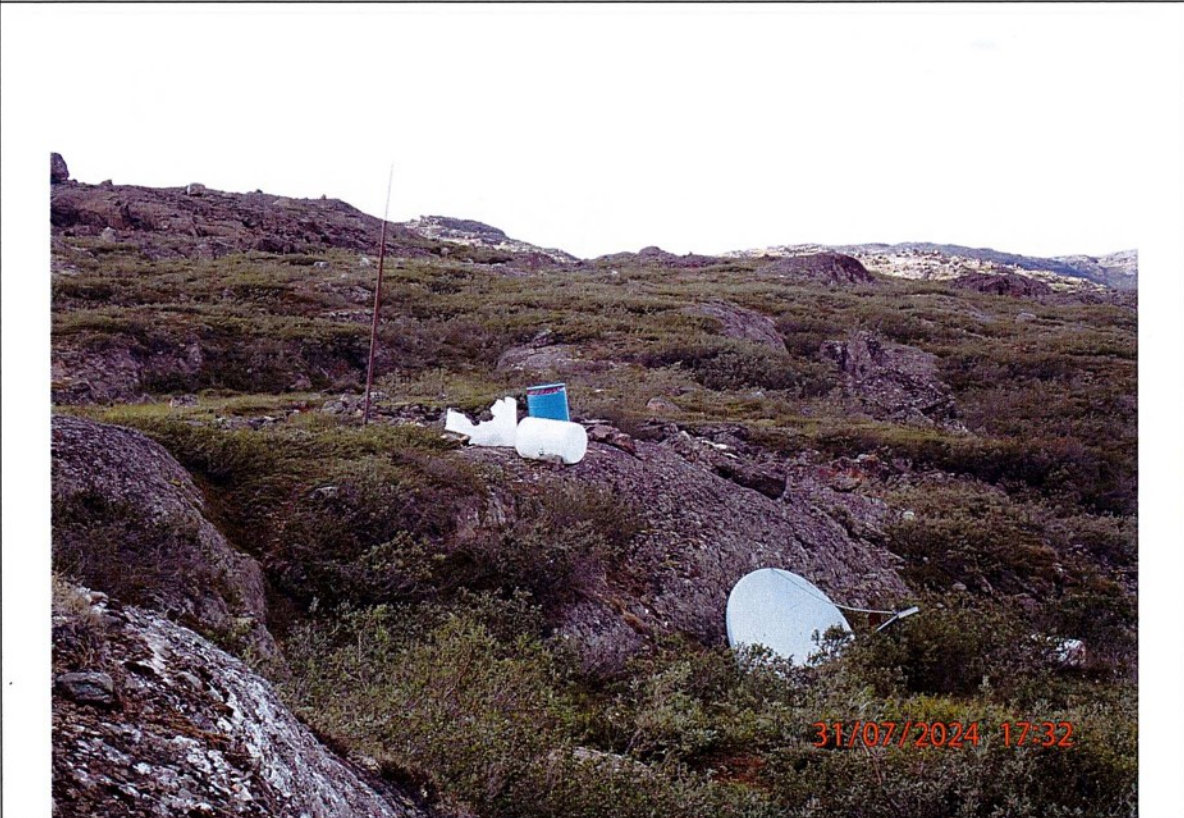
Photo Log
Photo 13

On the hill above camp. 3 drums are shown in the image and 1 broken drum, a long drill rod post and a satellite dish.

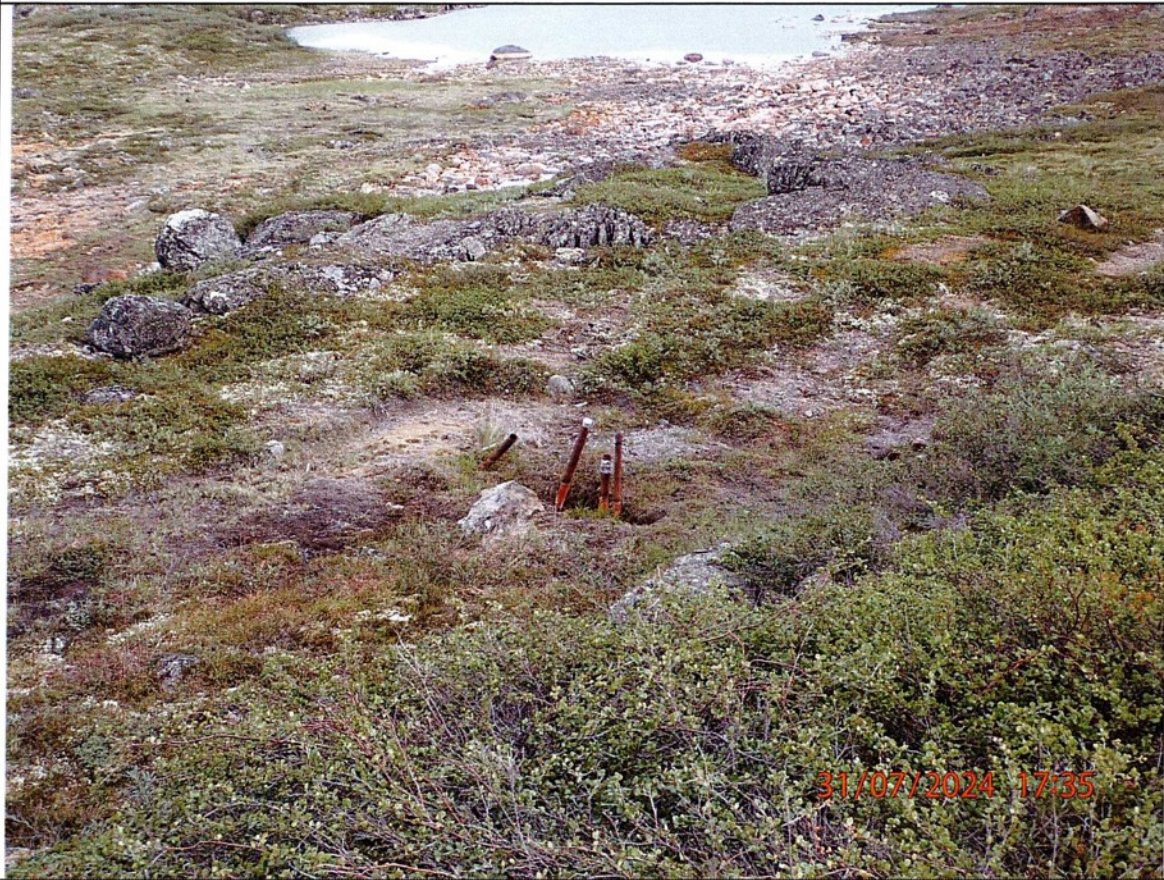
Photo 14

Part I Item 10 of the issued water license states: "The Licensee shall restore all drill holes and disturbed areas to natural conditions immediately upon completion of the drilling. The restoration of drill holes must include the removal of any drill casing materials. Where drill casing cannot be removed the Licensee shall cut off the casing at ground level and identify with signage."

Drill rods at 67°22'39.12"N 110°50'36.58"W
