Attachment 10 – Inspections and Responses

WATER LICENCE INSPECTION FORM

CROWN LAND USE INSPECTION FORM

Reference: High Lake Camp Inspection

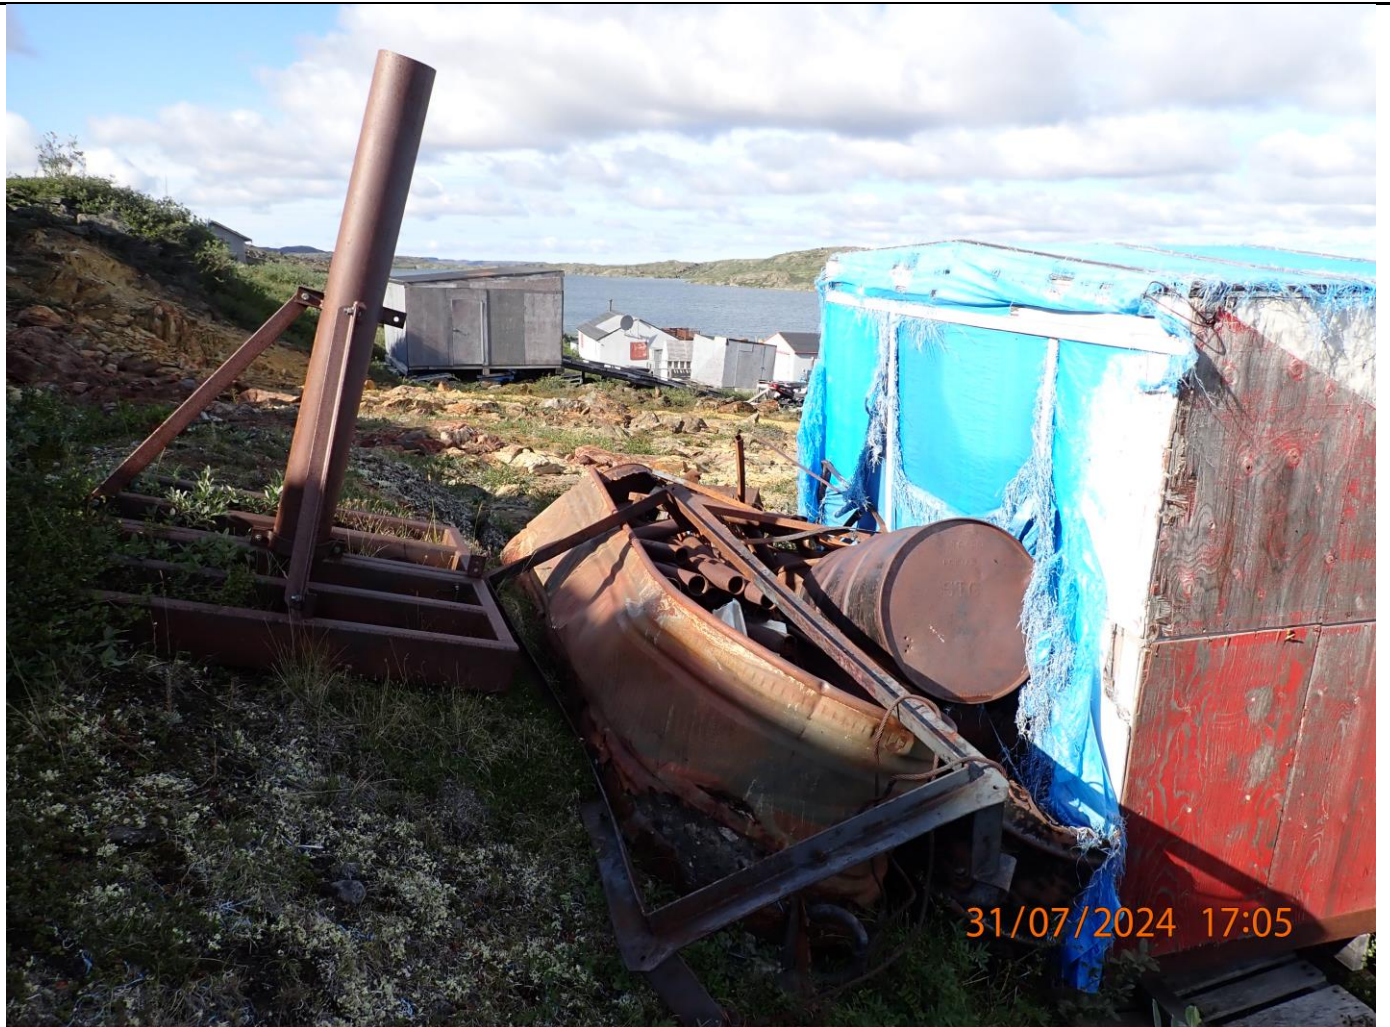
Photo 3

1. Inspectors arrive at 5:00pm, Aerial photos of the Site were taken (Photo#1and #2)
2. A pile of scrap metal was observed beside a drill shack (Photo #3)

Scrap metal and parts

All scrap metal shall be removed form site including any garbage, discarded barrels or debris. All fuel must be stored in secondary containment. All building doors, windows and walls must be repaired and closed to prevent access from wildlife. All drill rods shall be cut to grade, capped and scrap metal rod removed from site. The metal dish should be stored in camp for removal from site or stored in camp for future use. A detailed plan and timeline to achieve the actions required shall be submitted to me at james.bolt@rcaanc-cirnac.gc.ca by December 20 2024. Actions required should be planned for completion prior to July 31 2025.

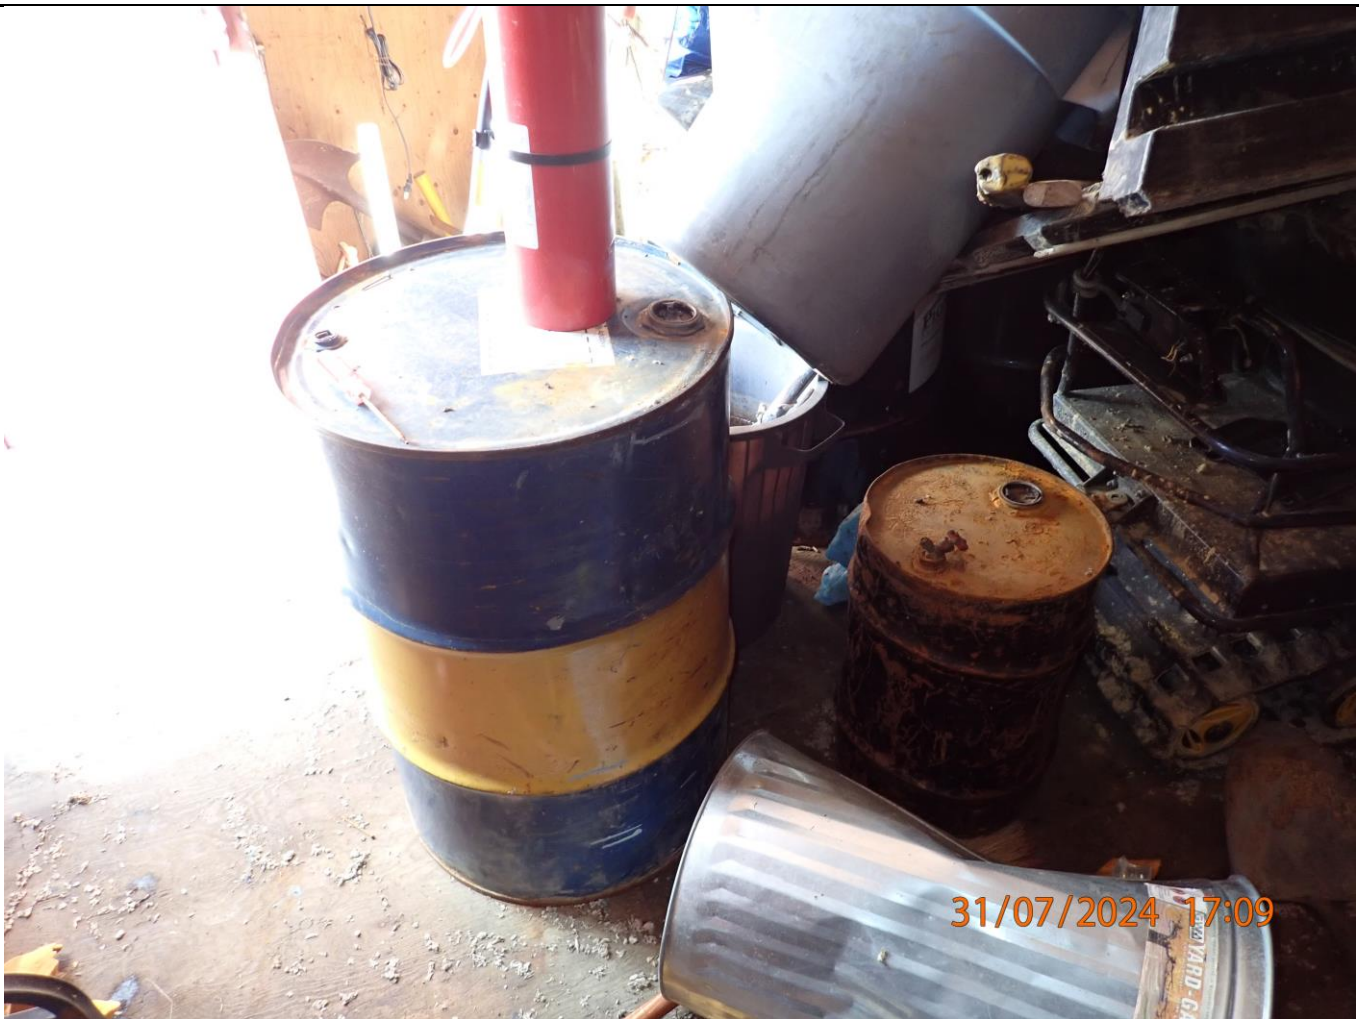
Photo 4

3. 3 drums of fuel inside the mechanic shop were observed out of secondary containment (Photo #4 and #5)
4. A door of the main building was observed open and bear disturbance and poop inside the building was observed. The bear may have entered or exited through the window near the kitchen as the ply wood covering the window was observed on the ground. (Photo #6, #7, #8, #9, #10)

2 fuel containers out of secondary containment inside the mechanic shop.

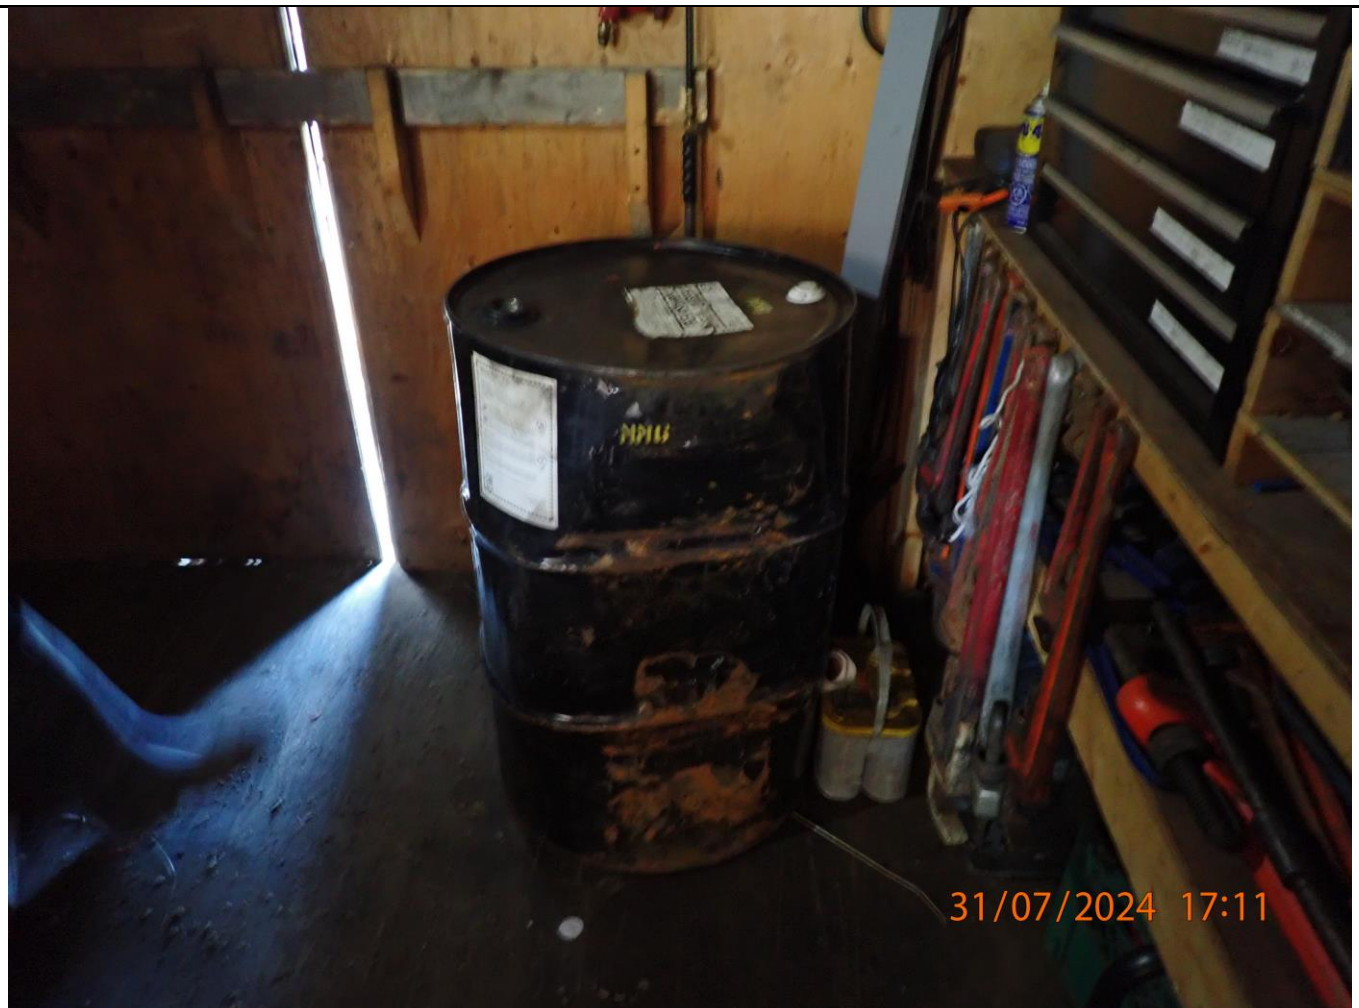
Photo 5

1 fuel drum outside of containment inside the mechanic shop

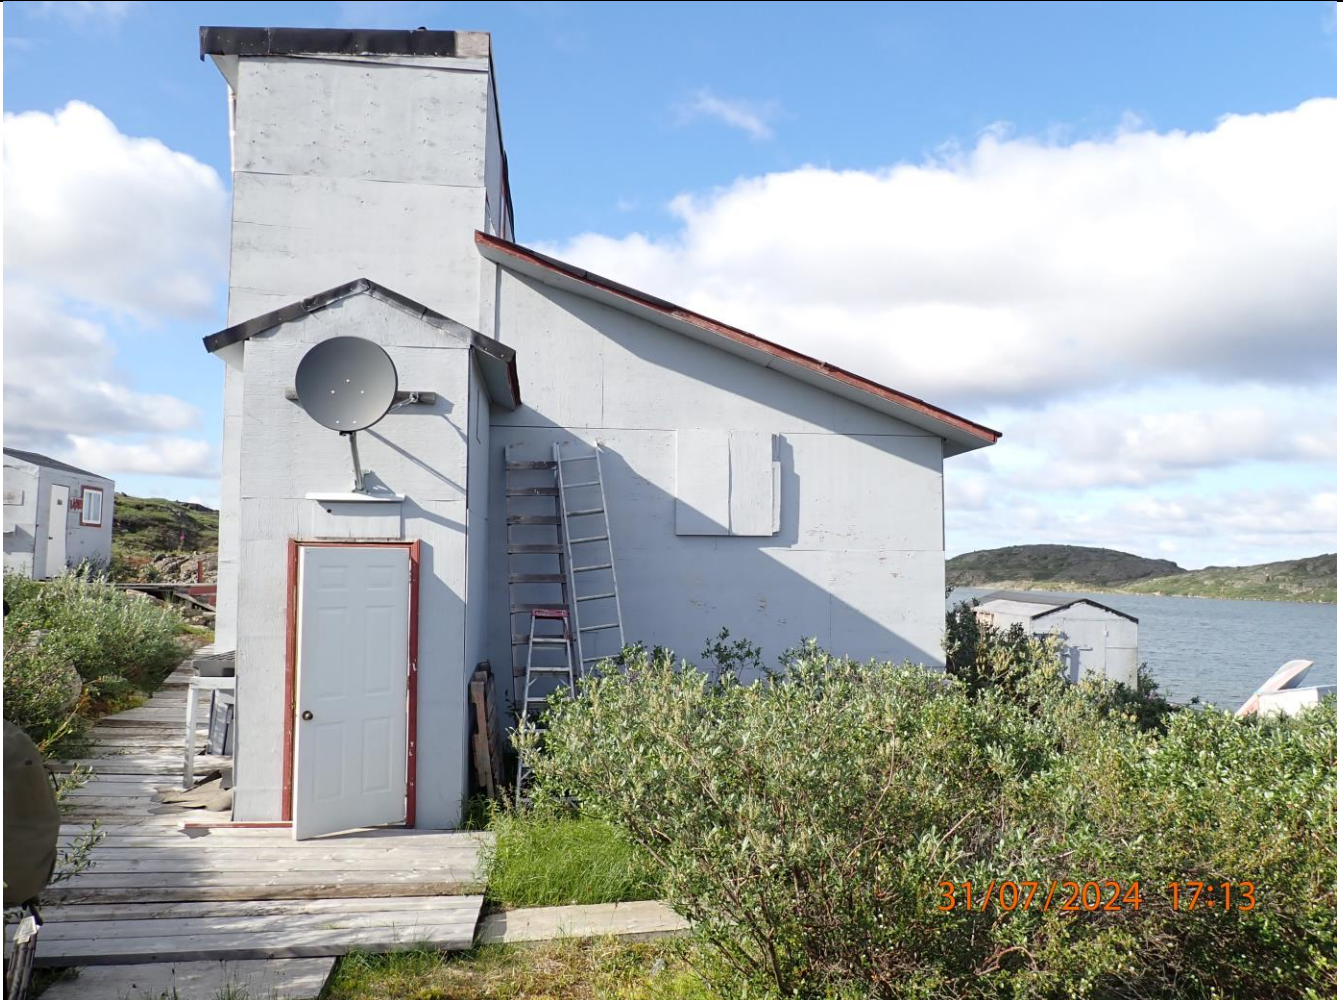
Photo 6

Main building with door open.

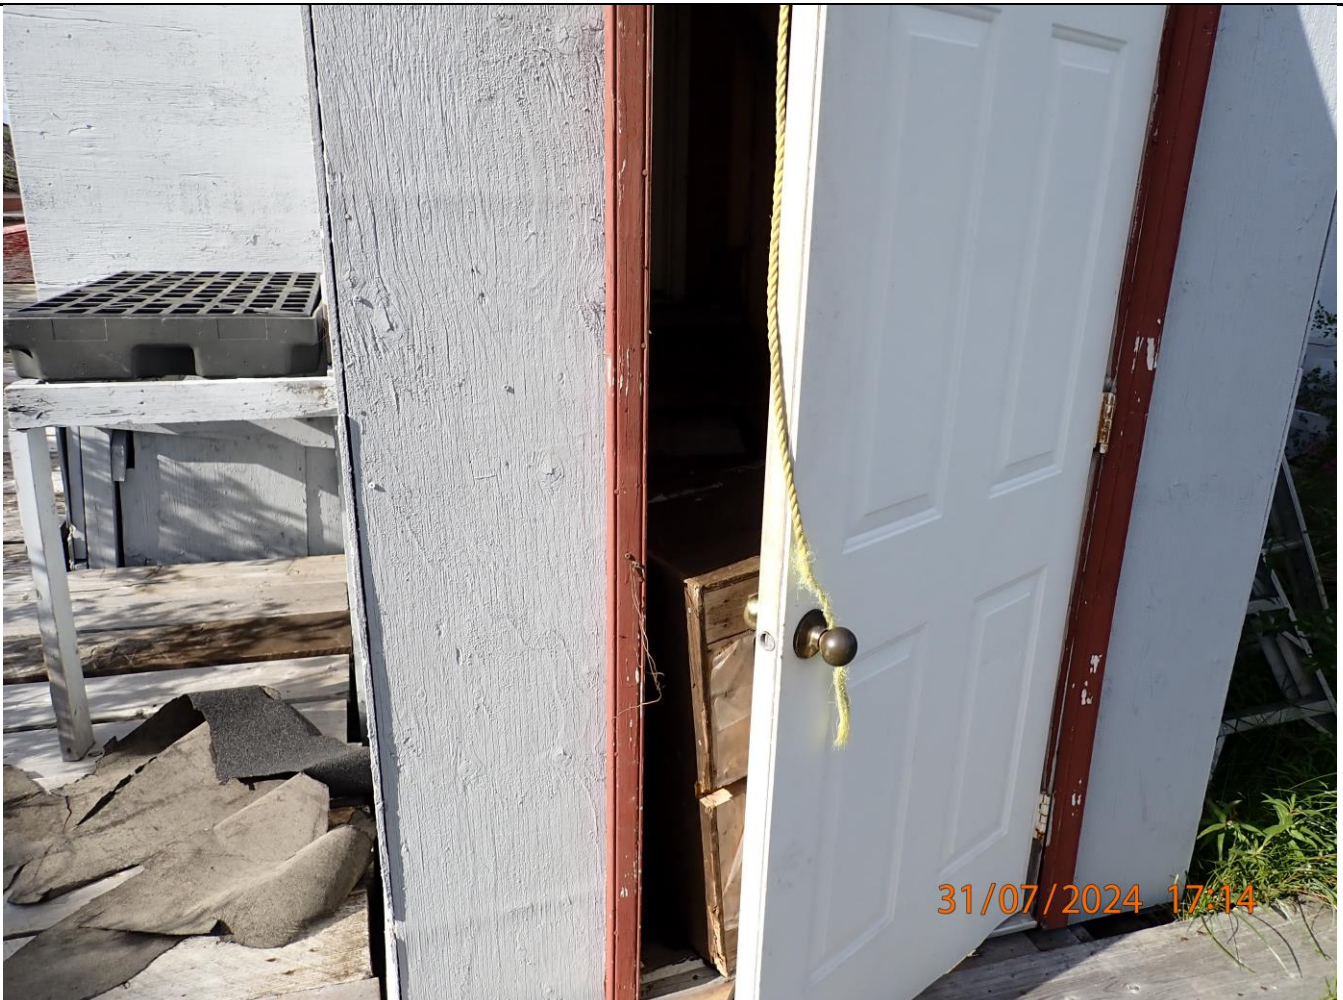
Photo 7

Roofing material outside main building, image shows box in door way. Bear sign is apparent in the building.

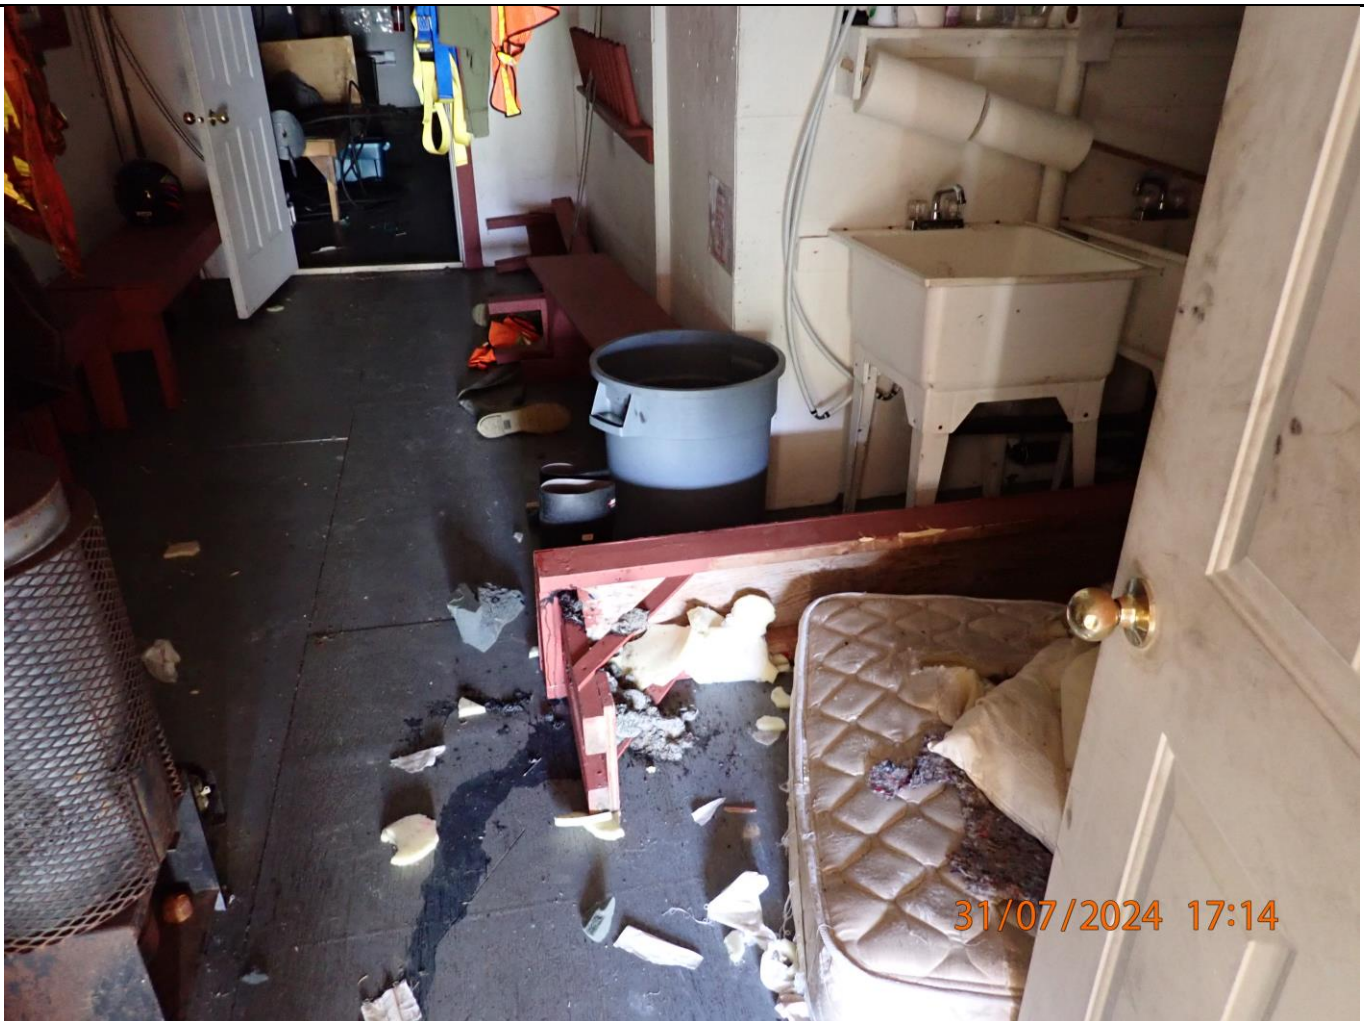
Photo 8

Inside the main building entrance, bear scat is observed on the bench and floor.

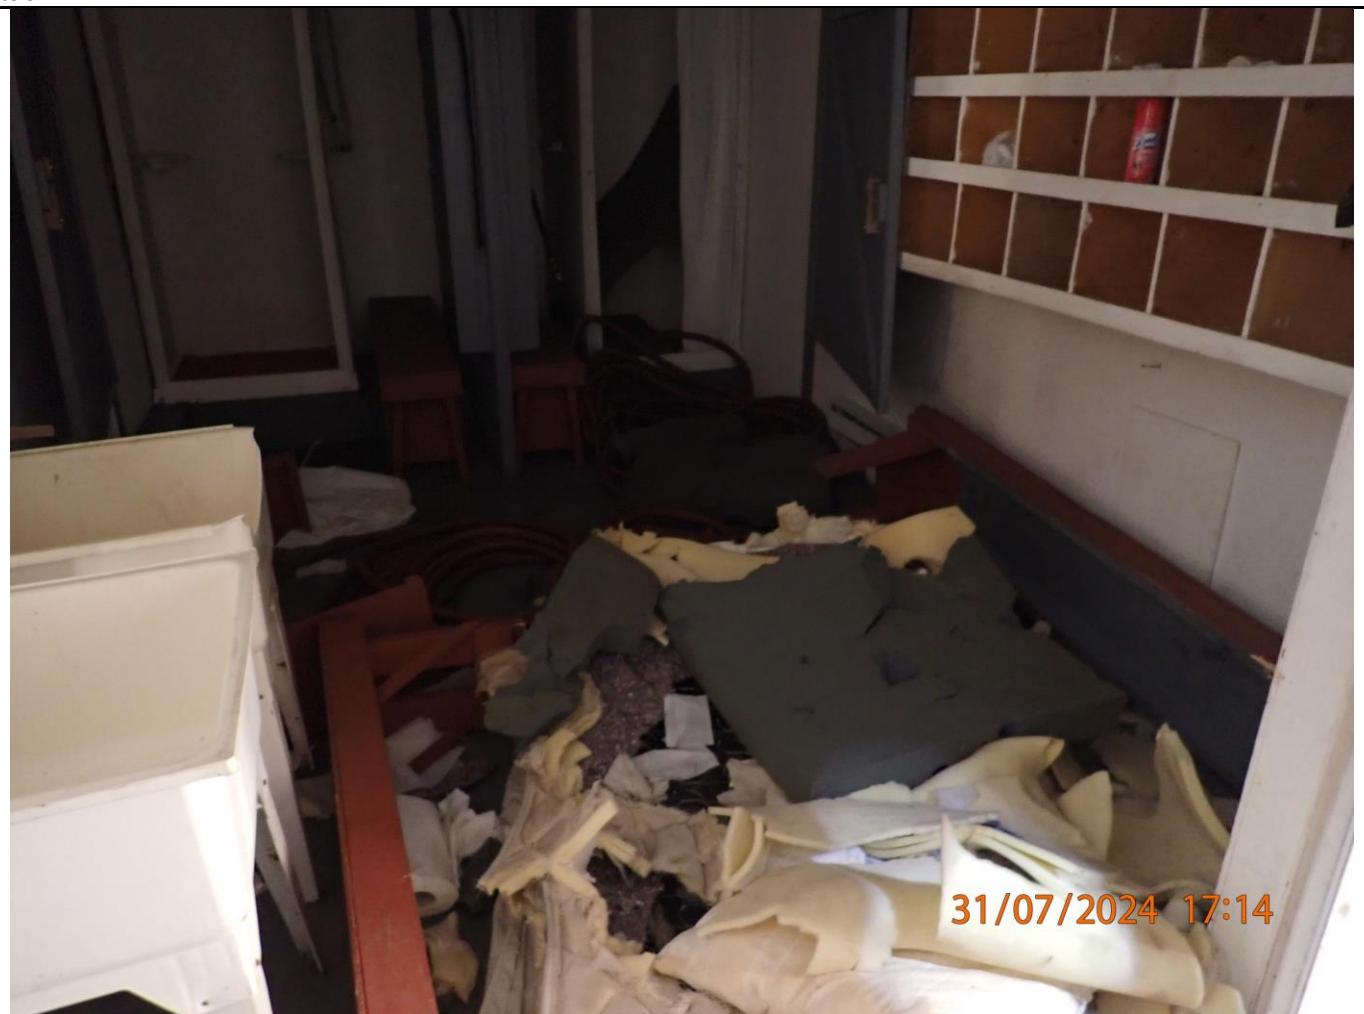
Photo 9

Inside the main building entrance, mess caused by a bear

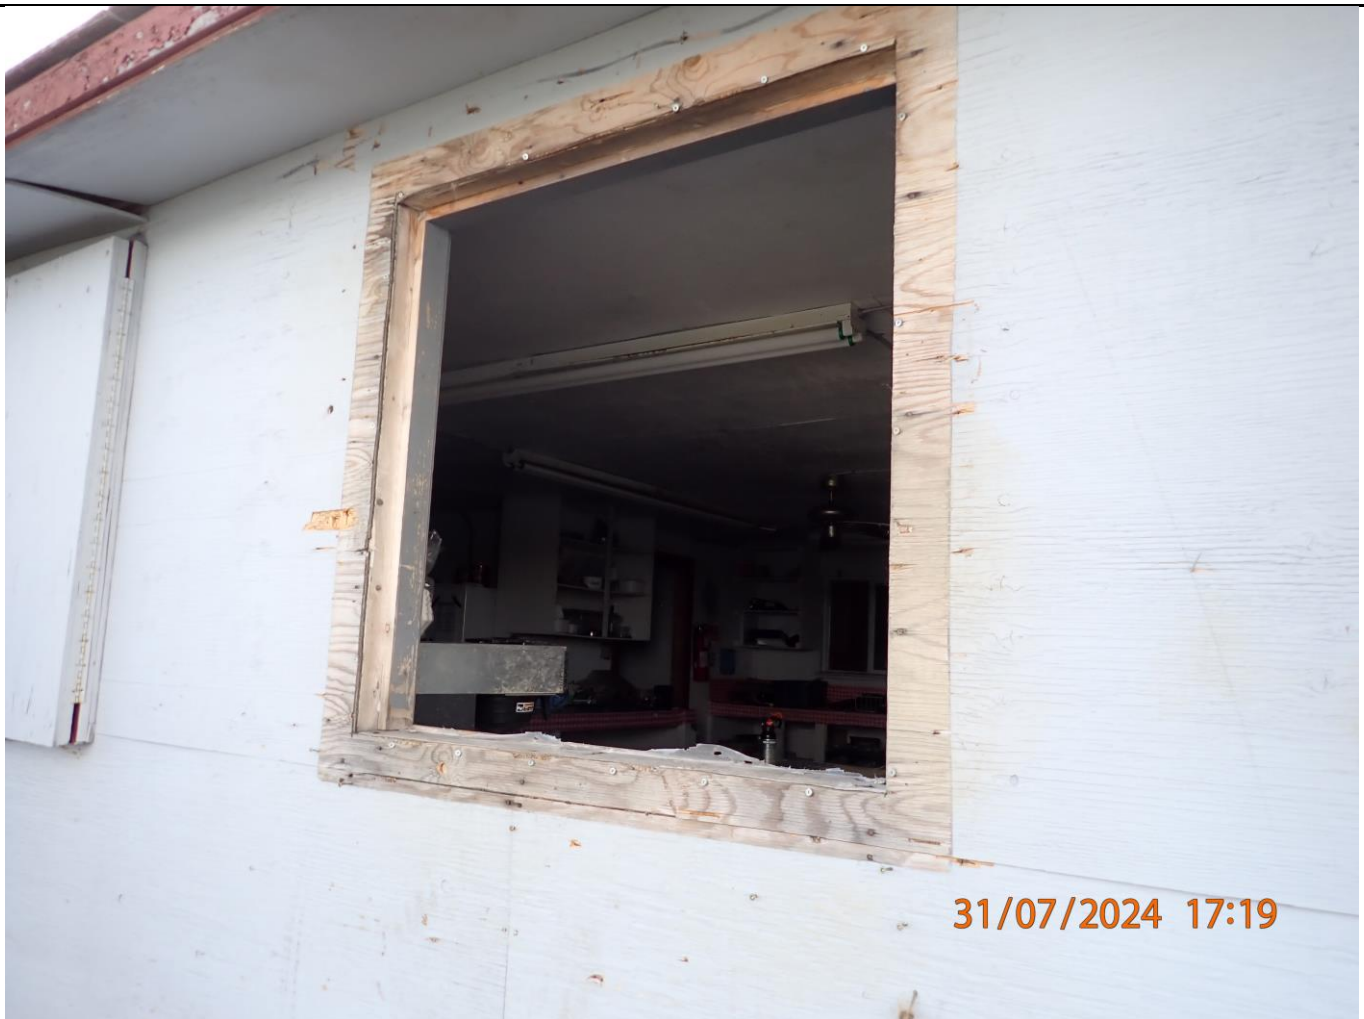
Photo 10

Main building kitchen window open, the plywood was observed on the ground.

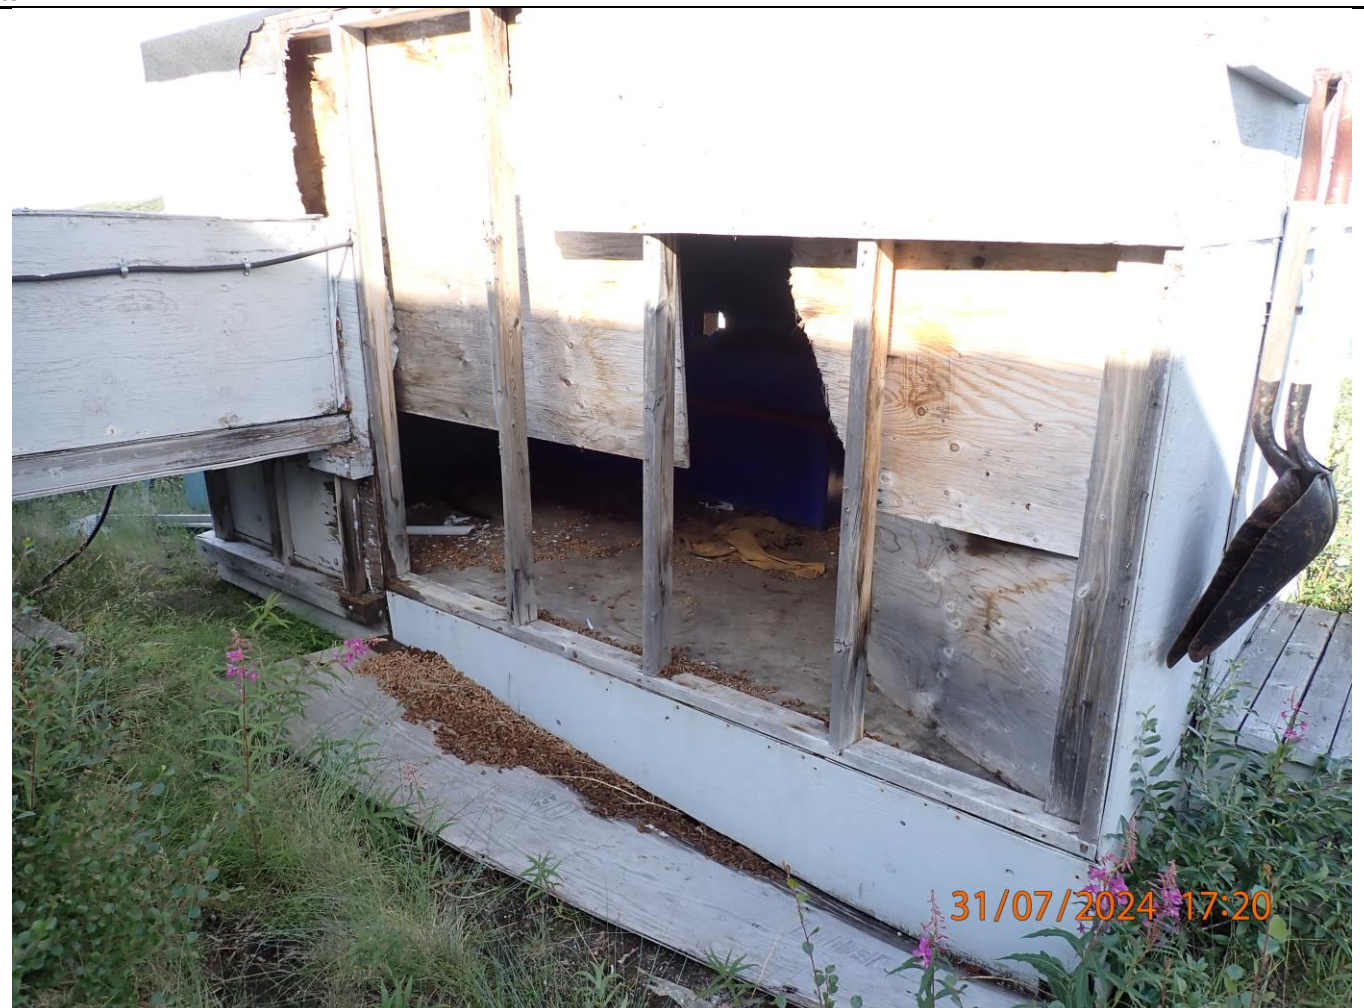
Photo 11

5. A small shack that is connected to the main dry/kitchen building was observed to have broken plywood siding and an open window. A lot of Ptarmigan poop inside the shack and on the side of the shack show that wildlife is using the building for shelter. This small shack may be the generator shack. (Photo #11 and #12)

Small shack beside main building shown with an open side wall and ptarmigan droppings inside.

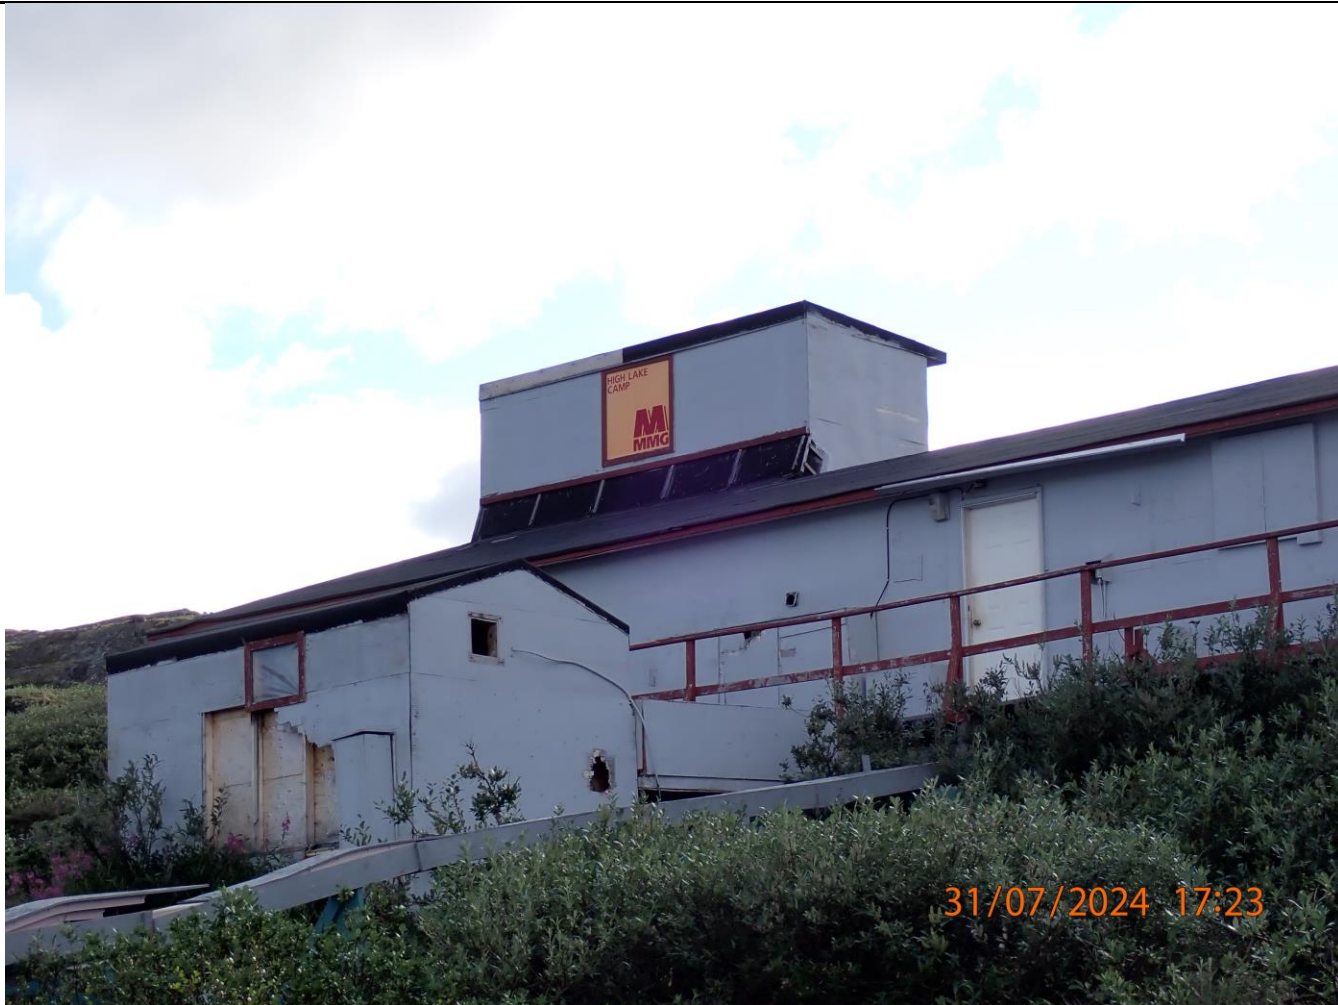
Photo 12

Another view of the shack beside the main building, Plywood from the wall is missing, an open window and a hole in the back wall is shown.

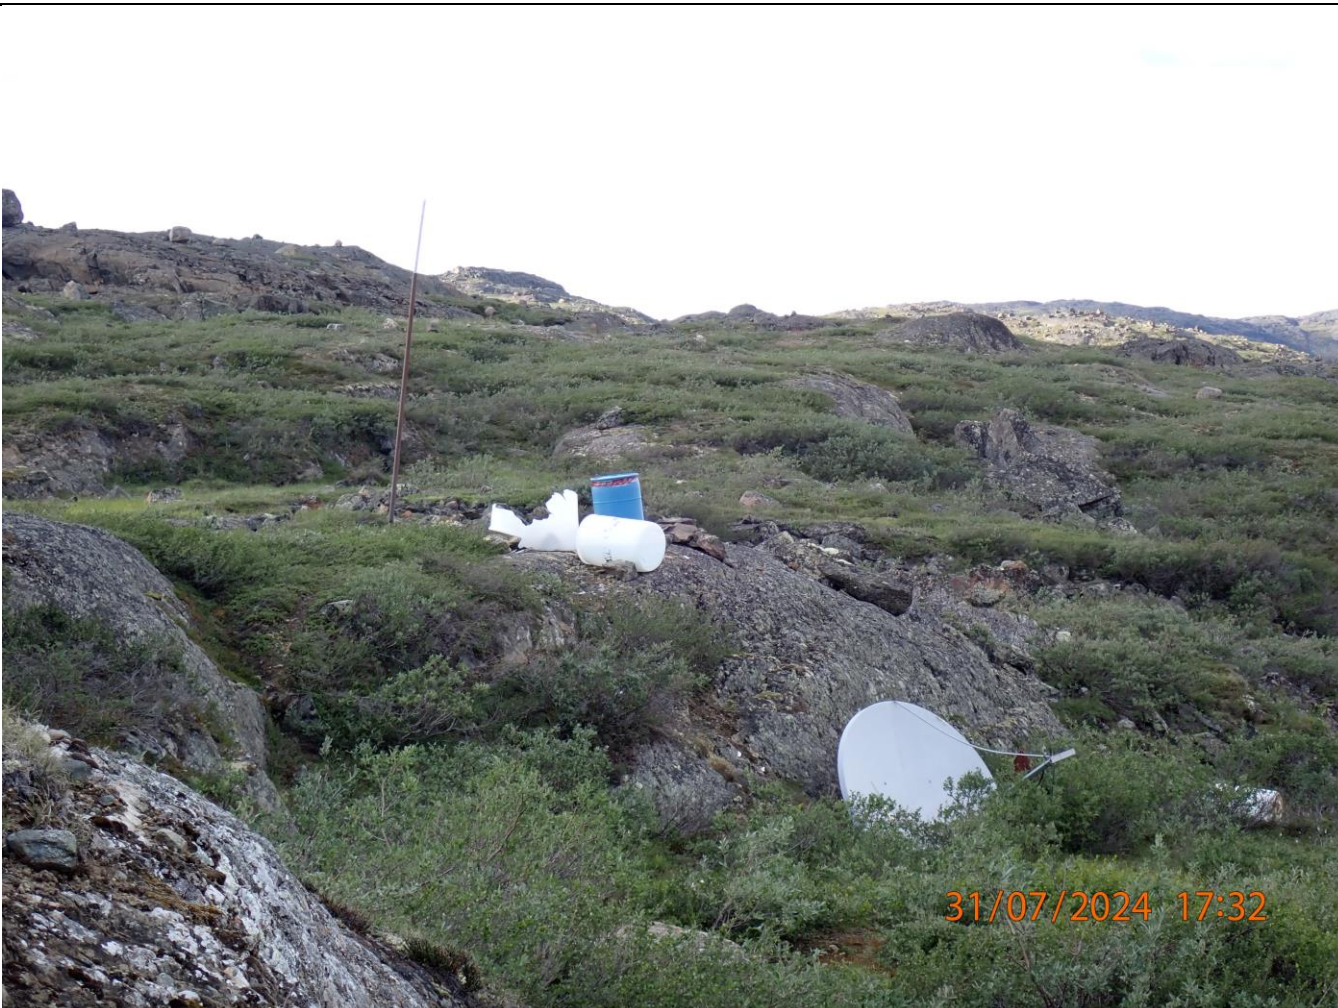
Photo 13

6. 3 52 litre plastic drums were observed on the hill beside a drill rod. 1 of the 3 drums were broken. (Photo #13) The drill rod and the drums should be removed form the hill and stored in camp for eventual removal from site.

7. A large metal satellite dish and another 52 litre plastic drum was observed just below the plastic drums and the drill rod mentioned above. (Photo #13) The dish should and drum should be brought back into camp and stored for removal from site or used in camp.

On the hill above camp. 3 drums are shown in the image and 1 broken drum, a long drill rod post and a satellite dish.

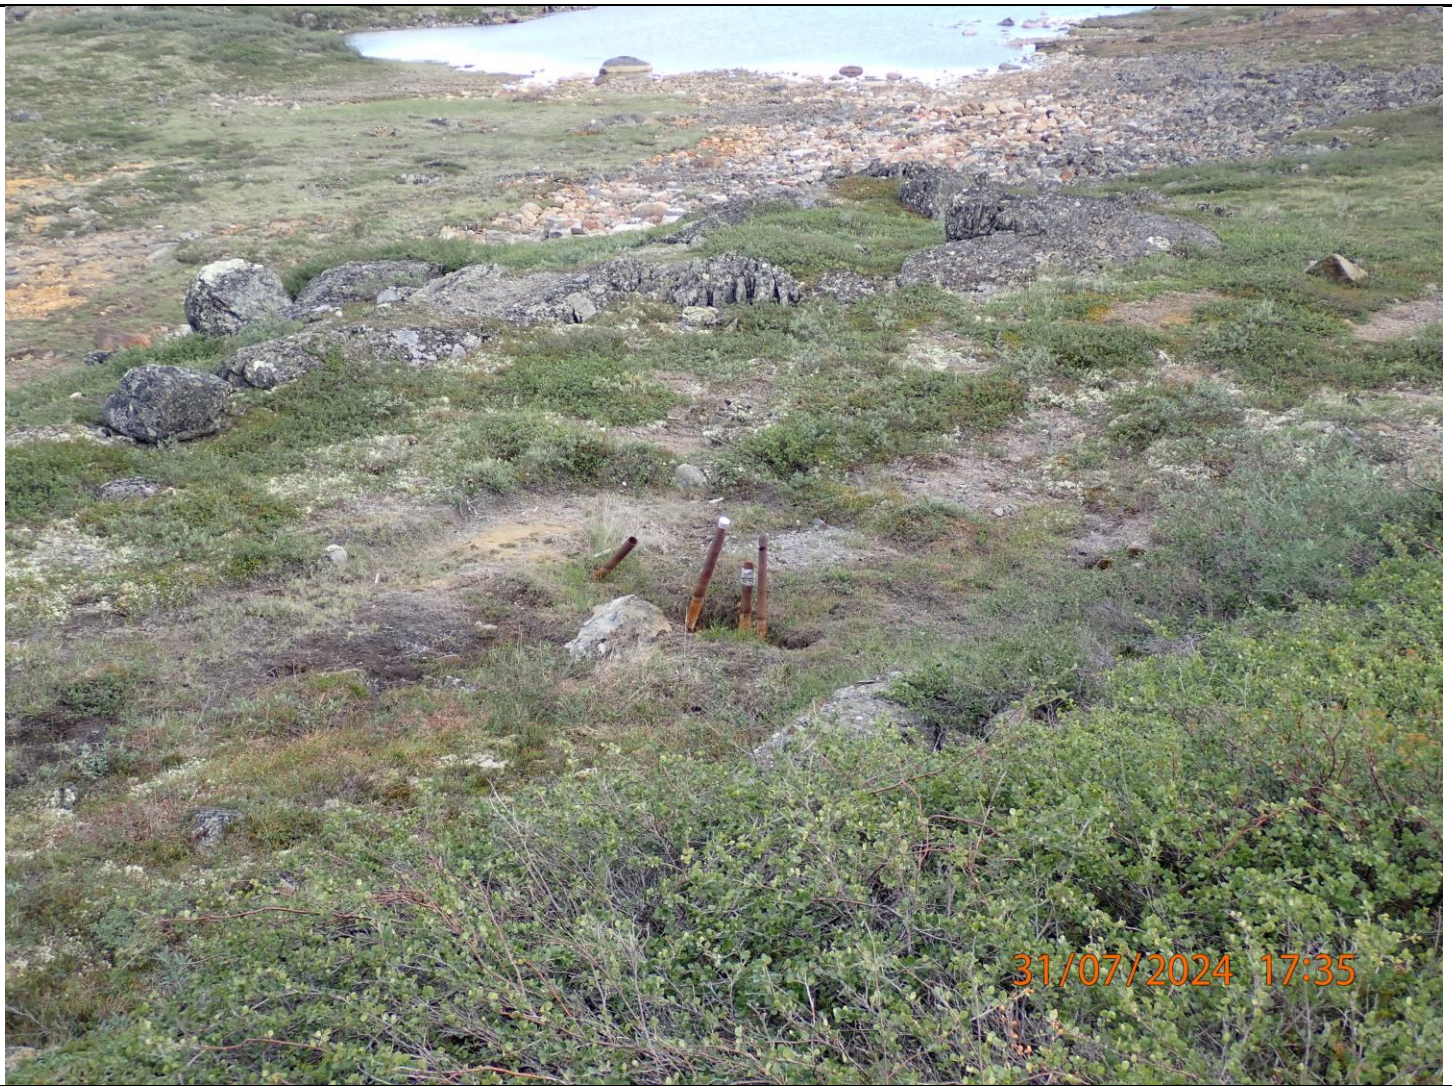
Photo 14

8. 4 drill rods were observed on the east side of camp at 67*22'39.12"N 110*50'36.58"W. All 4 drill rods were over 6 inches long and only 1 of them capped. All 4 need to be cut at grade and capped.

Drill rods at 67°22'39.12"N 110°50'36.58"W

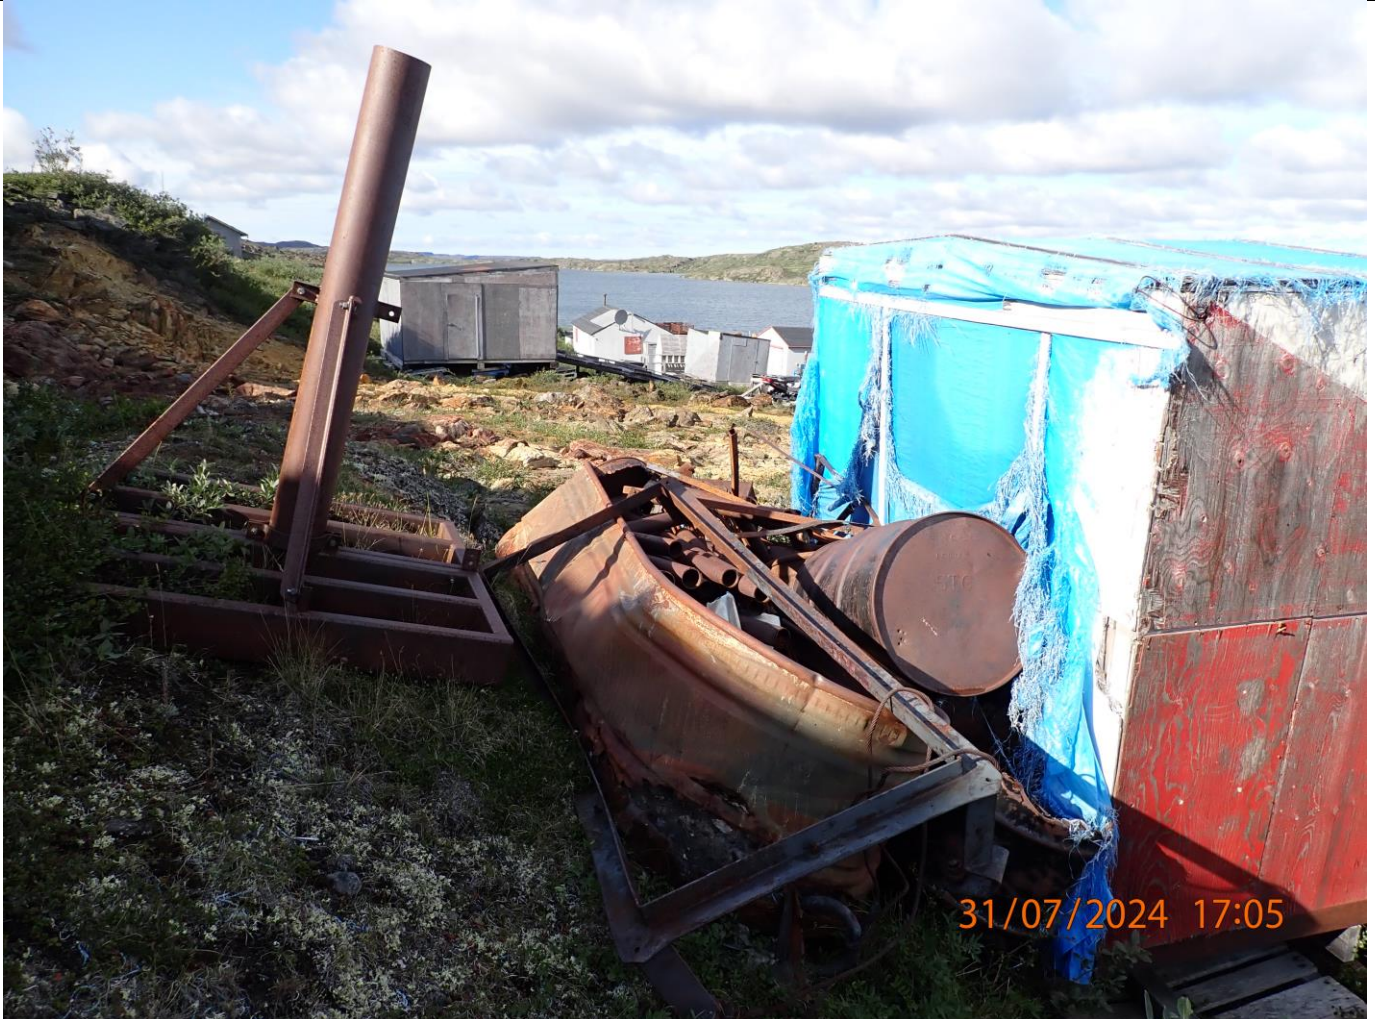
Photo 3

- Inspectors arrive at 5:00pm, Aerial photos of the Site were taken (Photo#1and #2)
- A pile of scrap metal was observed beside a drill shack (Photo #3)

Scrap metal and parts

All scrap metal shall be removed from site including any garbage, discarded barrels or debris. All fuel must be stored in secondary containment. All building doors, windows and walls must be repaired and closed to prevent access from wildlife. All drill rods shall be cut to grade, capped and scrap metal rod removed from site. The metal dish should be stored in camp for removal from site or stored in camp for future use. A detailed plan and timeline to achieve the actions required shall be submitted to me at james.bolt@rcaanc-cirnac.gc.ca by December 20 2024. Actions required should be planned for completion prior to July 31 2025.

MMG commits to continuing annual maintenance visits to High Lake to ensure compliance with all permits and licences however there is limited opportunity for the removal of scrap metal through these annual visits. MMG plans to re-establish this camp in 2026 and if this occurs, removal of scrap metal can be done in parallel with resupply operations.

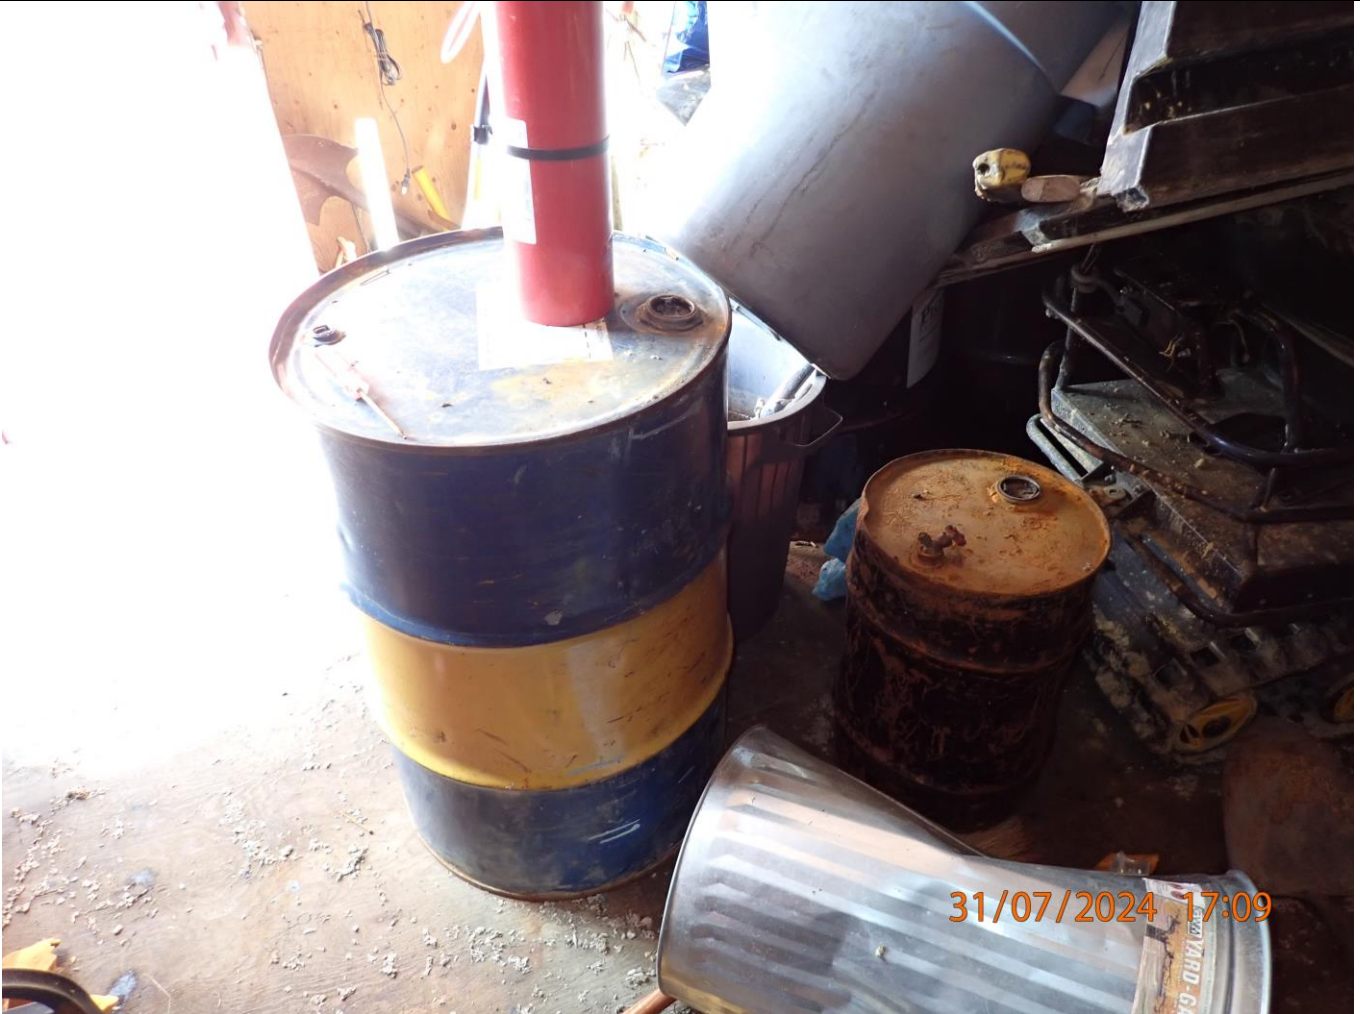
Photo 4

- 3 drums of fuel inside the mechanic shop were observed out of secondary containment (Photo #4 and #5)
- A door of the main building was observed open and bear disturbance and poop inside the building was observed. The bear may have entered or exited through the window near the kitchen as the ply wood covering the window was observed on the ground. (Photo #6, #7, #8, #9, #10)

2 fuel containers out of secondary containment inside the mechanic shop.

MMG commits to placement of all fuels within in secondary containment including instaberm, movable rigid spill trays, or similar impermeable containment. Secondary containment will be sized to 110 % of the volume of the largest tank it is to contain, or 100% of the largest tank plus 10% of the aggregate capacity of the stored tanks, whichever is greater. MMG also commits to covering all outdoor spill trays to prevent the containment from filling with precipitation. This will be completed during the next annual care and maintenance site visit.

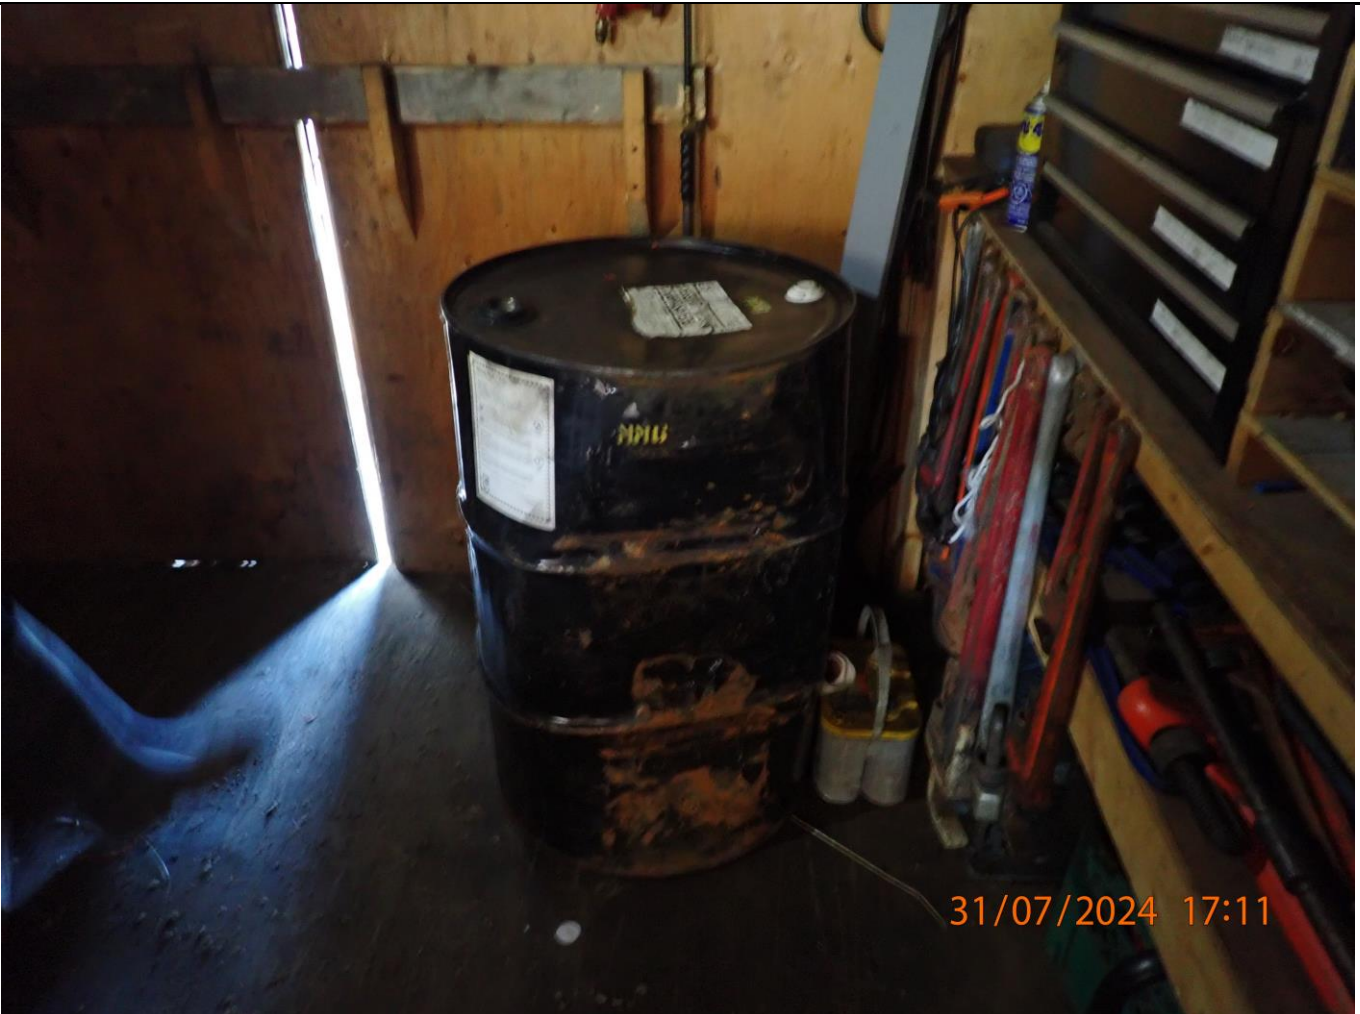
Photo 5

1 fuel drum outside of containment inside the mechanic shop
