Attachment 10 – Inspections and Responses

WATER LICENCE INSPECTION FORM

CROWN LAND USE INSPECTION FORM

Reference: High Lake Camp Inspection

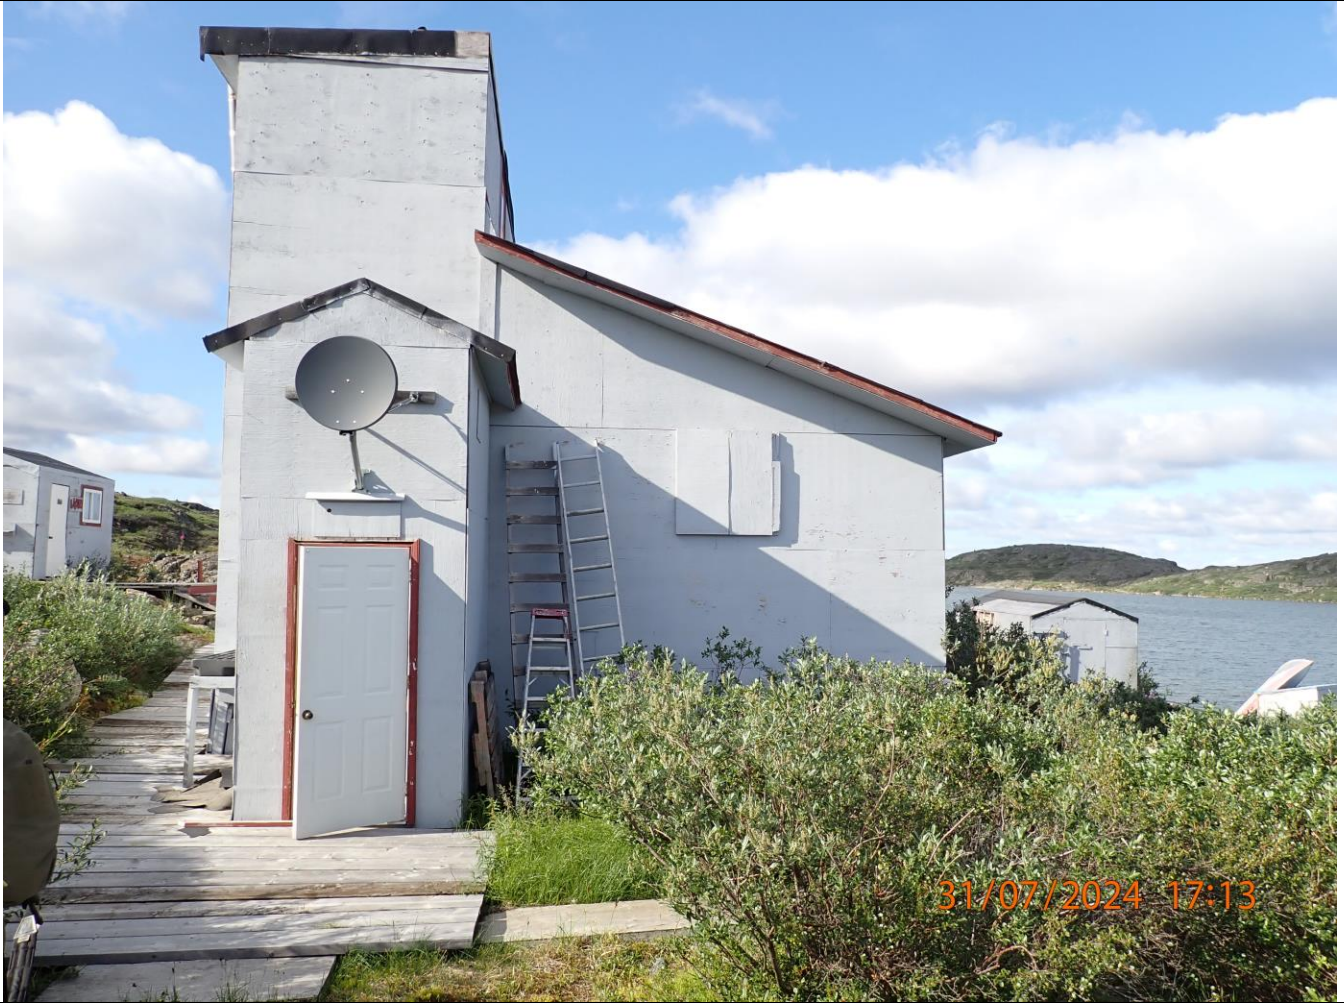
Photo 6

- 3 drums of fuel inside the mechanic shop were observed out of secondary containment (Photo #4 and #5)
- A door of the main building was observed open and bear disturbance and poop inside the building was observed. The bear may have entered or exited through the window near the kitchen as the ply wood covering the window was observed on the ground. (Photo #6, #7, #8, #9, #10)

Main building with door open.

All scrap metal shall be removed from site including any garbage, discarded barrels or debris. All fuel must be stored in secondary containment. All building doors, windows and walls must be repaired and closed to prevent access from wildlife. All drill rods shall be cut to grade, capped and scrap metal rod removed from site. The metal dish should be stored in camp for removal from site or stored in camp for future use. A detailed plan and timeline to achieve the actions required shall be submitted to me at james.bolt@rcaanc-cirnac.gc.ca by December 20 2024. Actions required should be planned for completion prior to July 31 2025.

MMG completes annual care and maintenance site visits to address any changes to the site condition and return the site to compliance with the water licence and land use permit. MMG commits to clearing buildings of wildlife detritus and fortifying buildings to prevent usage by wildlife. This will be completed during the next care and maintenance site visit.

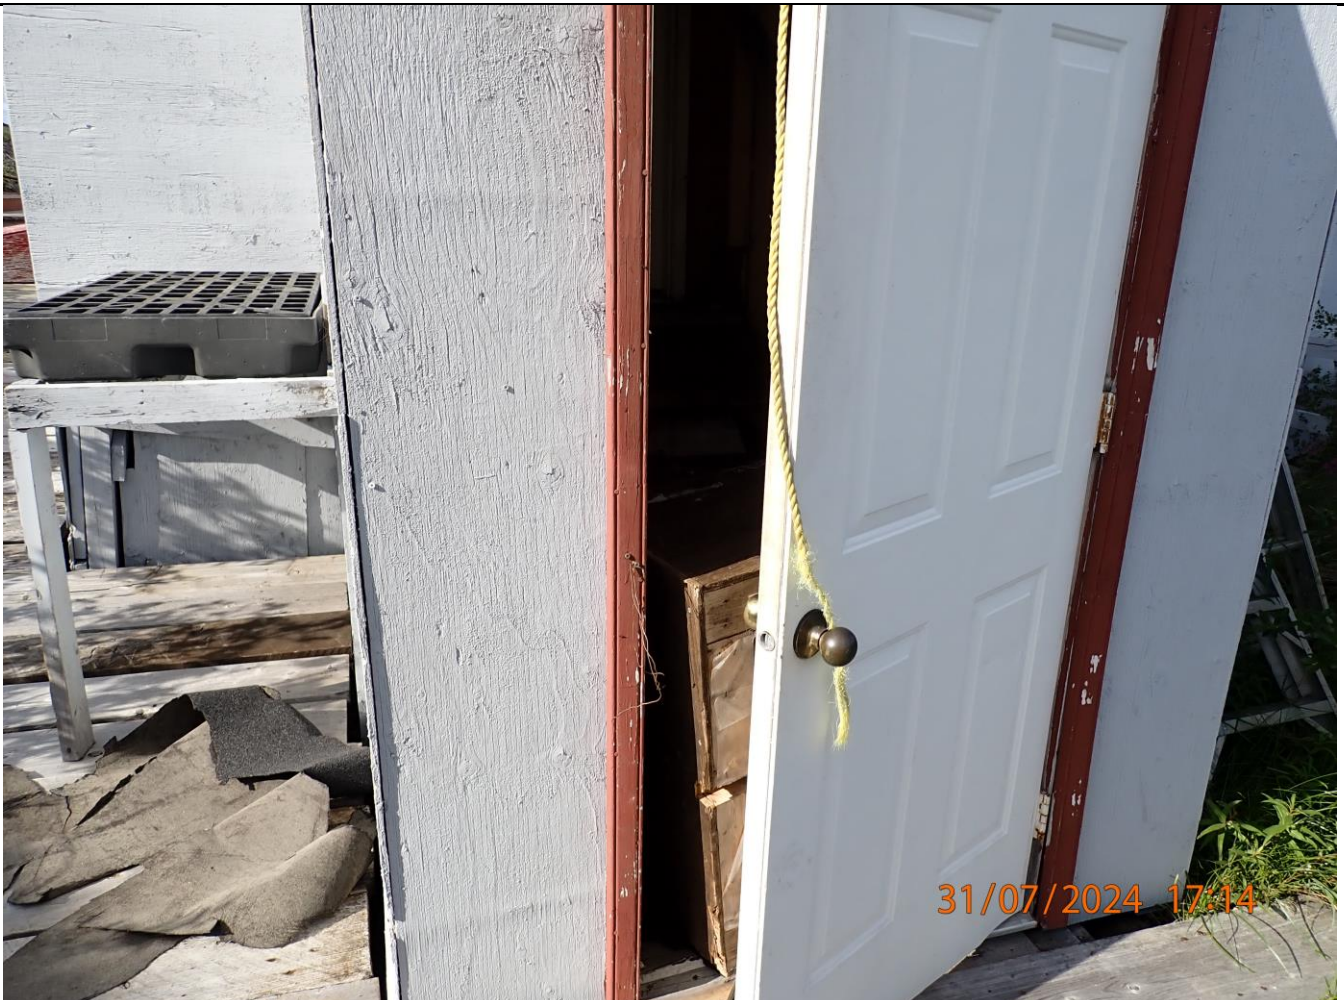
Photo 7

Roofing material outside main building, image shows box in door way. Bear sign is apparent in the building.

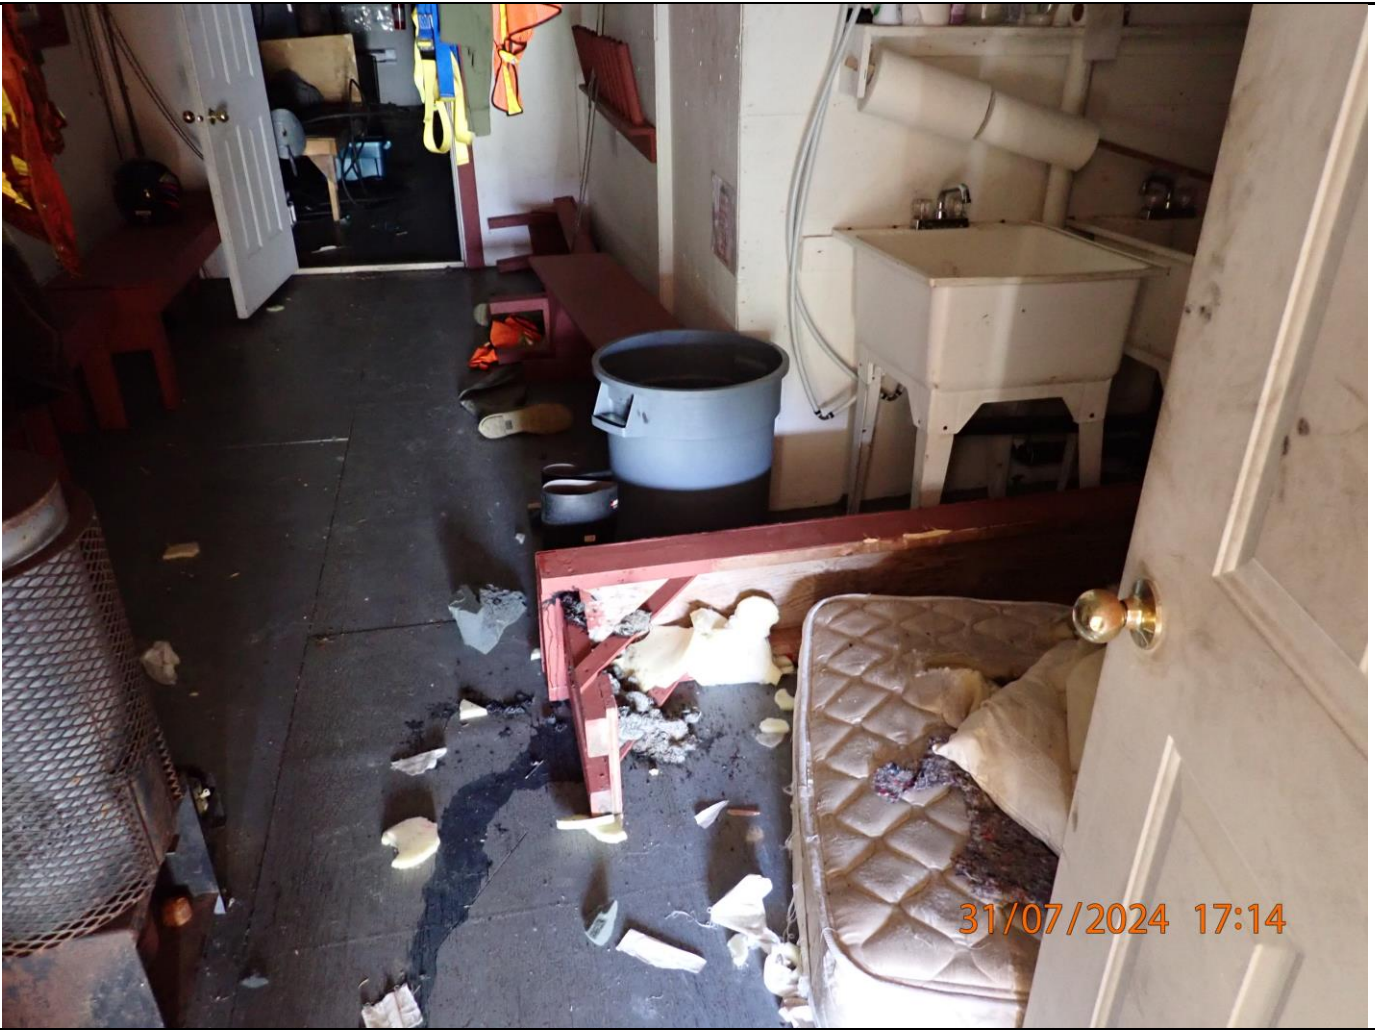
Photo 8

Inside the main building entrance, bear scat is observed on the bench and floor.

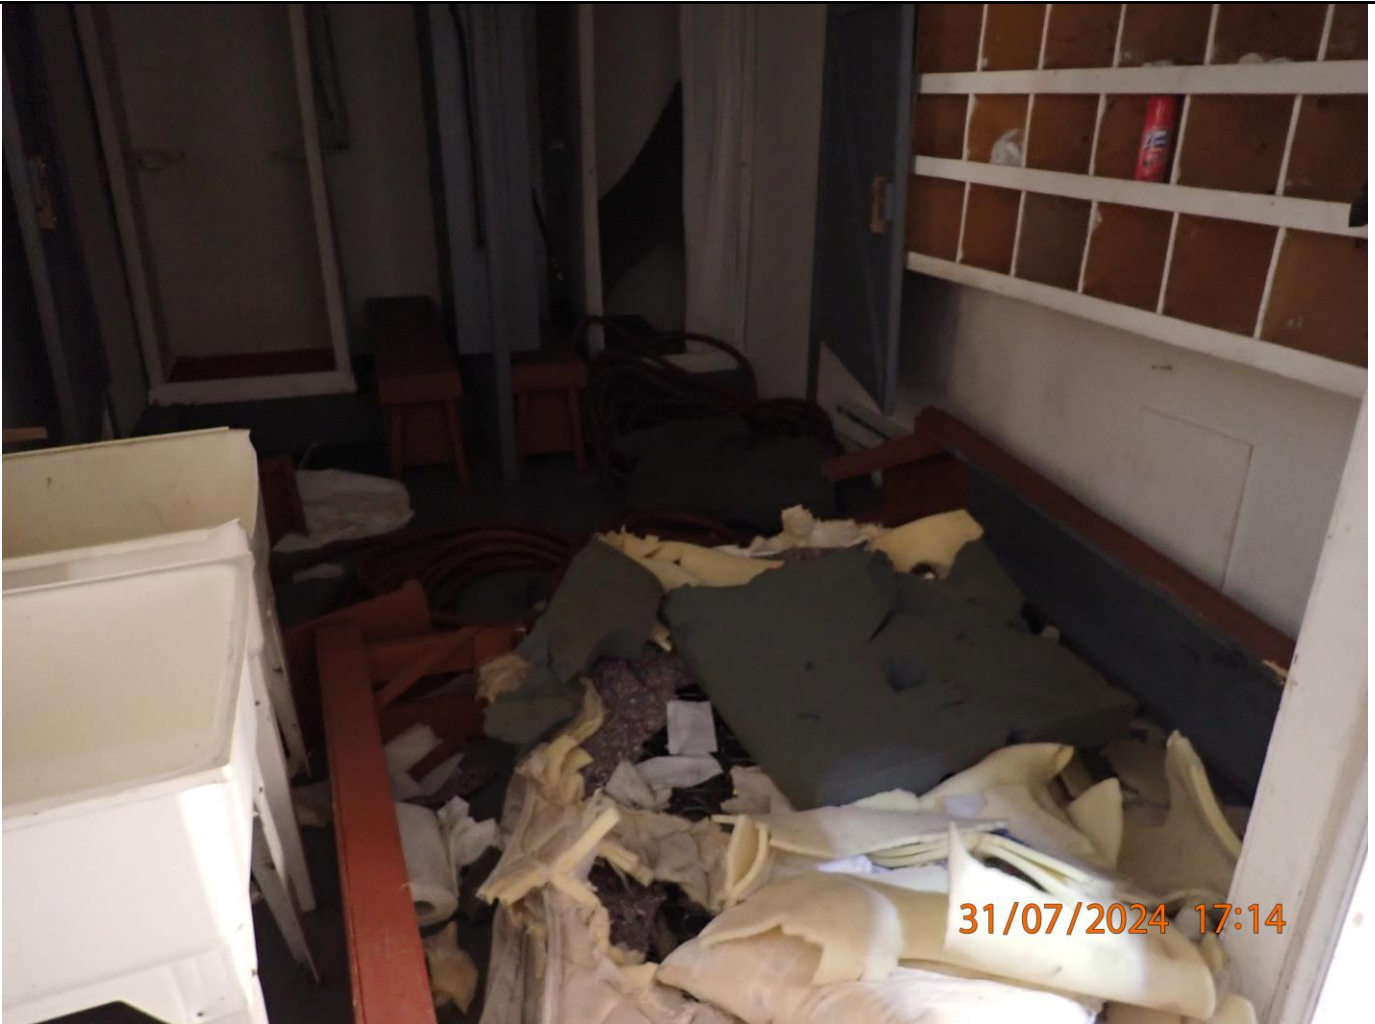
Photo 9

Inside the main building entrance, mess caused by a bear

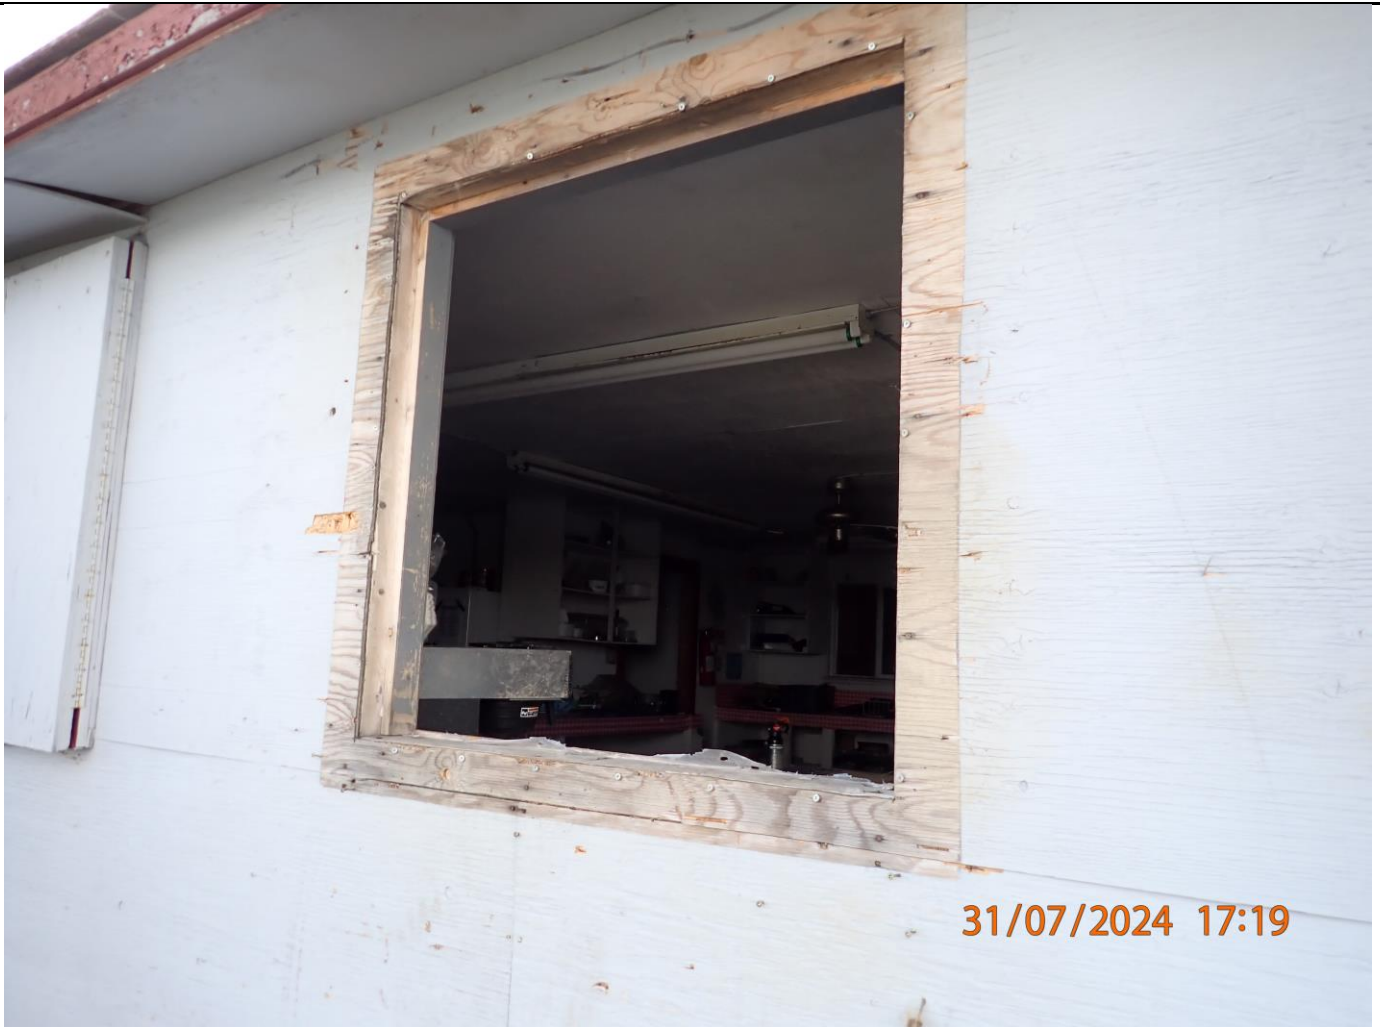
Photo 10

Main building kitchen window open, the plywood was observed on the ground.

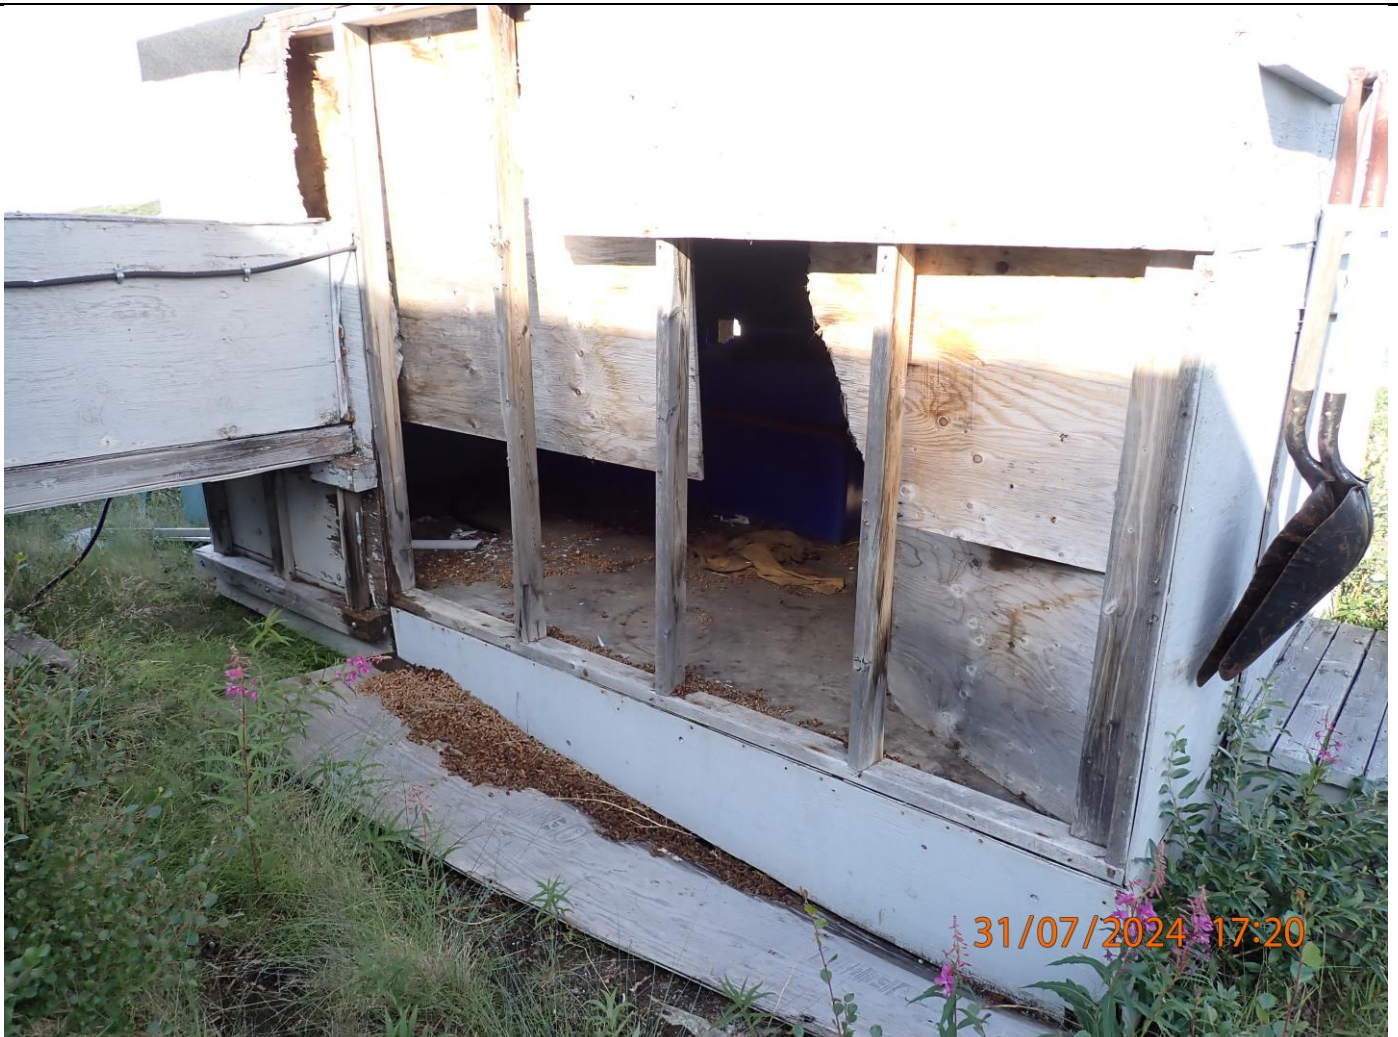
Photo 11

- A small shack that is connected to the main dry/kitchen building was observed to have broken plywood siding and an open window. A lot of Ptarmigan poop inside the shack and on the side of the shack show that wildlife is using the building for shelter. This small shack may be the generator shack. (Photo #11 and #12)

Small shack beside main building shown with an open side wall and ptarmigan droppings inside.

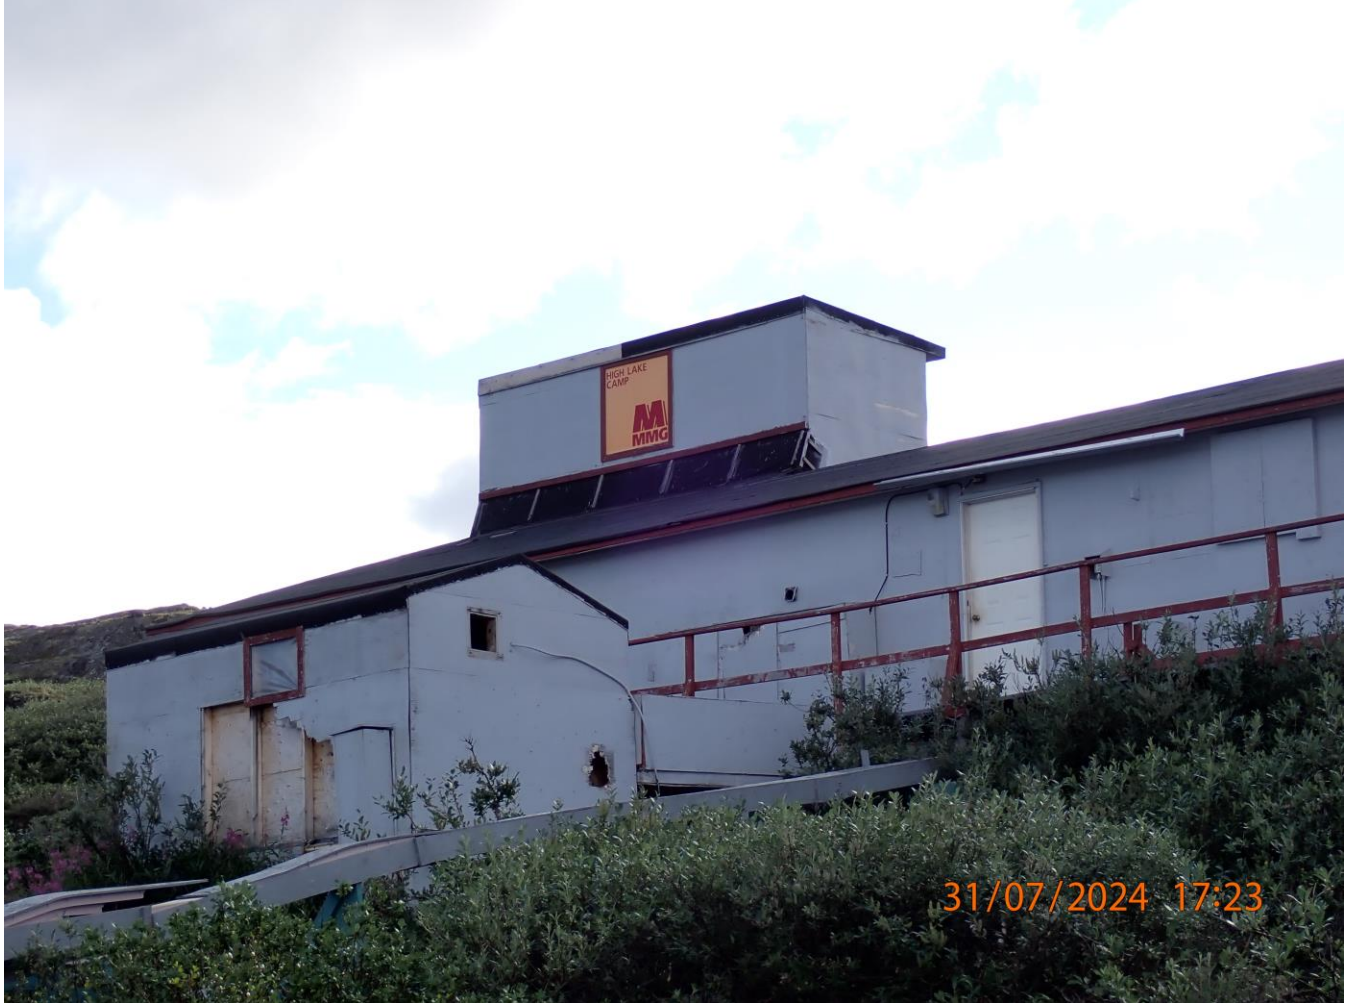
Photo 12

Another view of the shack beside the main building, Plywood from the wall is missing, an open window and a hole in the back wall is shown.

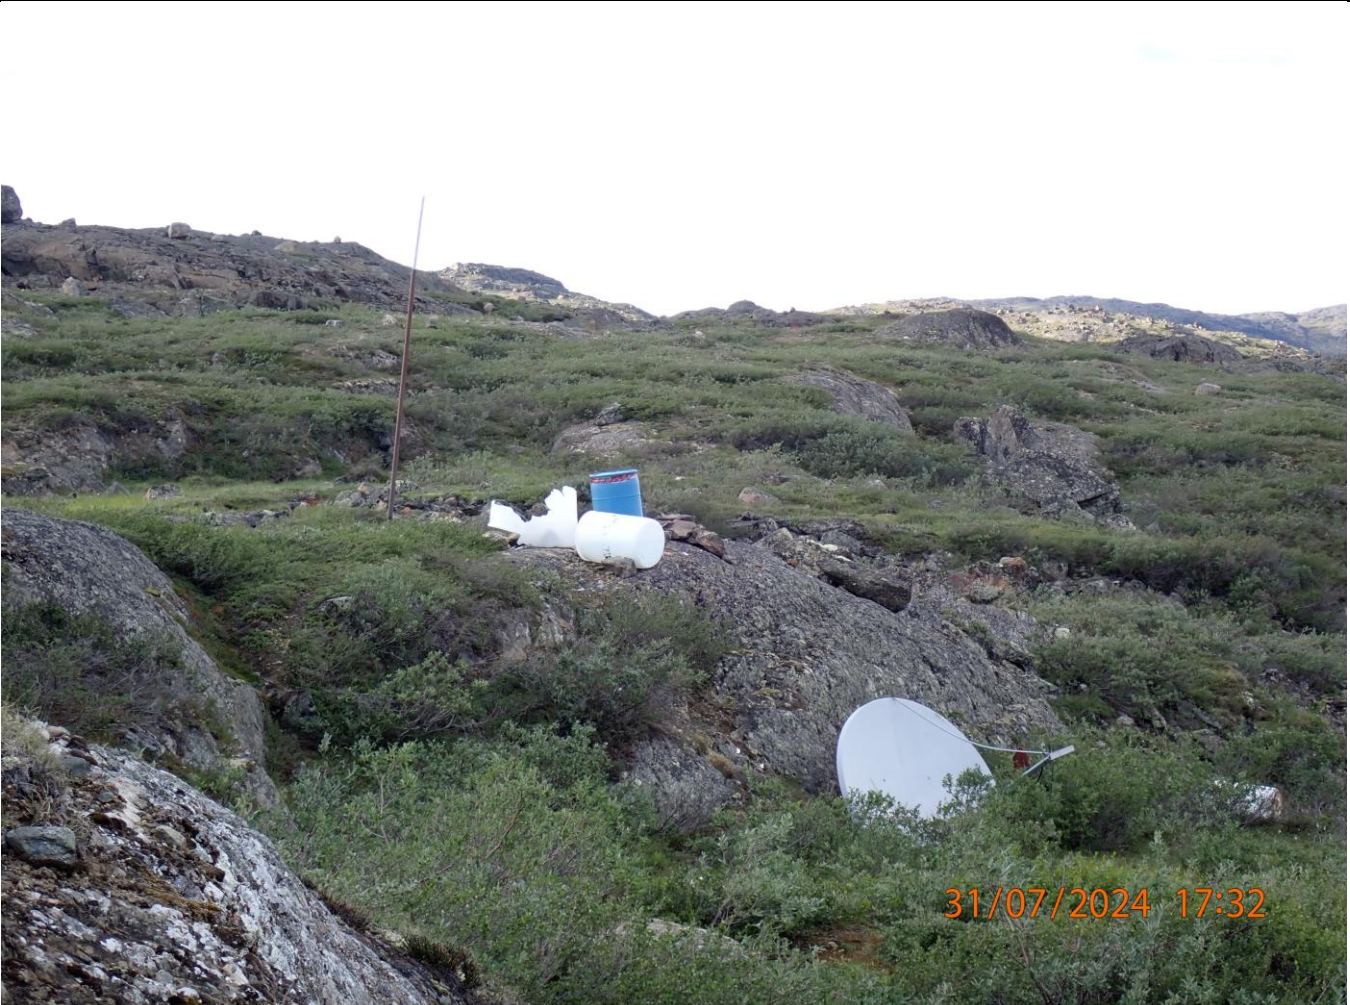
Photo 13

- 3 52 litre plastic drums were observed on the hill beside a drill rod. 1 of the 3 drums were broken. (Photo #13) The drill rod and the drums should be removed form the hill and stored in camp for eventual removal from site.

- A large metal satellite dish and another 52 litre plastic drum was observed just below the plastic drums and the drill rod mentioned above. (Photo #13) The dish should and drum should be brought back into camp and stored for removal from site or used in camp.

On the hill above camp. 3 drums are shown in the image and 1 broken drum, a long drill rod post and a satellite dish.

MMG commits to gathering the plastic drums and satellite dish and storing appropriately during the next care and maintenance site visit. Prior to resumption of activity at High Lake, MMG will review ECCO's publication "Solid Waste Management for Northern and Remote Communities" prior to a change in project phase to ensure High Lake waste management practices are aligned with this guidance.

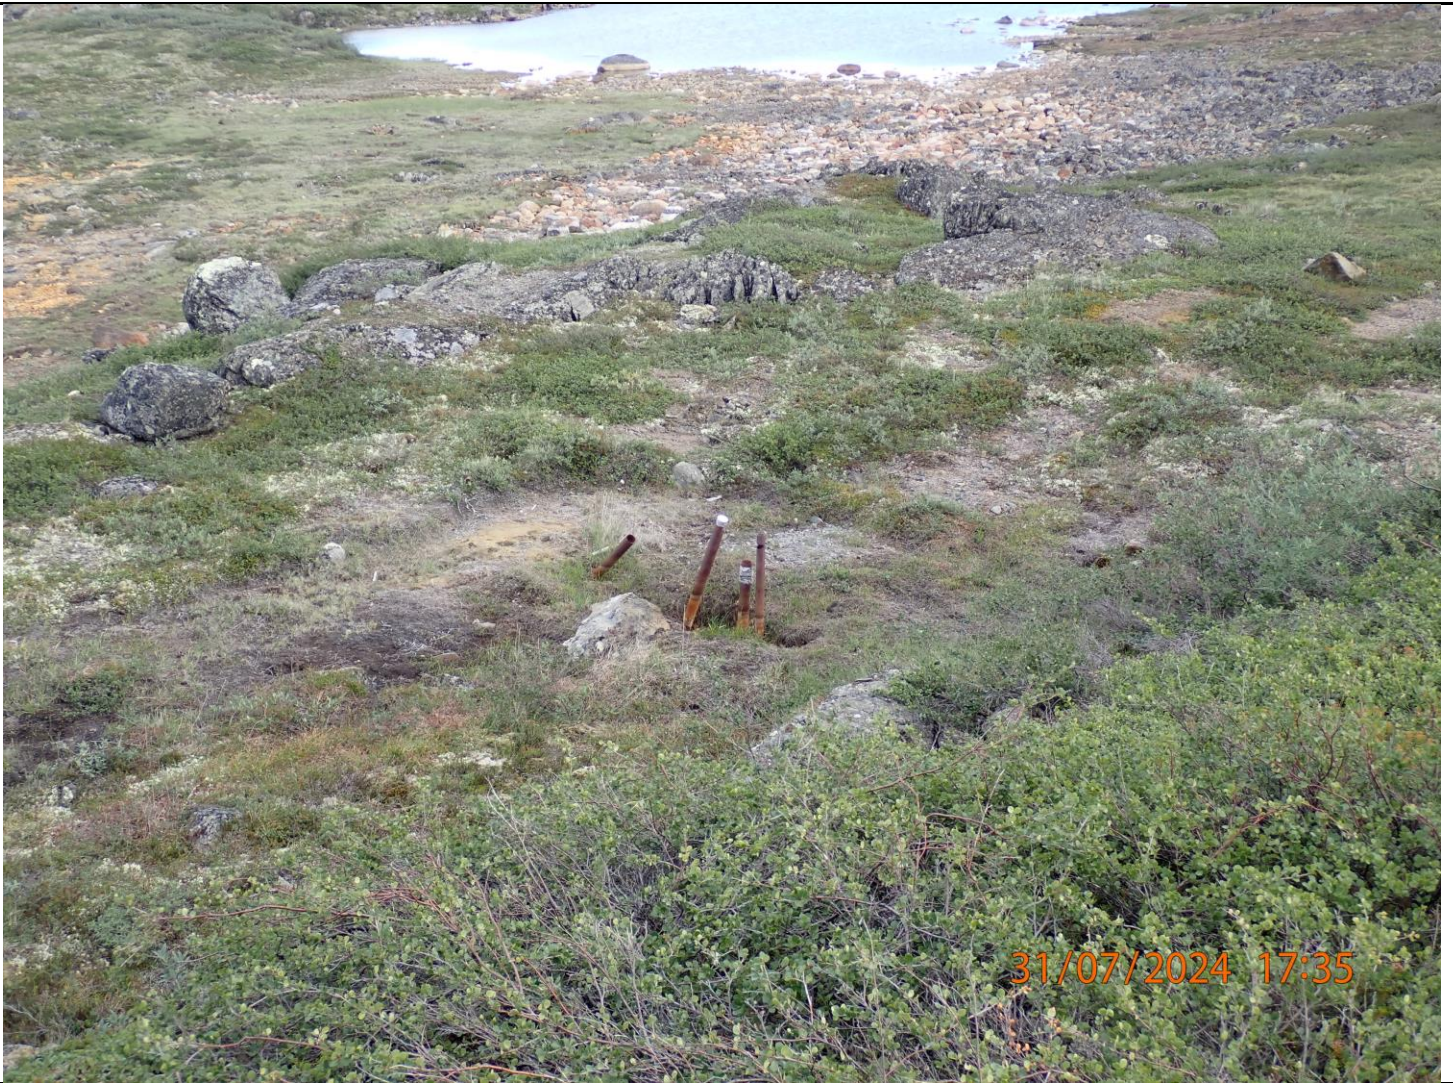
Photo 14

- 4 drill rods were observed on the east side of camp at 67*22'39.12"N 110*50'36.58"W. All 4 drill rods were over 6 inches long and only 1 of them capped. All 4 need to be cut at grade and capped.

Drill rods at 67°22'39.12"N 110°50'36.58"W

MMG commits to the closure and restoration of all drill holes and disturbed areas upon final closure of exploration tenements at the High Lake Project. At that time, drill casings will be cut at or below ground level and covered with soil. At present, High Lake camp is in a period of extended care and maintenance, with only annual site inspections and necessary site maintenance activities being conducted.
