**PROPOSED LONG TERM REMEDIAL STRATEGY –  
FUEL SPILL, WINDY LAKE CAMP, NUNAVUT, SPILL  
NUMBER 04-388**

EBA File No: 1740065-003

**REVIEW OF THE RESPONSE BY MIRAMAR HOPE BAY  
LIMITED TO THE JUNE 16, 2004 OIL SPILL AT WINDY  
LAKE CAMP**

**FSC Project Number: 2005-0820  
Date: October 25, 2005**

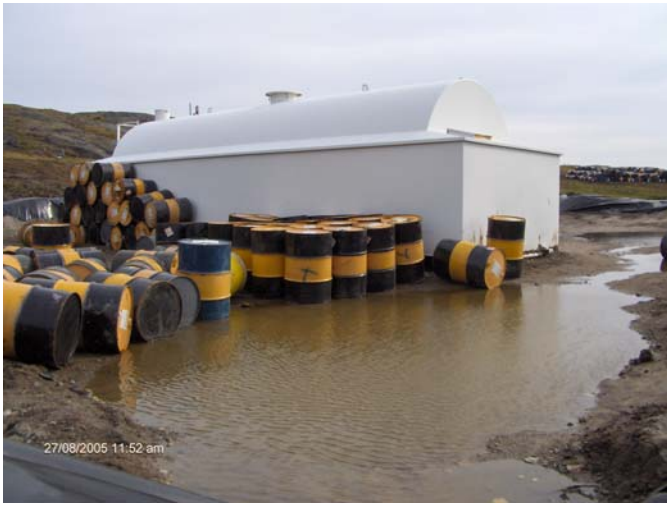
Some drums were observed within the containment area (Photo 1). These drums were empty. We understand that they used to contain Jet A and B fuels and were previously stored just on the bank of the berm of the main storage area adjacent to the road. The section of the road between the main storage area and the LTA contained some stains suggesting contamination.

**Photo 1**      **Drums and water within the containment area.**

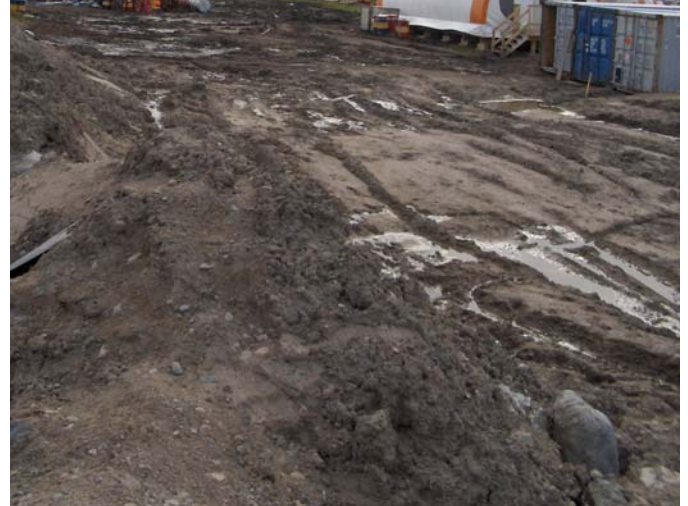
FSC was informed by the MHLB staff that the stains resulted partly from leaks from the jet A/B drums before they were moved to the lined area, and from leaks from equipment (e.g. front loader) used at this location. We were told that at one time, the soil in this location was excavated and moved to the LTA. However, at the time of the visit there were still stains (Photo 2).

**Photo 2**      **The area between LTA and Main Storage contain some stains suggesting contamination – bank of the berm of storage area is to the left**

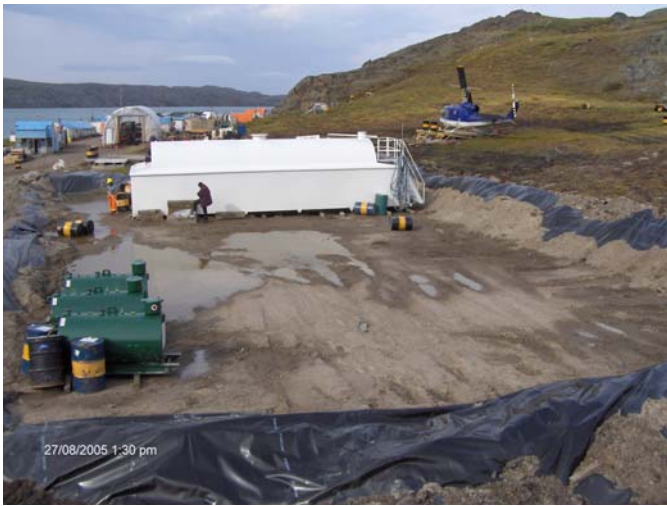
During the site visit, we observed that the 50,000 L tank from which the spill occurred (“spill tank”) has been abandoned. There is a 70,000 L, double wall, AST standing close to the previous location of the 50,000 L AST. A secondary containment barrier has been built around the fuel storage area enclosing the 70,000 L and the previous location of the spill tank.

**Photo 3**      **Secondary Containment surrounding 70,000 L AST and the previous Location of spill tank.**

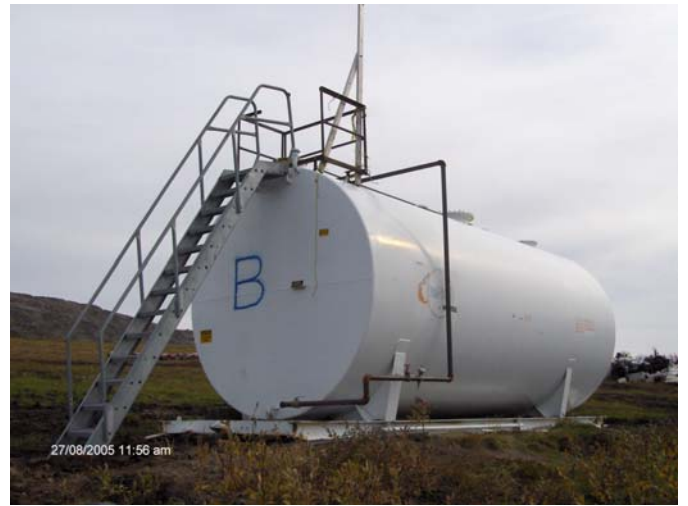
As reported under section 3.4.1 above, the spill of June 2004 was believed to have been caused as a result of the fuel line separating from the tank at a connection in the line due to high wind speeds on the night of the incidence. We understand that the operators failed to use the fuel transferring system on the tank. Rather, they used two pieces of general-purpose hose secured together by a “hose joiner and clamps” to drain fuel from the top of the 50,000 L tank. The new system for fuel dispensing was installed prior to the incident.

**Photo 4**      **The fuel transferring systems – with three (3) anti-siphoning valves**

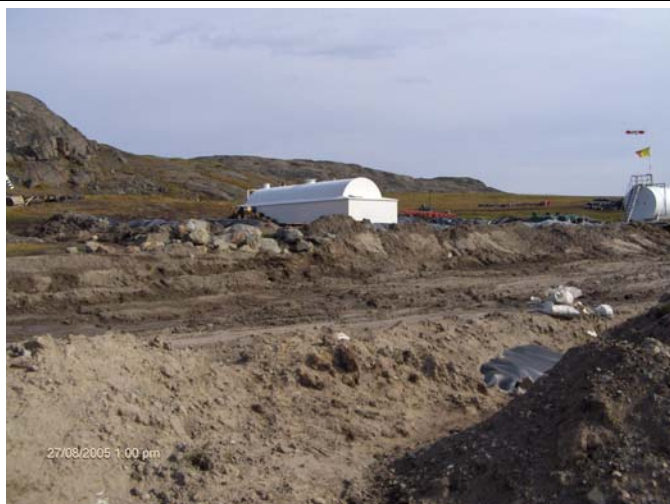
**Photo 5**      **LTA with 2004 and 2005 Soil stockpiles**

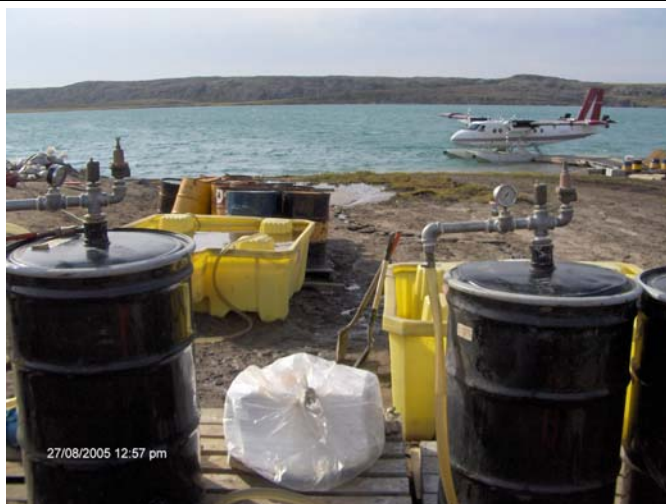
**Photo 6**      **Water Treatment Unit**

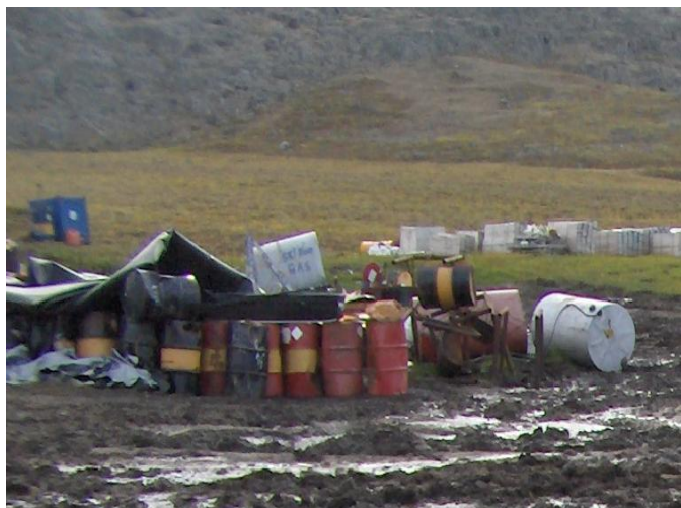
At two locations on the site (one to the southeast and the other to the northeast of the main fuel storage area) were several drums. Our site contact, MHBL’s Environmental Coordinator informed us that some of the drums contain Jet-B fuel, while others are empty. The empty drums were uncovered. We also learnt that overflows from the uncovered empty drums have caused the distribution of remnant fuel in the tank to the surroundings of the drums. This is evident from the stains in and around the locations of the drums (Photo 7). There are no containment barriers around these drums.

**Photo 7**      **Stains around the storage barrels**

Fuel drums should be stored within containment barriers. Barrels containing liquids should be labelled and properly covered. All empty barrels should be labelled, properly covered and stored appropriately.

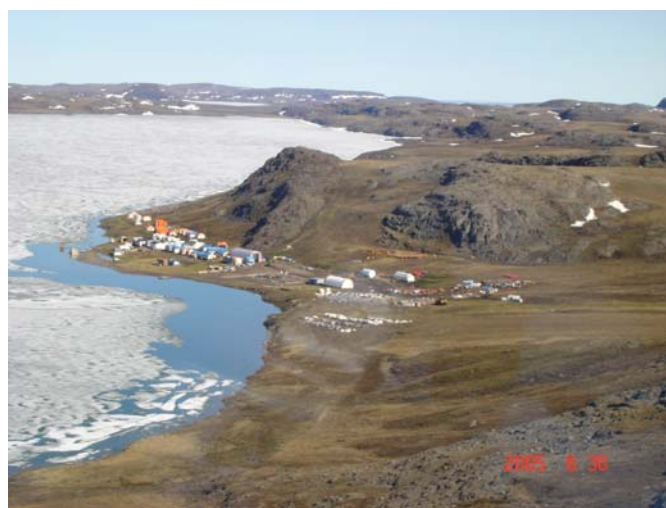
**Photo 8**      **Strip of Land adjacent to the Lake (Photo obtained from Miramar after the site visit) – More photos in Appendix E**
