RE: August 20, 2002 Water Licence Inspection - Report

INDUSTRIAL WATER USE INSPECTION REPORT

Licence No.: NWB2HOP0002

Windy Camp Inspection Pictures 2002

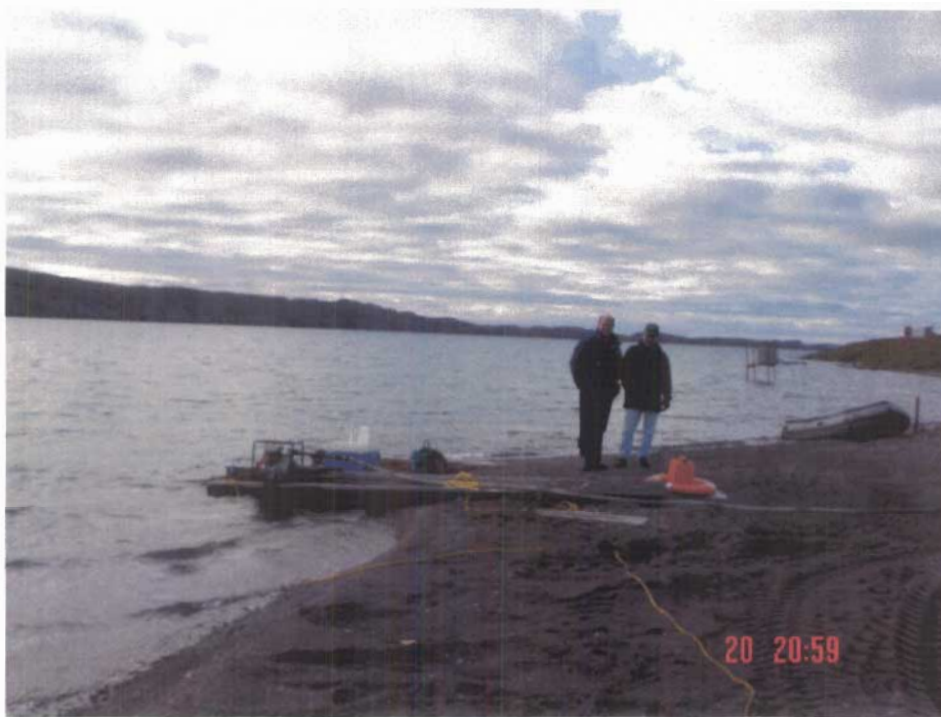
- ☐ **Water Supply:** The Water Intake is located 30 meters from the dock on Windy Lake. A gas-powered pump was located on the dock by the Water Intake Structure (Photo 1). There was no spill protection equipment in the vicinity of the gas-powered pump adjacent to the water supply. A spill kit or other form of spill protection should be supplied in this area. The Ultra Violet Water Disinfection System was operational at the time of inspection (Photo 2). Enclosed water samples taken at the dock on Windy Lake indicate that pH (7.74 vs 6.5- 8.5), Colour (<5 TCU vs 15 TCU), Arsenic (<0.001 mg/L vs 0.025 mg/L), Cadmium (<0.0003 mg/L vs 0.005 mg/L), Iron (0.17 mg/L vs 0.3 mg/L), Lead (0.001 mg/L vs 0.01 mg/L), Zinc (<0.01 mg/L vs 5 mg/L) are found to be within the *Guidelines for Canadian Drinking Water Quality*.

Comments: Of concern was the presents of a gas powered pump located on Windy Lake on top of the dock within 30 meters of the Water Intake Structure . No spill protection or absorbent equipment was observed in the vicinity of the gas powered pump. A spill kit is required in this area.

Photo # 1. Potable water supply intake on Windy Lake at right of photo, location of drinking water sample.

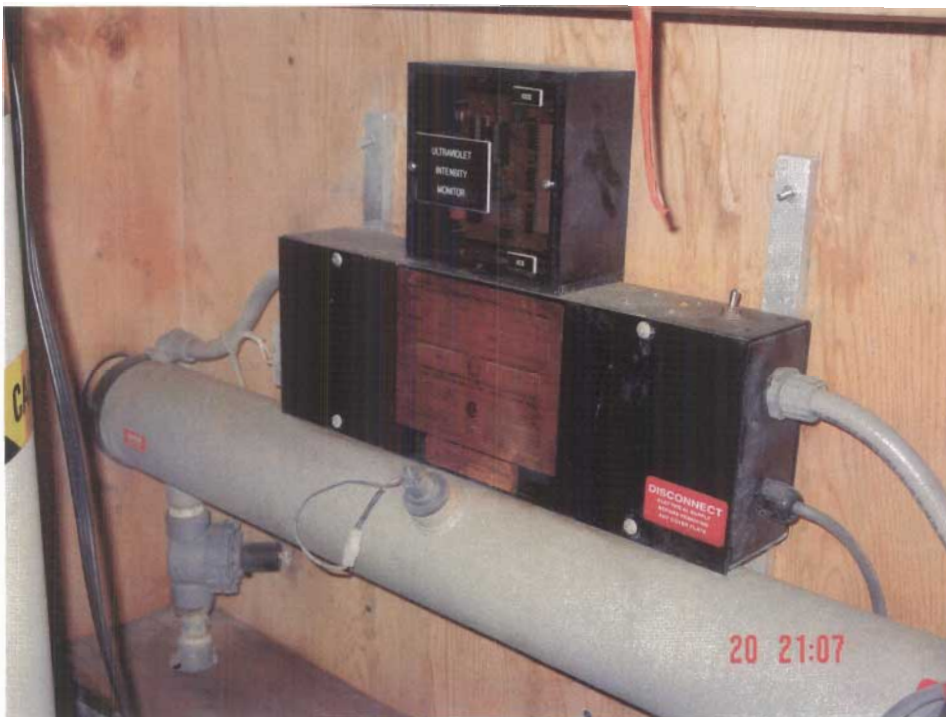
Photo # 2. Ultra Violet Disinfection System for potable water.

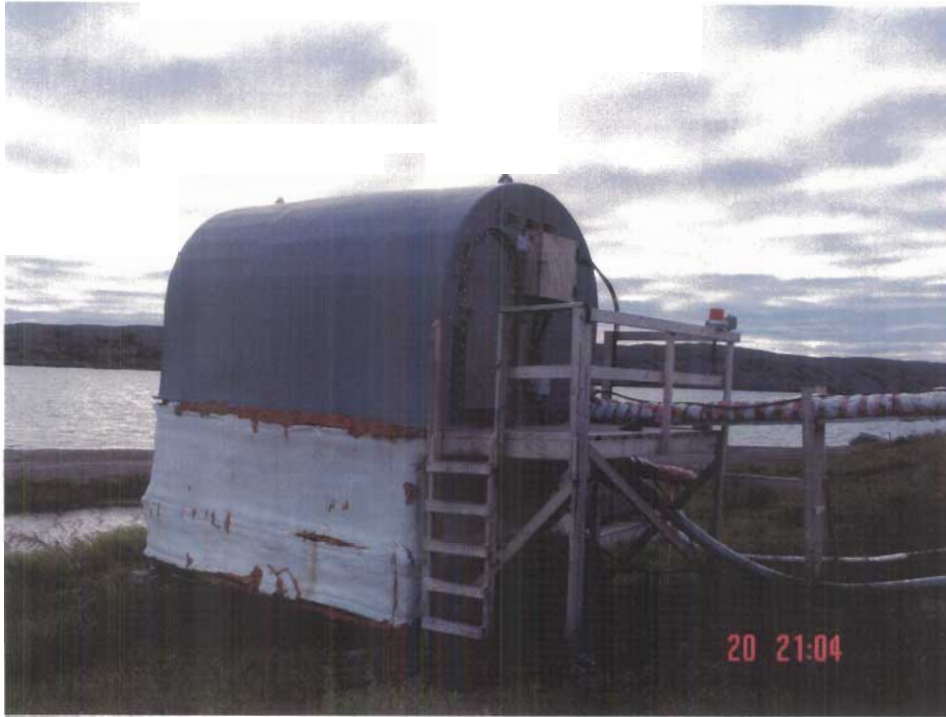
- ☐ **Waste Disposal:** Wastewater is collected in a sewage reservoir. Collected wastewater is transferred to (Photo 4) the Rotating Biological Contractor (RBC), where microbial action breaks down the nutrient load in the sewage effluent (Photo 3). After treatment in the RBC the sewage effluent is transferred to a holding tank (Photo 7). When sufficient volume is achieved, the holding tank is discharged on land 120 meters from the camp site (Photo 5). No removal of sewage sludge has occurred from the RBC in 2002. Enclosed samples of

Photo # 3. Sewage treatment system Rotating Biological Contactor.

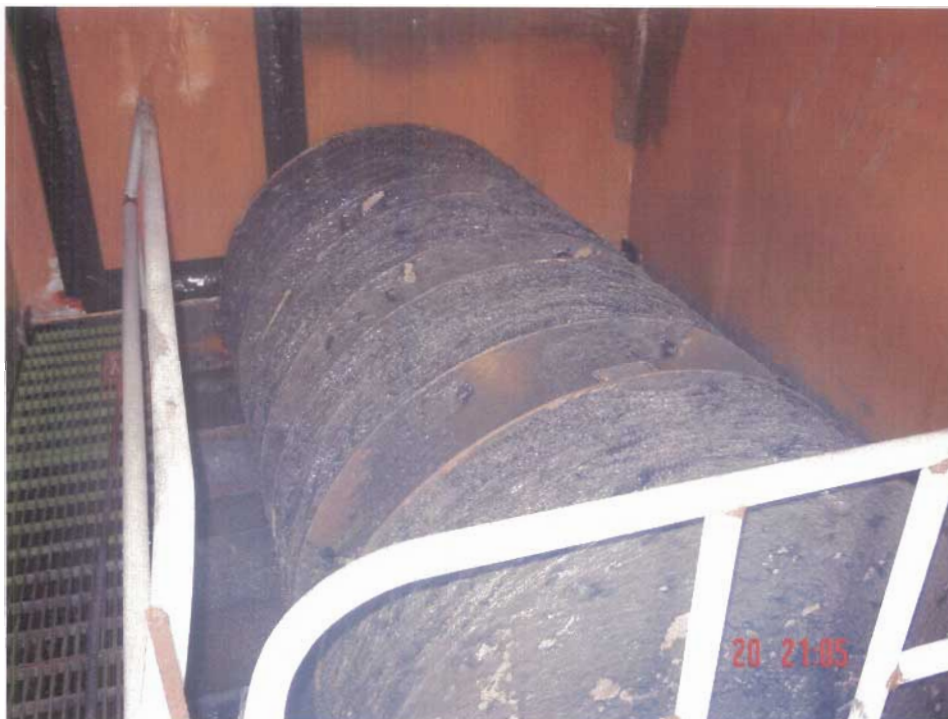
Photo # 4. Interior workings of Rotating Biological Contactor.

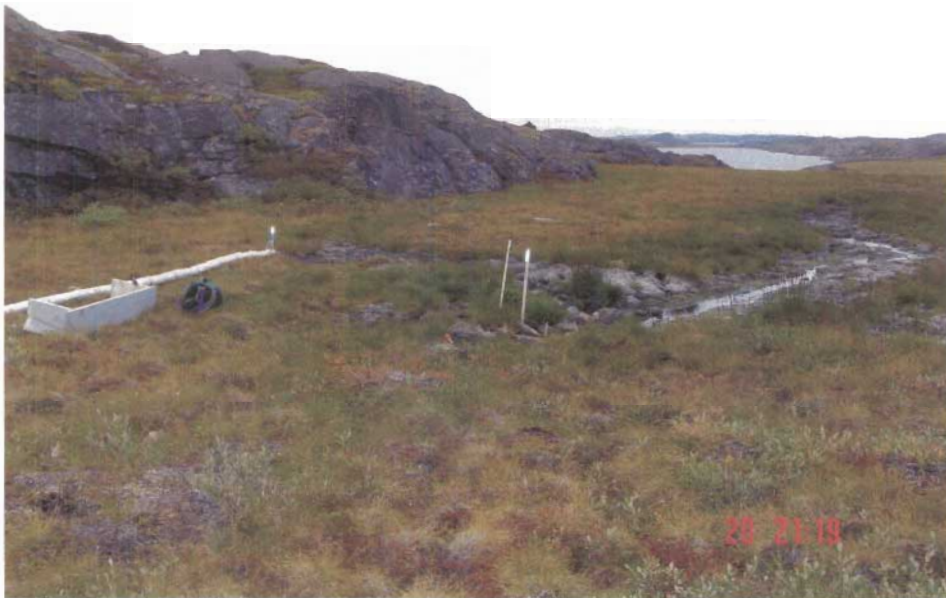
Photo # 5. Sewage system effluent discharge on land behind Windy Camp.

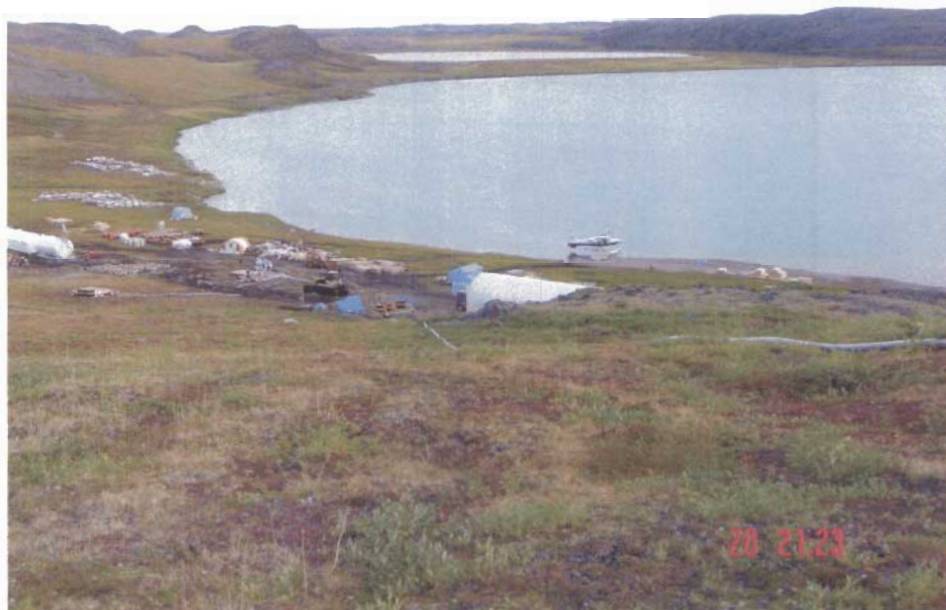
- ☐ **Fuel and Chemical Storage:** The fuel storage area is not fully bermed (Photo 6 & 9). The cleanup of Spill (02-451) 7,000 liters of diesel fuel is well under way. Most of the contaminated soil has been excavated and drummed (Photo 7 & 10). The soil has been removed to the permafrost layer. Samples of water taken from Windy Lake indicated that no fuel oil made its way to the water. All fuel containment and storage equipment will be stored in an area that is equipped with secondary spill protection. This spill protection will include a berm to prevent the unauthorized release of chemical or fuel from all storage and transfer vessels. An impermeable liner will be installed within all berm areas to eliminate the escape of spilled chemicals. All berm areas are to be monitored for snow and water accumulation to insure sufficient spill containment volume (at least %120) of all storage containers. Prior to discharge of snow or water from berm area, contents are to be tested for chemical or oil content and if required berm contents will be drummed and shipped off site for destruction or recycling by a Licenced Hazardous Waste Treatment Facility. (Photo 11 & 12).

Photo # 6. Fuel storage and bulk staging areas.

General Comments: All fuel containment and storage equipment shall be stored in a bermed area that is lined with an impermeable Prior to any discharge of snow or water from within the berm area the contents shall be tested for chemical or oil content, and if required contents shall be stored and handled as hazardous waste. Until the contents are shipped offsite for licenced destruction or recycling.

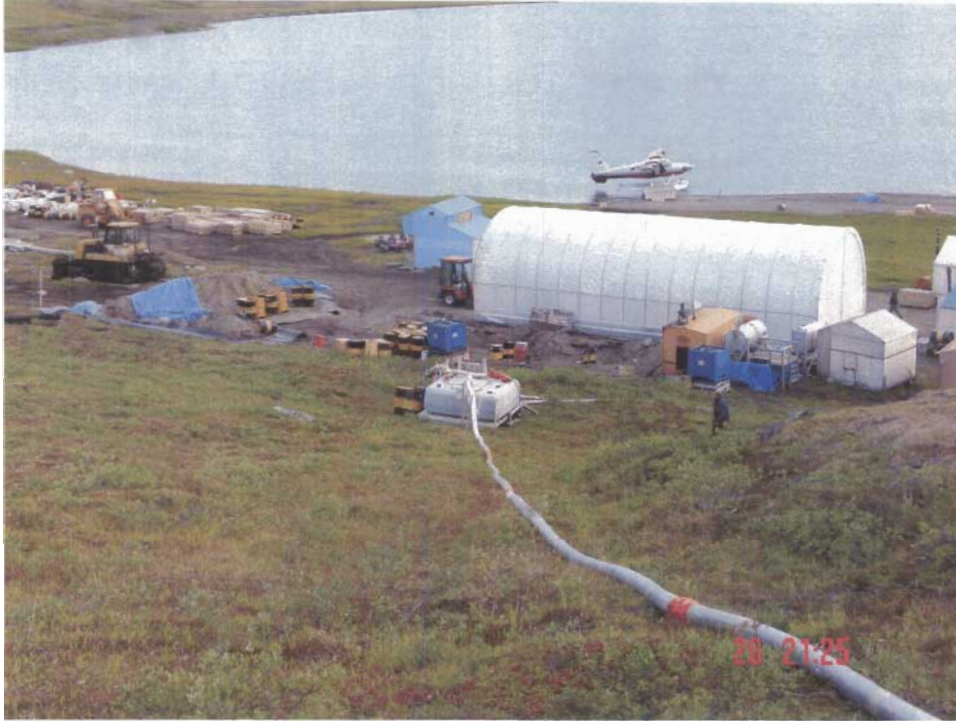
Photo # 7. Location of sewage reservoir prior to discharge behind Windy Camp.

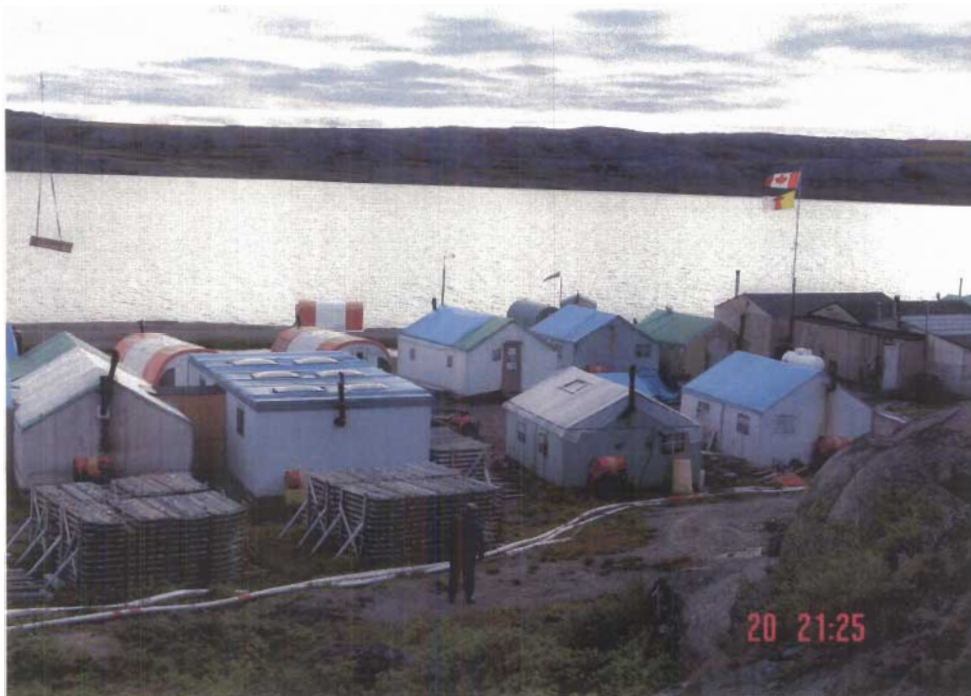
Photo # 8. Sewage lines to holding tank at back of Windy Camp.

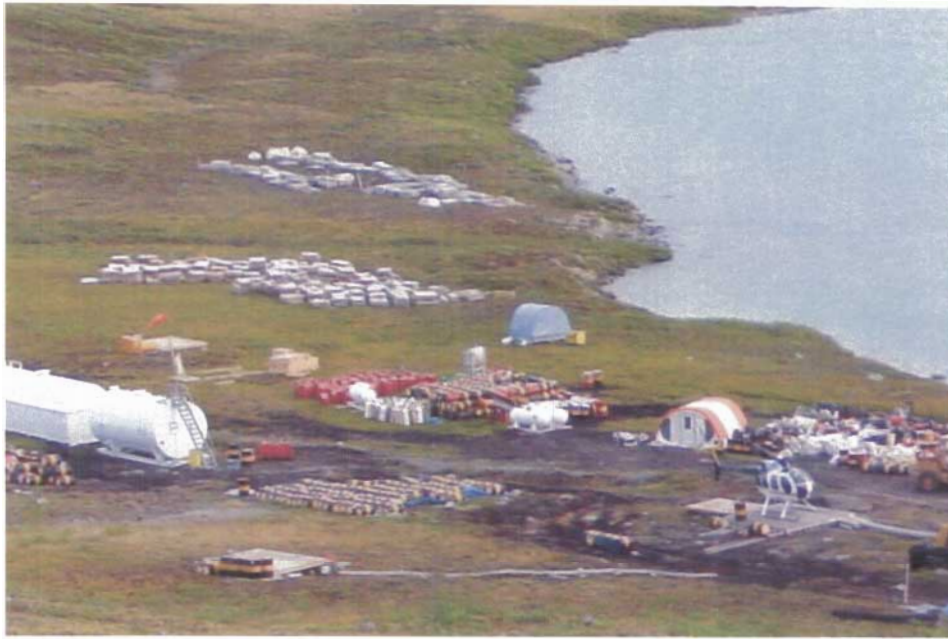
Violations of Act or Licence: The Licencee has caused a unauthorized release into the environment in the form of, Spill (02-451) 7,000 liters of diesel fuel on August 1, 2002. Miramar has failed to submit the following reports, SNP measurements for 2002 as required under (Part E Item 4) a revised Spill Contingency Plan as required under (Part F Item 2) of the Water Licence. Failure to submit required documentation constitutes a breach of the Nunavut Waters and Nunavut Surface Rights Tribunal Act

Photo # 9. Location of fuel oil spill (02-451) and staging area.

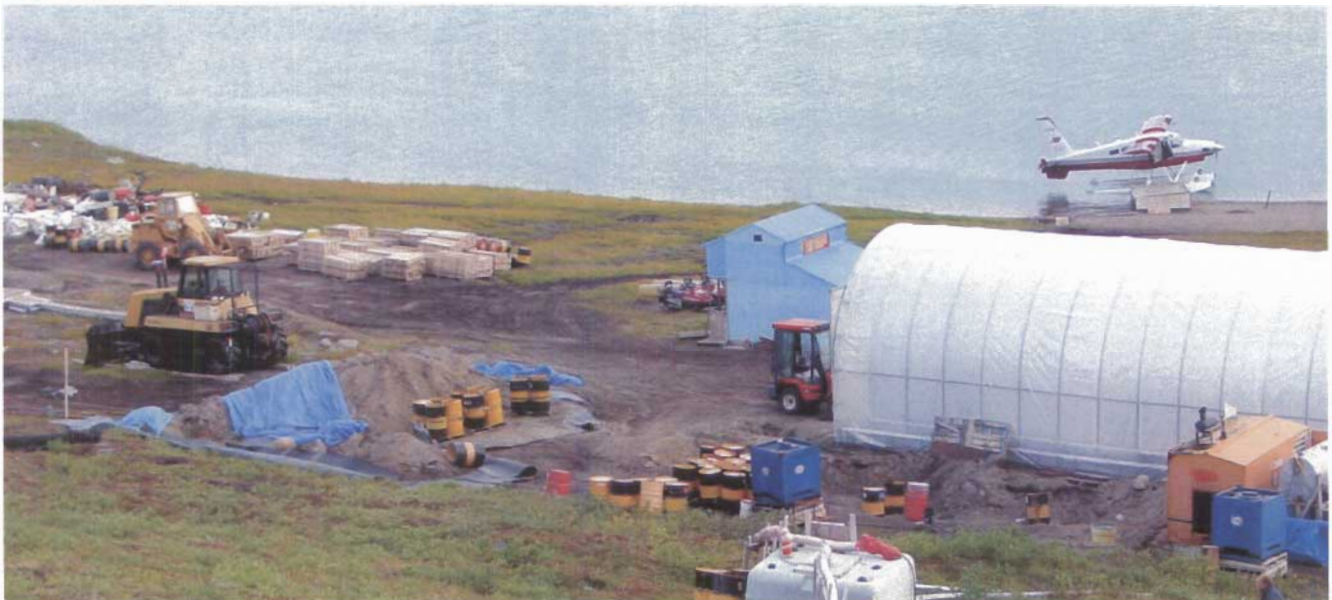
Photo # 10. Spill (02-451) cleanup at Windy Camp.
