Hope Bay Joint Venture**Cambiex Exploration Inc. & Miramar Mining Corporation**

Re: Spill on Windy Lake Spill #00-044

**Cat Train Incident
March 10, 2000**

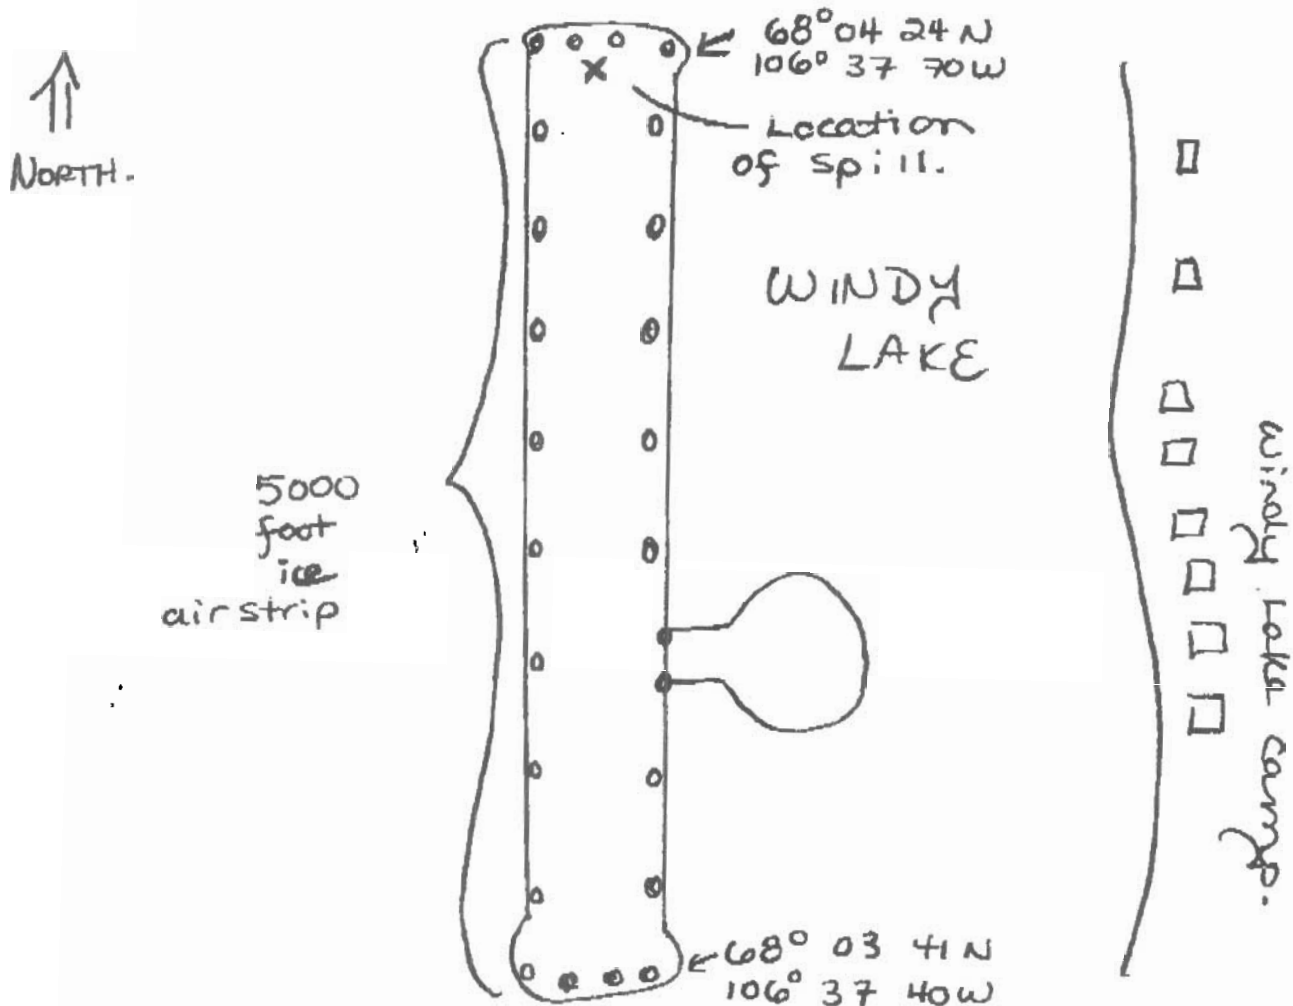
No of Pages 2. Please note map below is not
to scale.
