## WATER LICENCE INSPECTION FORM

Licensee	Licensee Representative
TMAC Resources Inc.	Sarah Warnock
Licence No. / Expiry	Representative's Title
2BE-HOP1222	Environmental Supervisor
Land / Other Authorizations	Land / Other Authorizations
Date of Inspection	Inspector
14/08/2019	Candice Pedersen
Activities Inspected	
<input type="checkbox"/> Camp <input type="checkbox"/> Roads/Hauling	<input checked="" type="checkbox"/> Drilling <input type="checkbox"/> Other:
<input type="checkbox"/> Mining	<input type="checkbox"/> Construction <input type="checkbox"/> Other:
	<input type="checkbox"/> Reclamation
	<input checked="" type="checkbox"/> Fuel Storage

On August 14<sup>th</sup> 2019 a water licence inspection was conducted by Crown Indigenous Relations and Northern Affairs Canada (CIRNAC) Inspector Candice Pedersen accompanied by Sarah Warnock of TMAC Resources, Bridget Campbell of CIRNAC and Coral Newman of Kitikmeot Inuit Association (KIA). The only facility inspected was a Drill Shack at coordinates: 67° 54'46.07 N 106° 33'35.48 W

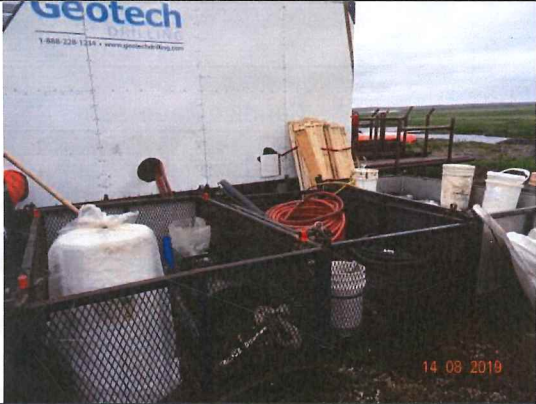
Inspector Pedersen notes the drill shack is clean and organized; gear is stored in metal bins outside the drill shack (*see photo log #1*). Inspector notes an open orange bladder (*see photo log #2*) filled with water, when questioned what its use Inspector Pedersen is informed that is drill water that is being recirculated for the drill. The water freeboard from the berm is about 2-3 inches at the lowest point.

Description: Organized			
Photo Log # 2		Location (NAD 83 DD MM SS.SS)	
Photo #2		N	W

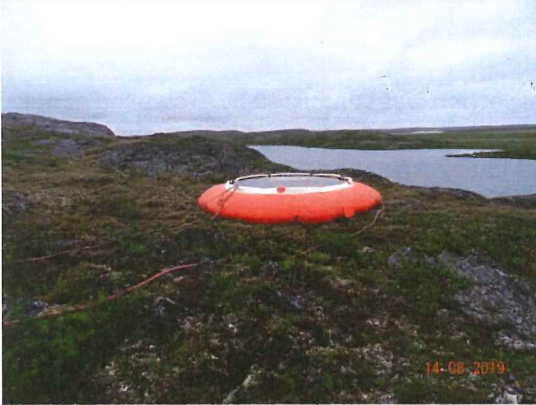
Description: Orange bladder with reused water			
Photo Log # 3		Location (NAD 83 DD MM SS.SS)	
Photo #3		N	W

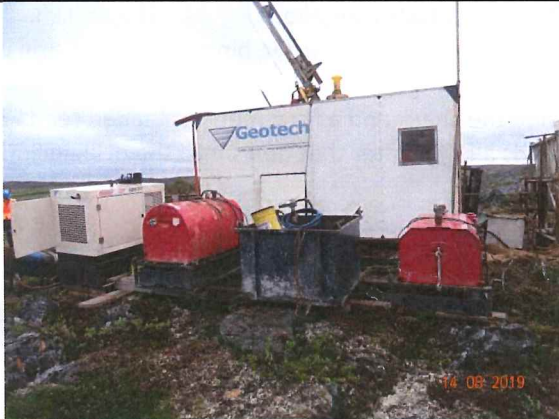
Inspector sees two double walled fuel tanks next to the shack (*see photo log #3*), Inspector is informed one is for the generator and the other is for the interior.

Description: Double walled fuel tanks			
Photo Log # 4		Location (NAD 83 DD MM SS.SS)	
Photo #4		N	W

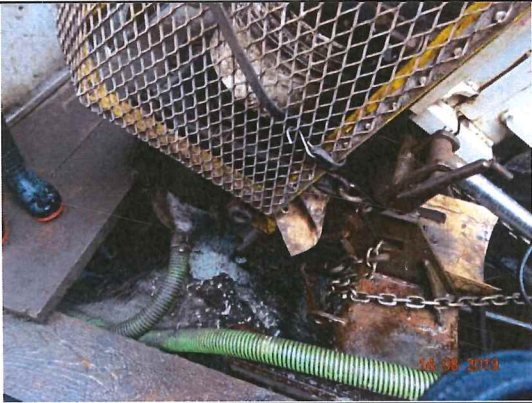
Inside the shed one drill is operational, two employees are in the shed. Coco mesh is being used around the drill and the bed rock to reduce the amount of water splash back (*see photo log #4*). The drill shack is clean, however, some drill waste is seen outside, coming from under the drill and near the bin that collects drill waste. However, not in big quantities (*see photo log #5*)

Description: coco mesh to reduce splash back from the drill

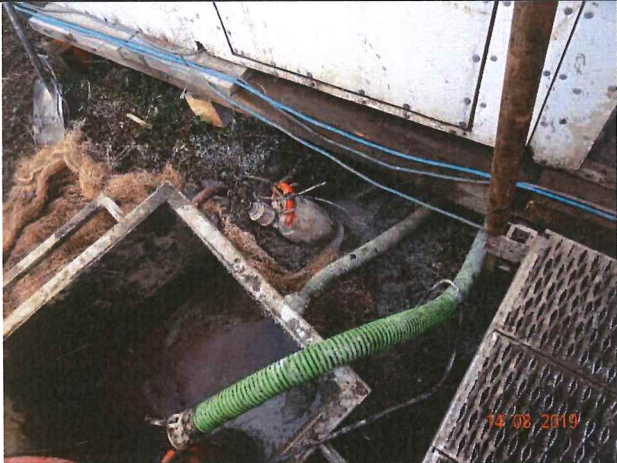
Photo Log # 5

Description: Very Small amount of drill waste

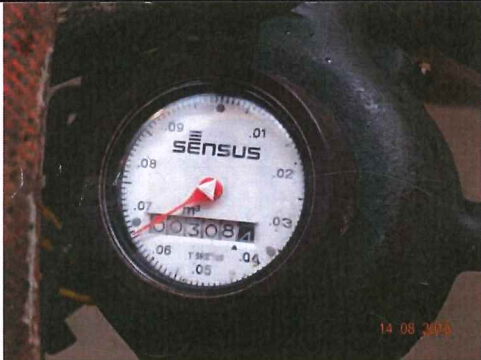
Photo Log # 6

A bin with recycled water is placed inside the shack and a flow meter attached reads 3084 cubic meters. (*see photo log #6*) Inspector is informed this meter reads all the water that flows into the drill, including recycled water.

Description: Flow meter, including all reused water
