**NWB2HOP0002**

**August 11-12, 2001 Industrial Water Use Inspection - Report**

## INDUSTRIAL WATER USE INSPECTION REPORT

Licensee: Miramar Hope Bay/Hope Bay Gold, Windy Lake Licence No.: NWB2HOP0002

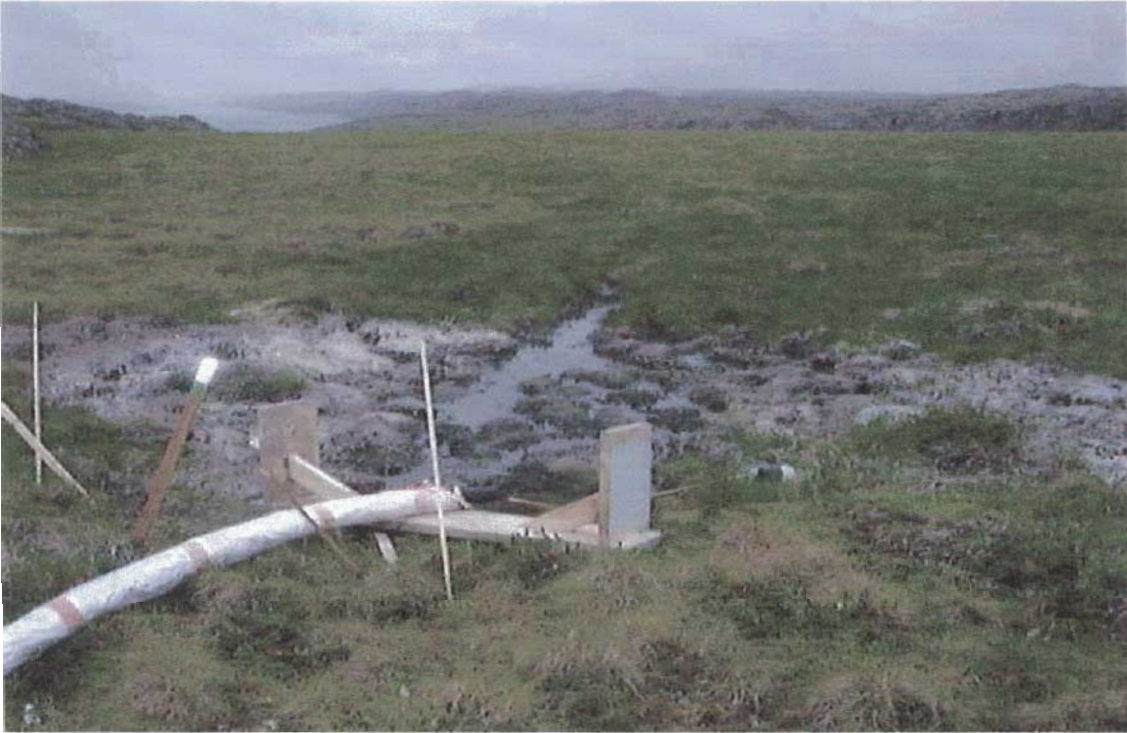
- **Sewage disposal:** The Licensee has completed the installation of a sewage treatment system (RBC), which has been operational since springtime. Sewage effluent from the facility is discharged overland; however, no flow was observed at the time of the inspection (figure 1). Although no sewage sludge has yet been removed from the treatment unit, the Licensee eluded to plans of on land disposal over impacted areas. In this regards, the Inspector reminds the Licensee of the need to provide the Nunavut water Board (NWB) with relevant information prior to initiating such measures.

figure 1. Sewage effluent discharge point; 2001/08/12.

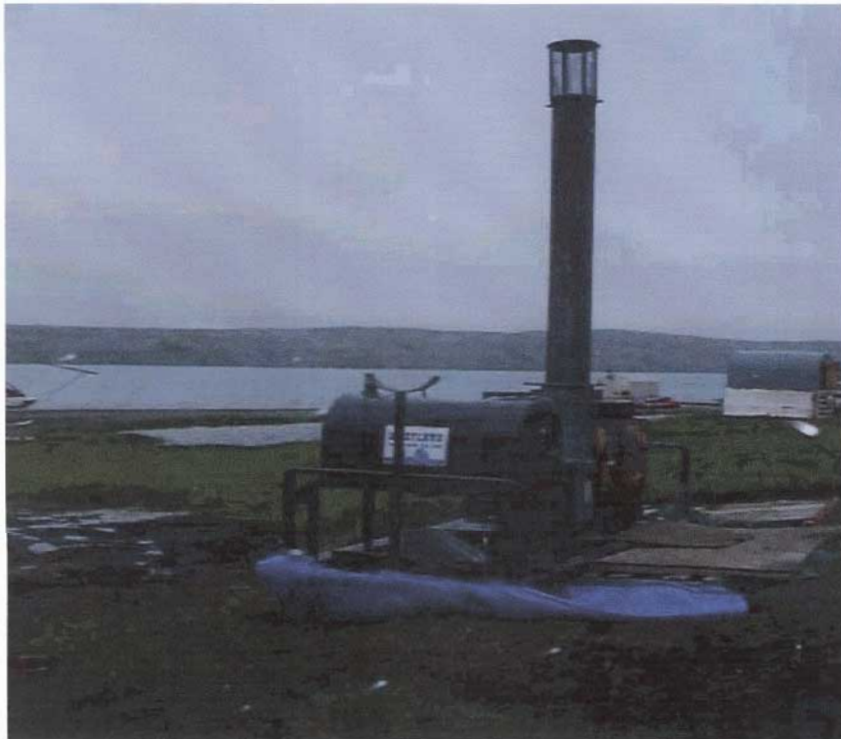
figure 2. New incinerator at relocated site further from shoreline; 2001/08/12.

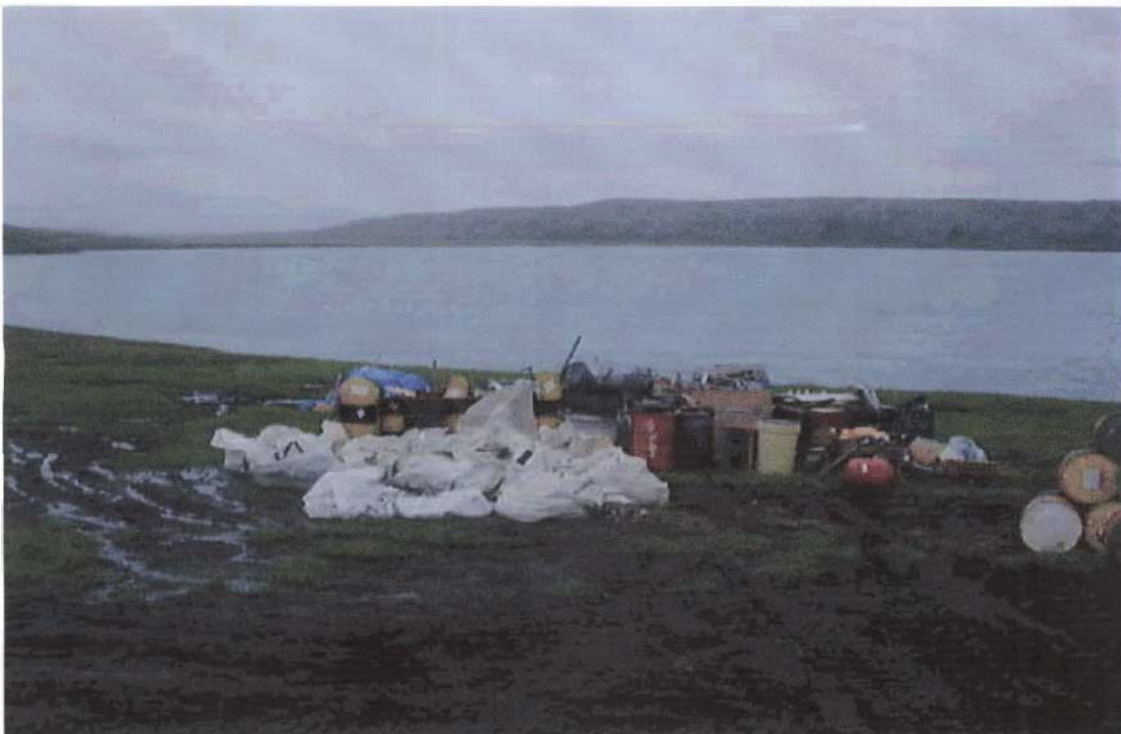
- **Solid waste disposal:** During the summer, the Licensee has commissioned a new incinerator (figure 2). In addition, the incineration site has been further withdrawn from the shoreline. However, non-combustible wastes are being stockpiled (figure 3) since the Licensee indicated that shipping out the solid waste was no longer considered a viable option. In this regards, the Inspector outlines that terms (part E, item 4) of Water licence NWB2HOP0002 stipulate that alternative disposal means ought to receive prior approval from the NWB.

figure 3. Solid wastes staged prior to eventual disposal; 2001/08/12.

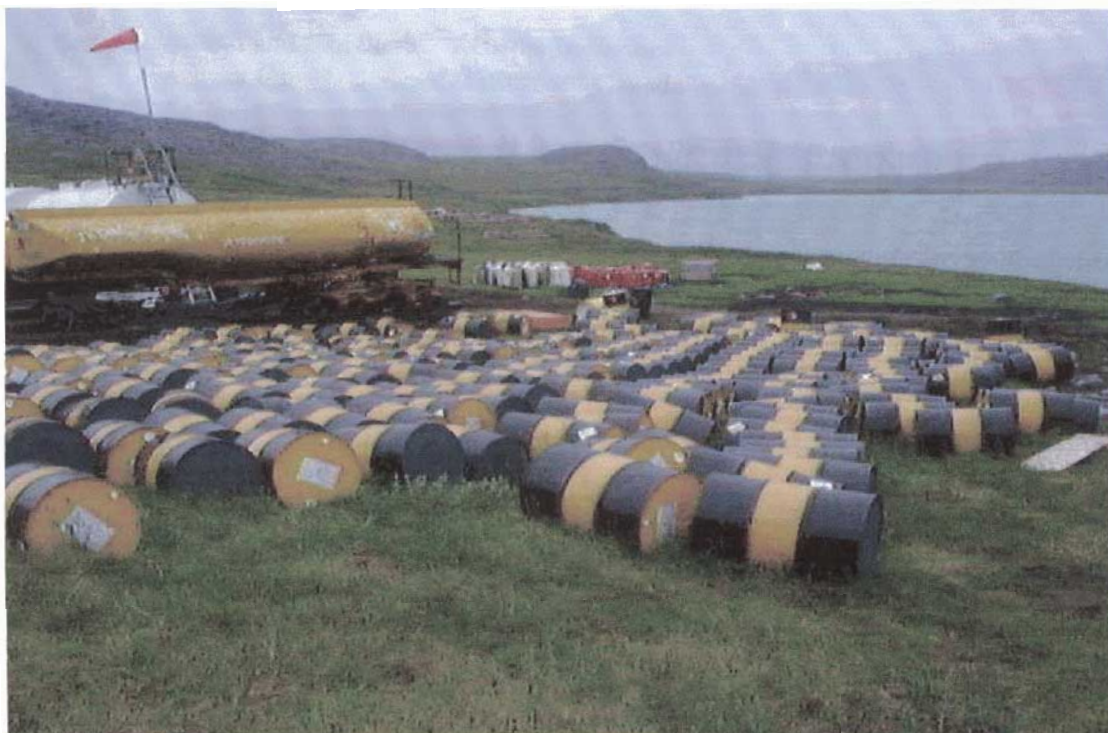
- **Fuel Storage:** Various improvements to the fuel management practices at the Windy camp were noted during the inspection. Accordingly, by restricting drum usage to helicopter support and local activities, the Licensee has diminished the likelihood of spill incidents in the vicinity of the fuel storage area (figure 4). Further, at the time of the inspection, the replacement of questionably effective drip-trays (figure 5) with more spill proof structures was underway (figure 6). Nevertheless, the Inspector trusts that appropriate measures will be undertaken prior to the disposal of the water and/or fuel accumulated in the drum trays.

figure 4. Bulk fuel storage site; 2001/08/12.

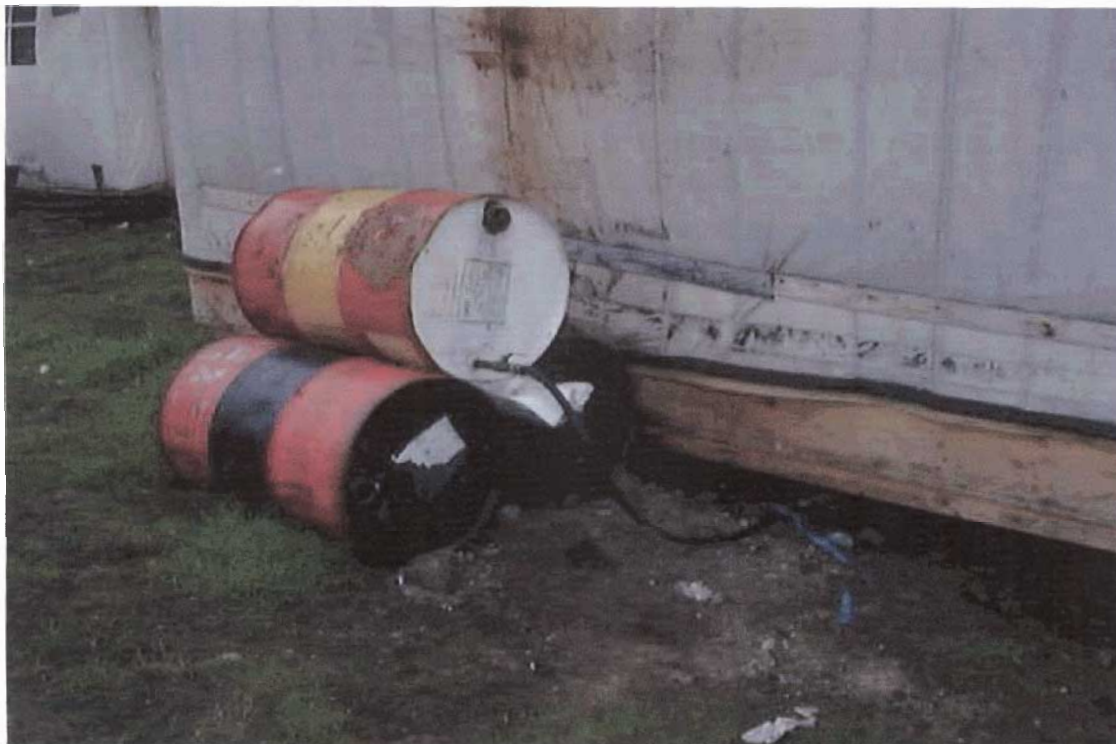
figure 5. Old housing units fuel supply system; 2001/08/12.

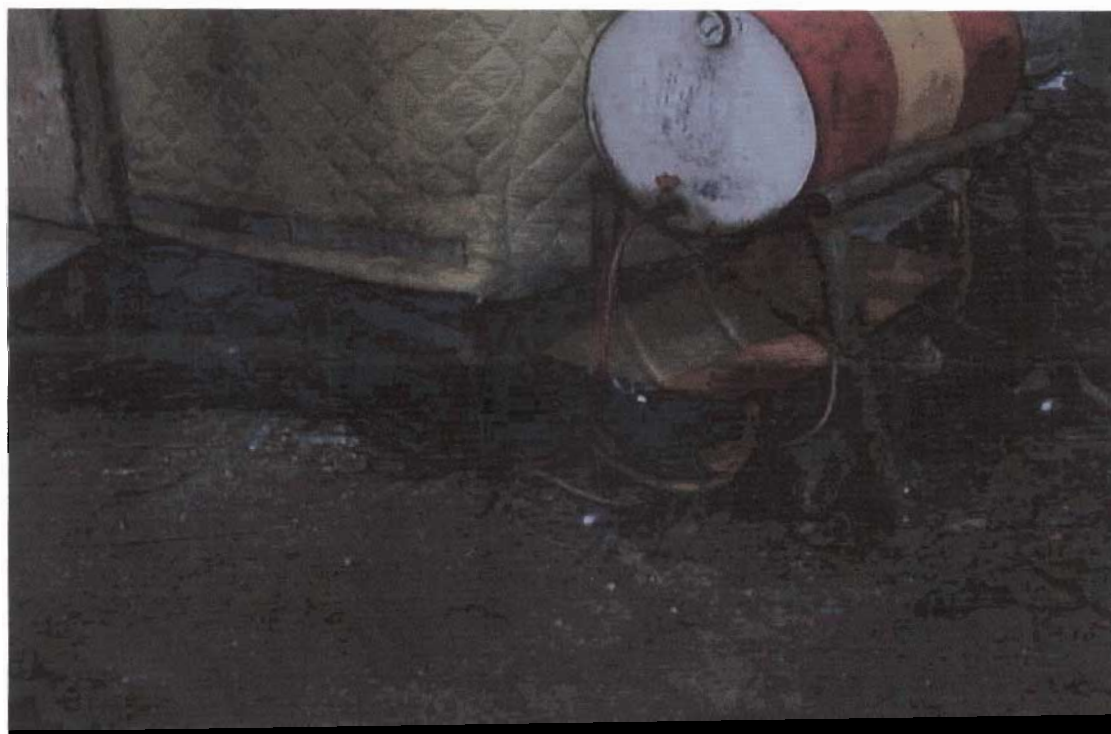
figure 6. New housing units fuel supply system; 2001/08/12.
