September 21, 2015

Re: 2BE-HOP1222 AANDC July 18-19, 2015 Inspection Report Required Action Item

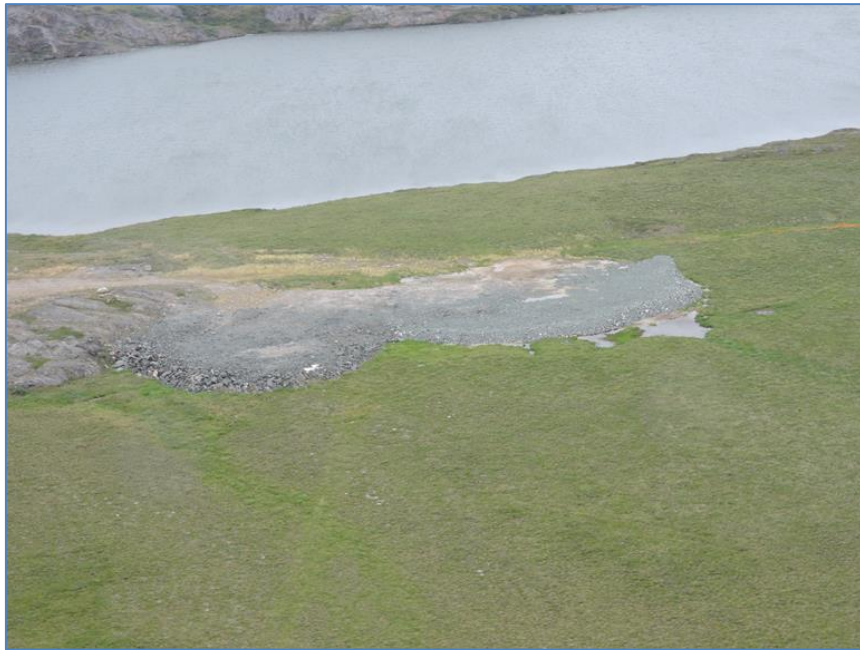
Comments in the Inspection Report concerning the remediation work performed over winter 2014/2015 at the Patch Lake laydown cutting sump identified exposed cuttings and some pooling water that remained on the downslope side of the sump. The comments also noted that impacts to vegetation in the area were less evident. The Report's Action Item required a determination of the effectiveness of the remediation measures taken for seepage of brine from the cuttings sump (Spill #13-357), and whether further action was required.

As part of the follow-up to Spill 13-357, a seasonal water quality monitoring program was instituted to measure potentially elevated contaminants of concern that may be originating from the sump and migrating downslope through the tundra. Monitoring conducted this summer, compared with previous years' monitoring results (2013 through 2015) indicate conductivity and chloride concentrations near the sump, and in shallow groundwater between the sump and Imniagut Lake is decreasing. Vegetation in the area is also recovering, as can be seen in the photo provided below (Figure 1).

Figure 1. August 2015 Aerial view of Patch Cuttings Sump looking east, showing vegetation recovery.

The remediation work performed last winter stabilized the majority of exposed cuttings, and this fall the standing water along the western margin of the sump will be delineated to monitor changes in this area.

Water quality monitoring will also be continued to determine if the remediation to date effectively mitigates further high-saline seepage from the sump.
