WINDY LAKE EXPLORATION CAMP

GREY WATER FINAL SPILL REPORT # 05-198

MIRAMAR HOPE BAY LIMITED

Document # MBLENV-GWR-09-2005
May 25 2005

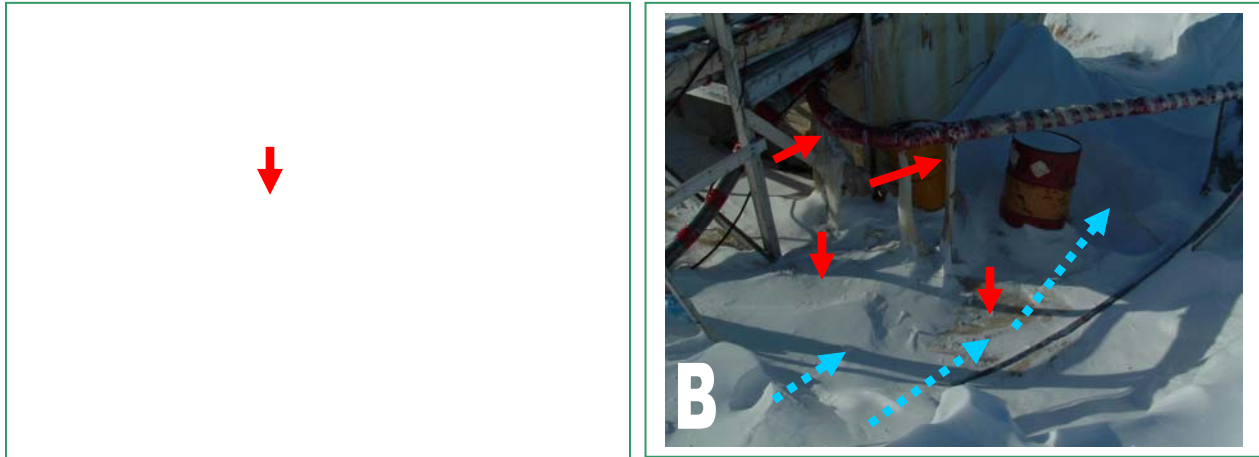
During flushing of the sewer lines, flushed freshwater was let to drain. Flushed water was seen between the Overflow tank and the RBC, and the back of the RBC plant. Frozen flushed water was also seen under the snow over the top of the overflow tanks and at the foot of the

tank. The impact of flushing could not really be determined as the whole area was covered with high snow banks. Evidence of the dried water could be seen in photographs shown in Appendix 3 of this report.

A: Red arrow indicating location of Windy Lake RBC plant, B: Solid red arrows indicating observed frozen flushed freshwater after flushing of sewer lines. Dotted blue arrows indicate spring runoff direction - southward toward Windy Lake.

- (i) To meet the above objectives, the first priority was to determine the faecal coliform content of the “observed” frozen media of concern; and
- (ii) Remove the frozen “observed” media by chipping before spring runoffs. The chipped portions to be disposed off into the RBC Final Clarifier and released together with the final effluent.

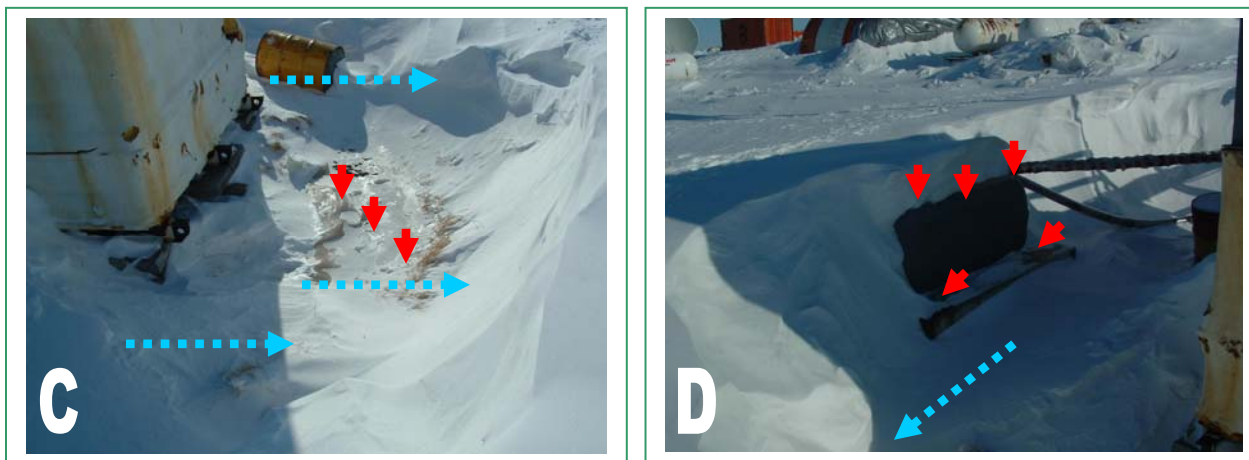
The visual impacted area measured approximately 10 m². As the high bank of snow covered the whole area around the RBC, it was quite impossible to determine the exact route of the flushed water thereby calculating the impacted area. Appendix 3 shows a series of photographs taken of the impacted area.

C: Solid red arrow indicating frozen flushed freshwater at the back of the RBC; D: Solid red arrows indicating, "Observed" media on top and bottom of the overflow tank. Dotted blue arrows indicate spring runoff direction - southward towards Windy Lake.
