# **Patch Lake Tank Farm Secondary Containment Facility, As-Built Report Hope Bay, Nunavut, Canada**

**Miramar Hope Bay Limited**  
Suite 300, 889 Harbourside Drive  
North Vancouver, BC V7P 3S1  
Canada

**SRK Project No. 1CM014.010**

**October 2007**

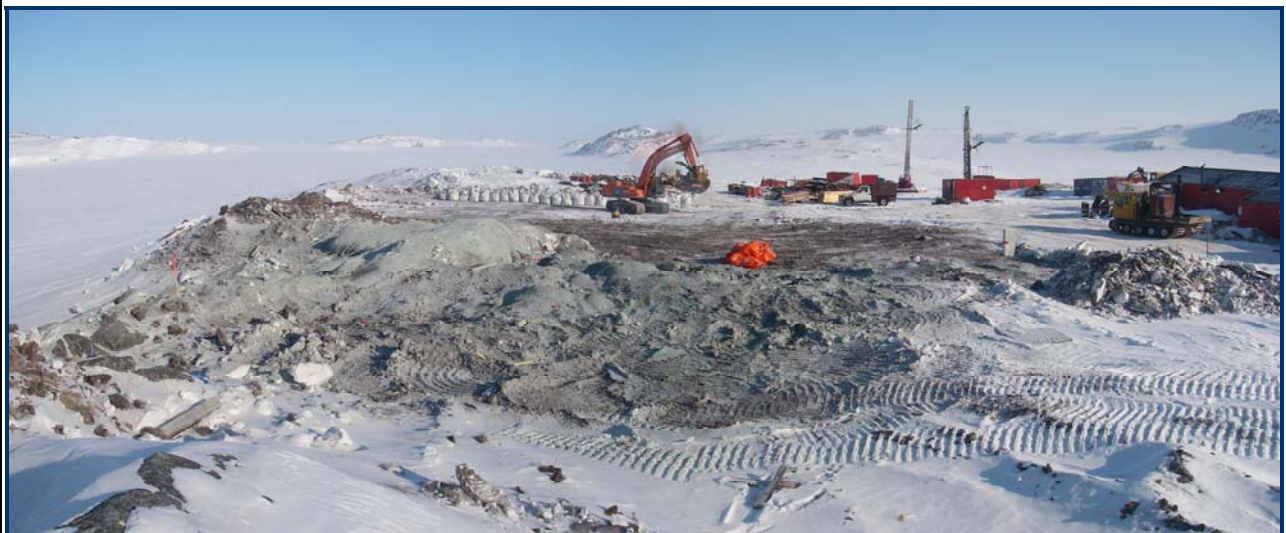
2. Test pit being excavated in ice rich overburden at north end of pad.

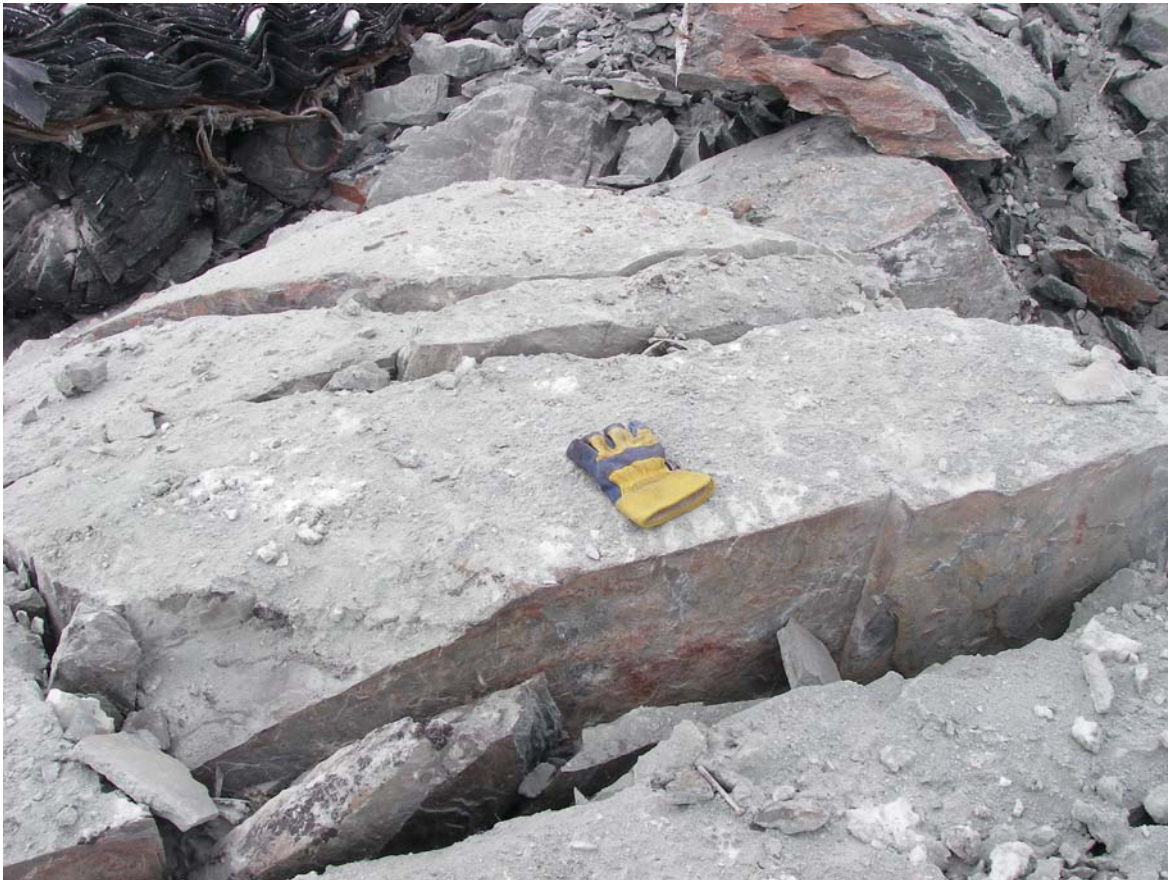
1. Oversize from the blast developed from back breaks and poor fragmentation.

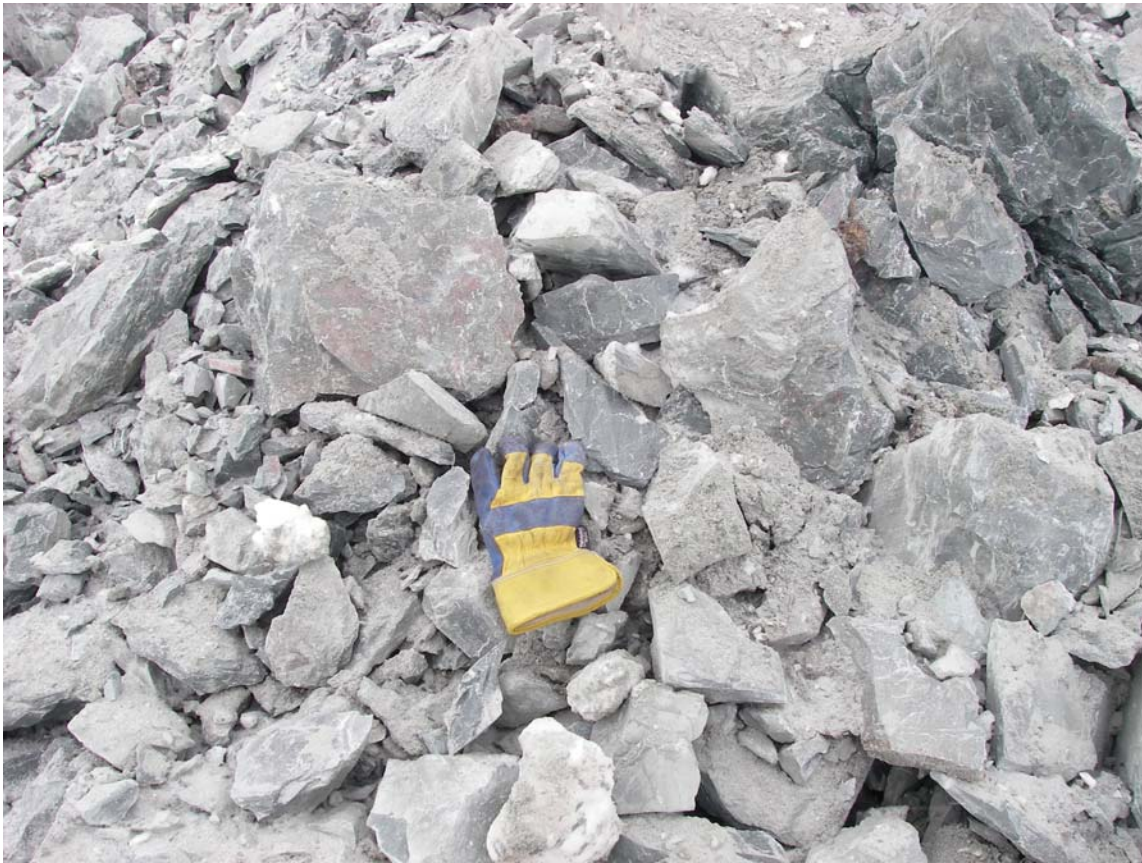
2. Typical fragments from the blast, estimated only 70% of the blasted material.

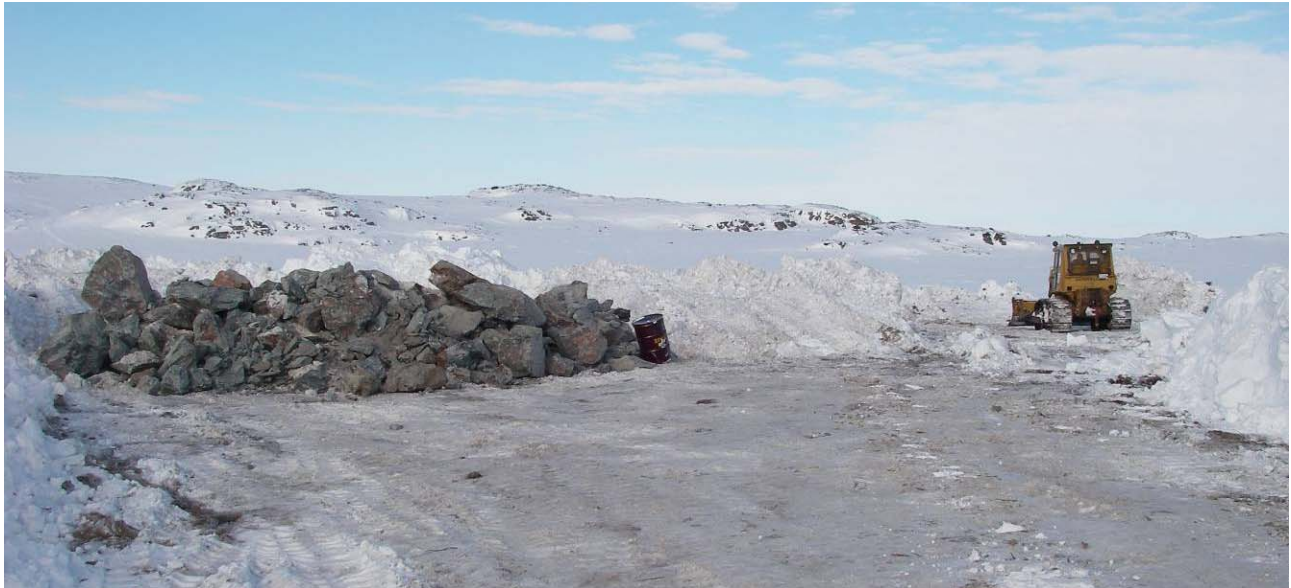
3. Unsuitable stockpile area is located approximate where the dozer is operating. Oversize are placed near the edge of the area for

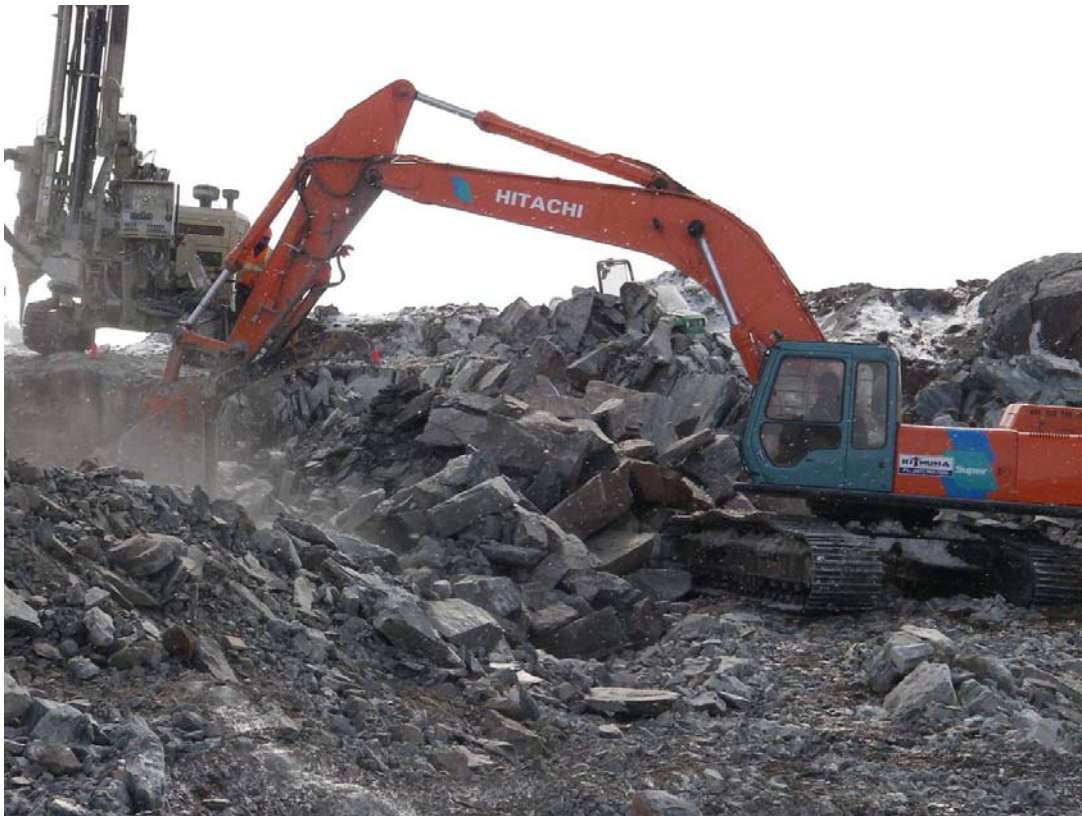
Photo 2: Large fragments produced from the blast due to wide spacing joint sets.

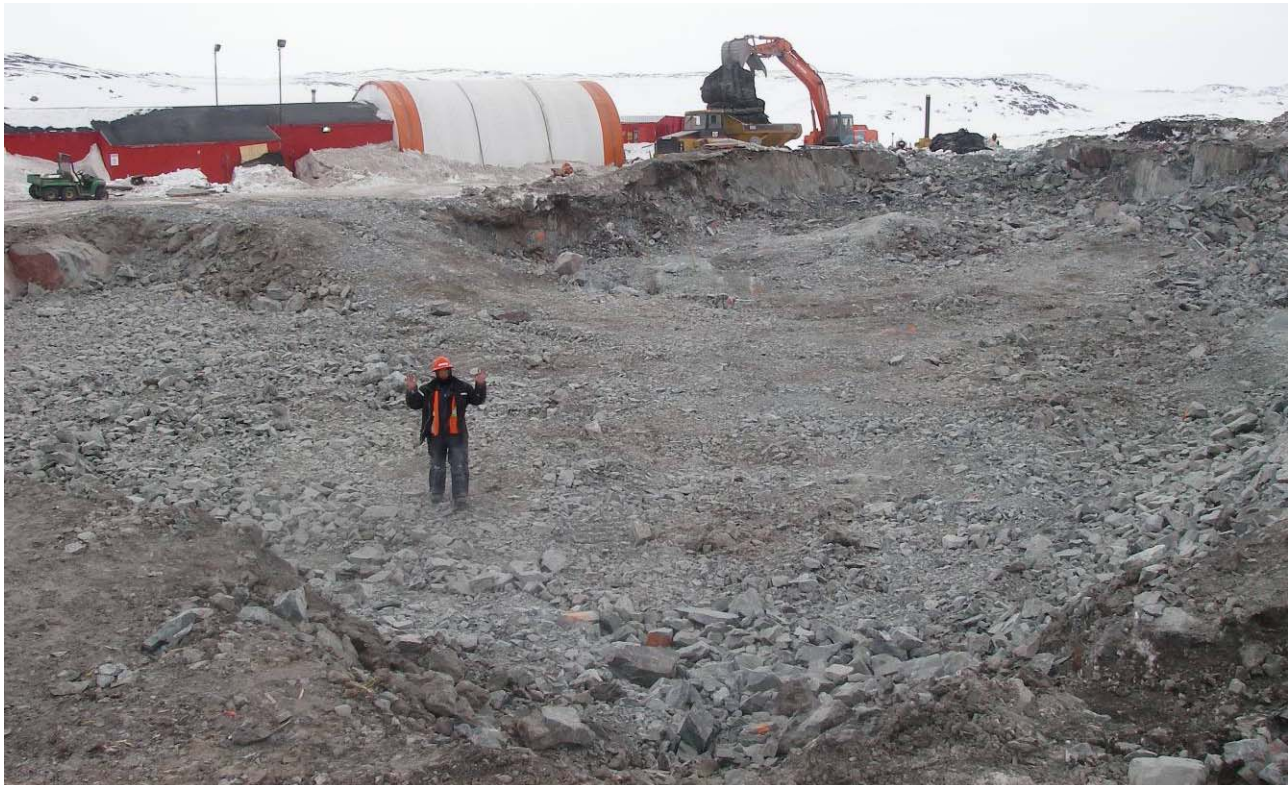
Photo 1: Current status of the farm including three high points in background, north-west side.

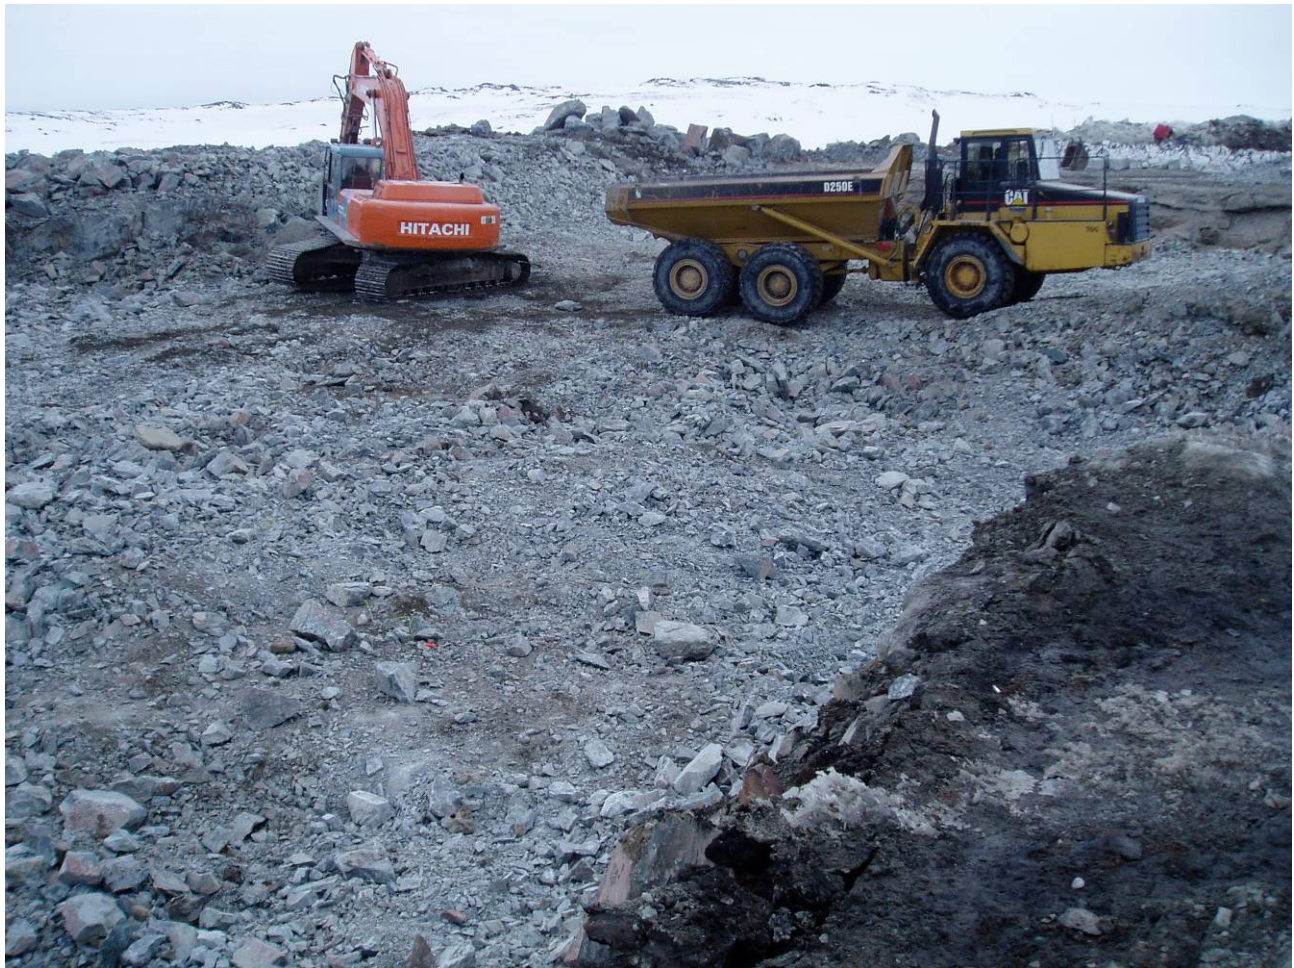
Photo 2: Three high points have been blasted near the end of day shift.

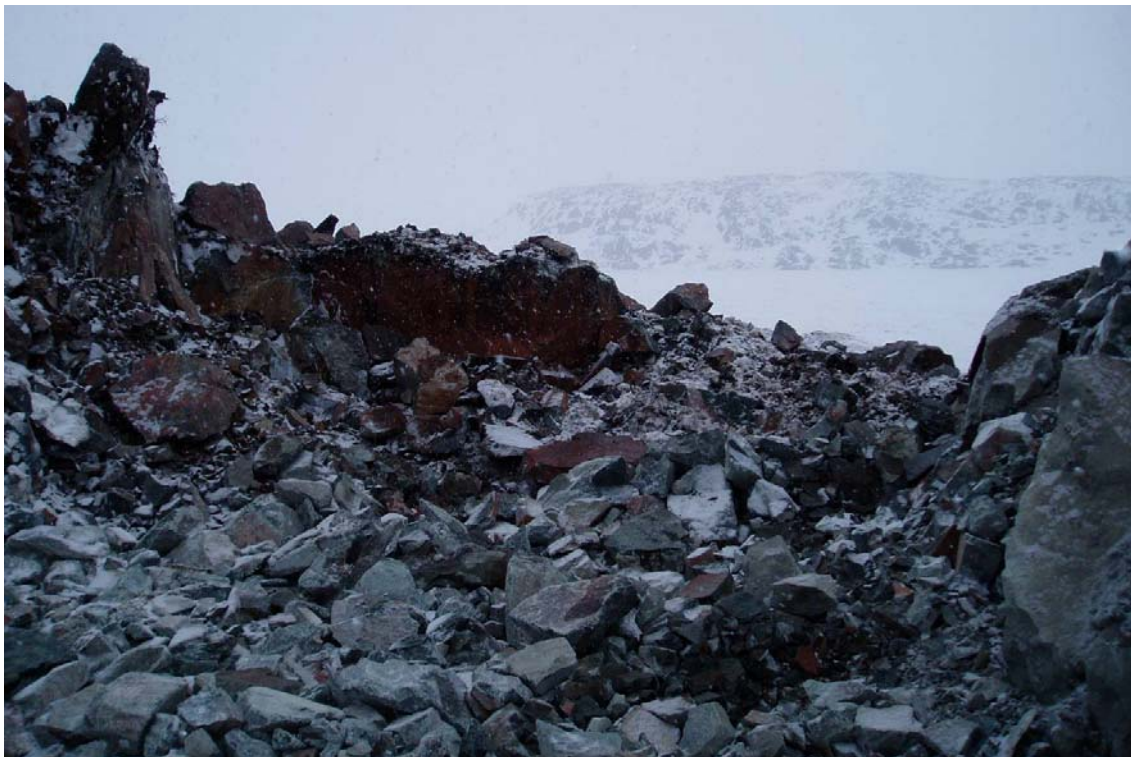
Photo 2: Rock wall at daylight point which needs to be removed.

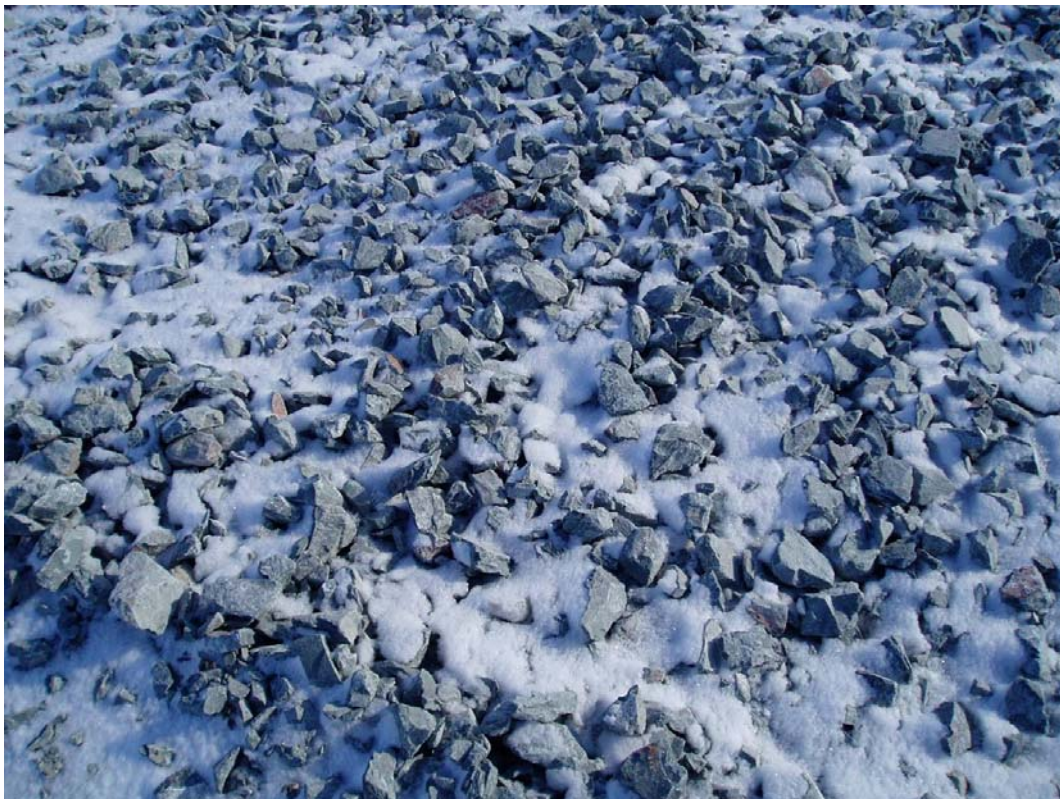
Photo 1: Loose, uncompactd rock on farm floor.

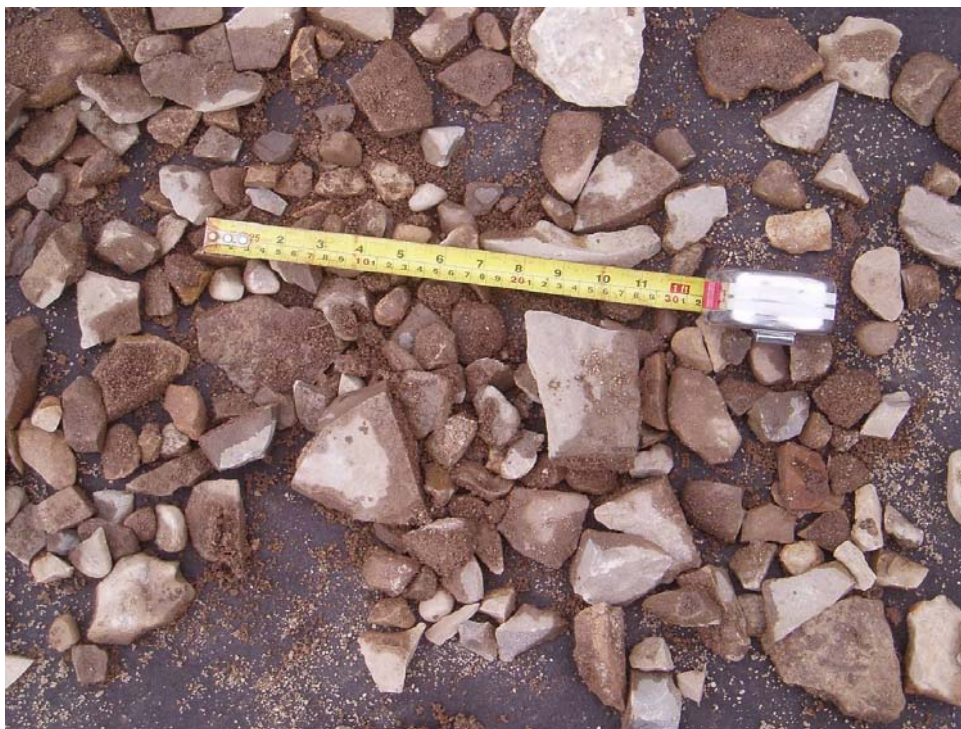
Photo 1: Sharp rocks picked out from one tote of sand.
