Re: 2BE-HOP0713 Notice of Artesian Flow

SECTION 1. ACCIDENT/INCIDENT REPORT

Spontaneous Water Flow at Drills – Jan 21 – 23, 2010

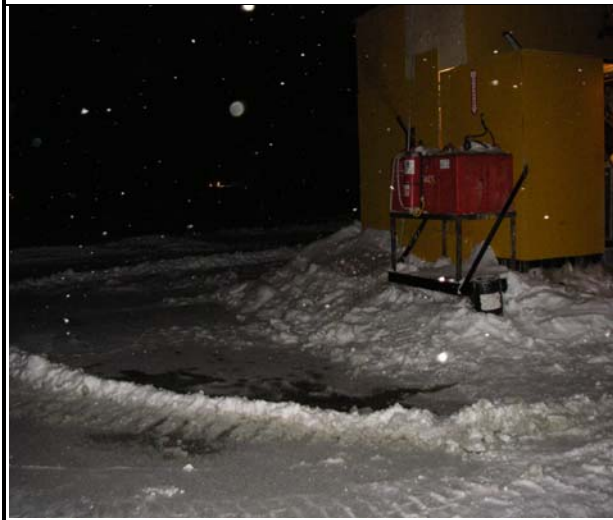
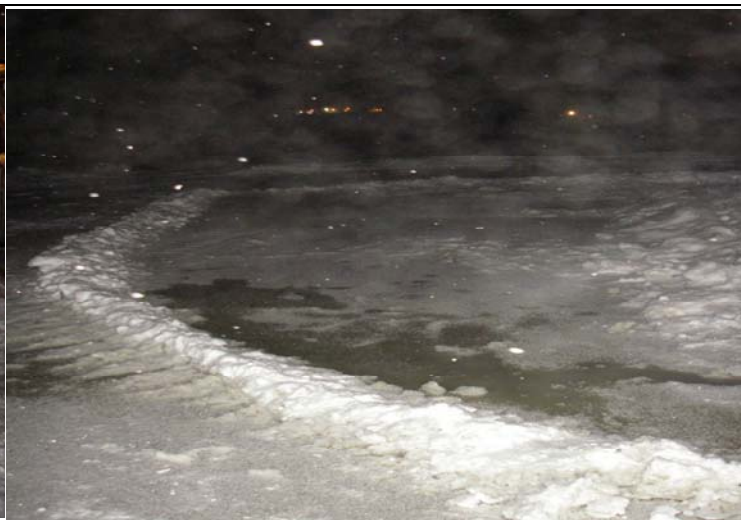
At approx. 11:00am, near 316M depth under Doris Lake, the drill encountered spontaneous flow of water from the drill hole. Water flowed spontaneously out of the 3" casing, quickly at first, then tapering off in pressure. (Flow continued for close to an hour, estimated by the driller). The water was captured initially, but soon overwhelmed and overflowed the water circulation tank, and drained through the drill shack floor onto the ice under and surrounding the drill. The overflowed water contained some cuttings sediment. This spill will be cleaned-up by machine when the drill is moved. Location of intersect: 300 m downhole in 10TDD690: E 433582 N 7557960 Elevation -245.5 m Further investigation revealed leaking was first noticed at 298m

Drilling was halted. A snow berm was erected around the drill to contain the overflow near the drill. The occurrence was reported to site ESR. Site ESR notified HBML Manager of Compliance, who alerted the INAC Inspector via email. By approx. 4pm, no further flow was observed and drilling commenced in the presence of site ESR to monitor. Drilling was monitored for 1 hour, to an approx depth of 625m. No further flow was noted, but drilling had previously been consuming more water than usual according to the driller (M. Landry), and had possibly been consuming more water through the previous night shift (water use records to be verified).

A decision was made the morning of Jan 23/10 for Orbit 24, due to the water flow on the ice causing degradation, to cap the hole and temporarily abandon this location until the area refreezes.
