MIRAMAR HOPE BAY LTD

Re: Follow-up Report – Spill Report 02-451: Water License: NWB2HOP0207

Spill # 02-451, a spill of diesel fuel occurred at Windy Camp on August 1, 2002 at approximately 14:30 Hrs.

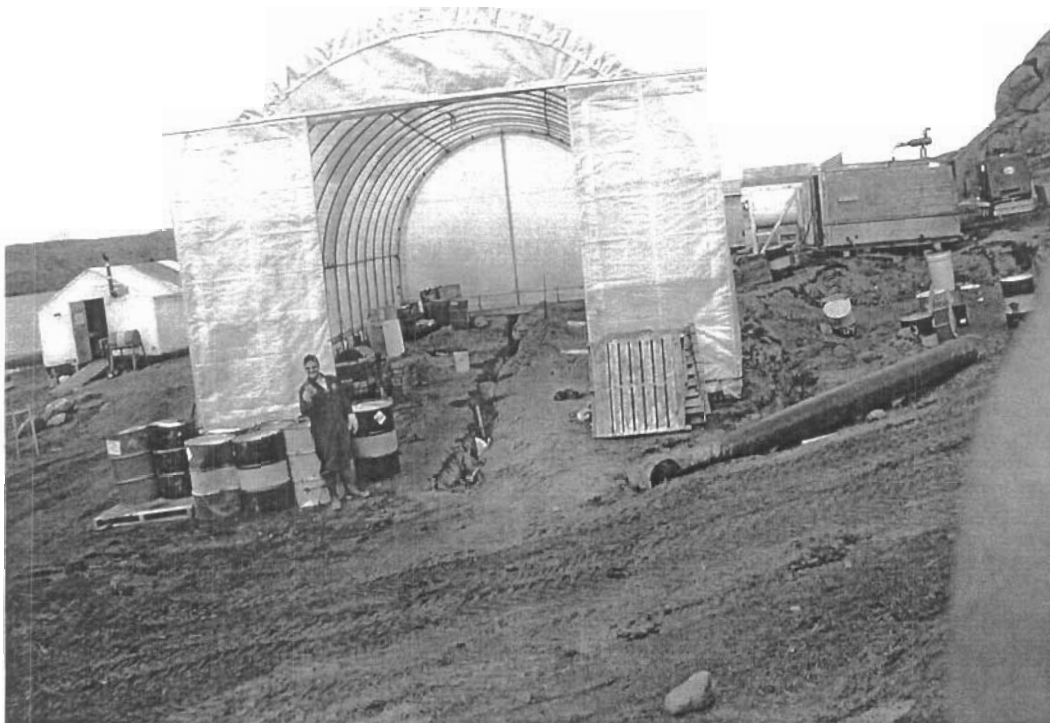
As a further monitoring tool, and as mentioned above, a cut-off trench was dug along the length of the large storage shed, including the excavation of test holes (4) within the trench and down-slope inside the storage shed as well as another test hole (1) further down-slope and outside the storage shed (see Photo # 5). "Enviro-mat" absorbent material was placed in the trench and test holes (see Photo # 6), designed to collect any diesel fuel that accumulates within these test holes. Minimal diesel fuel is being collected on the "enviro-mat" and to monitor any collection of diesel fuel, the "enviro-mat" is being monitored daily and if required, disposed of in the incinerator. Site personnel will continue to observe these locations, however; the information collected to date indicates that minimal fuel is reporting to these locations, a further indication that the remedial measures taken by site personnel in response of this spill incident, confirms that most of the diesel fuel has either been recovered as liquid or in the excavated material mentioned earlier. We estimate that 99% of the fuel spilled has been recovered, again, either as recovered liquid or in contaminated soil.

Photo #5: Trench and test holes in storage shed.

Although the potential of diesel fuel entering any water body is very remote, MHBL will monitor the site during the 2003 open water season, however; as the large storage shed is required for storage of critical equipment for the winter period, the trench and test holes will be lined with a significant amount of "enviro-mat", empty 45 gallon drums will be placed in the test holes and the area will be backfilled with uncontaminated material and leveled to facilitate the storage of the critical equipment. One of the test holes will be excavated in the summer of 2003 and based on the findings, further remedial action will be undertaken. It should be noted, however; that based on recent results, actions in 2003 are expected to be minimal.

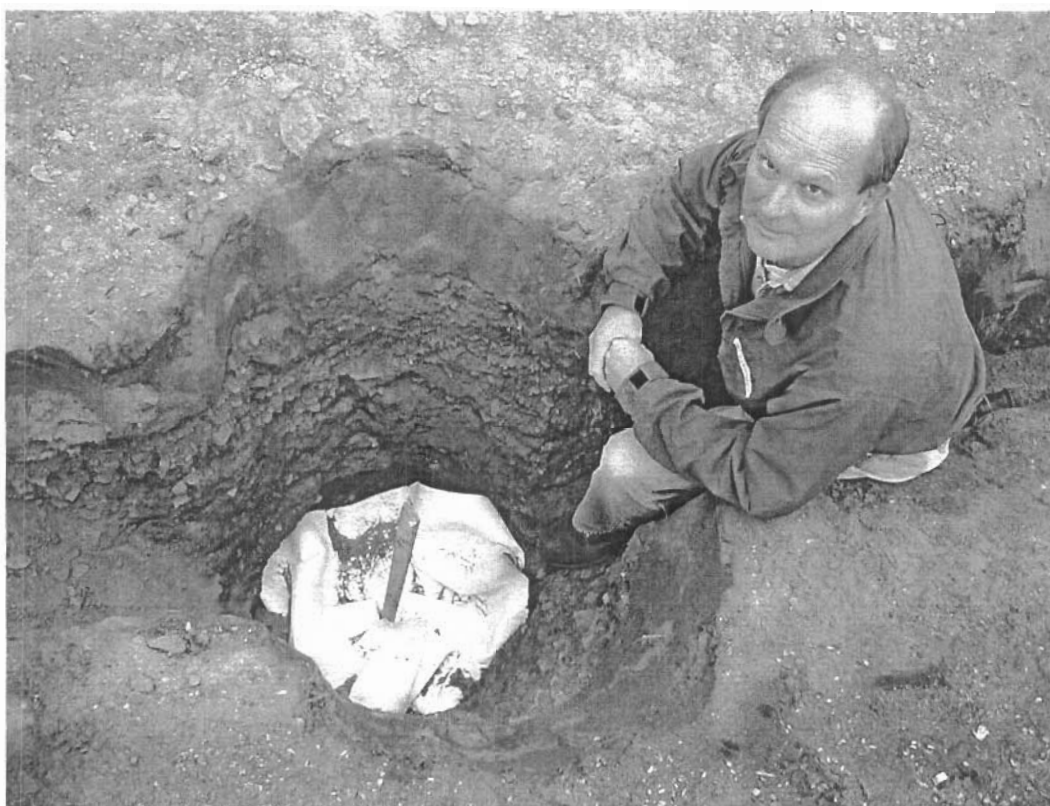
Photo #6: 'Enviro-mat' in test hole.

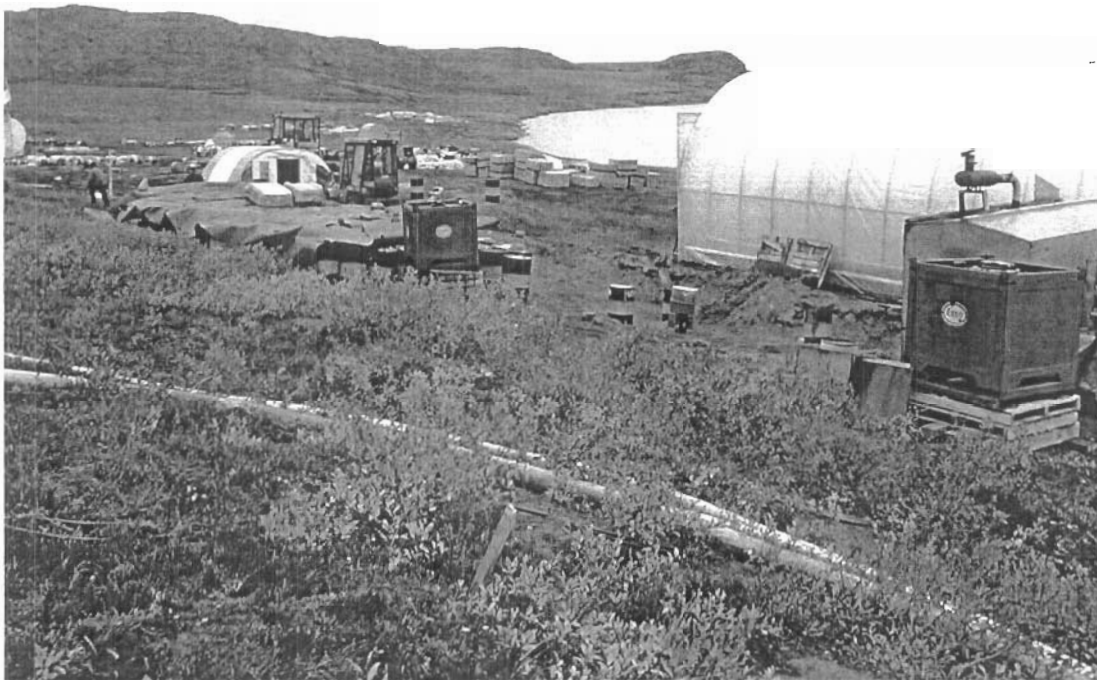
As mentioned above, contaminated soil has been transferred into 45 gallon drums (see photo # 7) for future disposal. Discussions with Environment Canada has indicated that the material could be placed on the proposed airstrip at the Doris Hinge project, once developed, as this is seen to be an acceptable method to "land-farm" this type of contaminated material. Final disposal practices will be provided after further internal discussions.

Photo #7: Drums under cover and cleaned area.

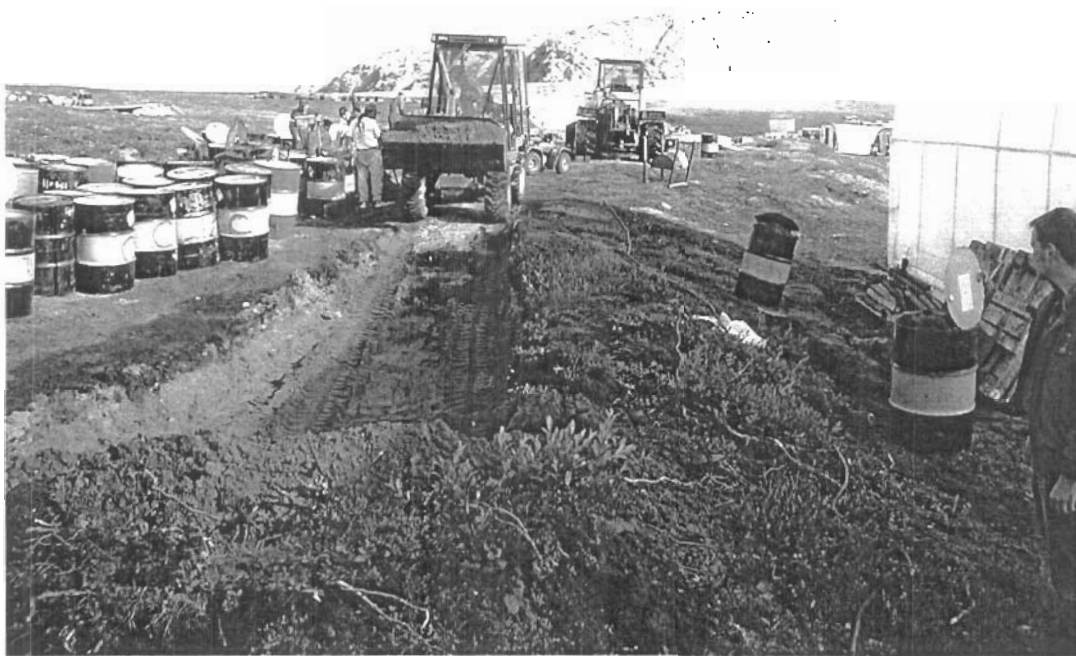
The area of the spill was underlain by 8" grass and organics, with coarse sand underneath. The grass and organic material was cleaned using absorbent 'enviromat'. This material, along with about 60cm sand underneath, has been recovered and transferred into 45 gallon drums. Two trenches were dug down-slope of the spill site one of which ran the full length of the large storage tent. The spill area is located approximately 120m from Windy Lake.

Photo #3: Kabota excavating contaminated soil.

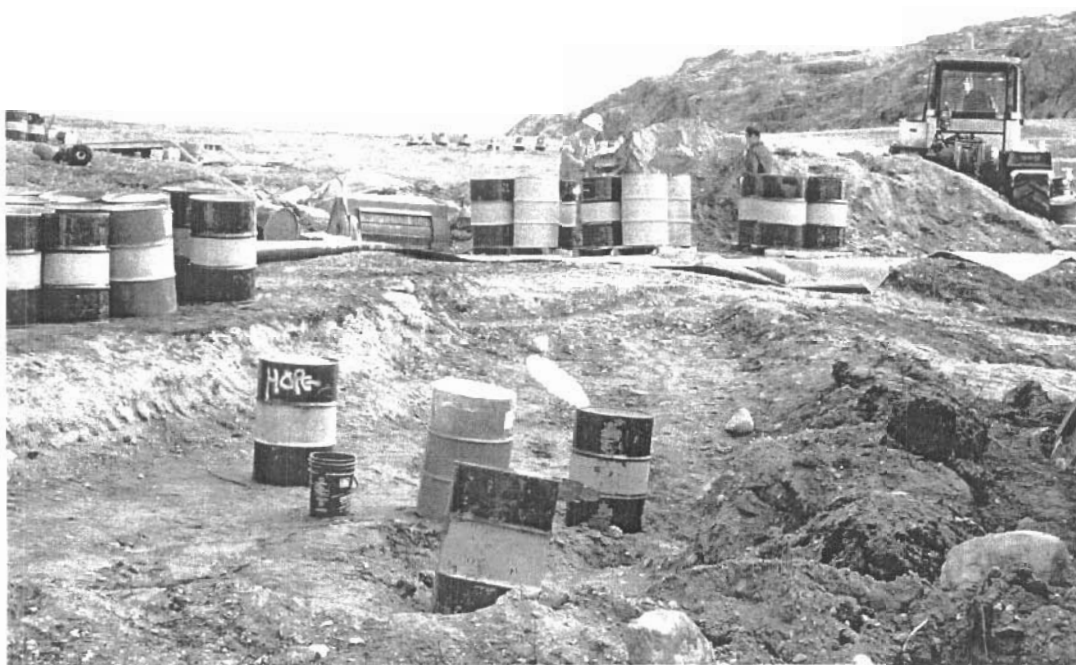
All of the camp crew and geologic personnel participated in the cleanup (mostly digging trenches and filling drums with contaminated sand and soil). A helicopter was dispatched to Boston Camp to retrieve remaining geotextile fabric and HDPE liner material that was used in the construction of the tank farm at Boston. Saturated soil was excavated using the Kubota tractor and the soil was temporarily stored on the area covered by the HDPE liner material until it was transferred into 45 gallon drums (see Photo # 3). The material has since been transferred to approximately 400 - 45 gallon drums and stored in an appropriate location, and final disposal will be undertaken once various options are investigated (See Photo # 4).

Photo #4: Transferring contaminated soil into 45 gallon drums.

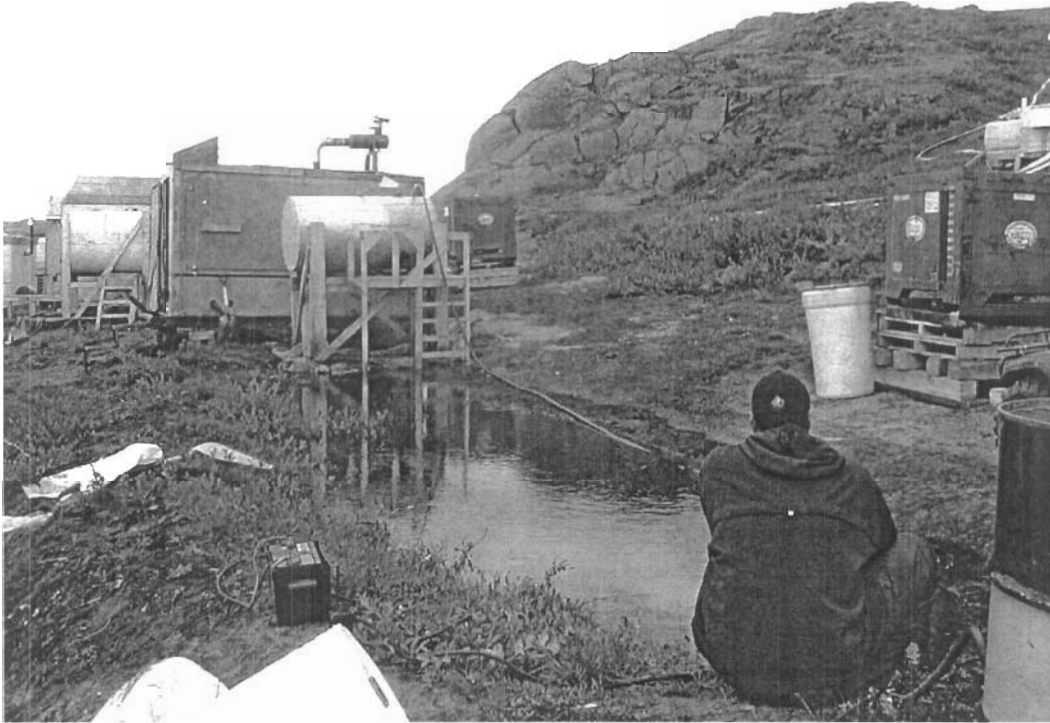
The generator fuel tank (the tank being filled) is located above a natural berm of sand and organic material, and the fuel ponded in a small depression just south of the generator fuel tank (see Photo # 1). When the spill was discovered, fuel was just starting to overflow through a small spillway previously dug through the top of the berm, to minimize runoff catchment in the area.

Photo #1: Generator tank and spill ponded behind natural berm.

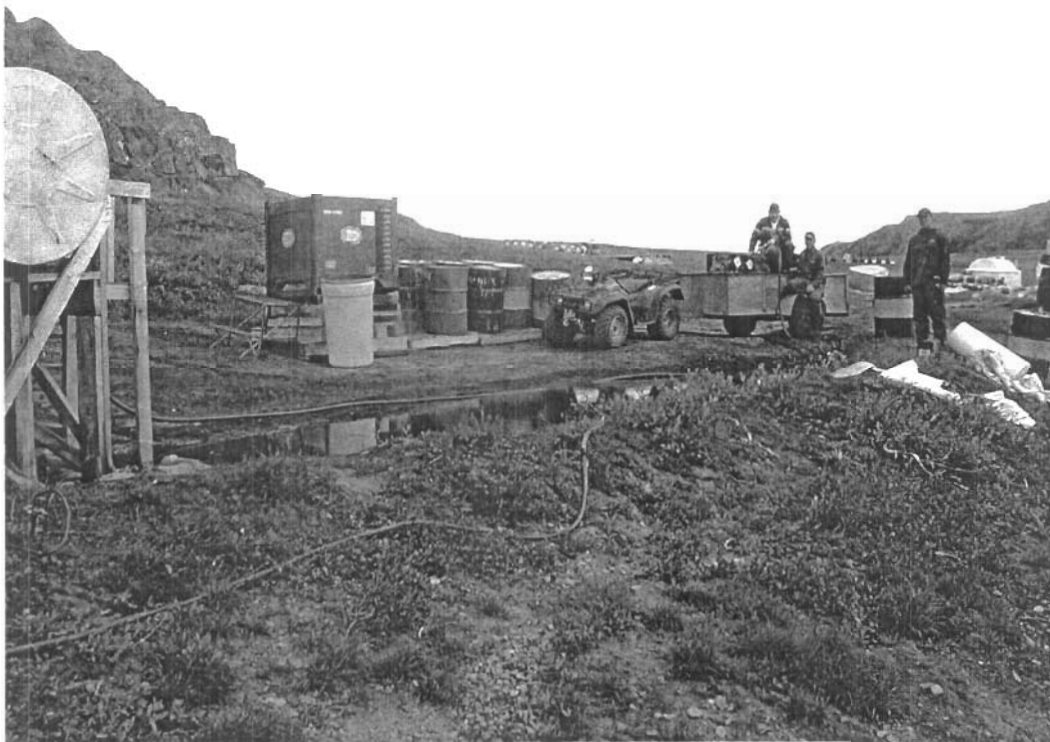
The Spill Response Plan was immediately placed into action. Standing fuel was pumped into 45 gallon drums from the ponded area (see Photo #2). An estimated 3300 litres (16 Drums) of liquid was recovered.

Photo #2: Standing fuel being pumped into 45 gallon drums.
