Windy Lake Camp Treated RBC Effluent Incident Report
Spill Number #08-061

HOPE BAY MINING LIMITED

March 2008

In-house Document # HBMLENV 01 2008
March 2008

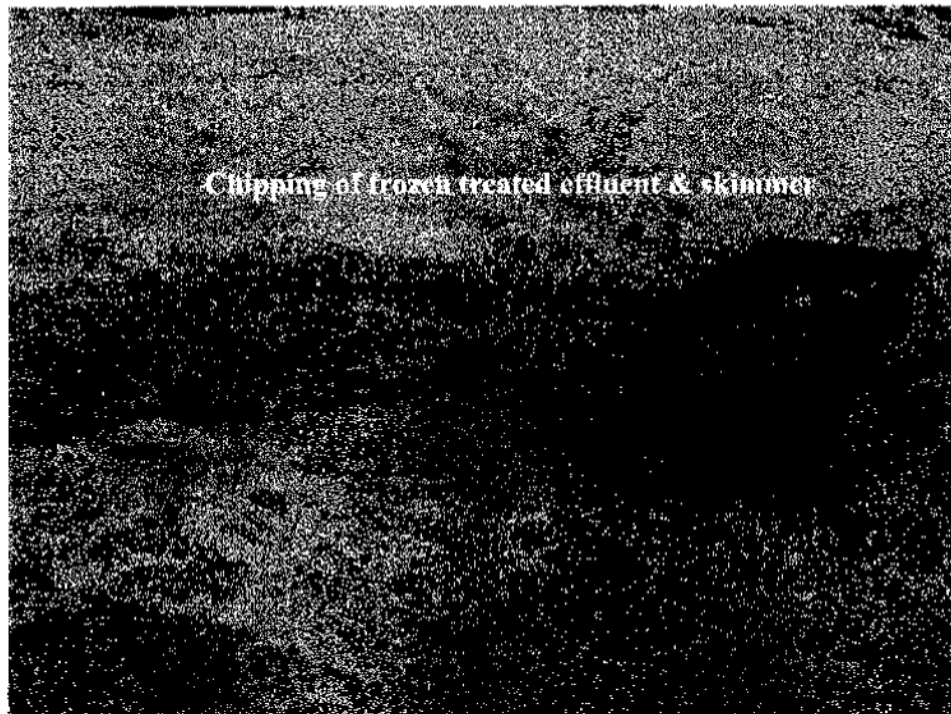
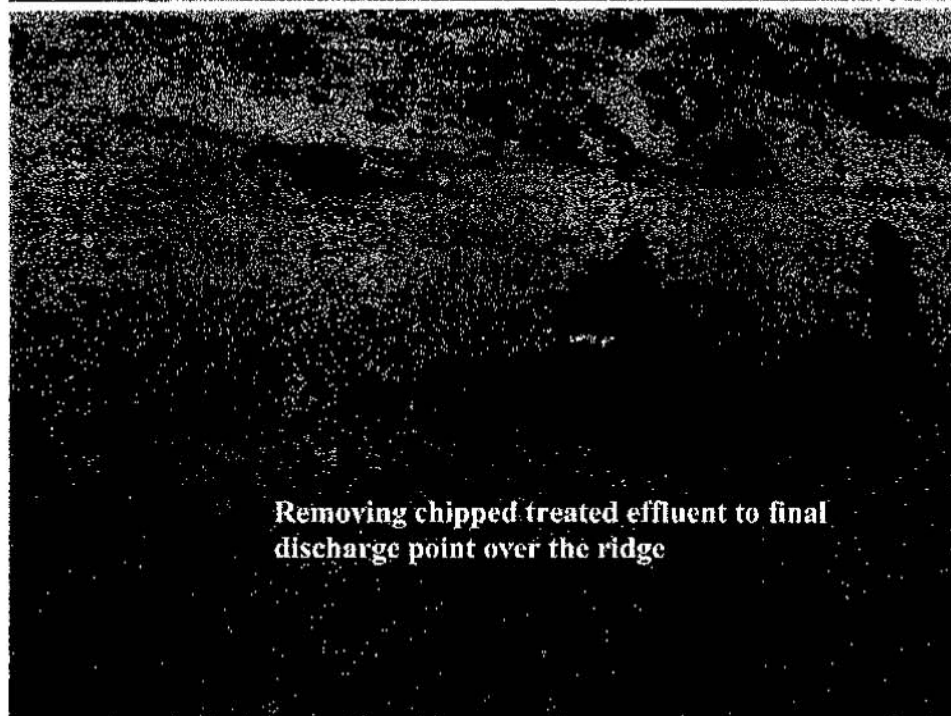
7.5 Appendix E – Pictures of Clean up

On February 20, camp crew started chipping off the frozen treated sewage effluent. This continued through the day until the weather changed and prevented further (Appendix E).

Corncobs were spread over the area influenced after chipping of the frozen treated sewage effluent was stopped. The intent is to absorb any residual water once the temperature gets warmer.

On February 20 2008, camp maintenance started chipping frozen treated effluent out and hauling it inside skimmer to the final discharge point over the hill east of Windy Camp to be co-disposed together with the normal treated effluent. Chipping of frozen treated effluent stopped when it become impossible to chip any further.
