2BE-IZO0712 Inspection of July 3rd, 2012

Photos from Inspection

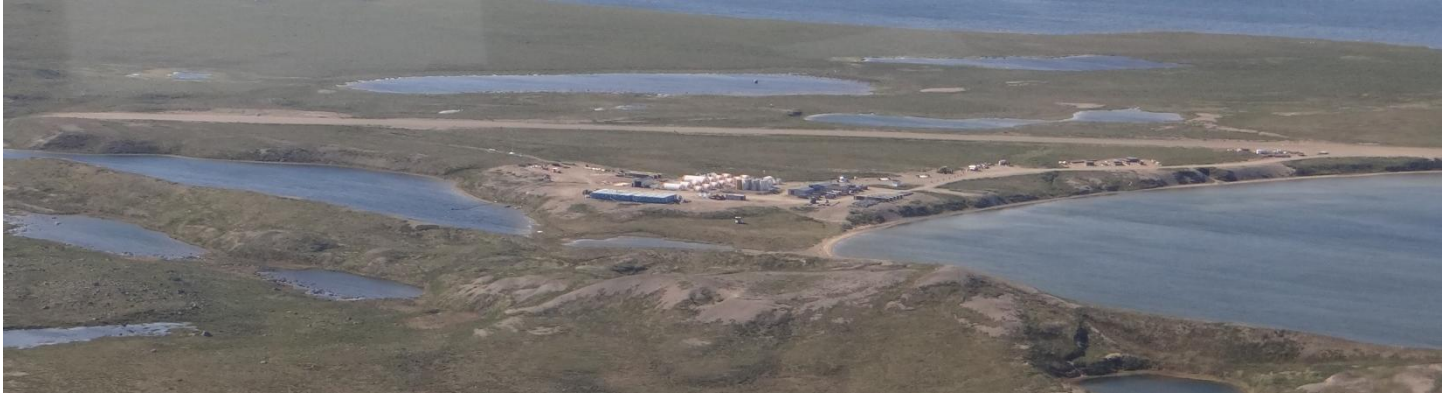
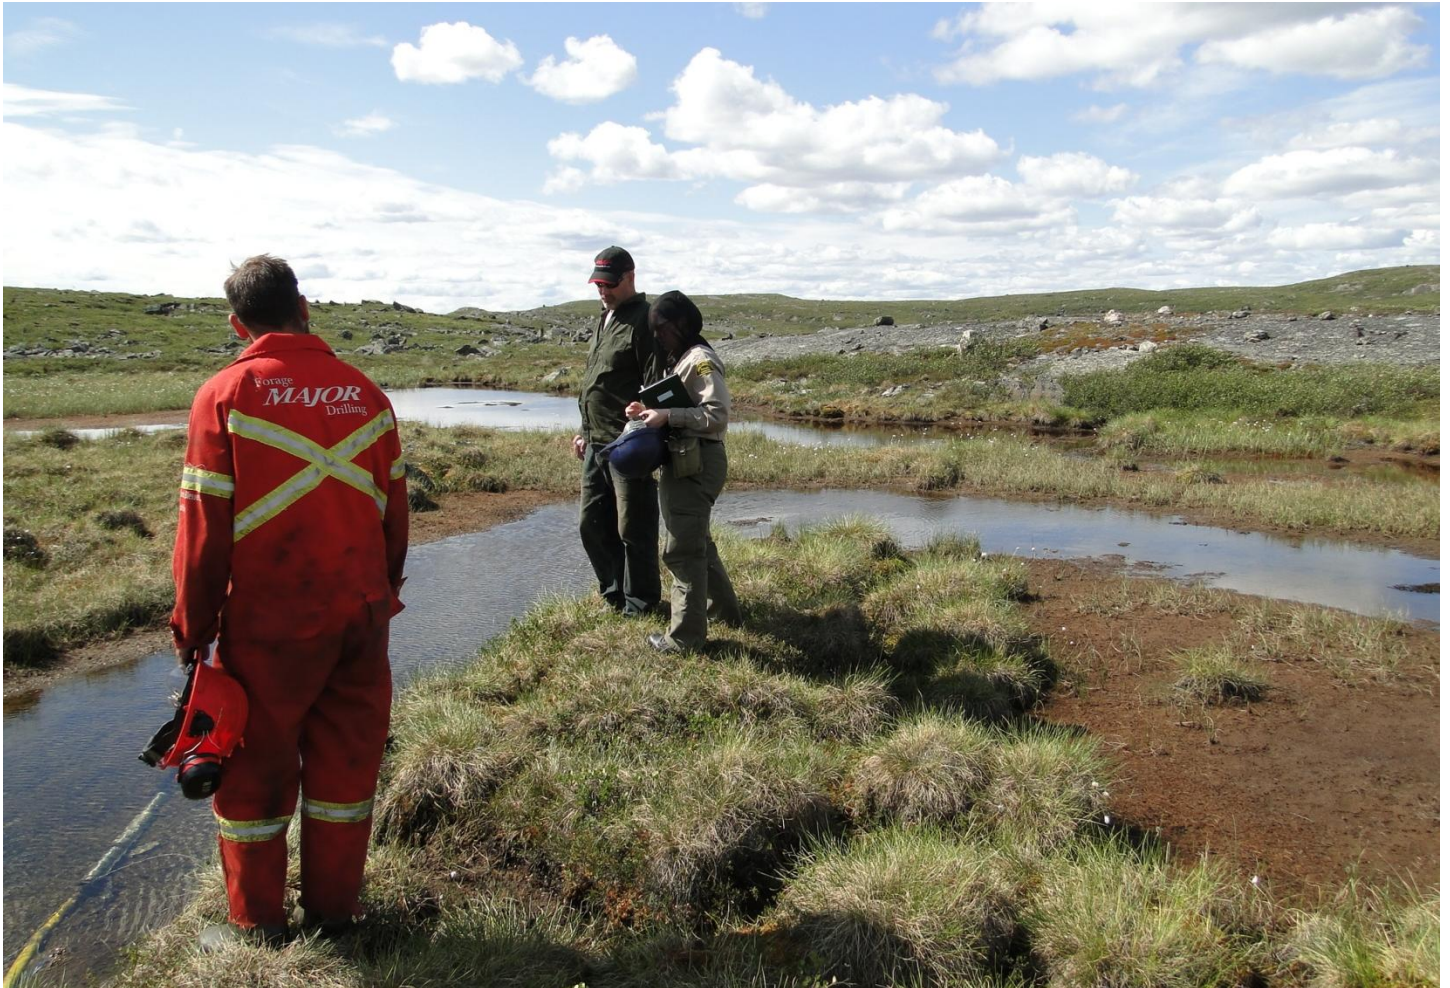
Figure 1. Water source in use for Drill 1466. Screen visible on the intake.

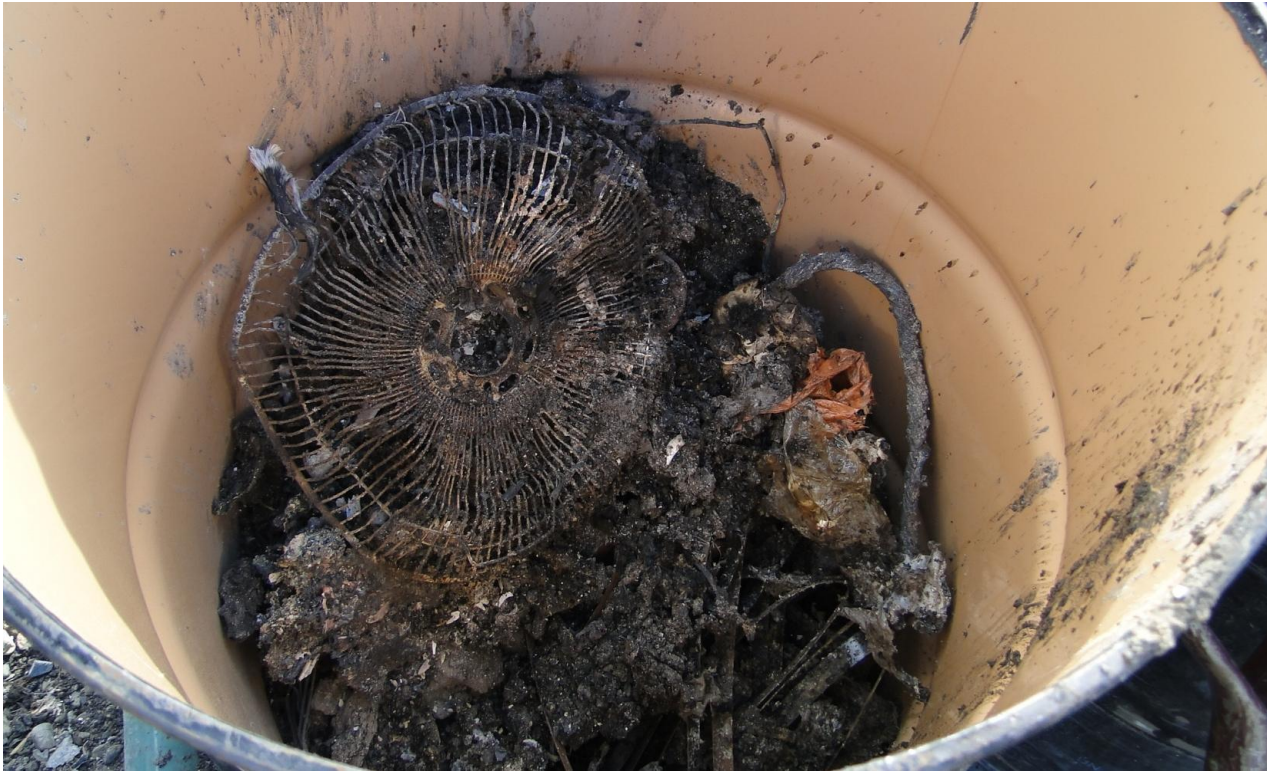
Figure 2. Waste from the incinerator, showing items which are not to be burned.

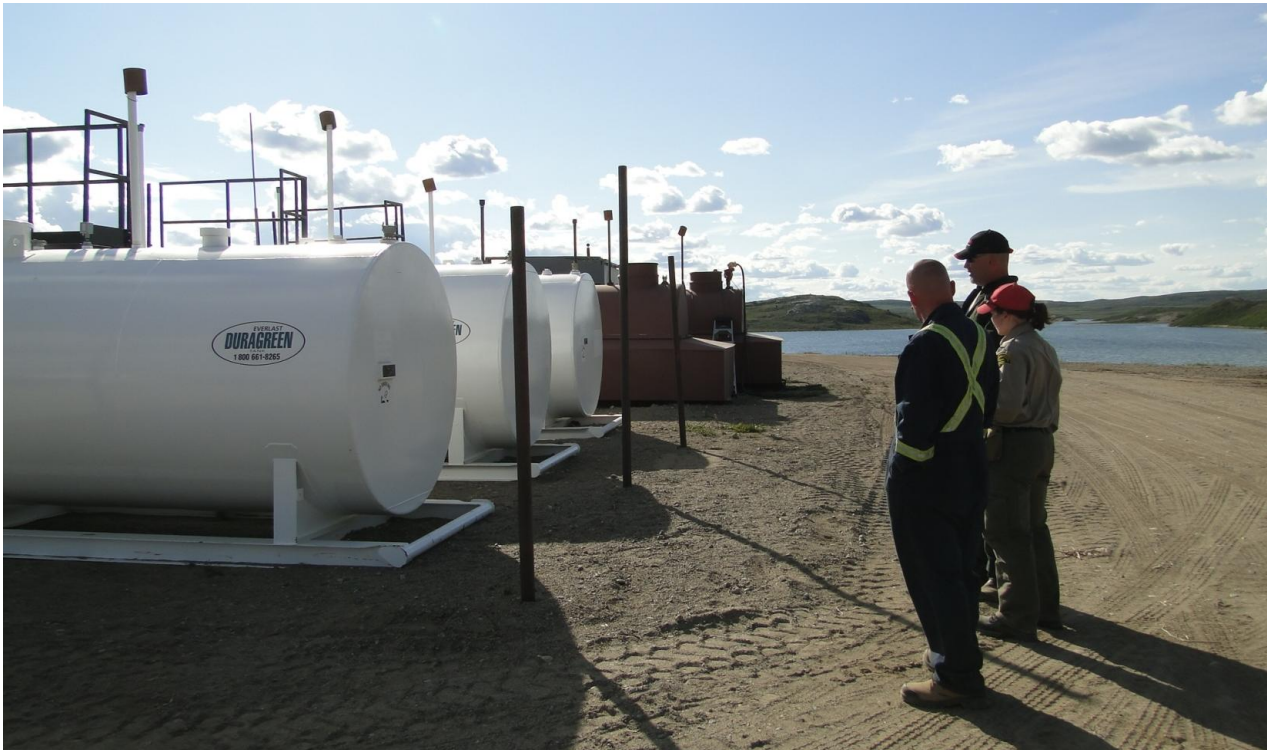
Figure 3. New 11,000 L tanks.

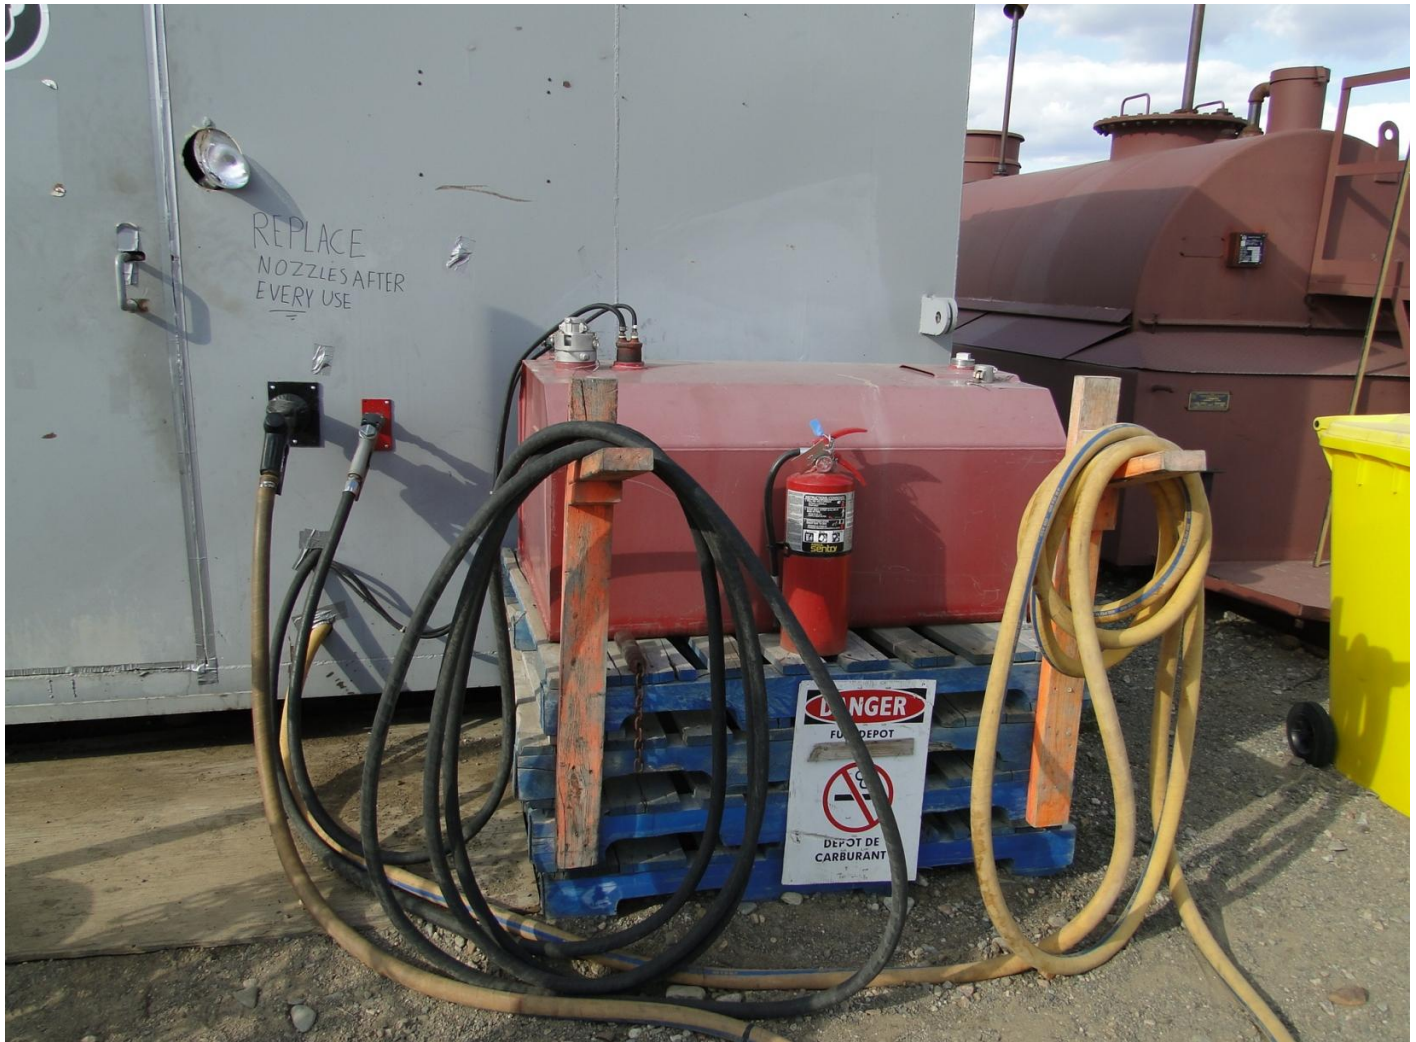
Figure 4. Fuel Transfer Station. Nozzles contained to avoid drips; spill kit visible.

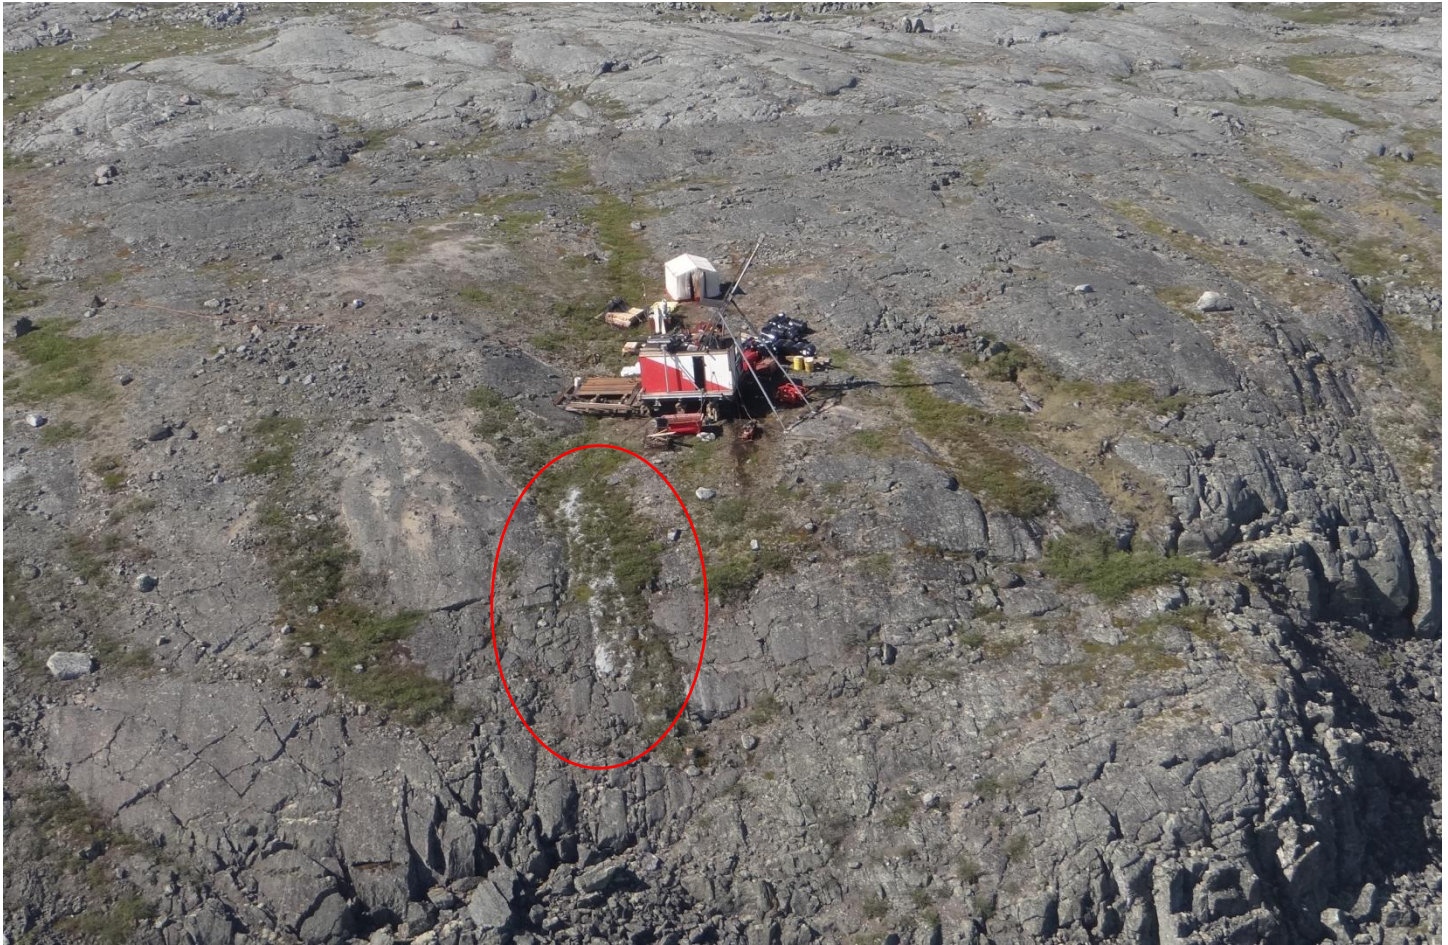
Figure 5. Drill 1493, with drill waste spilling down the side of the hill.

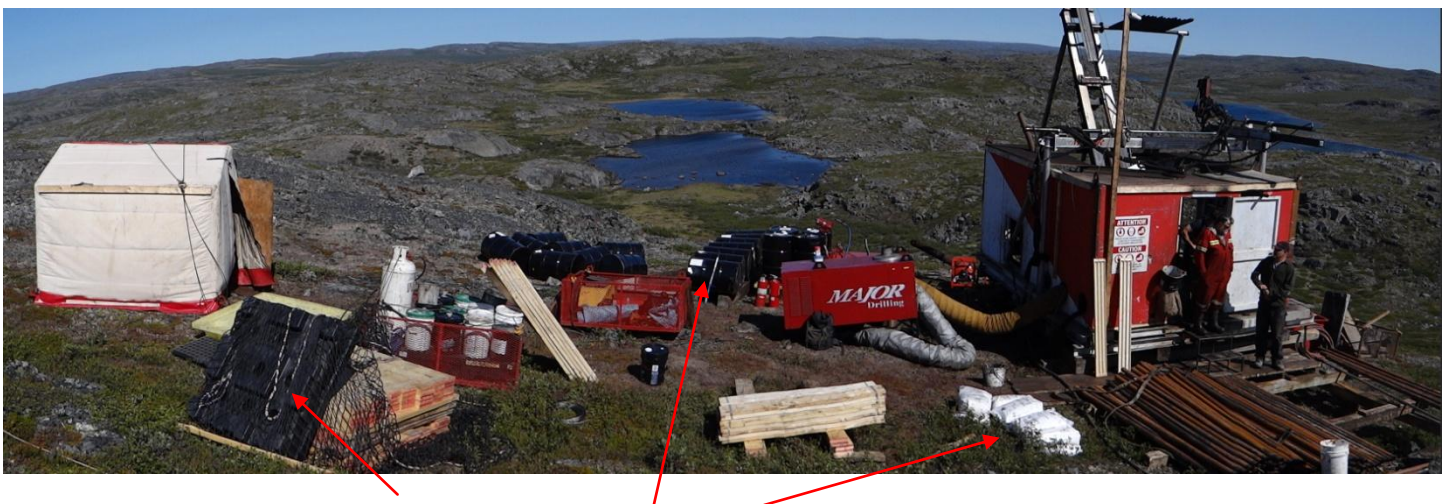
Figure 6. Drill 1493 setup - showing pallets sitting unused, while fuel and salts have no containment.

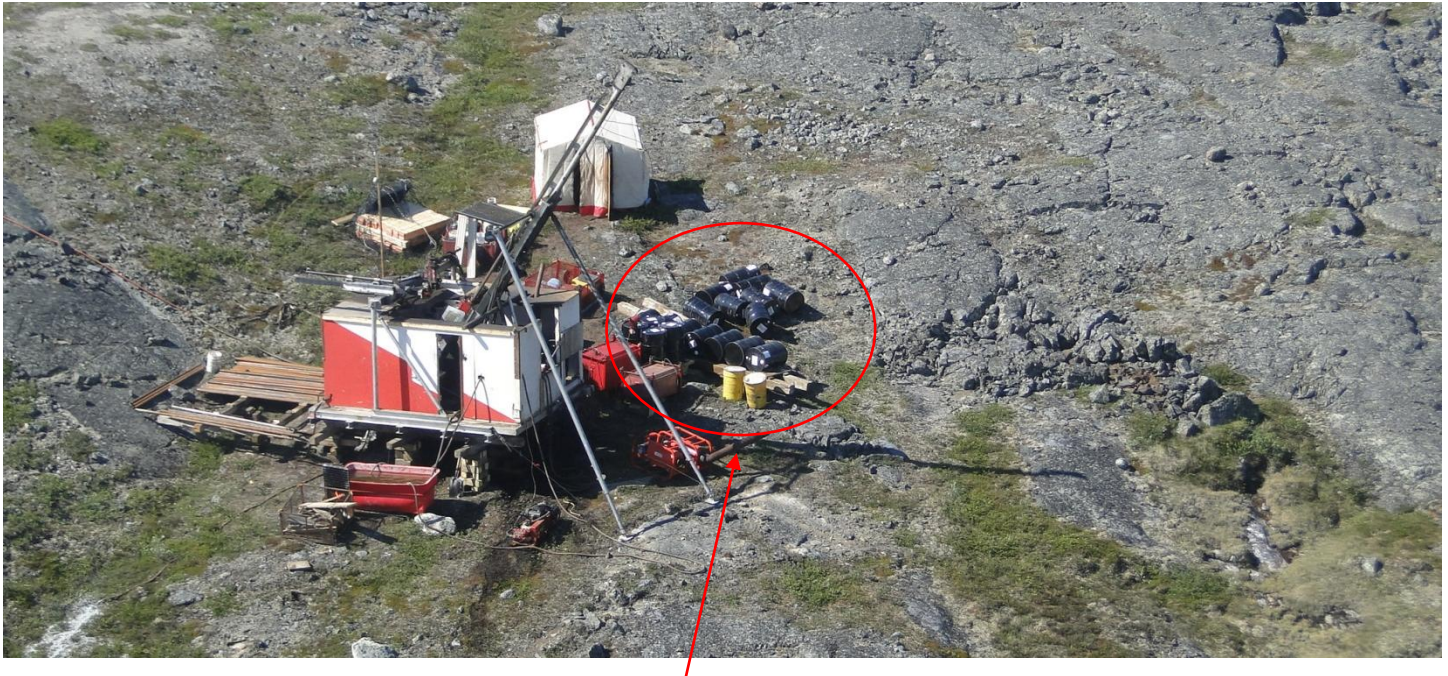
Figure 7. Drums held on timbers, sloped off the hill at a downward angle.

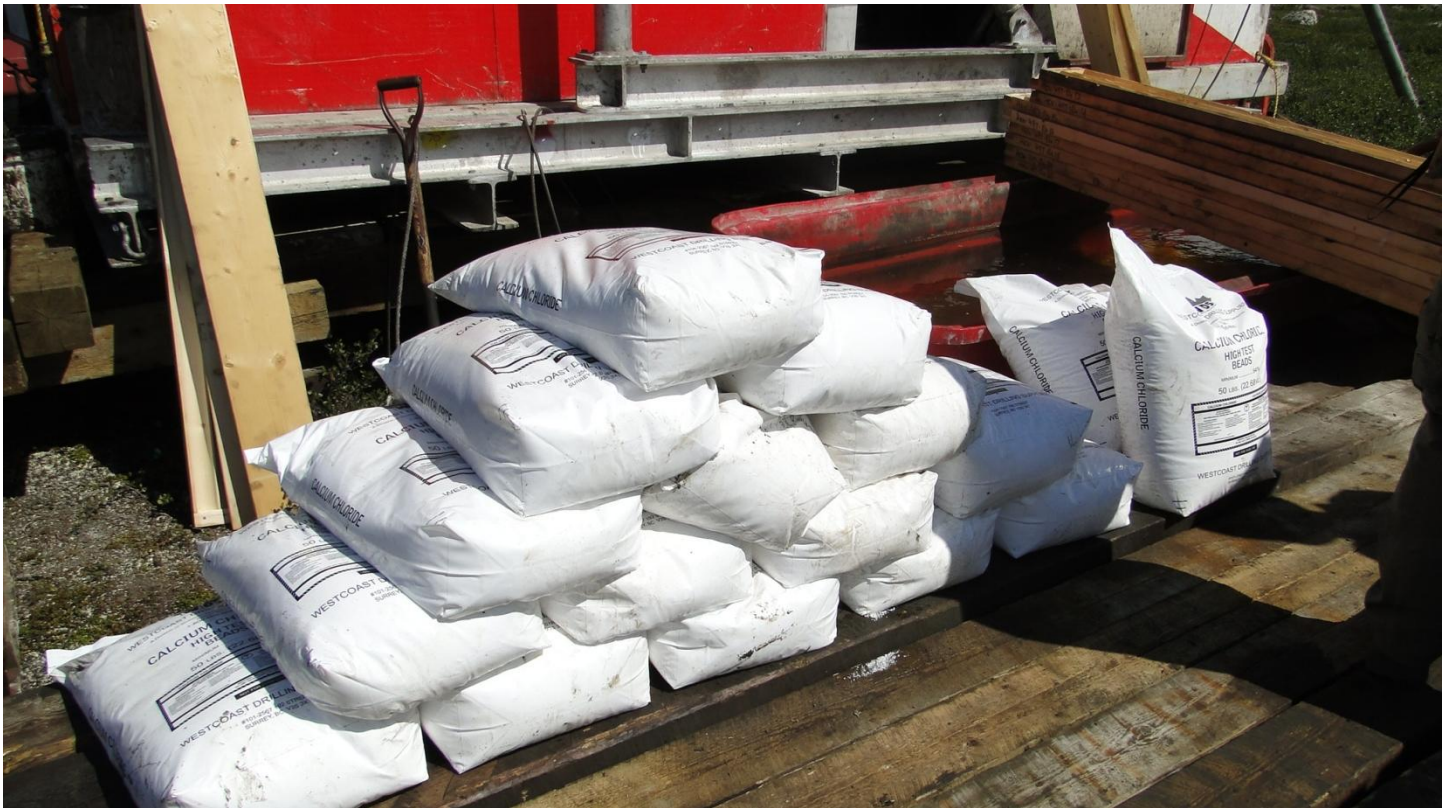
Figure 8. Salt stored without containment.

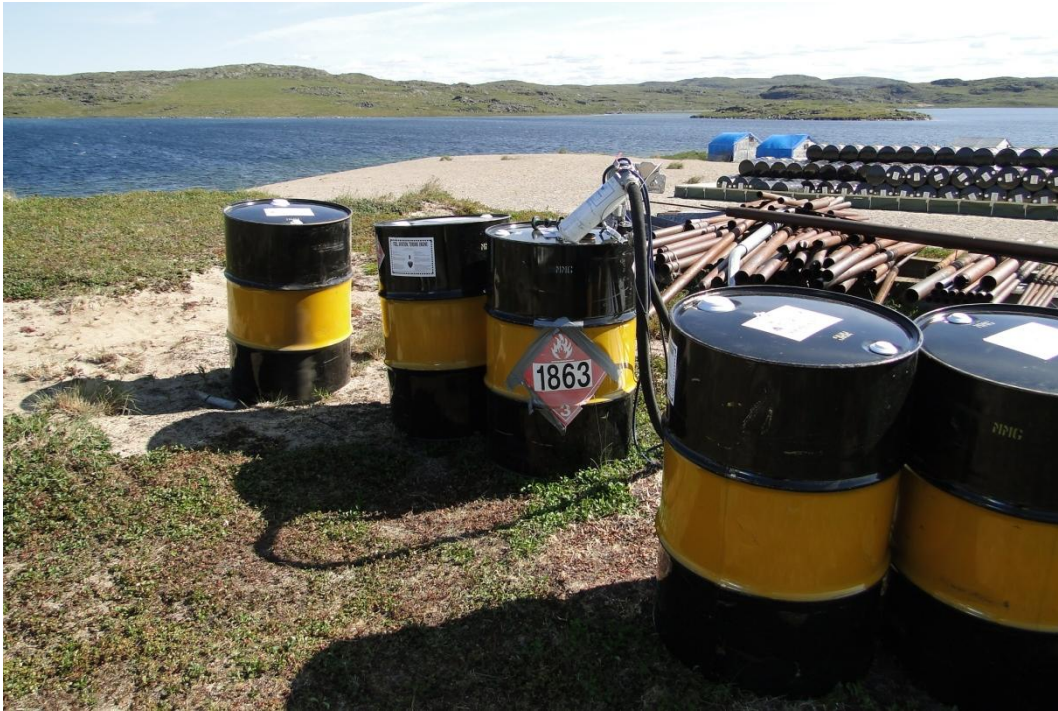
Figure 9. Hood helicopter refueling area - no secondary containment.

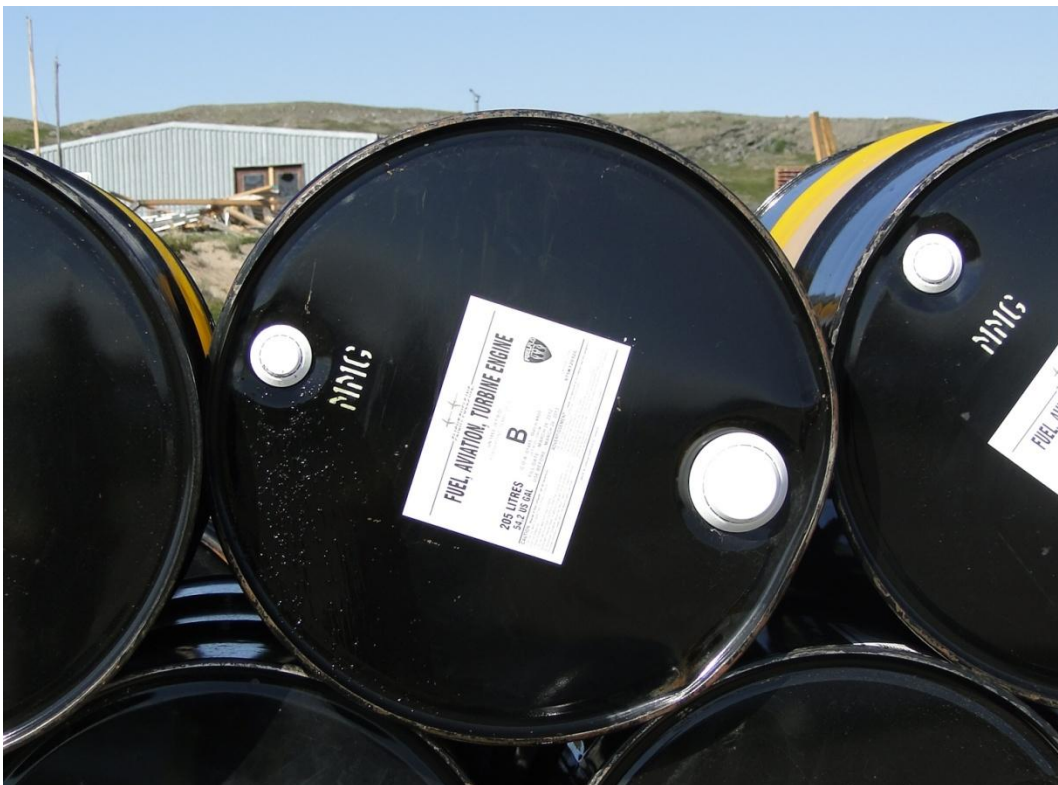
Figure 10. Leaking barrel at Hood.

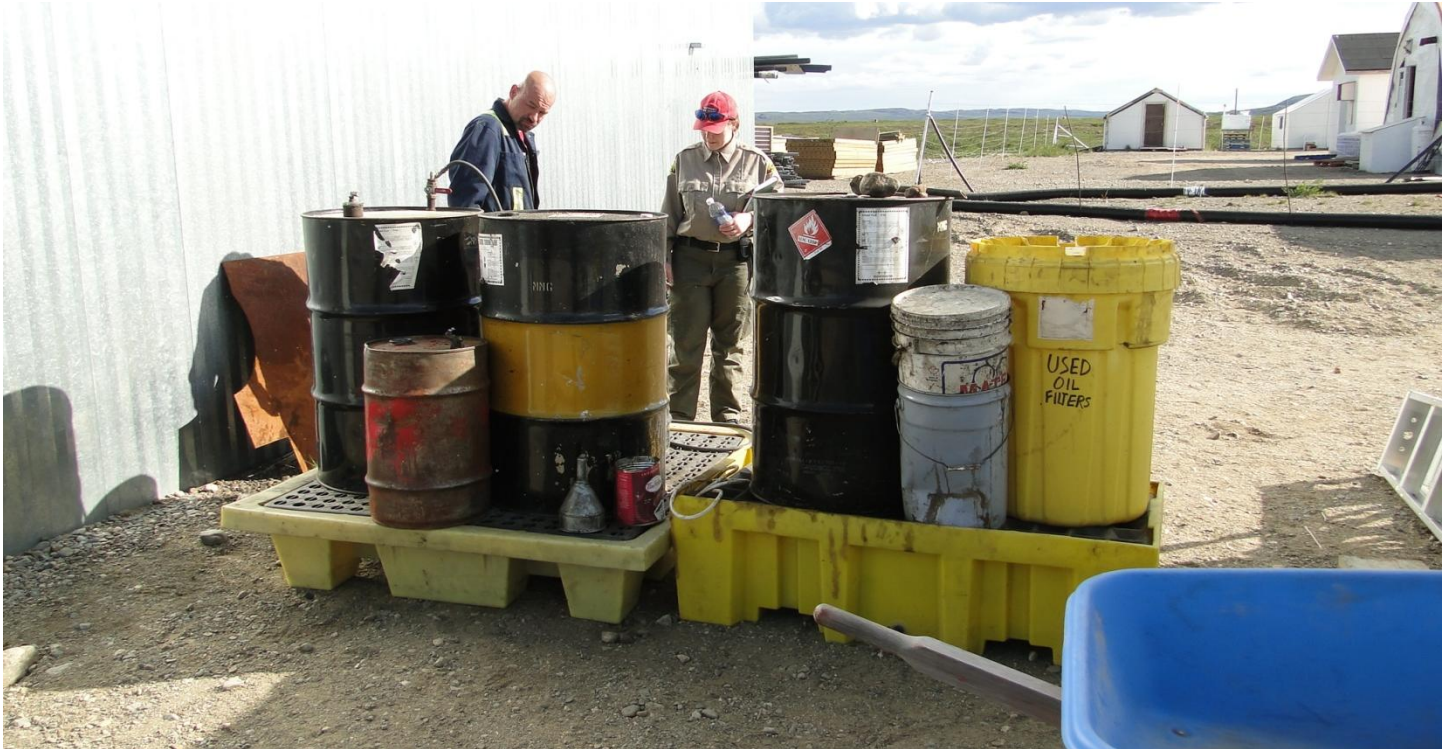
Figure 11. Good use of containment for waste products in camp.

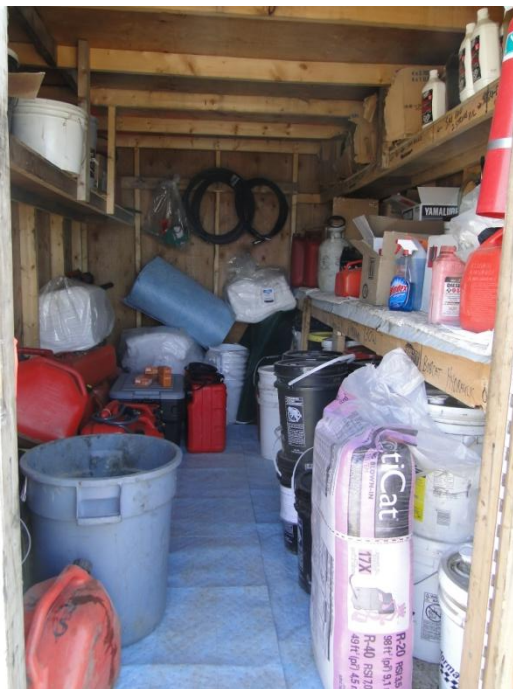
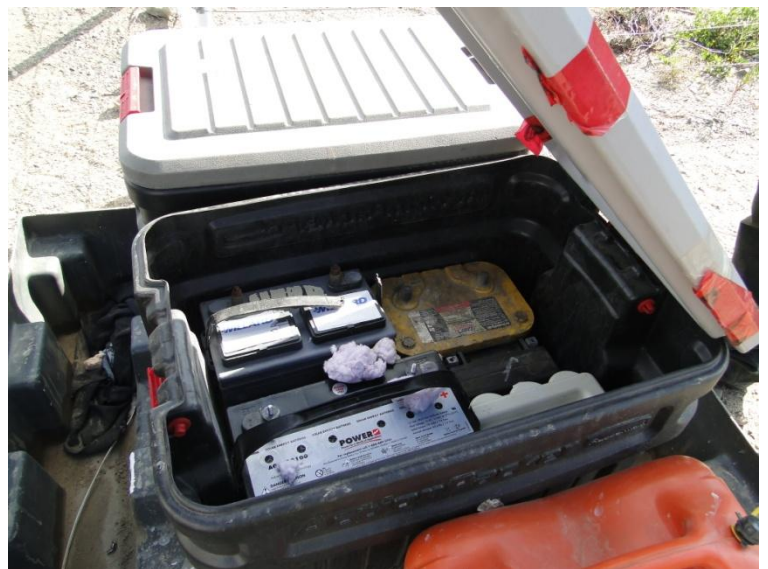
Figure 12. Absorbent beneath jerry cans as preventative measure. Waste batteries contained in suitable bin.

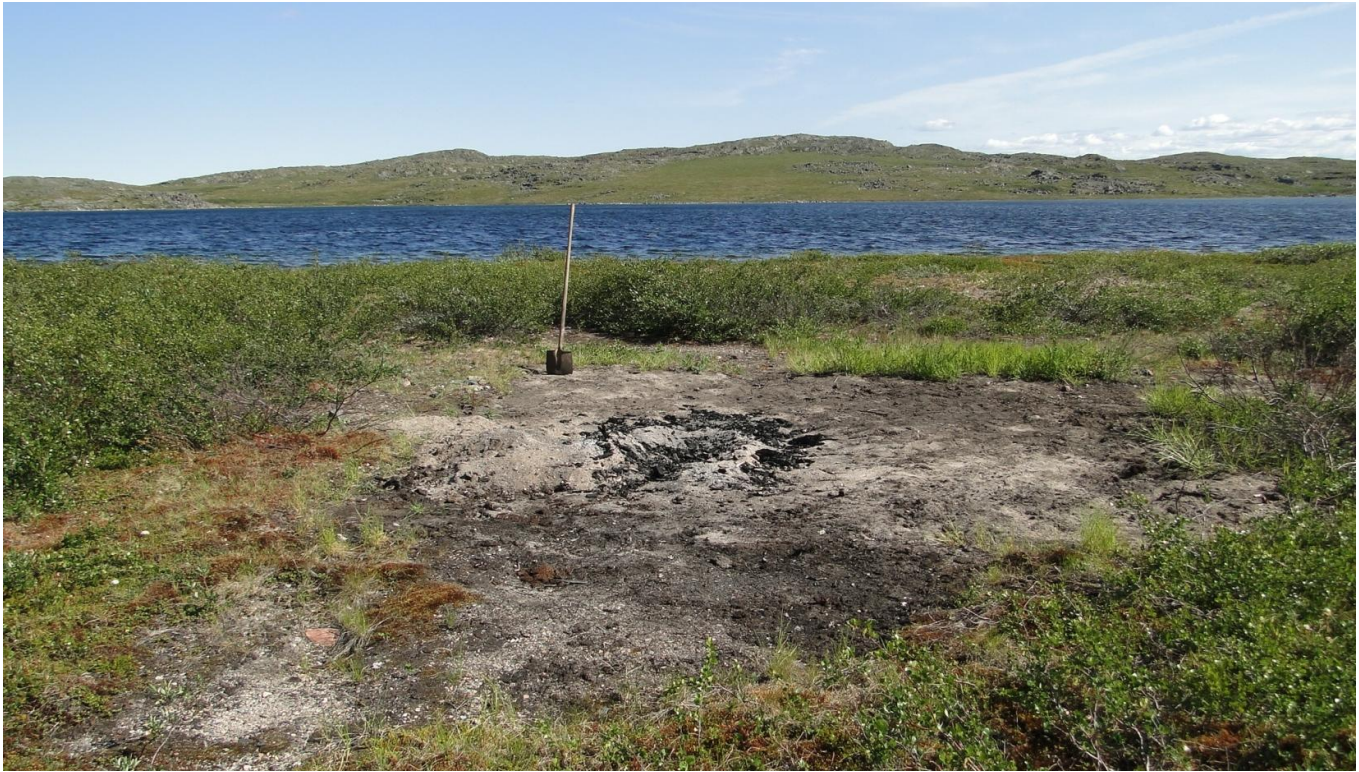
Figure 13. Ashes remaining after burning of camp structure at Hood.

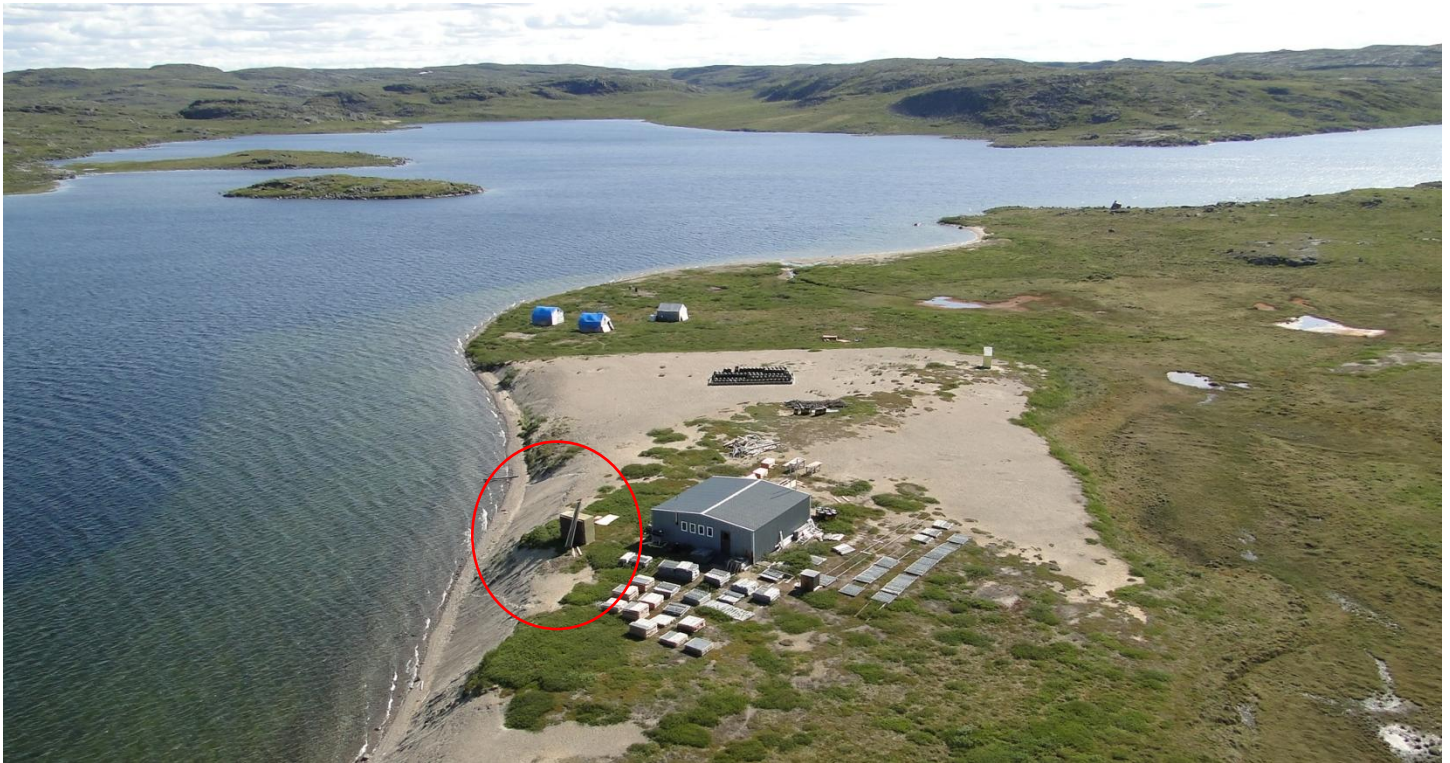
Figure 14. Core rack possibly <30 m from high water mark.
