Attachment 12 – Inspections and Responses

CROWN LAND USE INSPECTION FORM

WATER LICENCE INSPECTION FORM

Reference: Ham Lake Camp Inspection

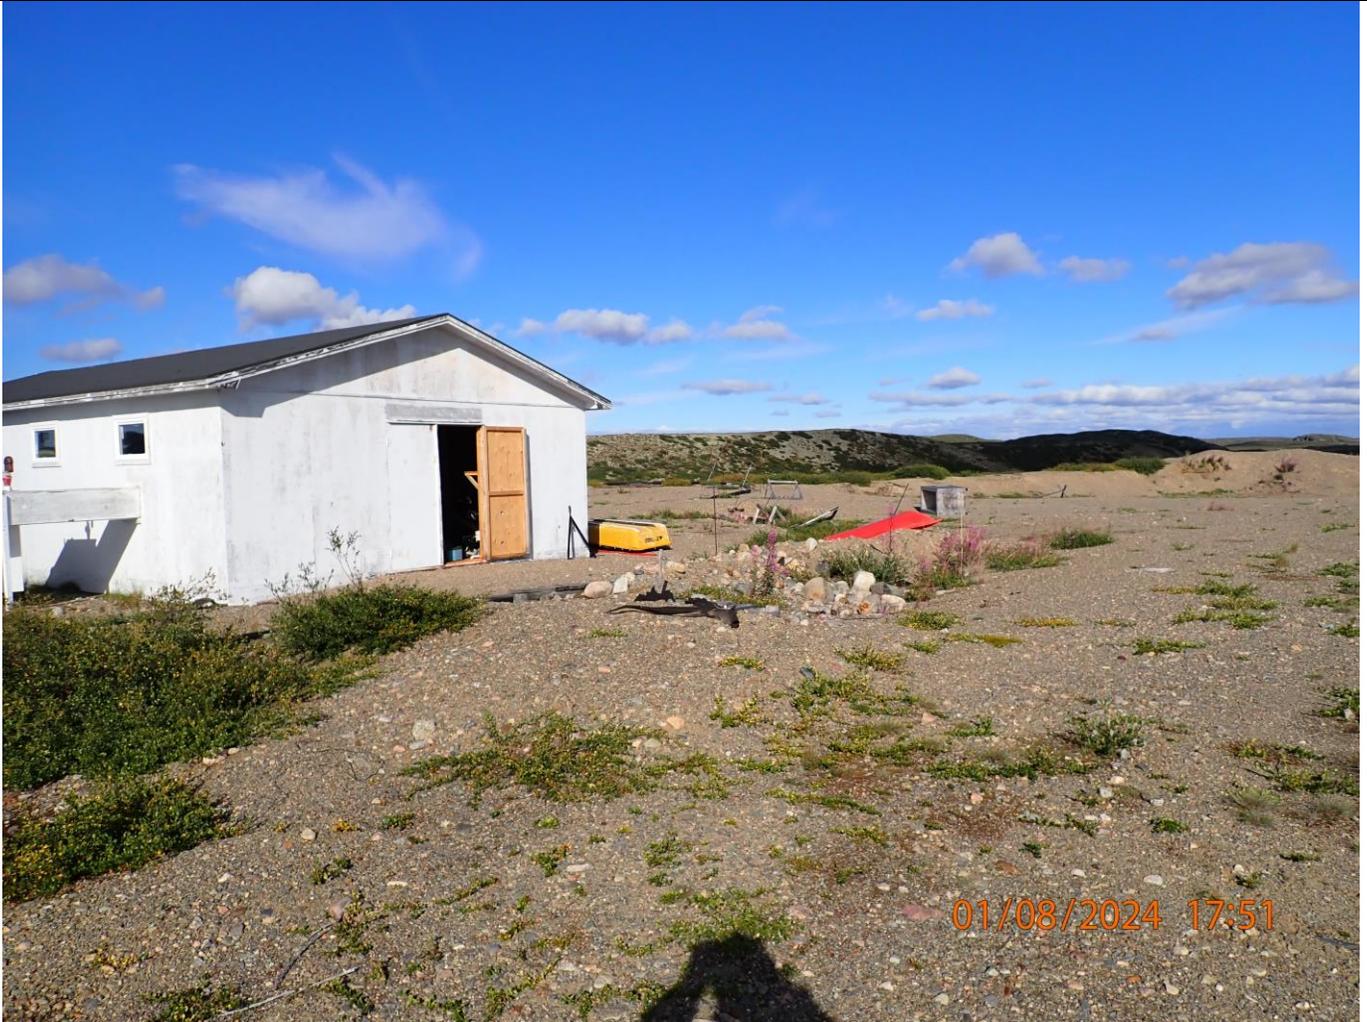
Photo 4

1. Inspectors arrive on site at 5:40pm on August 1, 2024. Aerial photos were taken (Photo #1, #2, #3)
2. During the inspection the Inspectors noted several buildings with their doors open. 1 weather haven had its door open, the core shack had an open door, the building that houses the bobcat/skidoos and the garage beside it that houses the loader had their doors open. (Photo #4 shows the shop with a door open, this building stores skidoos and the bobcat inside, Photo #1 shows the garage door open) (Photo # 12 and #13 show the open door of the core shack and the inside of the core shack.)

Open door of a storage shed, inside are skidoos, equipment and a bobcat.

All buildings windows and doors shall be repaired and covered to prevent the entry of wildlife.

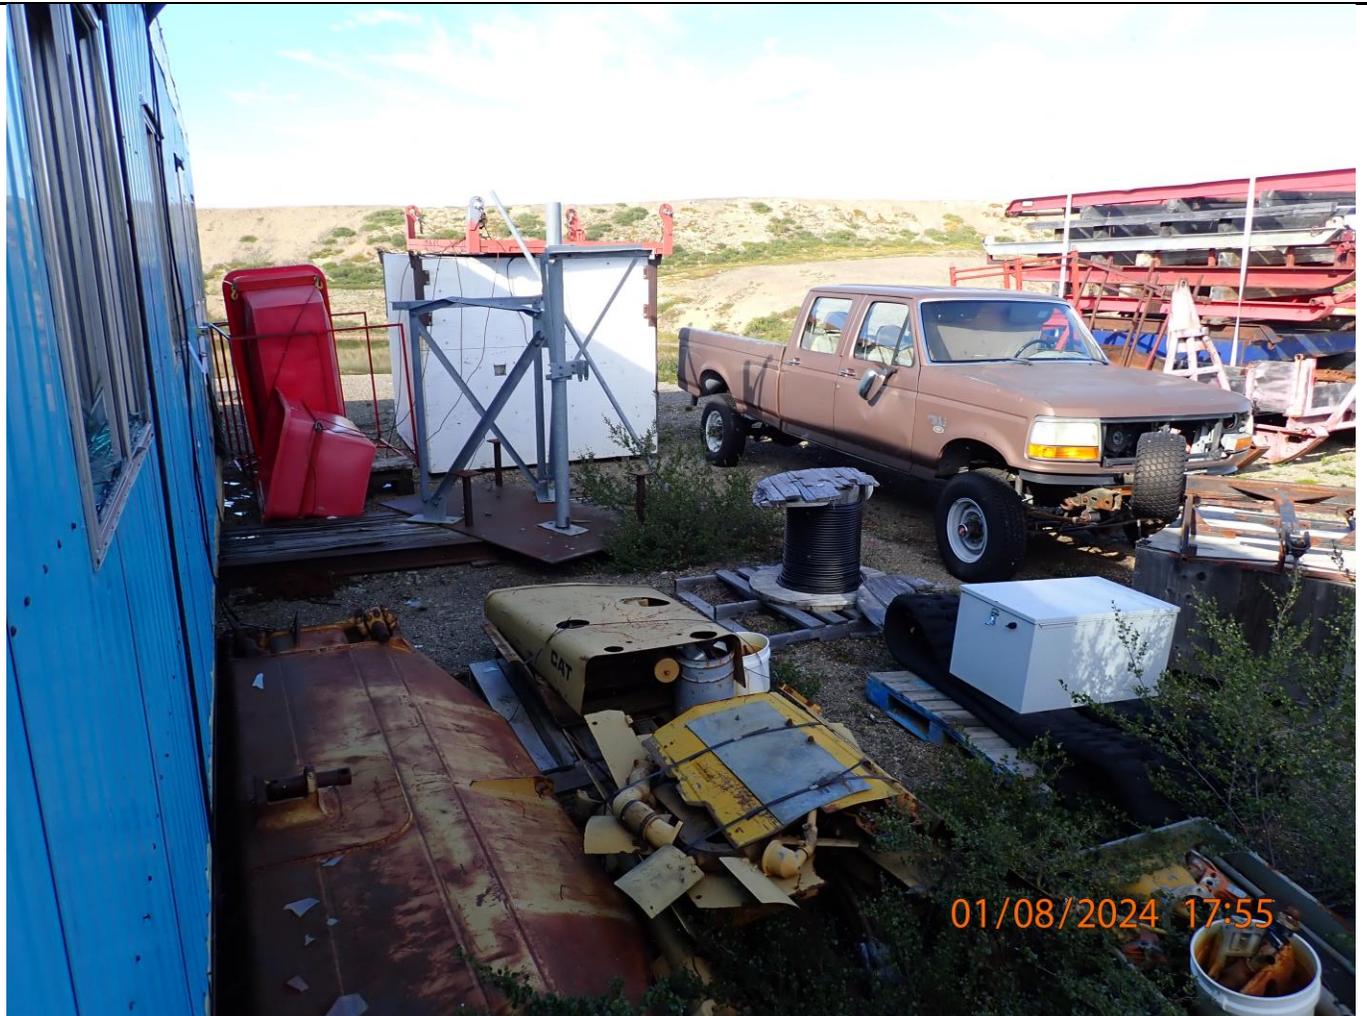
Photo 5

3. Various types of scrap metal and old parts were observed on site. All metal and parts were well sorted but anything not required for the project shall be removed from site. (Photo #5 and #6)

And old truck, old parts and equipment outside the old trailer accommodations.

All scrap metal discarded machine parts and unused equipment shall be removed from site.

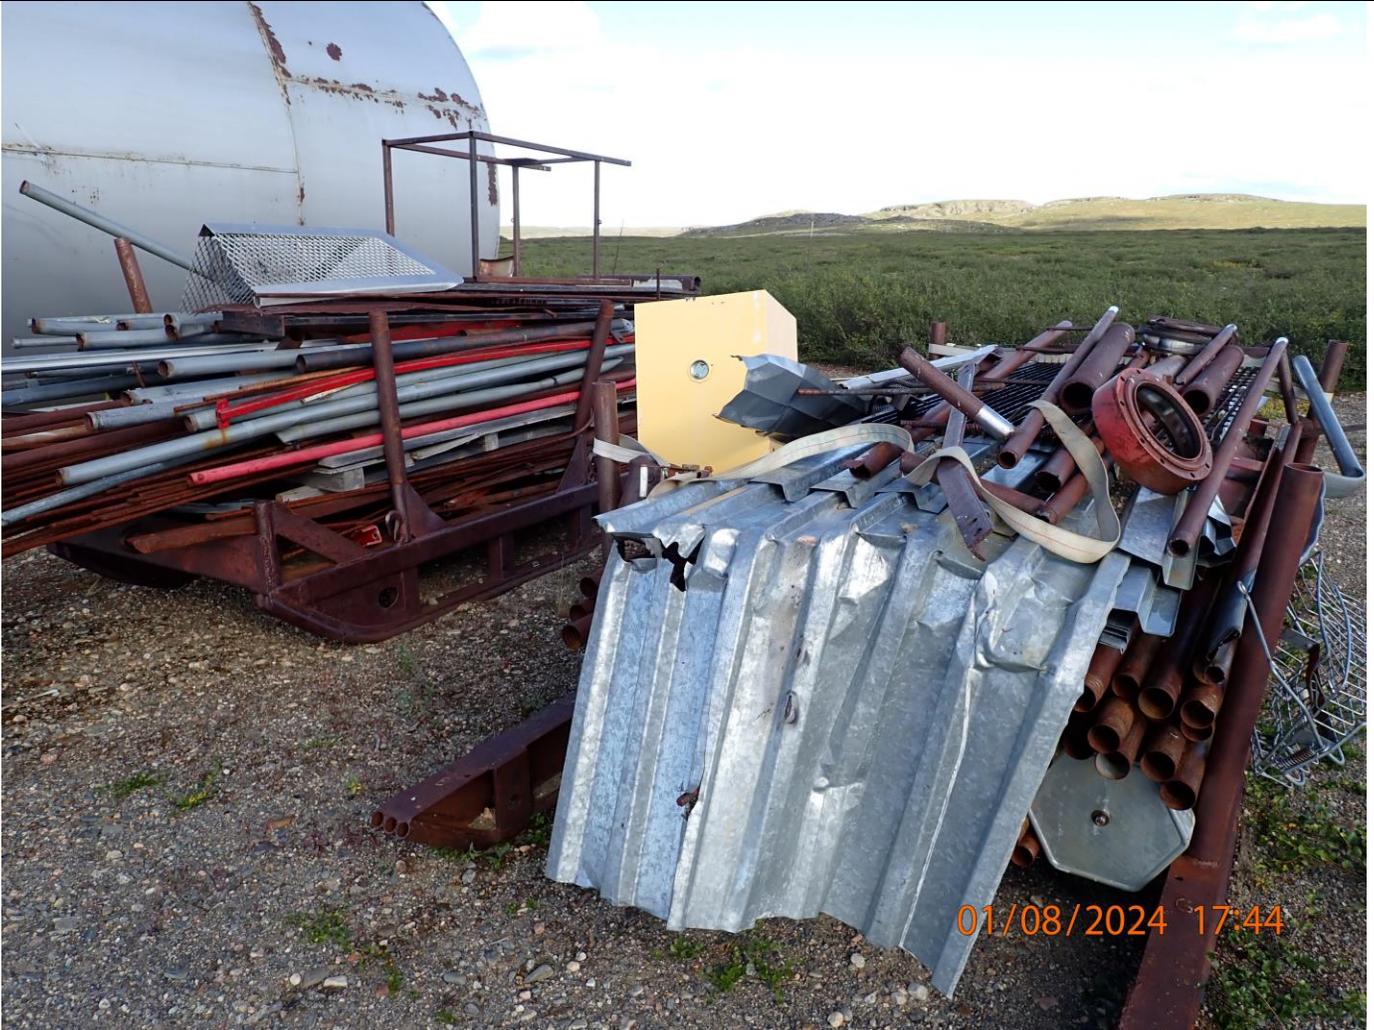
Photo 6

Scrap metals stored beside fuel tanks close to the airstrip.

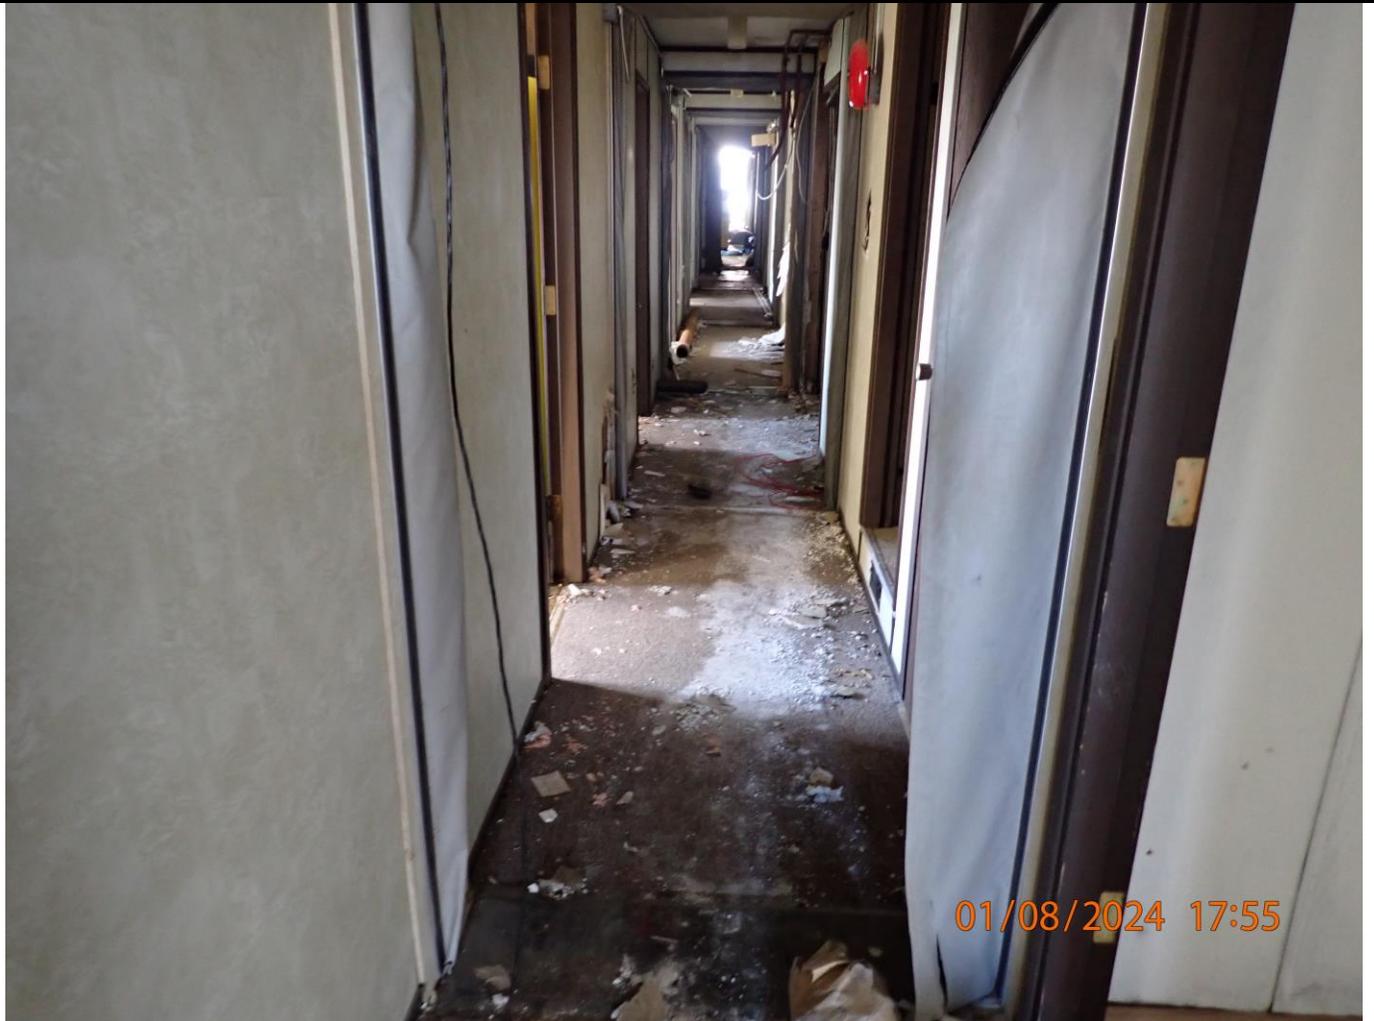
Photo 7

4. The old accommodations buildings (trailers) shall be removed from site at the earlier possible opportunity. A bottle of Nitric Acid was observed on a bed in one of the rooms along with garbage throughout the buildings. A lot of the windows were broken and some doors open, signs of bear activity were apparent throughout the trailers. Plants were observed growing on the floors and the old beds. It seems like the trailers are being used as a type of storage facility as it was observed that helicopter rigging gear, water pumps and various hoses and connections, Styrofoam, reflective insulation, absorbents (Can-Dry supreme all purpose absorbent), tools/chains, and other types of equipment were present inside the trailers. (Photo #7,#8,#9,#10,#11) All this equipment and garbage needs to be removed, stored properly and the trailers need to be seal shut and closed off until they can be removed from site.

View inside the old trailer accommodations. The door at the back was open, a lot of windows were open.

All the equipment and garbage/chemicals in the old accommodations trailers needs to be removed, stored properly and the trailers need to be sealed shut and closed off to prevent access by wildlife until they can be removed from site.

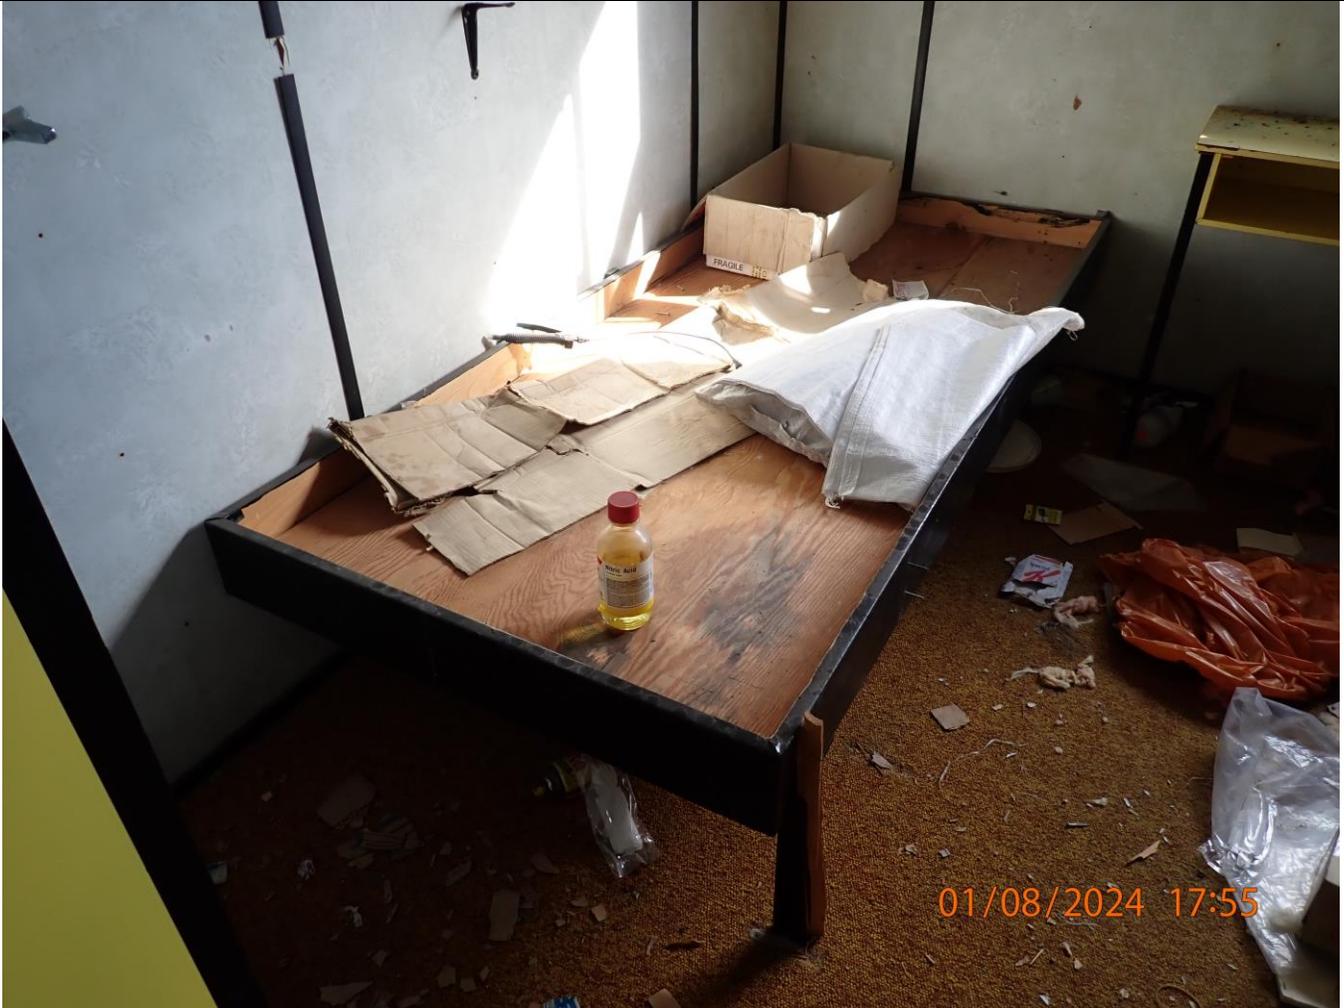
Photo 8

Nitric Acid on the bed. Garbage all over the room.

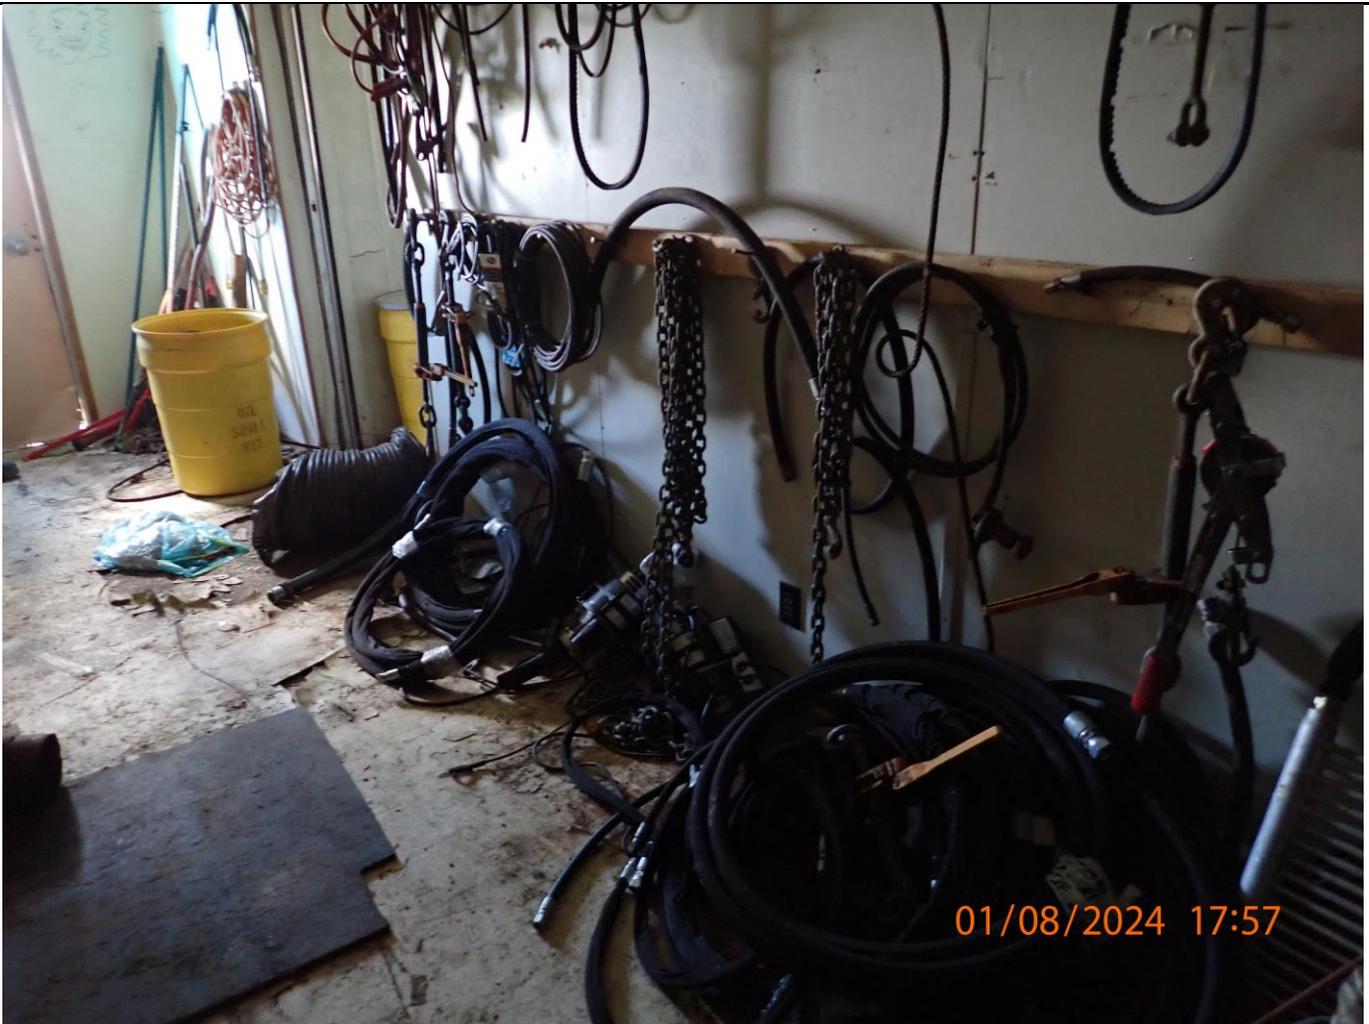
Photo 9

Chains, various hoses, water pumps, and other equipment stored in the old accommodation trailers.

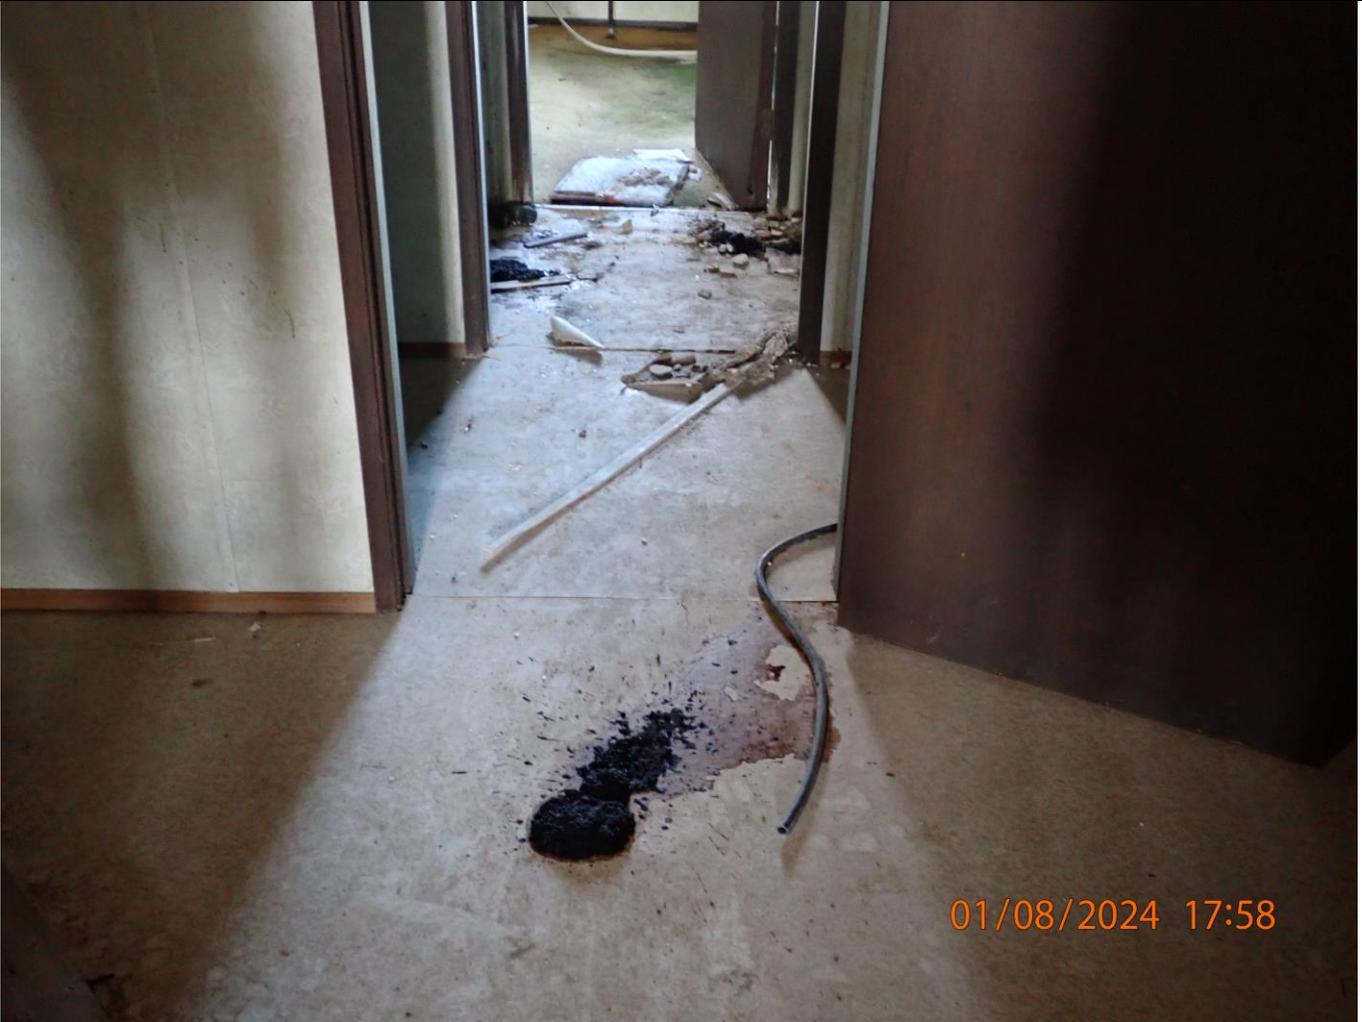
Photo 10

Bear scat and building material shown on the floor of the old accommodation trailers.

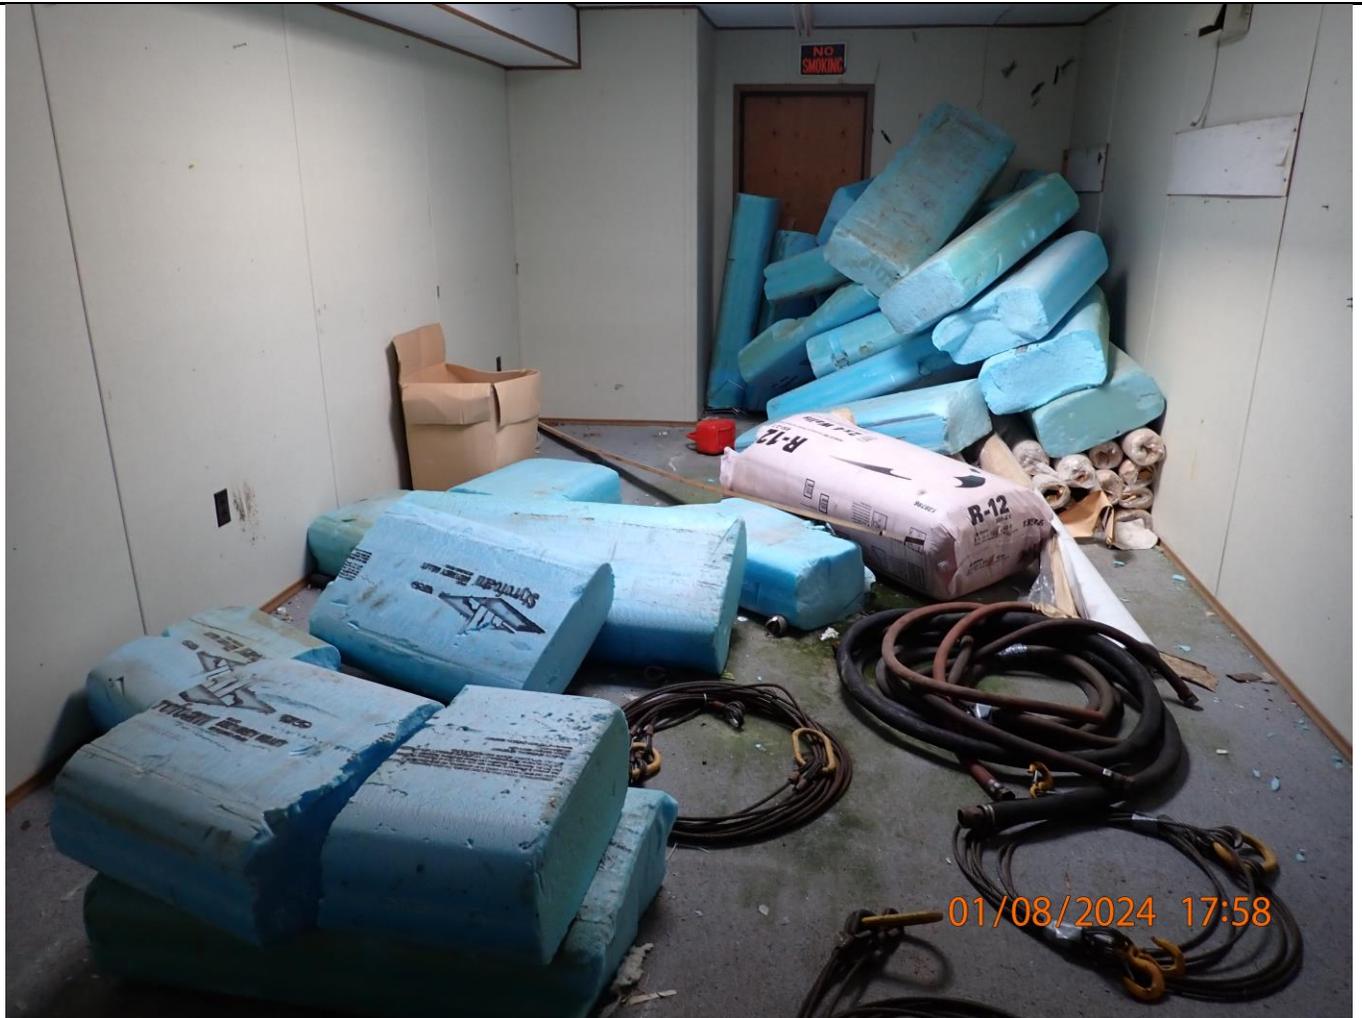
Photo 11

Helicopter slinging gear and Styrofoam/fiberglass insulation stored in the old accommodations trailers.

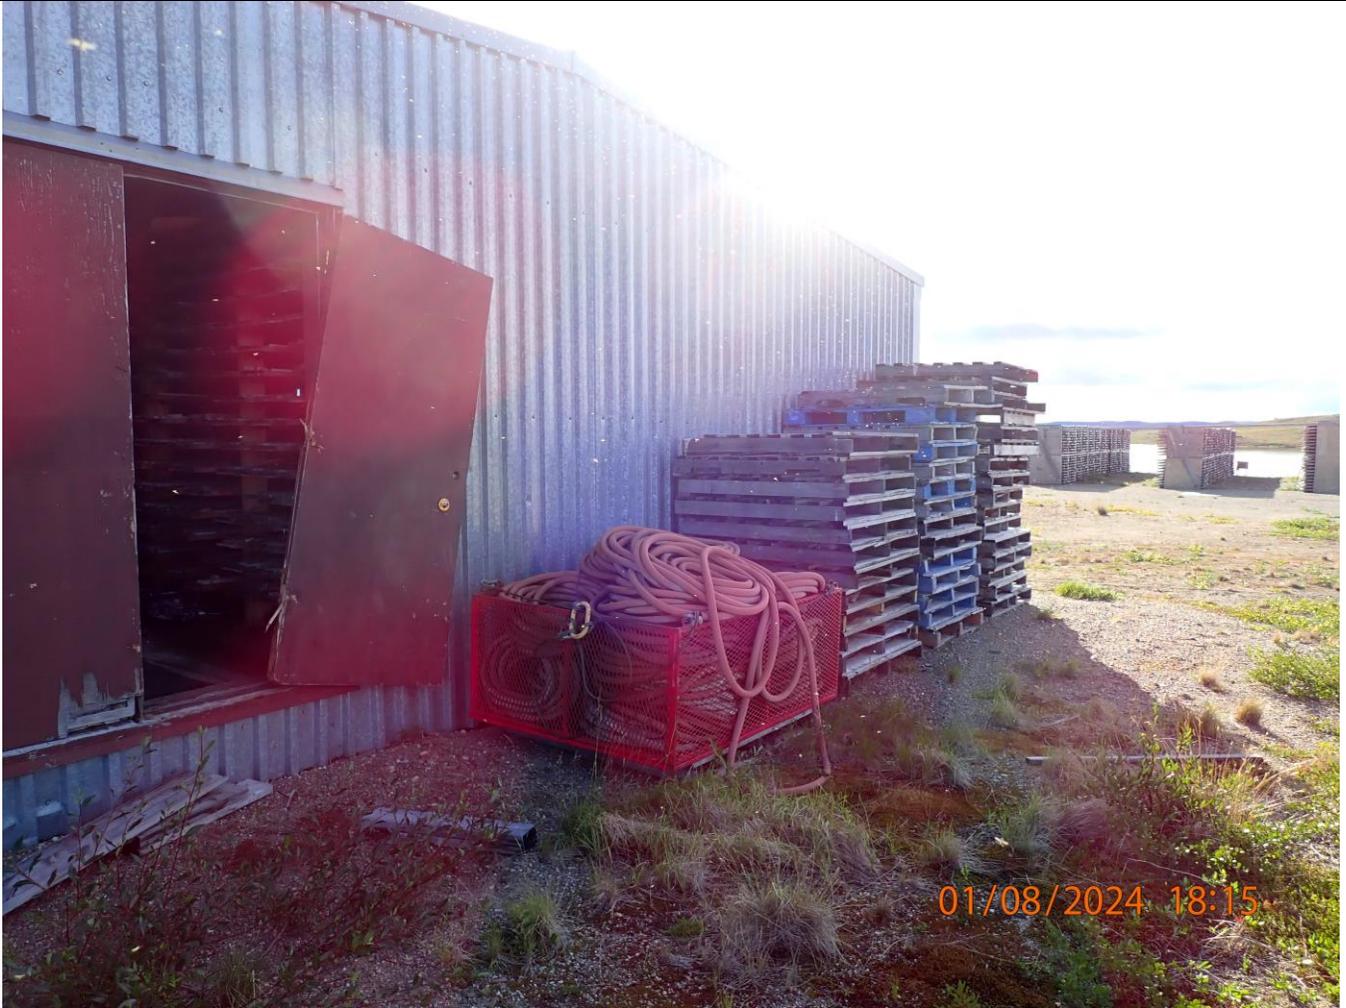
Photo 12

Core shack door open

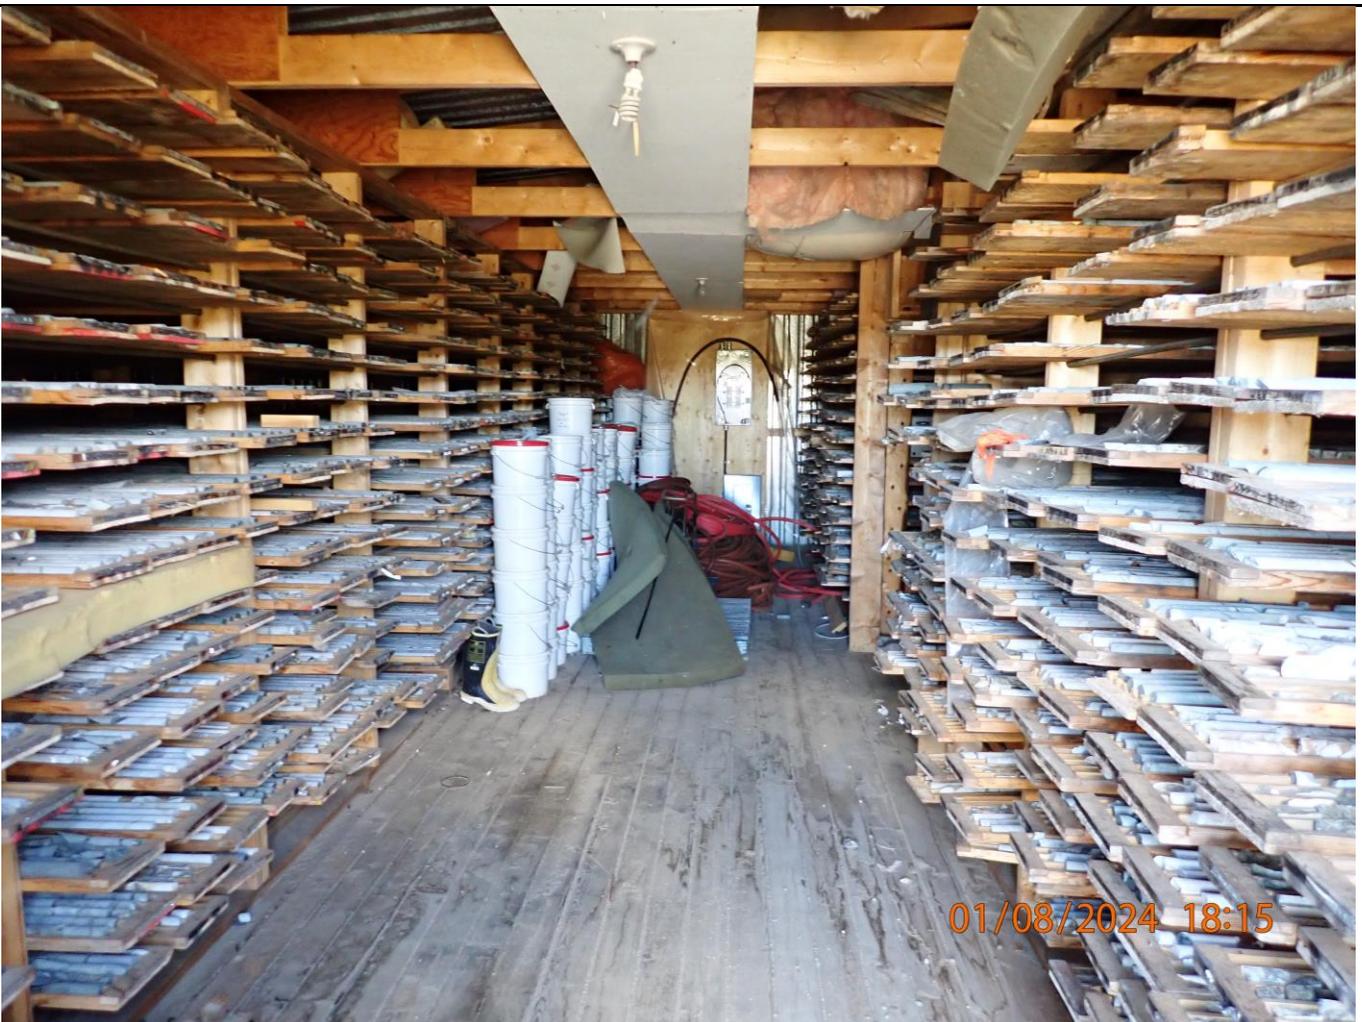
Photo 13

Inside core shack that had its door open.

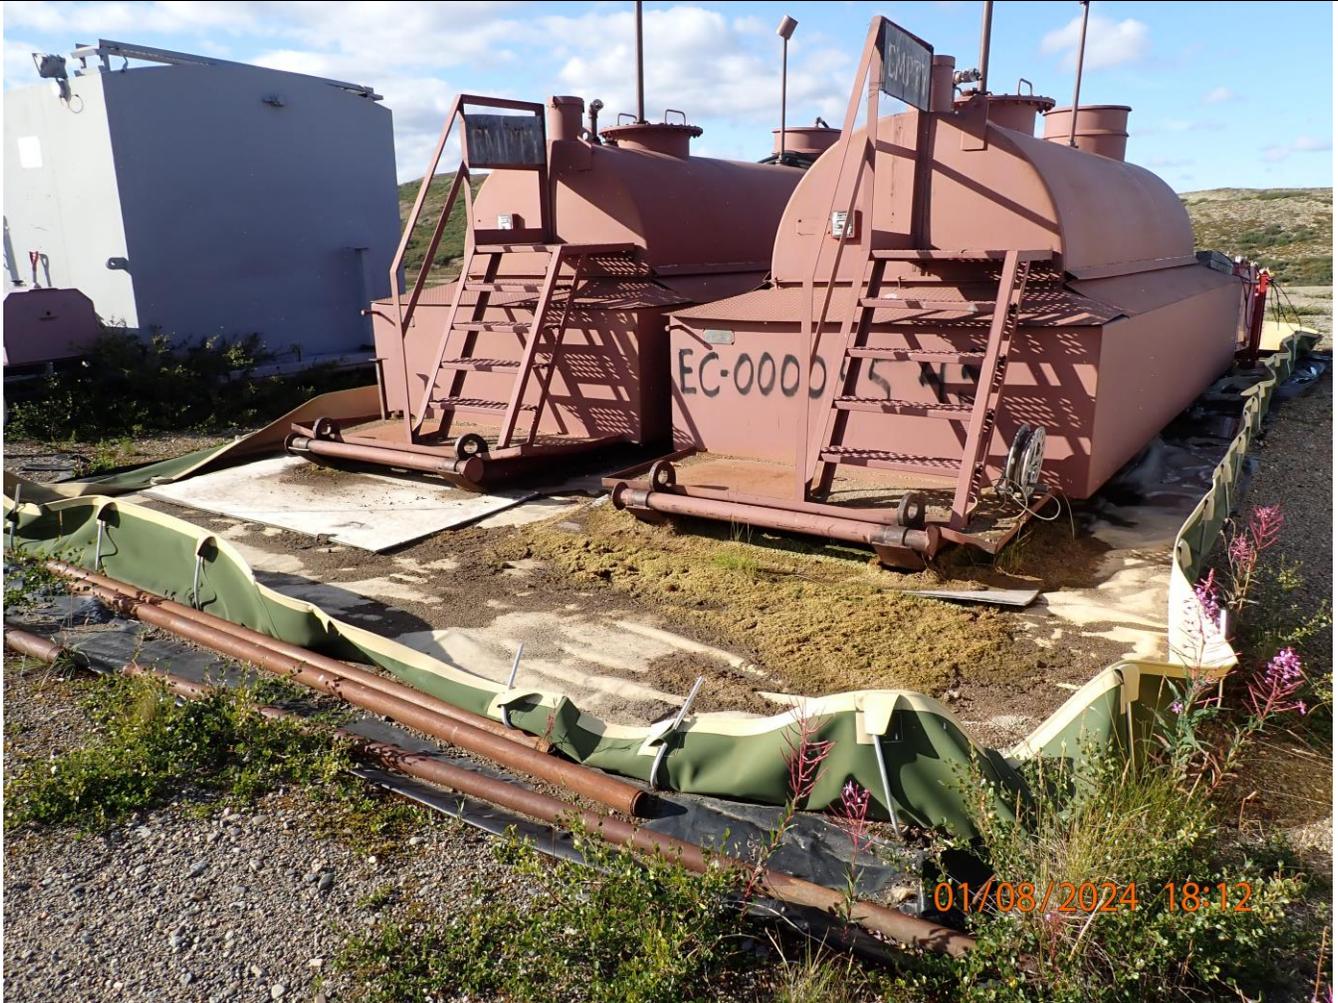
Photo 14

5. A secondary containment berm was observed with failed side walls. (Photo #14) inside the secondary containment are 2 large fuel tanks labelled as empty. Inside the berm was some water under tanks and moss has started to grow in the berm.

Failed secondary containment. Moss and some water present inside the berm.

All secondary containment utilized shall be flagged have a cover on them when regular inspection is not possible. Failed secondary containments shall be changed for a new ones. Unused fuel tanks shall be removed from site.

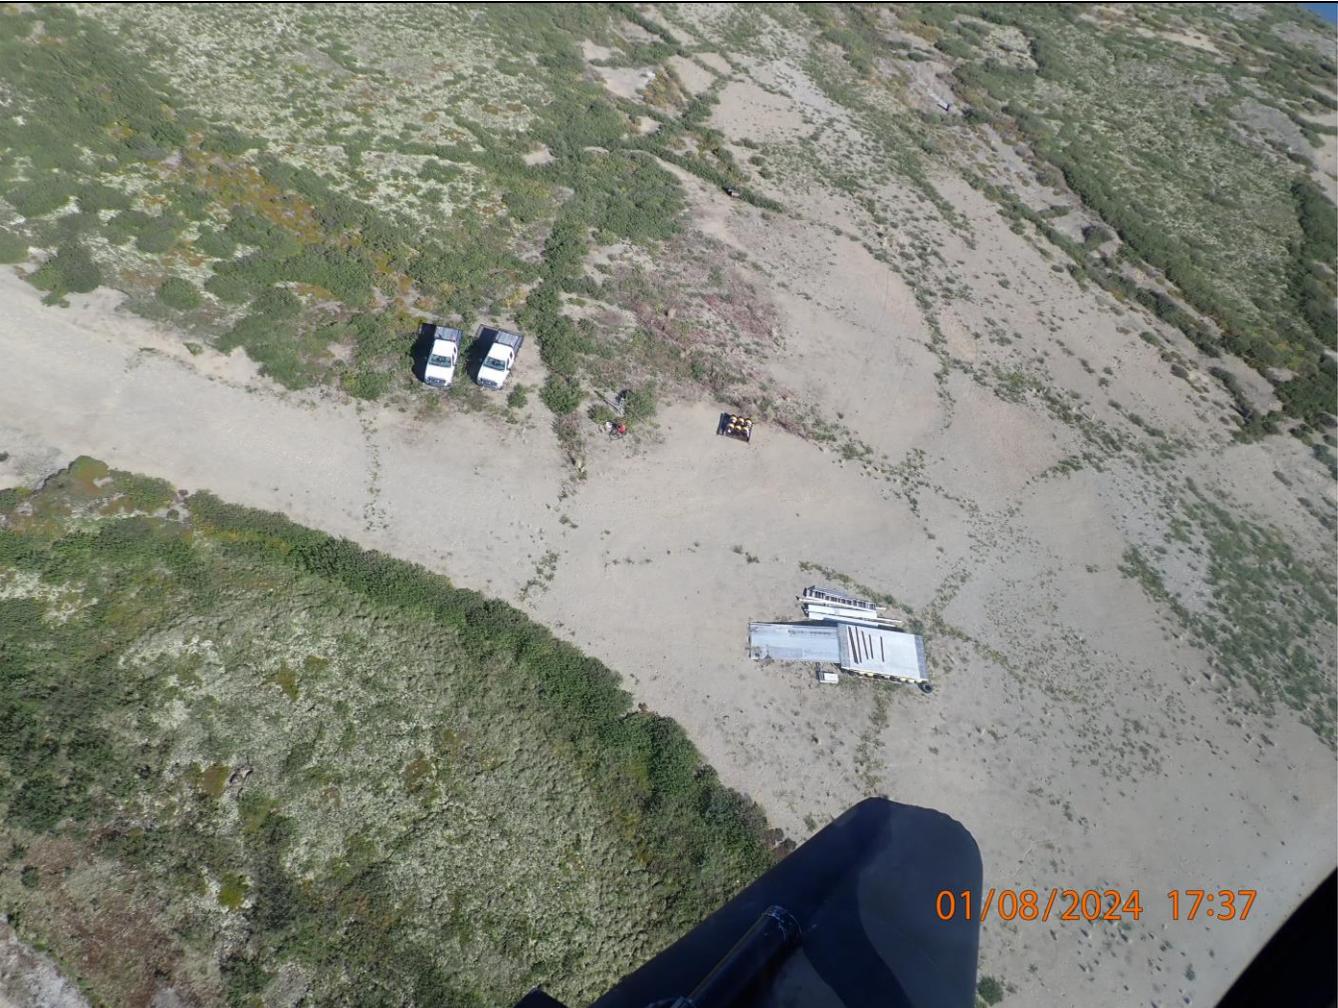
Photo 15

6. 6 drums of fuel were observed near the air strip/helicopter pad that were stored in secondary containment but not covered.

2 trucks, a Fire extinguisher, 6 fuel drums in an uncovered secondary containment and a heli pad near the airstrip.

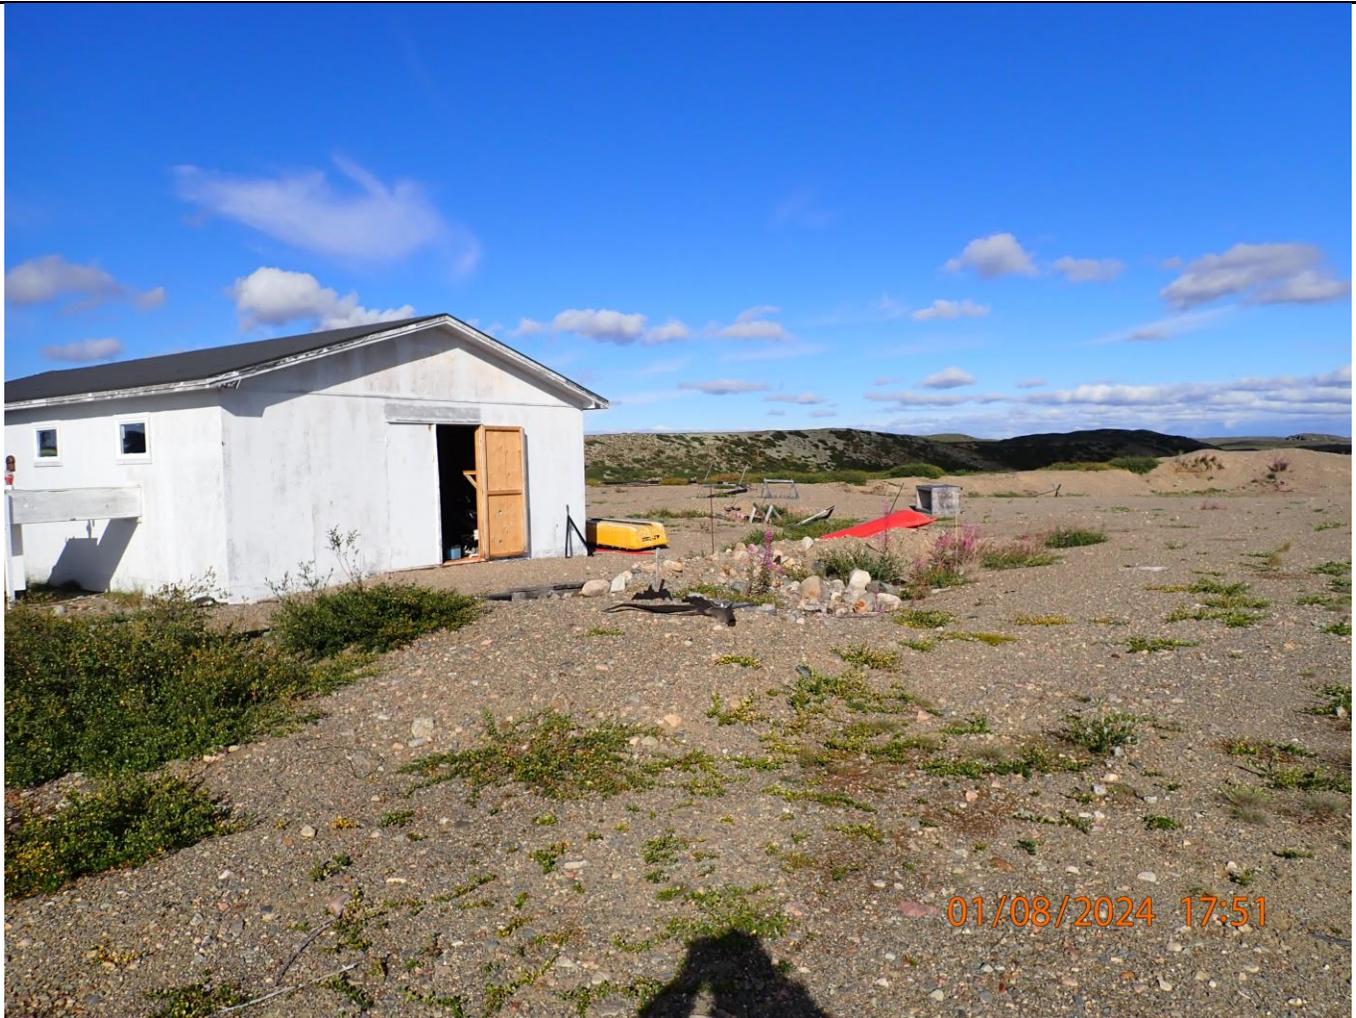
Photo 4

1. Inspectors arrive on site at 5:40pm on August 1, 2024. Camp Location 65*41'06.30"N 112*52'53.93"W. Aerial photos where taken (Photo #1, #2, #3)
2. During the inspection the Inspectors noted several buildings with their doors open. 1 weather haven had its door open, the core shack had an open door, the building that houses the bobcat/skidoos and the garage beside it that houses the loader had their doors open. (Photo #4 shows the shop with a door open, this building stores skidoos and the bobcat inside, Photo #1 shows the garage door open) (Photo # 12 and #13 show the open door of the core shack and the inside of the core shack.)

Open door of a storage shed, inside are skidoos, equipment and a bobcat.

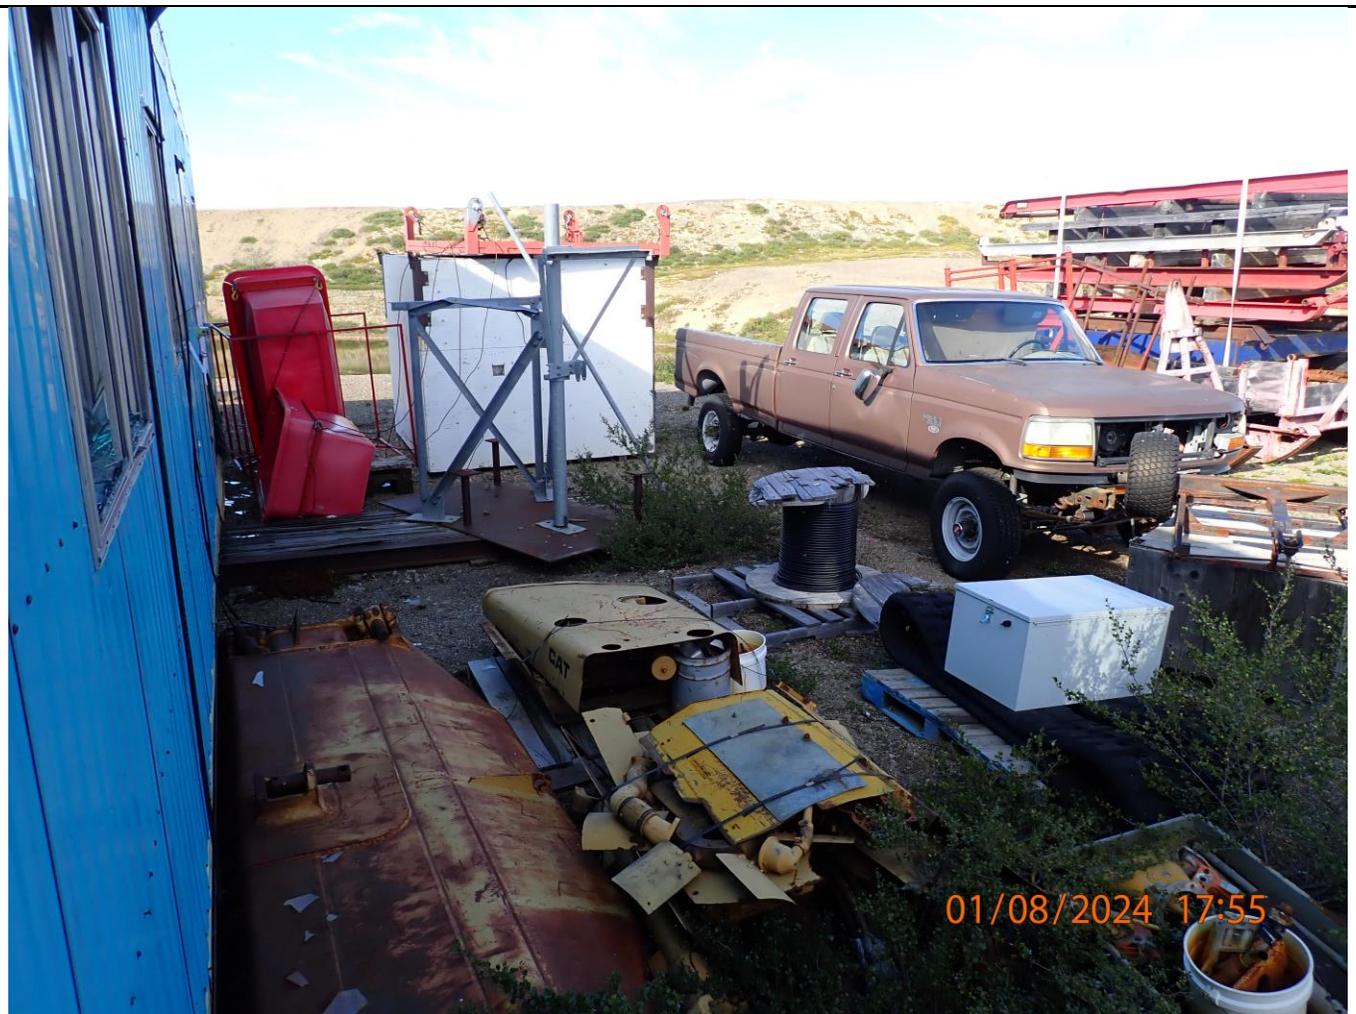
Photo 5

3. Various types of scrap metal and old parts were observed on site. All metal and parts were well sorted but anything not required for the project shall be removed from site. (Photo #5 and #6)

And old truck, old parts and equipment outside the old trailer accommodations.

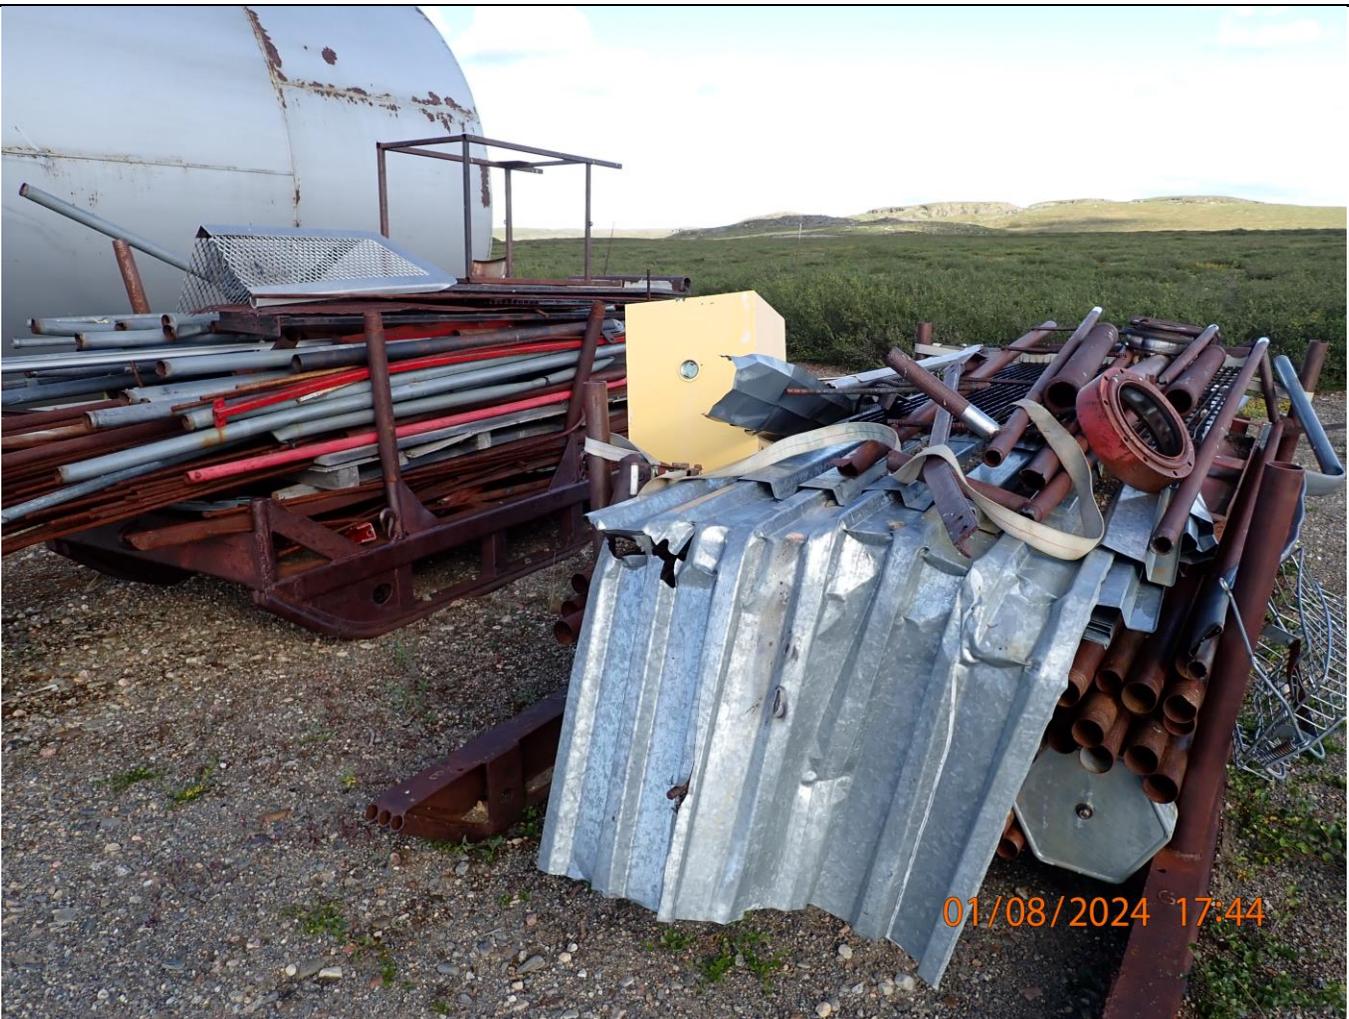
Photo 6

Scrap metals stored beside fuel tanks close to the airstrip.
