Attachment 12 – Inspections and Responses

CROWN LAND USE INSPECTION FORM

WATER LICENCE INSPECTION FORM

Reference: Ham Lake Camp Inspection

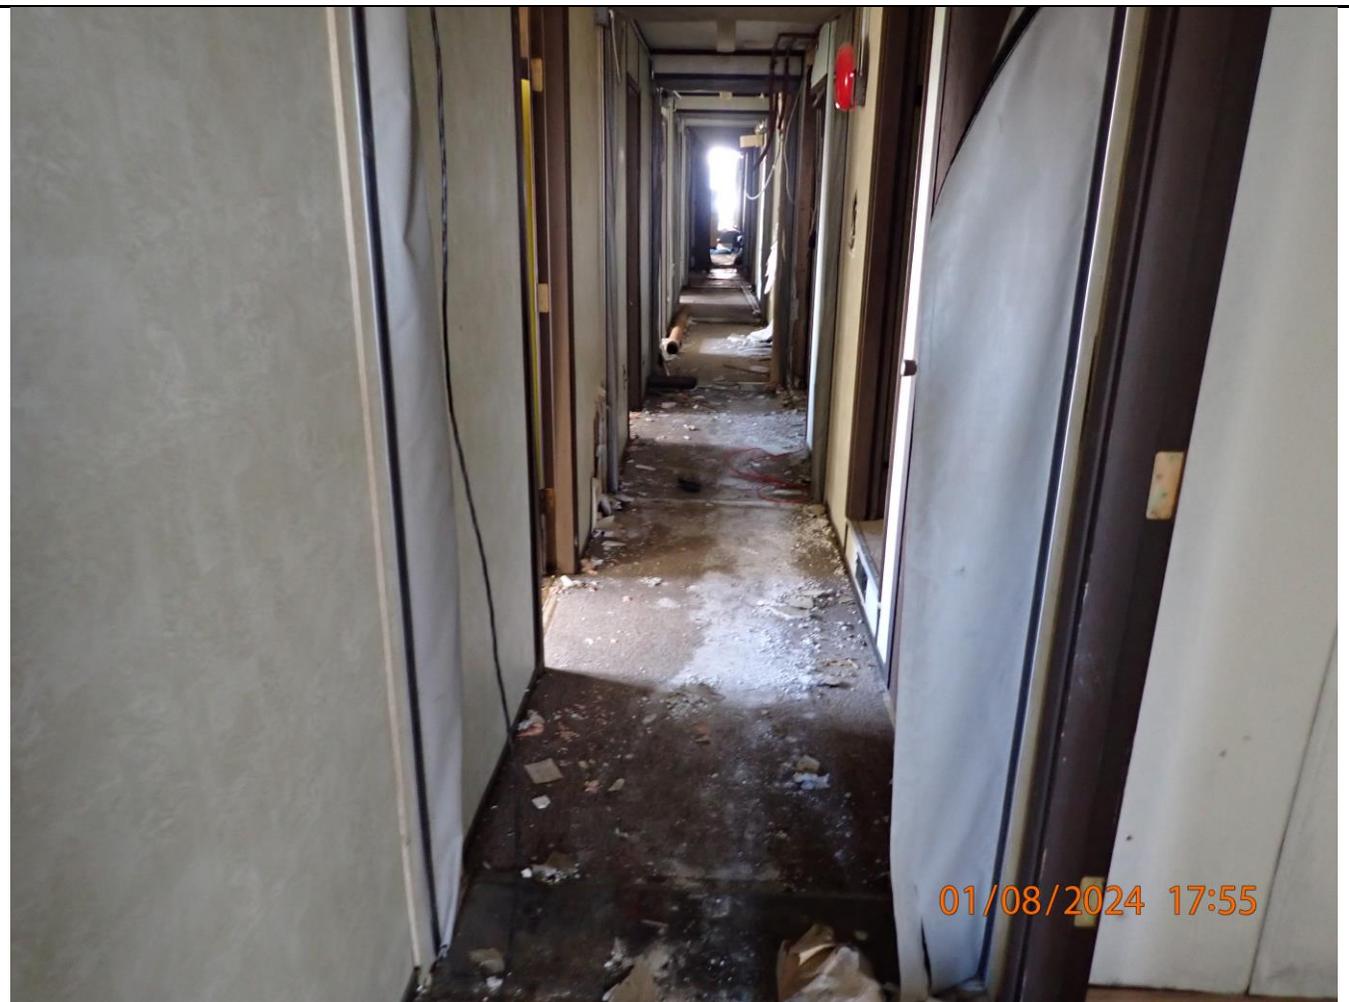
Photo 7

4. The old accommodations buildings (trailers) shall be removed from site at the earlier possible opportunity. A bottle of Nitric Acid was observed on a bed in one of the rooms along with garbage throughout the buildings. A lot of the windows were broken and some doors open, signs of bear activity were apparent throughout the trailers. Plants were observed growing on the floors and the old beds. It seems like the trailers are being used as a type of storage facility as it was observed that helicopter rigging gear, water pumps and various hoses and connections, Styrofoam, reflective insulation, absorbents (Can-Dry supreme all purpose absorbent), tools/chains, and other types of equipment were present inside the trailers. (Photo #7,#8,#9,#10,#11) All this equipment and garbage needs to be removed, stored properly and the trailers need to be seal shut and closed off until they can be removed from site.

View inside the old trailer accommodations. The door at the back was open, a lot of windows were open.

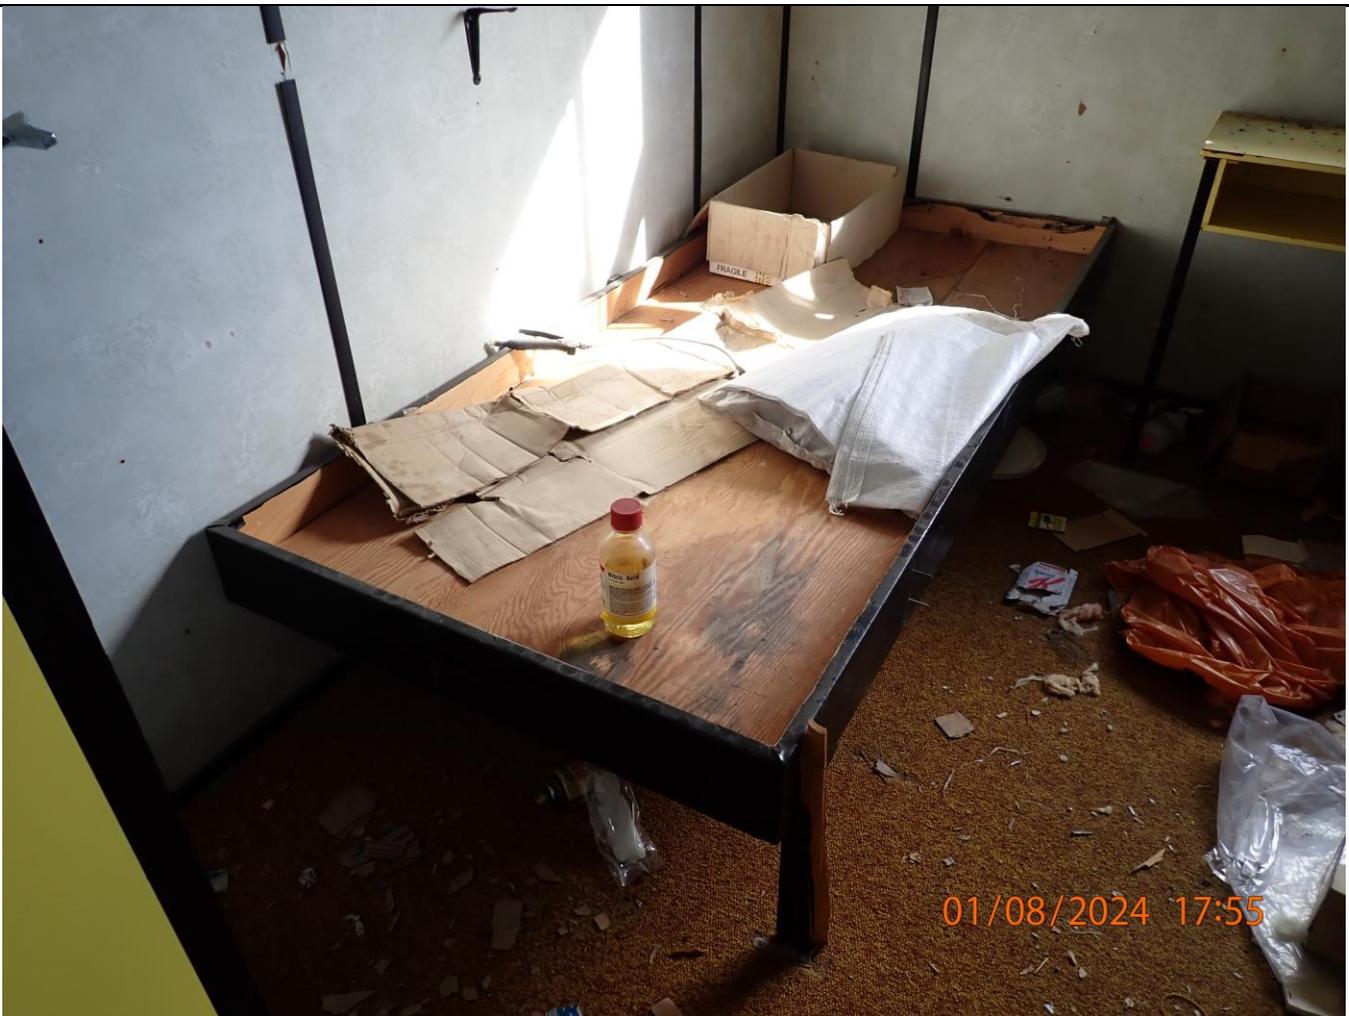
Photo 8

Nitric Acid on the bed. Garbage all over the room.

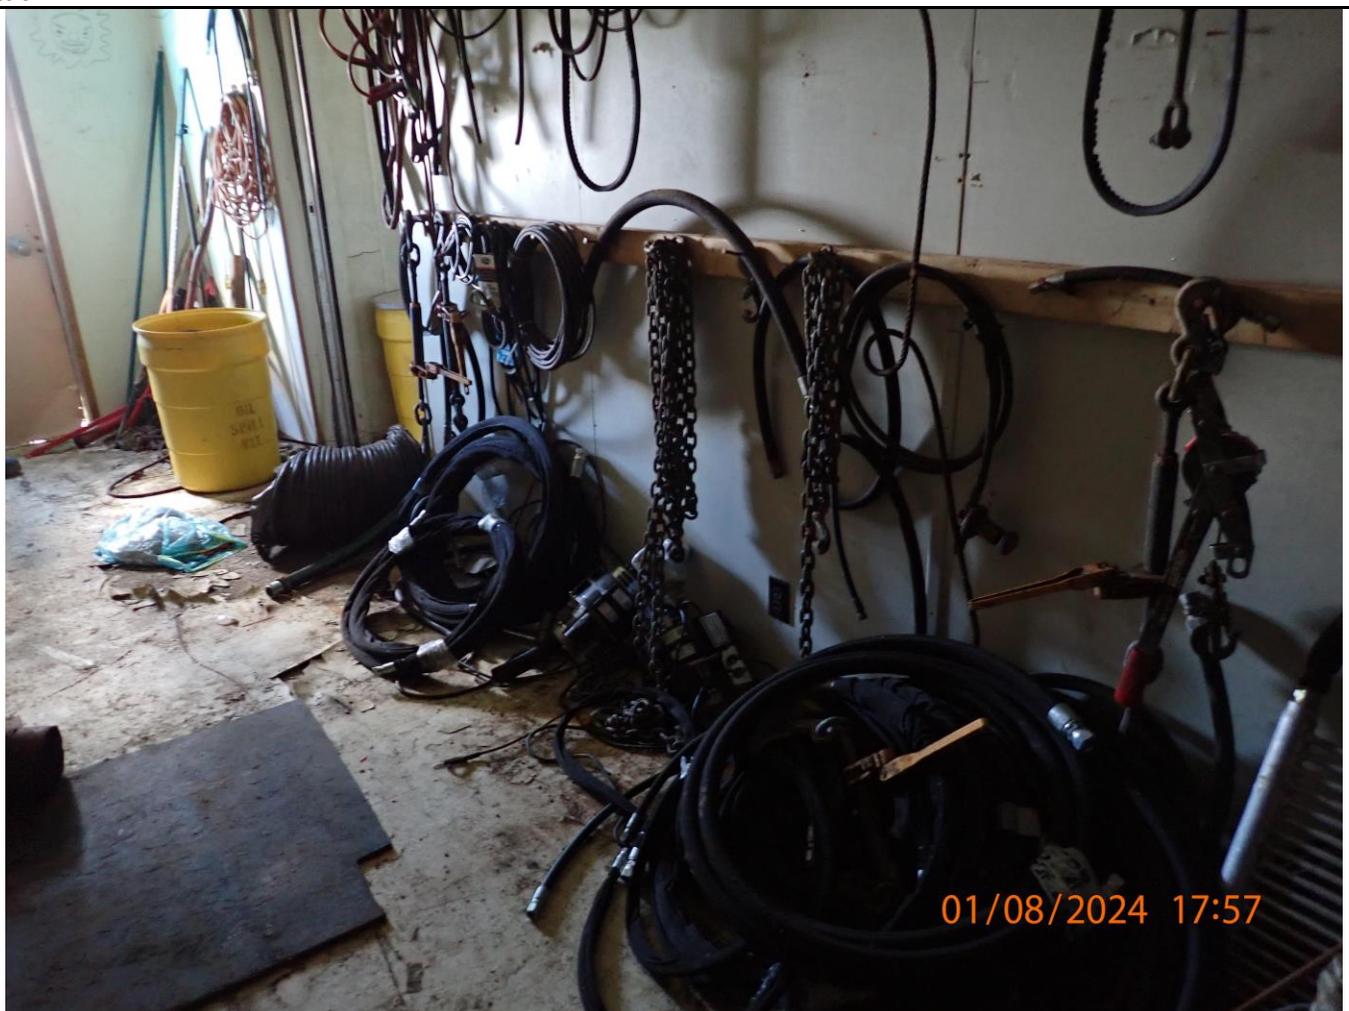
Photo 9

Chains, various hoses, water pumps, and other equipment stored in the old accommodation trailers.

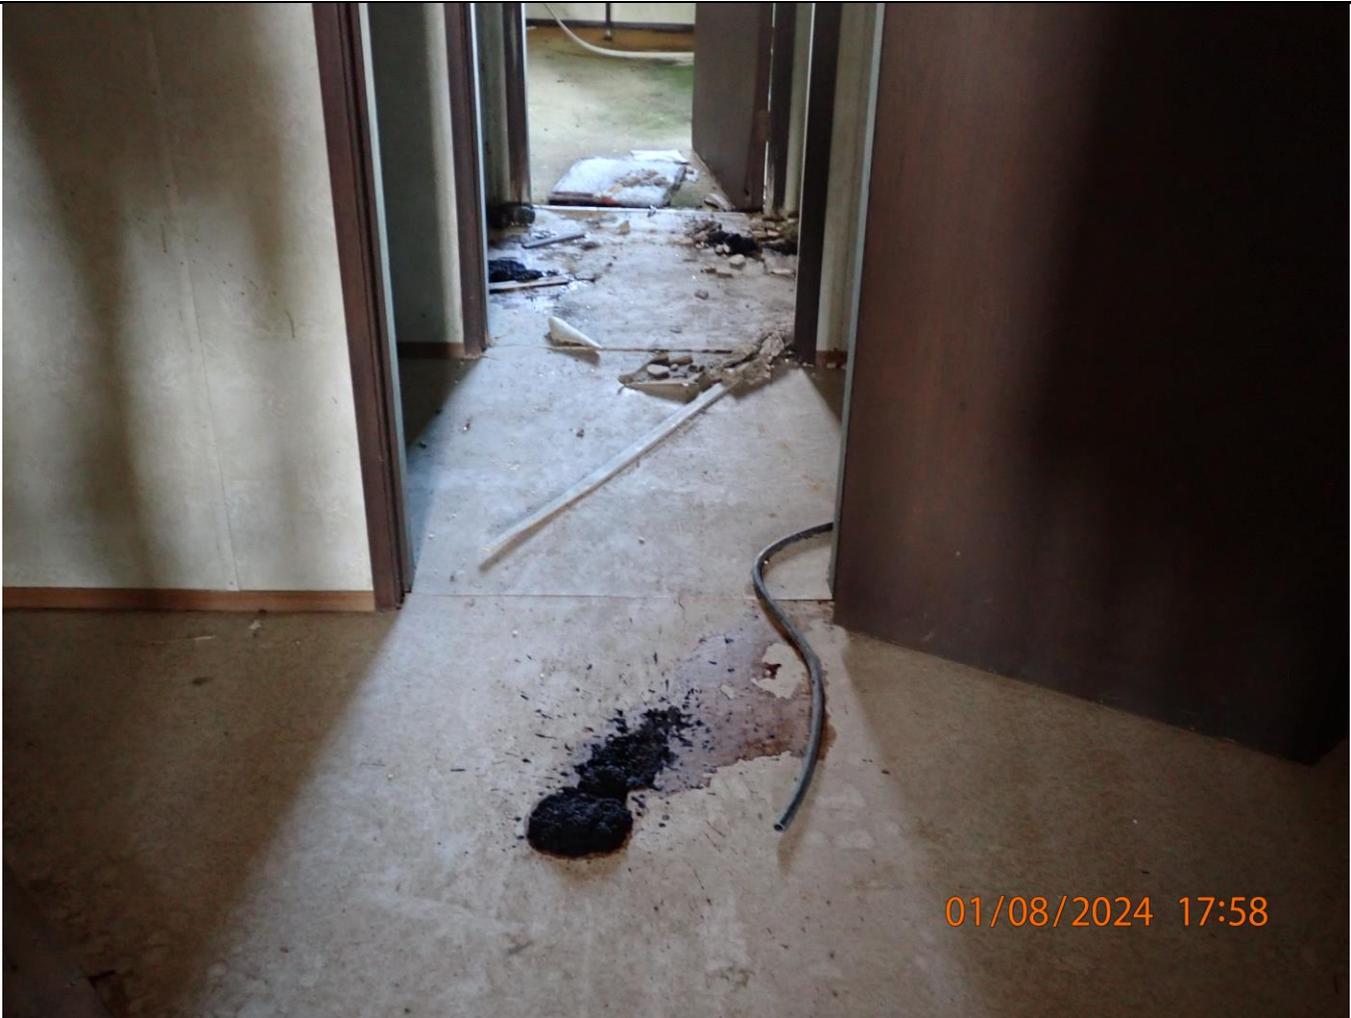
Photo 10

Bear scat and building material shown on the floor of the old accommodation trailers.

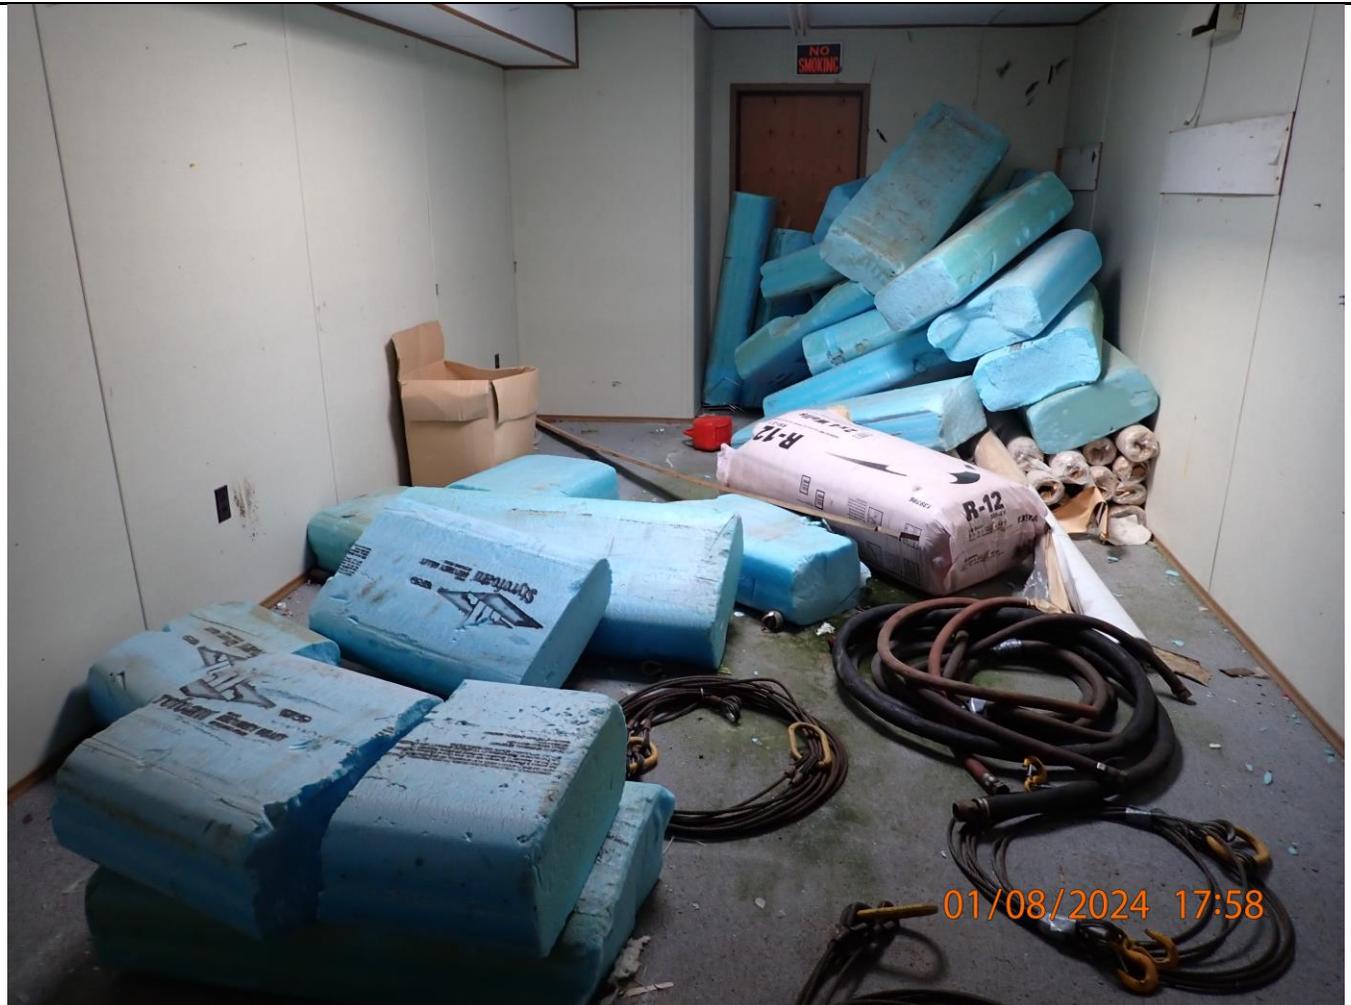
Photo 11

Helicopter slinging gear and Styrofoam/fiberglass insulation stored in the old accommodations trailers.

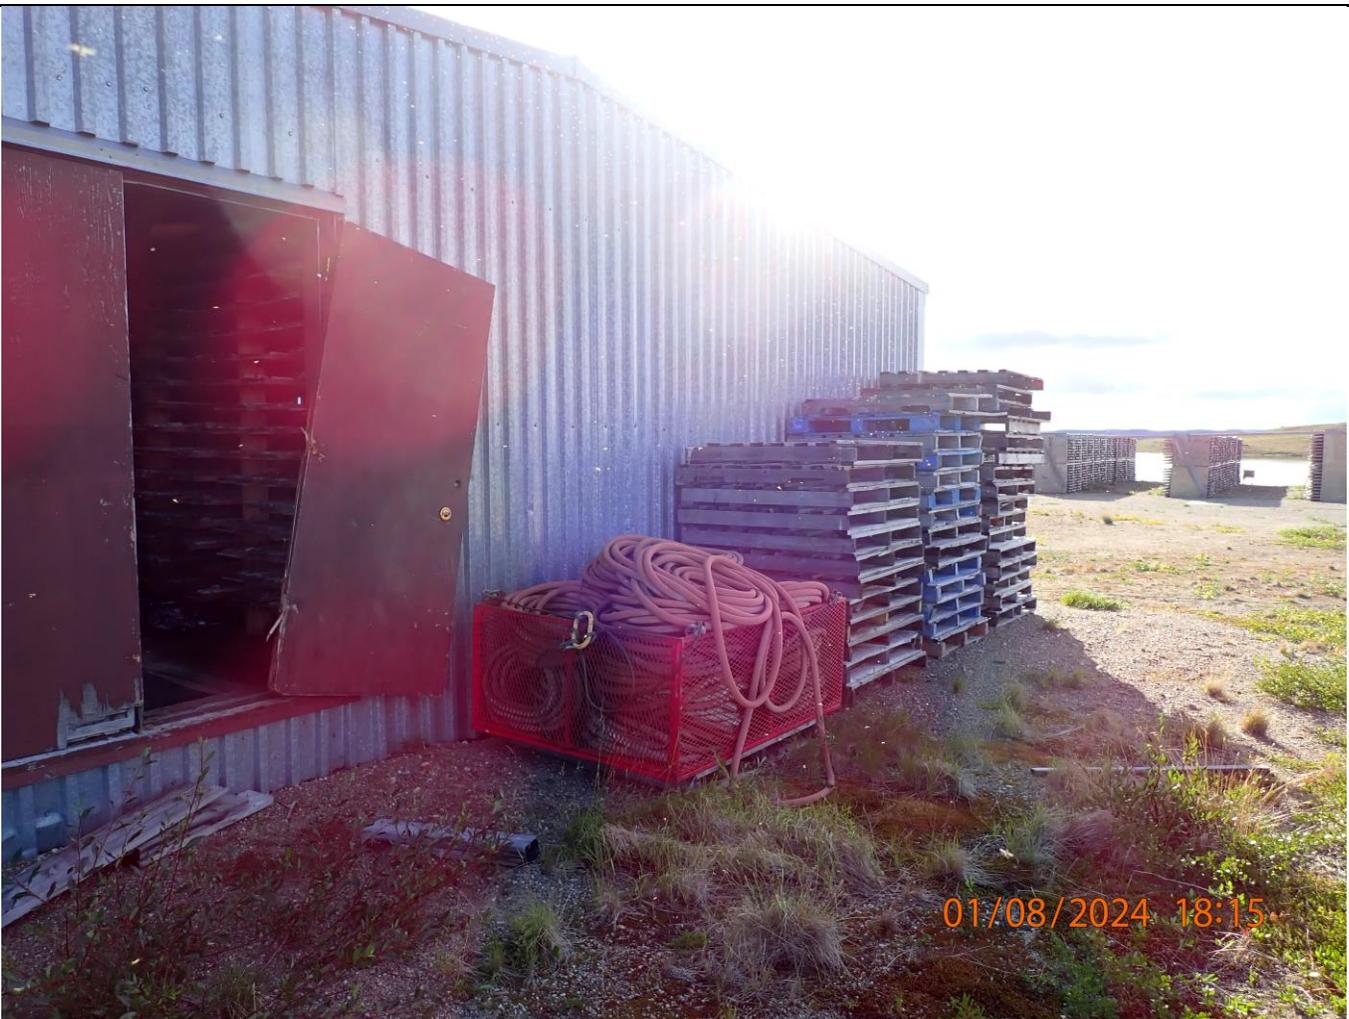
Photo 12

Core shack door open

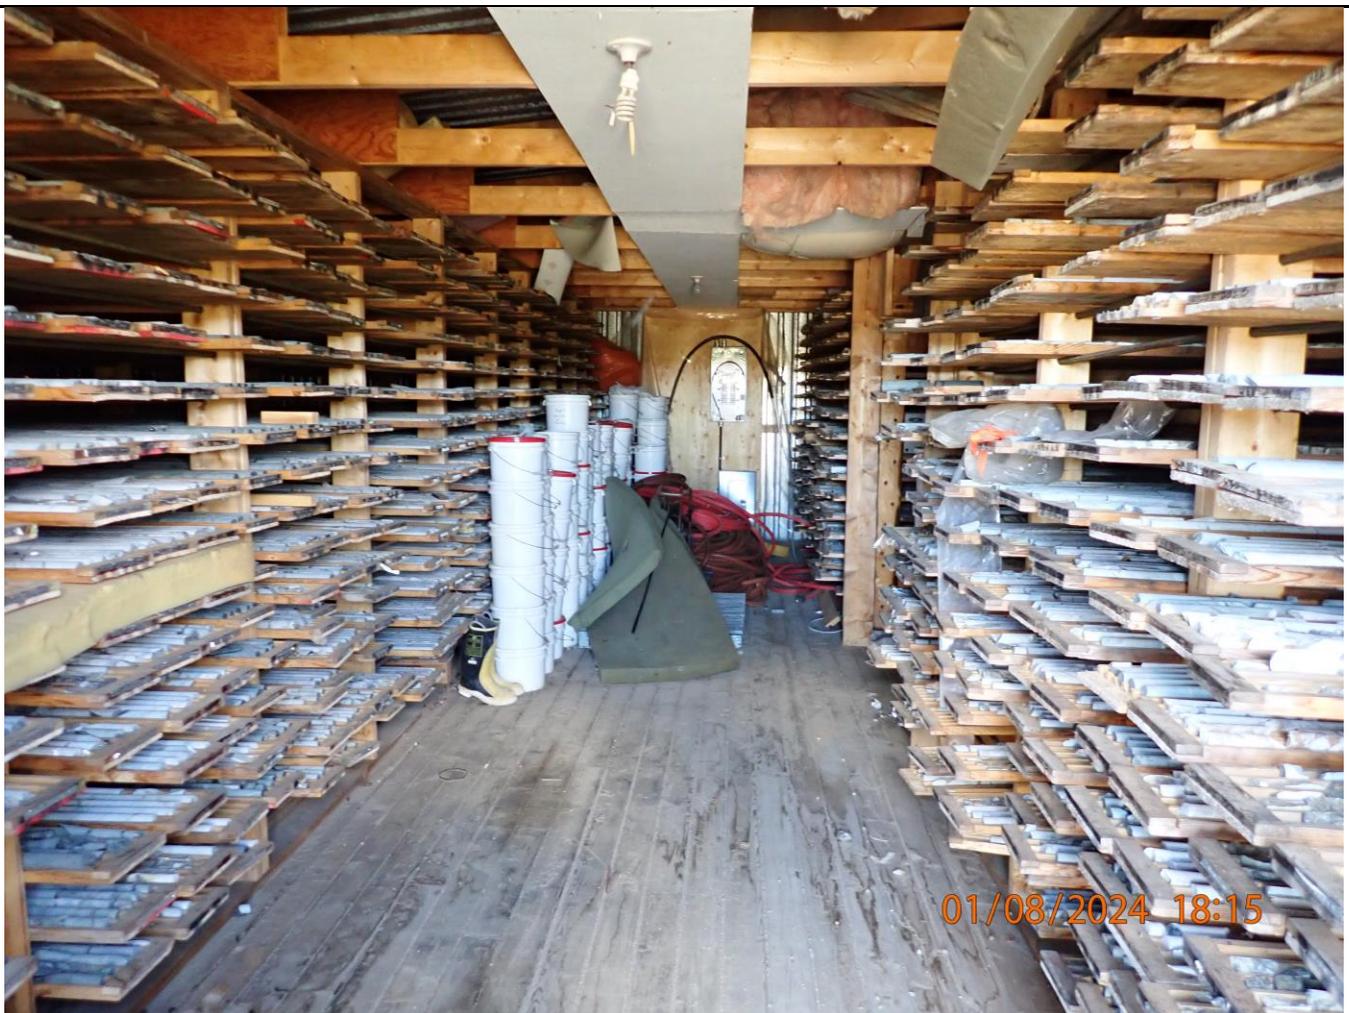
Photo 13

Inside core shack that had its door open.

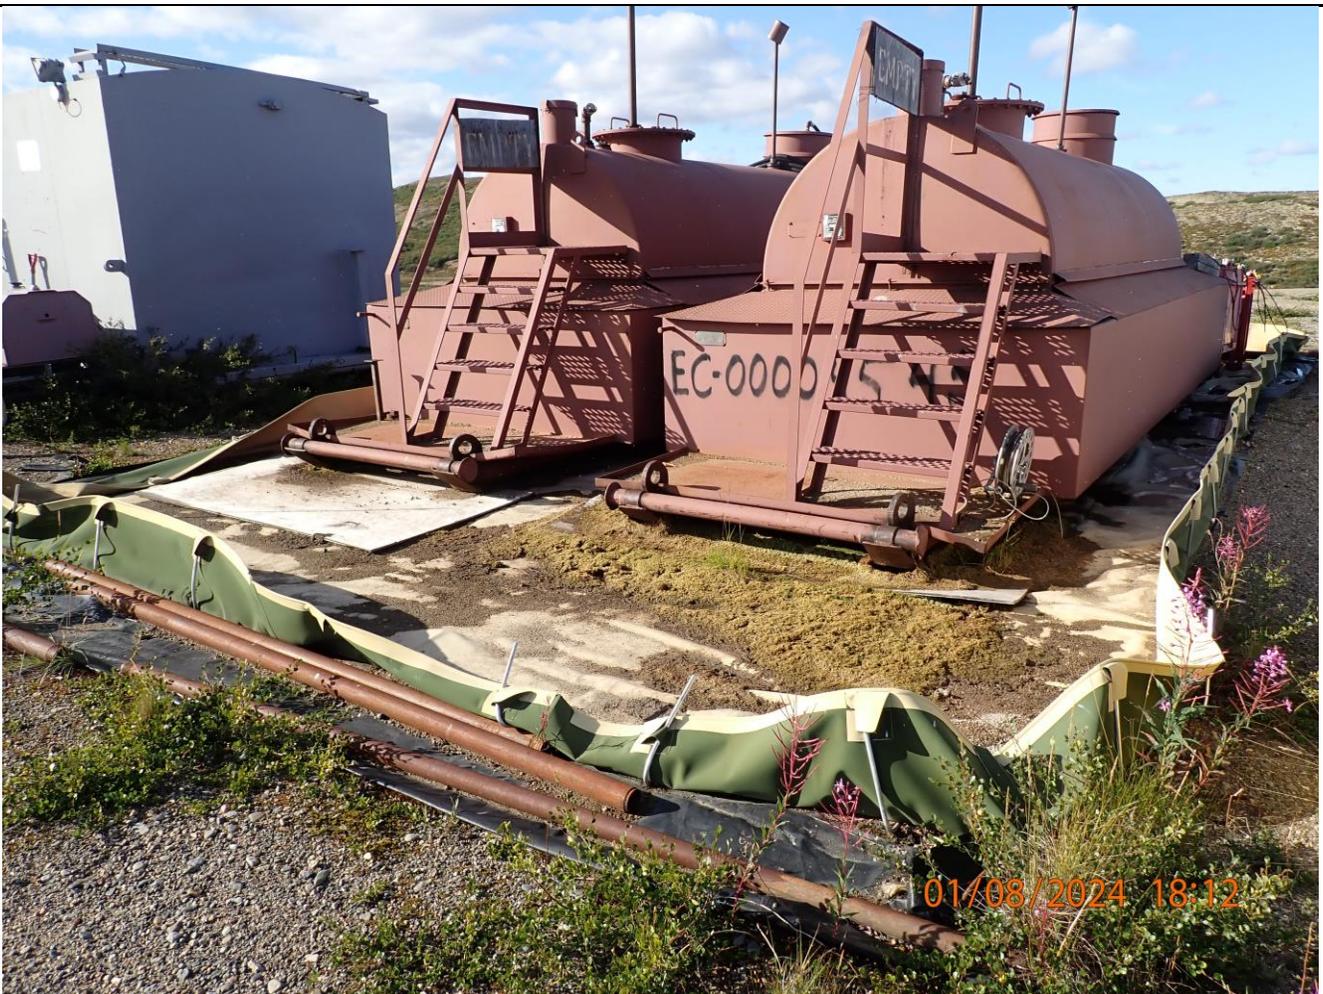
Photo 14

5. A secondary containment berm was observed with failed side walls. (Photo #14) inside the secondary containment are 2 large fuel tanks labelled as empty. Inside the berm was some water under tanks and moss has started to grow in the berm.

Failed secondary containment. Moss and some water present inside the berm.

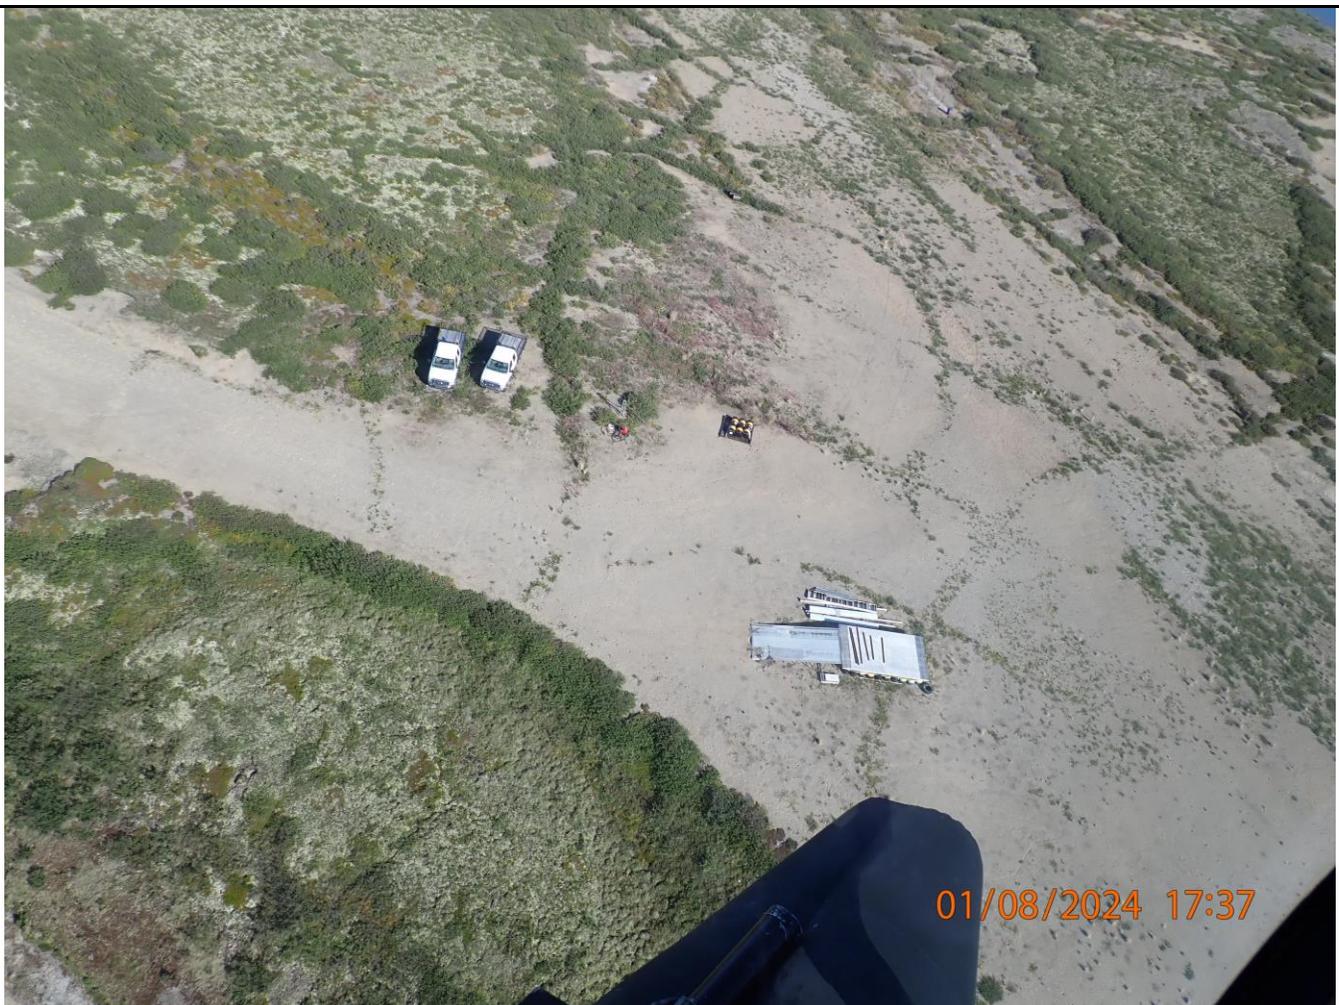
Photo 15

6. 6 drums of fuel were observed near the air strip/helicopter pad that were stored in secondary containment but not covered.

2 trucks, a Fire extinguisher, 6 fuel drums in an uncovered secondary containment and a heli pad near the airstrip.

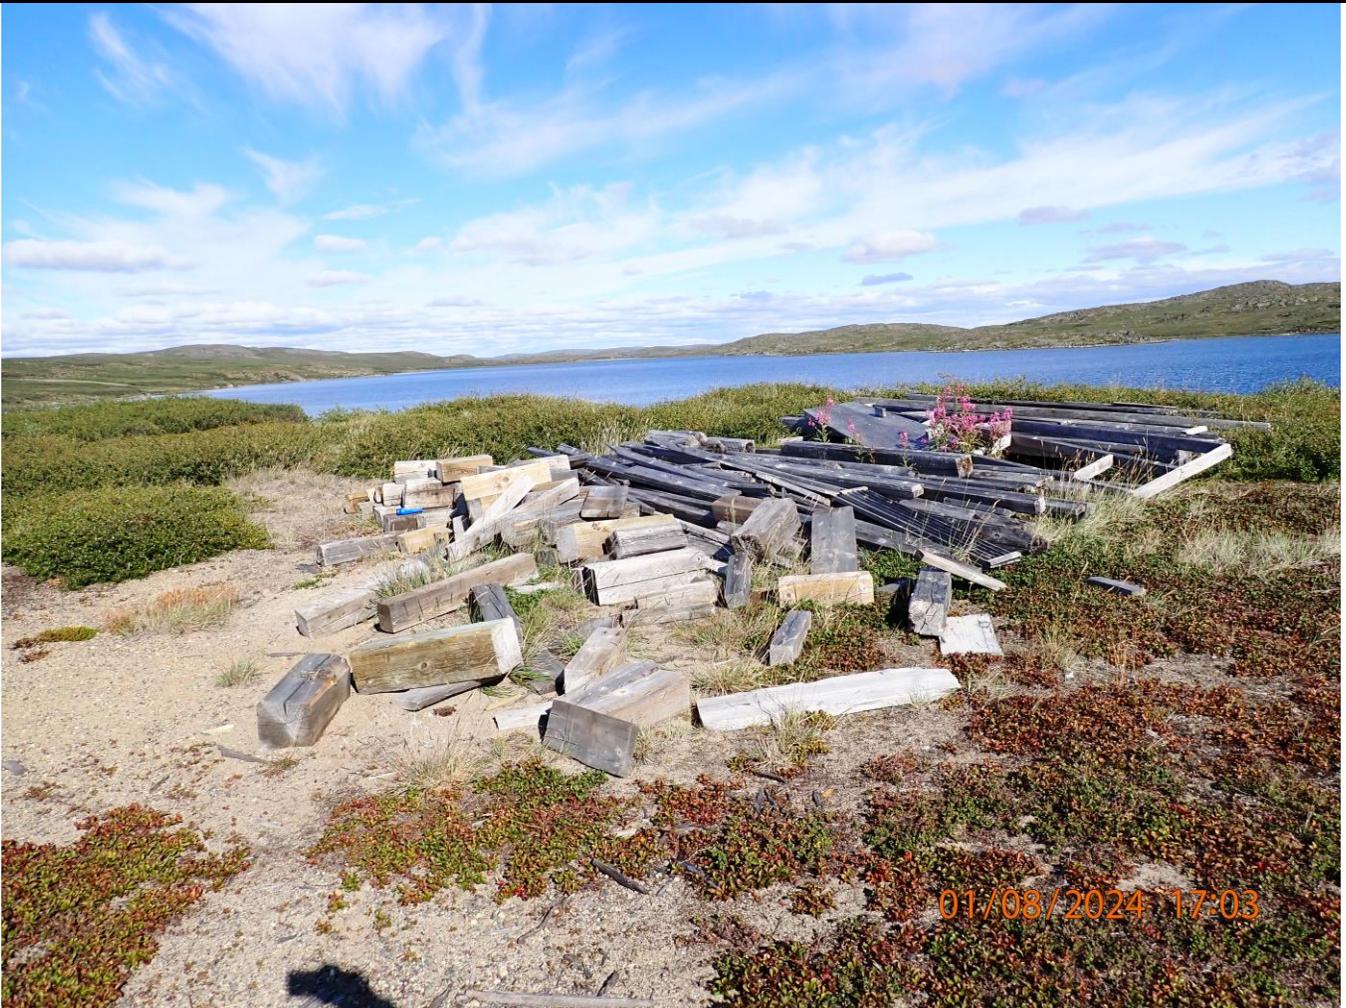
Photo 4

Description: Stack of Lumber present on site.

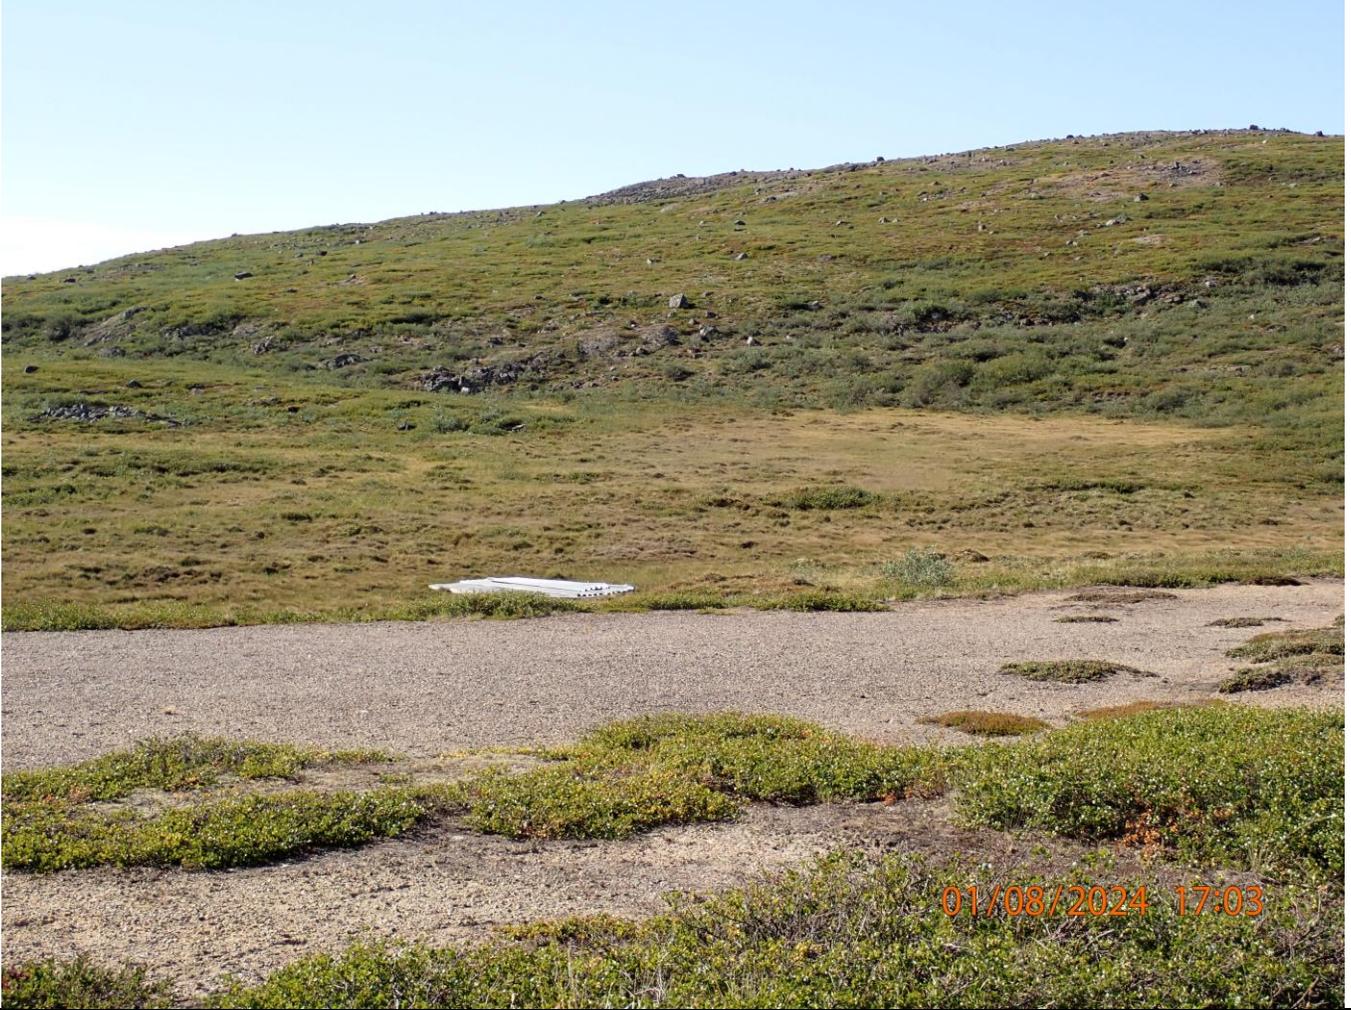
Photo 5

Description: Metal sheet roofing placed on top of a wooden wall in the tundra.

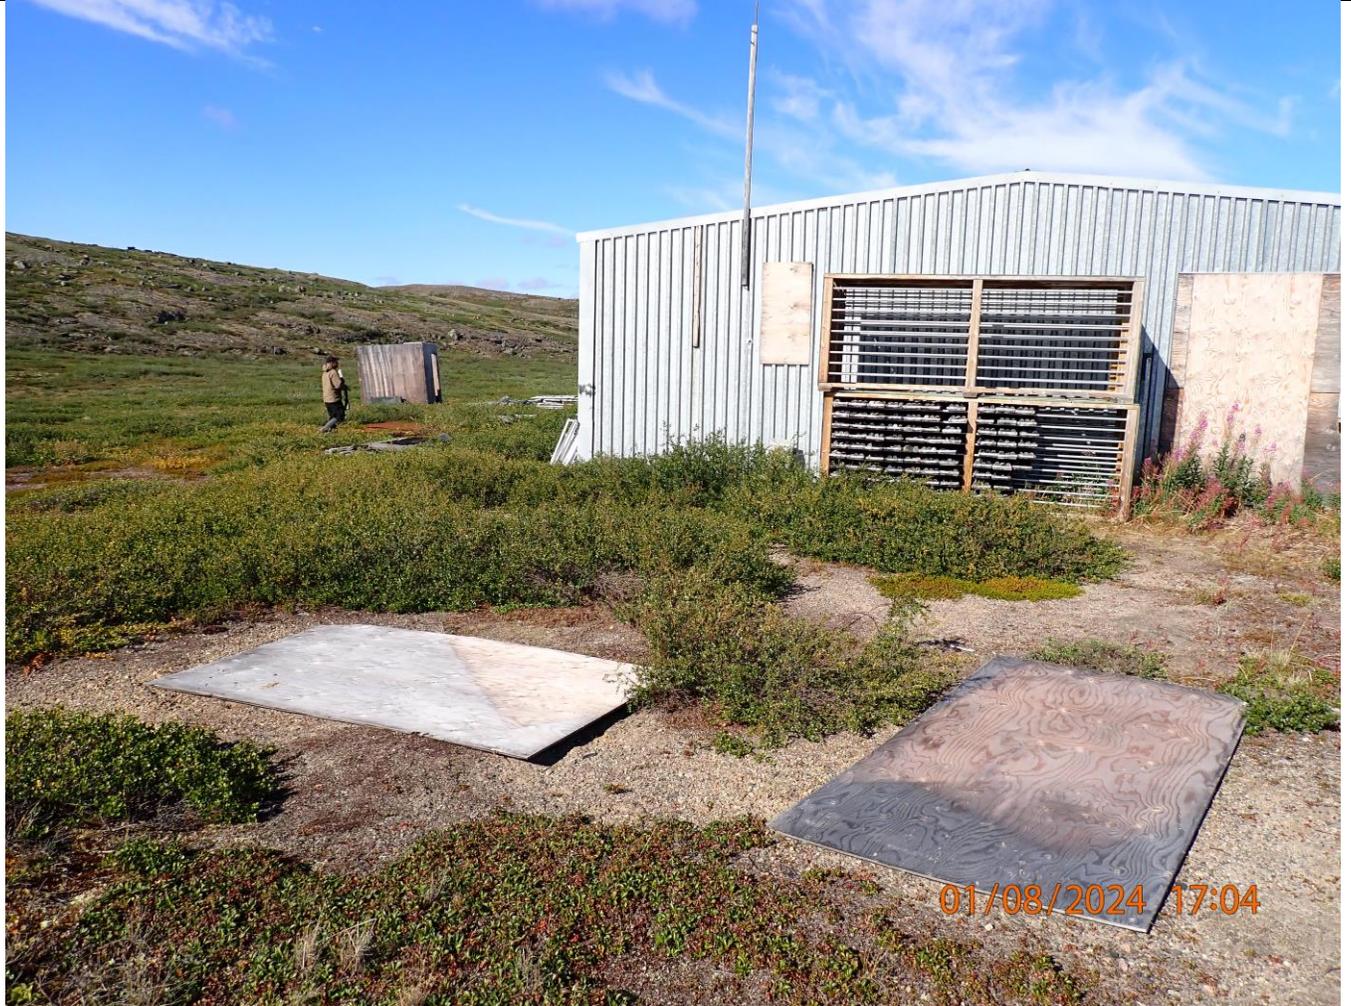
Photo 6

Description: ply wood debris behind the core shack (silver)

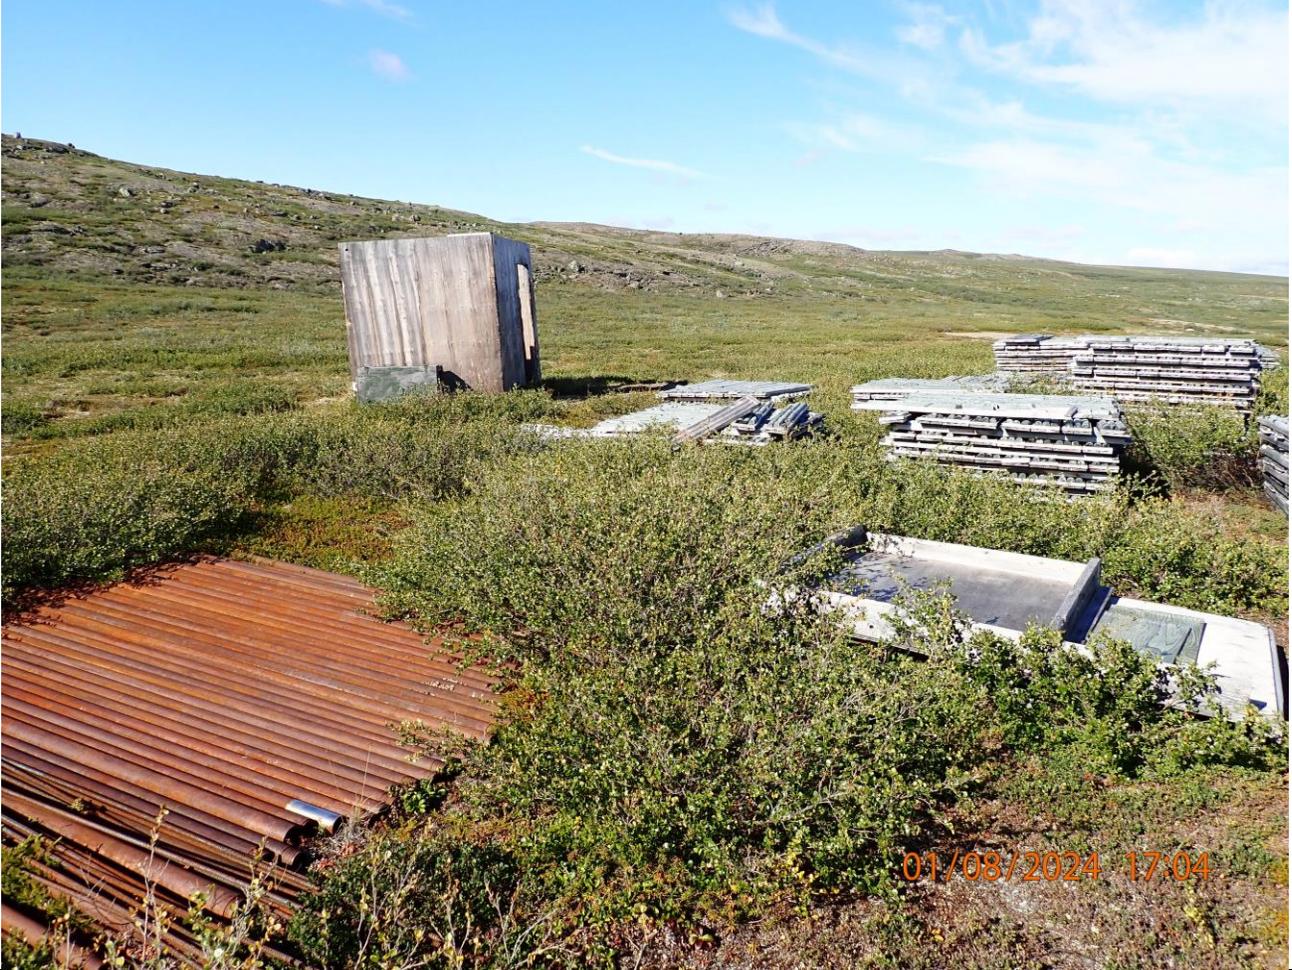
Photo 7

7. A small abandoned shack was observed on site with no roof and no door. There was nothing in the shack that would attract wildlife. Reclamation of this building is required. (Photo #7)

Description: Stacked drill rods, abandoned shack and some core boxes.

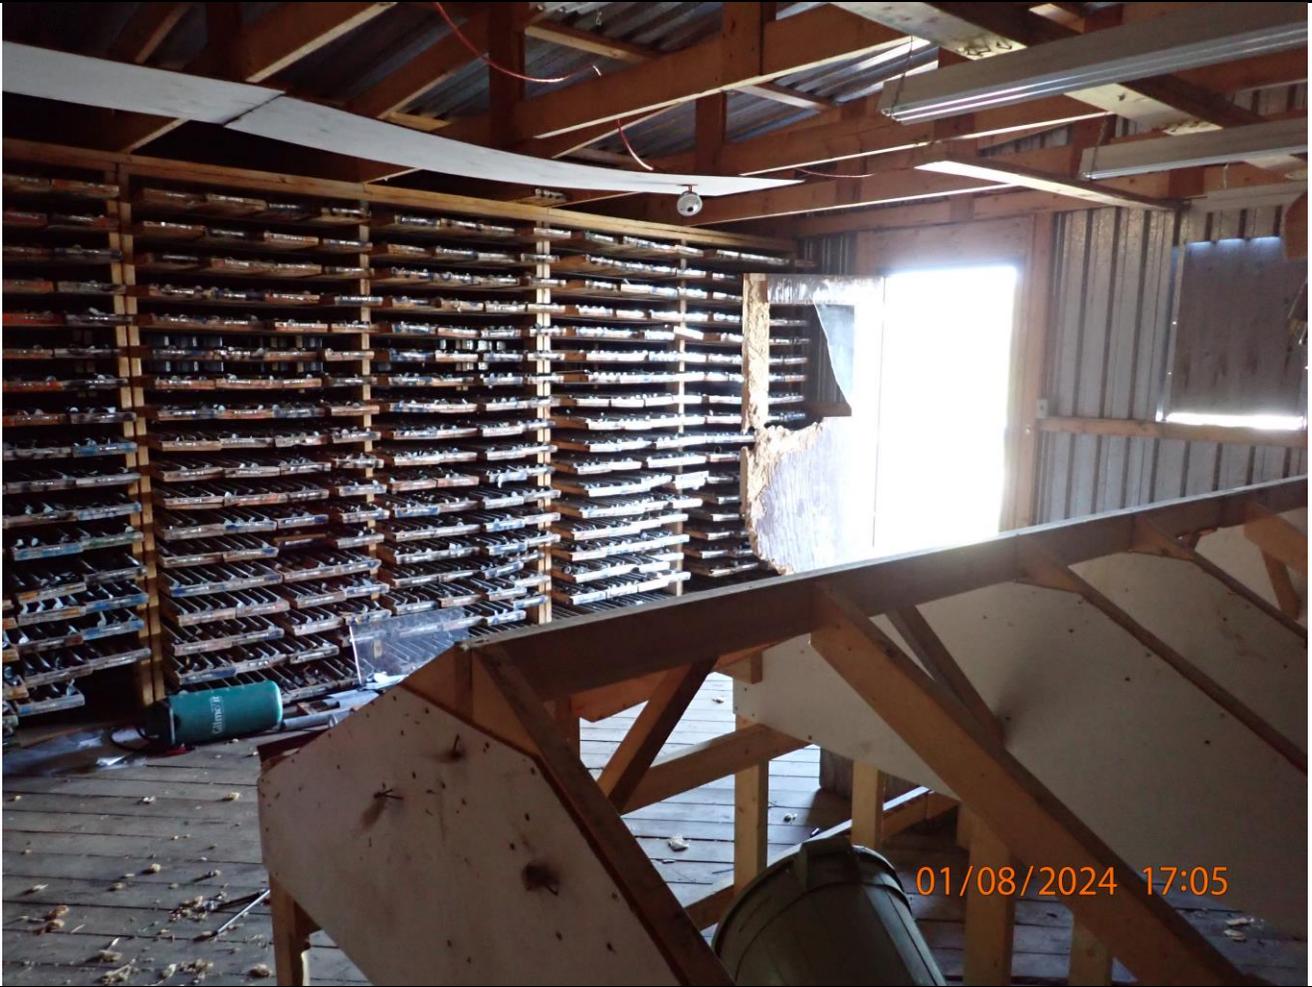
Photo 9

8. Core boxes were observed on the north side of the core shack. No issues noted. (Photo #8)
9. The door of the core shack was damaged and open. Signs of a bear breaking in were observed as the door was broken, scratched and chewed up (Photo #9)

Description: Core shack door as seen from inside. The door is heavily damaged and unable to close.

-In regards to comment #9 and #10: The building at Hood camp (core shack) should be repaired to deny entry of wildlife into the building.

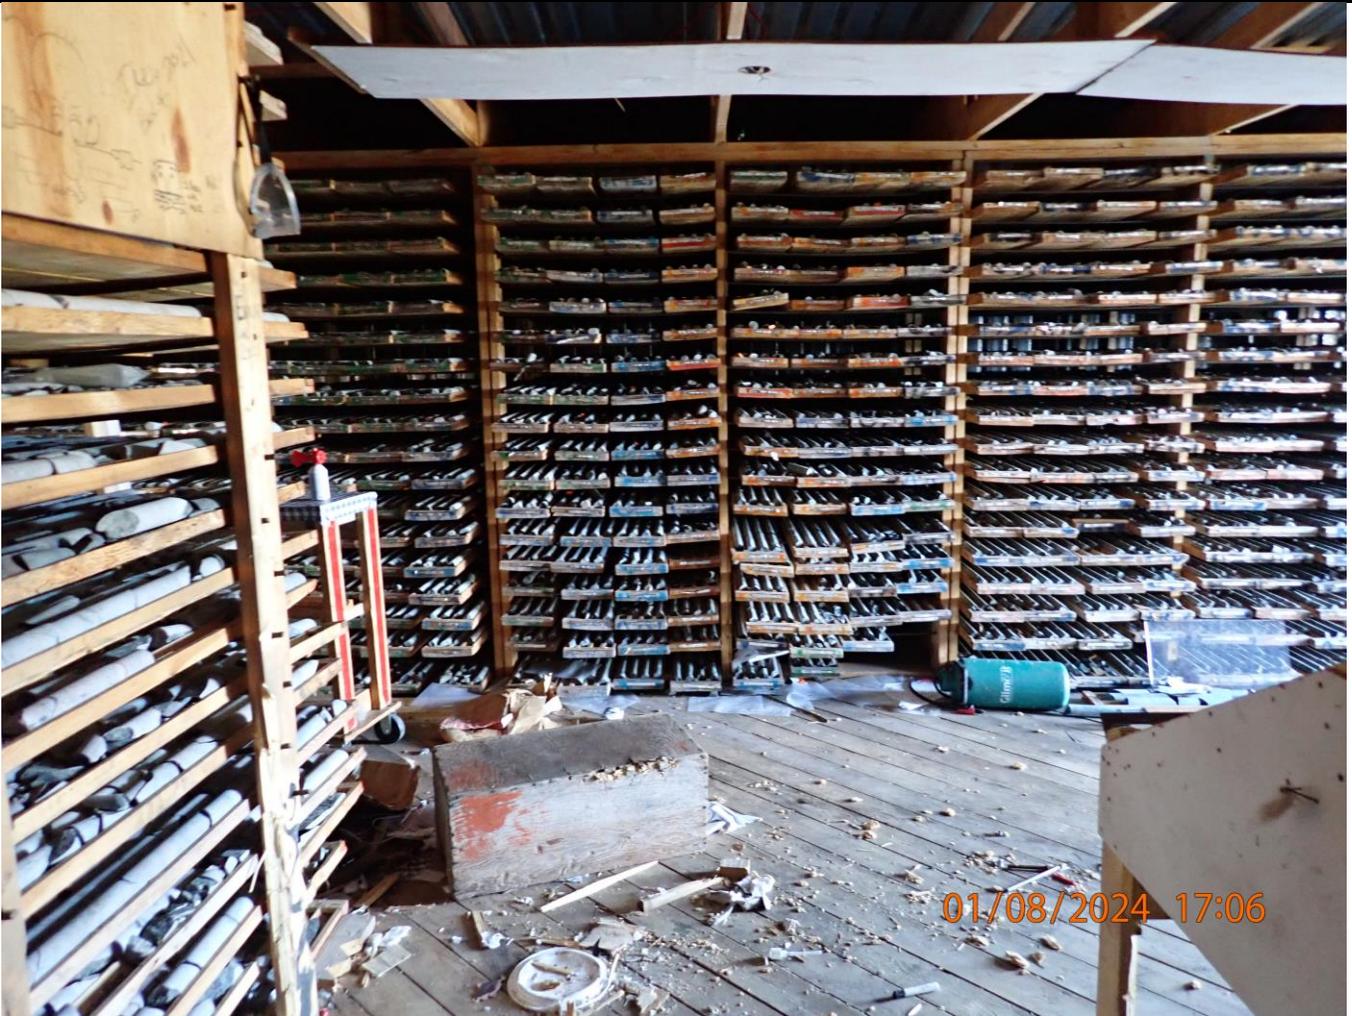
Photo 11

10. Signs of a bear staying in the core shack were observed. Debris and mess were observed all around the floor (Photo #10 and #11)
11. A steel frame was observed close to the shore of the lake (Photo #12)

Description: Debris inside the core shack

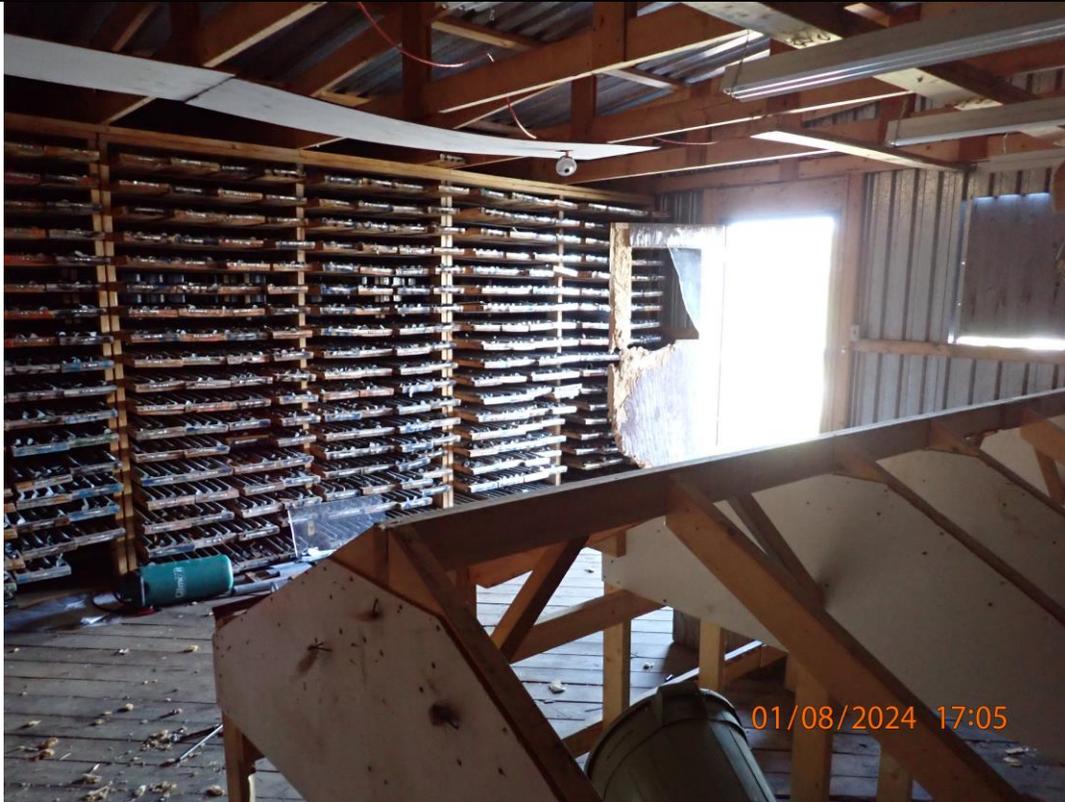
Photo 9

Description: Core shack door as seen from inside. The door is heavily damaged and unable to close.

-In regards to comment #9 and #10: The building at Hood camp (core shack) should be repaired to deny entry of wildlife into the building.

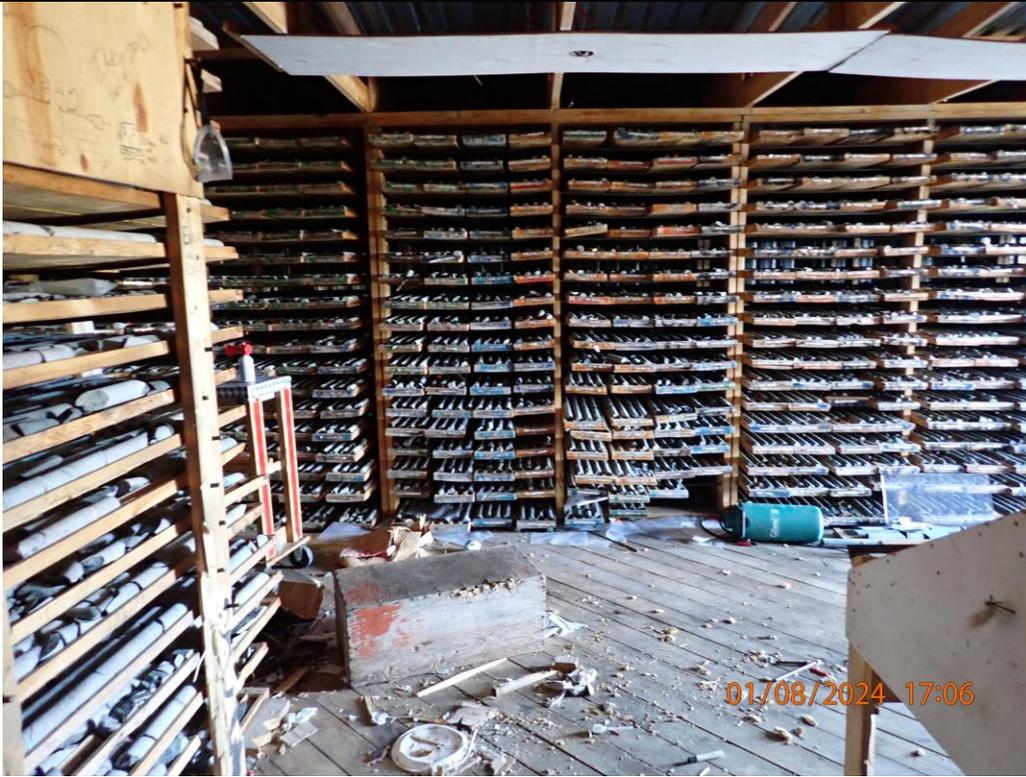
Photo 11

- 10. Signs of a bear staying in the core shack were observed. Debris and mess were observed all around the floor (Photo #10 and #11)
 - 11. A steel frame was observed close to the shore of the lake (Photo #12)
- No other concerns were noted at this site. No fuel or contaminants present on site.

Description: Debris inside the core shack
