Attachment 12 – Inspections and Responses

CROWN LAND USE INSPECTION FORM

WATER LICENCE INSPECTION FORM

Reference: Ham Lake Camp Inspection

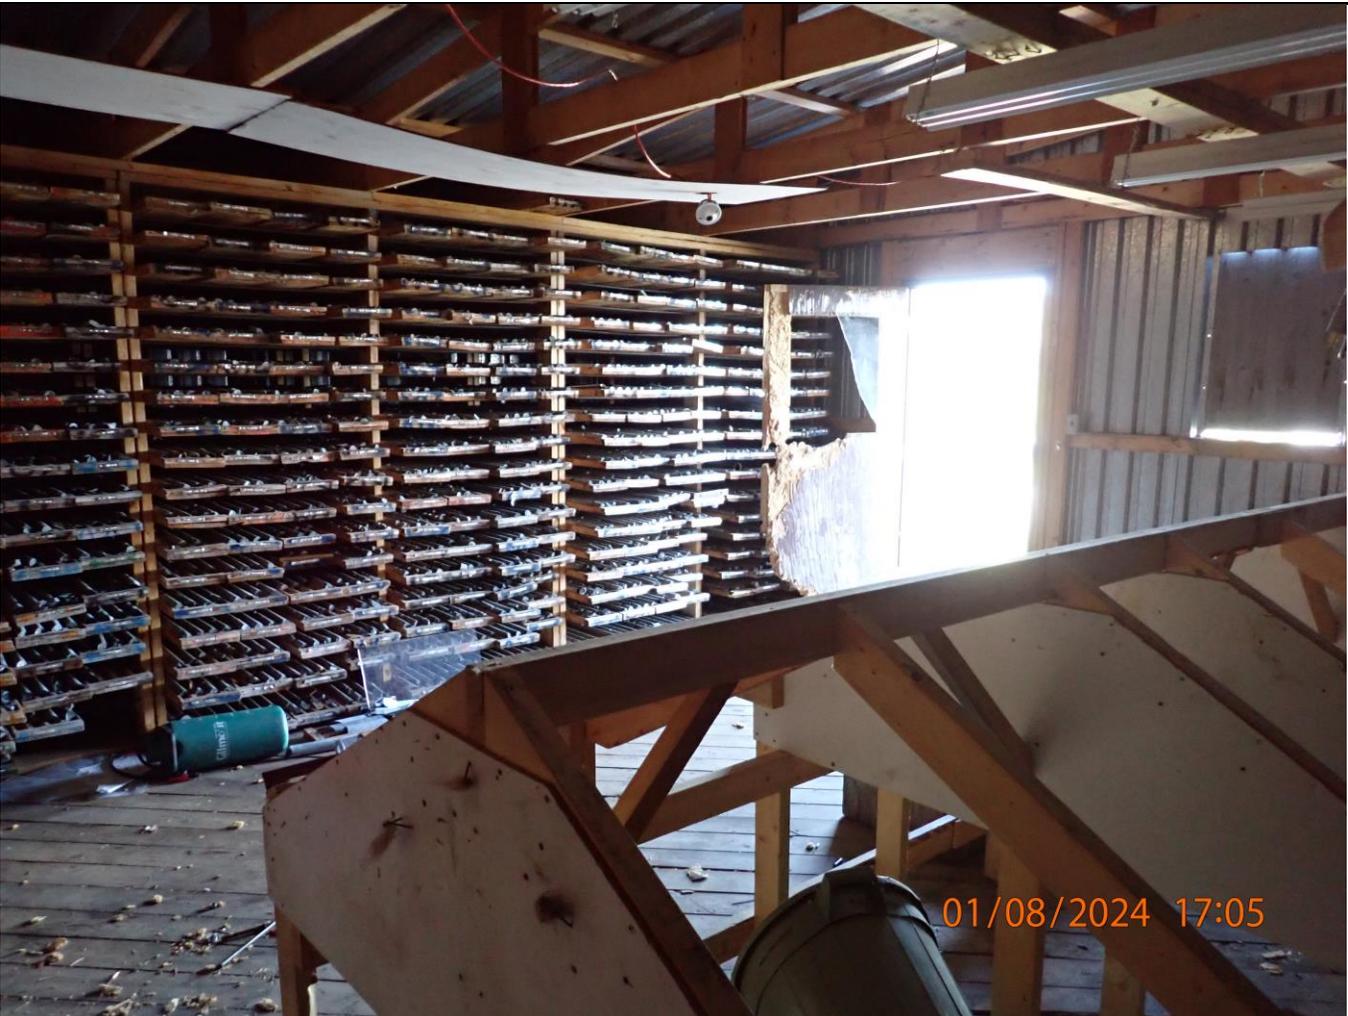
Photo 9

Description: Core shack door as seen from inside. The door is heavily damaged and unable to close.

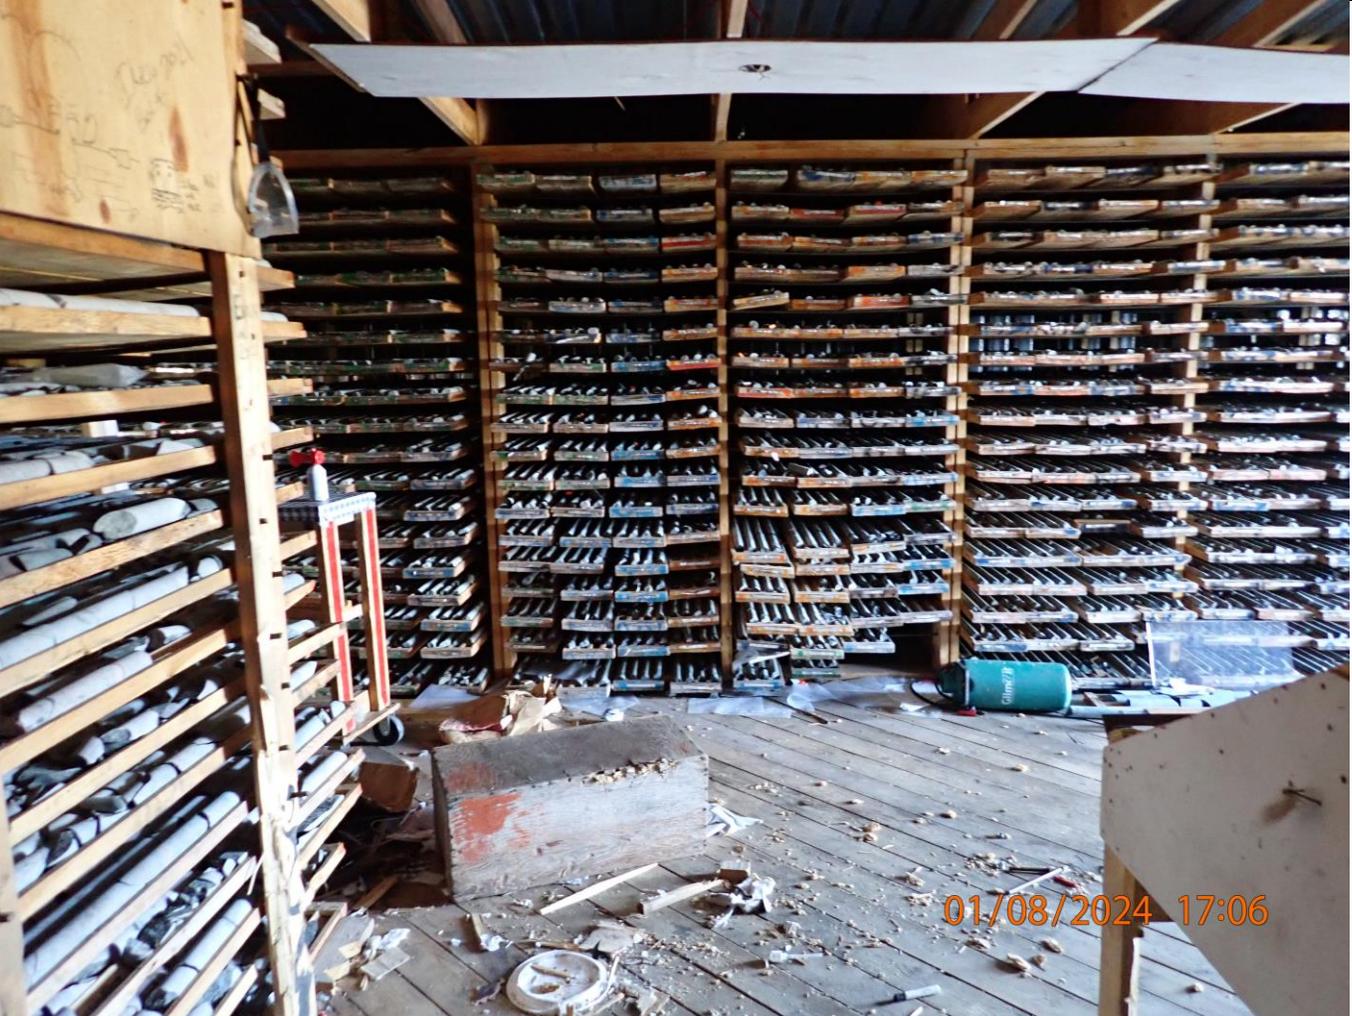
Photo 11

Description: Debris inside the core shack
