## Water Licence Inspection Report

Authorization	Representative
<b>MMG (Hood Camp)</b>	<b>Sarah Hasek</b>
Authorization No. / Expiry	Representative's Title
86I2-1 (2BE-IZO2328)	<b>Tenement Officer</b>
Other Authorization/s	
N2024C0022	
Activities Inspected	
<input checked="" type="checkbox"/> Camp, Commercial <input type="checkbox"/> Drilling <input type="checkbox"/> Mining <input type="checkbox"/> Construction <input checked="" type="checkbox"/> Reclamation <input type="checkbox"/> Fuel Storage <input type="checkbox"/> Roads/Hauling <input type="checkbox"/> Winter Hauling <input type="checkbox"/> Camp, Private <input type="checkbox"/> Other <small>Click or tap here to enter text.</small>

On August 1, 2024, I, Isaiah James Bolt, Inspector with the Crown Indigenous Relations and Northern Affairs Canada (CIRNAC), writer of this report, Along with fellow inspector Jonathan Mesher, of CIRNAC, conducted an on-site visit of Hood Camp (86I2-1)(2BE-IZO0712) to ensure compliance of their lease and water license.

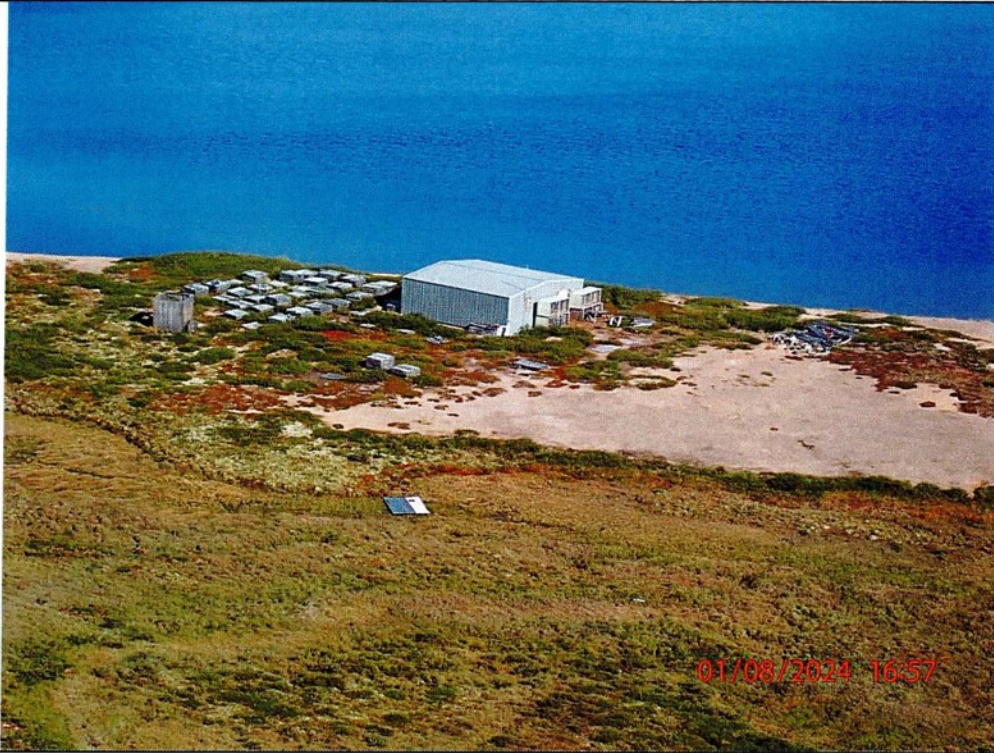
Photo 1

Description: Aerial View of Hood Camp. Core shack is the large building, core boxes, drill rods and an abandoned shack observed.

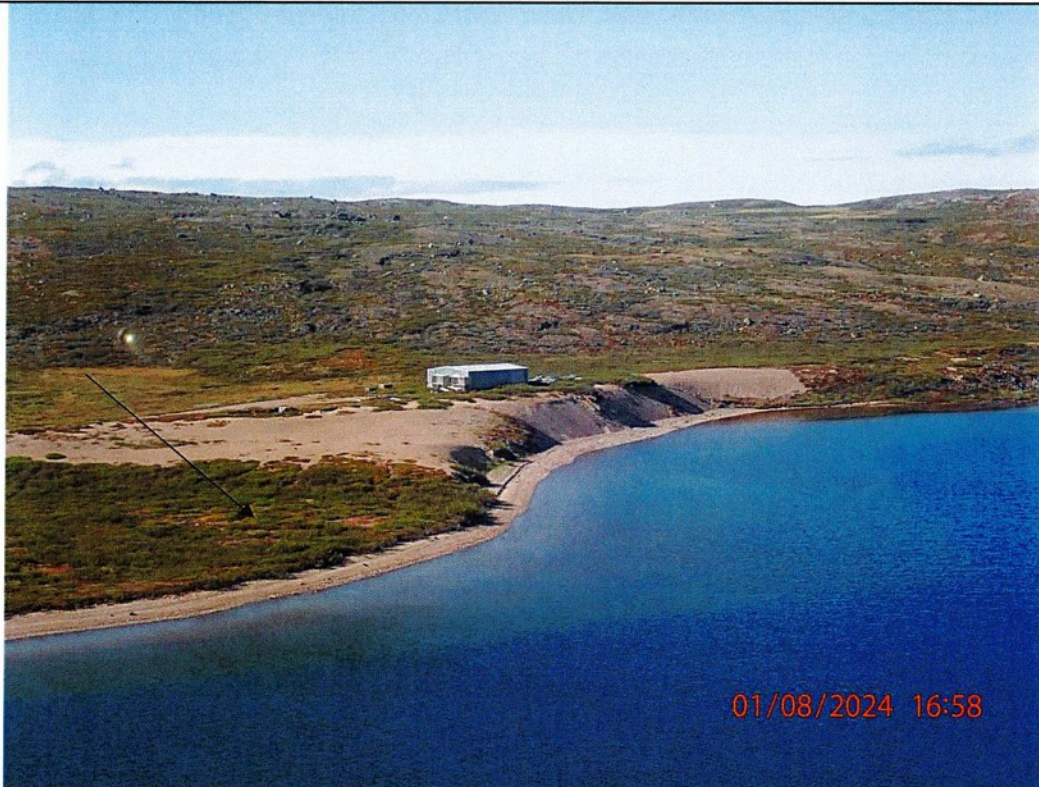
Photo 2

Based on the last inspection from Eva Paul in 2017, it seems 3 cabins along the shore have been removed from site, along with the trash barrels and debris around the cabins. No concerns noted.

Description: Aerial View #2, showing the removal of 3 cabins that used to be where the arrow on the image is pointing.

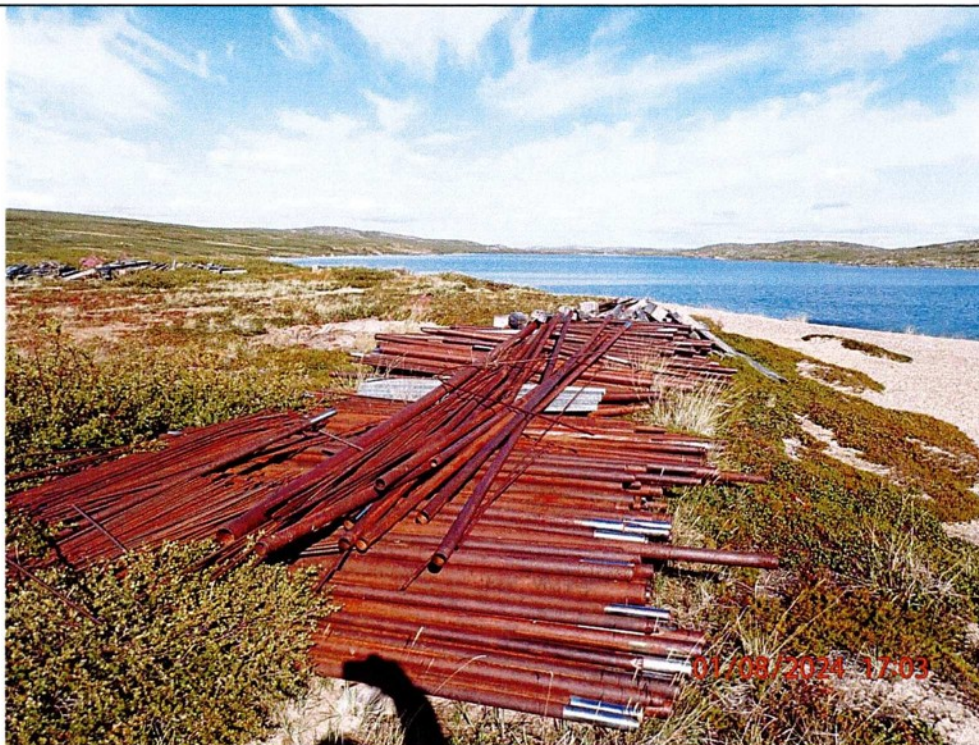
Photo 3

-In regards to comment #3,#4, #5, #6, #7 and #11: Part I, Item 5 of the issued water license states: "The licensee shall remove from the site, all infrastructure and site materials, including all fuel caches, drums, barrels, buildings and contents, docks, water intakes, pumps and lines, materials and equipment prior to the expiry of this license".

Description: Stack of drill rod present on site.

-Remove all equipment related to the undertaking and restore the land back to its natural state. Information about the future plans of the core shack should be reported to the Inspector, (i.e.. demobilization, deconstruction).

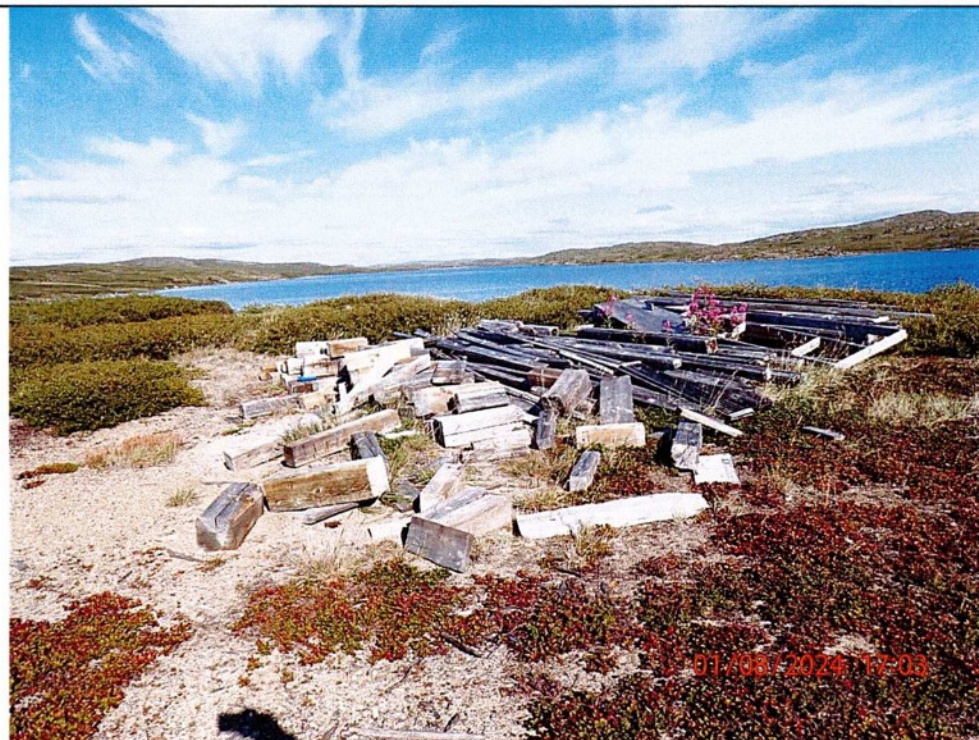
Photo 4

Description: Stack of Lumber present on site.

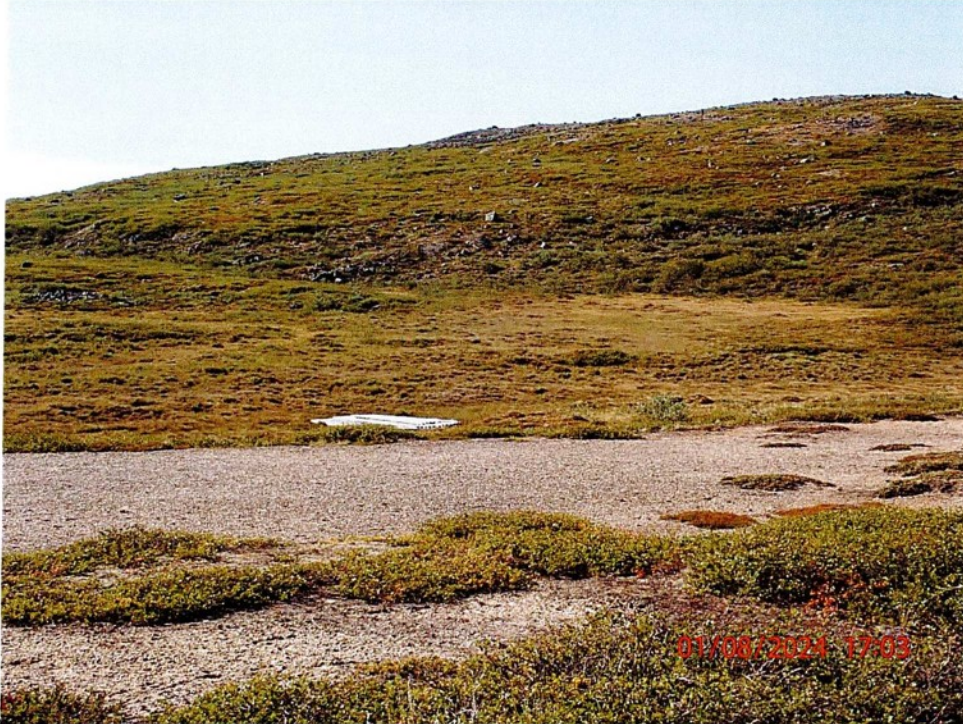
Photo 5

Description: Metal sheet roofing placed on top of a wooden wall in the tundra.

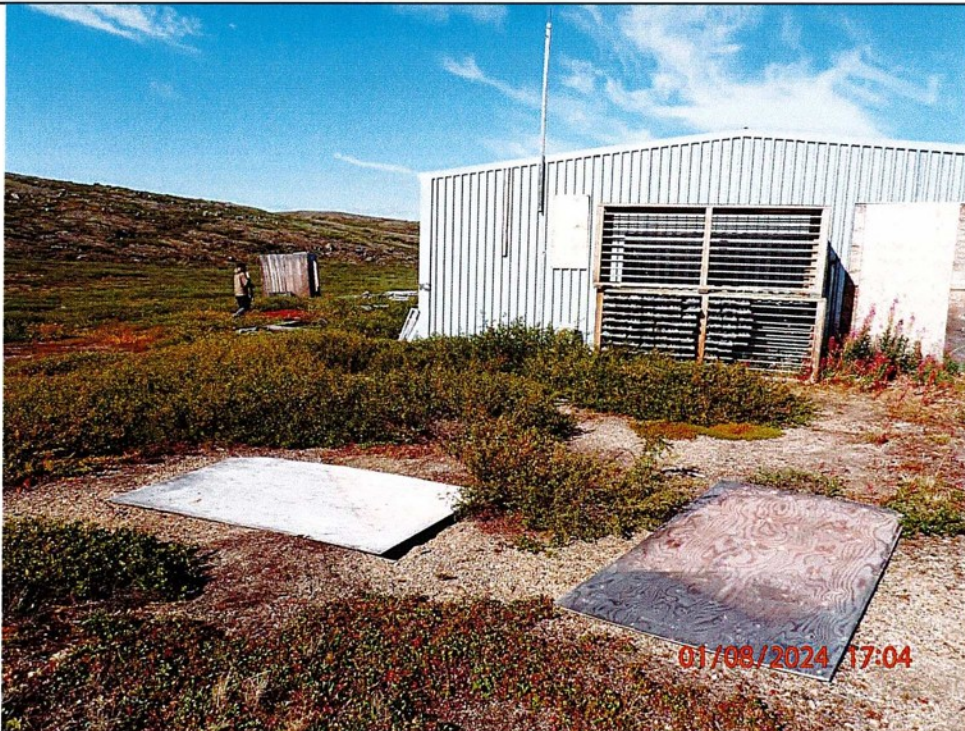
Photo 6

Description: ply wood debris behind the core shack (silver)

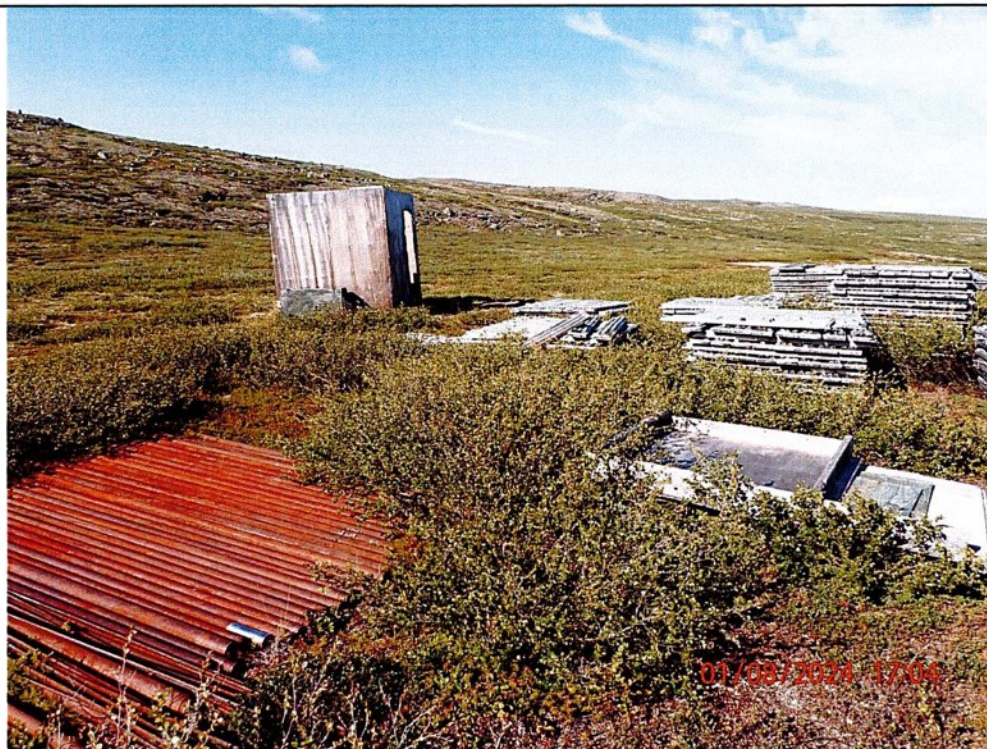
Photo 7

Description: Stacked drill rods, abandoned shack and some core boxes.

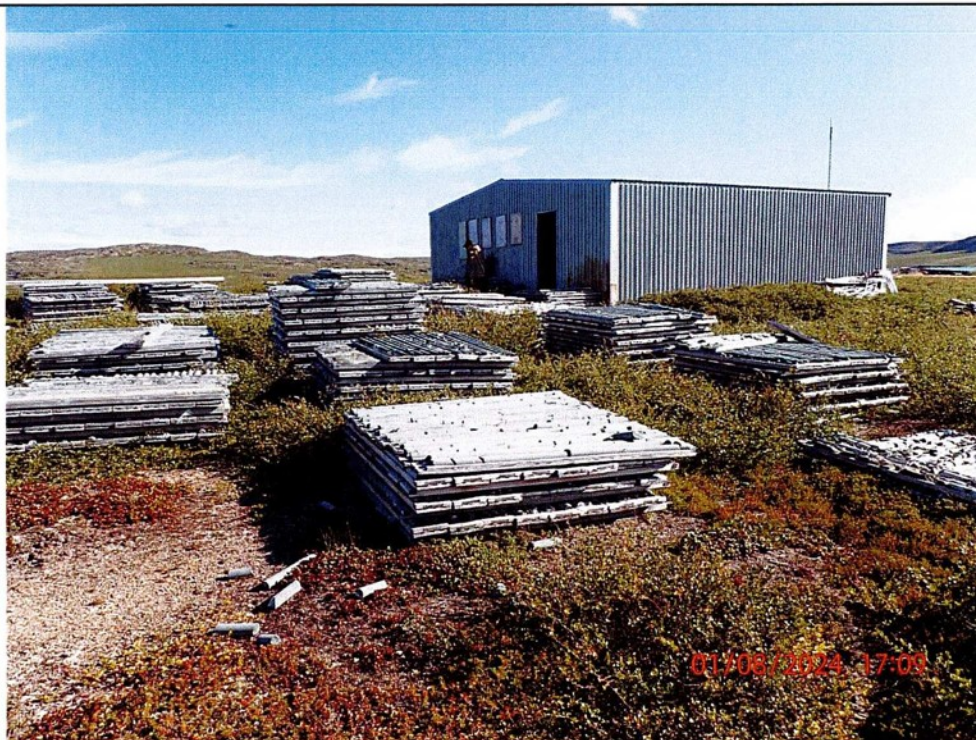
Photo 8

Description: Core boxes outside, core shack (Silver) shown with an open door

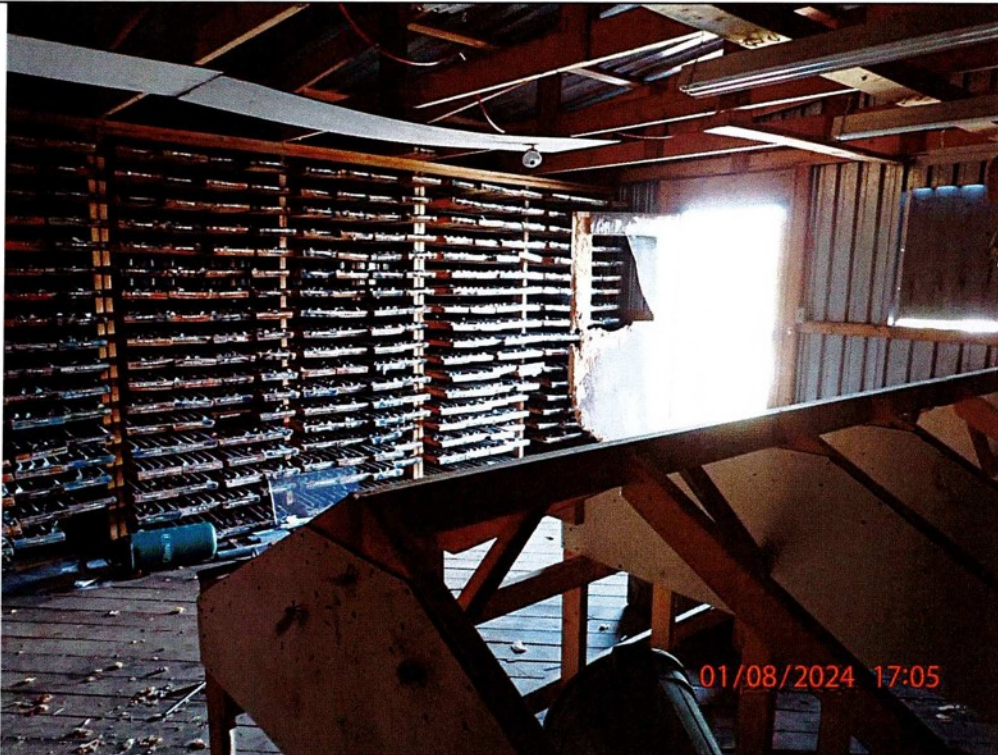
Photo 9

1. Inspectors arrived on site at 5:00PM on August 1<sup>st</sup>, 2024.
2. Aerial Photos were taken (Photo # 1 and #2)
3. Drill rods were present on site in a stacked manner. (Photo #3)
4. A pile of lumber was observed on site (Photo # 4)
5. Roofing material was stacked on top of a wooden wall in the tundra (Photo #5)
6. Ply wood debris observed on the ground behind the core shack. (Photo #6)
7. A small abandoned shack was observed on site with no roof and no door. There was nothing in the shack that would attract wildlife. Reclamation of this building is required. (Photo #7)
8. Core boxes were observed on the north side of the core shack. No issues noted. (Photo #8)
9. The door of the core shack was damaged and open. Signs of a bear breaking in were observed as the door was broken, scratched and chewed up (Photo #9)

-In regards to comment #9 and #10: The building at Hood camp (core shack) should be repaired to deny entry of wildlife into the building.

Description: Core shack door as seen from inside. The door is heavily damaged and unable to close.

-Ensure buildings that are housing core, are up to operational standards to deny entry of wildlife as per the Inspectors request.

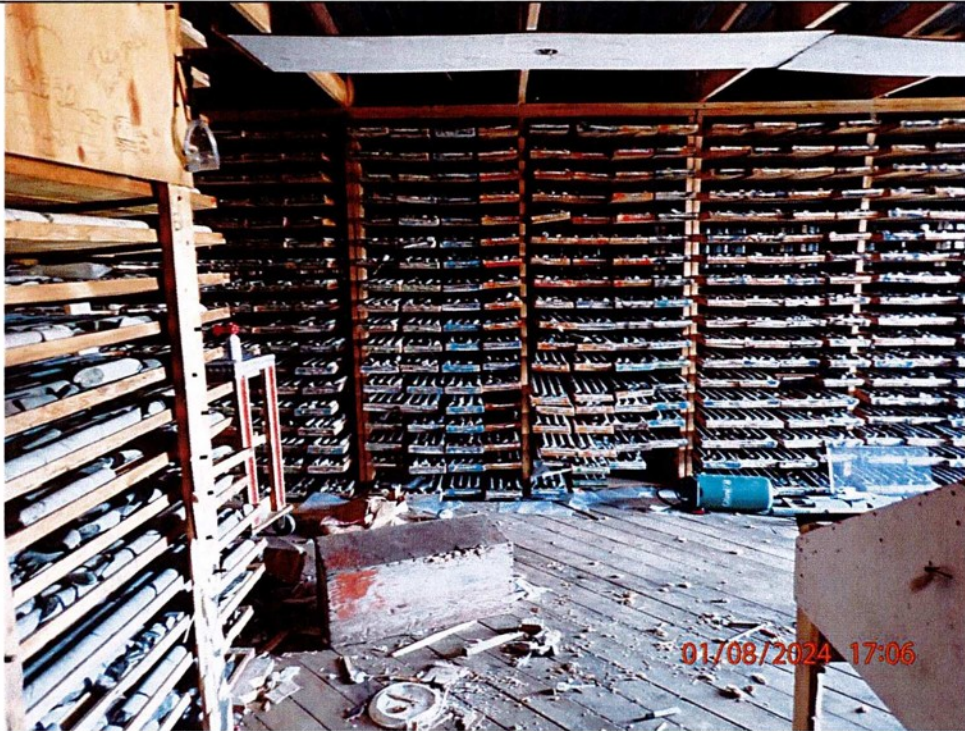
Photo 11

10. Signs of a bear staying in the core shack were observed. Debris and mess were observed all around the floor (Photo #10 and #11)
11. A steel frame was observed close to the shore of the lake (Photo #12)
- No other concerns were noted at this site. No fuel or contaminants present on site.

Description: Debris inside the core shack

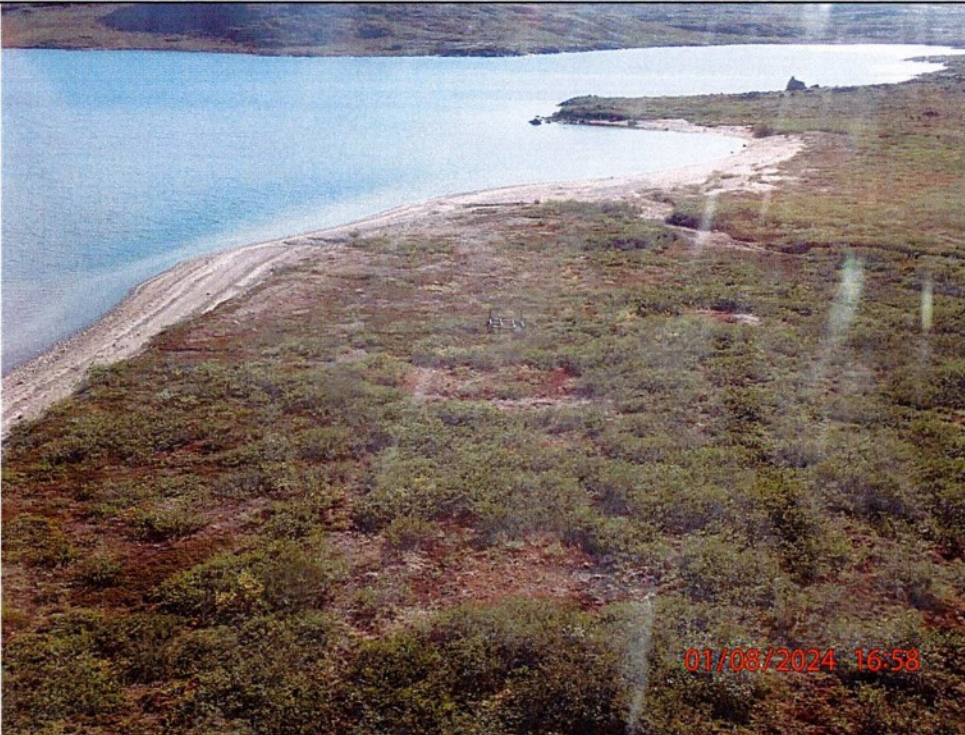
Photo 11

Description: A large steel frame on the tundra close to where old cabins were situated.
