WATER LICENCE INSPECTION FORM

Licensee	Licensee Representative
MMG Resources INC.	Greg Martin
License No. / Expiry	Representative's Title
2BE-IZO2328	
Land / Other Authorizations	Land / Other Authorizations
N2024C0022	
Date of Inspection	Inspector
01/08/2024	Isaiah James Bolt
Activities Inspected	
<input checked="" type="checkbox"/> Camp <input type="checkbox"/> Drilling <input type="checkbox"/> Mining <input type="checkbox"/> Construction <input checked="" type="checkbox"/> Reclamation <input checked="" type="checkbox"/> Fuel Storage	
<input type="checkbox"/> Roads/Hauling <input type="checkbox"/> Other:	<input checked="" type="checkbox"/> Other: Care & Maintenance

On August 1, 2024, I, Isaiah James Bolt, Inspector with the Crown Indigenous Relations and Northern Affairs Canada (CIRNAC), accompanied by Inspector Jonathan Mesher with CIRNAC, conducted an inspection of 2BE-IZO2328 to ensure compliance against their License.

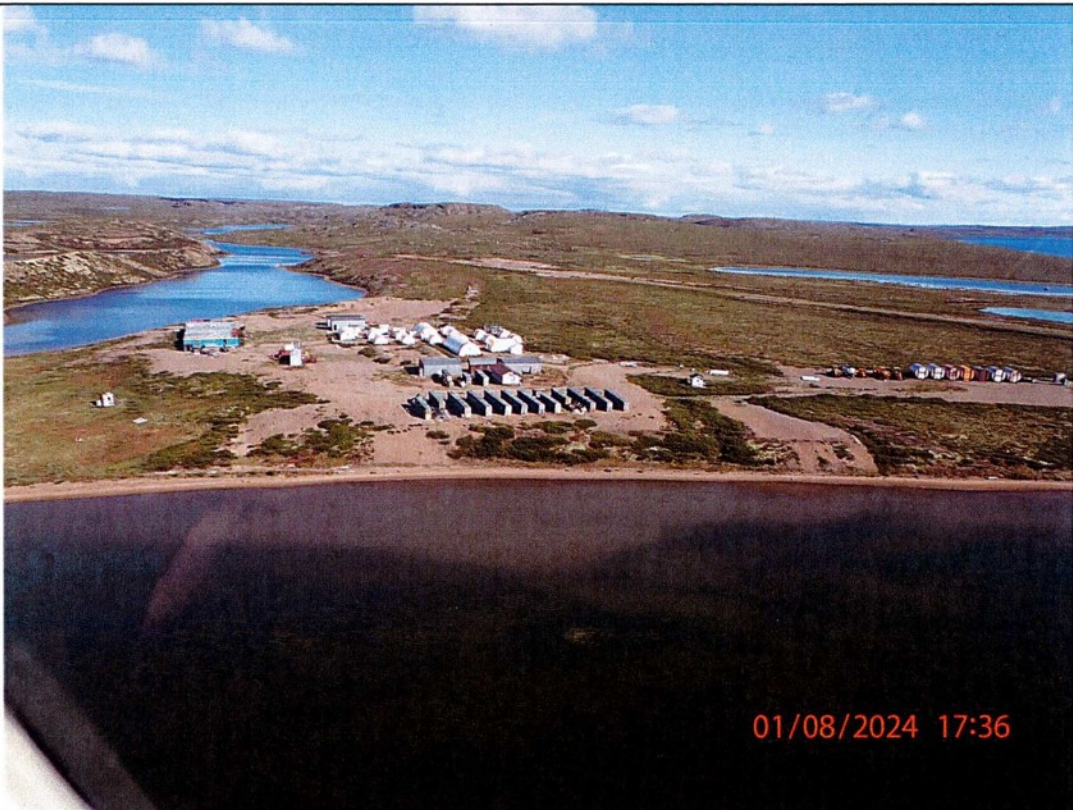
Date	Camera	Inspector
August 1, 2024	Olympus Tough TG-6	Isaiah James Bolt
Photo Log # 1		
Photo 1

Aerial view of Izok camp on Ham lake. The airstrip, accommodations, equipment and fuel tanks are shown.

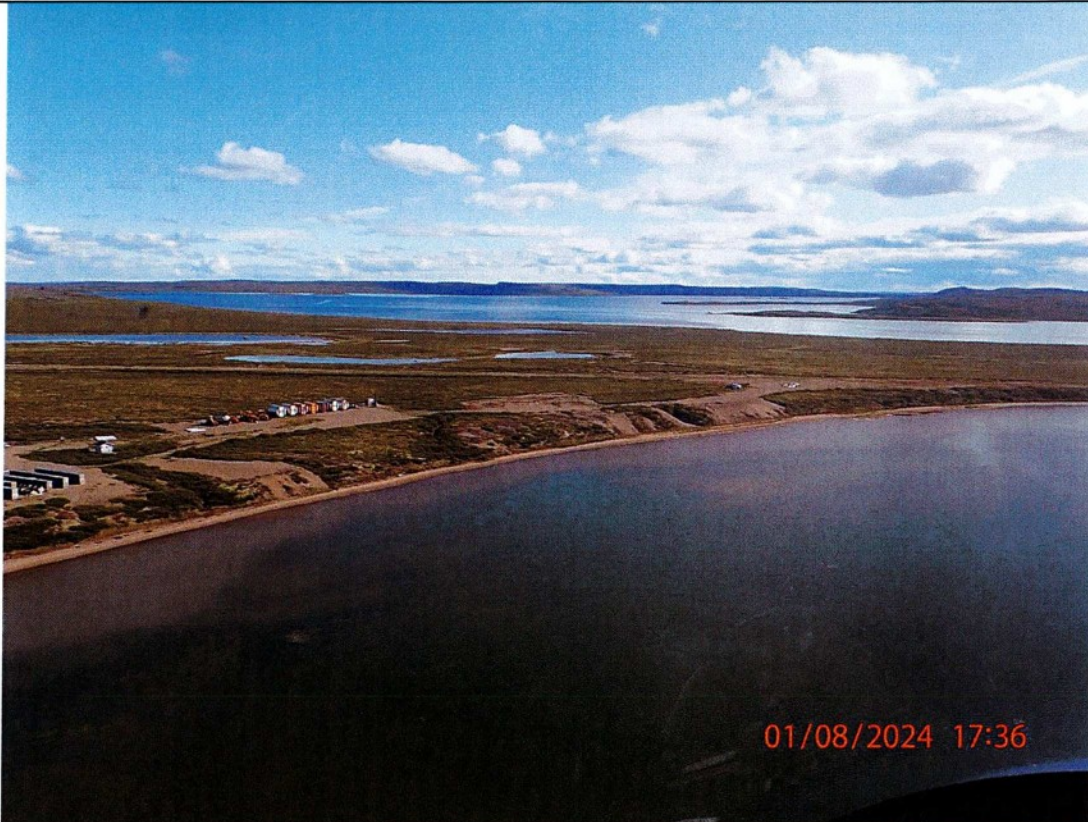
Photo 2

Aerial View of Izok camp on ham lake showing the rest of the airstrip, equipment, and fuel tanks stored on site.

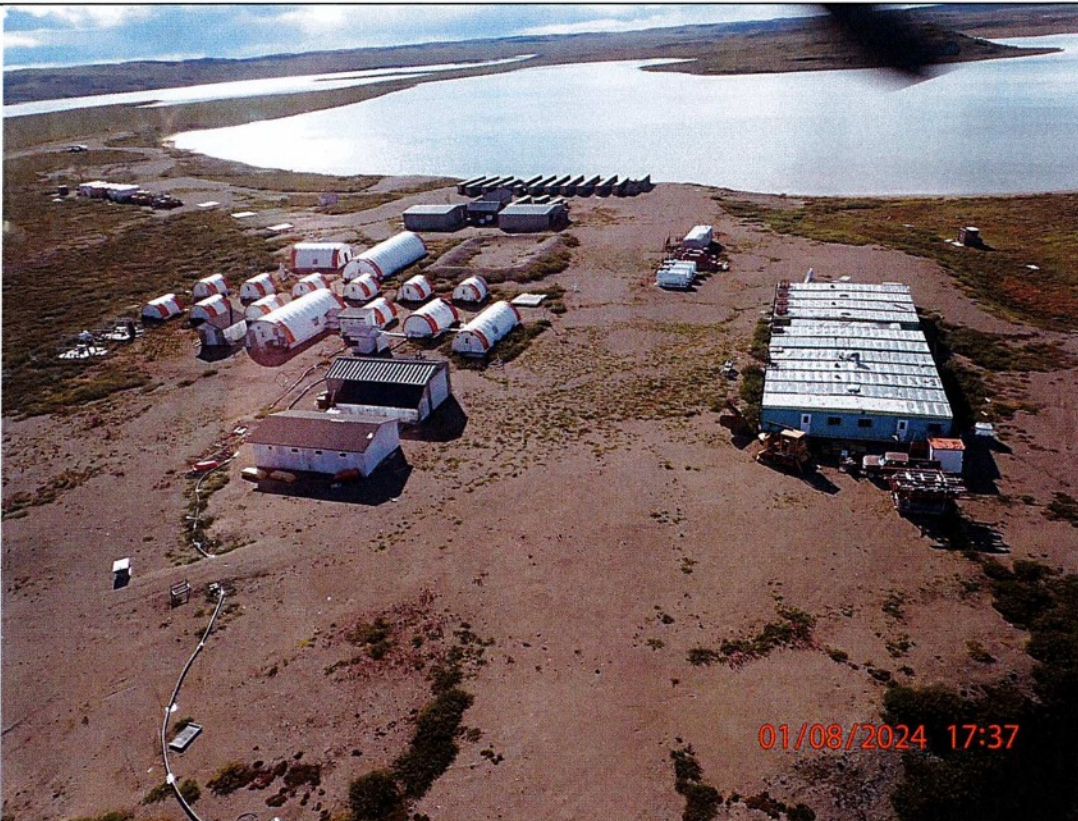
Photo 3

Aerial of Izok camp. Looking west.

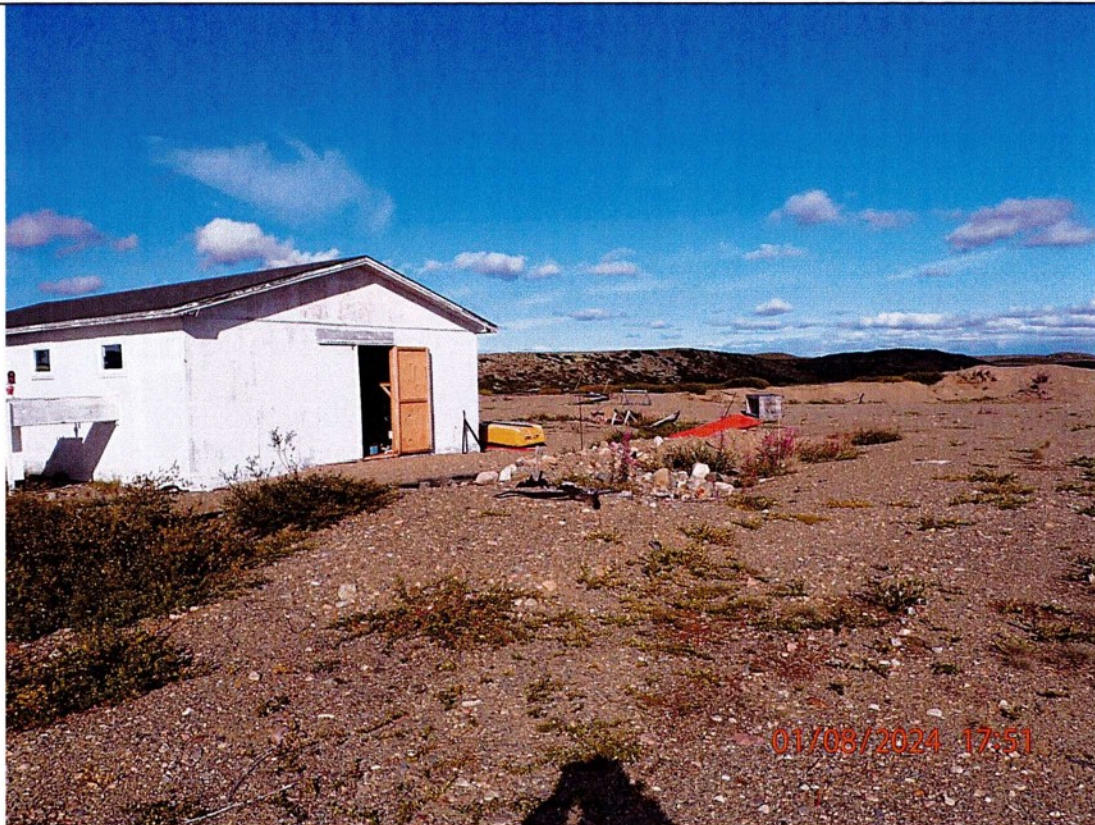
Photo 4

1. Inspectors arrive on site at 5:40pm on August 1, 2024. Camp Location 65°41'06.30"N 112°52'53.93"W. Aerial photos where taken (Photo #1, #2, #3)
2. During the inspection the Inspectors noted several buildings with their doors open. 1 weather haven had its door open, the core shack had an open door, the building that houses the bobcat/skidoos and the garage beside it that houses the loader had their doors open. (Photo #4 shows the shop with a door open, this building stores skidoos and the bobcat inside, Photo #1 shows the garage door open) (Photo # 12 and #13 show the open door of the core shack and the inside of the core shack.)

Open door of a storage shed, inside are skidoos, equipment and a bobcat.

All buildings windows and doors shall be repaired and covered to prevent the entry of wildlife.

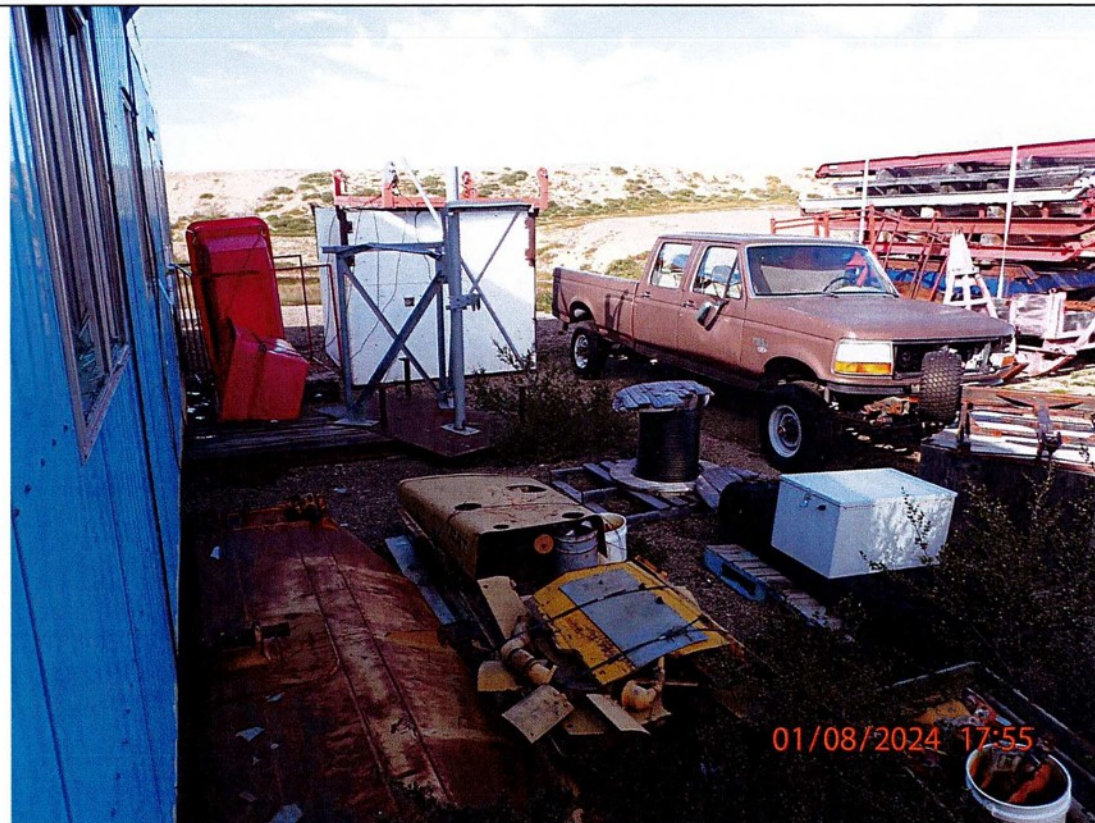
Photo 5

3. Various types of scrap metal and old parts were observed on site. All metal and parts were well sorted but anything not required for the project shall be removed from site. (Photo #5 and #6)

And old truck, old parts and equipment outside the old trailer accommodations.

All scrap metal discarded machine parts and unused equipment shall be removed from site.

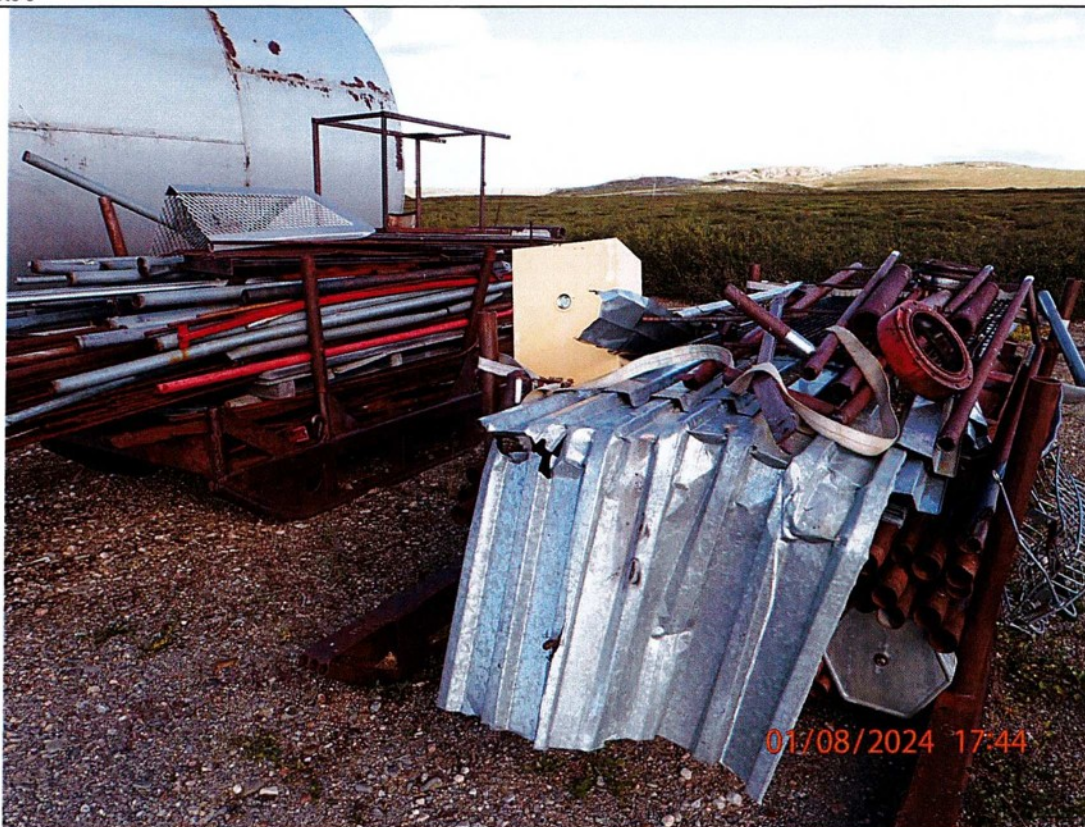
Photo 6

Scrap metals stored beside fuel tanks close to the airstrip.

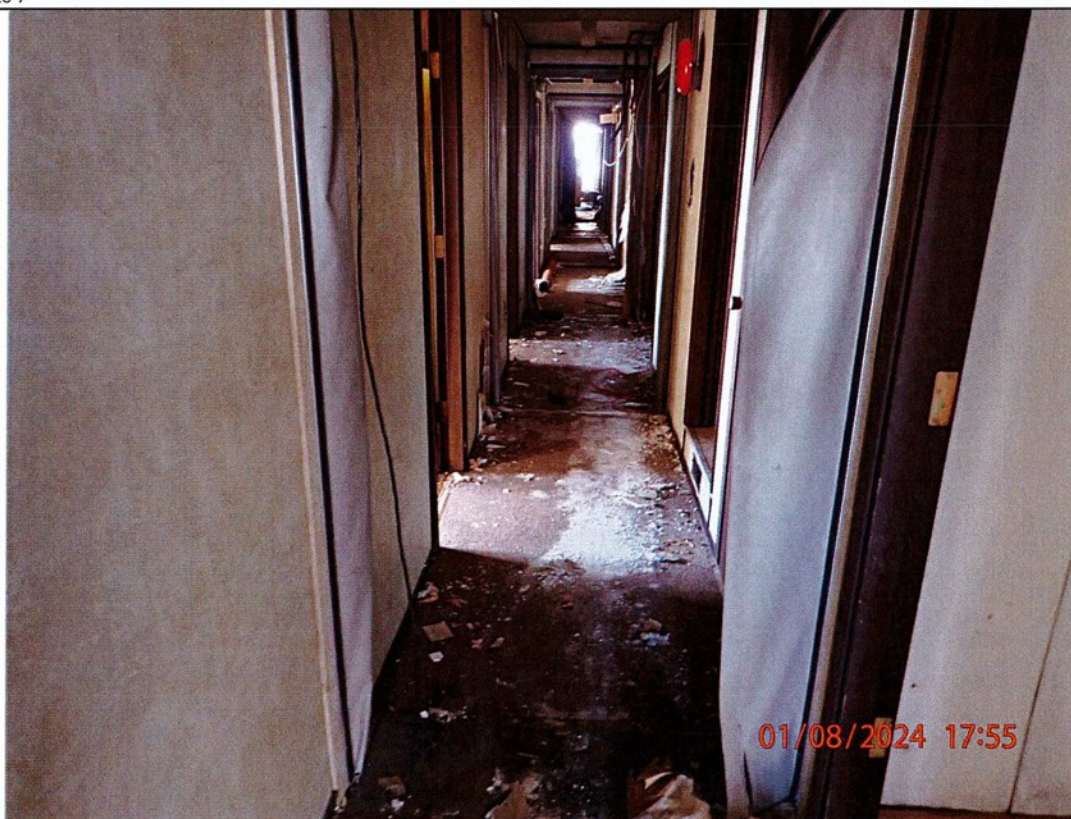
Photo 7

4. The old accommodations buildings (trailers) shall be removed from site at the earlier possible opportunity. A bottle of Nitric Acid was observed on a bed in one of the rooms along with garbage throughout the buildings. A lot of the windows were broken and some doors open, signs of bear activity were apparent throughout the trailers. Plants were observed growing on the floors and the old beds. It seems like the trailers are being used as a type of storage facility as it was observed that helicopter rigging gear, water pumps and various hoses and connections, Styrofoam, reflective insulation, absorbents (Can-Dry supreme all purpose absorbent), tools/chains, and other types of equipment were present inside the trailers. (Photo #7,#8,#9,#10,#11) All this equipment and garbage needs to be removed, stored properly and the trailers need to be seal shut and closed off until they can be removed from site.

View inside the old trailer accommodations. The door at the back was open, a lot of windows were open.

All the equipment and garbage/chemicals in the old accommodations trailers needs to be removed, stored properly and the trailers need to be sealed shut and closed off to prevent access by wildlife until they can be removed from site.

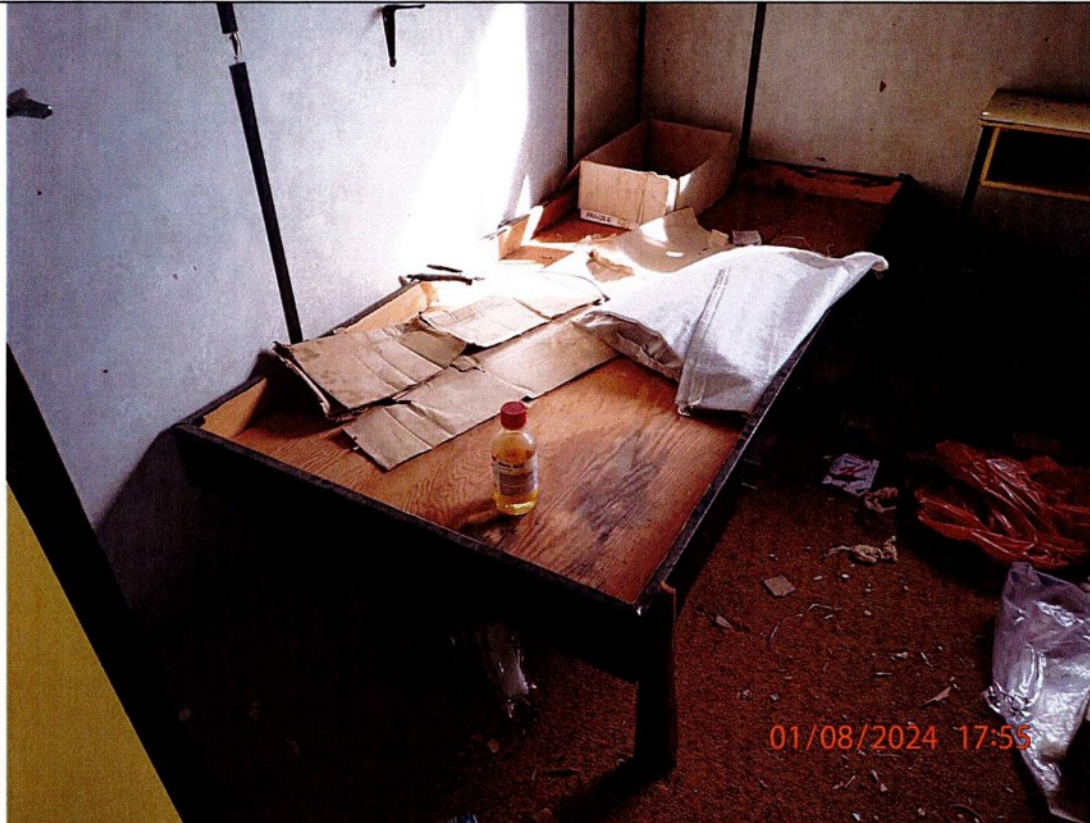
Photo 8

Nitric Acid on the bed. Garbage all over the room.

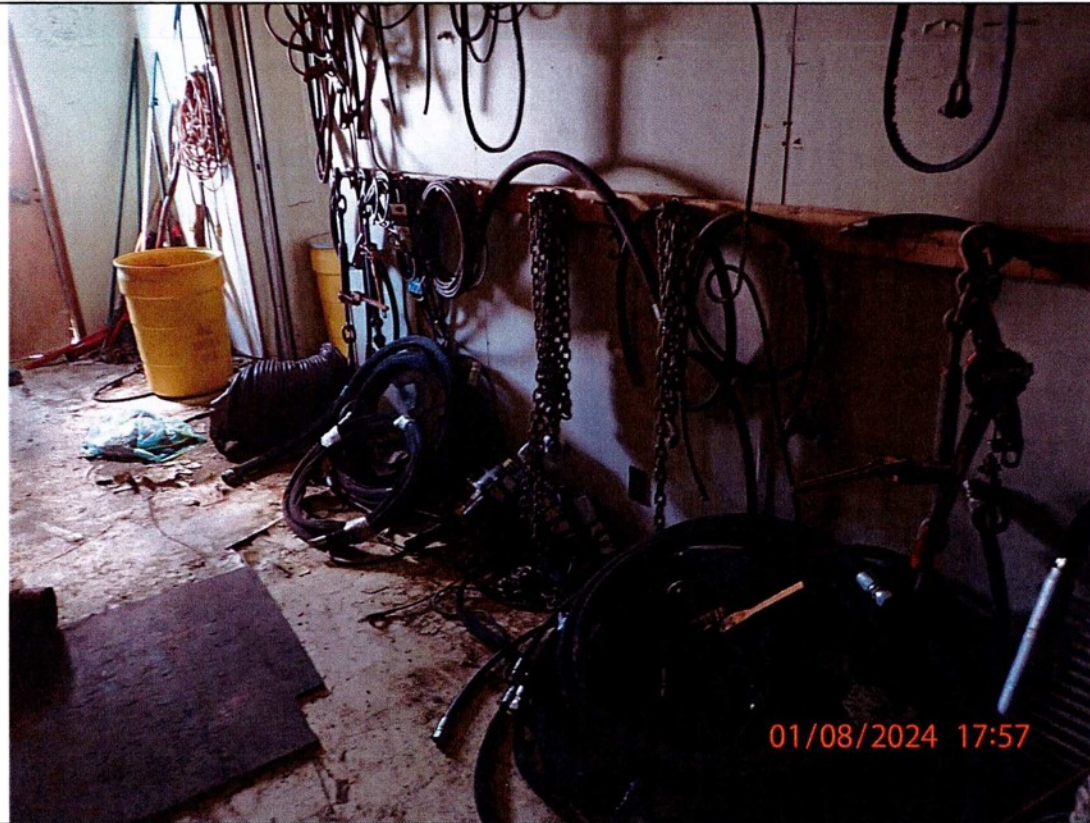
Photo 9

Chains, various hoses, water pumps, and other equipment stored in the old accommodation trailers.

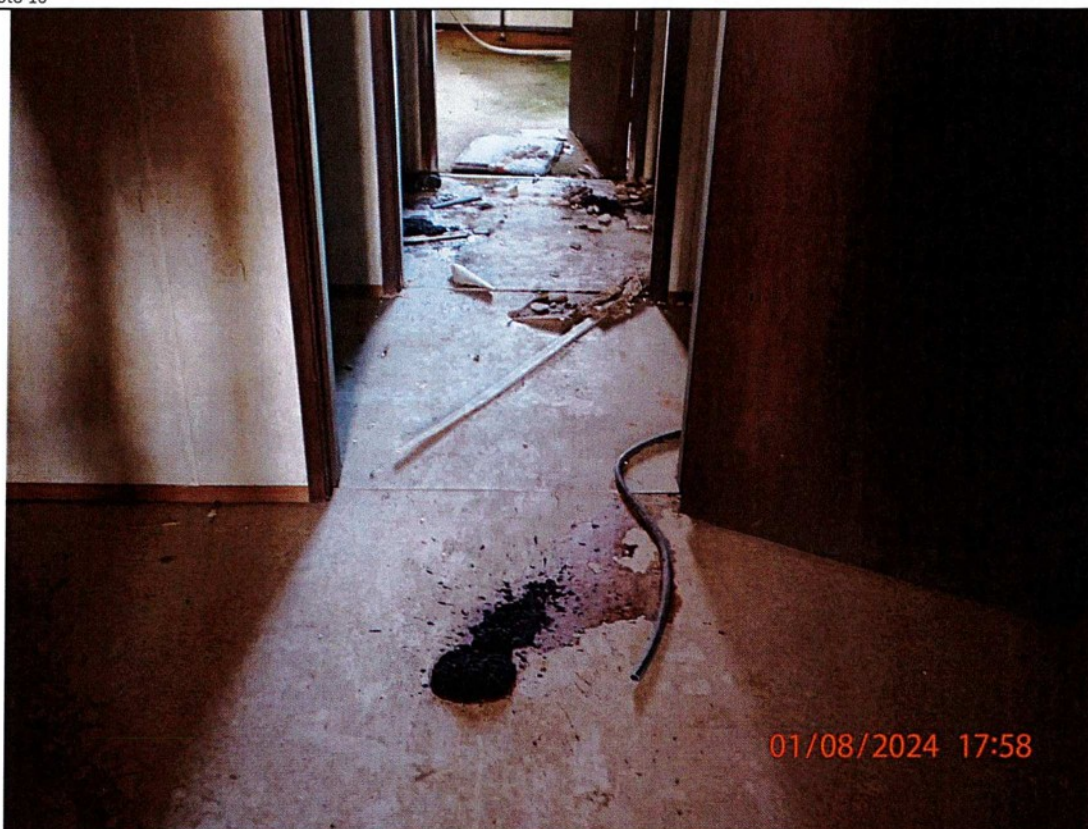
Photo 10

Bear scat and building material shown on the floor of the old accommodation trailers.

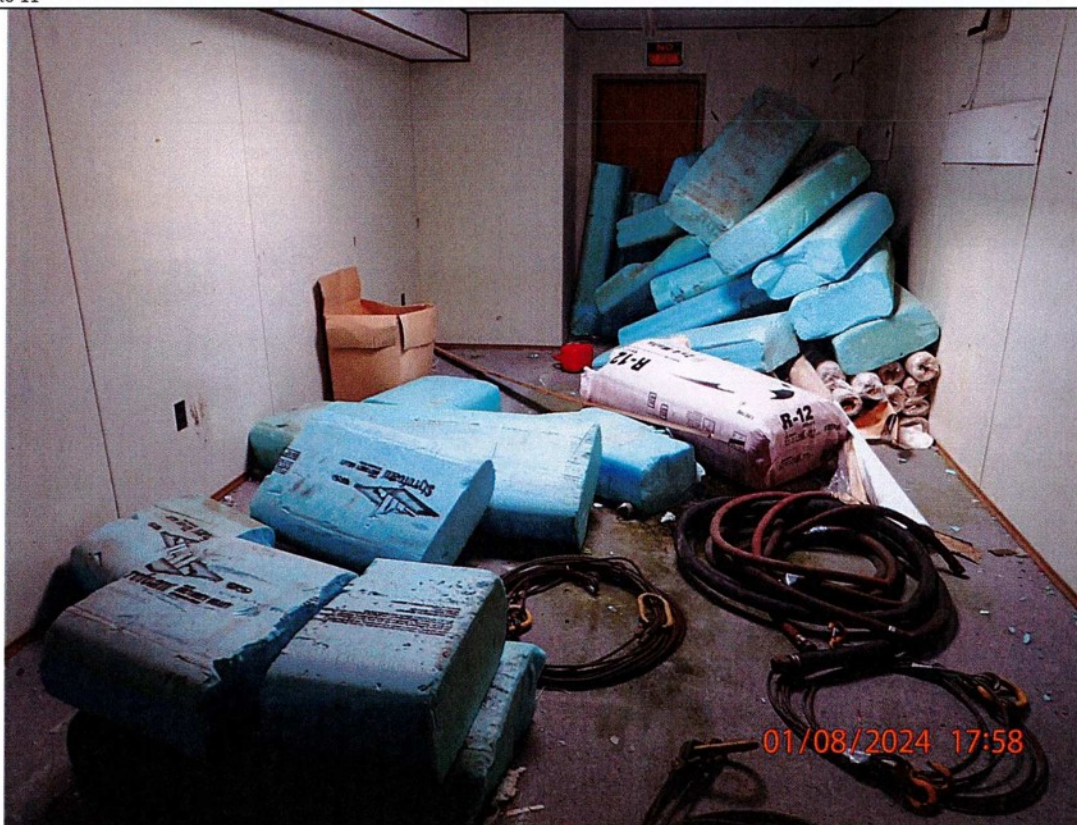
Photo 11

Helicopter slinging gear and Styrofoam/fiberglass insulation stored in the old accommodations trailers.

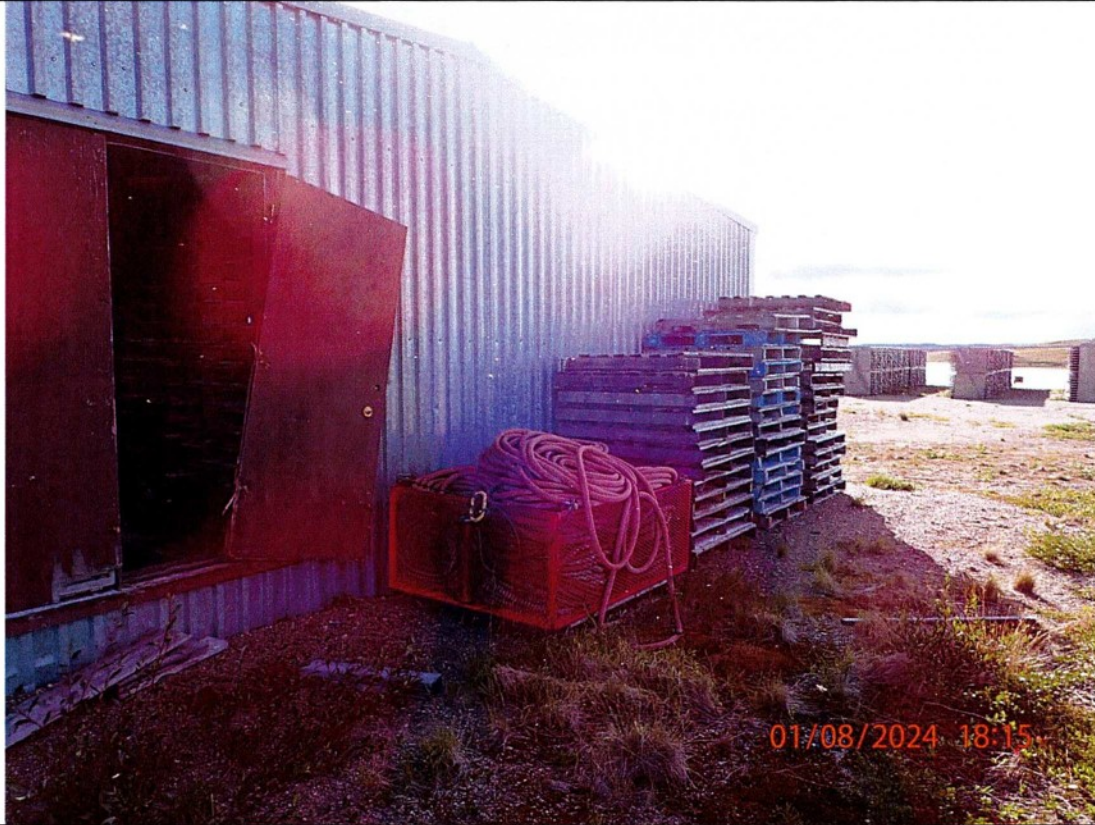
Photo 12

Core shack door open

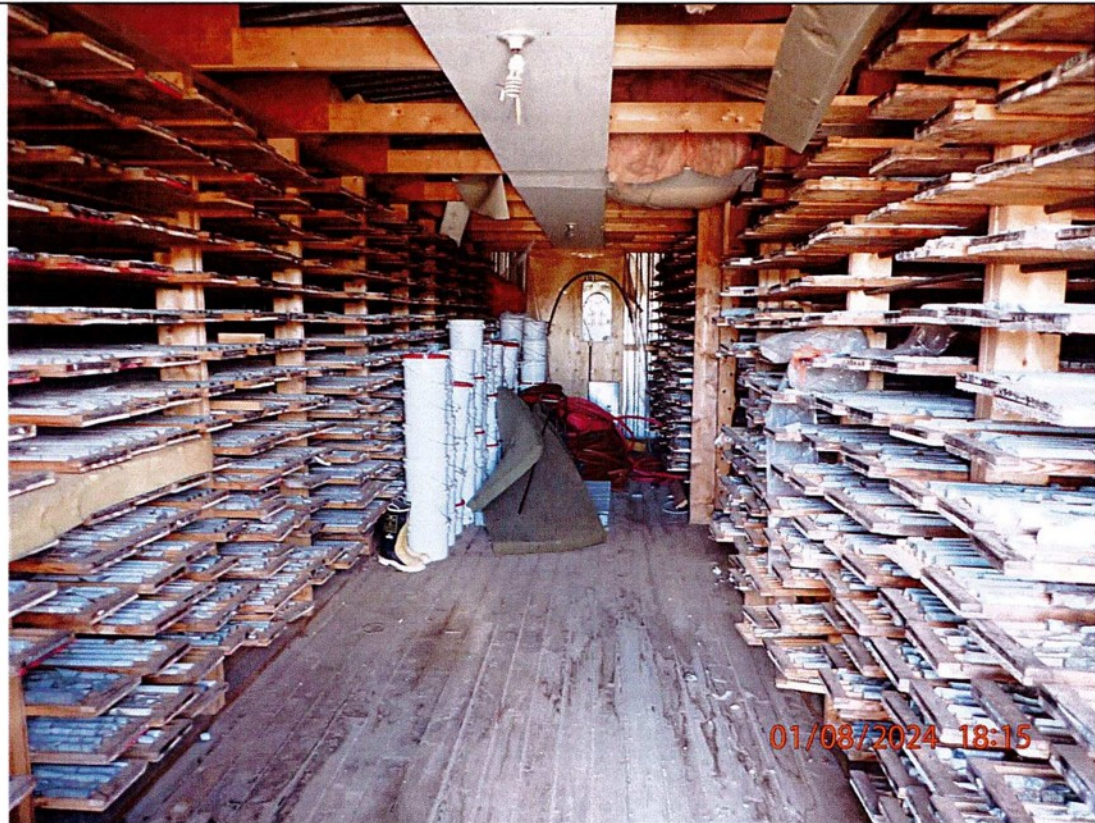
Photo 13

Inside core shack that had its door open.

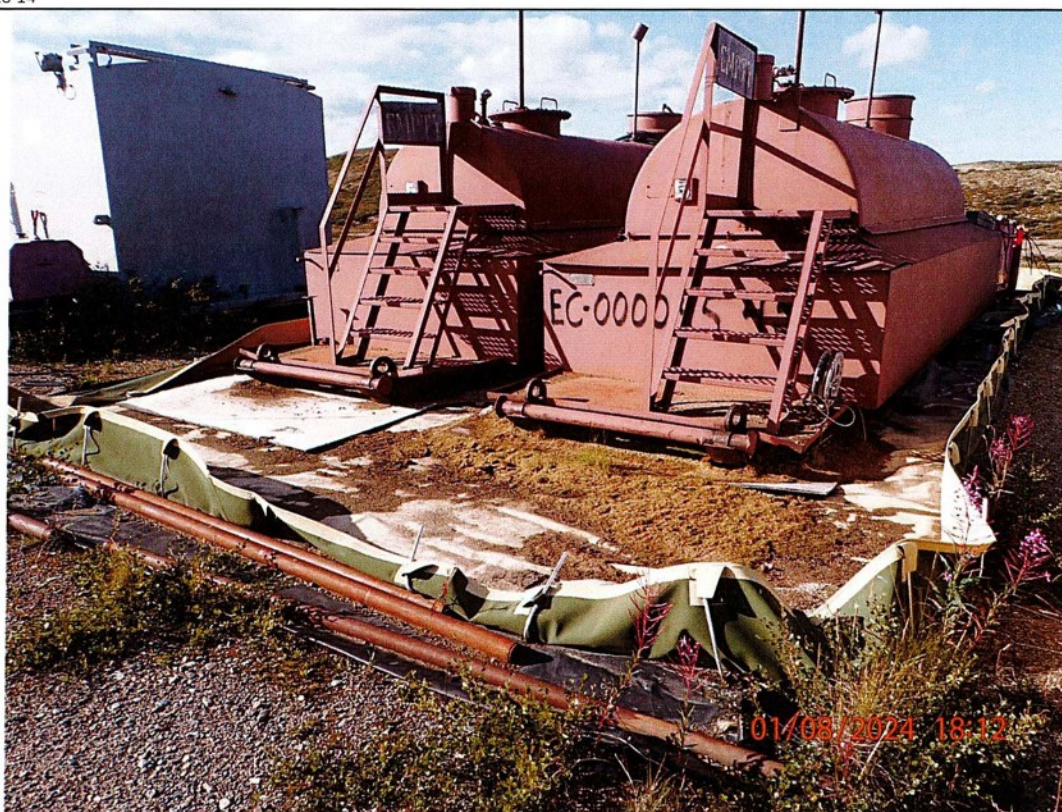
Photo 14

5. A secondary containment berm was observed with failed side walls. (Photo #14) inside the secondary containment are 2 large fuel tanks labelled as empty. Inside the berm was some water under tanks and moss has started to grow in the berm.

Failed secondary containment. Moss and some water present inside the berm.

All secondary containment utilized shall be flagged have a cover on them when regular inspection is not possible. Failed secondary containments shall be changed for a new ones. Unused fuel tanks shall be removed from site.

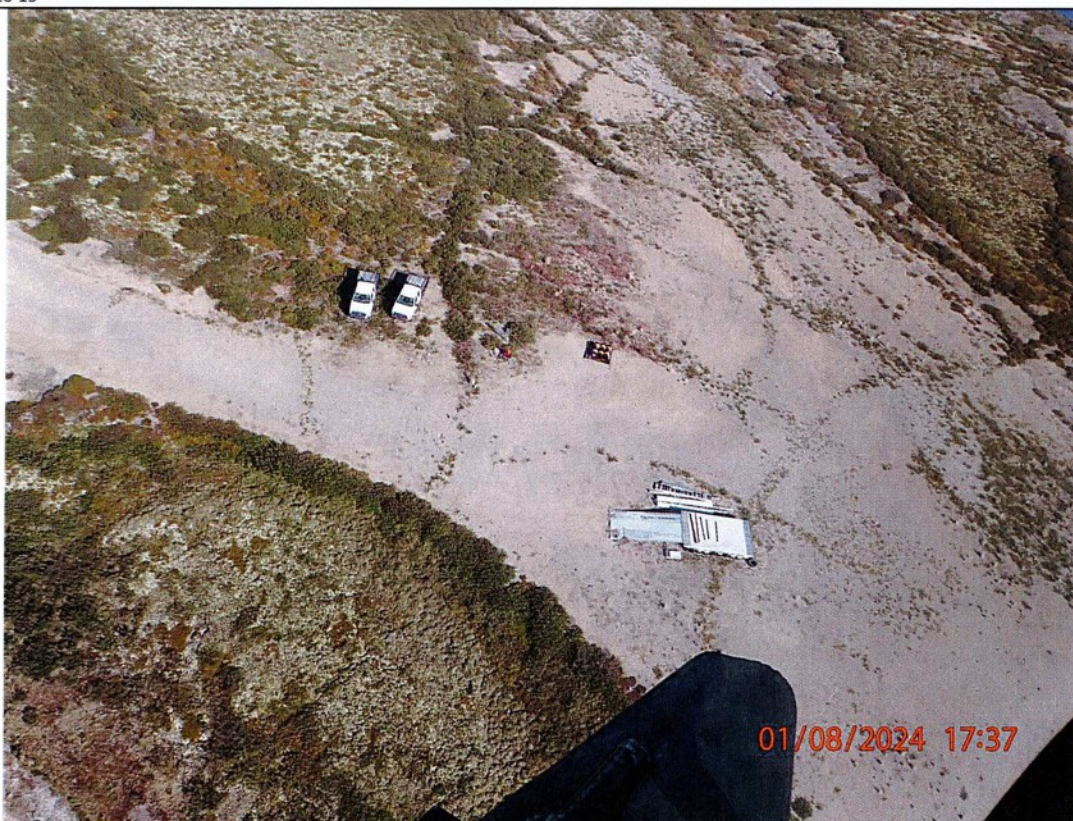
Photo 15

6. 6 drums of fuel were observed near the air strip/helicopter pad that were stored in secondary containment but not covered.

2 trucks, a Fire extinguisher, 6 fuel drums in an uncovered secondary containment and a heli pad near the airstrip.
