**WATER LICENCE INSPECTION FORM**☒ Original
☐ Follow-Up Report

Licensee Kodiak Copper Corp. (formally Dunnedin Ventures)	Licensee Representative Jeff Ward
Licence No. / Expiry 2BE-KDP1722/ May 30 th , 2022	Representative's Title VP Exploration
Land Authorization No. / Expiry N2018C0022/ October 31 st , 2023	Project Name Kahuna Diamond Property
Date of Inspection August 6 th , 2020	Inspector RMO C. Wilson
Activities Inspected <input checked="" type="checkbox"/> Camp <input type="checkbox"/> Drilling <input type="checkbox"/> Mining <input type="checkbox"/> Construction <input type="checkbox"/> Reclamation <input checked="" type="checkbox"/> Fuel Storage <input type="checkbox"/> Roads/Hauling <input type="checkbox"/> Other: Airstrip <input type="checkbox"/> Other: Bulk Sample

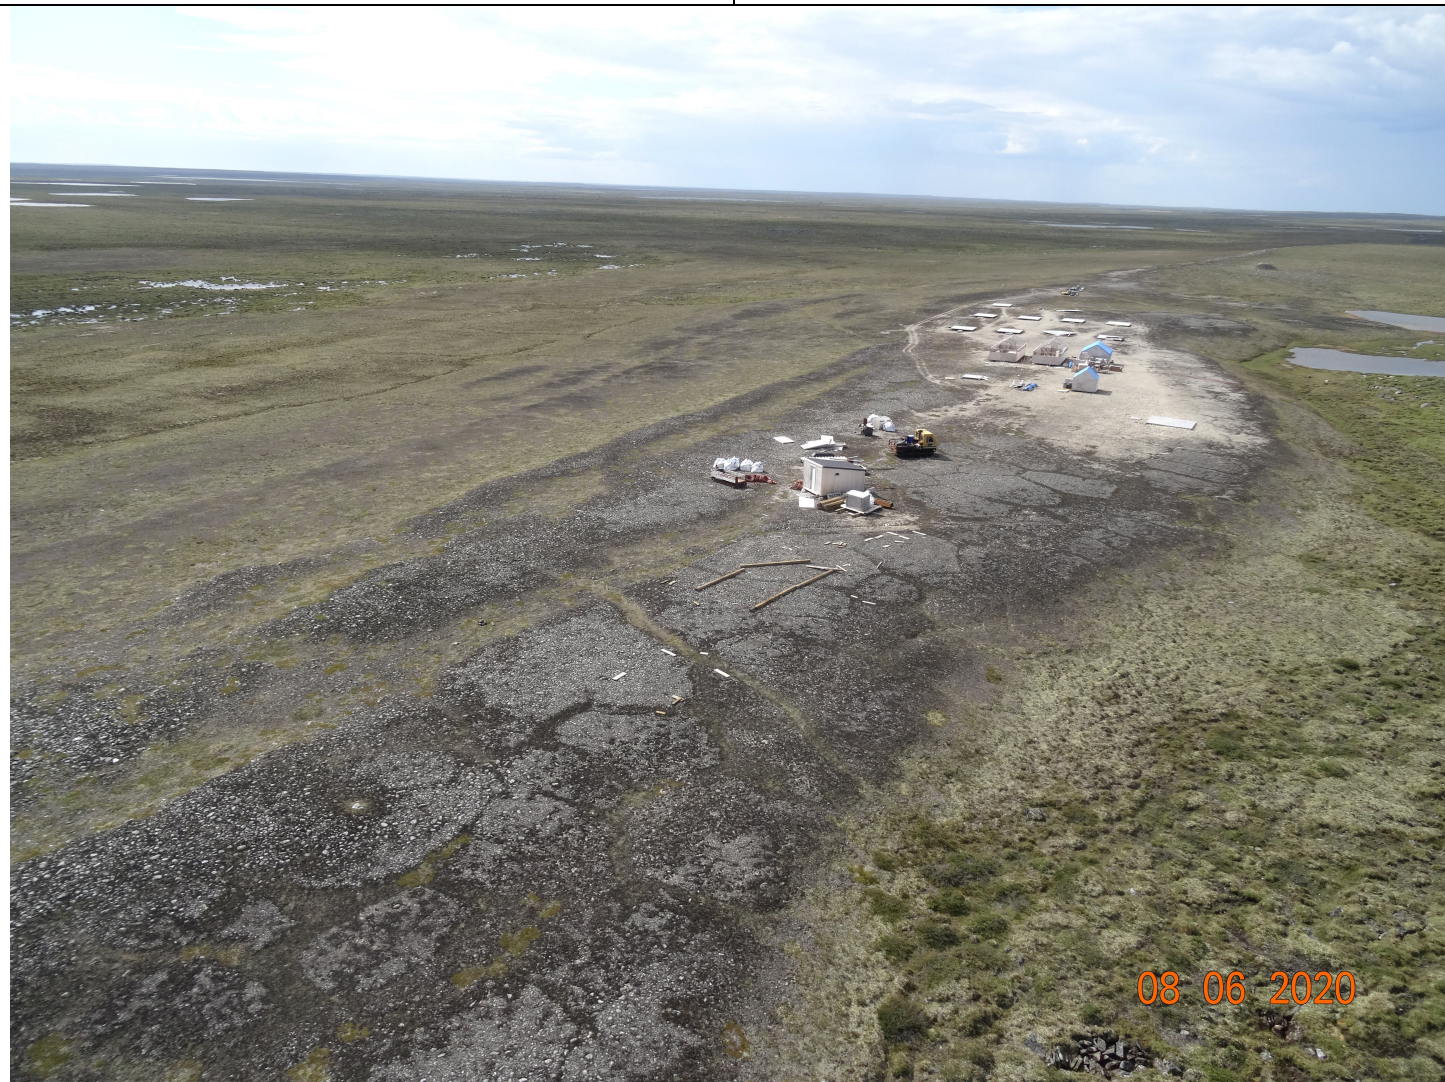
Date:	Authorization Number:	Camera/Model:	Inspector
August 6th, 2020	2BE-KDP1722	Sony DSC-HX50V Cyber shot	RMO Wilson
Photo No.	Lat/Long (DD.MM.SS.SS, NAD83)		
Photo 1	N63° 02' 22.", W91° 29' 40.80"

Kahuna Field Camp

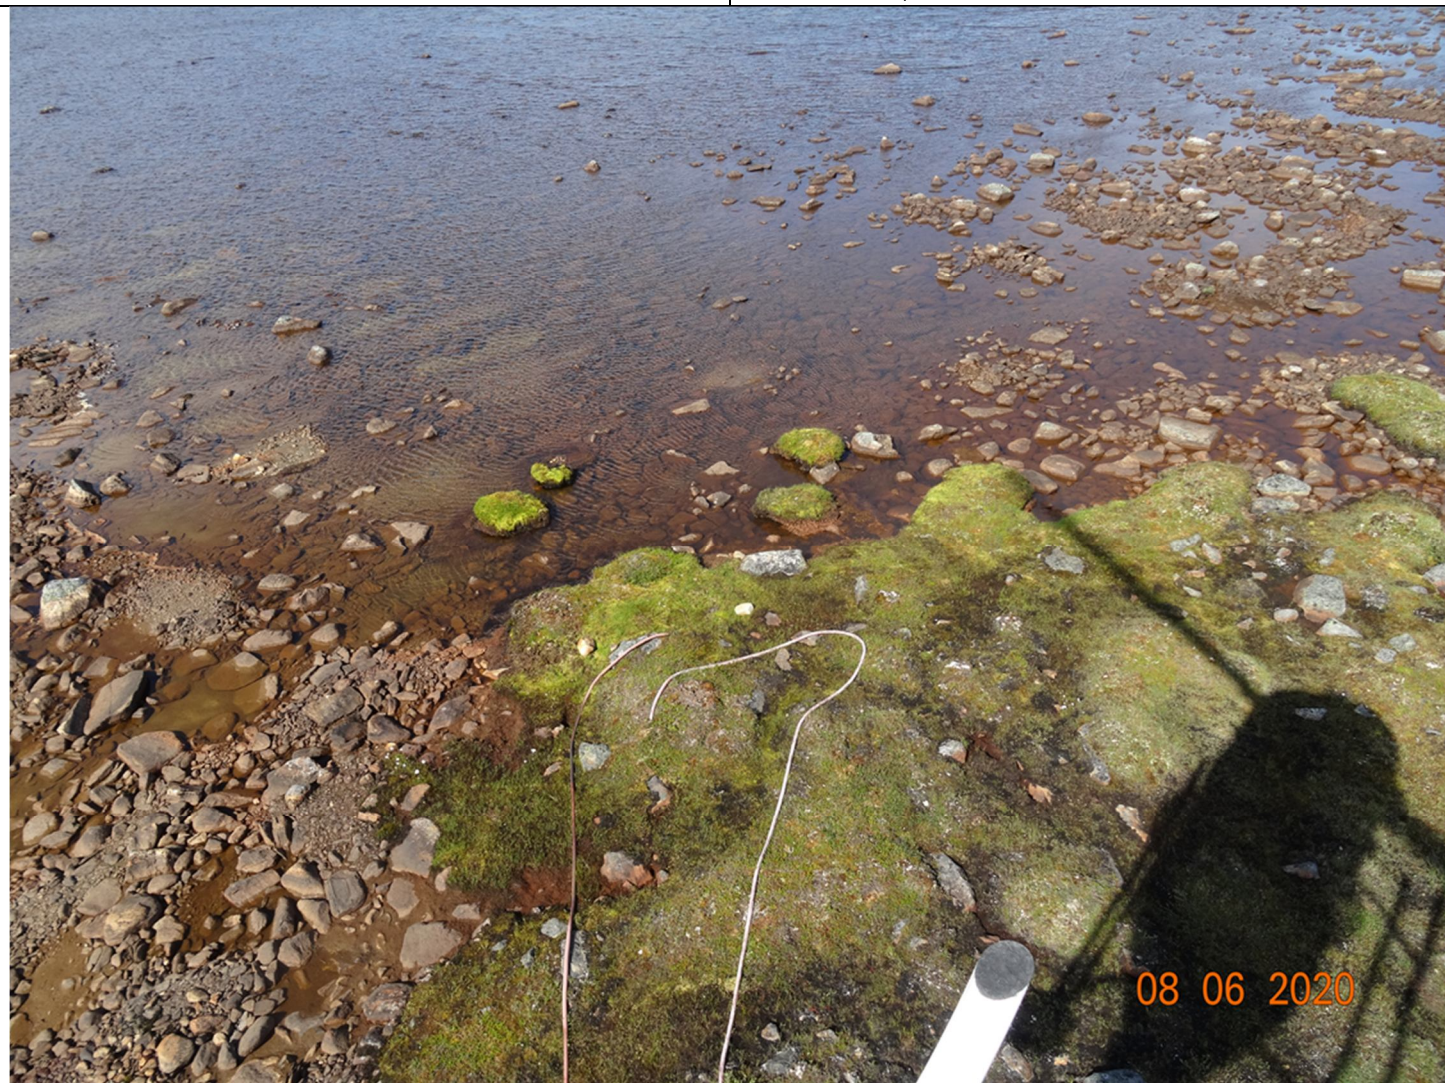
Photo 2

1. No fresh water has been used in 2019/2020. The fresh water intake hose is located at a small unnamed lake at N63° 2' (Photo 2).
2. No greywater has been released in 2019/2020. The sump is located in the interior of the camp at N63° 2' 22.91", W91° 29' 53.18". The sump is covered but part of the cover is damaged (Photo 3). Improvements should be made to the sump to protect the ground from degradation.

Water intake line.

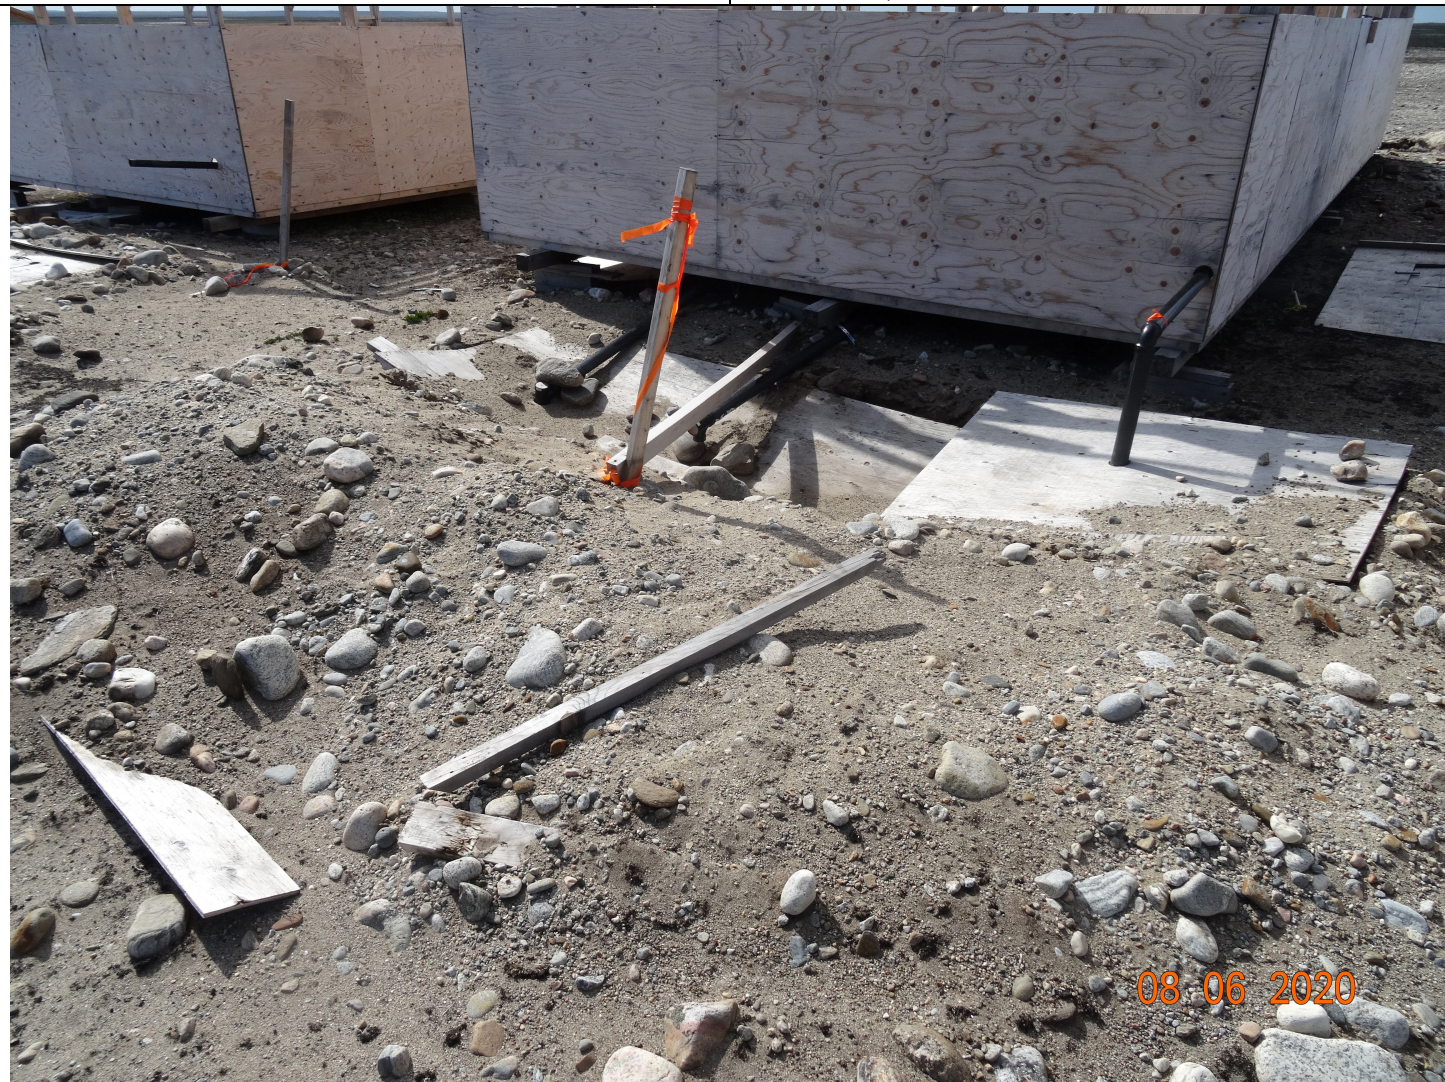
Photo 3

Grey water sump at the Kahuna Field Camp.

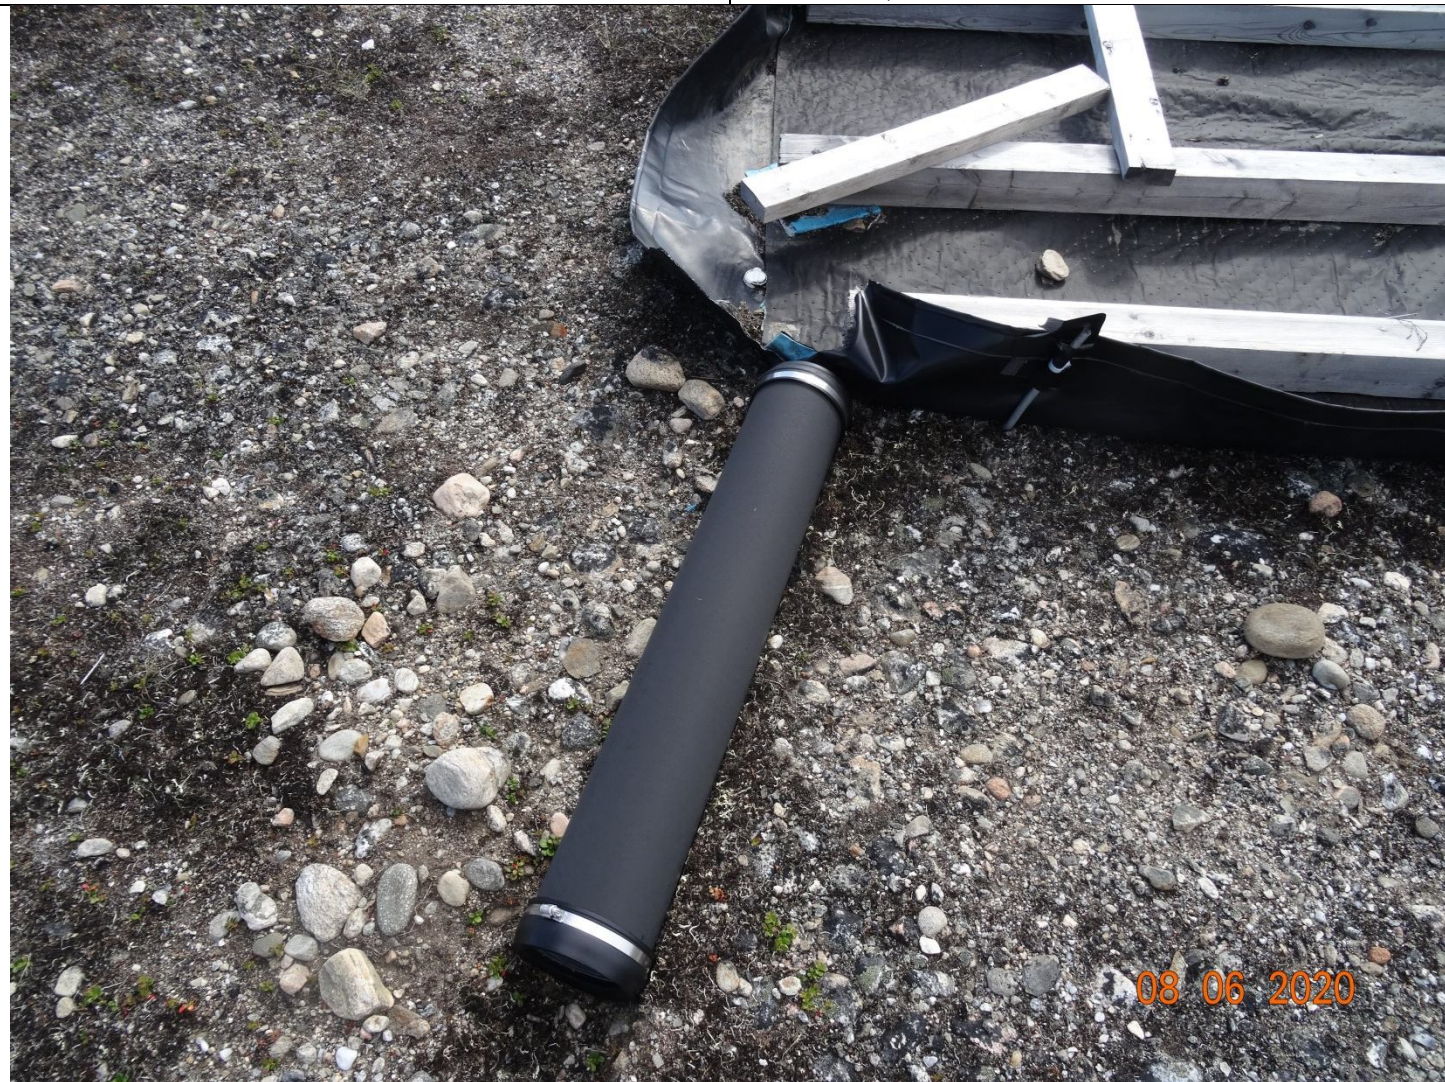
Photo 4

3. Two fuel caches in secondary containment berms are noted west of the camp. The berms are fitted with hydrocarbon water filters. A rip is noted on one of the berm next to the filter (Photo 4). Overall fuel storage respected the commitments made in the 2019 Fuel Management Plan.
4. A drip tray is noted under a tracked piece of equipment as a spill prevention measure (Photo 5).
5. Six open buckets of an unknown material are noted inside a plywood box at the camp. The unknown materials has sheen and smells of hydrocarbons (Photo 6).

Ripped secondary containment berm

SECTION 2 <input type="checkbox"/> Comments (s.____) <input checked="" type="checkbox"/> Non-Compliance with Act or Licence (s.2) <input type="checkbox"/> Action Required (s.____)		
No instances of non-compliance at this time related to the Nunavut Water Act or the current water licence.		
SECTION 3 <input type="checkbox"/> Comments (s.____) <input type="checkbox"/> Non-Compliance with Act or Licence , (s.____) <input checked="" type="checkbox"/> Action Required (s.3)		
ACTIONS REQUIRED		
-Kodiak will provide information to the Inspector regarding the six open buckets of unknown material prior to December 1 st , 2020.		
-Kodiak will secure the ripped secondary containment berm and provide photographic evidence of this to the inspector prior to the next inspection.

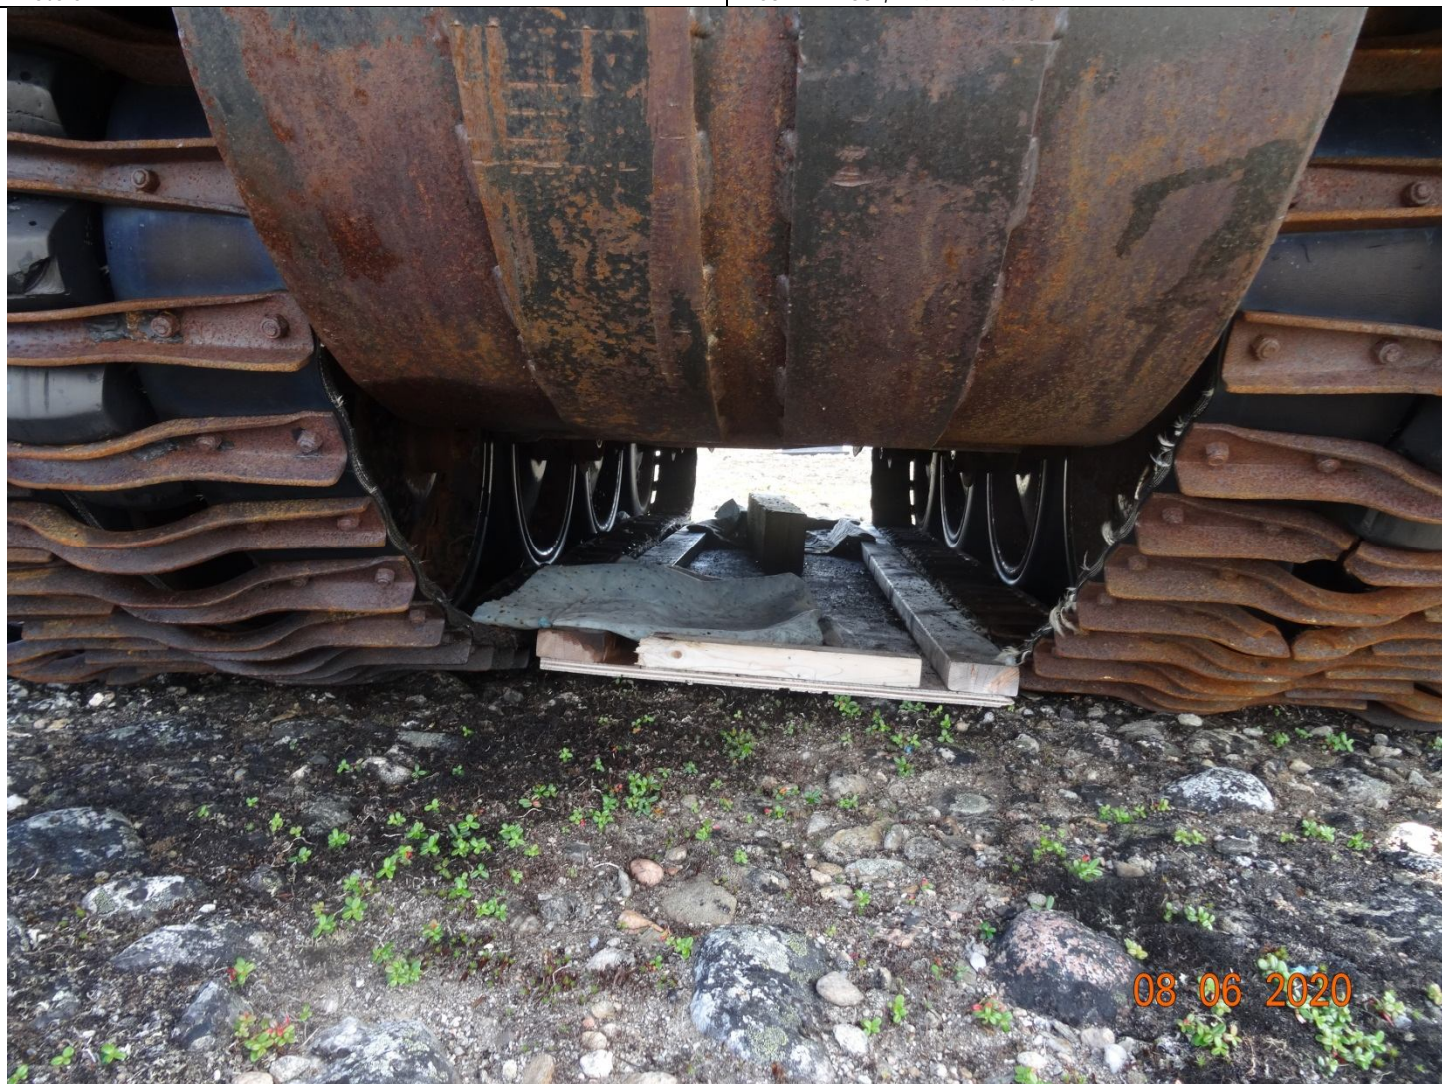
Photo 5

Spill mitigation, Drip tray under stored equipment.

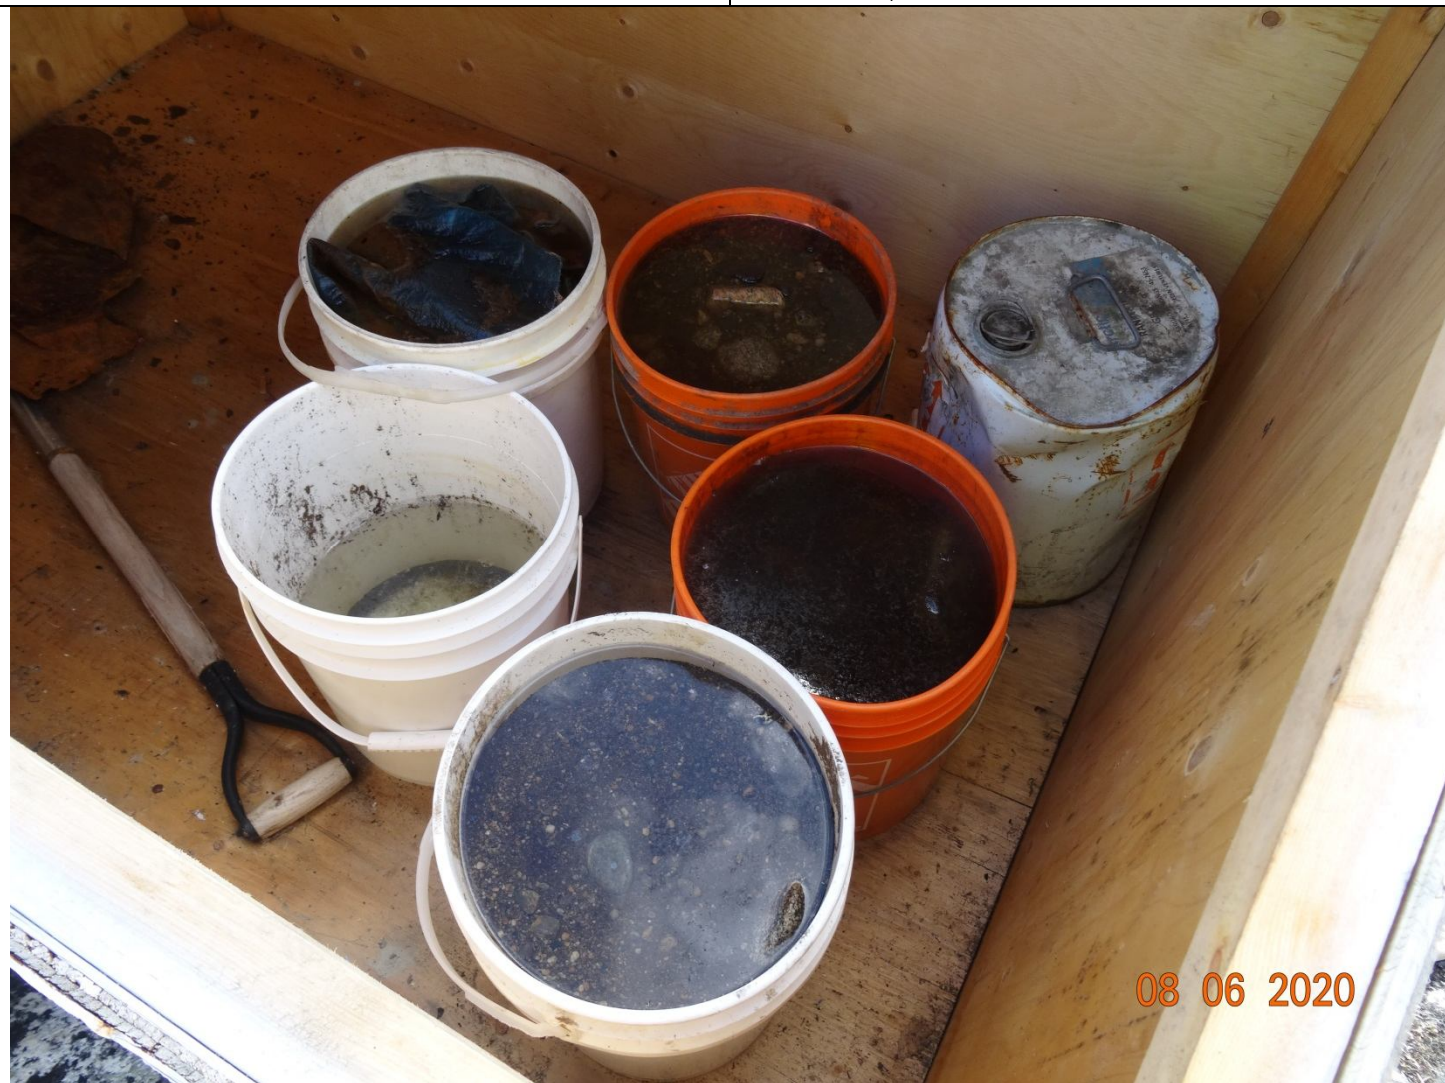
Photo 6

Six open bucket of unknown material.

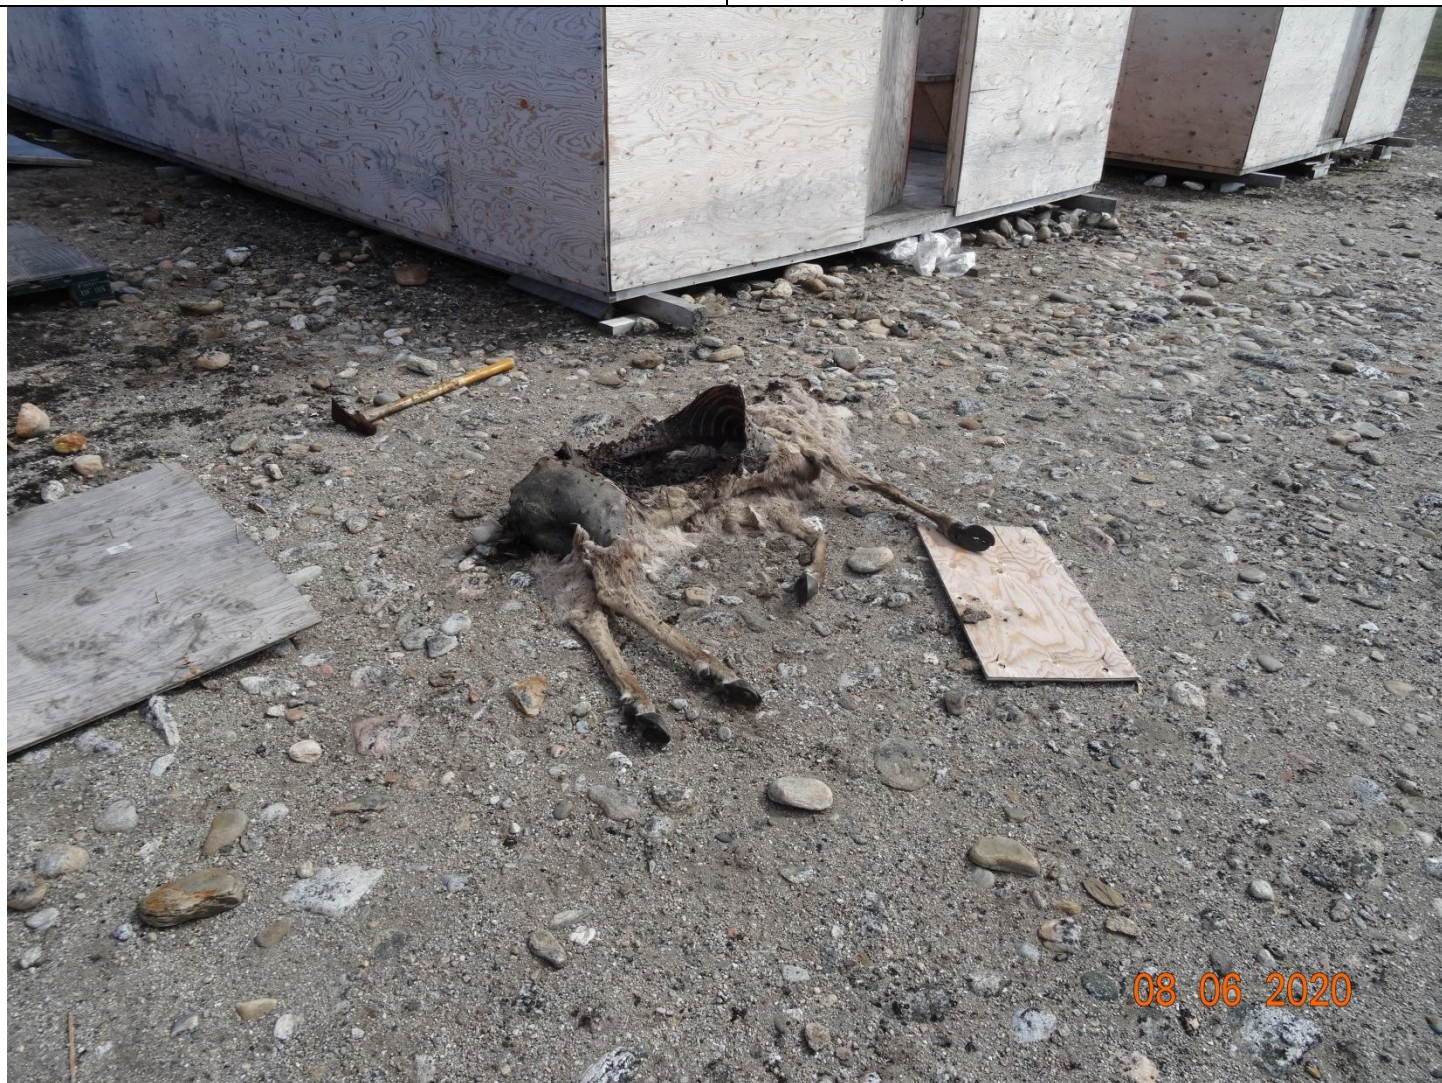
Photo 7

6. A dead caribou is noted in the interior of the camp (photo 7). The animal was reported to the Rankin Inlet Conservation Officer.

Dead Caribou at Kahuna Field Camp.
