LAND USE PERMIT INSPECTION FORM

Permittee	Representative
Solstice Gold Corporation	Marty Tunney
Permit No. / Expiry	Representative's Title
N2018C0020	President
Other Authorizations/ Expiry	Project Name
2BE-KGP1823/ December 16 <sup>th</sup> , 2023	Kahuna Gold Project
Date of Inspection	Inspector
12/07/2019	RMO Wilson
Activities Inspected	
<input type="checkbox"/> Campsite <input type="checkbox"/> Drilling <input type="checkbox"/> Mining <input type="checkbox"/> Construction <input type="checkbox"/> Reclamation <input type="checkbox"/> Fuel Storage	
<input type="checkbox"/> Roads/hauling <input type="checkbox"/> :Other:

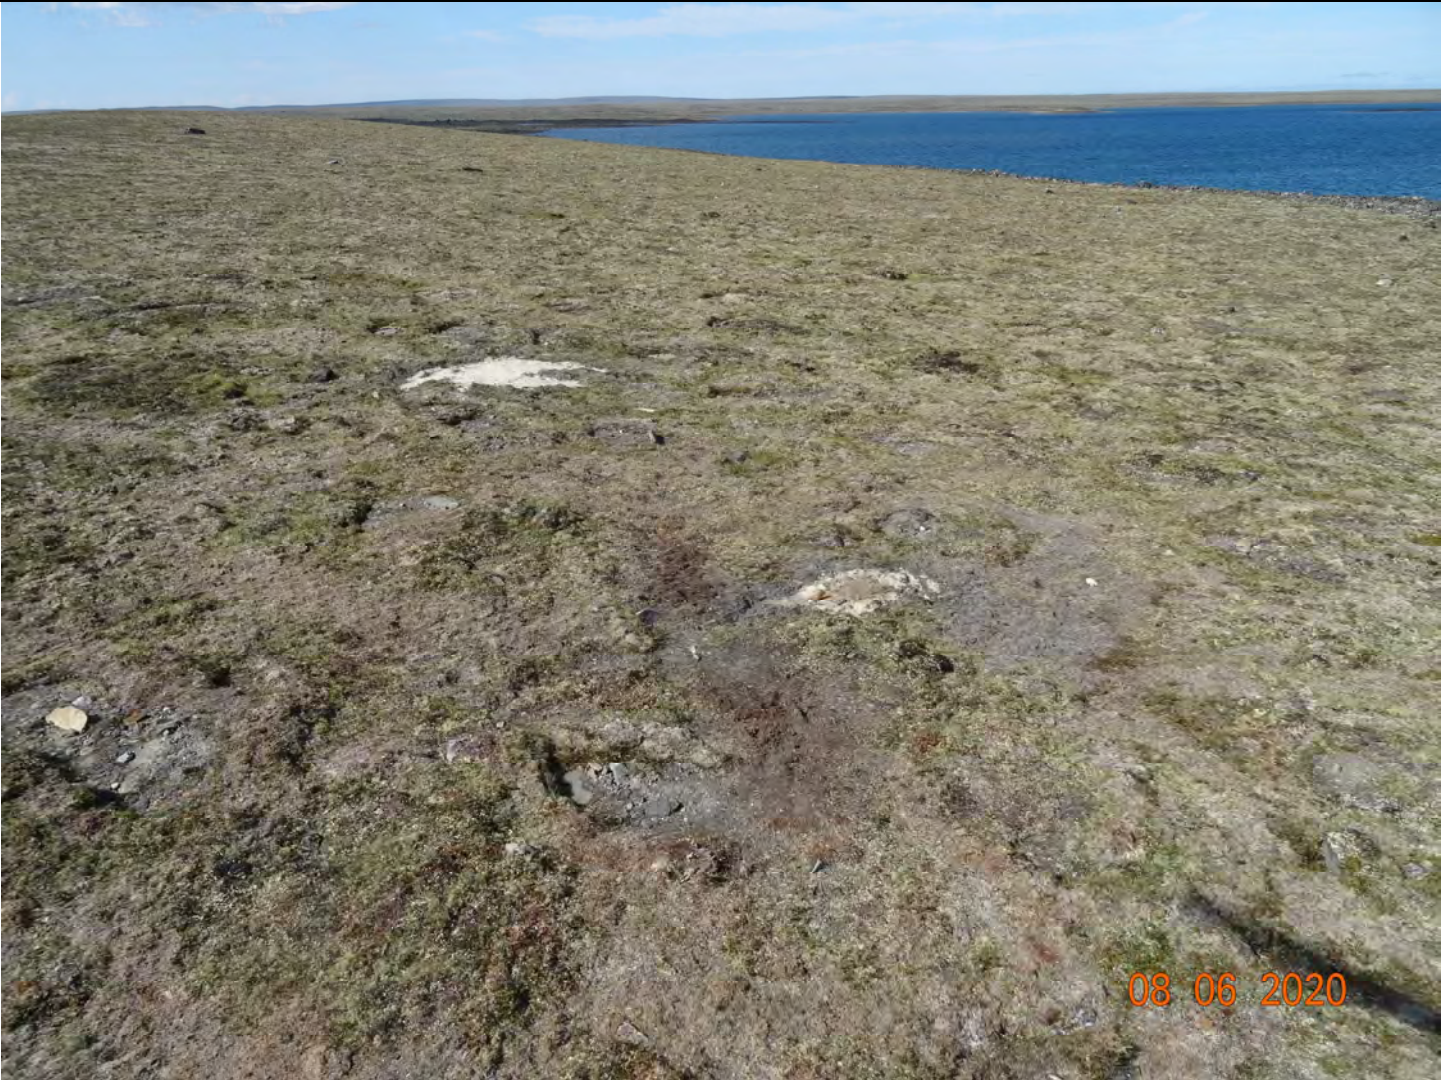
Photo 2

Drill Site 2019-04, casing not cut and capped.

1. A total of five drill sites were inspected. The holes were drilled during the 2018 drilling campaign.			
Drill Site Name	Approximate Location	Observations	Actions Required
2019-04	N63° 4' 53", W91° 26' 4"	Isolated cuttings, collar still present, not capped, over 30m from water.	-Remove collar or cut and cap.
2019-03	N63° 4' 36", W91° 24' 55"	Isolated cuttings, collar cut off at the ground, over 30m from water.	None
2019-05	N63° 4' 19.93", W 91° 23' 36.8"	Small amount of garbage, collar still present, isolated cuttings, over 31m from water.	-Remove collar or cut and cap. -Remove garbage.
2019-02	Unknown	The drill site was never found.	N/A
2019-06	N63° 5' 46", W91° 22' 43"	Collar still present, isolated cuttings, hole is over 31m from water but cutting may be at 31m	-Remove collar or cut and cap. -Ensure cutting are over 31m from water.
SECTION 2	<input type="checkbox"/> Comments	<input checked="" type="checkbox"/> Non-Compliance with Act or Regulations	<input type="checkbox"/> Action Required

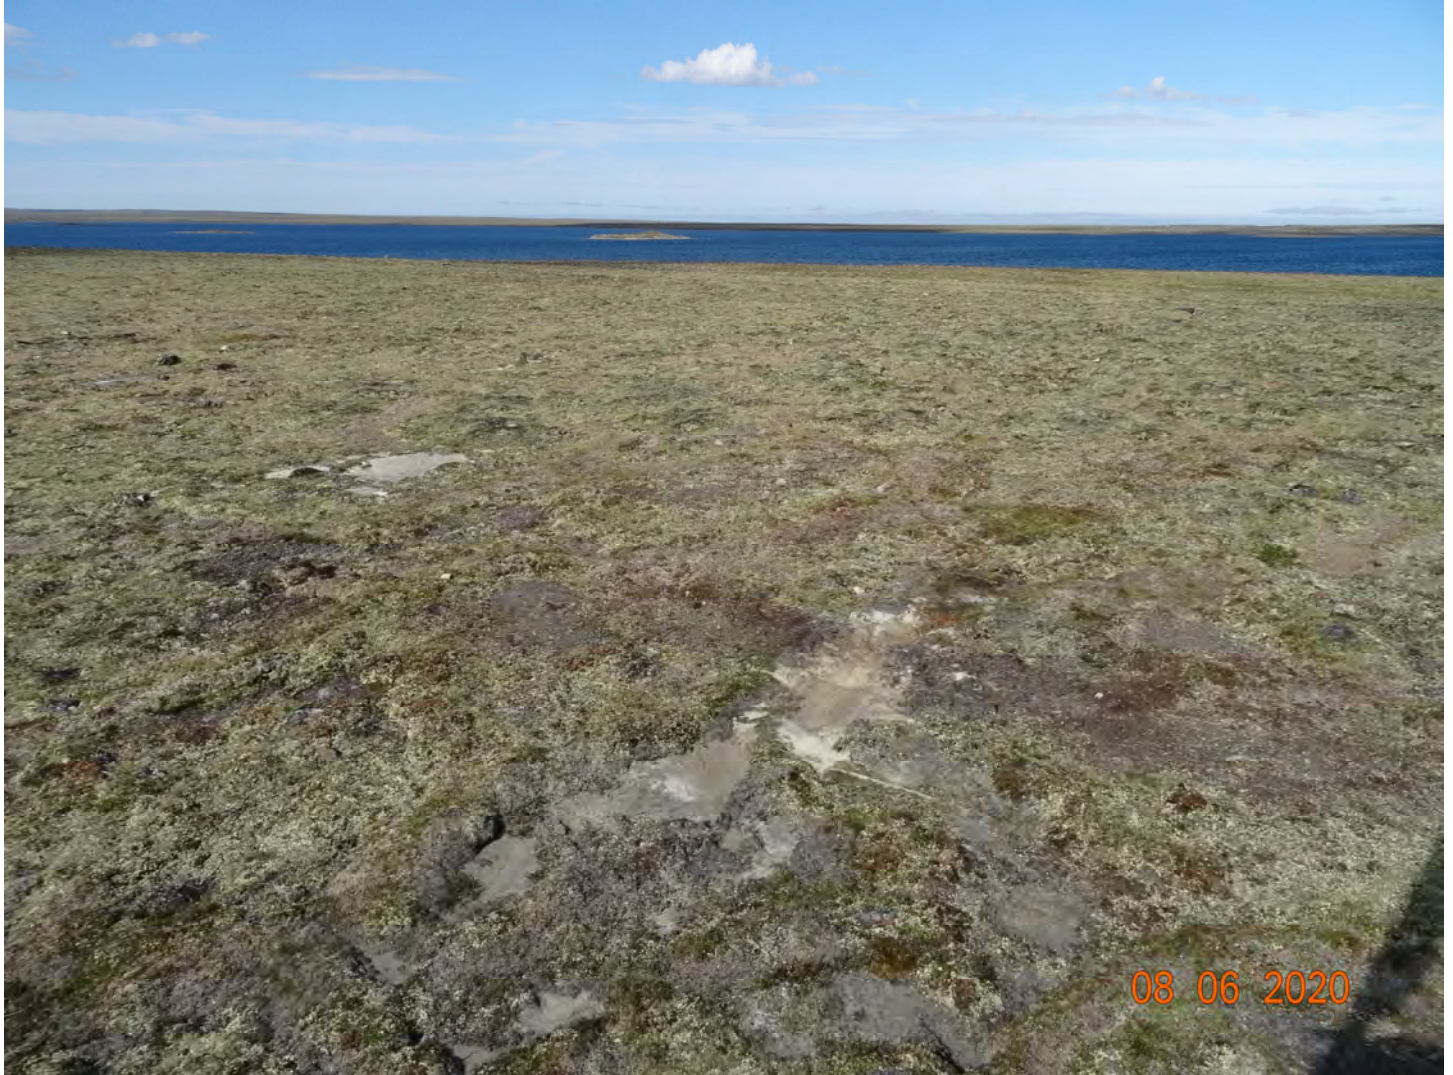
Photo 3

Drill Site 2019-03

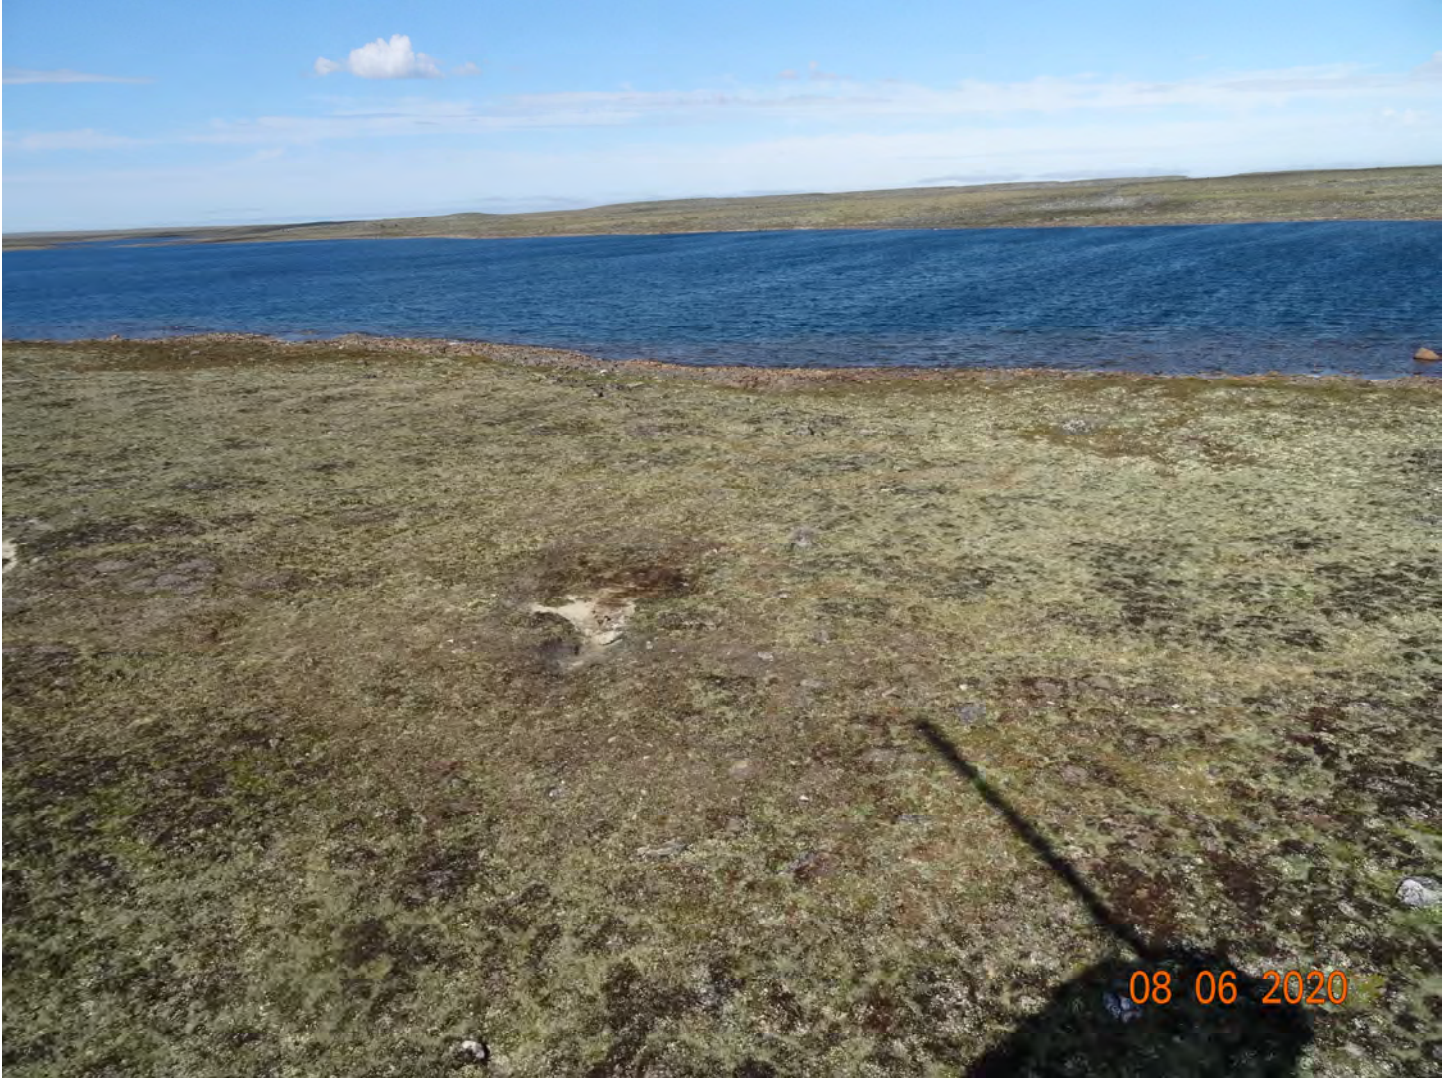
Photo 4

Drill Site 2019-05, Casing still in ground

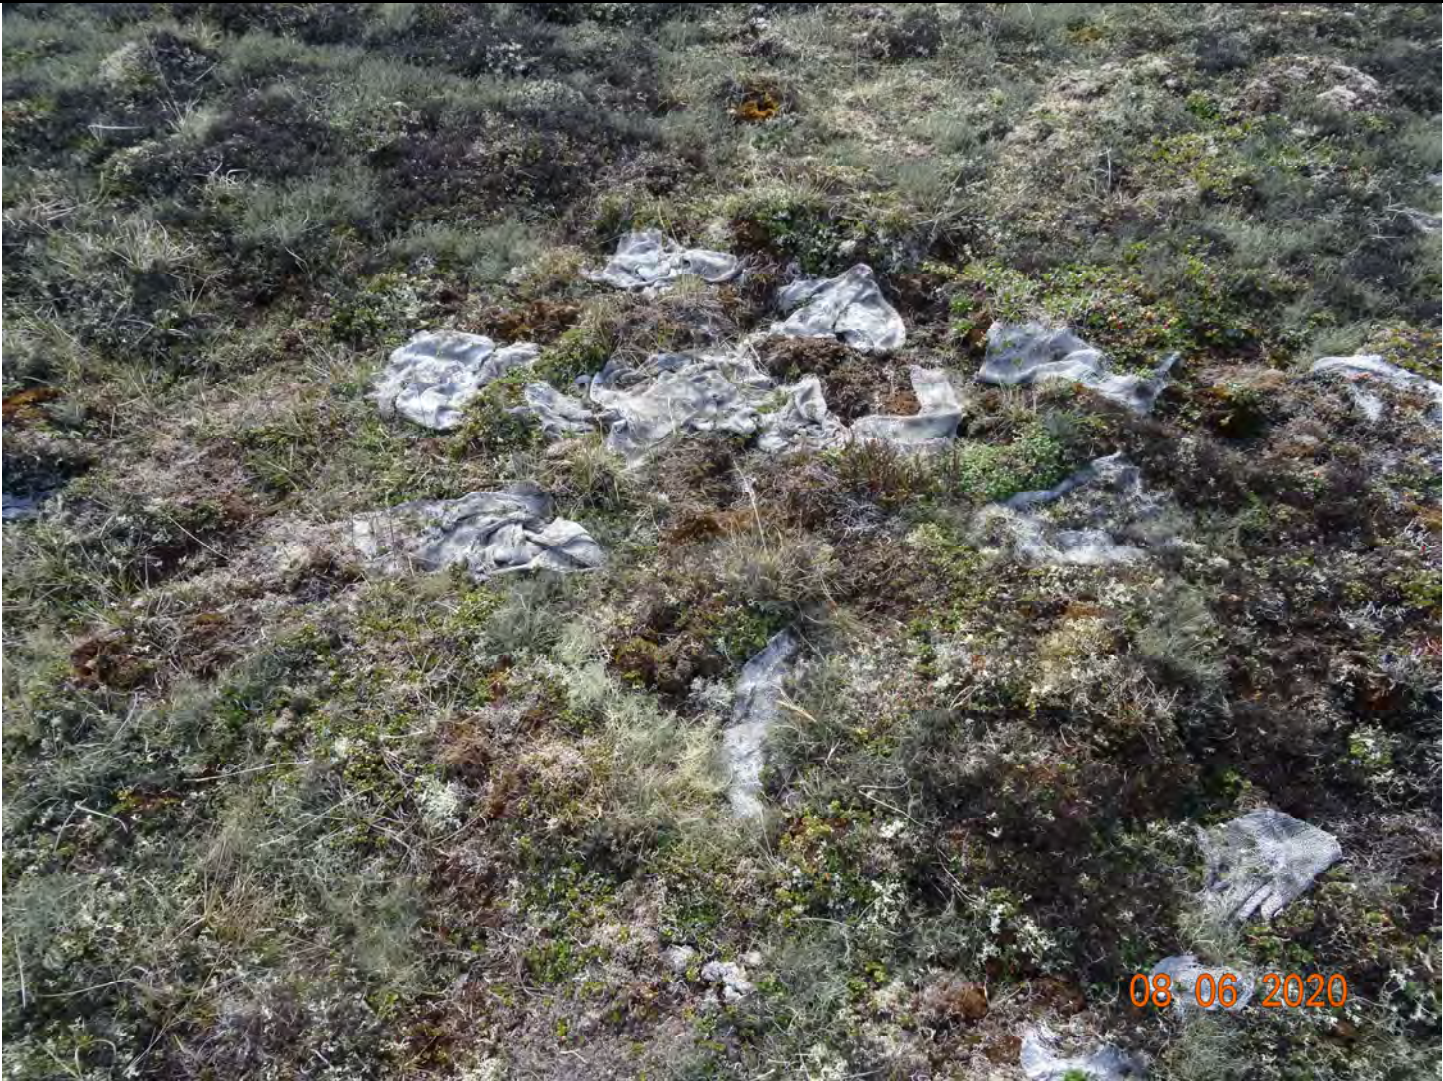
Photo 5

Drill Site 2019-05, Garbage at site

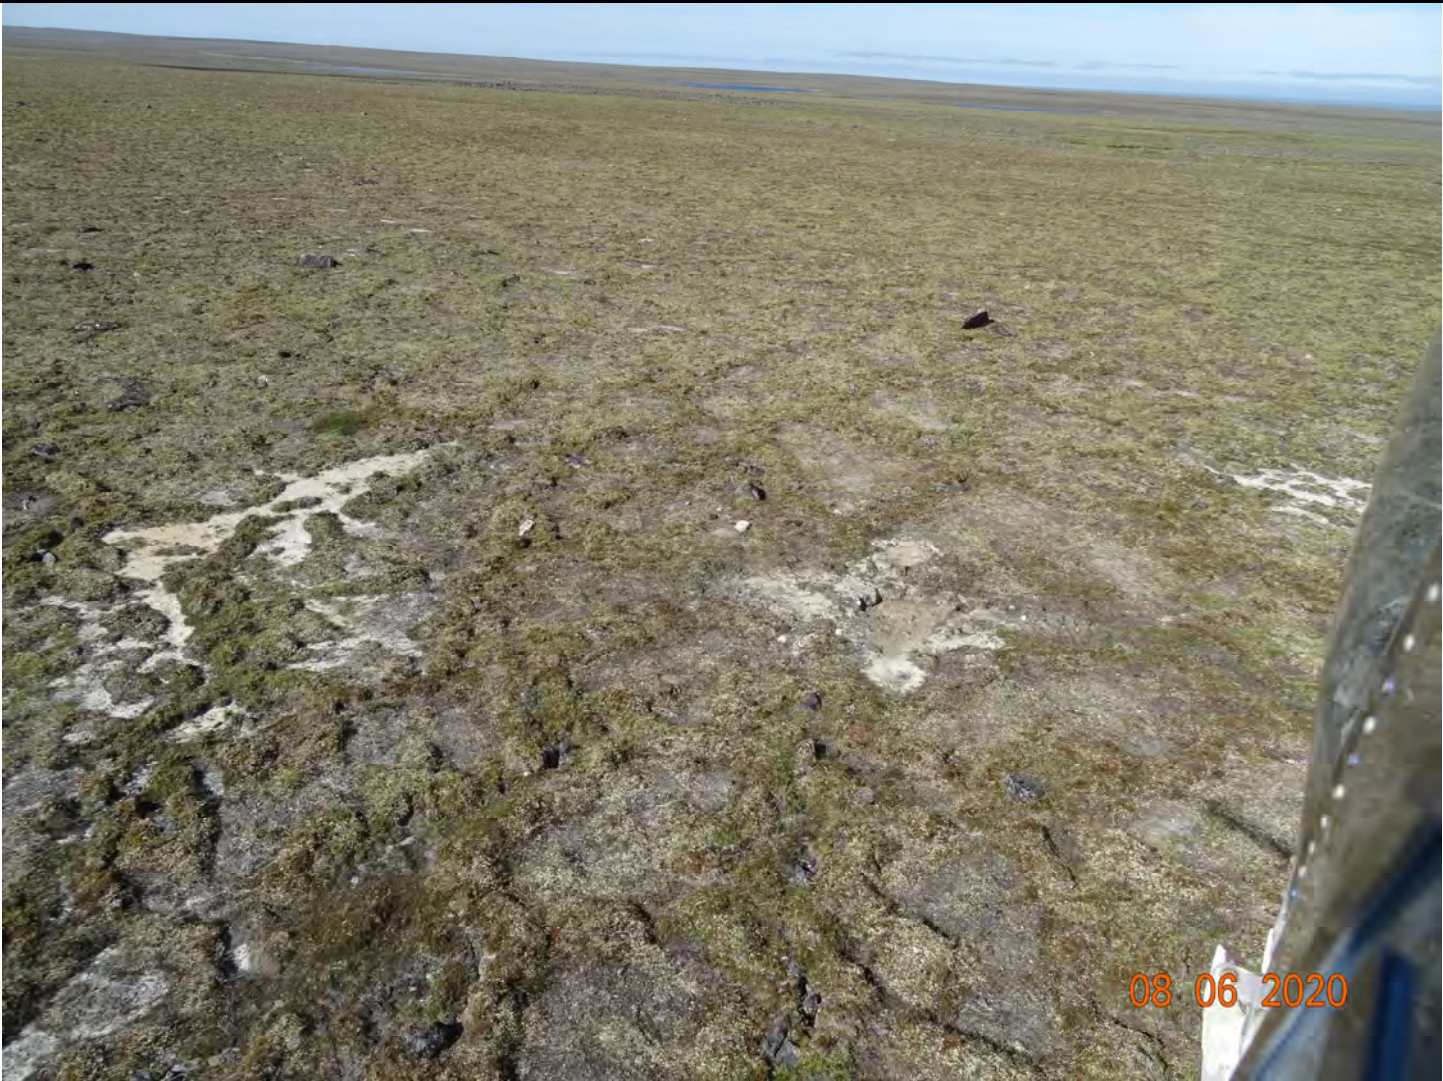
Photo 6

Drill Site 2019-06, Collar in ground and not capped.
