Re: Kiggavik – Follow-up Report to June 23, 2009 spill of potentially contaminated drill muds

**AREVA Resources Canada Inc.
Kiggavik Project, Nunavut**

Final Incident Report for June 23, 2009 Spill

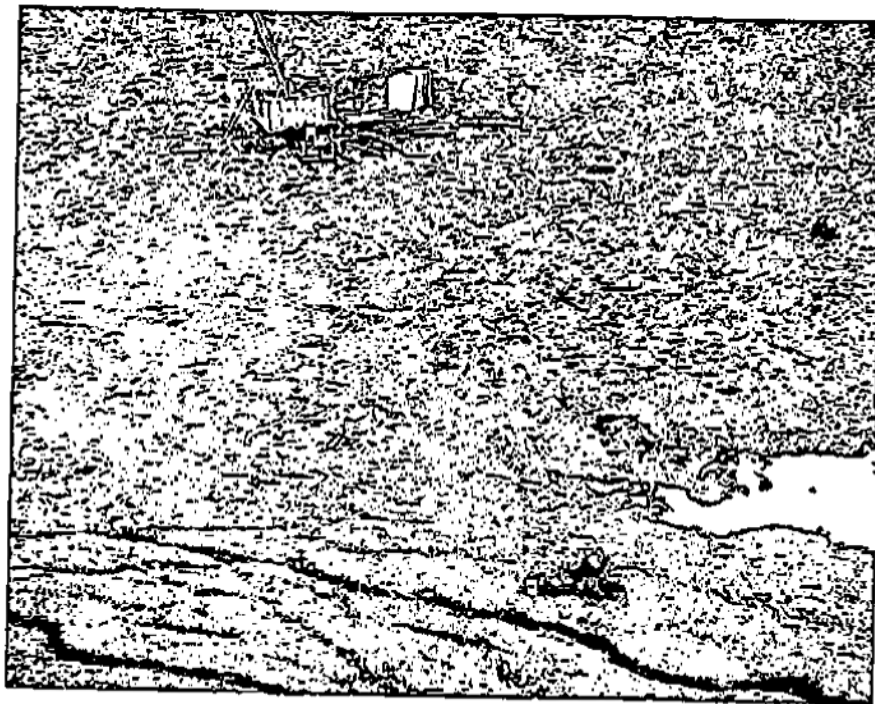
Figure 5 – Red Coloured Casing Water from END-09-05 June 23, 2009

increase in snow melt (Graph 1). The red coloured water from the drill casing mixed with melt water was able to make its way to the closest temporary stream. Sandbag berms were put in place prior to installation of casing in close vicinity of drill. Casing was installed during the night and further sandbagging within the area was not installed once the direction of water flow was established. Dayshift crew did not do any further sandbagging and continued to drill during the day. Daily inspections were conducted by Radiation and Environment supervisor at approximately 1500 hours on June 22nd, and discovered the run off of drill casing water flowing toward the stream. At this time, a sandbag berm was put in place to prevent further flow of drill casing water. (Figures 5 and 6).

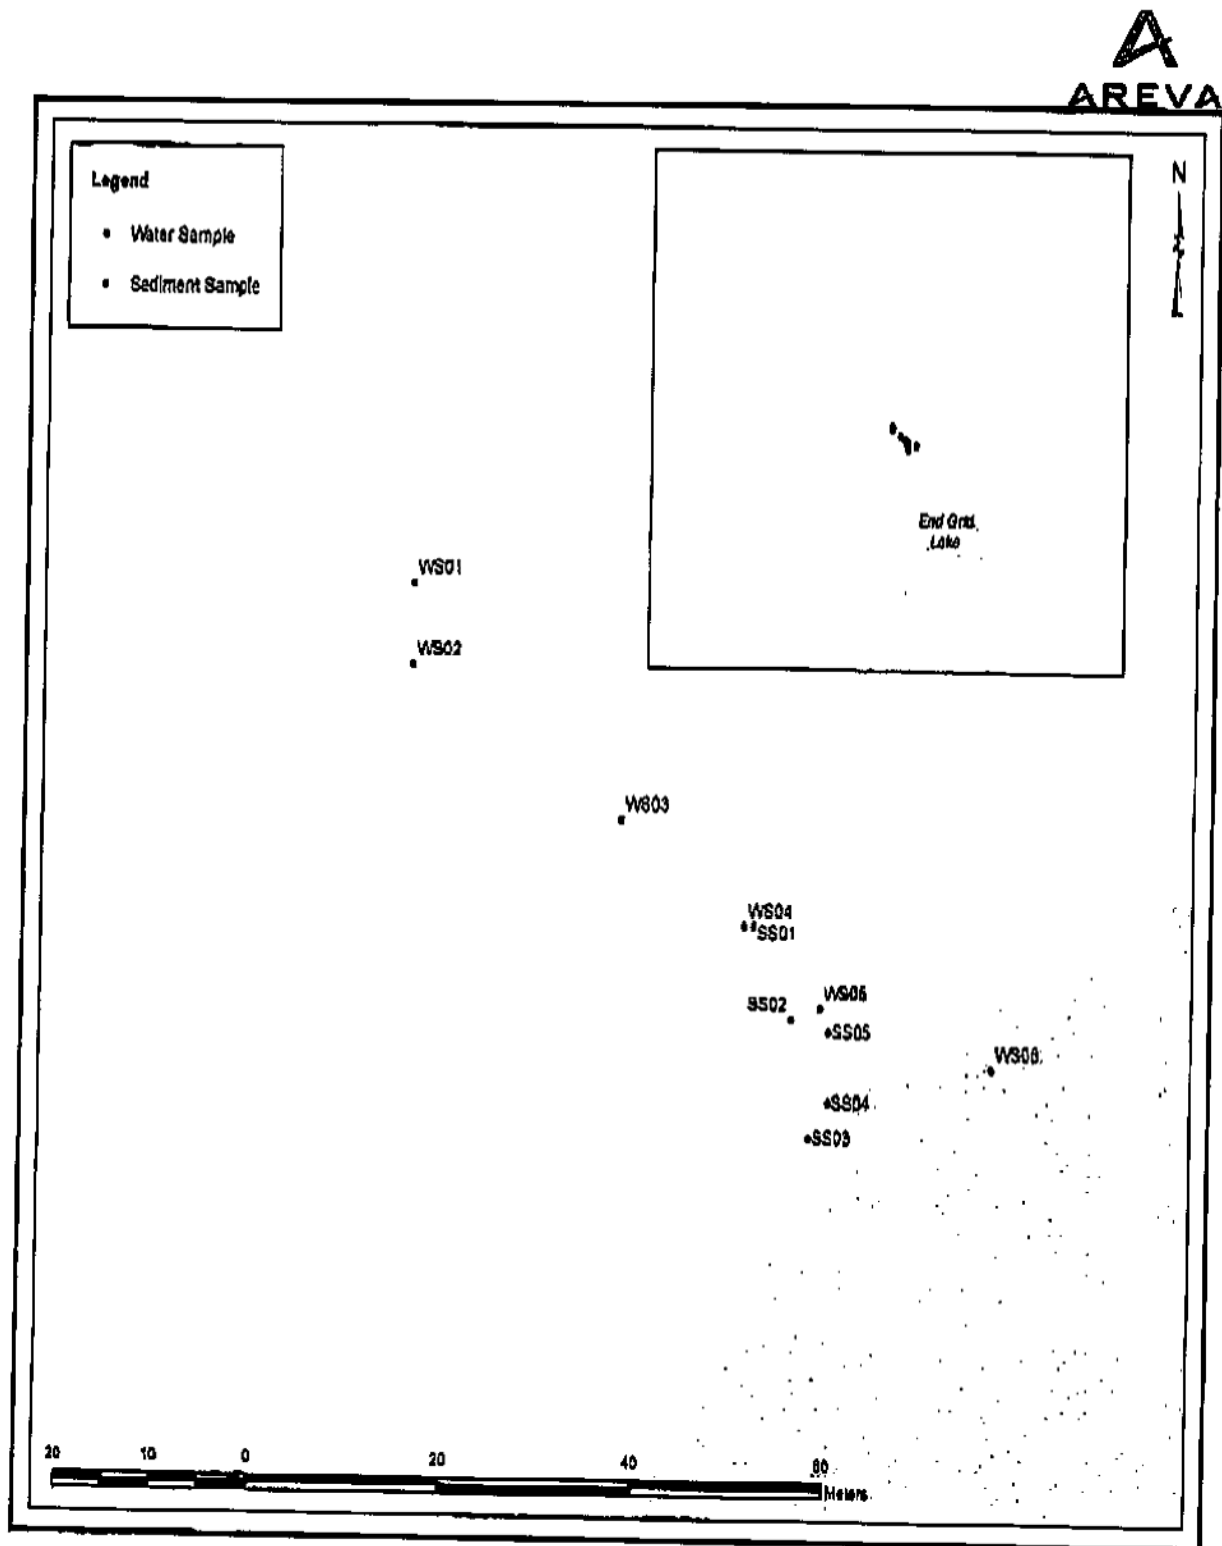
Figure 7 – Map of Water and Sediment Sample Locations

On June 24, six water samples were collected from the drill casing, water runoff and red tinged area of lake (Figure 7). These samples were preserved and sent to the Saskatchewan Research Council (SRC) for analysis. Complete analytical results of the water testing are presented in Appendix I, along with a summary table comparing the results to Canadian Water Quality Guidelines (CWQG) and Saskatchewan Surface Water Quality Objectives (SSWQO). AREVA has made a commitment that where published guidelines or regulations related to uranium exploration in Nunavut are not available, to adhere to regulated or best management practices from their activities in Saskatchewan.
