Kiggavik Project

Final Spill Report

July 17, 2015

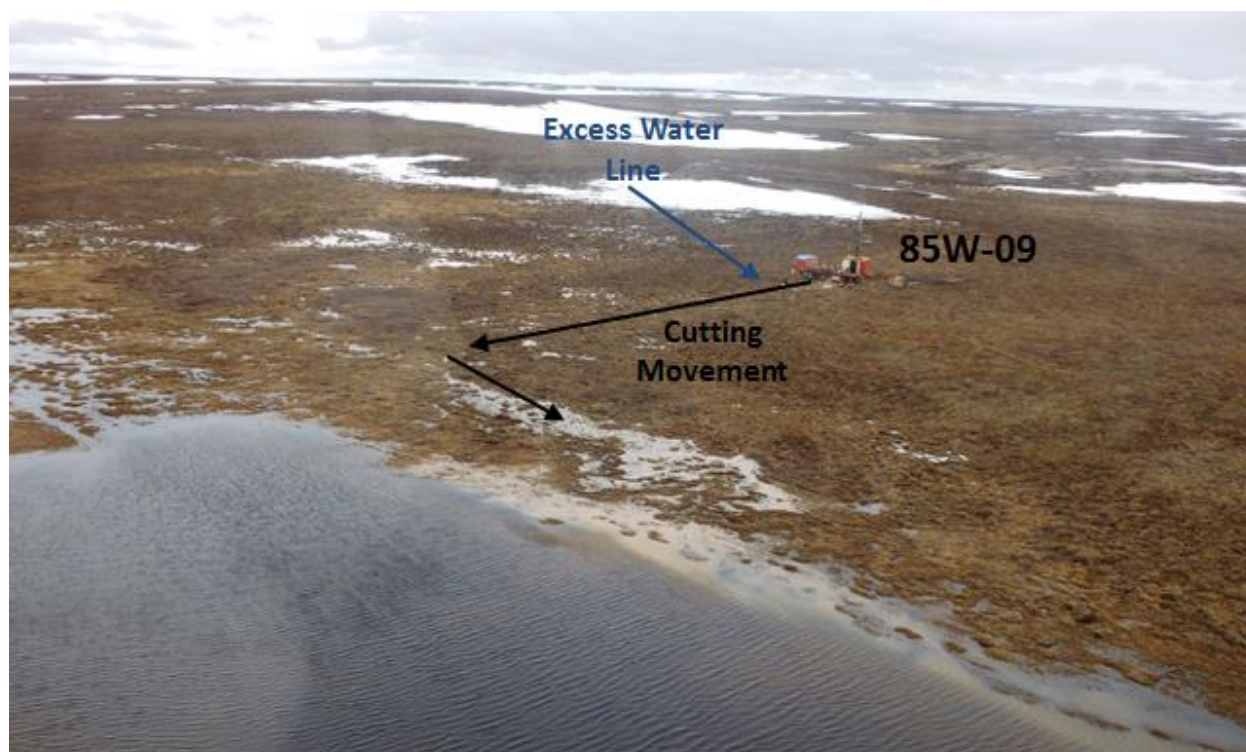
During a routine drill inspection conducted by the SHEQ Supervisor and Project Geologist, a spill was detected in a waterbody near Drill 1 at approximately 4:30 pm on June 17, 2015. Potentially contaminated drill return water and cuttings from underneath the drill were not properly contained and were washed downhill away from the drill. The excess clean water line further facilitated the downhill migration of the drill cuttings into a water body 120 m to the west. The spill site is located at 64°25'18" N, 97°48'17" W (14W 557576 7144542). An aerial survey was conducted on June 17 to better gauge the impacted area from the spill depicted in Figure 1 below.

Figure 1. Discharge of Potentially Contaminated Return Water (June 17, 2015)

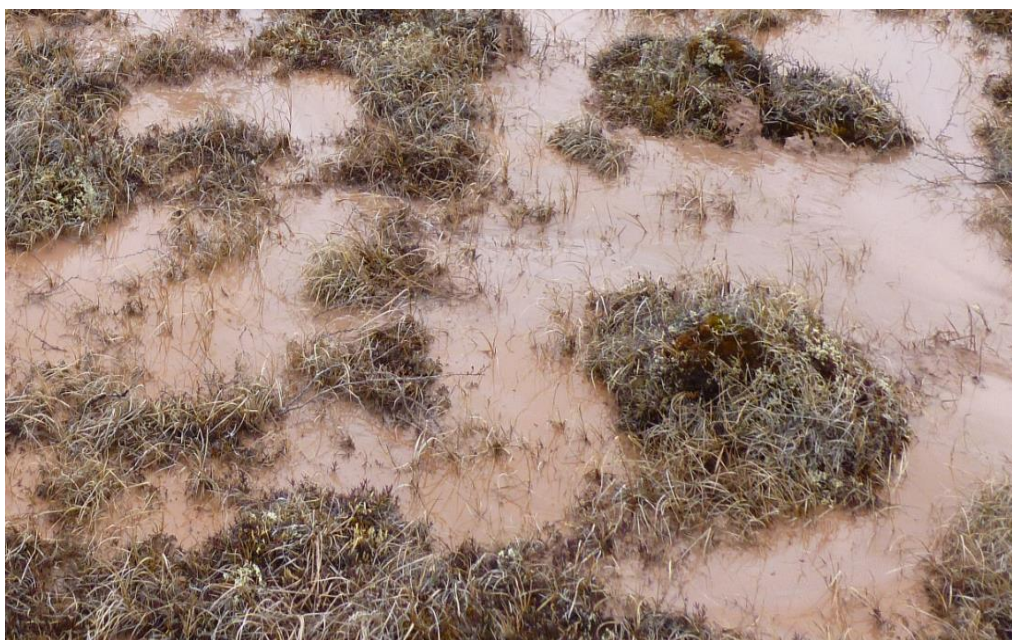
A ground survey was also conducted indicating that the spill was a combination of runoff water, drill return water, and cuttings from installation of the casing. The combination of drill return water and drill cuttings had the appearance of muddy water (Figure 2 and 3). The impacted area of the spill was estimated to be 200 m by 10 m (2000 m²).

Figure 2. Mixture of Drill Return Water and Drill Cuttings Near the Drill Area June 17, 2015

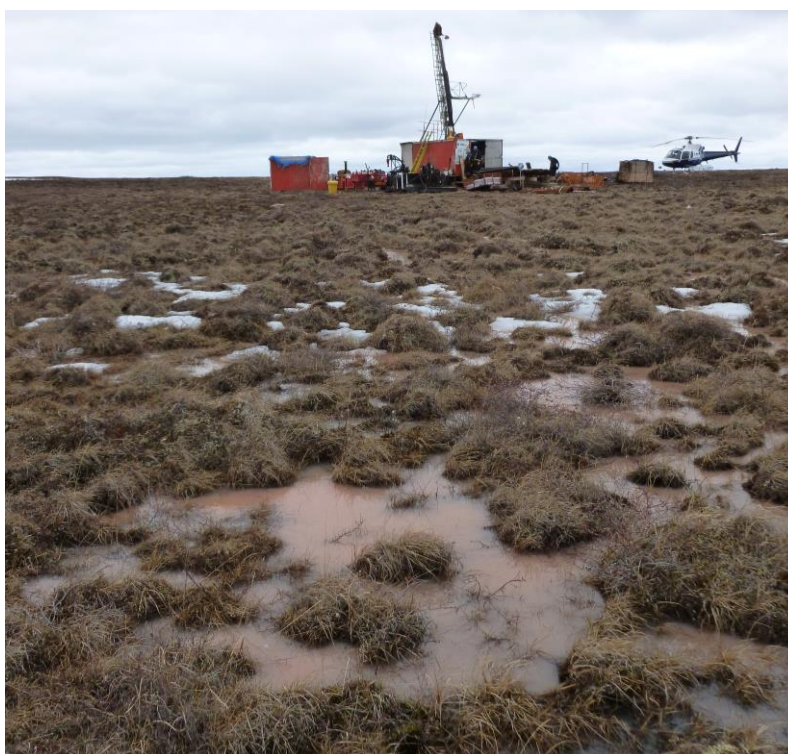
Figure 3. Runoff Water Mixed with Drill Return Water June 17, 2015

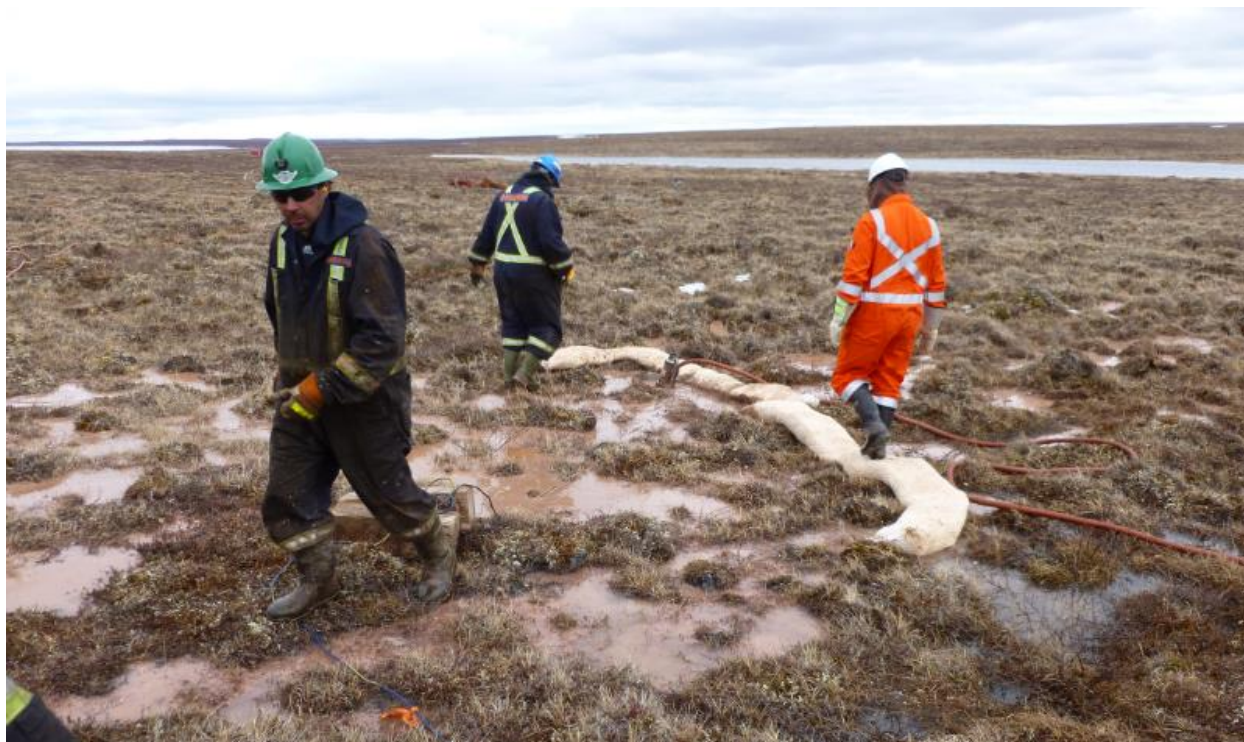
Figure 4. Installation of Filter Socks and Sump Pump on June 17, 2015

Following the identification of the spill, various corrective and preventative measures were implemented at the spill site. The excess clean water discharge line was immediately extended away from the site in order to reduce the amount of water flowing through the affected area. Socks filled with wood chips were placed at a bottleneck of the spill to reduce the transport of sediments towards the small water body. A sump pump was placed below the drill to intercept all new water and drill cuttings. Another sump pump was used to clean up affected areas around the drill and was then placed in the containment area to remove excess water and drill cuttings. Both sump pumps were set up to discharge water into the contained discharge area 200 m East of the drill and 320 m away from the small lake.

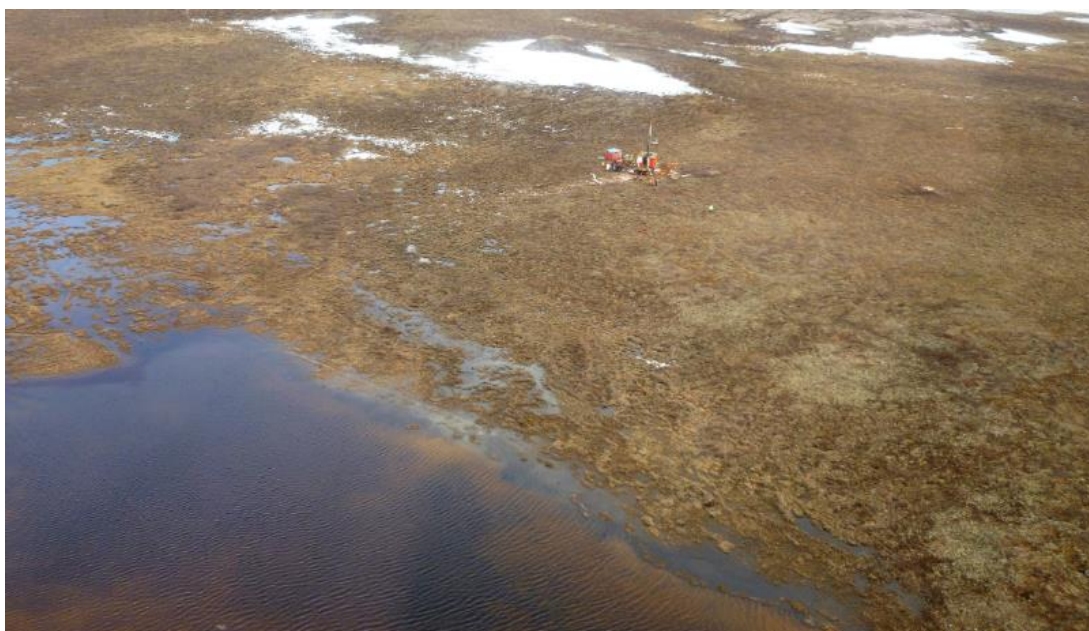
Figure 5. Aerial Survey of Spill Area on June 18, 2015

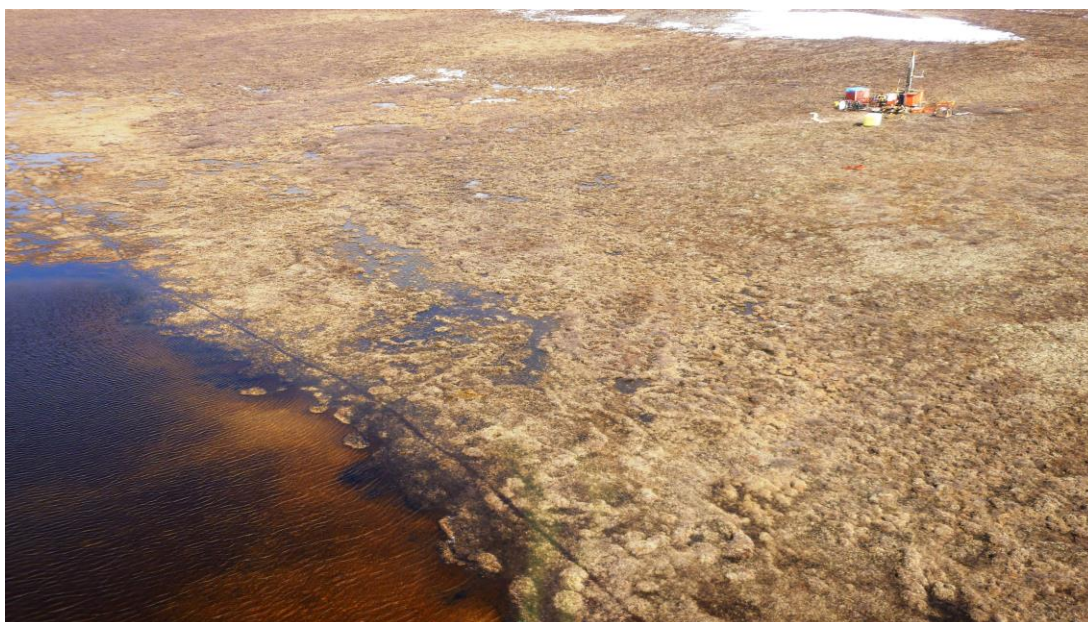
Figure 6. Aerial Survey of Spill Area on June 19, 2015

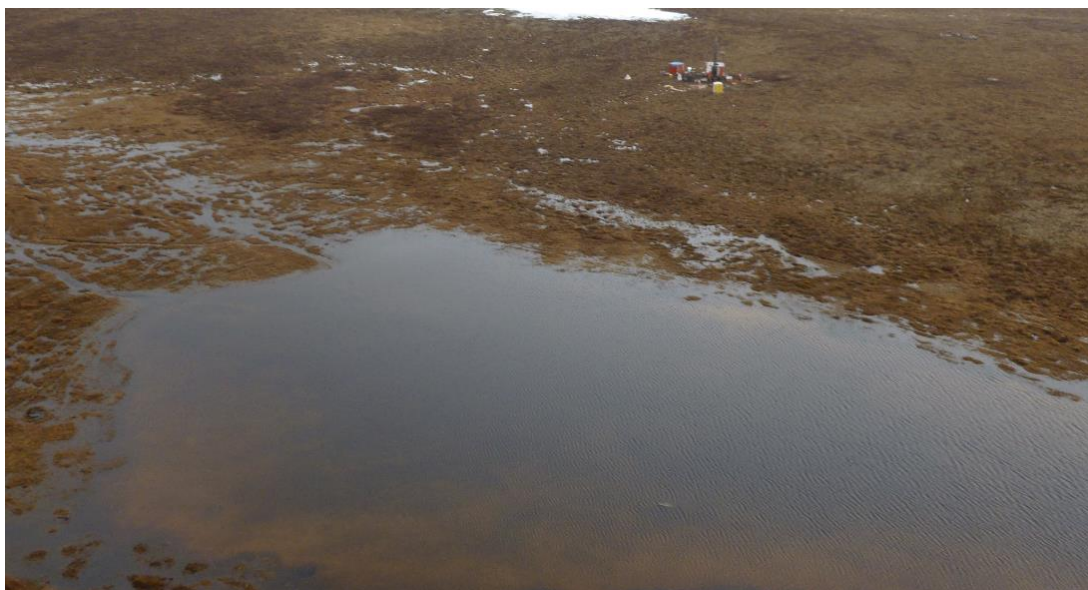
Figure 7. Aerial Survey of Sill Area on June 20, 2015

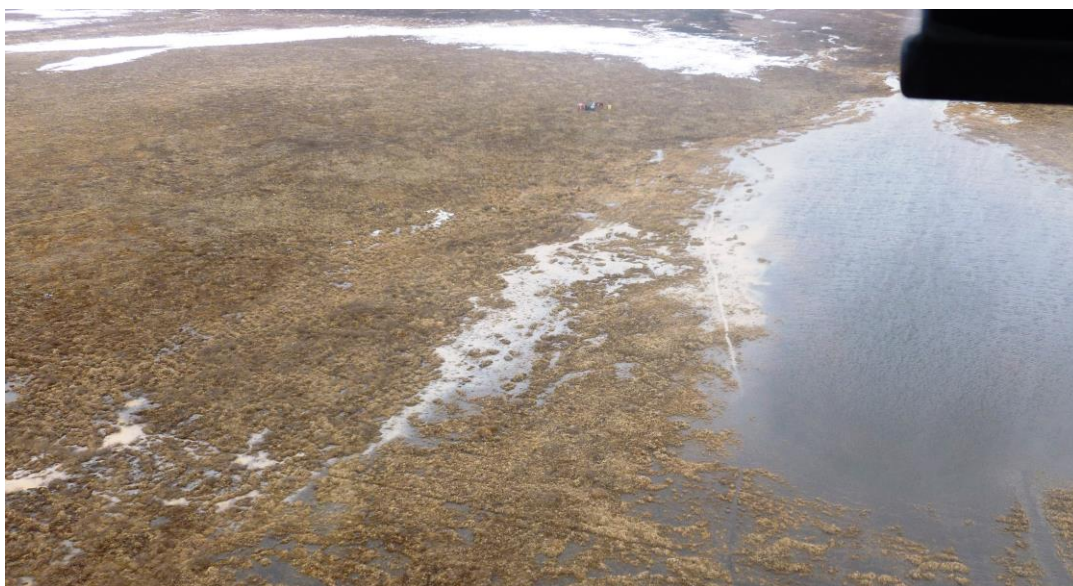
Photograph 1. Discharge of Potentially Contaminated Drill Return Water (June 17, 2015)

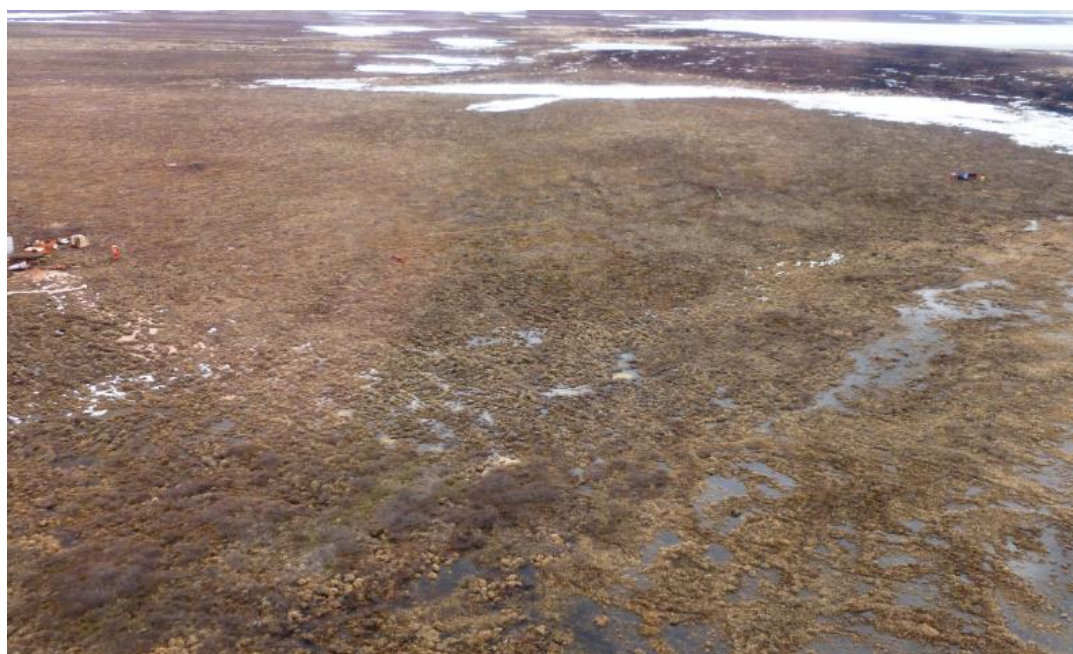
Photograph 2. Aerial Survey on June 18, 2015

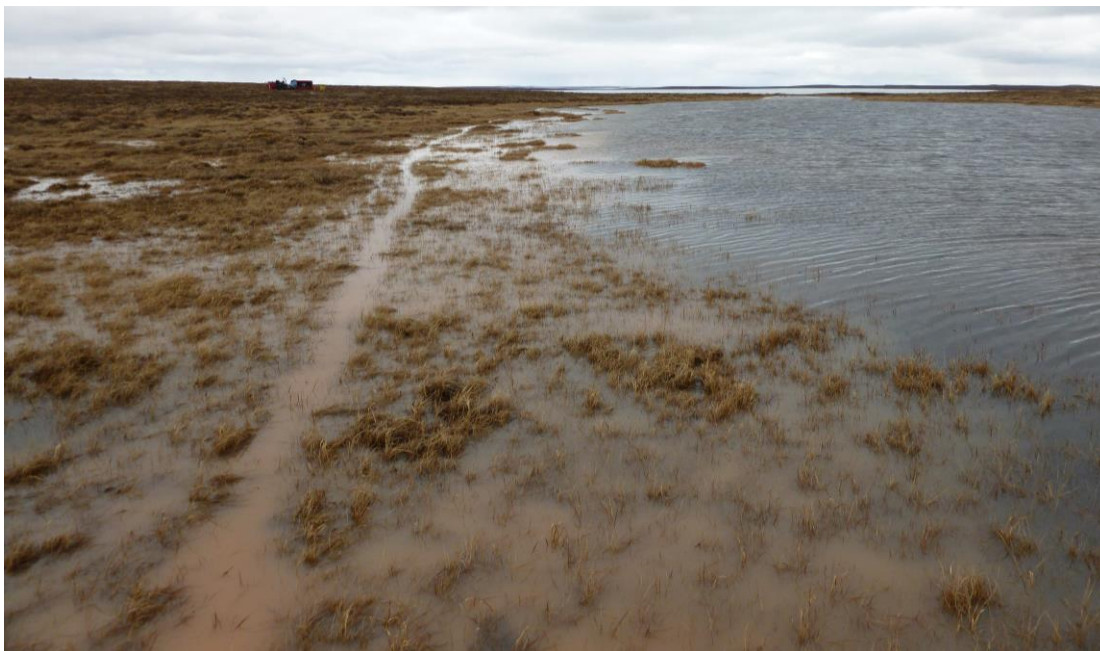
Photograph 3. Drill Return Water Discharge to Small Water Body (June 17, 2015)

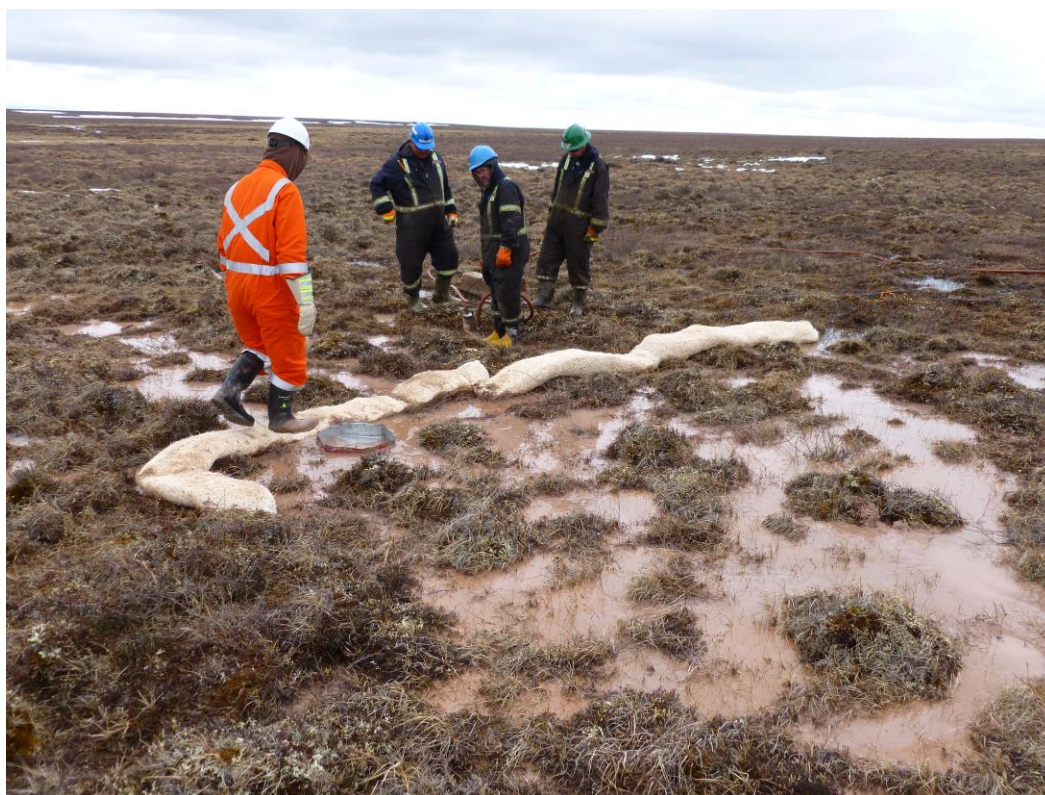
Photograph 4. Containing the Spill on June 17, 2015
