WATER LICENCE INSPECTION FORM

Licensee	Licensee Representative
Areva Resources Canada Inc.	Curtis Rhinas
Licence No. / Expiry	Representative's Title
2BE-KIG1318	SHEQ Coordinator (Summer Student)
Land / Other Authorizations	Land / Other Authorizations
KVL306C02	N2014C0001
Date of Inspection	Inspector
16/07/14	WRO C. Wilson
Activities Inspected	
<input checked="" type="checkbox"/> Camp	<input checked="" type="checkbox"/> Drilling
<input type="checkbox"/> Roads/Hauling	<input type="checkbox"/> Mining
	<input type="checkbox"/> Construction
	<input type="checkbox"/> Reclamation
	<input checked="" type="checkbox"/> Fuel Storage
	<input checked="" type="checkbox"/> Other: Water Discharge
	<input checked="" type="checkbox"/> Other: Spills

PHOTO LOG			
Date:	Authorization Number:	Camera/Model:	Inspector
July 16 <sup>th</sup> , 2014	2BE-KIG1318	Sony DSC-HX50V Cyber shot	WRO Wilson

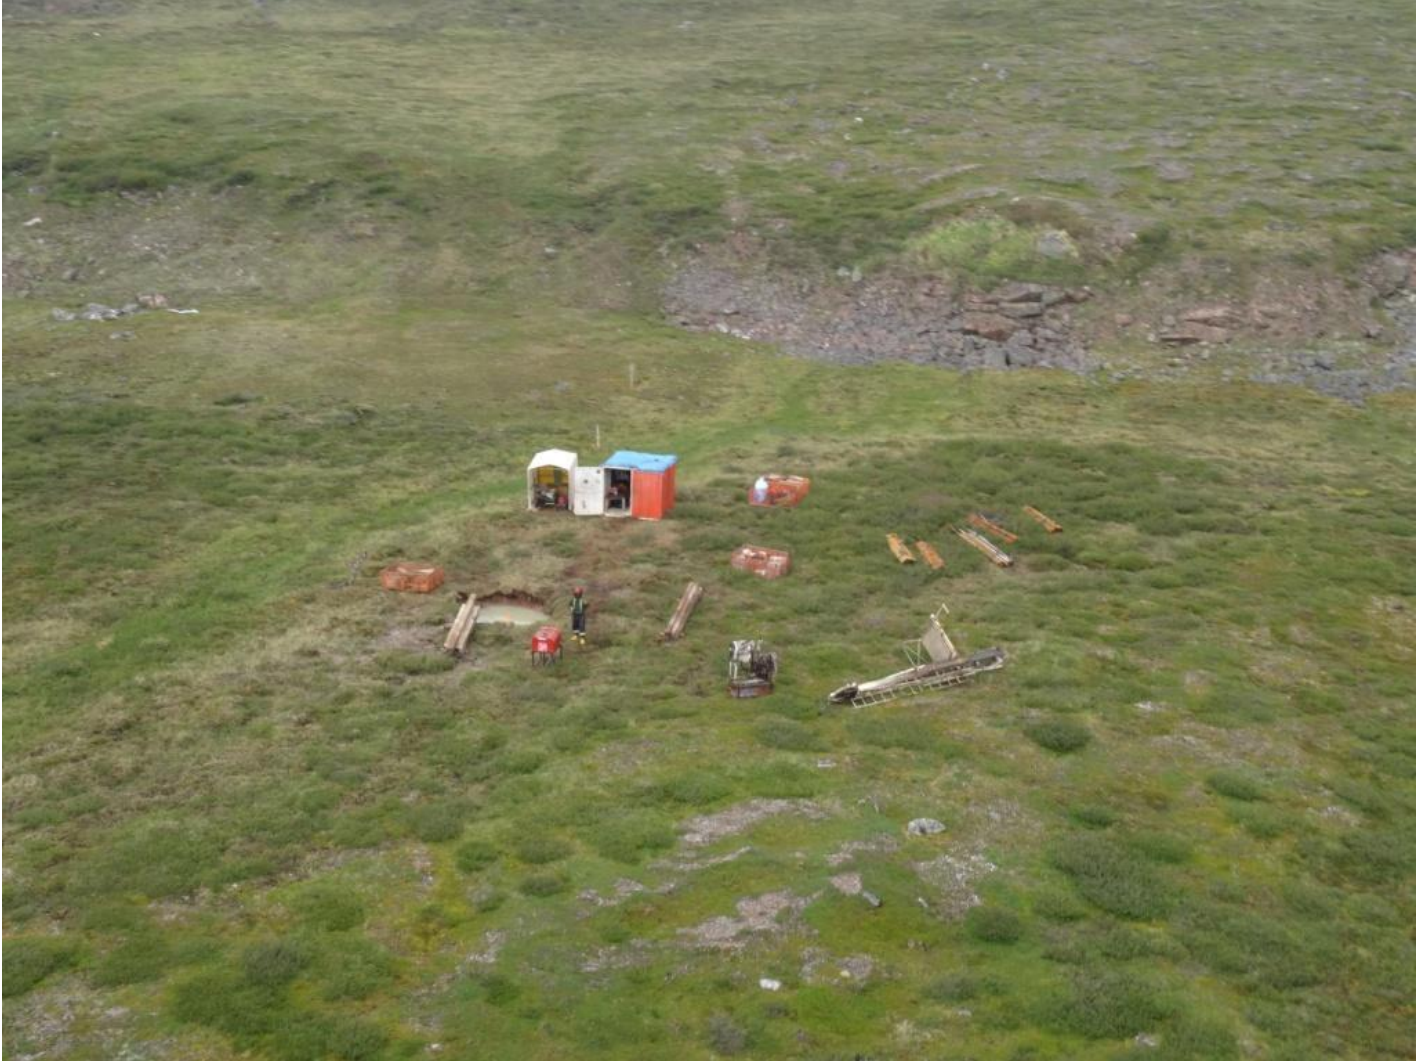
PHOTO 3

Area of caved in ground around a drill hole located near End Grid
