WATER LICENCE INSPECTION FORM

Licensee	Licensee Representative
Areva Resources Canada Inc.	Daniel Zunti, Stephanie Forseille
Licence No. / Expiry	Representative's Title
2BE-KIG1318/ July 21st, 2024	Exploration Representatives
Land / Other Authorizations	Land / Other Authorizations
IOL KVL3006C02	N2014C0014
Date of Inspection	Inspector
July 10 <sup>th</sup> 2017	WRO C. Wilson
Activities Inspected	
<input checked="" type="checkbox"/> Camp <input type="checkbox"/> Drilling <input type="checkbox"/> Mining <input type="checkbox"/> Construction <input type="checkbox"/> Reclamation <input checked="" type="checkbox"/> Fuel Storage	
<input type="checkbox"/> Roads/Hauling <input type="checkbox"/> Other: <input type="checkbox"/> Other: <input type="checkbox"/> Other:

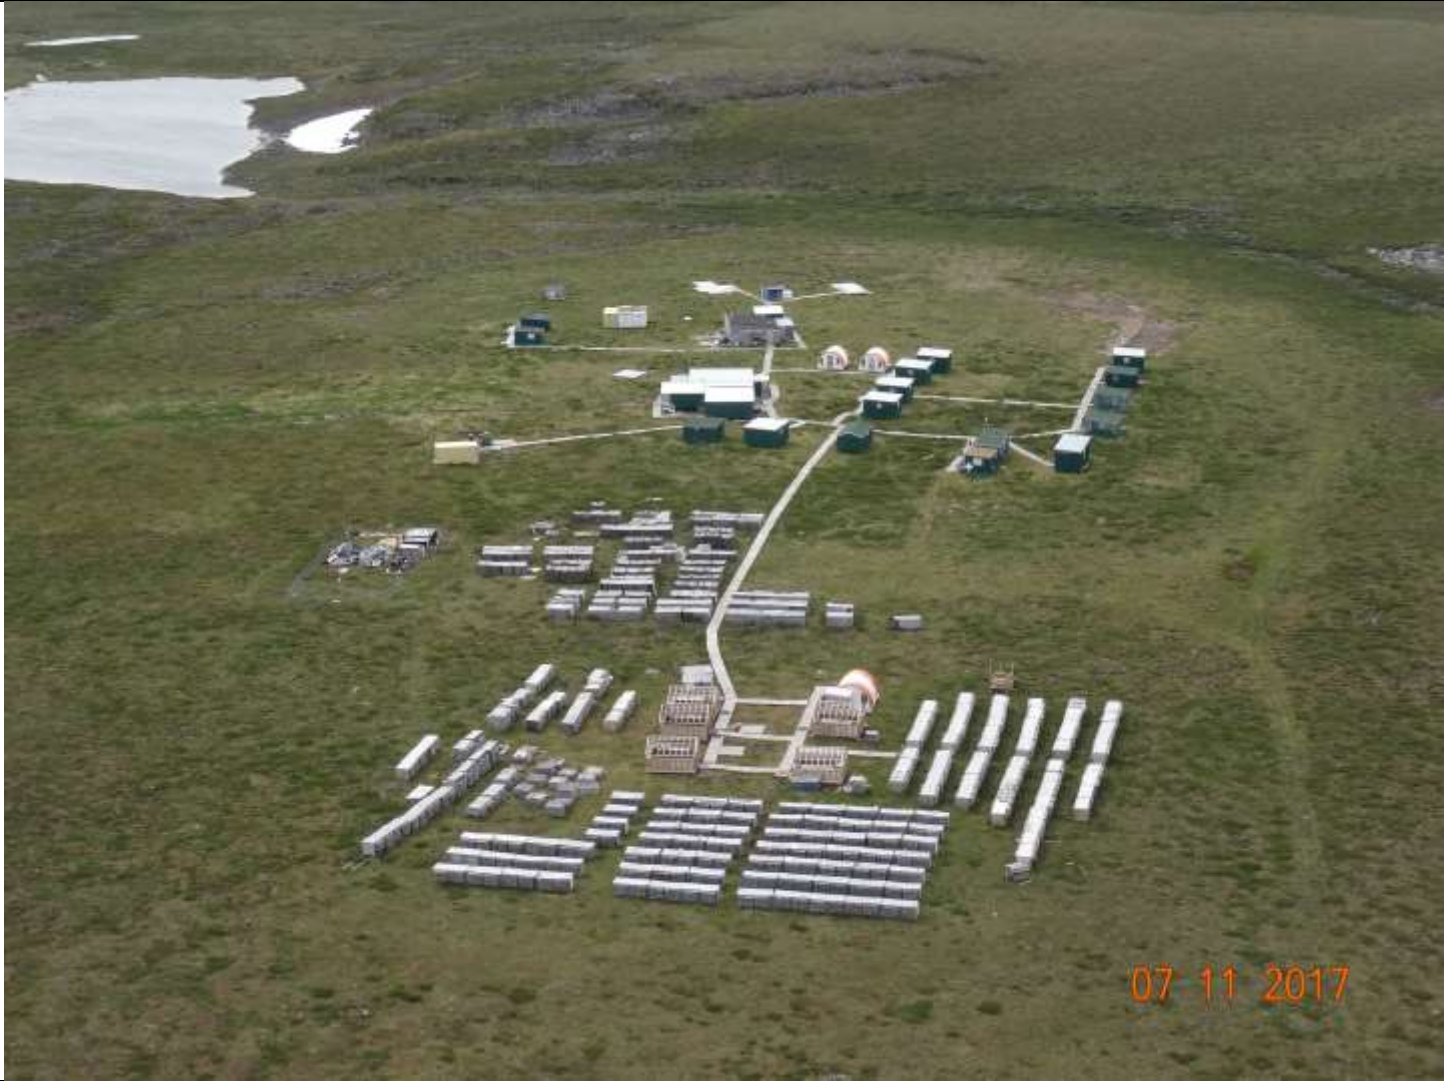
Description:  
Kiggavik Camp

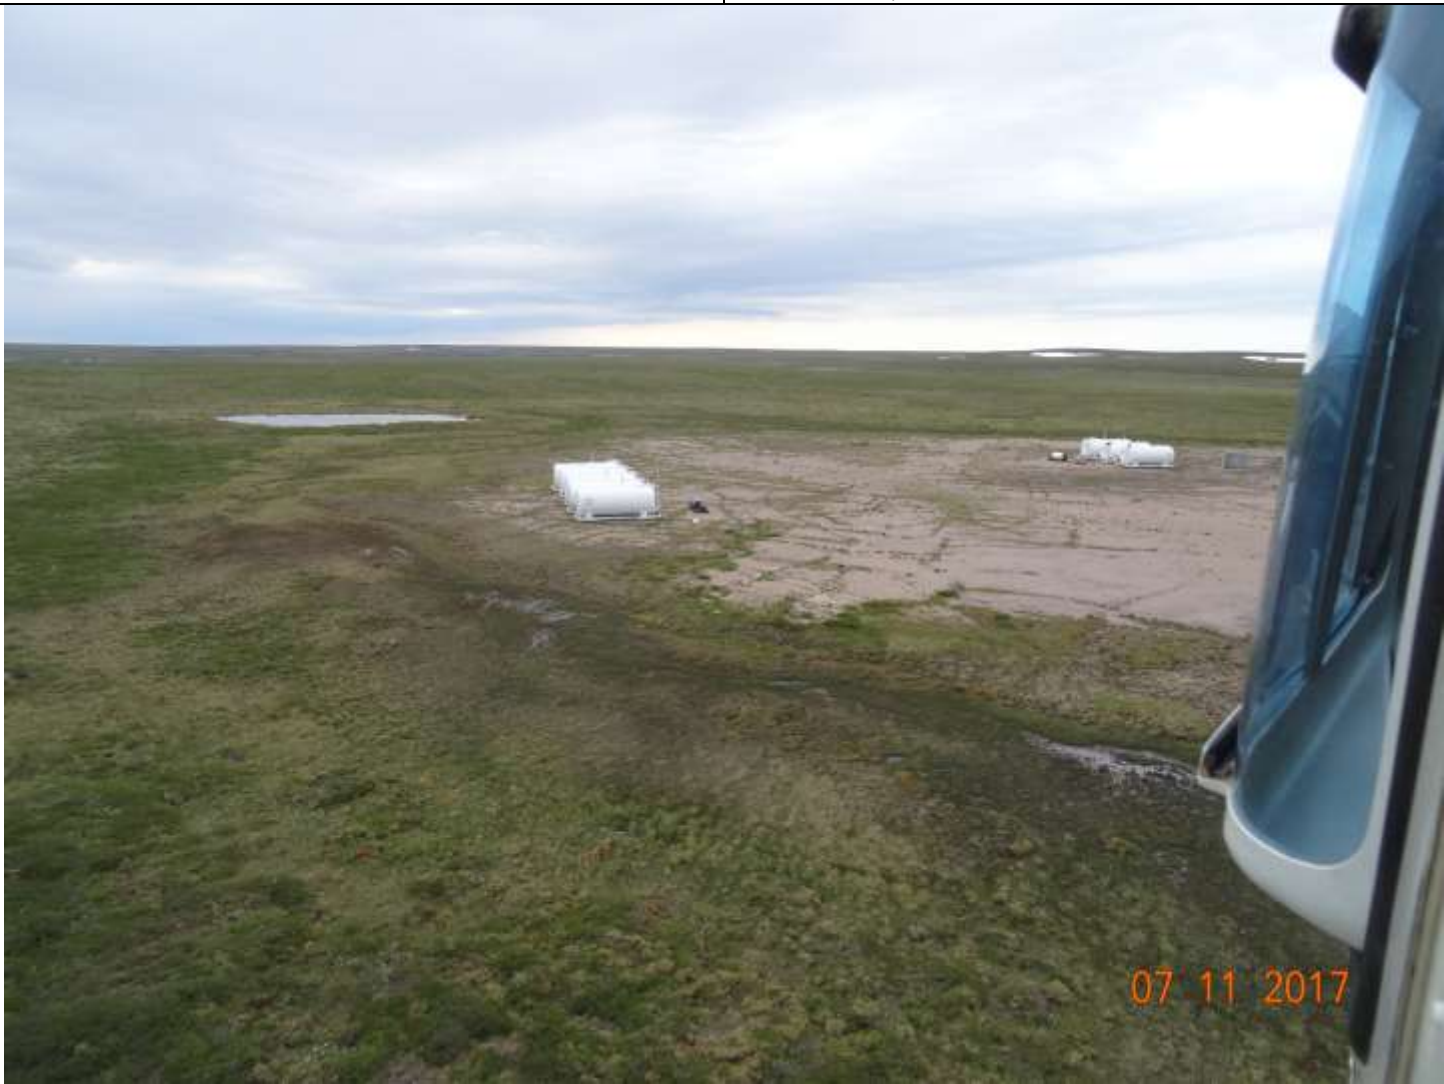
Photo 2

Bulk Fuel Farm- All the tanks are empty

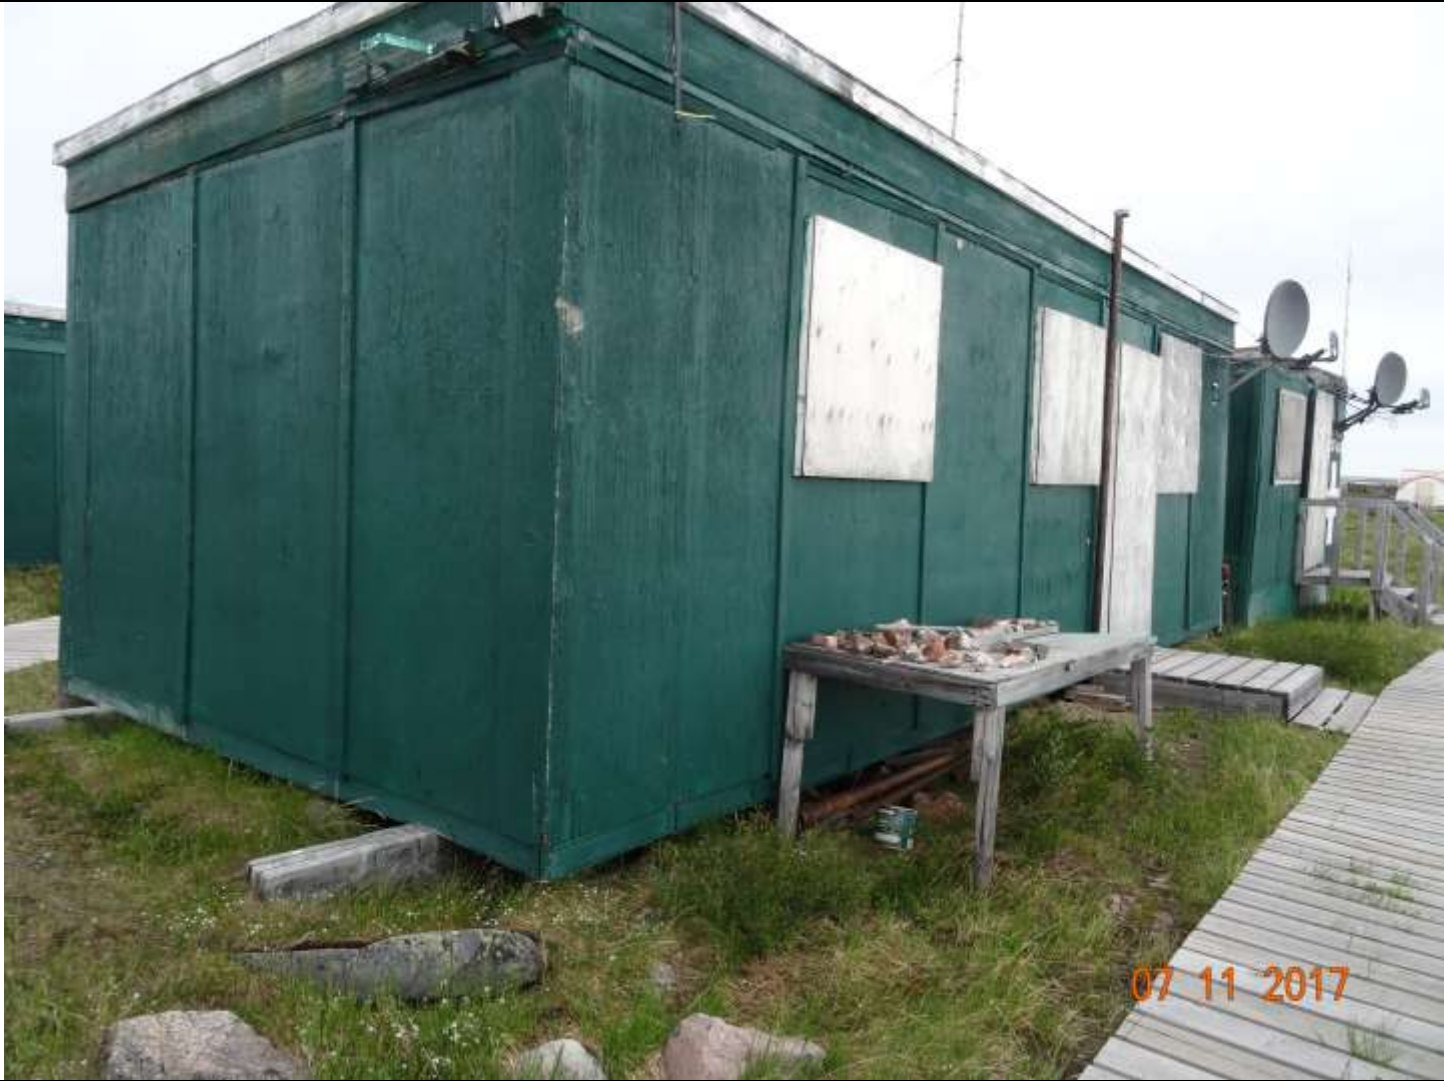
Locations name:  
Photo 3

Description  
Building are secure
