**AREVA Resources Canada Inc.**

**Kiggavik Project, Nunavut**

**Final Incident Report for July 6, 2008 Spill**

**August 8, 2008**

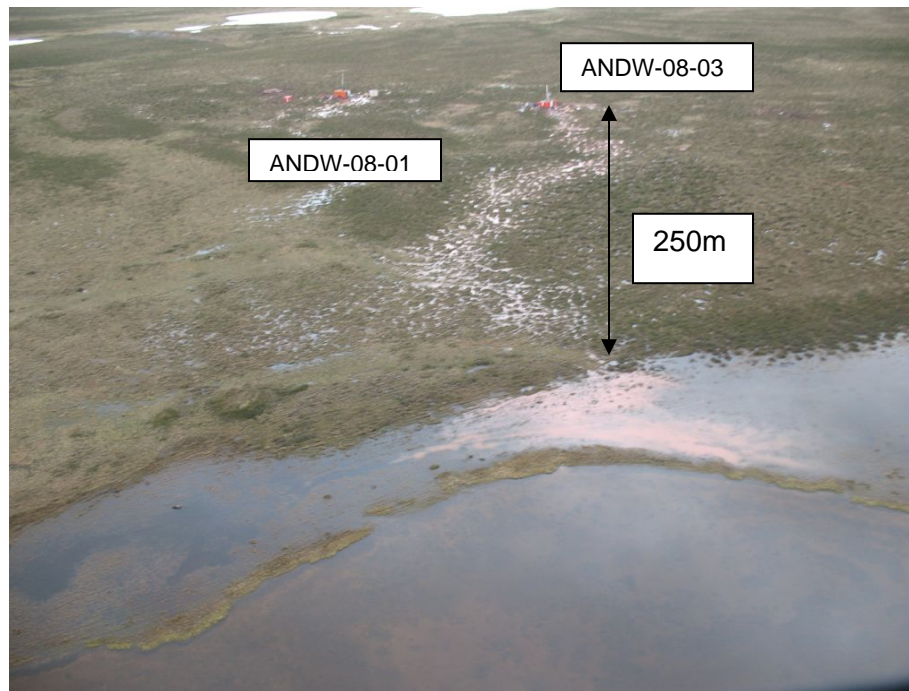
**Figure 2**      **North Shore of Andrew Lake July 6, 2008 – Looking North West**

- 6:06 pm - The EH&S Coordinator sends pictures (Figure 2) to the Project General Manager, Facility Supervisor and Senior Project Geologist. The drill waste is pooling within a small wetland along the shoreline of Andrew Lake.
- 6:17 pm - Drill return water is diverted further from the rig using a sump pump. Inflow of water to the lake stops.

Although a water sample was not collected from the main body of Andrew Lake immediately adjacent to the wetland, AREVA believes that Figure 2 shows the impact was primarily confined to the wetland area, which supports the conclusion that there was no significant impact on Andrew Lake.

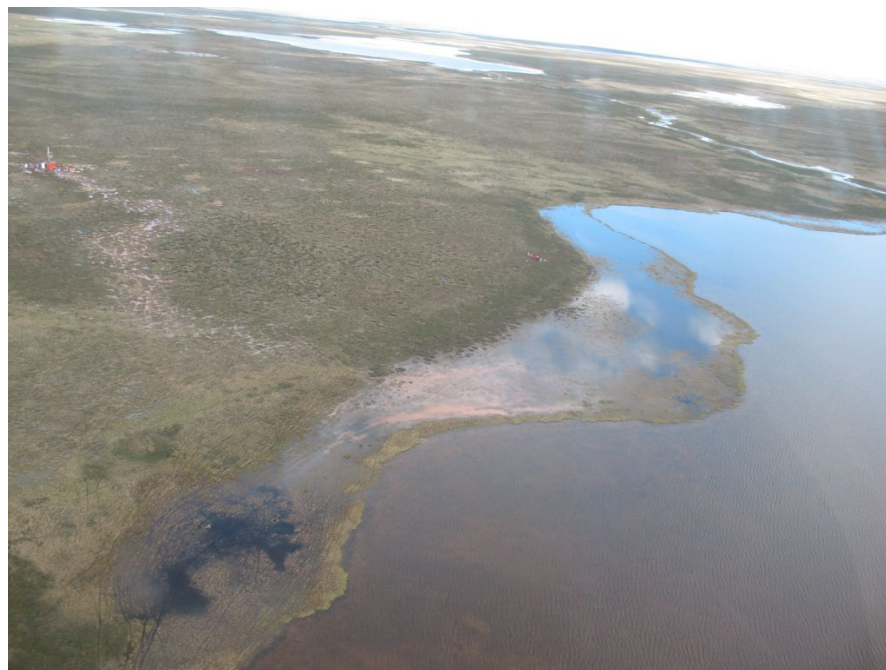
**Figure 3**      **North Shore of Andrew Lake July 7, 2008 - Looking West**

On July 6, 2008 an incident involving exploration drilling wastes occurred at the Areva Resources Canada Kiggavik Project exploration site (Figure 1), located 80 km west of the community of Baker Lake in Nunavut. Drill return water that was pooling near an active drill site entered the northwest part of Andrew Lake. The water had a strong reddish tinge due to the presence of extremely fine hematitic (iron mineral) clay in suspension. Upon entering the waterbody, the suspended hematite-clay particles began to settle, but the water along the shore retained a somewhat murky-red appearance for several days. Andrew Lake is a shallow water body, with a mean depth of approximately 20 cm. The wetland area affected by the reddish inflow is separated from the main water body by a sandbar. As shown in Figures 2, 3, 4, and 5 the red color progressively dissipated.

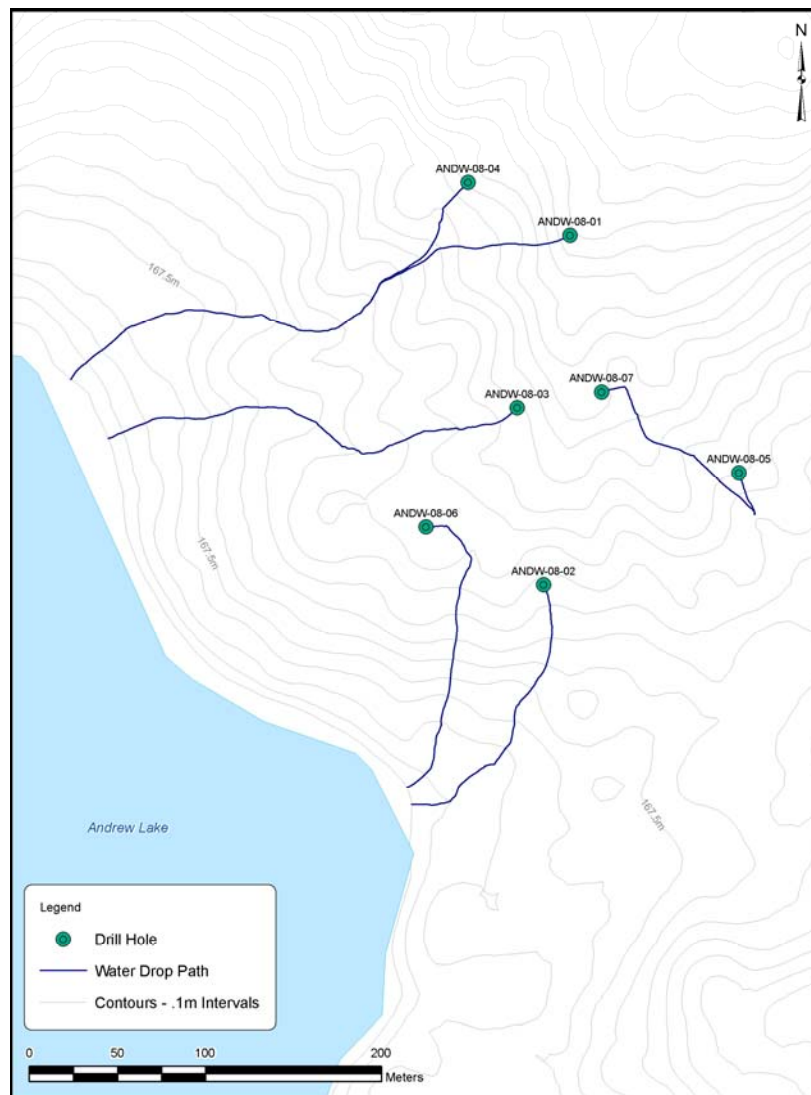
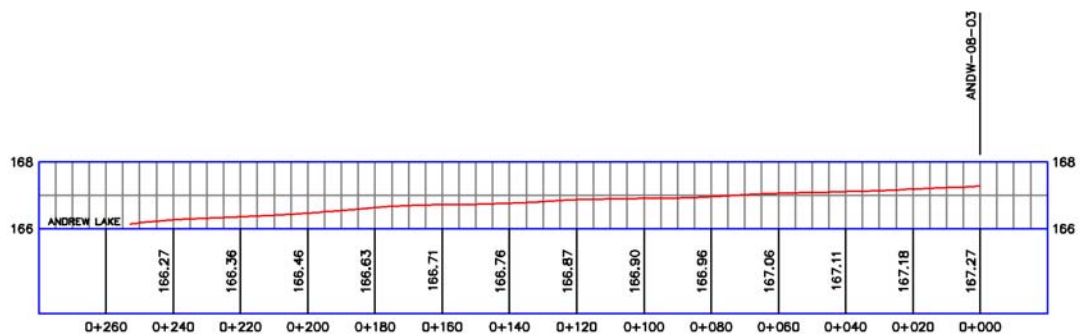
**Figure 6 Theoretical Flowpaths from ANDW-03-03 to Andrew Lake (based on LIDAR Data)**

Observations made on July 6 suggest that ground surface conditions significantly changed from July 5 to July 6 and that on July 6 water and sediments flowed over the last 30 to 40 m towards the lake within a few hours. This observation seems consistent with topographic data (Figure 6), which shows the gradient increasing near the lake. Further details are provided in the interim report previously submitted (Appendix 1) and in the assessment conducted by Golder Associates (Appendix 2).

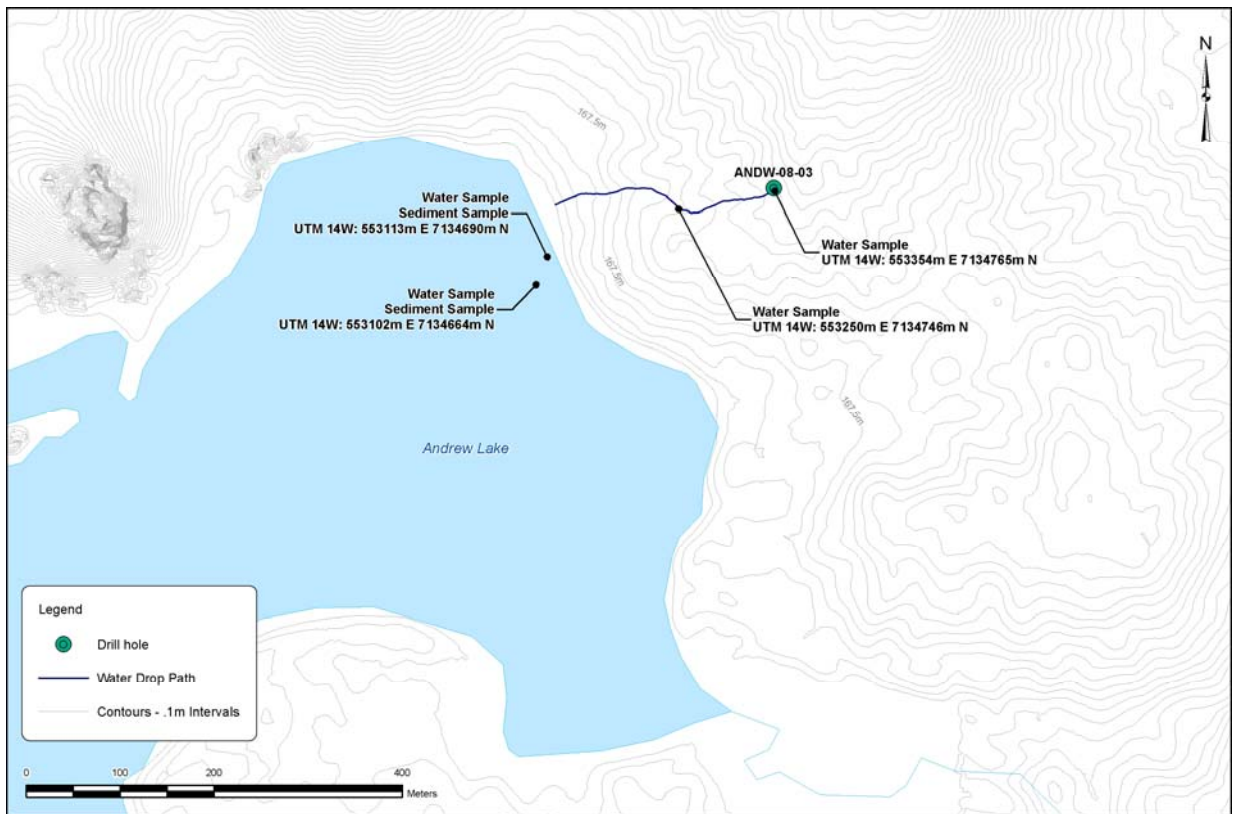
**Figure 7 Water Sample Locations**

1. Shaded values exceed Saskatchewan Surface Water Quality Objectives for the Protection of Aquatic Life (SSWQO PAL)
2. In the wetland area separated from the main body of the lake (See Figure 7)
3. At an intermediate location and a location close to the drilling (See Figure 7)

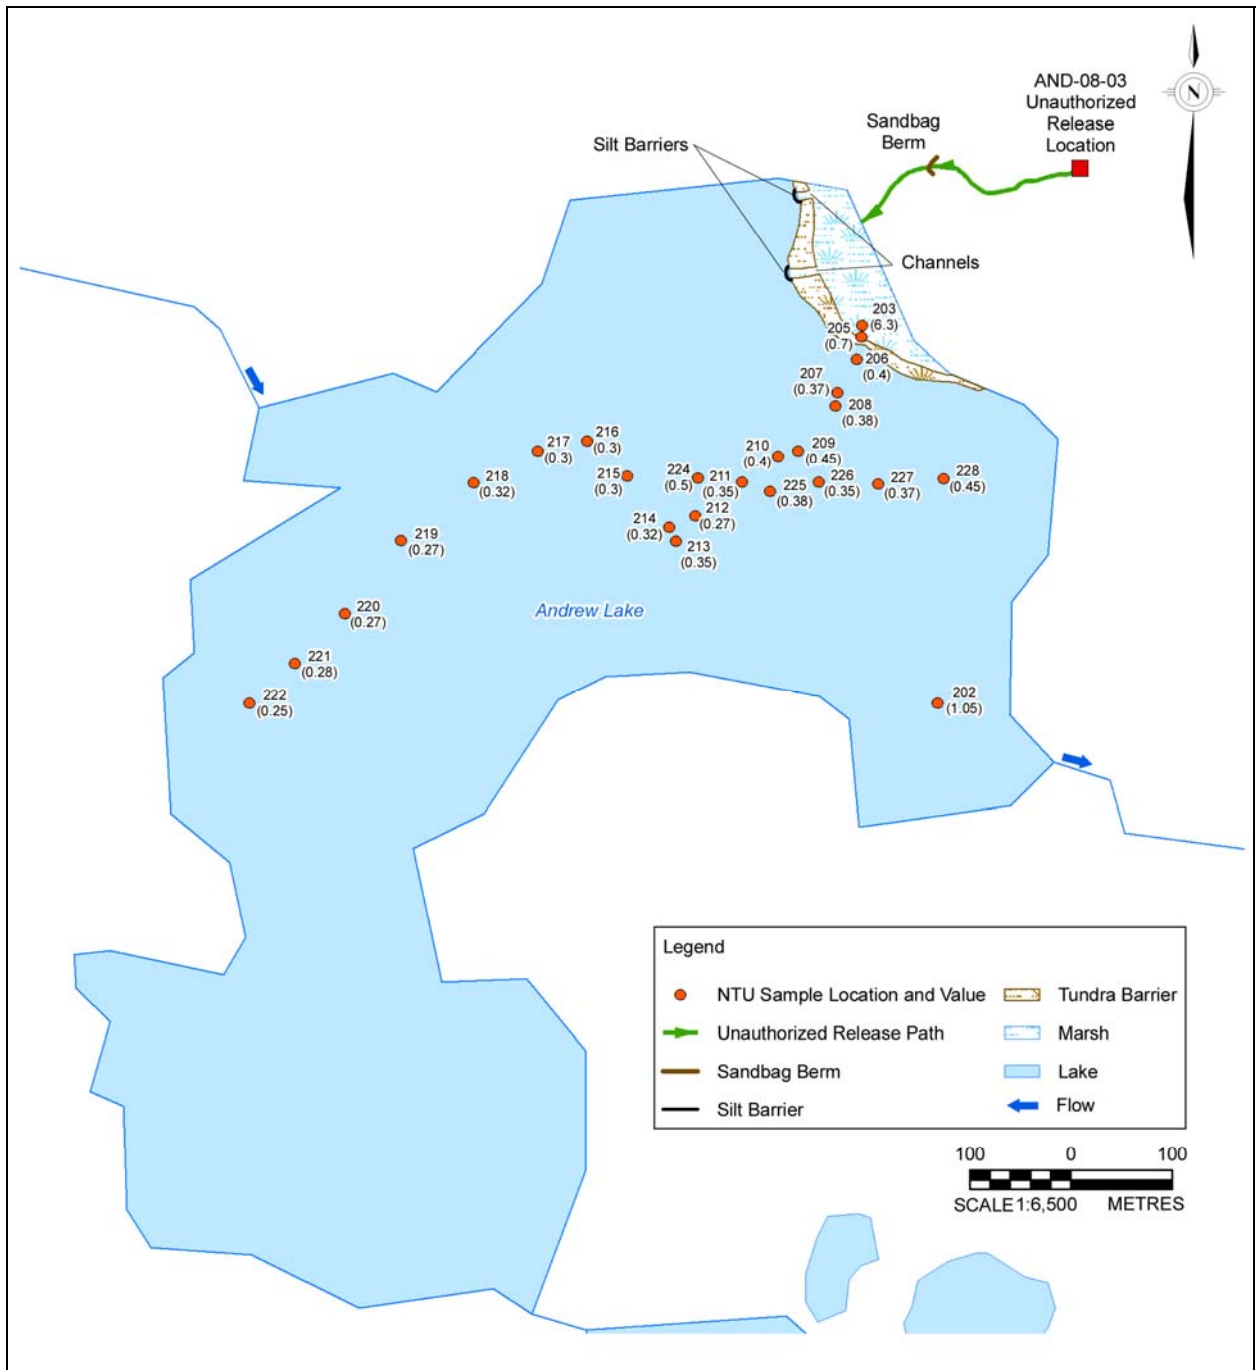
**Figure 8 Turbidity Survey**

Golder Associates performed a series of turbidity and total suspended solids (TSS) measurements within Andrew Lake on July 13, 2008. These results by waypoint (see Figure 8 for a map of locations) are shown in Table 2. The turbidity results are plotted spatially in Figure 8. The turbidity within the central part of the lake was approximately 0.27 NTU, while turbidity directly within the shoreline discharge reached 6.3 NTU. A baseline turbidity measurement taken at Andrew Lake during the 2007 season was 1.8 NTU, therefore with the exception of two locations, all measurements were within natural variability. Golder has concluded that these results indicate no residual impact on Andrew Lake.

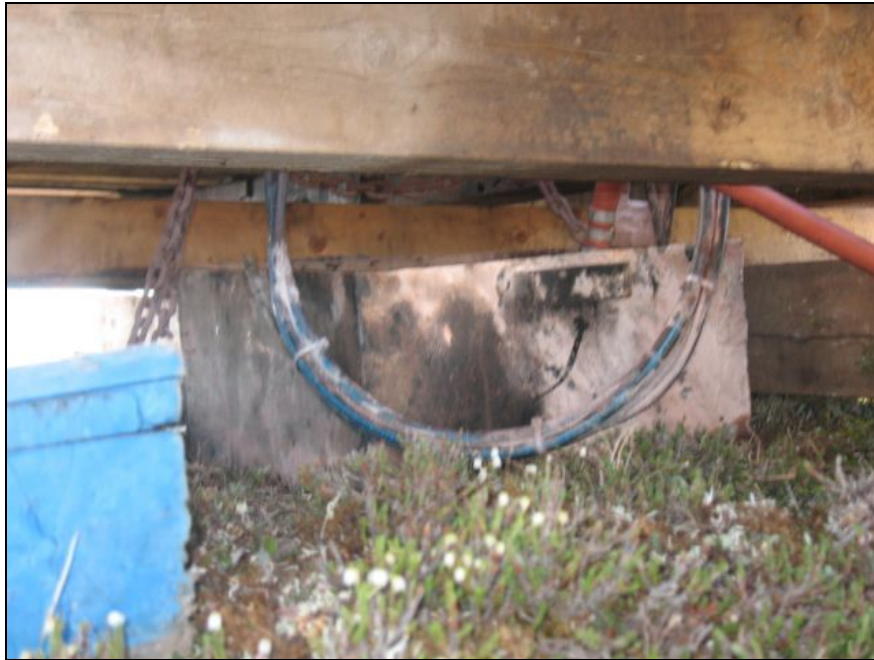
**Figure 9 – Set-Up END-08-03 showing the containment box**

The drilling contractor (Boart) has modified the drill system to reduce the potential for incident. In the revised system (Figures 9 to 11):

- A collection pan/casing box is placed around the casing under the drill,
- The return water is collected in the pan and pumped rather than being allowed to flow directly from the casing,
- Non-radioactive cuttings are pumped to a designated low-lying area,
- A manifold system is installed in order to better manage the water supply, with the objective of routing the supply water (fresh water) back to the lake and reducing the amount of fresh water pooling around the drill site,
- The separator set-up has not been modified and continues to be used to collect radioactive cuttings within the mineralized zones.

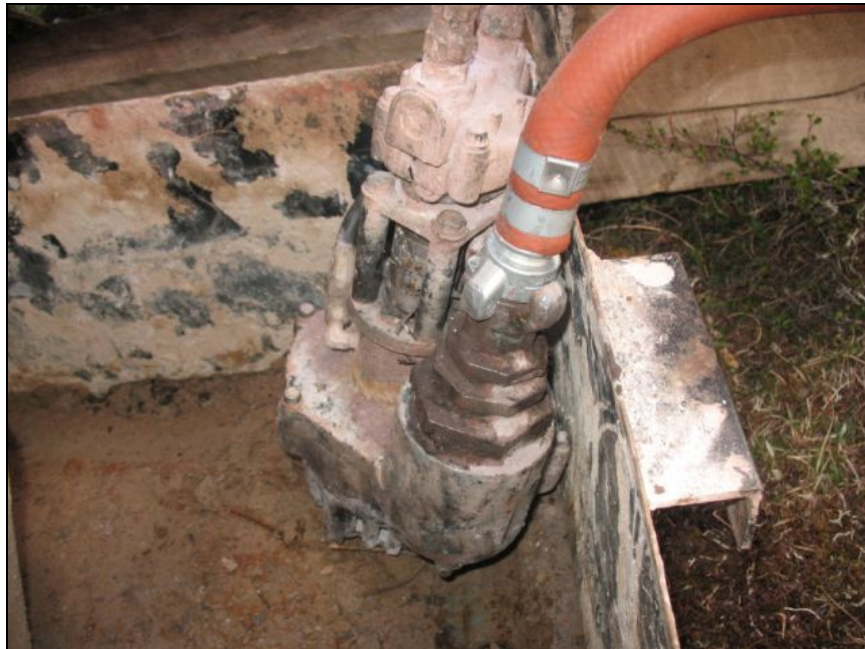
**Figure 10 – Set-Up END-08-03 showing the containment and cuttings pump**

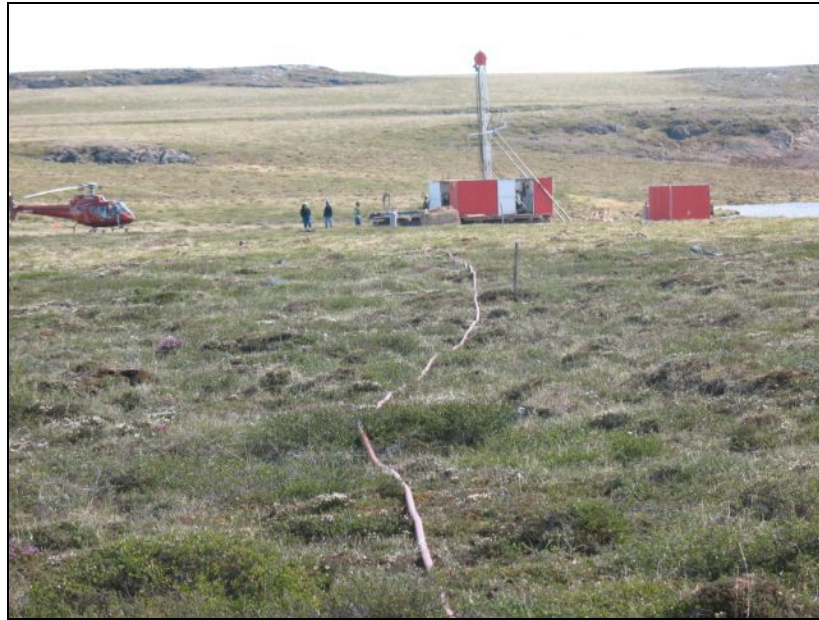
**Figure 11 – Set-Up at END-08-03 showing the non-radioactive cuttings discharge hose**

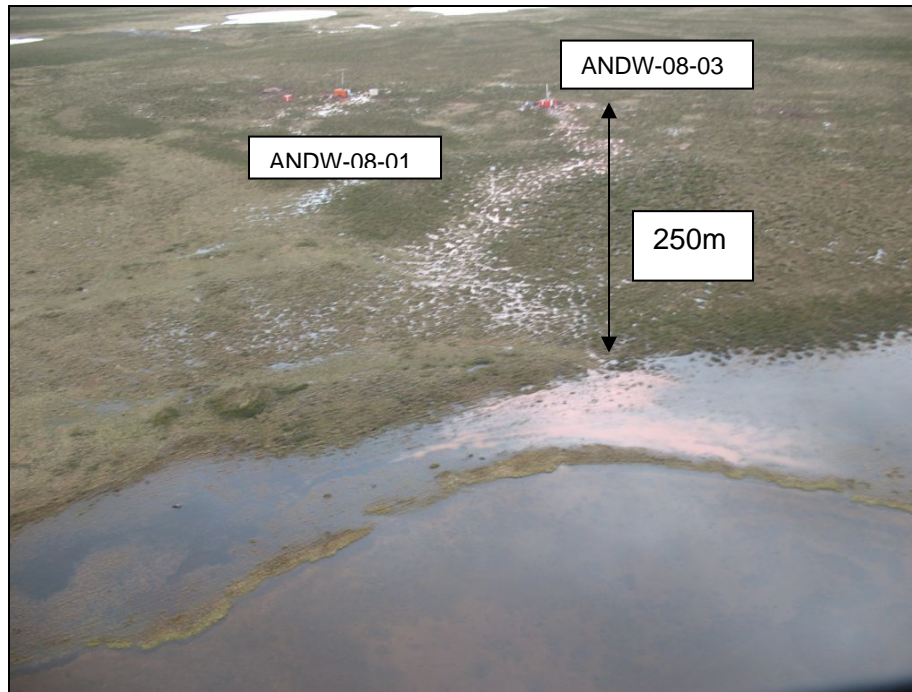
- 4:37 pm - The GM asks the EH&S Coordinator to see the pictures before making a decision.
- 6:06 pm - The EH&S Coordinator send pictures (i.e., Figure 1) to the GM, Facility Supervisor and Project Geologist.

Figure 1 - July 6, 2008 – 6 pm – Looking North West

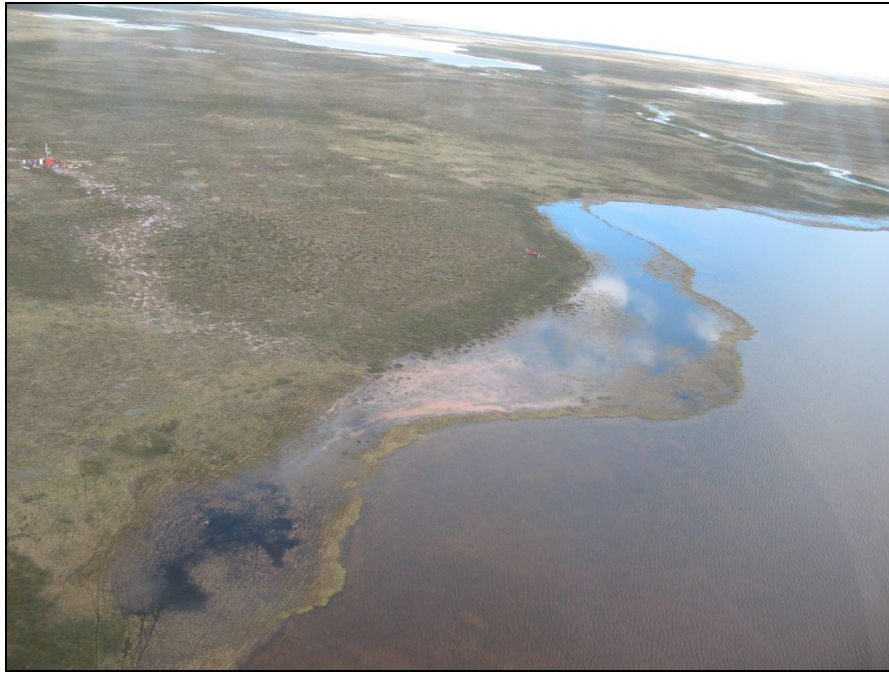
On July 6, 2008 water that was pooling from drill #2 on hole ANDW-08-03 at the Andrew Lake site entered the Northwest part of Andrew Lake. The water had a strong reddish tinge due to the presence of extremely fine hematitic (iron mineral) clay in suspension. Upon entering the shallow, stagnant and non-flowing water body, agitated hematite-clay particles began to settle to the surface, but gave the water a somewhat murky-red appearance. Andrew Lake is a shallow water body, with a mean depth of approximately 20 cm. The area affected by the reddish inflow is separated from the main water body by a sand bar (Figure 1). Figure 2 and 3 show that the red color progressively dissipated.

Figure 2 - July 7, 2008 - Looking West

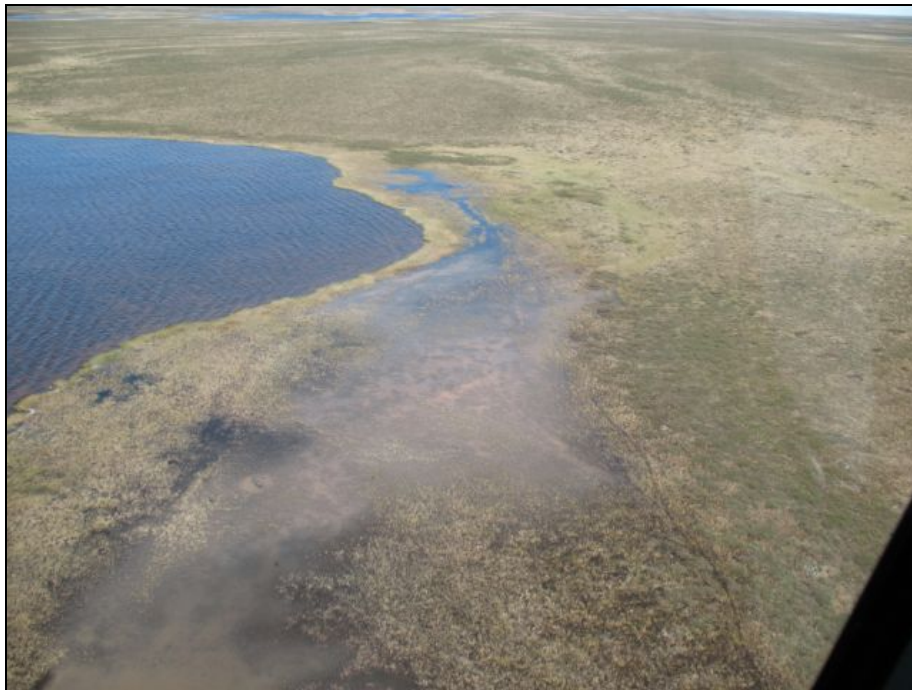
Figure 3 - July 8, 2008 - Looking East

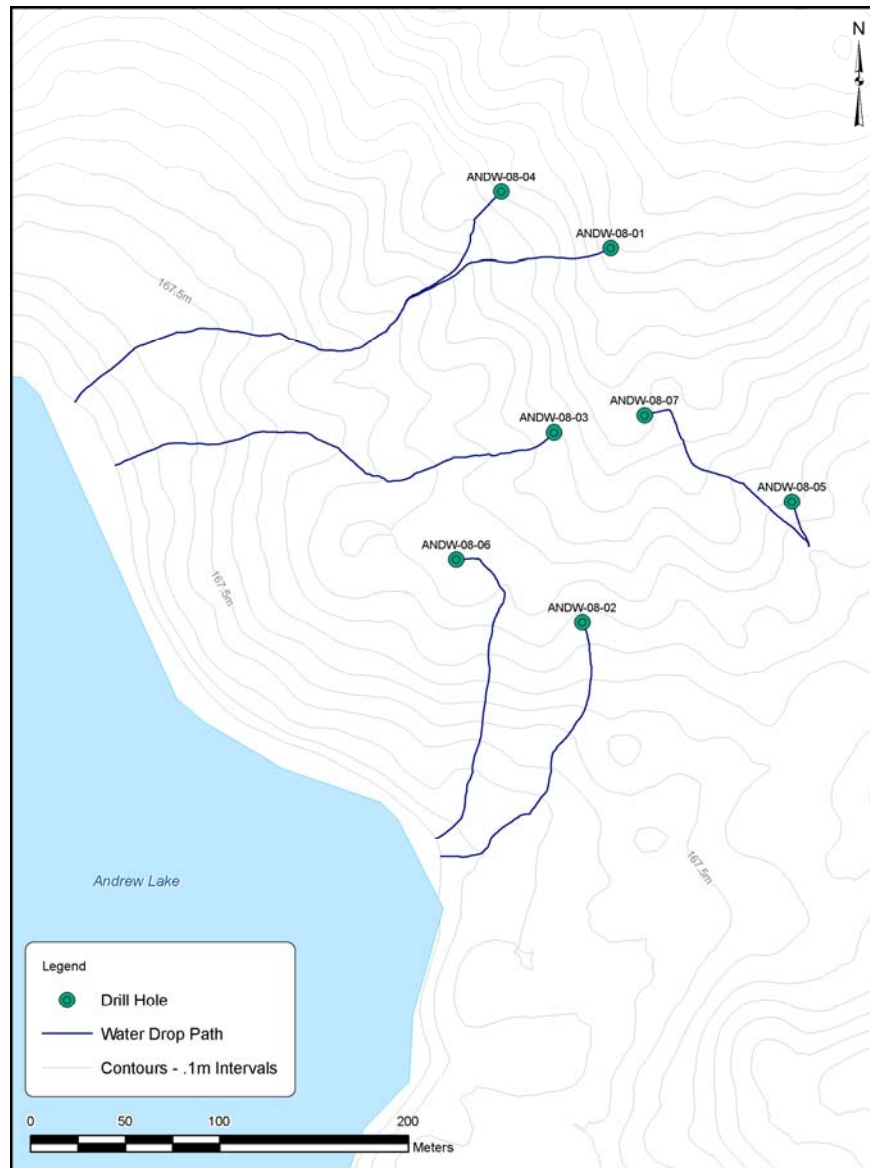
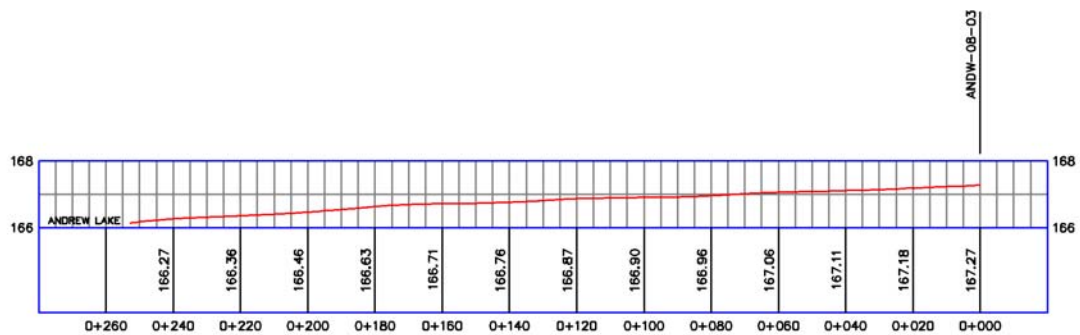
Figure 4 – Theoretical flowpaths from ANDW-03-03 to the Lake (based on LIDAR Data)

Observations made on July 6 suggest that ground surface conditions significantly changed from July 5 to July 6 and that on July 6 water and sediments flowed over the last 30-40 m towards the lake within a few hours. This observation seems consistent with topographic data (Figure 4).

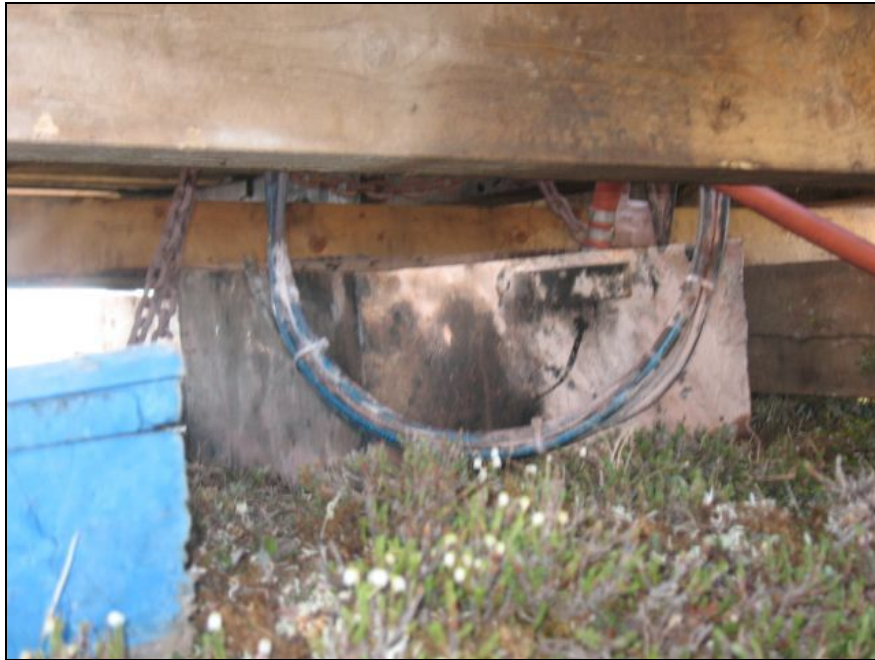
Figure 5 – Set-Up END-08-03 showing the containment box

The drilling contractor (Boart) was asked to modify its system to reduce the potential for incident. In the proposed system (Figures 5 to 7):

- A collection pan/casing box is placed around the casing under the drill,
- The return water is collected in the pan and pumped rather than being allowed to flow directly from the casing,
- A manifold system is installed in order to better manage the water supply, with the objective of routing the supply water (fresh water) back to the lake and reducing the amount of fresh water pooling around the drill site.
- The separator set-up is not modified and will continue to be used within the mineralized zones.

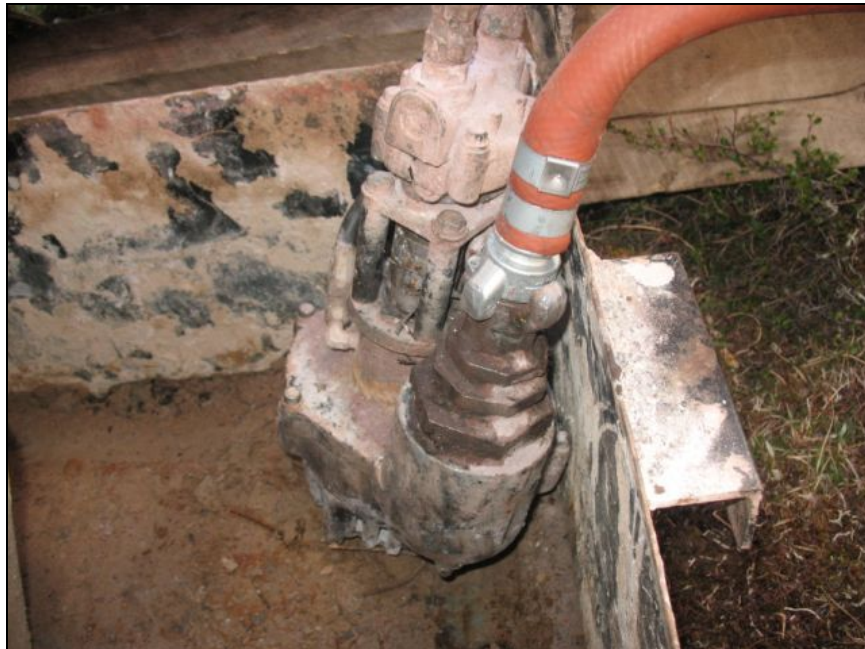
Figure 6 – Set-Up END-08-03 showing the containment and sludge pump

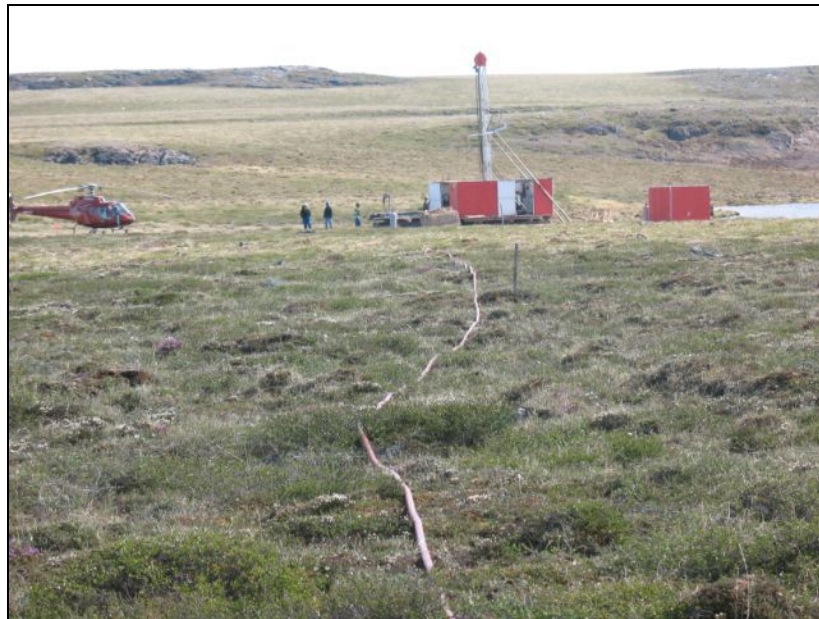
Figure 7 – Set-Up END-08-03 showing the discharge hose that runs 600 feet away from the drill

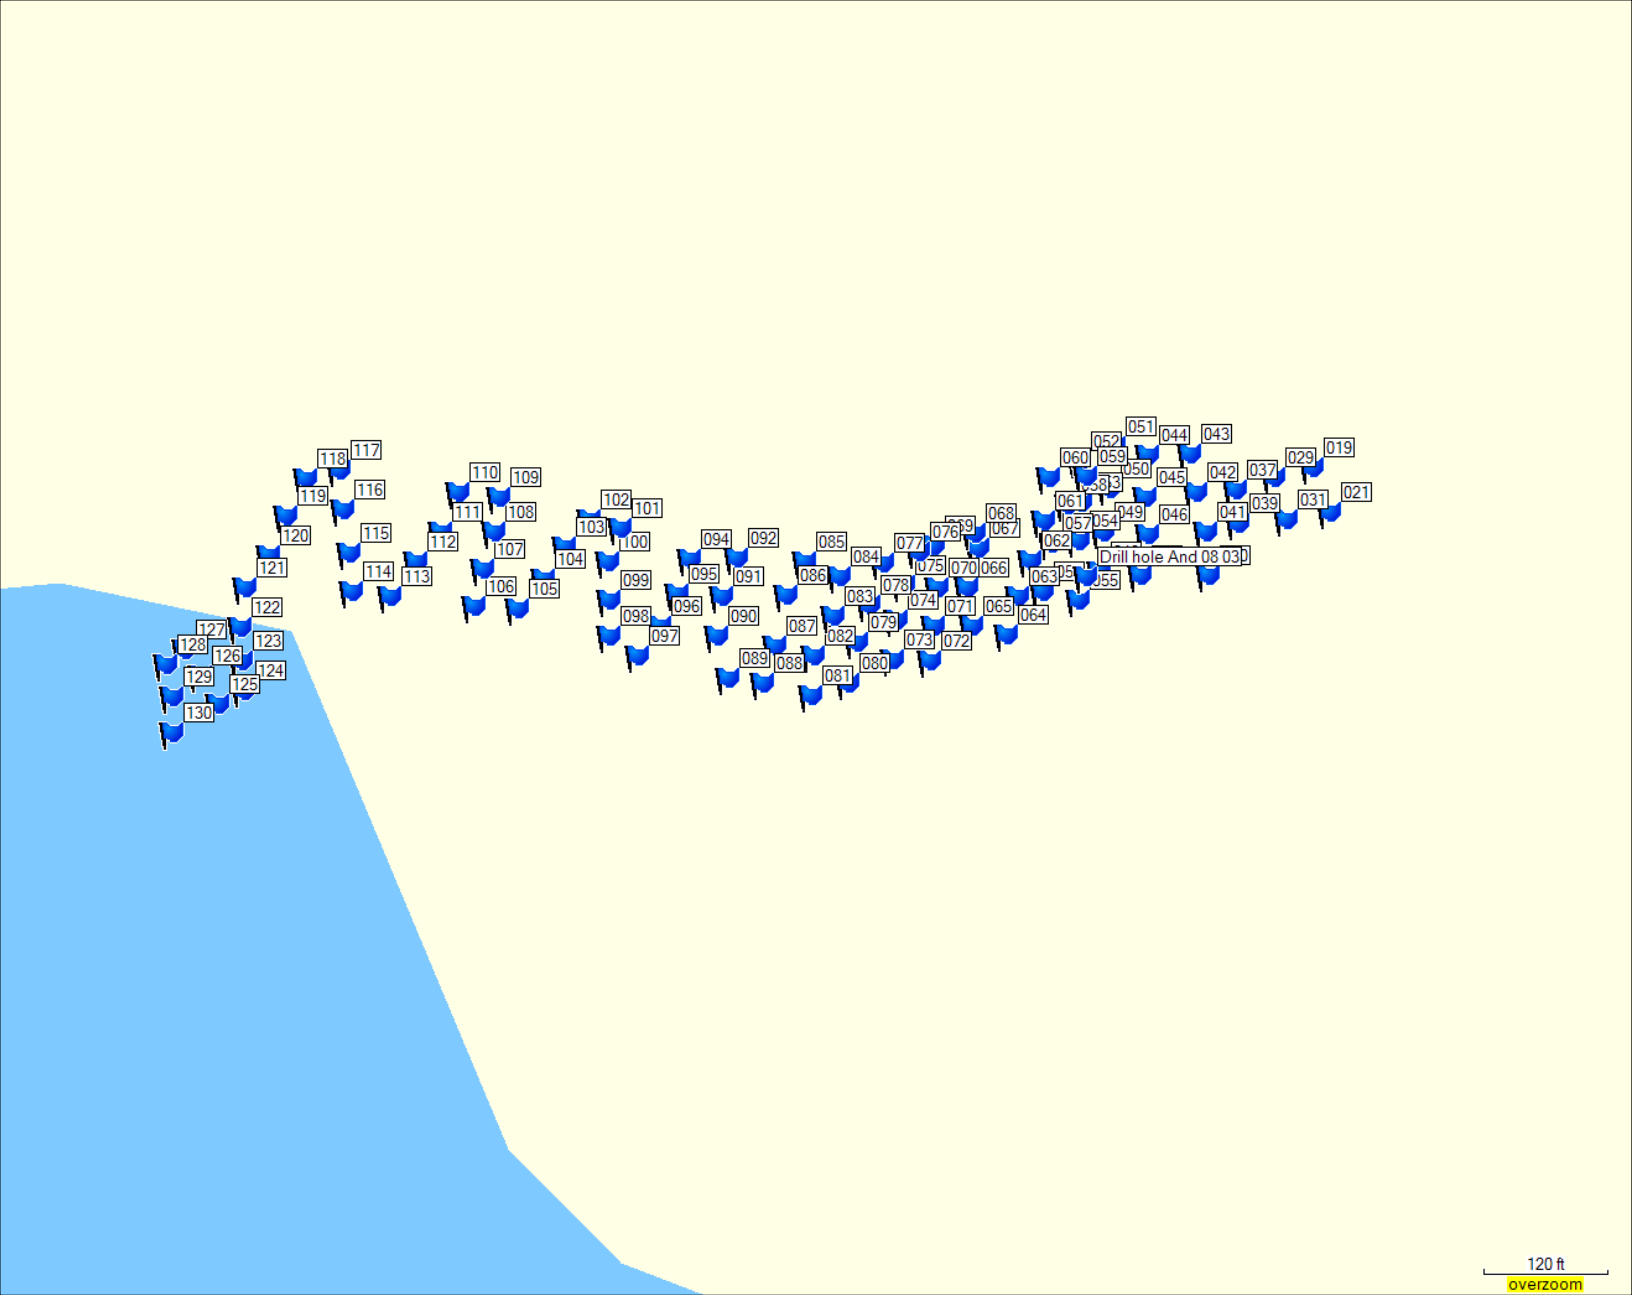
Post gamma Survey  
Andrew - 08-08 KS

A post-incident gamma radiation survey was conducted to measure the radioactivity levels along the discharge path. Radioactivity measurements were collected using an Automech gamma survey instrument. The readings recorded 1 m above the water sample locations and along the north shoreline of Andrew Lake read below 0.1  $\mu\text{Sv/h}$ . Along the discharge path leading to the lake, the survey measured an average of 0.07  $\mu\text{Sv/h}$ , with all points below 0.3  $\mu\text{Sv/h}$ . The pre-gamma survey, conducted prior to commencement of drilling at AND-08-03, showed an average dose rate of 0.12  $\mu\text{Sv/h}$ . Comparison of the pre- and post-gamma surveys indicates that gamma levels in the vicinity of the spill remain similar to pre-spill conditions. Raw survey data is available in Appendix 4.
