**Re: Kiggavik – Follow-up Report to August 04, 2008 spill of drill cuttings**

**AREVA Resources Canada Inc.  
Kiggavik Project, Nunavut**

**Final Incident Report for August 4, 2008 Spill**

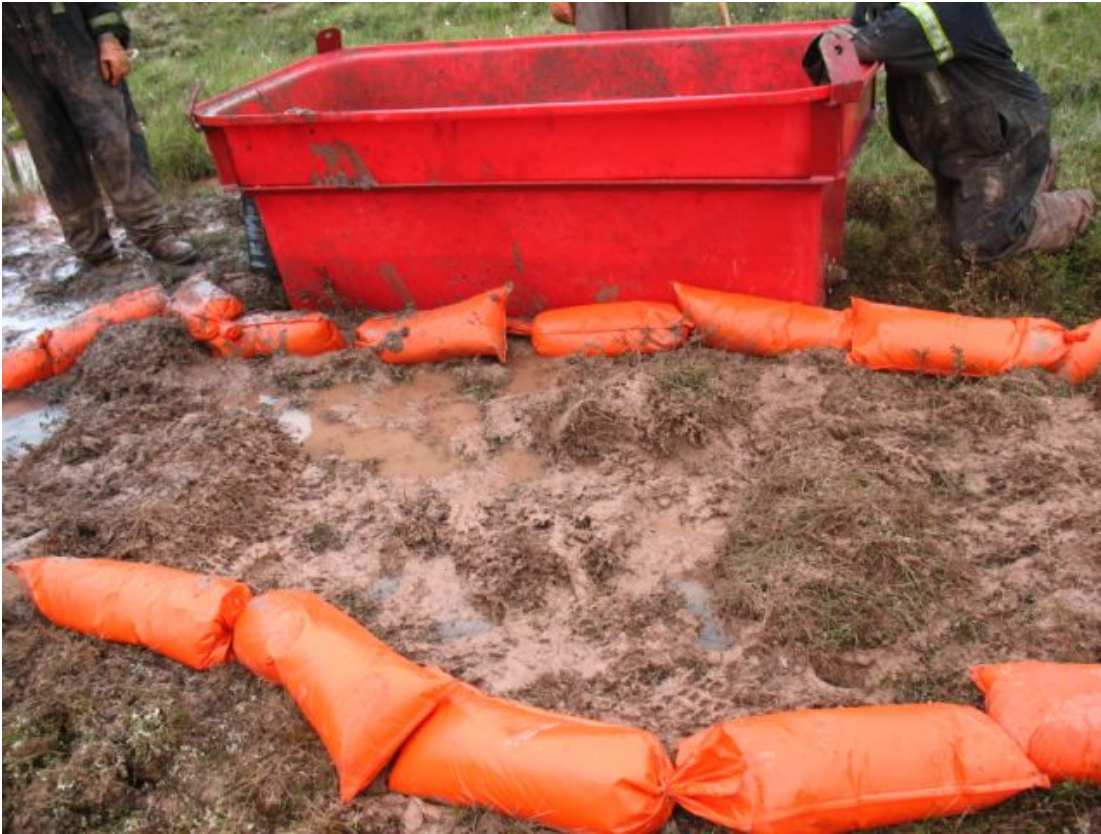
- The helicopter was lifting a bag of cuttings to transport it to the radioactive storage area.
- Upon lifting the cutting bag, the bag tore on the Cuttings separator harness.
- The side of the bag failed and approximately 0.25 m<sup>3</sup> of cuttings spilled onto the tundra, covering an approximately 2 m<sup>2</sup> area.
- The drillers immediately surrounded the spill with sand bags and started shoveling the mineralized cuttings into a cuttings tub (pictures 1 and 2).

The spill of cuttings at AND-08-04 impacted approximately 2 m<sup>2</sup> of tundra. Upon EH&S initial arrival at the spill site, the initial gamma survey indicated readings of 0.44 µSv/h. Additional cleaning of the spill site was conducted, the second gamma survey indicated measurements of 0.30 µSv/h.

**Photo #1: Spill of drill cuttings**

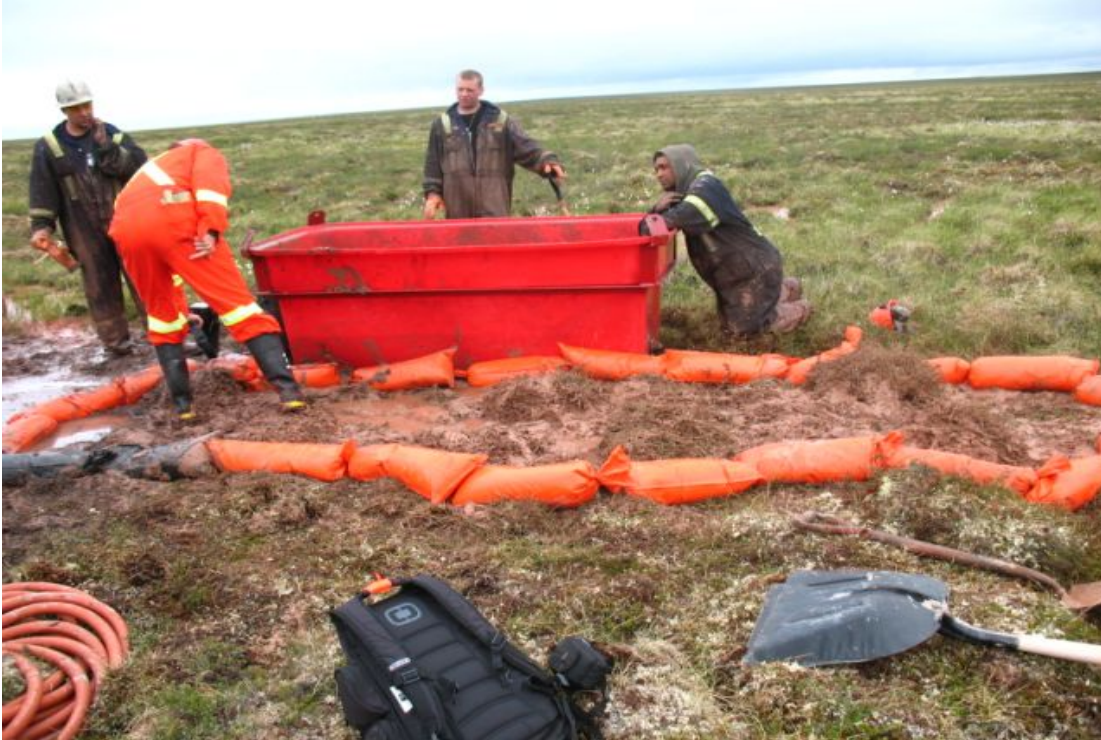
**Photo #2: Containment of spill with sand bags**

Sandbags were placed around area, cuttings were shoveled and put into new container							
<b>O</b> Do You Require Assistance? <input checked="" type="checkbox"/> No <input type="checkbox"/> Yes, describe: ᓄᓇᓂᓐᓂᓐ ᓄᓇᓂᓐᓂᓐ ᓄᓇᓂᓐᓂᓐ ᓄᓇᓂᓐᓂᓐ				<b>P</b> Possible Hazards to Persons, Property or Environment e.g. fire, drinking water, fish or wildlife ᓄᓇᓂᓐᓂᓐ ᓄᓇᓂᓐᓂᓐ ᓄᓇᓂᓐᓂᓐ ᓄᓇᓂᓐᓂᓐ ᓄᓇᓂᓐᓂᓐ ᓄᓇᓂᓐᓂᓐ ᓄᓇᓂᓐᓂᓐ			
None							
<b>Q</b> Comments and/or Recommendations ᓄᓇᓂᓐᓂᓐ ᓄᓇᓂᓐᓂᓐ ᓄᓇᓂᓐᓂᓐ ᓄᓇᓂᓐᓂᓐ						<b>FOR SPILL LINE USE ONLY</b> ᓄᓇᓂᓐᓂᓐ ᓄᓇᓂᓐᓂᓐ ᓄᓇᓂᓐᓂᓐ ᓄᓇᓂᓐᓂᓐ	
Method of Containment for mineralized cuttings to be reviewed for prevention of future recurrence.						Lead Agency ᓄᓇᓂᓐᓂᓐ ᓄᓇᓂᓐᓂᓐ ᓄᓇᓂᓐᓂᓐ ᓄᓇᓂᓐᓂᓐ	
						Spill Significance ᓄᓇᓂᓐᓂᓐ ᓄᓇᓂᓐᓂᓐ	
						Lead Agency Contact and Time ᓄᓇᓂᓐᓂᓐ ᓄᓇᓂᓐᓂᓐ ᓄᓇᓂᓐᓂᓐ ᓄᓇᓂᓐᓂᓐ ᓄᓇᓂᓐᓂᓐ ᓄᓇᓂᓐᓂᓐ	
						Is this file now closed? ᓄᓇᓂᓐᓂᓐ ᓄᓇᓂᓐᓂᓐ ᓄᓇᓂᓐᓂᓐ ᓄᓇᓂᓐᓂᓐ	
Reported By ᓄᓇᓂᓐᓂᓐ		Position, Employer, Location ᓄᓇᓂᓐᓂᓐ ᓄᓇᓂᓐᓂᓐ ᓄᓇᓂᓐᓂᓐ ᓄᓇᓂᓐᓂᓐ				Telephone ᓄᓇᓂᓐᓂᓐ

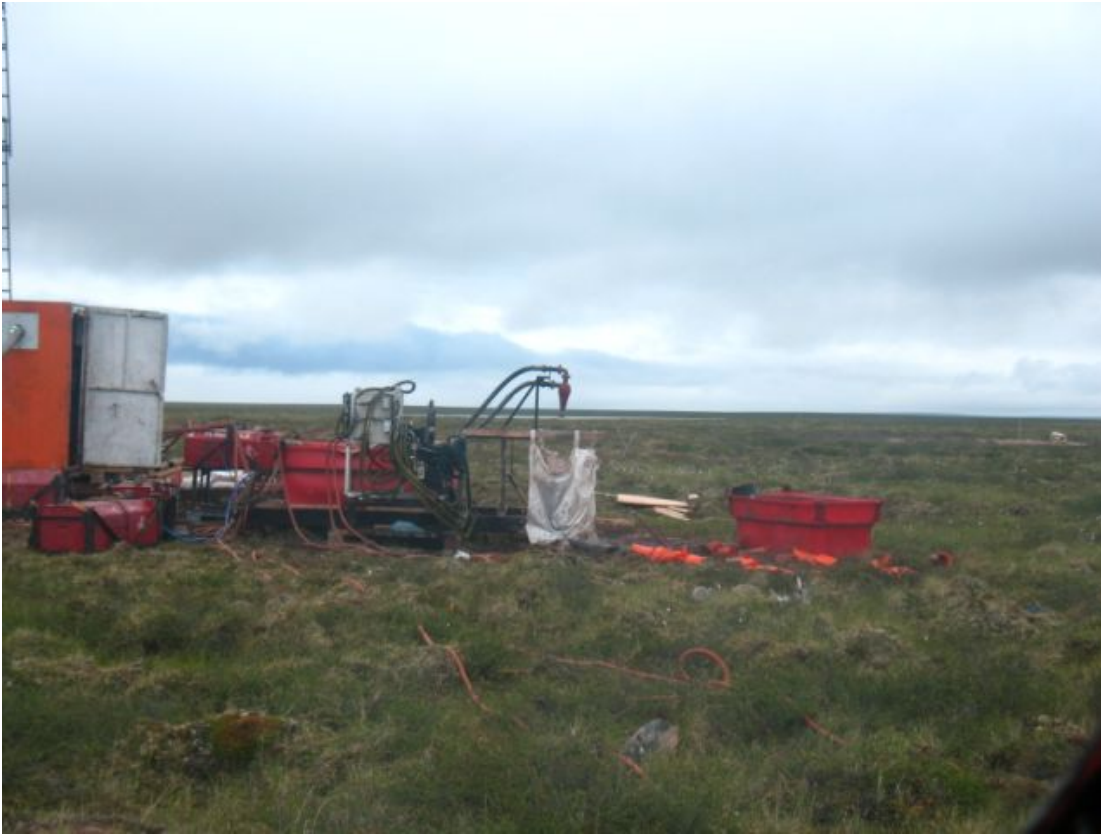
The cutting bags that were used for the 2008 drill program were left over bags from 2007 drill program. The drilling contractors properly packaged and filled the cutting bags, the lift conducted by the helicopter was found to have been conducted according to transport procedures, by connecting all four bag straps to the long line bell and lifting the helicopter off at a slow ascent. However upon ascent, Boart Longyear contractors did not guide the cuttings bag appropriately and the bag caught an edge on the separator. Upon lifting the bag, the bag tore on the cuttings separator harness. The bag was cut open and the drill cuttings were deposited on the ground.

**Photo #3: Separator Set-up**

- The torn bag was a result of proper long line procedures that were not followed. The drilling contractors were to guide the cuttings bag out of the separator harness. Work procedures for cuttings and cutting bags were reviewed.
- Drill bags were replaced with new stronger and more durable bags
- Environmental Management was added to the site orientation checklist to ensure that all drilling staff are aware of the proper procedures for cuttings and cutting bag management. All staff orientation records are kept to ensure that compliance of these new preventative measures are understood by all.
- Drill Cutting collected in the bags will be placed inside of a secondary containment such as a tub. The tub will act as the secondary containment to ensure that any incident with the removal of the cutting bag from the separator will be contained.
