**Re: Kiggavik – Follow-up Report to June 13, 2009 spill of mineralized core**

**AREVA Resources Canada Inc.**  
**Kiggavik Project, Nunavut**

**Final Incident Report for June 13, 2009 Spill**

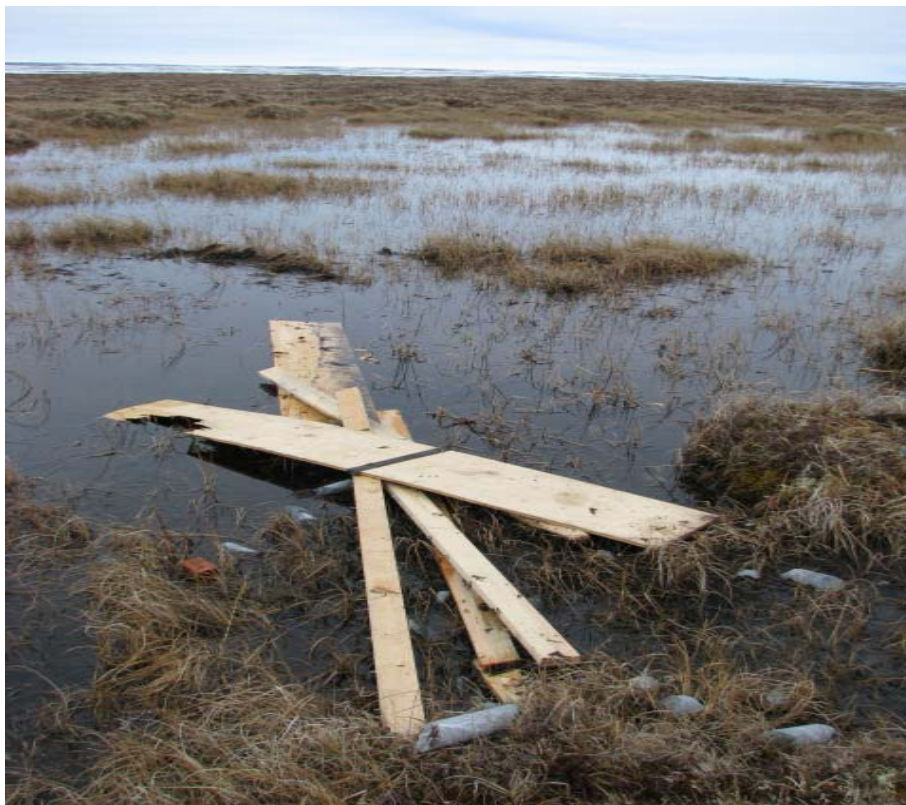
- 6:45 am The Environment and Radiation Protection (E&R) Supervisor is informed at the morning supervisor's meeting that box of core fell from a helicopter
- E&R Group looks for the dropped core box with the help of the Boart Longyear employee who saw it drop
- 8:10 am - E&R Group inspect spill site, see Figures 1-4.
- 8:15 am - E&R Group pick up spilled core and broken core box. All material spilled is in solid form and is easily cleaned up.
- 8:30 am - Gamma survey is conducted on the immediate and surrounding area (Appendix I).

**Figure 1 - Broken Core Box and Core Prior to Recovery, June 14, 2009**

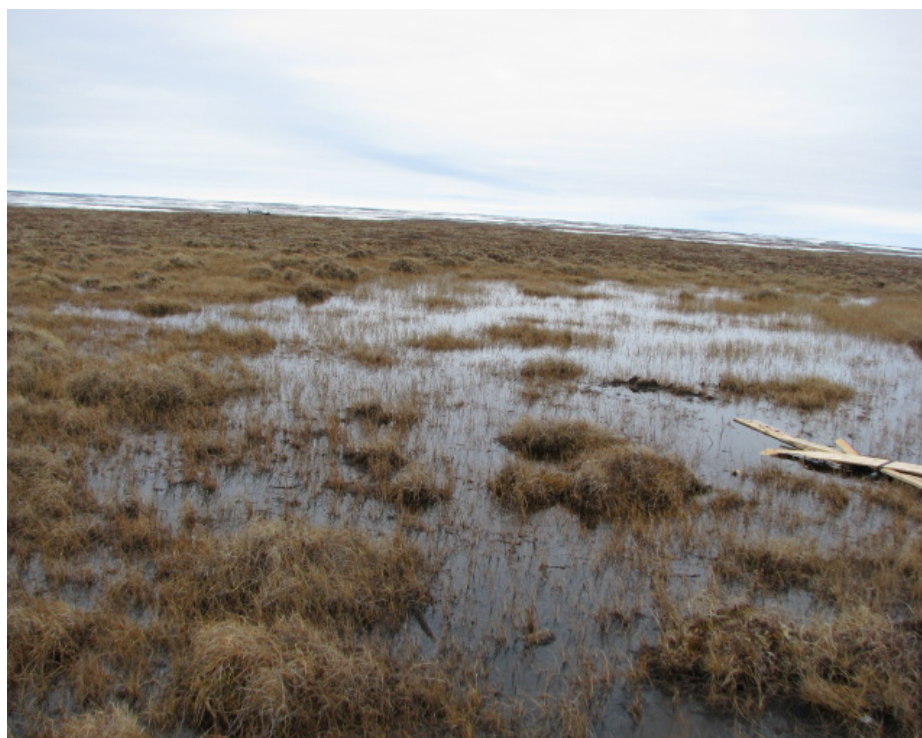
**Figure 2 – Pond Prior to Recovery June 14, 2009 – Looking North West**

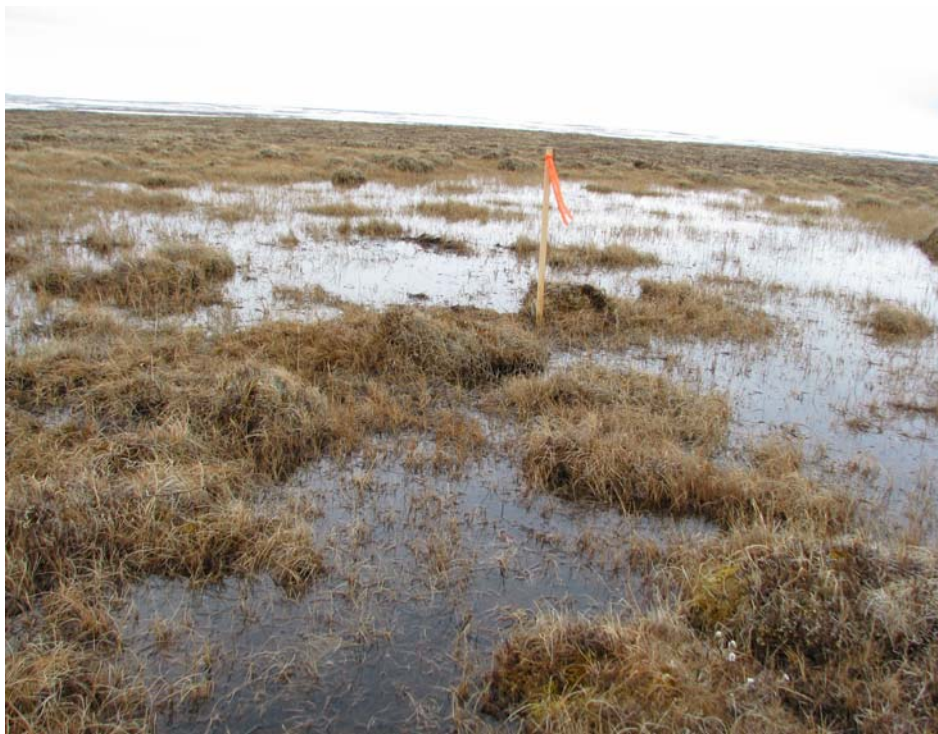
**Figure 3 – Pond After Recovery June 14, 2009 Looking West**

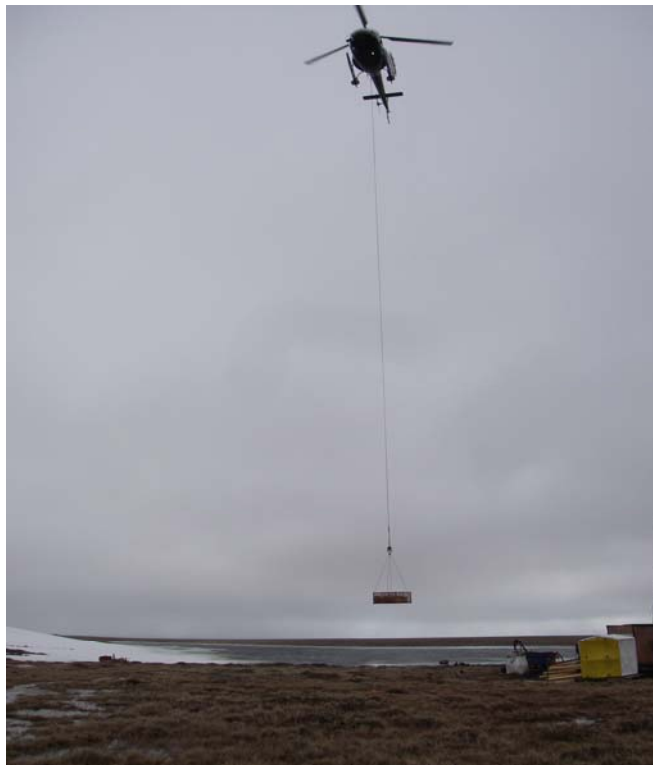
The method used to transport core from the drill rigs is as follows. Core boxes with sealed lids are placed in a metal basket with an open top (Figure 5) The metal basket with the core boxes is then slung at the end of a line under the helicopter from the drill rig to the core assessment area at Kiggavik (Figure 4). This method of transporting core boxes is new in 2009.

**Figure 4 – Helicopter Slings Core June 14, 2009**

AREVA now requires all personnel who are involved with loading core samples into metal baskets to use ratchet straps to secure the core boxes into the metal basket prior to transport. Employees involved directly or indirectly in slinging core are trained in the revised procedures for loading and unloading core boxes for transport. As a final check, should the core come back to camp loose in the basket the geology group at camp has been instructed to contact both the E&RP Supervisor and the Boart Longyear Foreman so that the issue may be dealt with immediately.

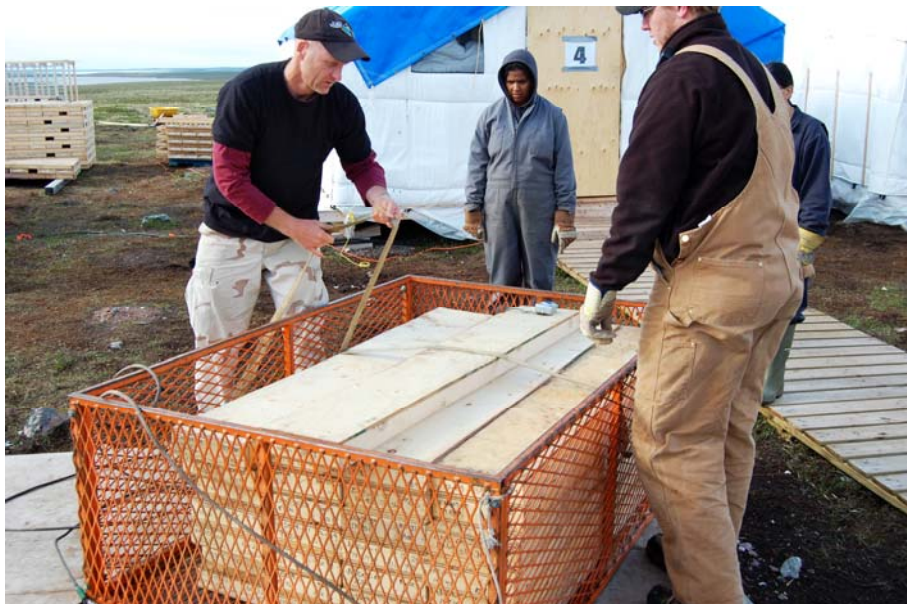
During transport on June 13 the core boxes were loaded into the basket and shortly after take-off, there was enough wind to lift a box enough so that it flew out of the basket and onto the ground.

**Figure 5 – Core Basket as Received by Geology Group**
