Kiggavik Project

July 16, 2014 Spill Report

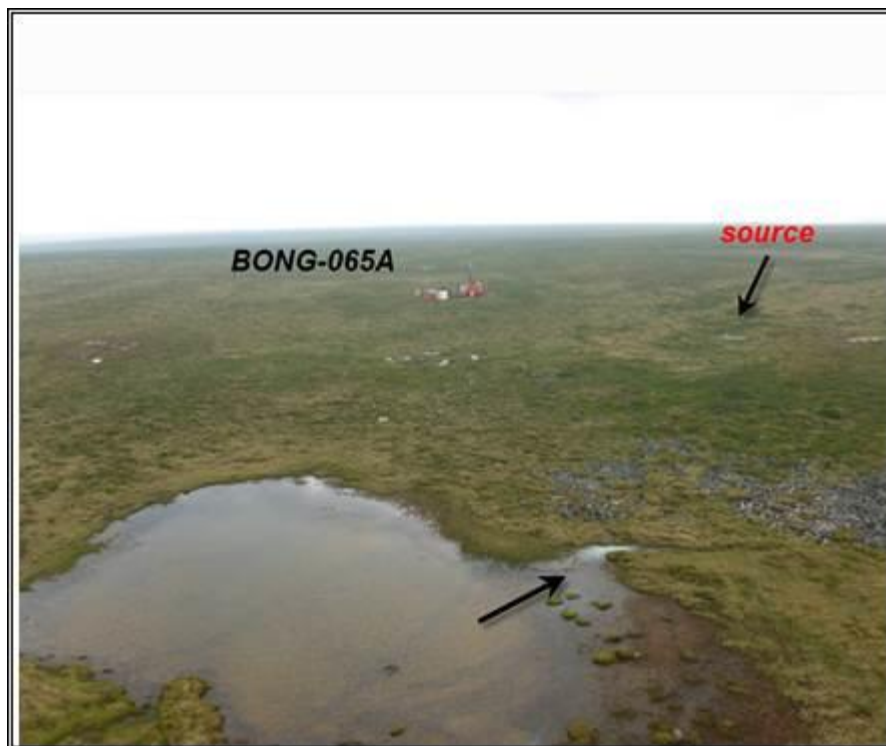
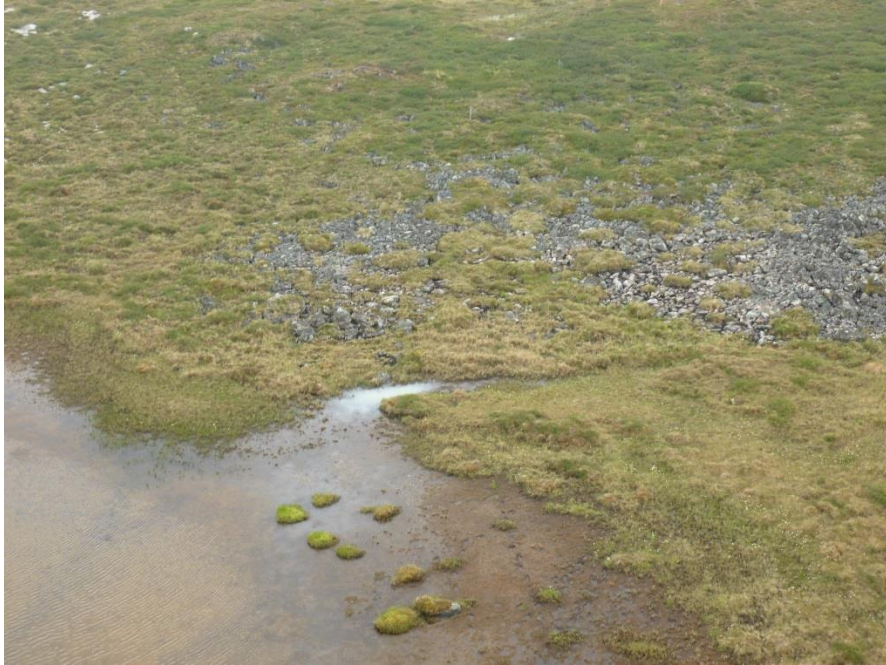
At approximately 3:15pm, as inspectors and AREVA staff flew over a drill rig at Bong-065A in the Kiggavik lease, a white discoloration was noted in the edge of a small body of water located nearby at 14W 562323E, 7143795N. Upon initial inspection, a hose discharging clean water from a nearby pump had appeared to create a flow of water that washed down a slope into the cuttings discharge site of a previous non-mineralized drill hole located about 50m from the water. The flowing water could have then come into contact with the cuttings material and carried it down into the water body. Also, the discharge material from the drill was found to be flowing back toward the drill and collecting in the drill pad area.

Steps were taken following discovery of the spill to limit the spill's extent. First, the pump responsible for pumping the clean water was stopped as this was believed to be contributing to the spill. Next, the excess clean water hose was relocated further away from the water body and on the opposite side of the drill. Finally, the drill's discharge hose was moved a considerable distance to the west to eliminate the return flow of drill discharge to the pad. The drill crews on site were subsequently instructed not to place their excess clean water hoses in places that could create a potential uncontrolled runoff into a water body and to alert AREVA staff if discharge fluids are accumulating around the drill. A sandbag berm was constructed around the cuttings discharge site the following day to prevent further drainage of cuttings material into the water. Samples were taken of the affected water and will be sent for analysis at the next opportunity.

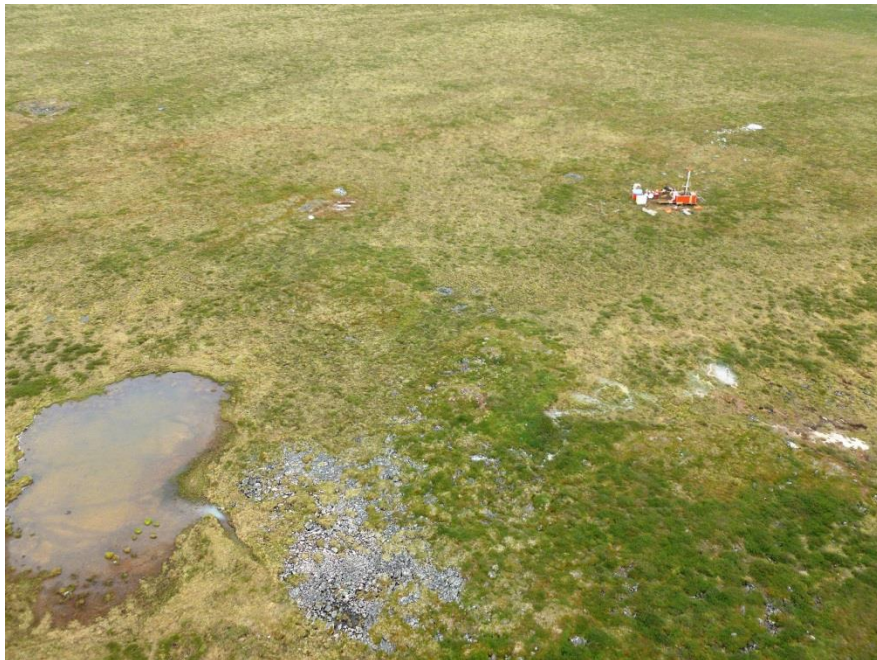
After returning to the site and examining the area further, it was determined that the excess clean water draining from the hose had not actually come in contact with the cuttings discharge site near the water. Instead, the discharge material appeared to have flown downhill from the discharge site and entered the water body independent of the excess clean water, which may have been due to recent heavy rains in the area.
