## ***Kiggavik Project Spill Report***

### ***Drill Cuttings Discharge***

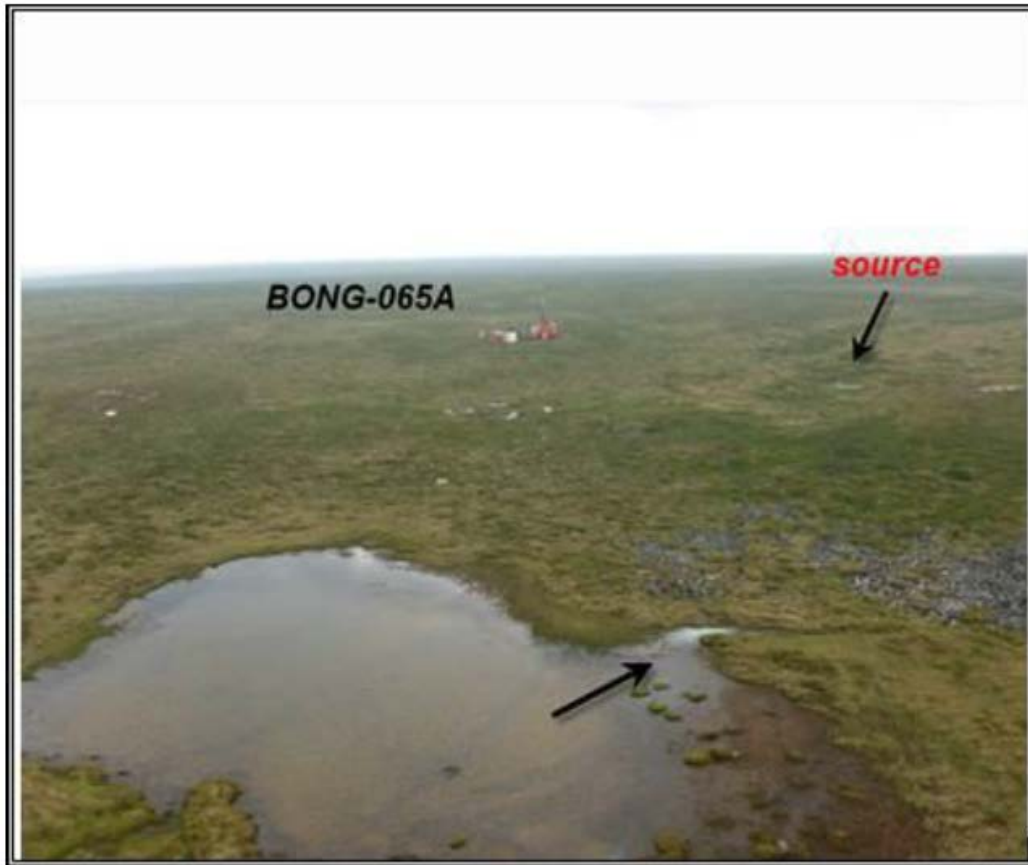
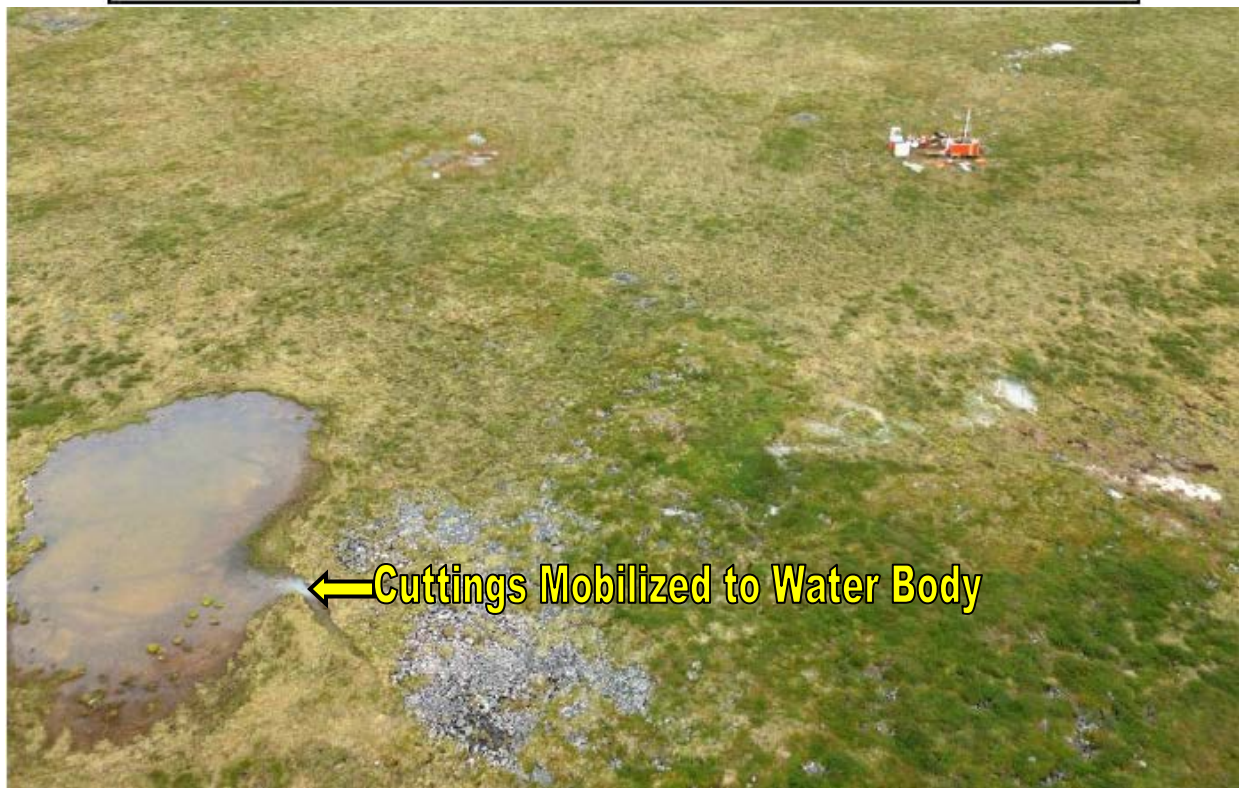
At approximately 3:15 pm, as the AANDC Water Resource Officers and AREVA staff flew over the drilling rig at Bong-065A for an inspection, a white discoloration was noted in the edge of a small water body located nearby (See Figure 2-1). Upon initial inspection, it appeared that a hose discharging clean water from a nearby pump flowed downslope into the cuttings discharge site of a previous non-mineralized drill hole located at 64°24'51" N, 97°42'31" W (14W 562225E 7143800N). Initially it appeared that the water intercepted the lightly coloured cuttings and transported the material into the water body.

Upon returning to the site for further investigation, it was determined that the excess water from the hose had not come into contact with the cuttings discharge site near the water. The discharge material appeared to have been remobilized independently of the pump water; likely by recent heavy rains, and flowed downhill into a rocky area. Here, it was allowed to penetrate below the ground surface where the cuttings then traveled to the adjacent water body and were observed collecting at the water's edge. It was difficult to measure the amount of discharged cuttings as it was suspended in the water, however the photos below depict the amount of material located at the water's edge which was approximately two feet across.

**Figure 2-1 Unauthorized Cuttings Discharge near Bong 065A – July 16, 2014**

Various corrective and preventative measures were implemented following the spill identification. To limit the spatial extent of the spill, the pump discharging clean water was stopped, and the hose was relocated to the opposing side of the drill. As the existing cuttings discharge area was migrating downhill towards the drill, the discharge hose was moved a considerable distance to the west to eliminate the return flow of drill discharge to the drill pad. The drill crews on site were subsequently instructed not to place their excess clean water hoses in places that could create a potential uncontrolled runoff into a water body and to alert AREVA staff if discharge fluids are accumulating around the drill. A sandbag berm was constructed around the cuttings discharge site the following day to ensure there was no further drainage of cuttings into the water. The site was monitored over the days following the spill and by July 18 the white discoloration of the water was no longer visible. Water samples were taken the day of the spill and again two weeks following the incident. The placement of drill discharge sites and follow-up inspection by AREVA staff and contractors was reviewed to ensure all personnel were aware of the requirements.

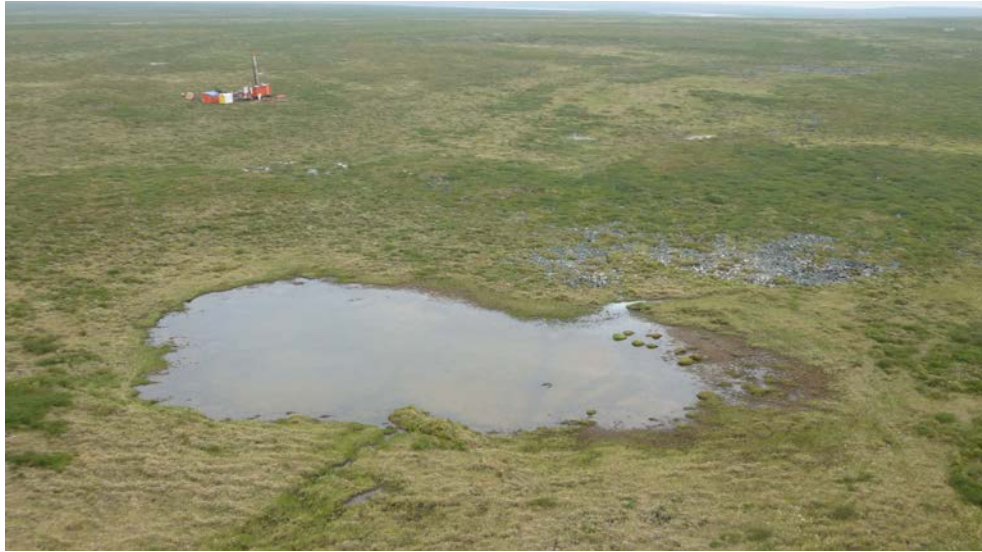
**Photograph 5-1 Unauthorized Cuttings Discharge – July 16, 2014**

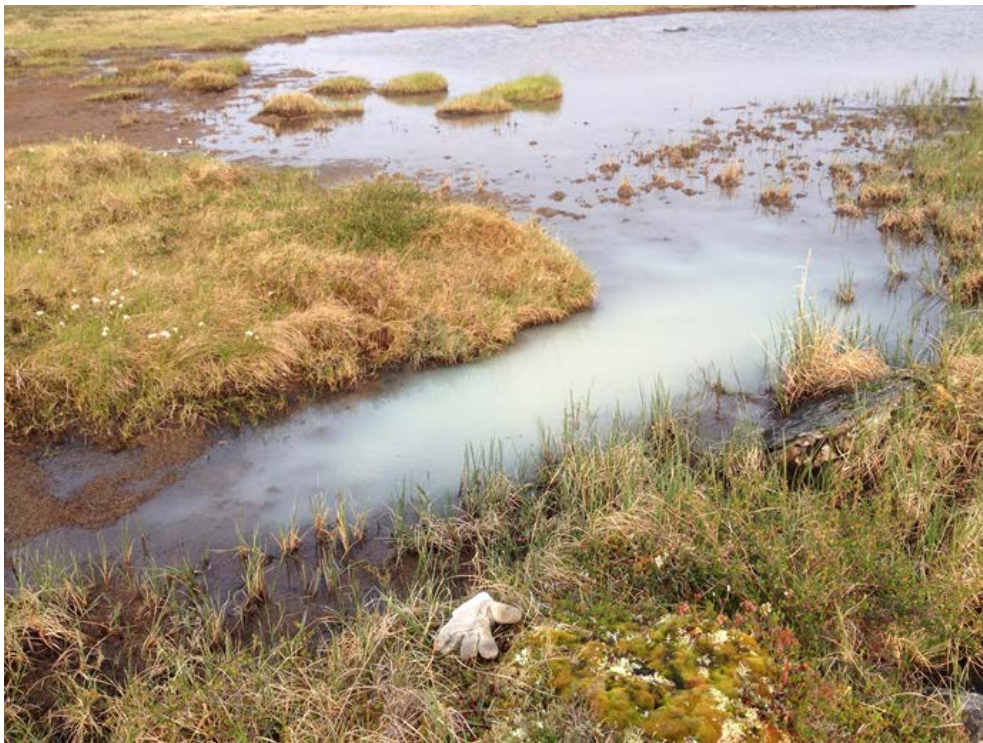
**Photograph 5-2 White Discoloration in Water – July 16, 2014**

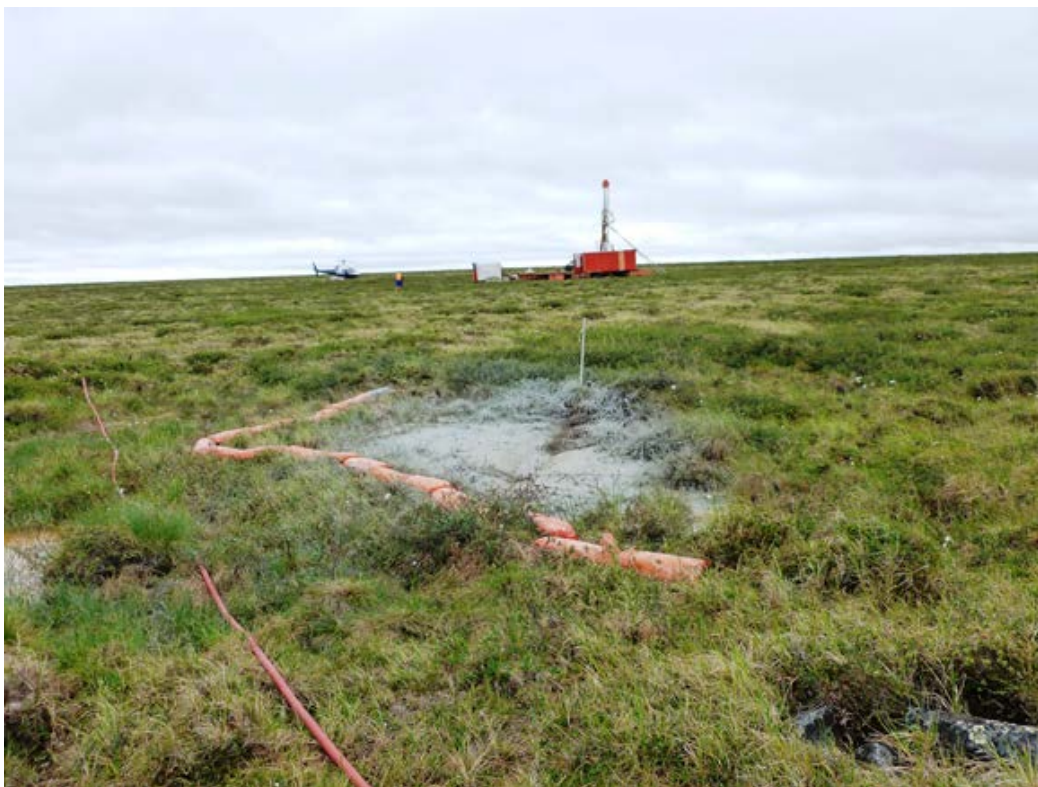
**Photograph 5-3 Bermed Cuttings – July 17, 2014**
