Kiggavik Project

7 Day Spill Report

June 18, 2015

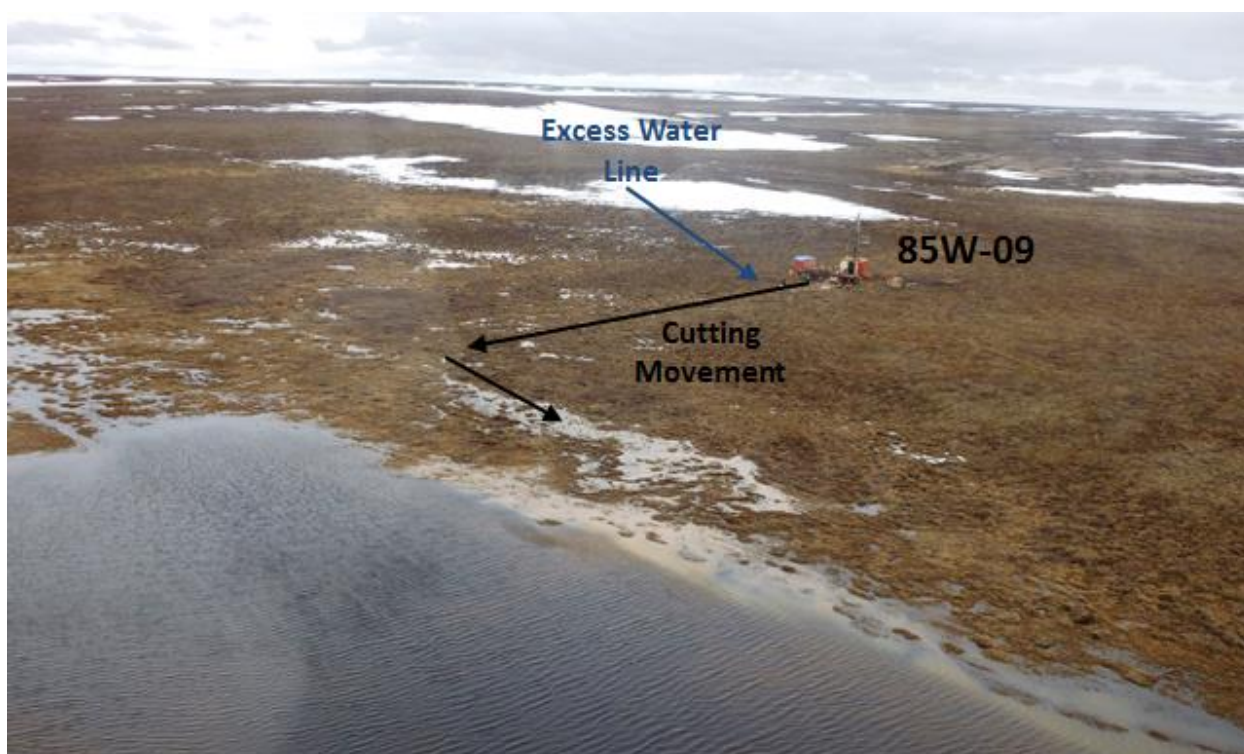
During a routine drill inspection conducted by the SHEQ Supervisor and Project Geologist, a spill was detected in a waterbody near Drill 1 at approximately 4:30 pm on June 17, 2015. Potentially contaminated drill return water and cuttings from underneath the drill were not properly contained and were washed downhill away from the drill. The excess clean water line further facilitated the downhill migration of the drill cuttings into a water body 120 m to the west. The spill site is located at 64°25'18" N, 97°48'17" W (14W 557576 7144542).

Figure 1. Discharge of Potentially Contaminated Return Water (June 17, 2015)

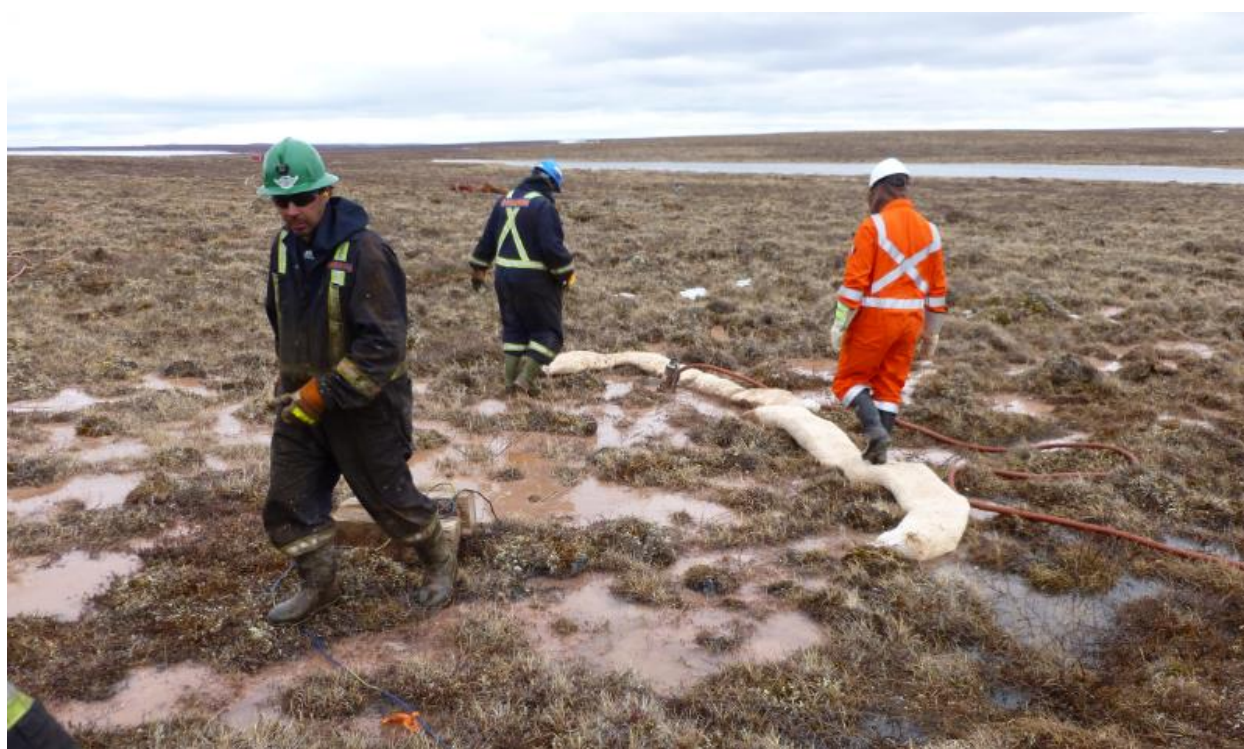
Figure 2. Installation of Filter Socks and Sump Pump on June 17, 2015

Following the identification of the spill, various corrective and preventative measures were implemented at the spill site. The excess clean water discharge line was immediately extended away from the site in order to reduce the amount of water flowing through the affected area. Socks filled with wood chips were placed at a bottleneck of the spill to reduce the transport of sediments towards the small water body. A sump pump was placed below the drill to intercept all new water and drill cuttings. Another sump pump was used to clean up affected areas around the drill and was then placed in the containment area to remove excess water and drill cuttings. Both sump pumps were set up to discharge water into the contained discharge area 200 m East of the drill and 320 m away from the small lake.

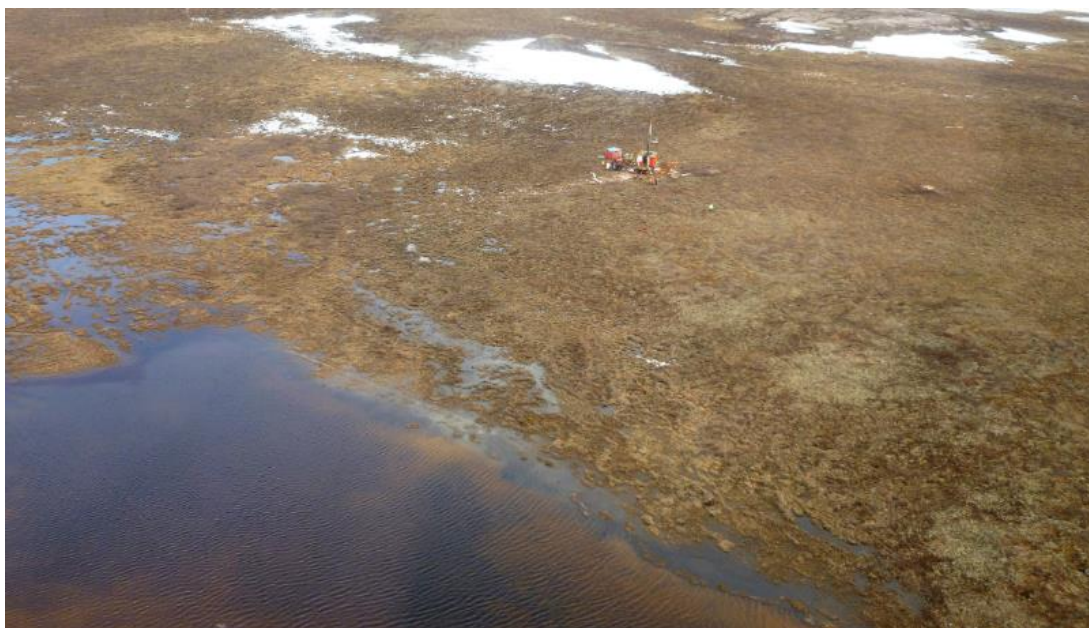
Aerial surveys of the area were conducted on June 18 and 19 which illustrate substantial improvement to the affected water body.

Figure 3. Aerial Survey of Spill Area on June 18, 2015

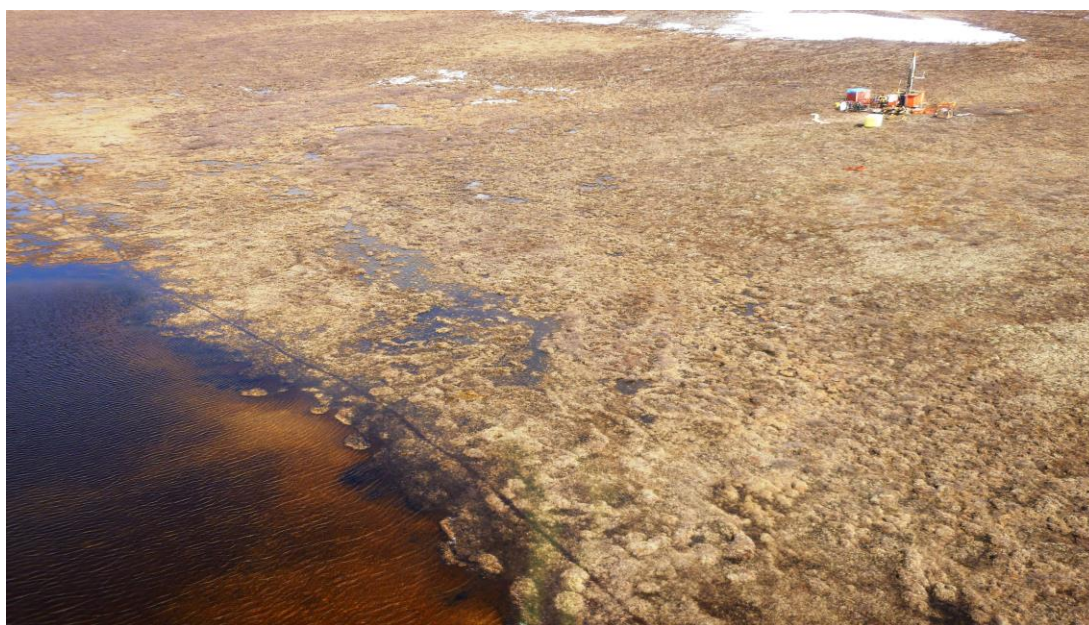
Figure 4. Aerial Survey of Spill Area on June 19, 2015

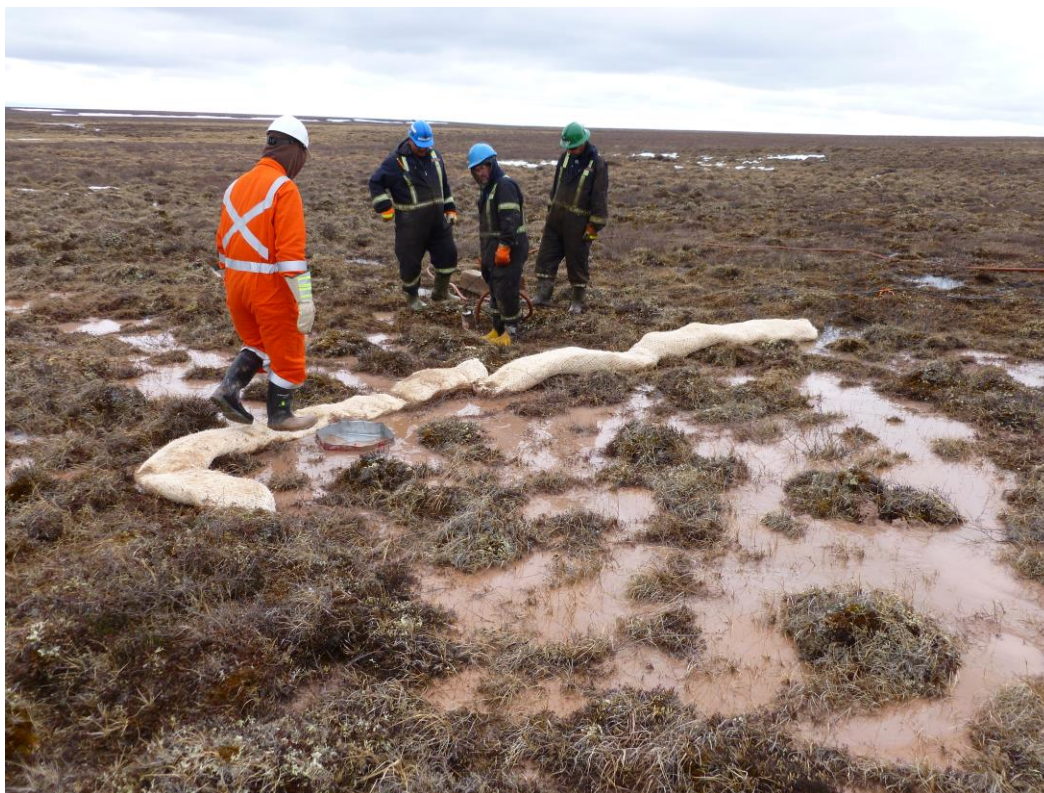
Photograph 4. Containing the Spill on June 17, 2015
