# WATER LICENCE INSPECTION FORM

<b>Licensee</b>		<b>Licensee Representative</b>	
DeBeers Canada Exploration Inc.		-	
<b>Licence No. / Expiry</b>		<b>Representative's Title</b>	
2BE-KIK0608		-	
<b>Land / Other Authorizations</b>		<b>Land / Other Authorizations</b>	
-		-	
<b>Date of Inspection</b>		<b>Inspector</b>	
16/07/2015		Eva Paul	
<b>Activities Inspected</b>			
<input checked="" type="checkbox"/> Camp	<input checked="" type="checkbox"/> Drilling	<input type="checkbox"/> Mining	<input type="checkbox"/> Construction
<input type="checkbox"/> Roads/Hauling	<input type="checkbox"/> Other:	<input type="checkbox"/> Other:	<input checked="" type="checkbox"/> Reclamation
			<input checked="" type="checkbox"/> Fuel Storage

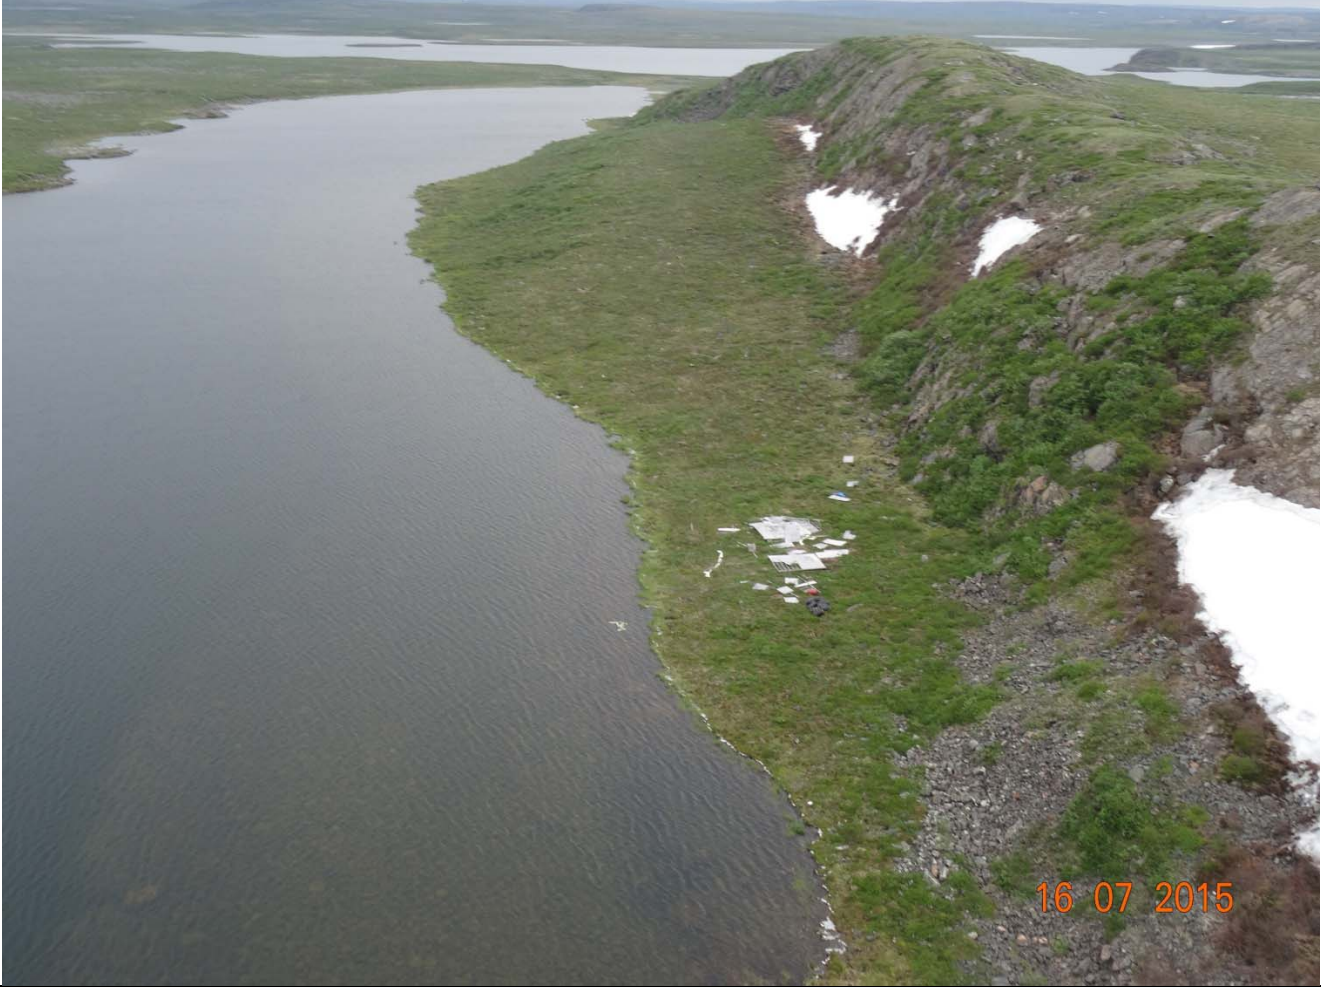
Date	Camera	Inspector	Authorization
16/07/2015	SONY DSC-HX50V	Eva Paul	2BE-KIK0608
Photo Log #1		Location (NAD 83 DD MM SS.SS)	
Photo DSC03613		N67 00 47.3	W113 09 07.7 (approximate, taken while flying)

**Description:** Remnants of 2004 camp and fuel barrels on Knife Lake.

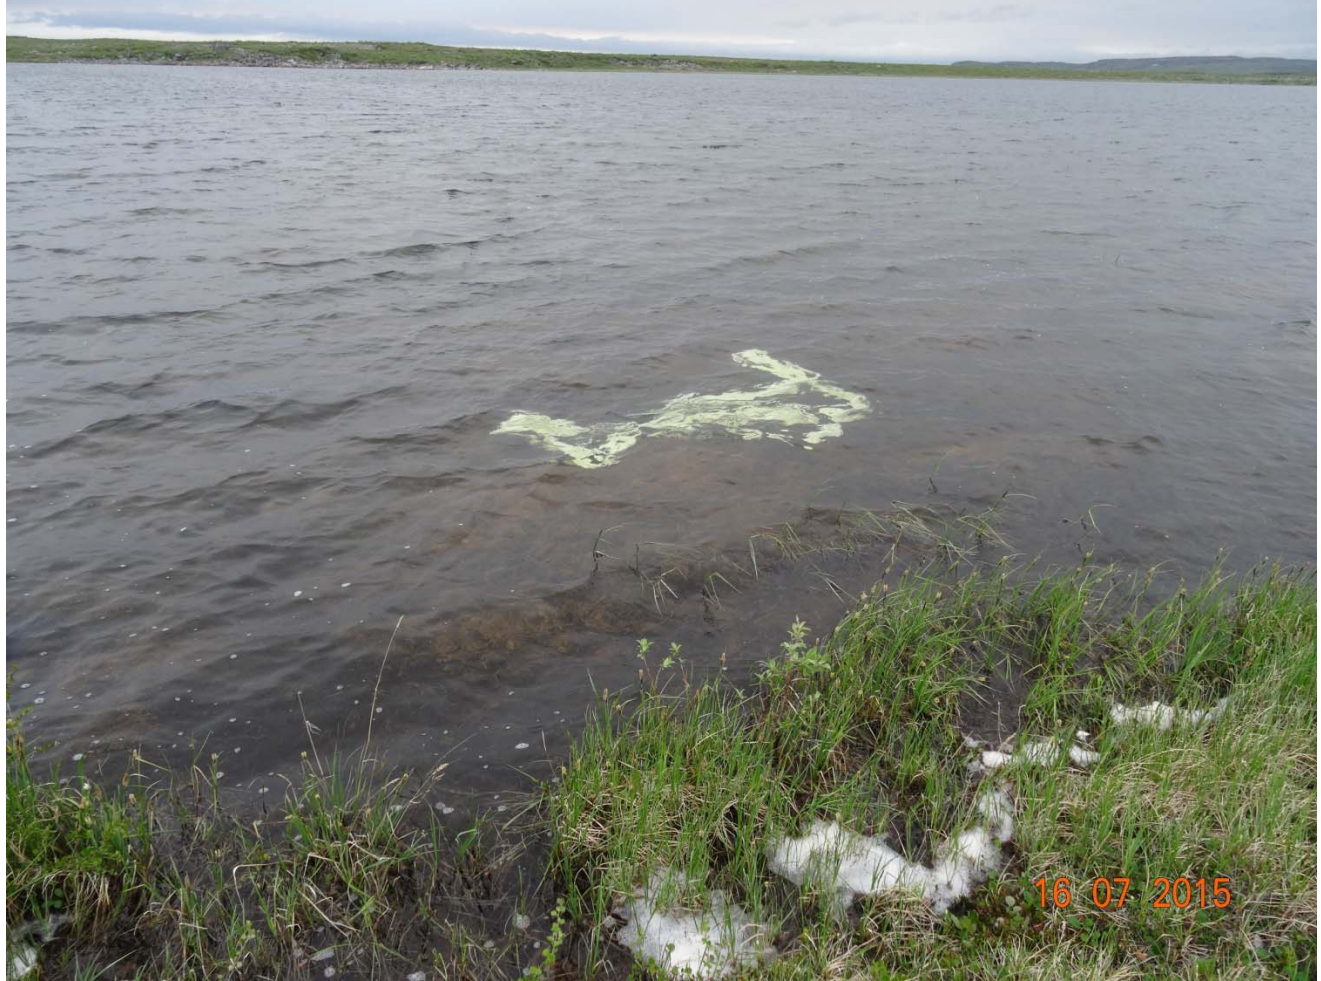
Photo Log #2	Location (NAD 83 DD MM SS.SS)
Photo DSC03622	Not recorded

**Description:** Plastic has blown into the lake.

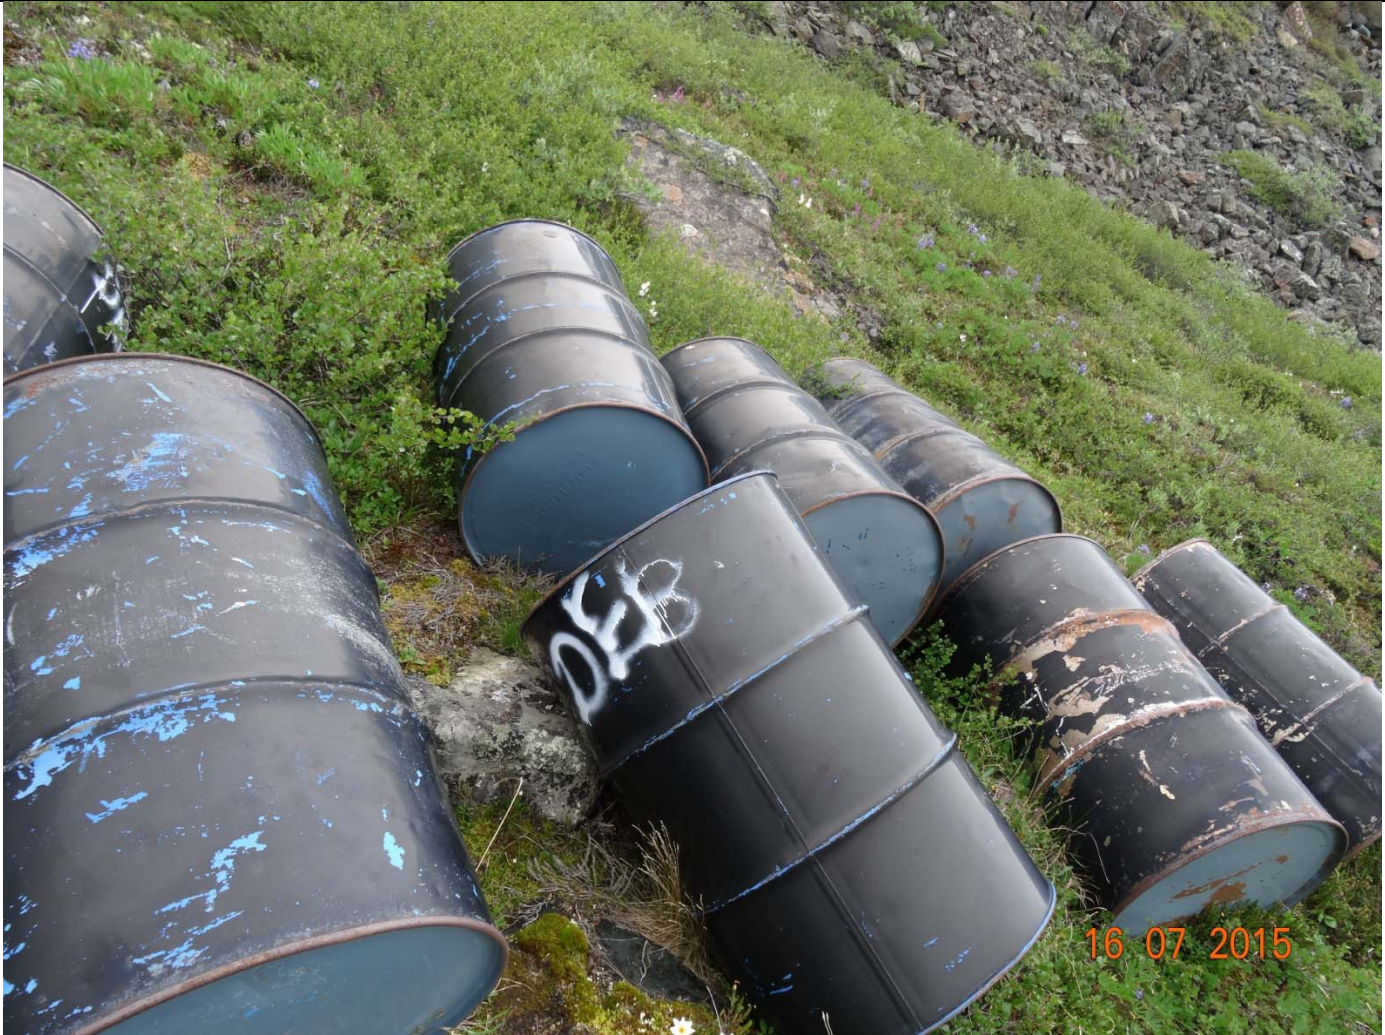
Photo Log #3

Description: 8 full drums of P-50.

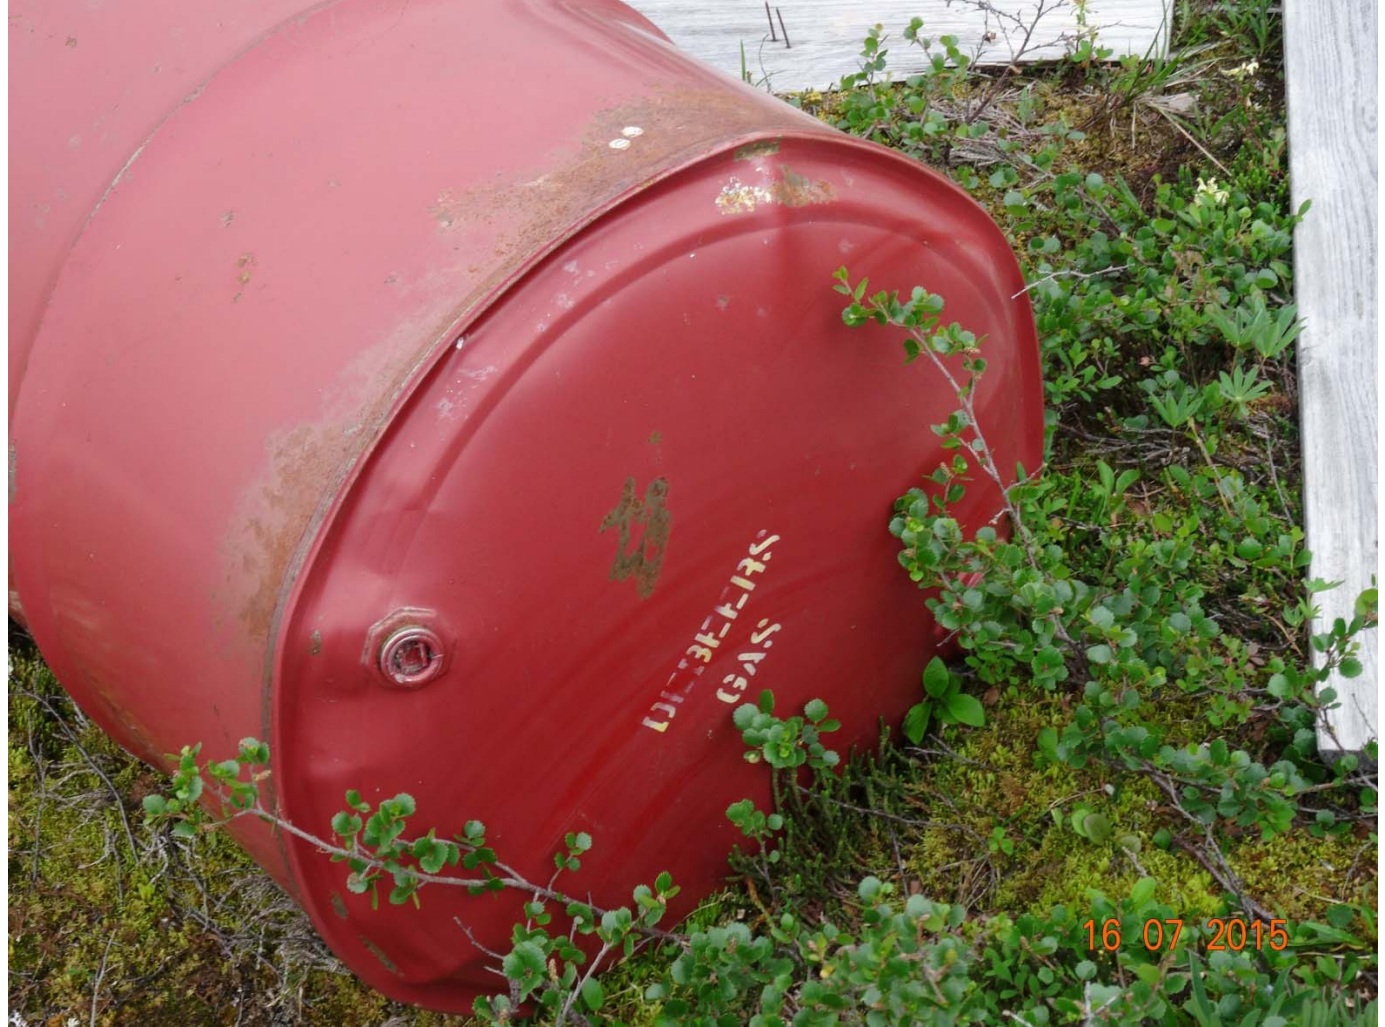
Photo Log #4

Description: 1 barrel of gasoline.

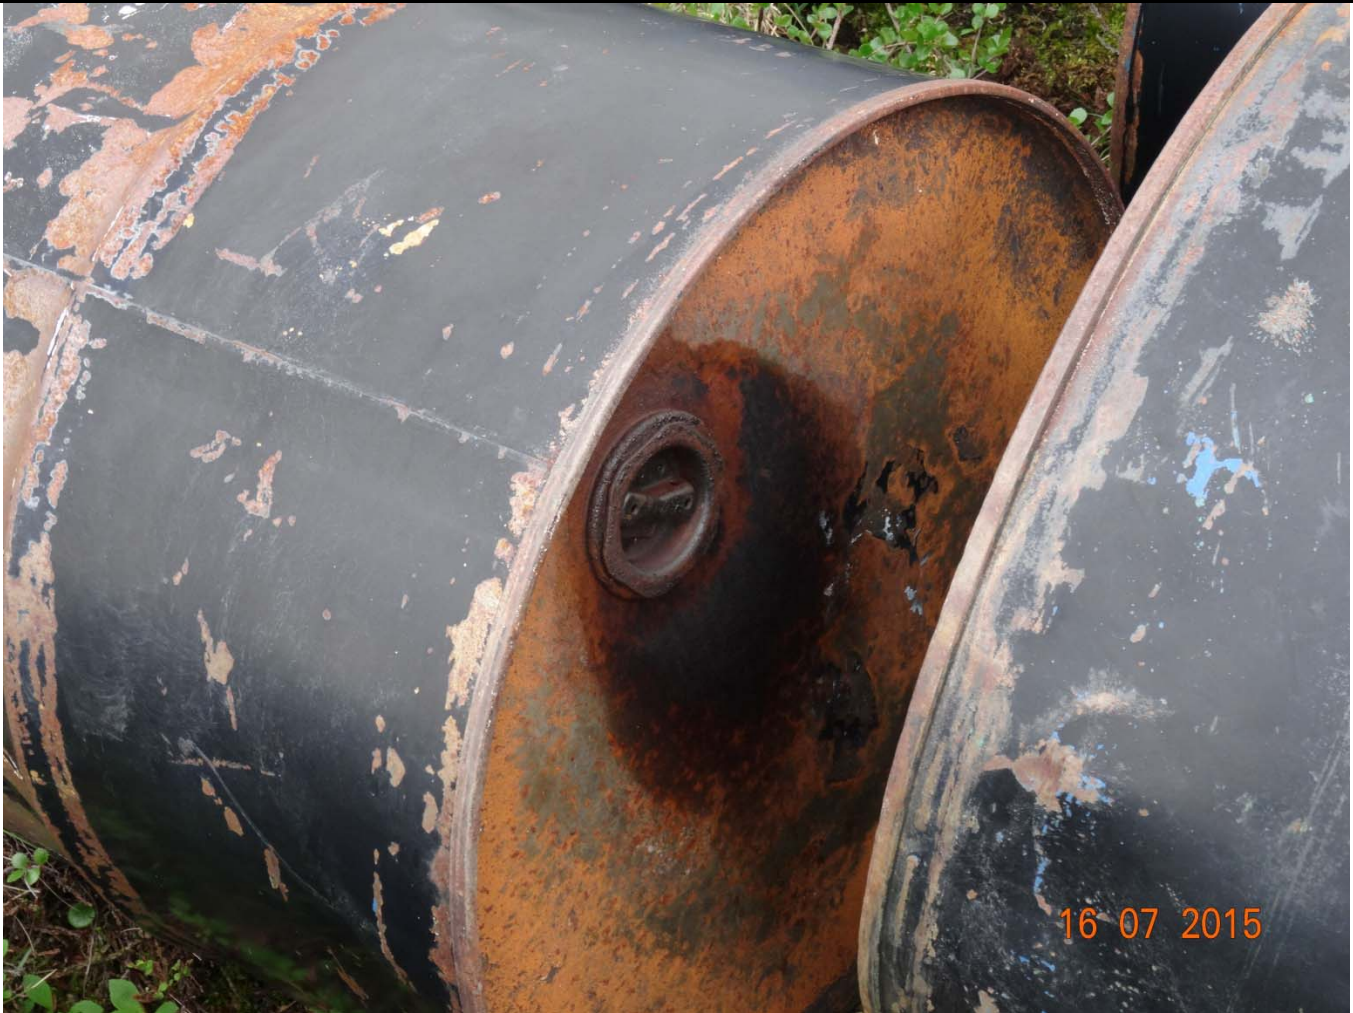
Photo Log #5

Description: One barrel of P-50 is beginning to seep.

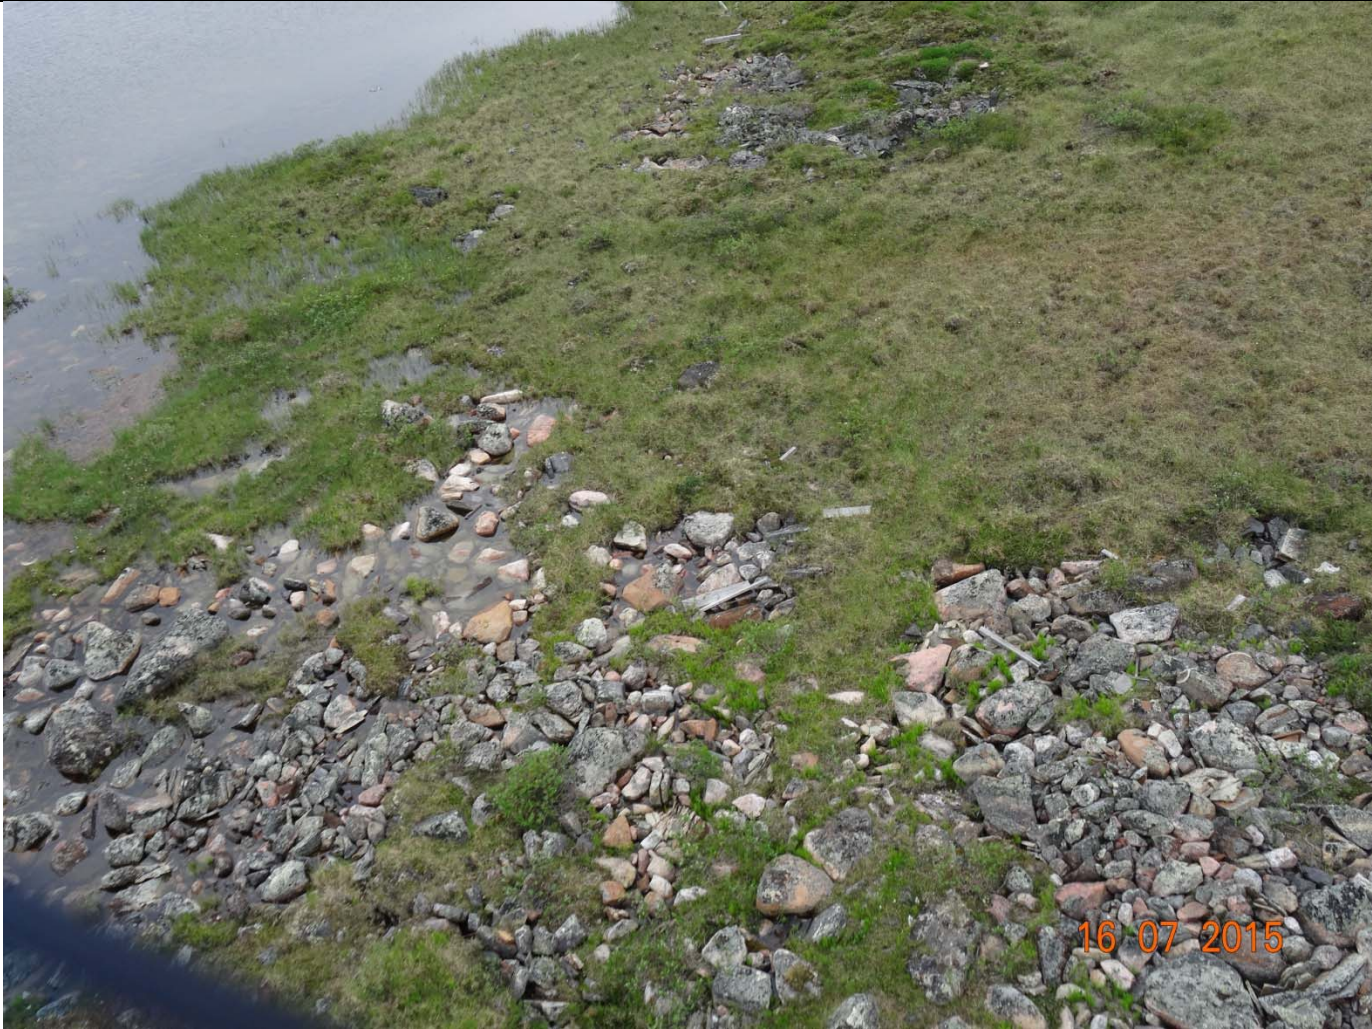
Photo Log #7

<b>SECTION 1</b>	<input checked="" type="checkbox"/> <b>Comments (s.1)</b>	<input checked="" type="checkbox"/> <b>Non-Compliance with Act or Licence (s.2)</b>	<input checked="" type="checkbox"/> <b>Action Required (s.3)</b>
<p>This project licence was first issued in 1997, and the project was licensed through until 2008. The licence expired in 2008 and was not renewed. An inspection was conducted on July 16, 2015 to determine whether abandonment and reclamation requirements have been met.</p> <p>Three sites associated with this project were inspected:</p> <ul style="list-style-type: none"> <li>a) Camp: N67 00 48.2 W113 09 29.8 (coordinates from 2004 annual report)</li> <li>b) Drill holes Kik-04-010c and Kik-04-011c: N67 00 46.6 W113 09 07.1 (coordinates from 2004 annual report)</li> <li>c) Reported fuel cache: N67 00 46.0 W113 09 00.2 (coordinates from N97C753 Final Plan)</li> </ul> <p>Findings are as follows:</p> <ul style="list-style-type: none"> <li>1) Camp was not removed from location (a). Wooden debris remains, and some garbage has blown into the lake over time. 8 full drums of P50 were found, one of which is beginning to leak, and one drum of gasoline was also present. The drums are marked as Debeers. The barrels are within 30m of the water, and with their age pose a risk of release. [Photos 1-5]</li> <li>2) No drill collars or casings were noted in the area where drilling occurred, however, timbers were strewn widely around. [Photos 6-8]</li> </ul>

Description: Debris left in drilling area.

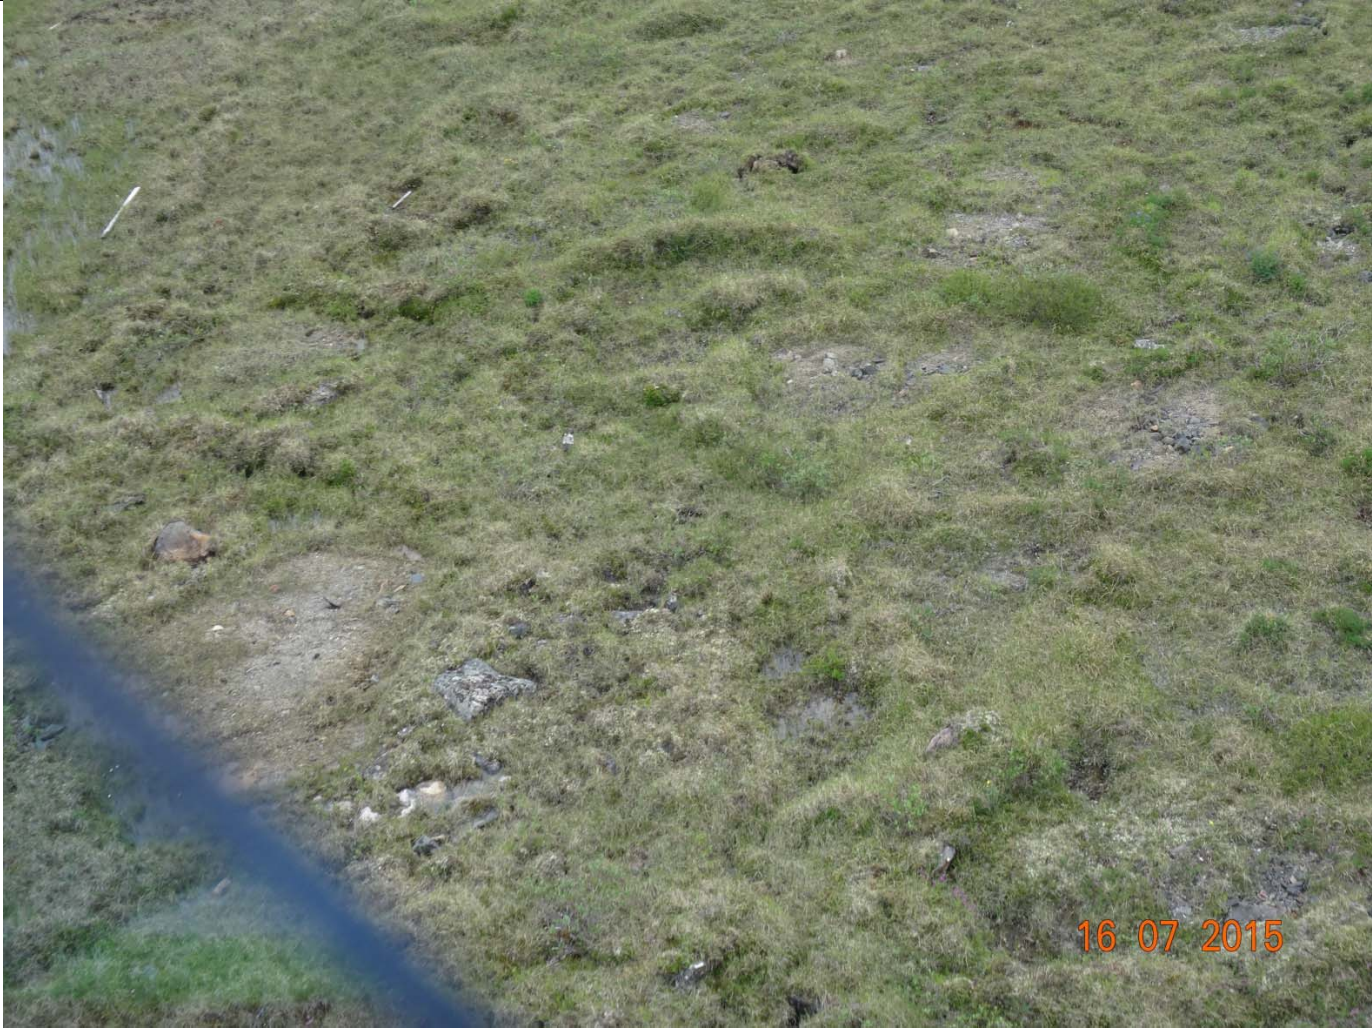
Photo Log #8

Description: Debris left in drilling area.
