**Water Licence: 2BE-KIR0812 Triex Minerals Corp. (subsidiary of Canterra Minerals); Land Use Permit: 2005C0023**

**Inspection photographs –July 28, 2010 for Kirwan Lake camp at coordinates  
N67° 17' 53.1" W116° 52' 55.7" (NAD 83)  
(taken by Water Resource Officer M. Joy)**

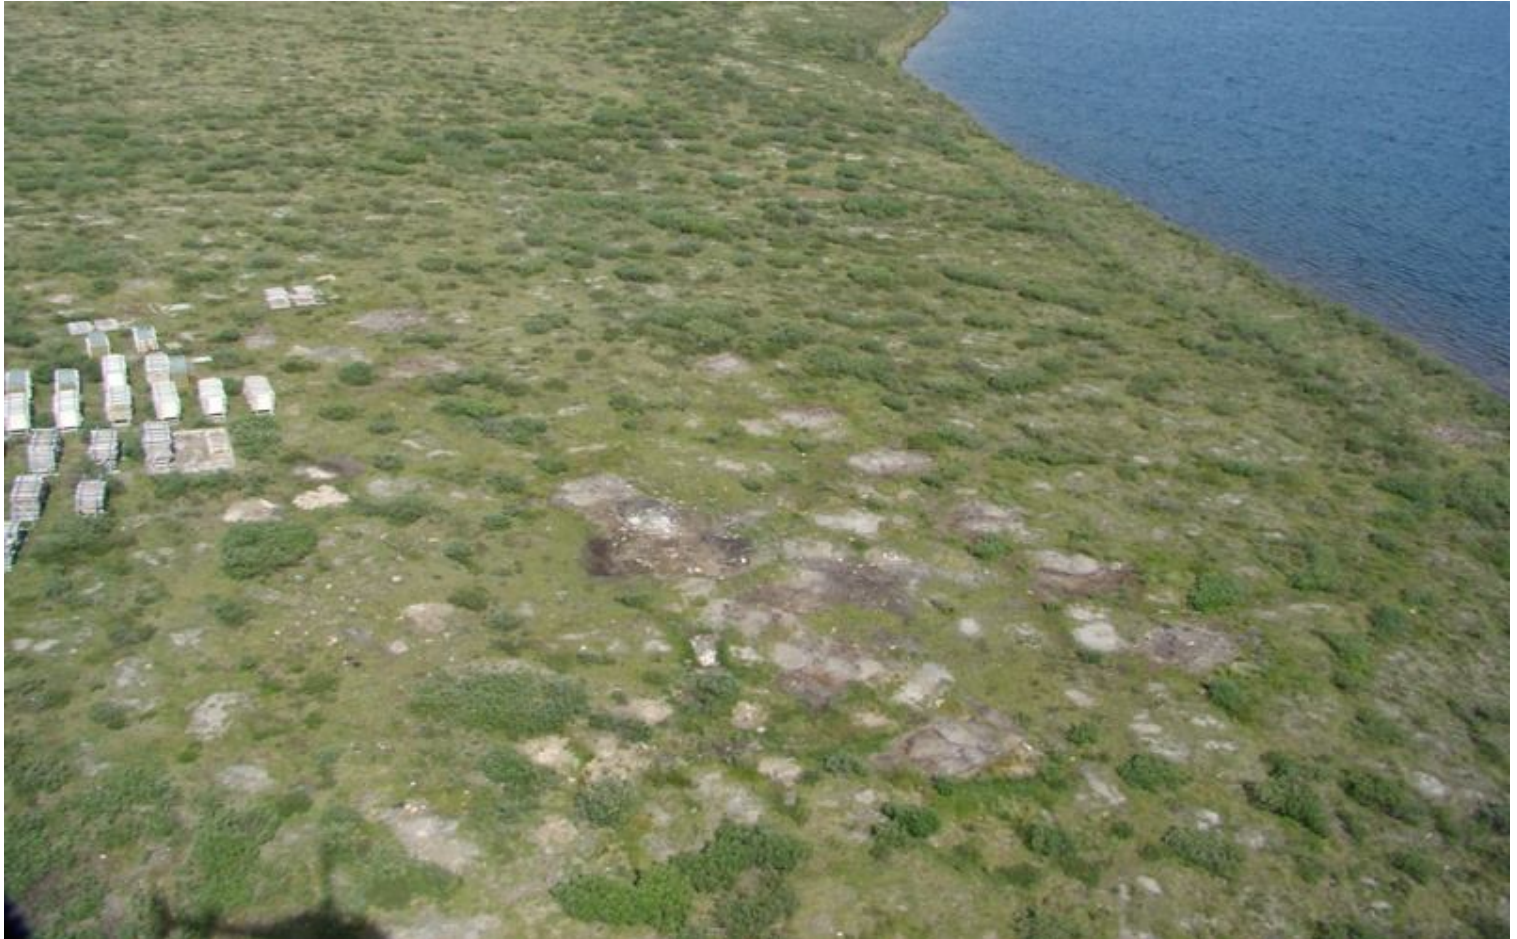
**Photograph 1: Aerial view of dismantled Kirwan Lake camp site**

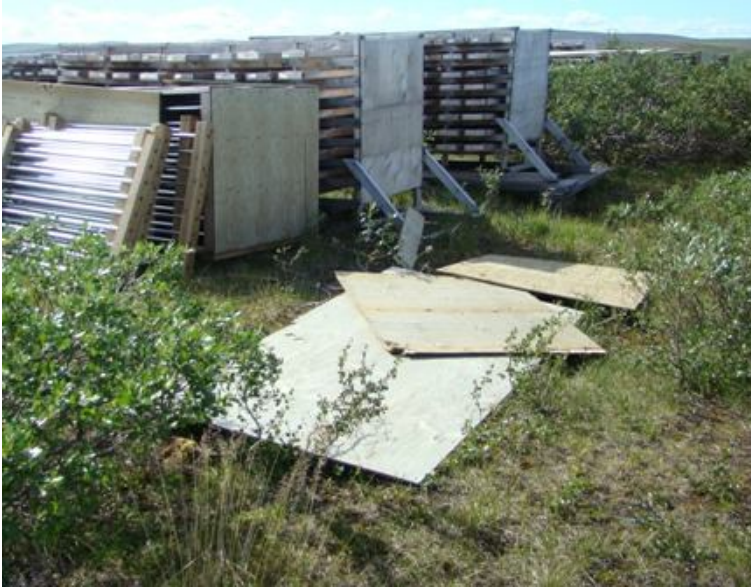
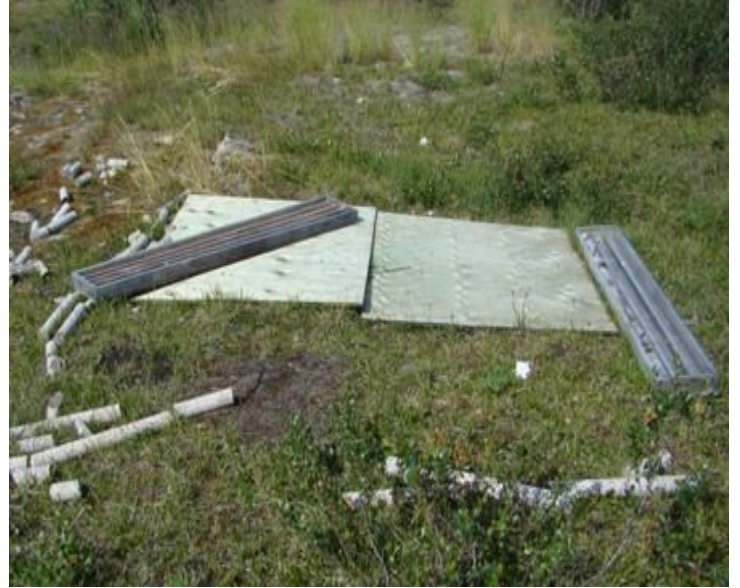
**Photographs 2 & 3: Panels of plywood left unsecured on site**

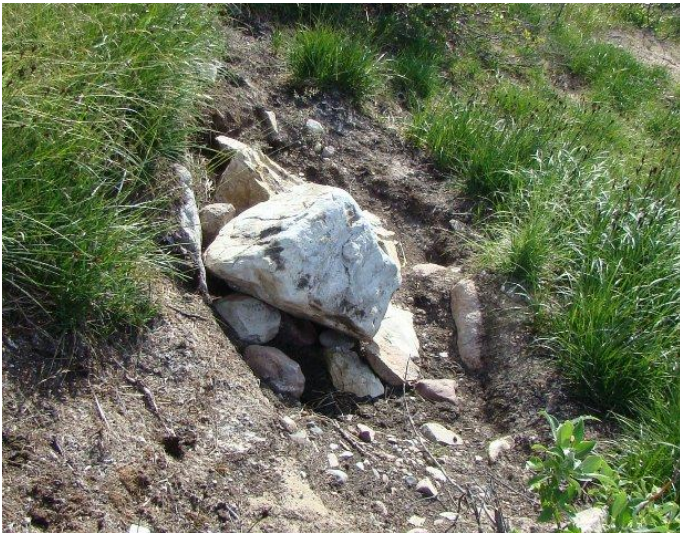
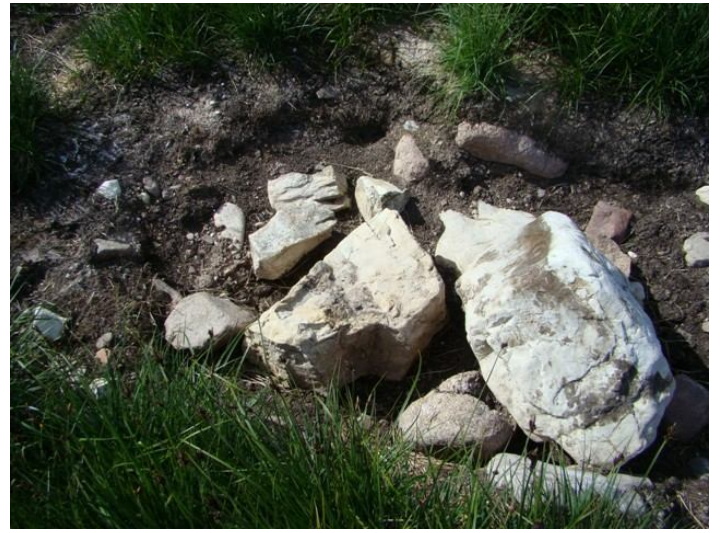
**Photographs 4 & 5: Former sump locations were backfilled with large rocks but not restored adequately. Backfill materials are too large for proper contouring and compaction to prevent permafrost degradation.**

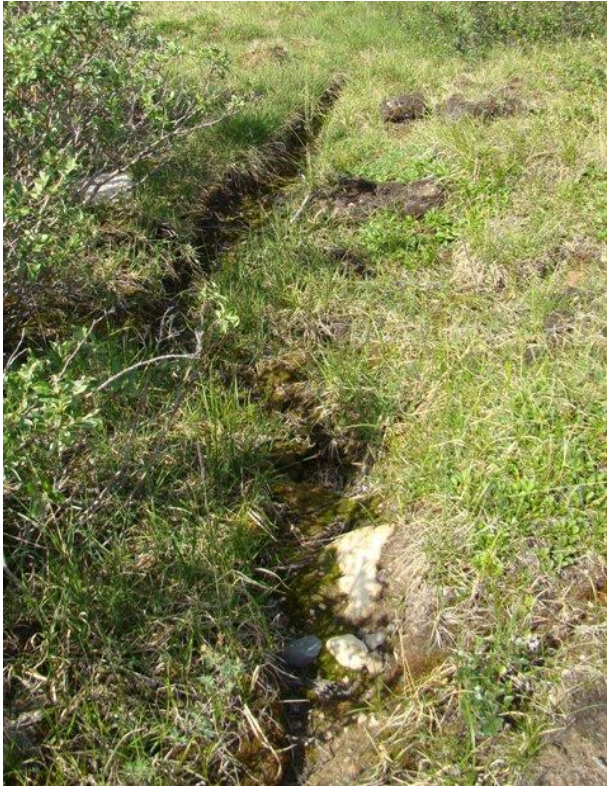
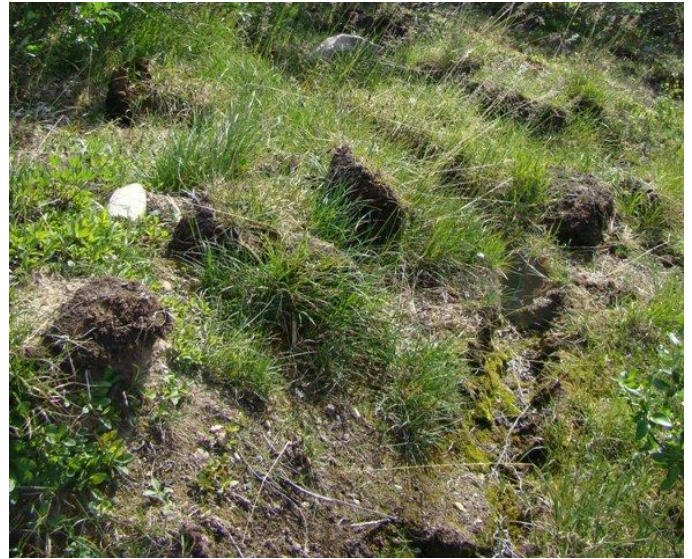
**Photographs 6 & 7: Trench that was created to assist with sump drainage was not backfilled. Trench is fairly extensive with several areas that have been widened out.**

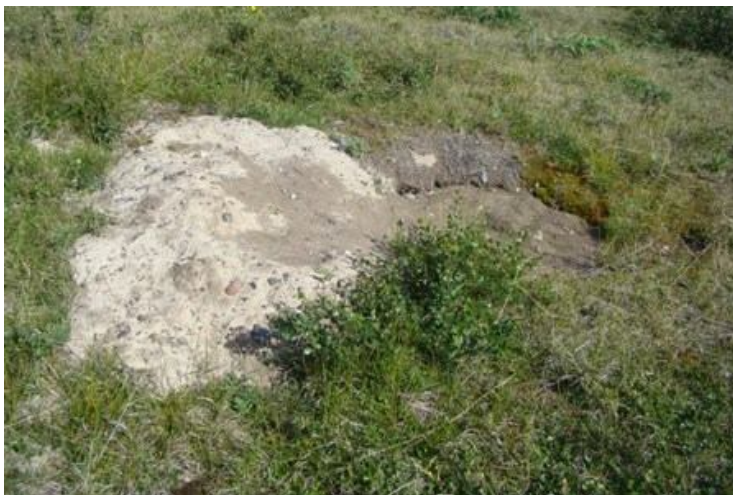
**Photograph 8: Former latrine site was not recontoured**

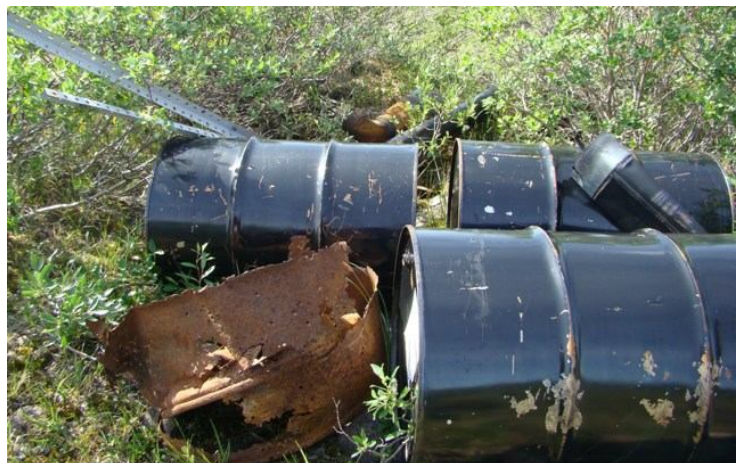
**Photograph 9: Pile of debris left near former float dock site**

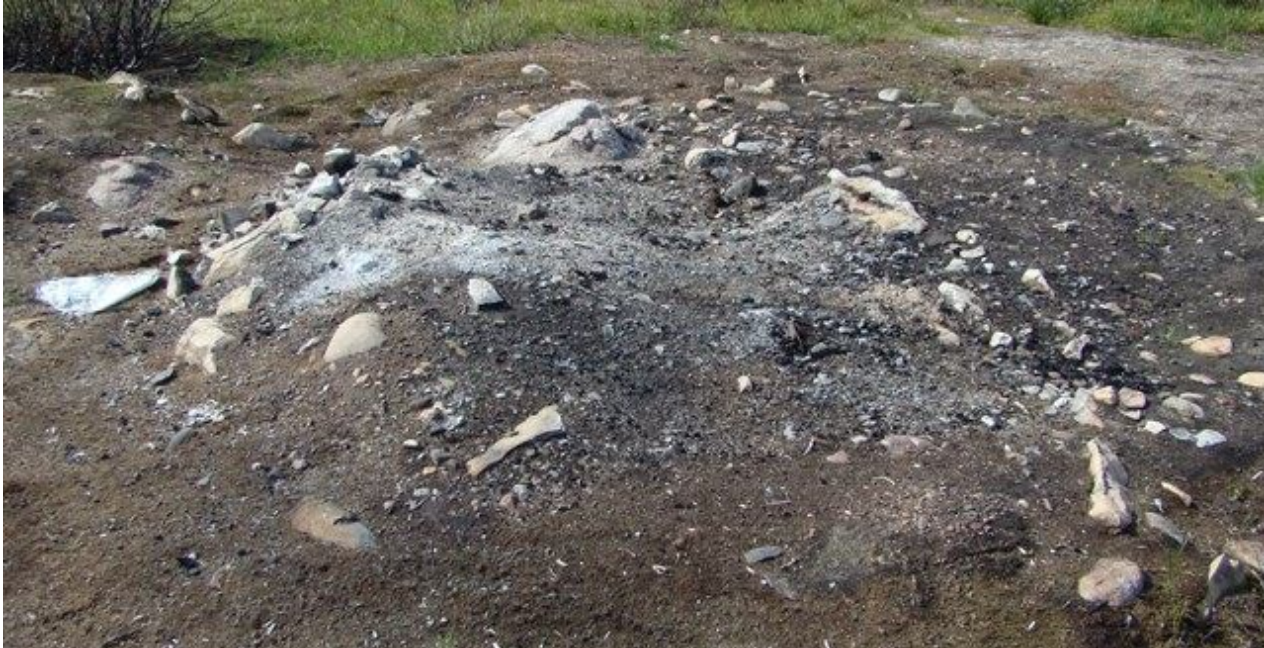
**Photograph 10: Site used for open burning –ash, metal and glass debris left behind**

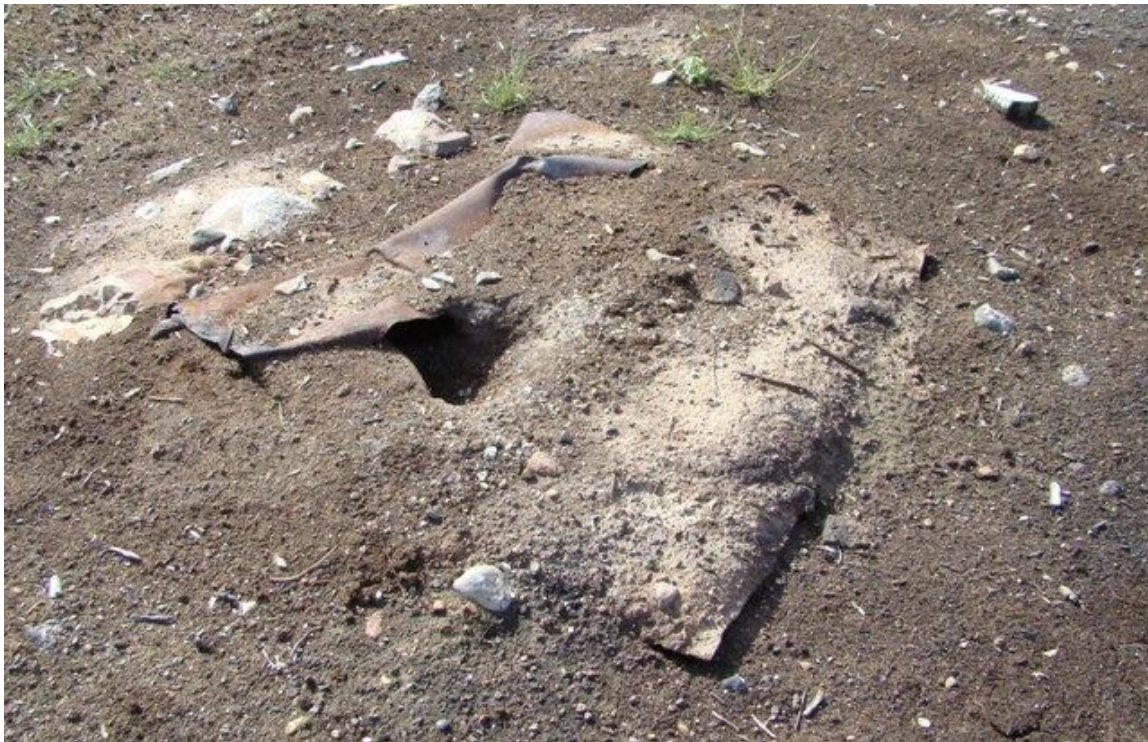
**Photograph 11: Site used for open burning –metal and debris left behind**
