Kiyuk Lake Field Visit and Inspection - August 2015

Northern Empire conducted a field visit to Kiyuk Lake in late August, after your site stop-over and noting some damage there in July. The goal of our visit was to respond to your concerns as soon as possible and before winter. To this end, a two person crew was dispatched to Nunavut to clean-up/winterize the Kiyuk camp, inspect fuel storage and remediate two minor spills noted during your visit. However during inspections, further fuel releases were discovered. These were addressed, reported and documented, as detailed below.

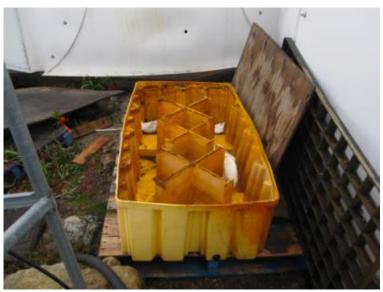
Figure 18: Emptying of secondary containment. Figure 19: Secondary containment after drainage.

- All drums used for heating (hot tanks) were removed from stands and pumped into bulk storage tanks.
- Secondary containment berms around fuel heater drums (hot tanks) were inspected for fuel sheen and/or fuel smell. If no sheen or smell found the water was drained and the drum removed. In two instances minor amounts of fuel sheen was found in the contained fluid. This water/fuel mix was pumped out of containment into a drum, which was sealed and stored for future demobilization.

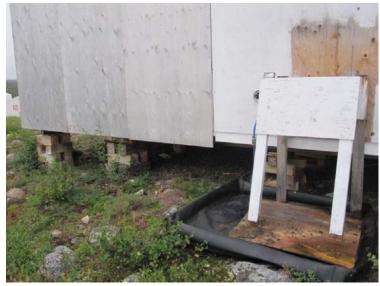
Figure 21: Hot tank area after tank removal and cleanup.

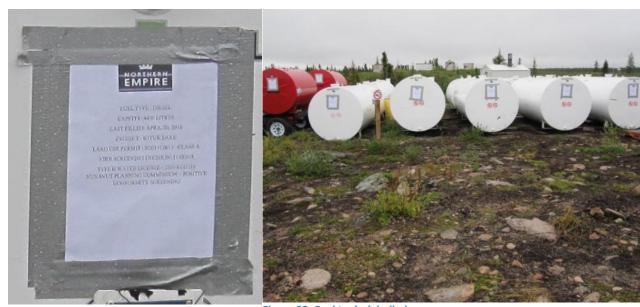
Figure 22: Fuel tank label.

- All bulk fuel storage tanks were inspected and labelled. All of the bulk tanks were in good condition except for tank #8 where a drip leak was immediately noticed at the bottom valve cap.
