**WATER LICENCE INSPECTION FORM**☒ Original
☐ Follow-Up Report

Licensee	Licensee Representative
Montego Resources Inc.	Unknown
Permit No. / Expiry	Purpose
2BE-KIY1722, July 21 st , 2022	Exploration
Other Authorizations/ Expiry	Project Name
N2019C0007, March 1 st , 2024	Kiyuk Lake Project
Date of Inspection	Inspector
September 17 th , 2021	RMO Wilson
Activities Inspected	
<input checked="" type="checkbox"/> Camp	<input type="checkbox"/> Drilling
<input type="checkbox"/> Roads/Hauling	<input type="checkbox"/> Mining
<input type="checkbox"/> Other:	<input type="checkbox"/> Construction
	<input type="checkbox"/> Reclamation
	<input type="checkbox"/> Fuel Storage
	<input type="checkbox"/> Other:

On September 17th, 2021 an inspection of Montego Resources Inc., Kiyuk Lake Project was completed by Crown-Indigenous Relations and Northern Affairs Canada (CIRNAC), Resource Management Officer, Christine Wilson (Inspector). The inspection was conducted to ensure compliance with applicable terms and conditions of water licence no. 2BE-KIY1722. This inspection was completed as a follow up to land use permit report no. [2020-KIV18-CW]. A copy of this report is attached in appendix 2.

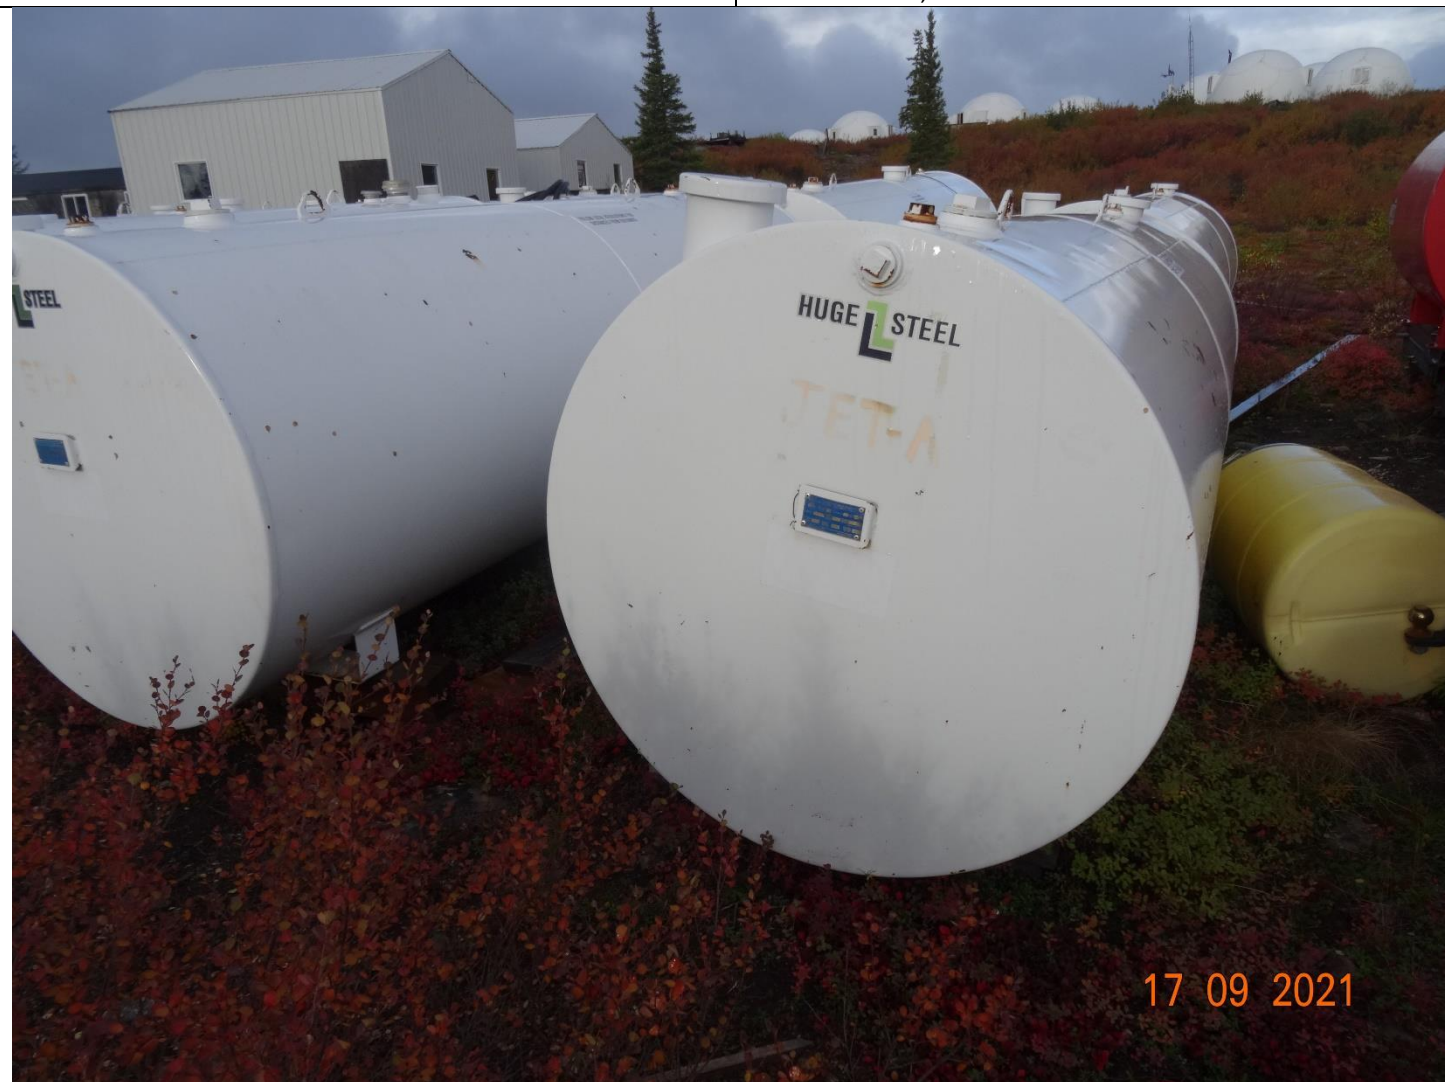
Date:	Authorization Number:	Camera/Model:	Inspector
September 17 th , 2021	2BE-KIY1722	Sony DSC-HX50V Cyber shot	RMO Wilson
Photo No.		Lat/Long (DD.MM.SS.SS, NAD83)	
Photo 1		N60° 27' 48.13", W100° 23' 1.00"

Full JET A fuel tank #1.

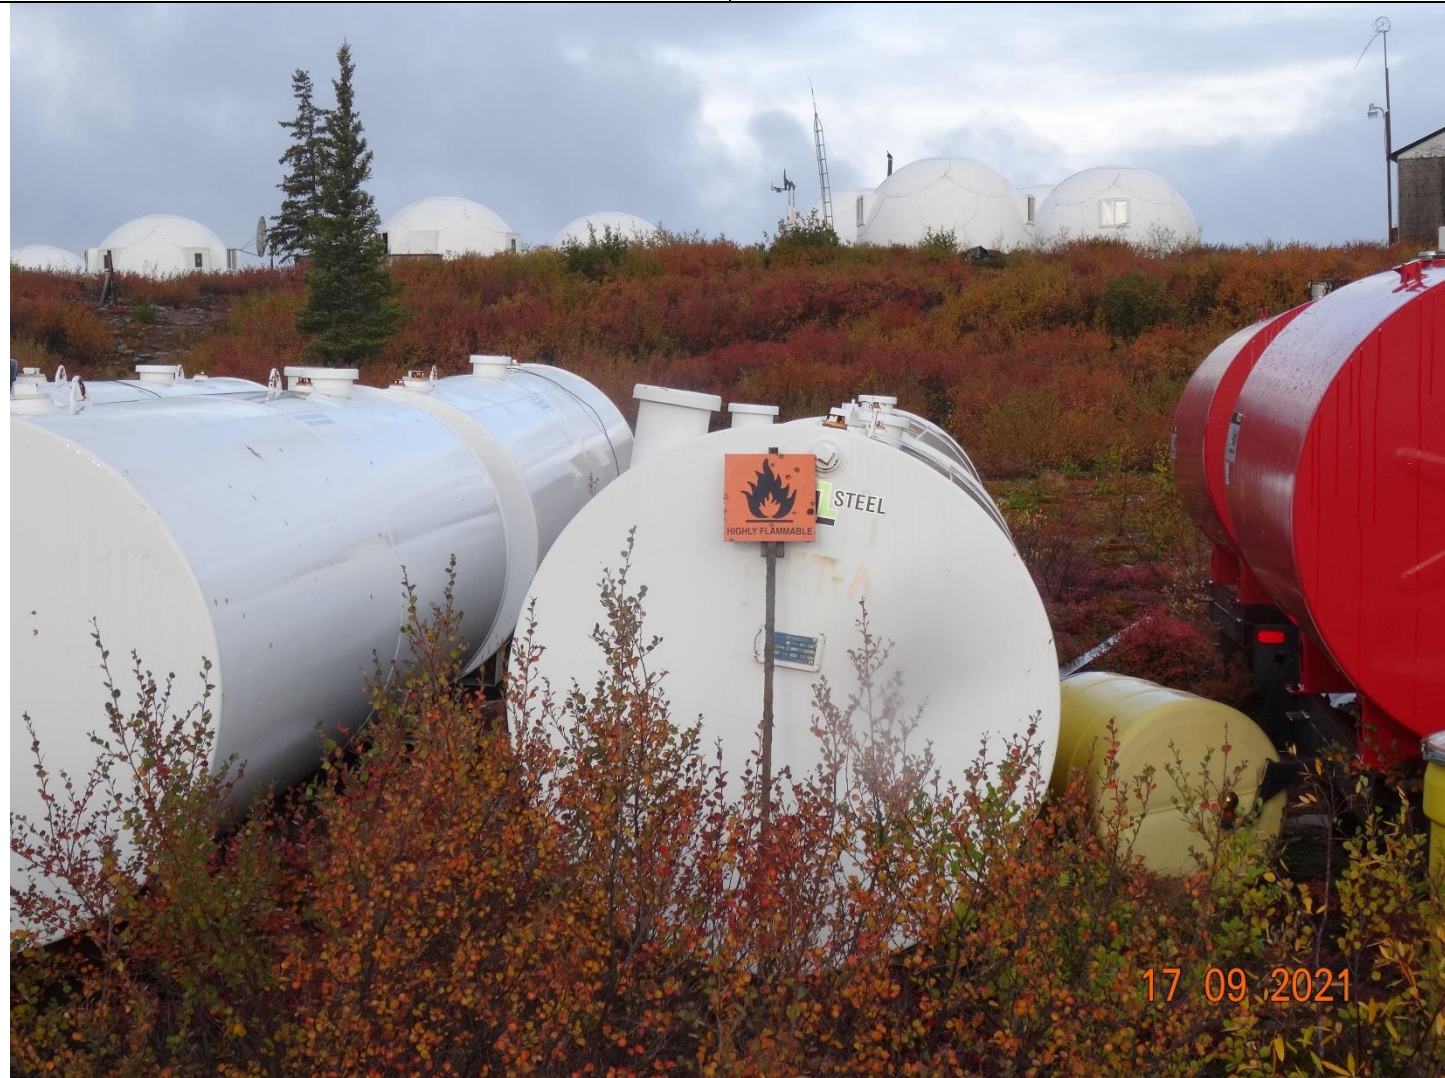
Photo 2

Tank # 1, sign used as an approximate gauge of level.

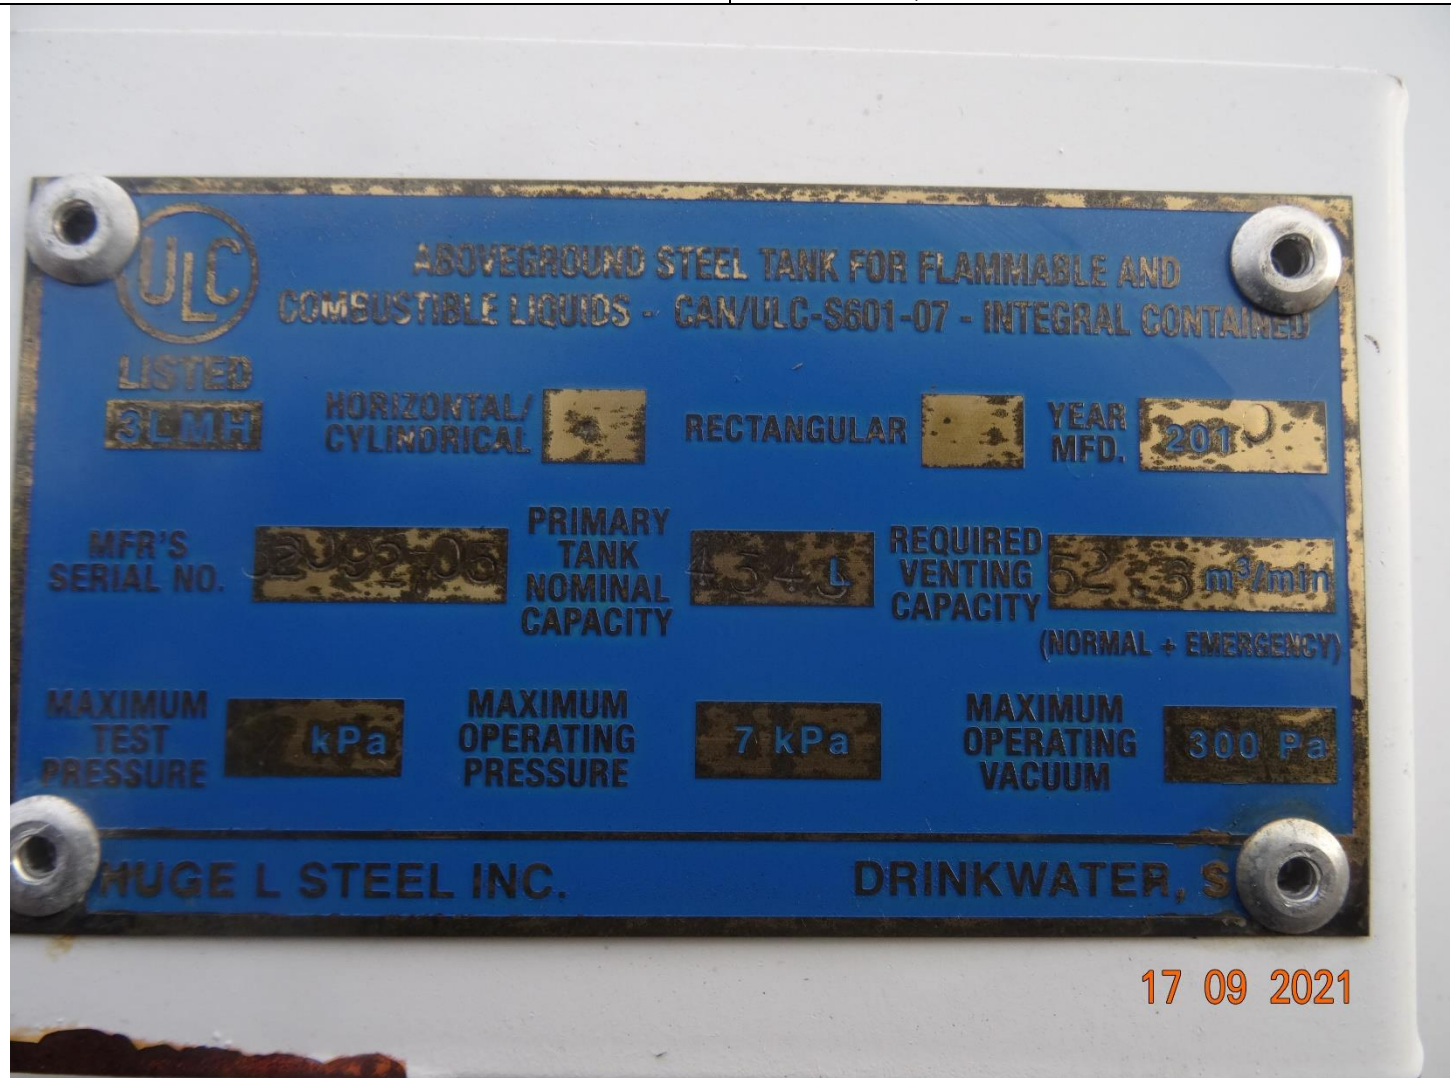
Photo 3

Tank # 1 placard, 4545L fuel storage tank.

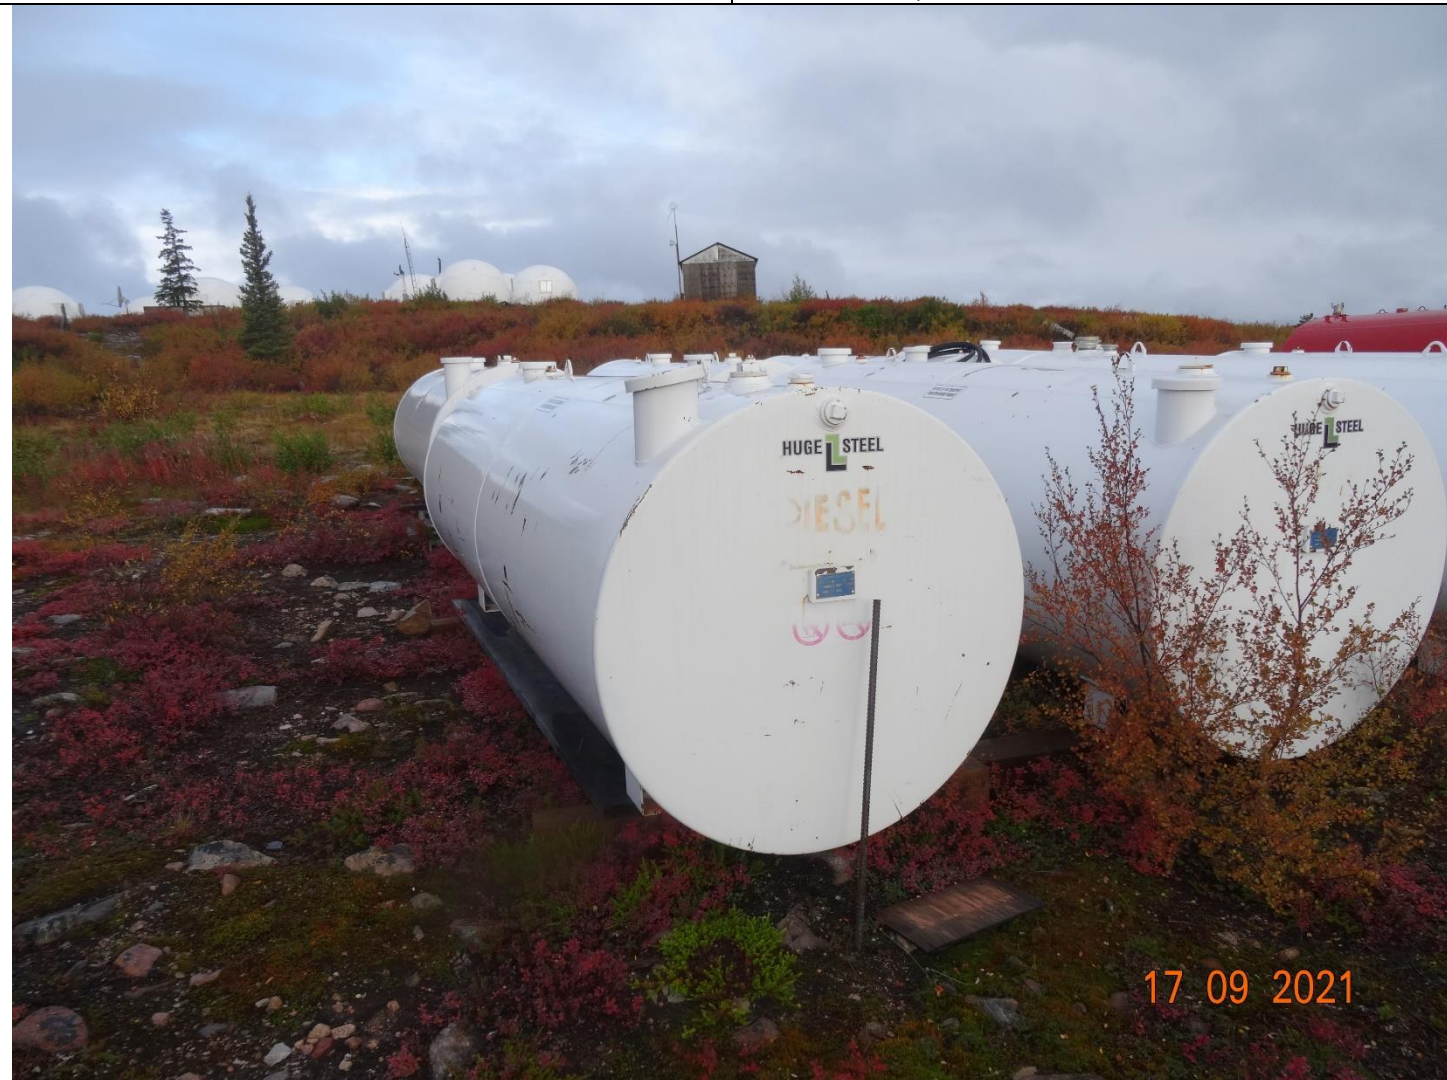
Photo 4

Tank # 2 partical full diesel fuel tank

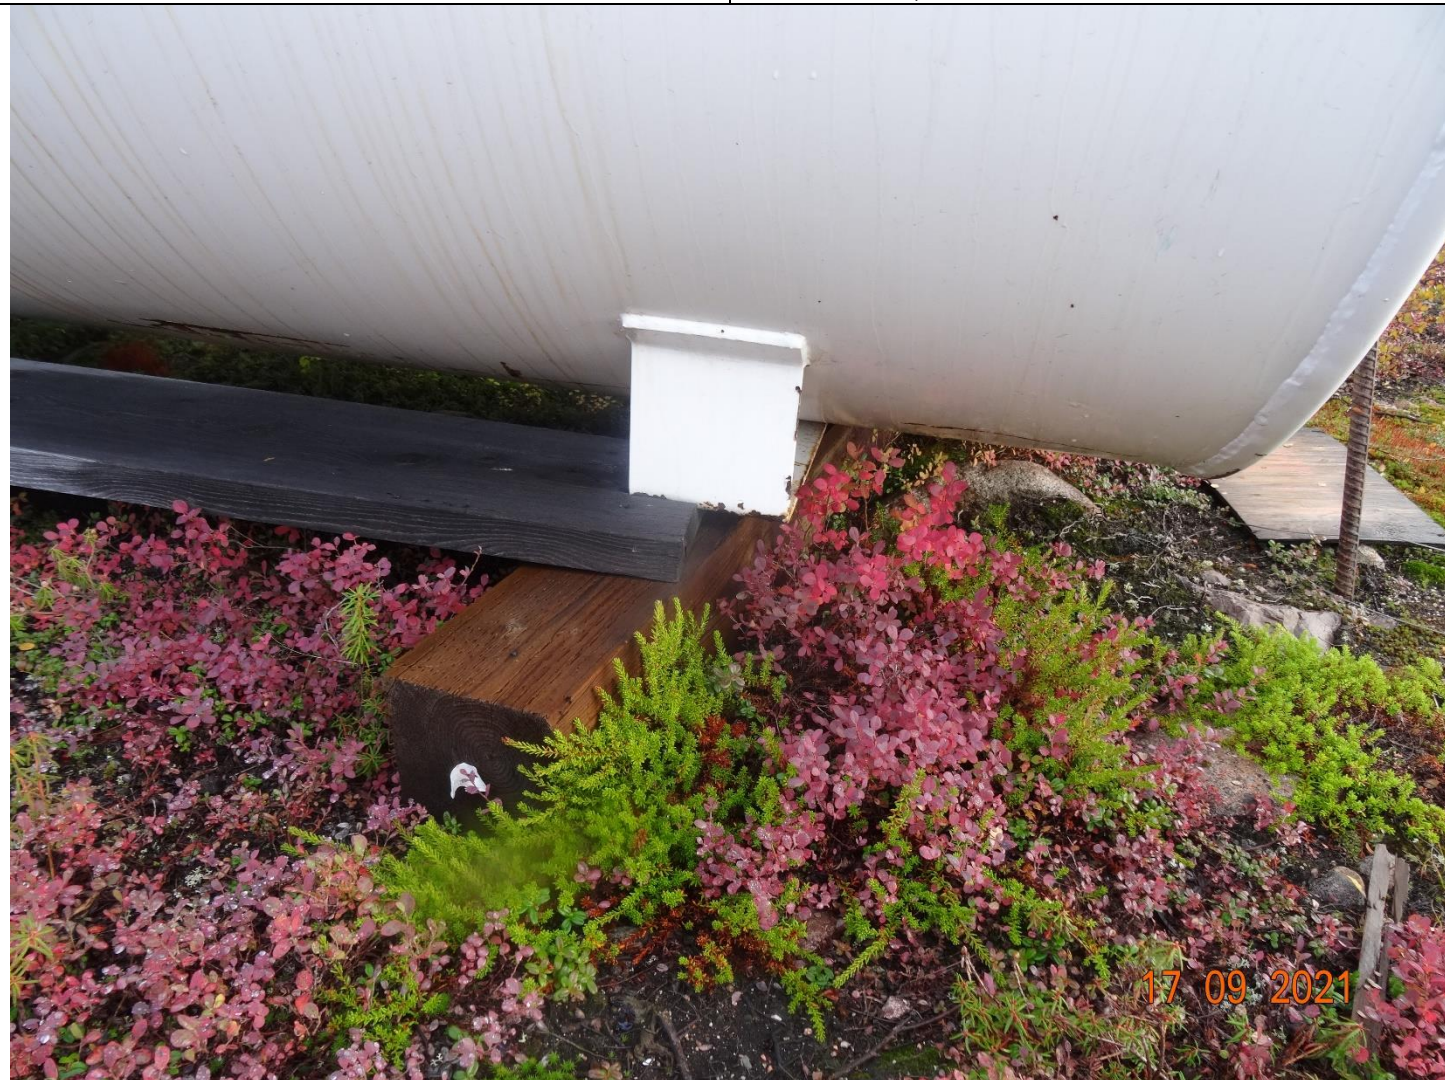
Photo 5

Tank #, misplaced wood footing

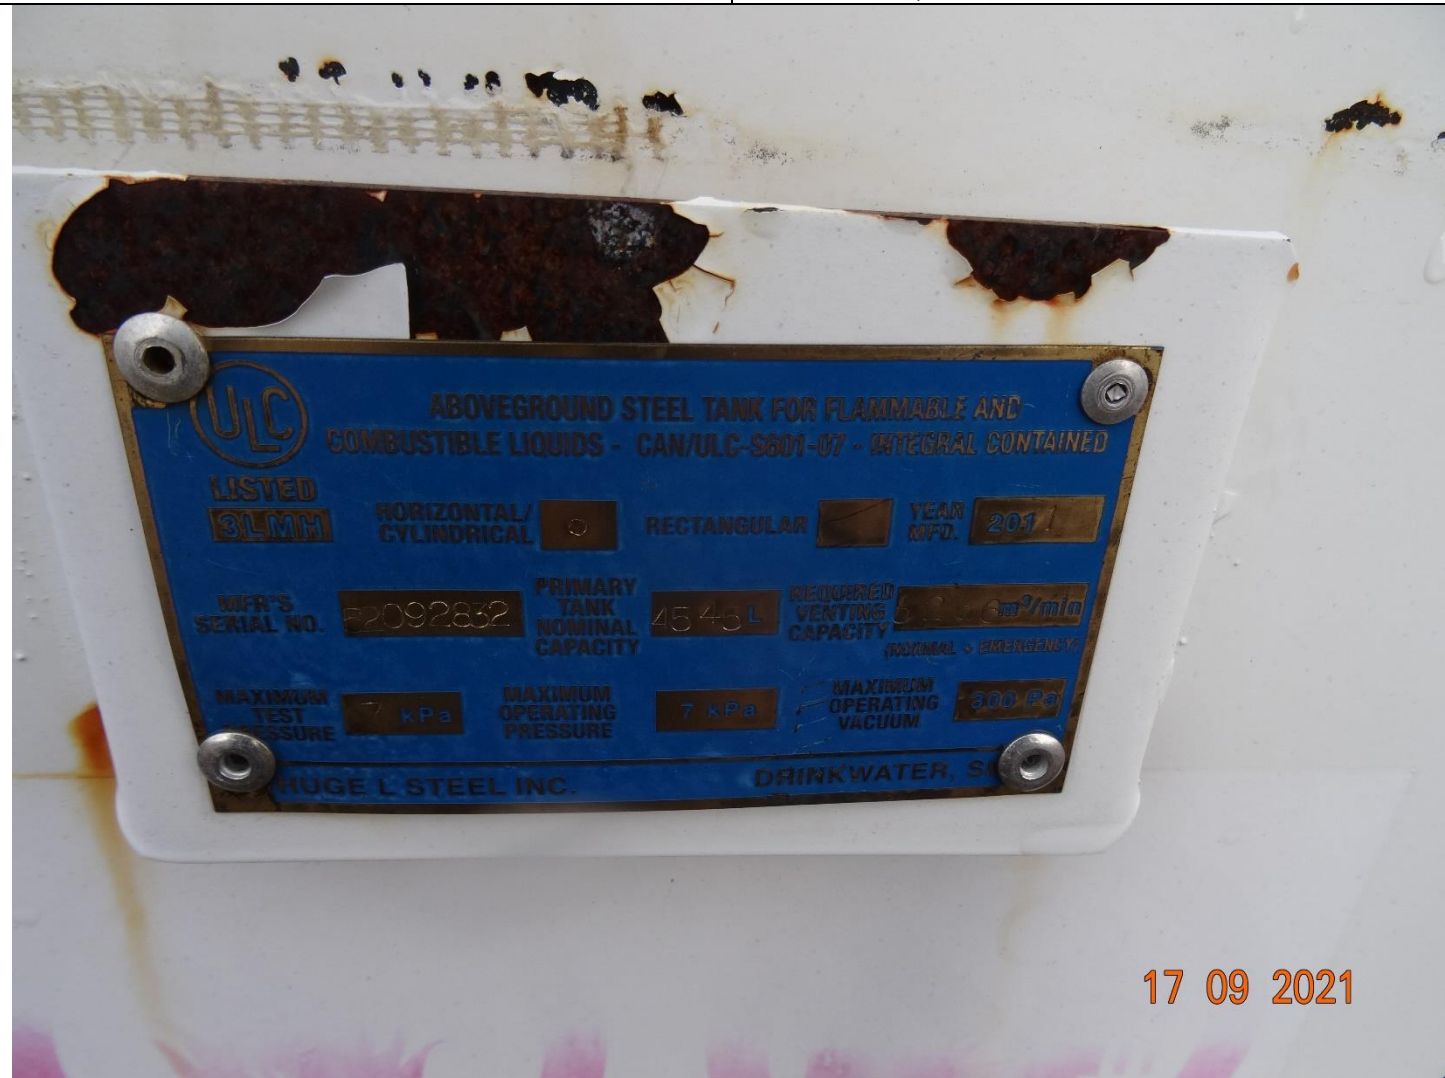
Photo 6

Tank # 2 placard for diesel partial

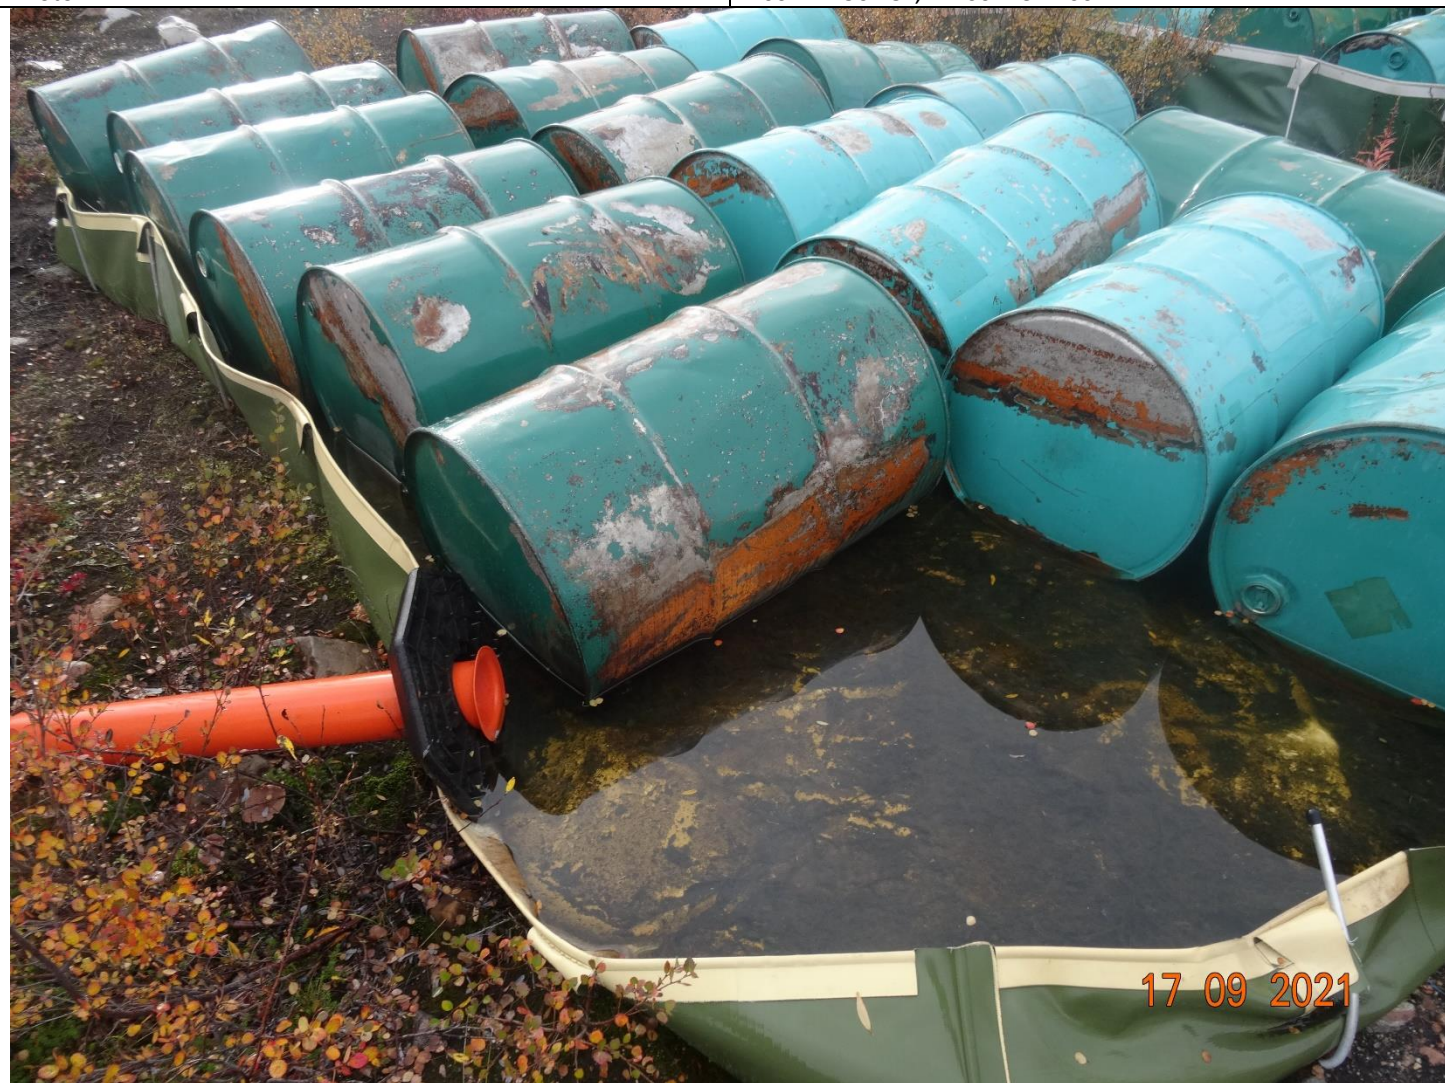
Photo 7

1. The Annual Report, as required by PART B item 2 are not available for review on the NWB FTP website.
2. The camp, generally located at N60° 27' 50.44", W100° 23' 4.65" appears to be in the same condition as noted in 2020.
3. The two spills located at; N60° 27' 50.44", W100° 23' 4.65" from a drum at the kitchen cabin and N60° 27' 48.50", W100° 22' 59.84" next to the incinerator shed, remain in the same condition as noted in 2020.
4. Two bulk fuel storage tanks are in need of maintenance. The tanks have sunk into the tundra and pose a risk of rolling over if not stabilized (photo 1-6).
5. Both drum fuel caches require maintenance. The berms are filled with water, the walls have collapsed and the water inside the berms have a sheen (photo 7-9).

Collapsed berm walls 1

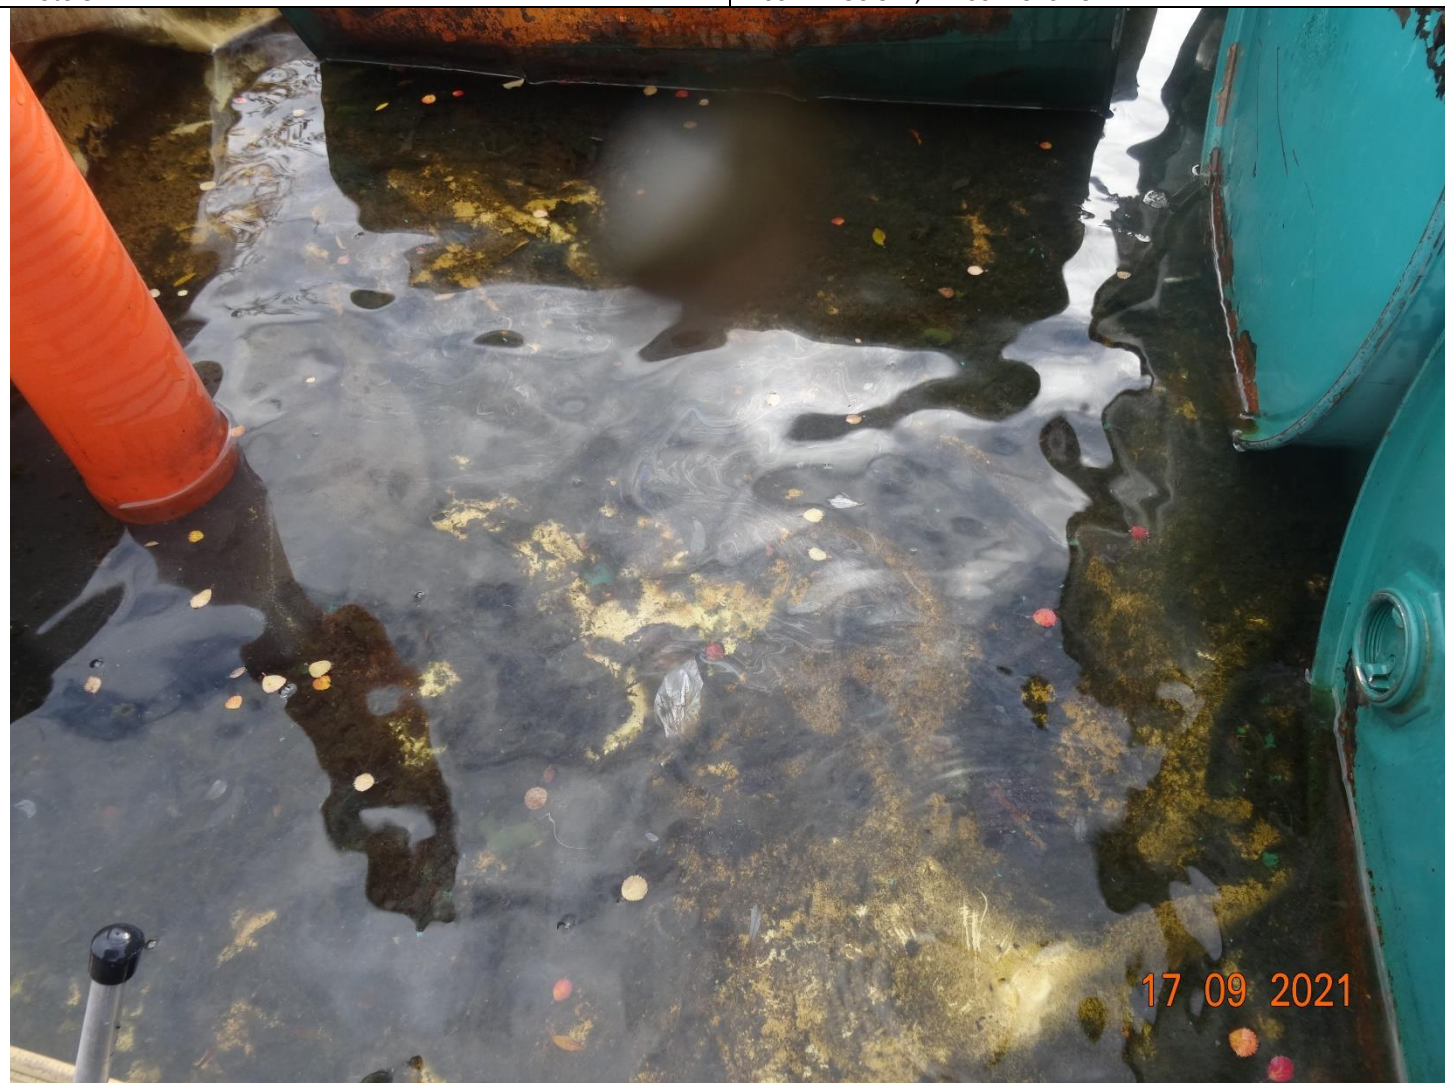
Photo 8

Sheen on the water in the secondary containment berm

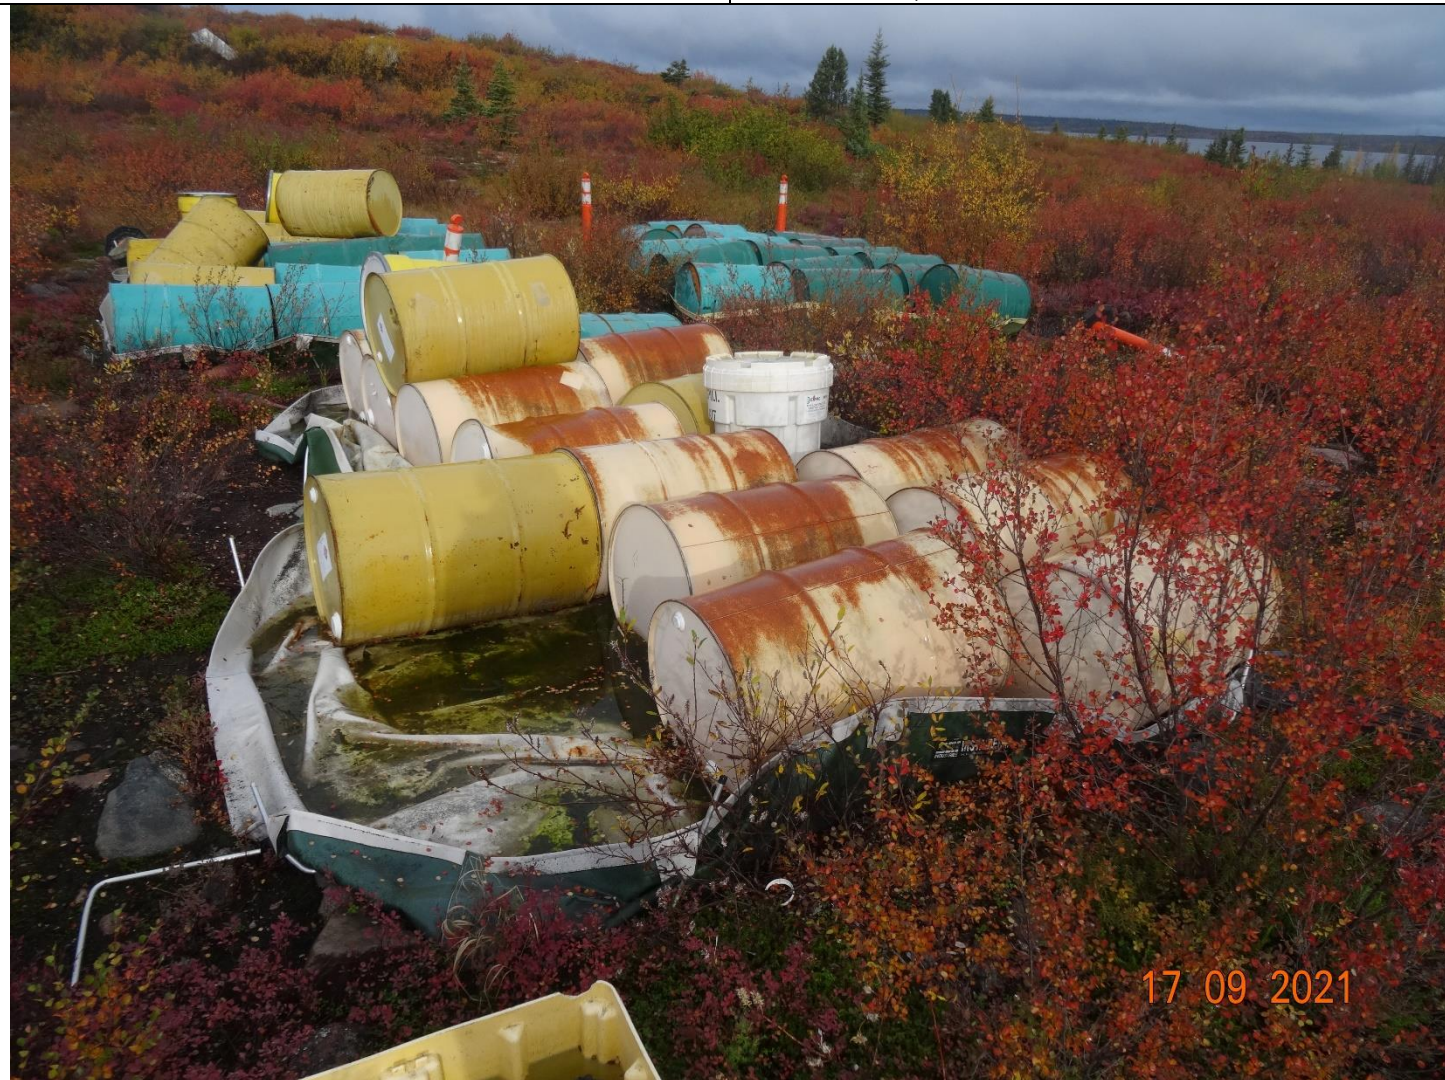
Photo 9

Collapsed berm walls 2

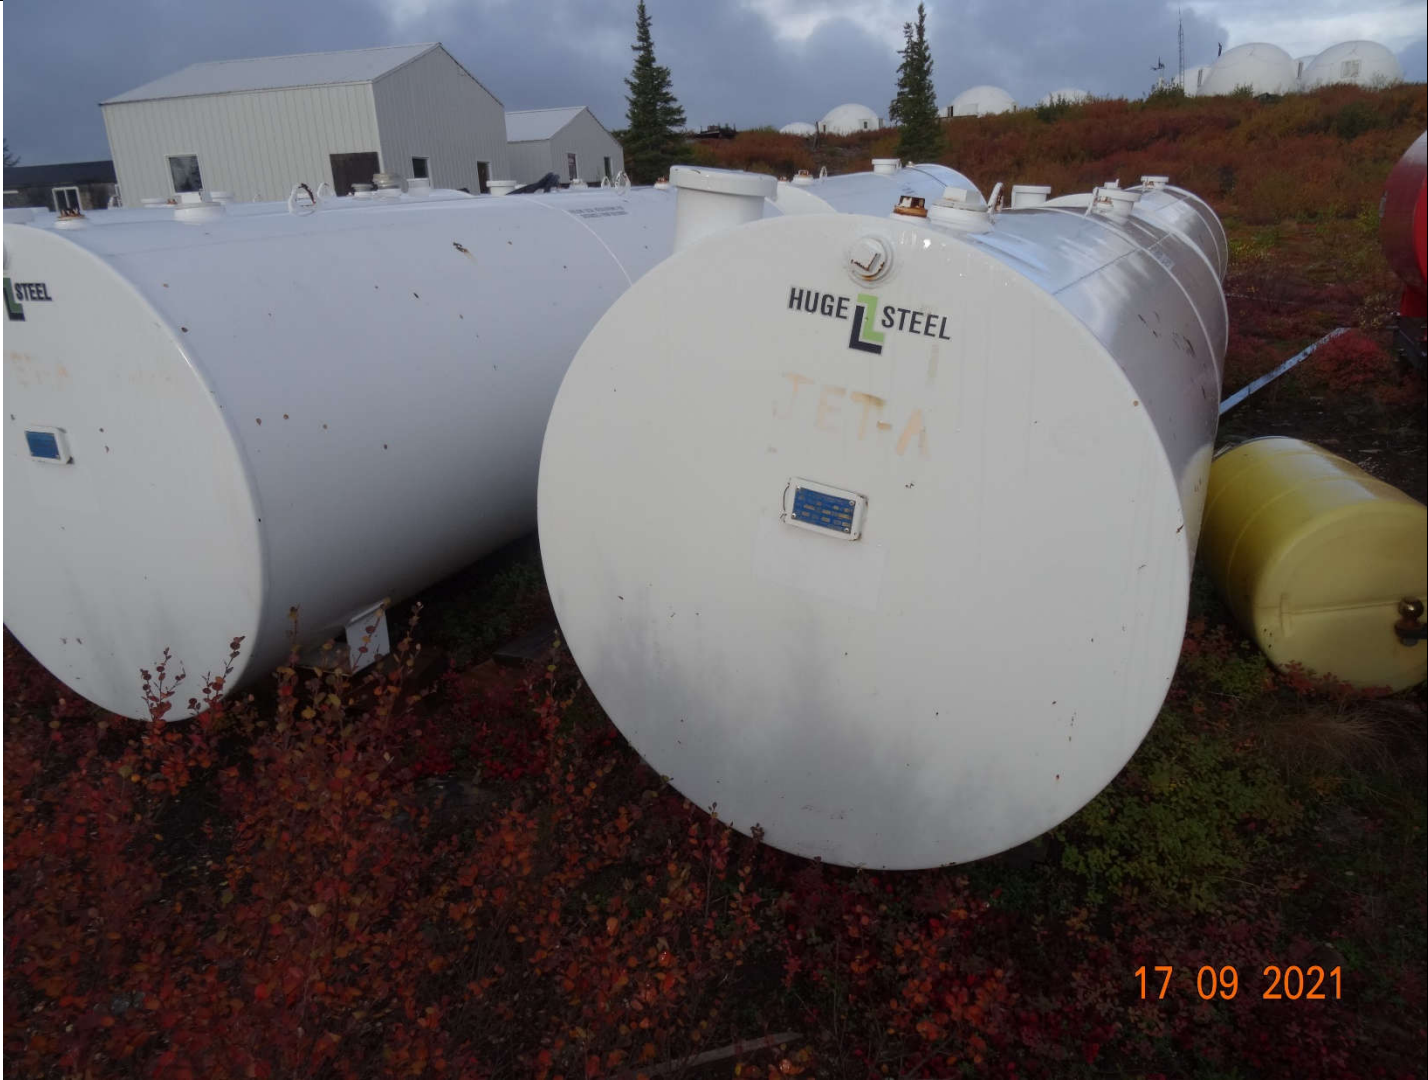
Date:	Authorization Number:	Camera/Model:	Inspector
September 17 th , 2021	N2019C0007	Sony DSC-HX50V Cyber shot	RMO Wilson
Photo No.		Lat/Long (DD.MM.SS.SS, NAD83)	
Photo 1		N60° 27' 48.13", W100° 23' 1.00"

Description:
Full JET A fuel tank #1.

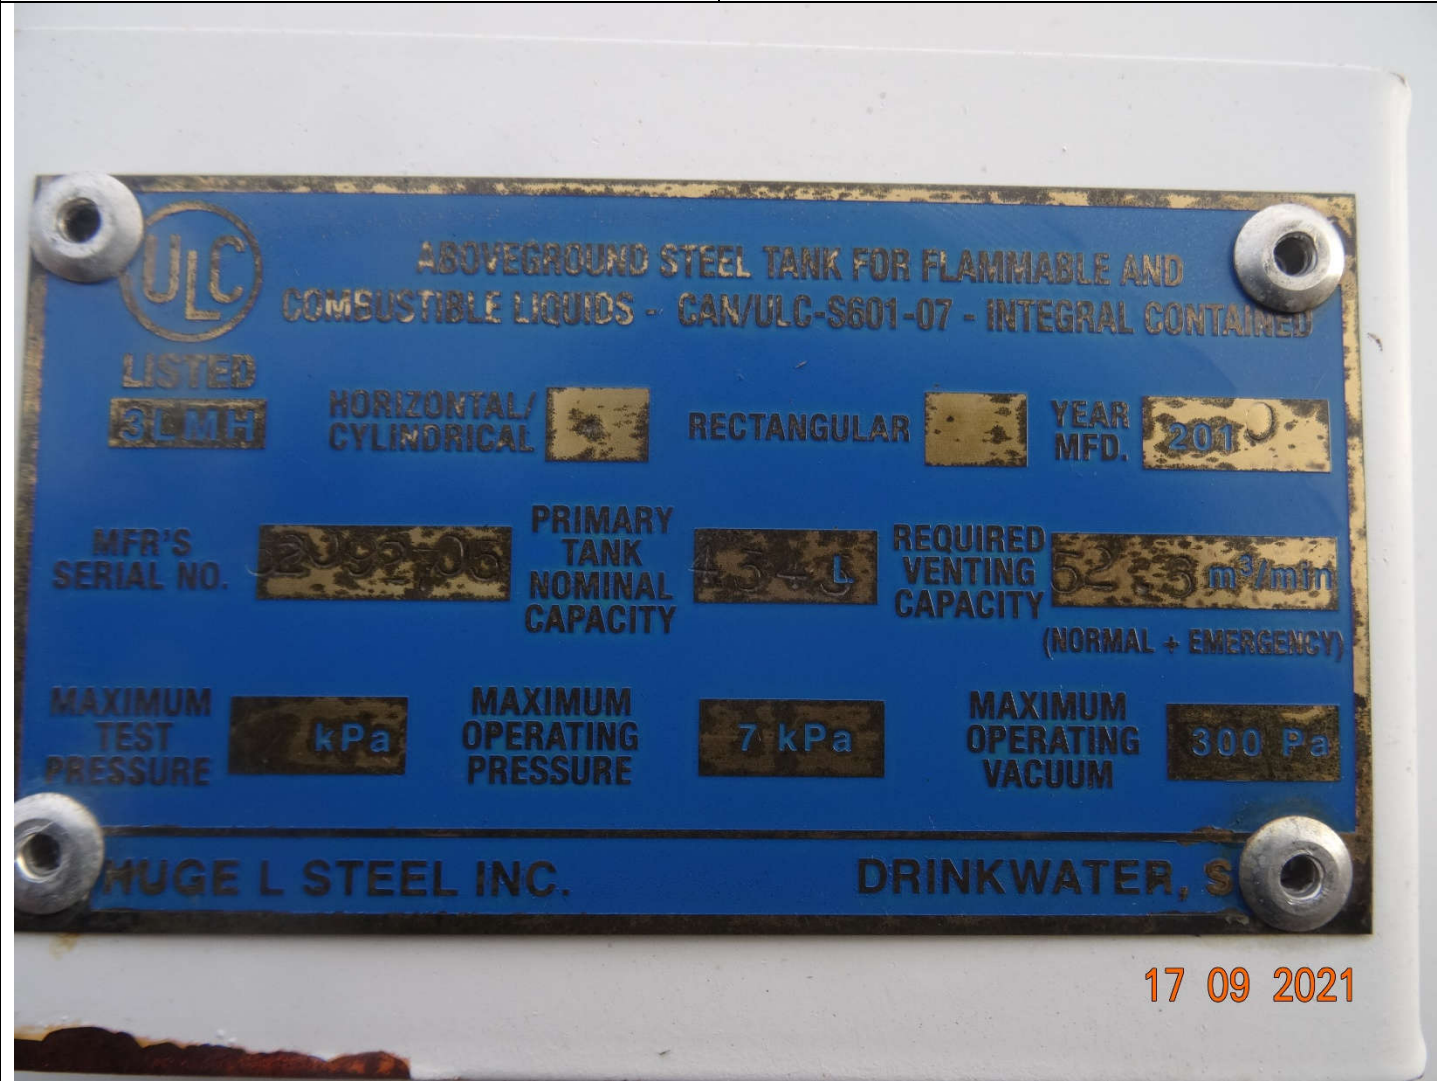
Photo No.	Lat/Long (DD.MM.SS.SS, NAD83)
Photo 3	N60° 27' 48.36", W100° 23' 1.21"

Description:
Tank # 1 placard, 4545L fuel storage tank.

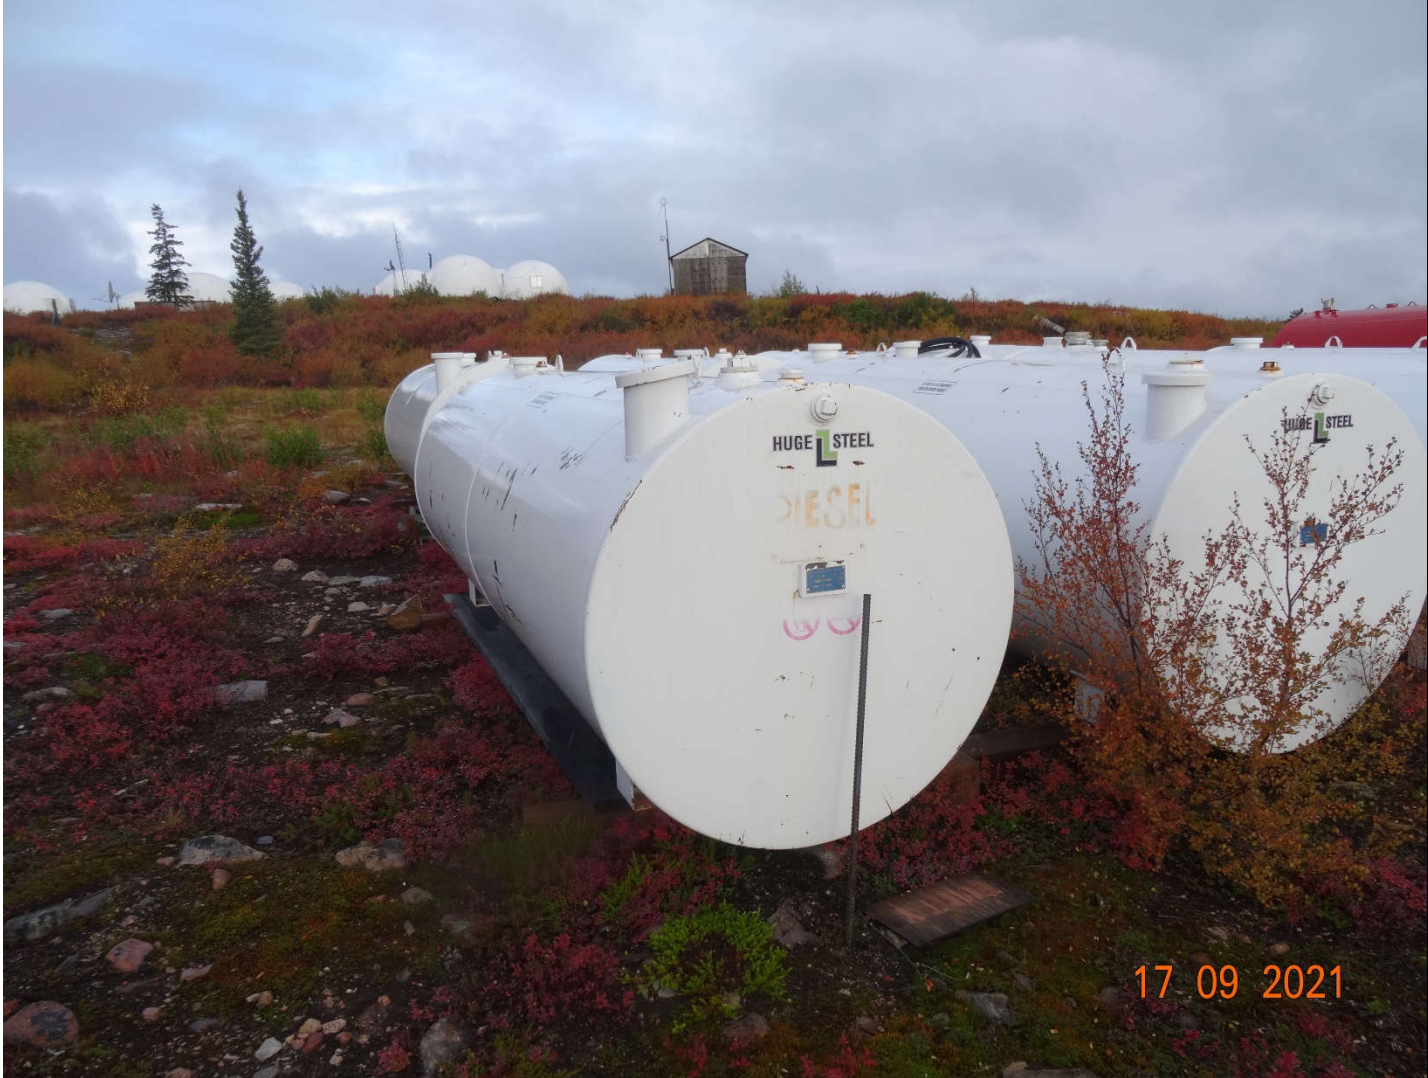
Photo 4

Tank # 2 partical full diesel fuel tank

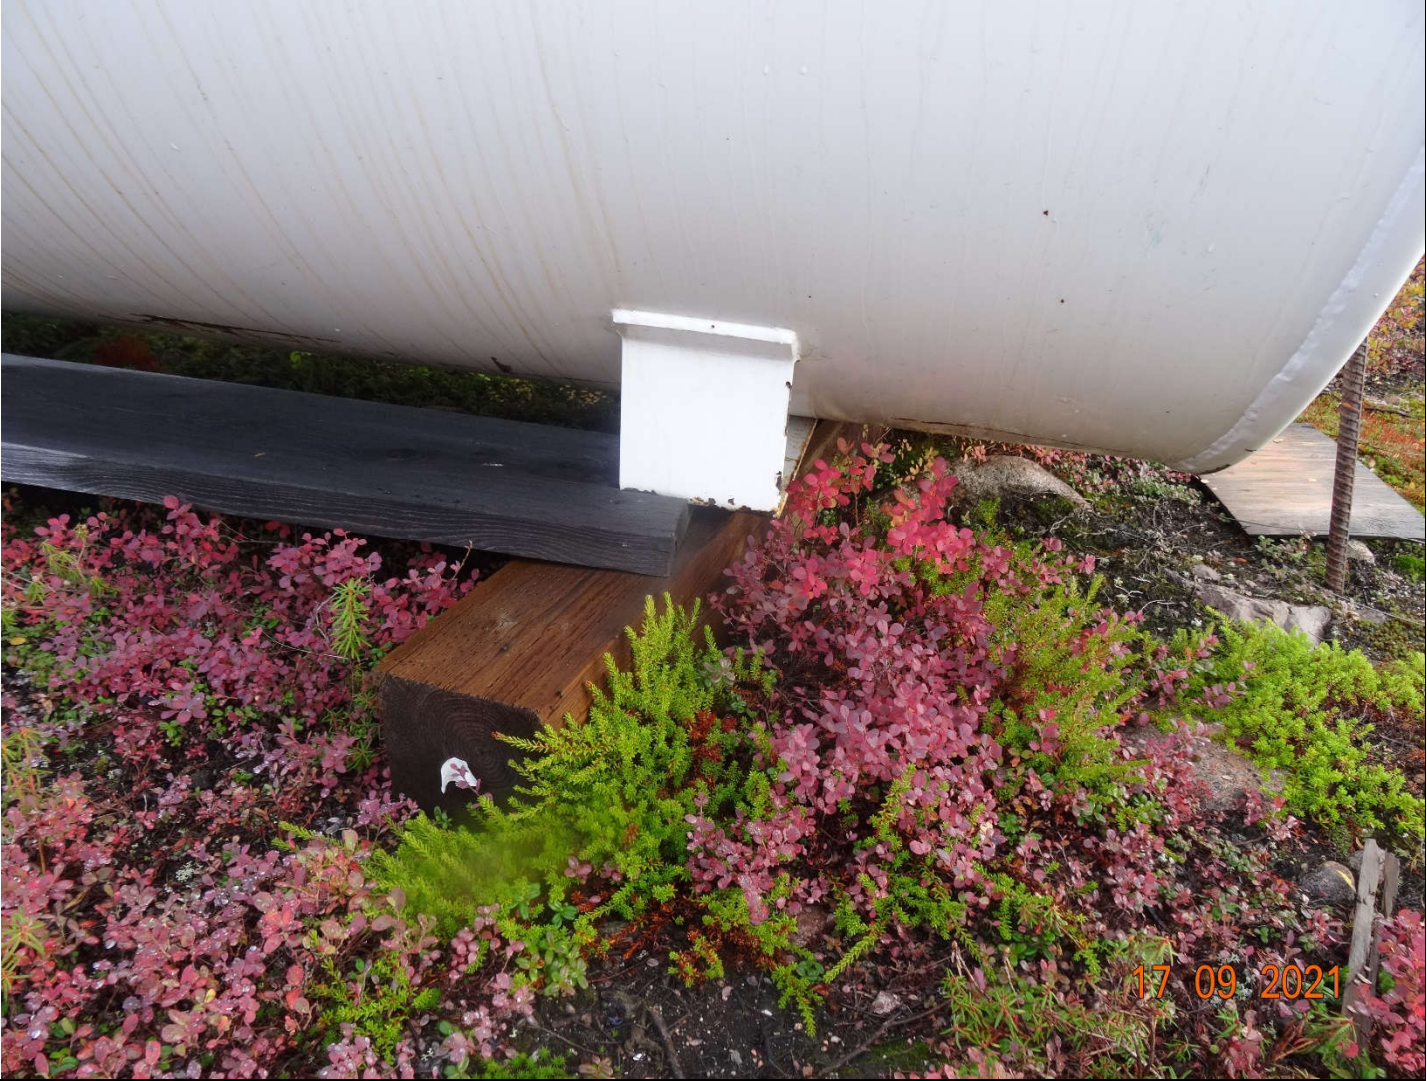
Photo No.	Lat/Long (DD.MM.SS.SS, NAD83)
Photo 5	N60° 27' 48.47", W100° 22' 59.63"

Description: Tank #, misplaced wood footing

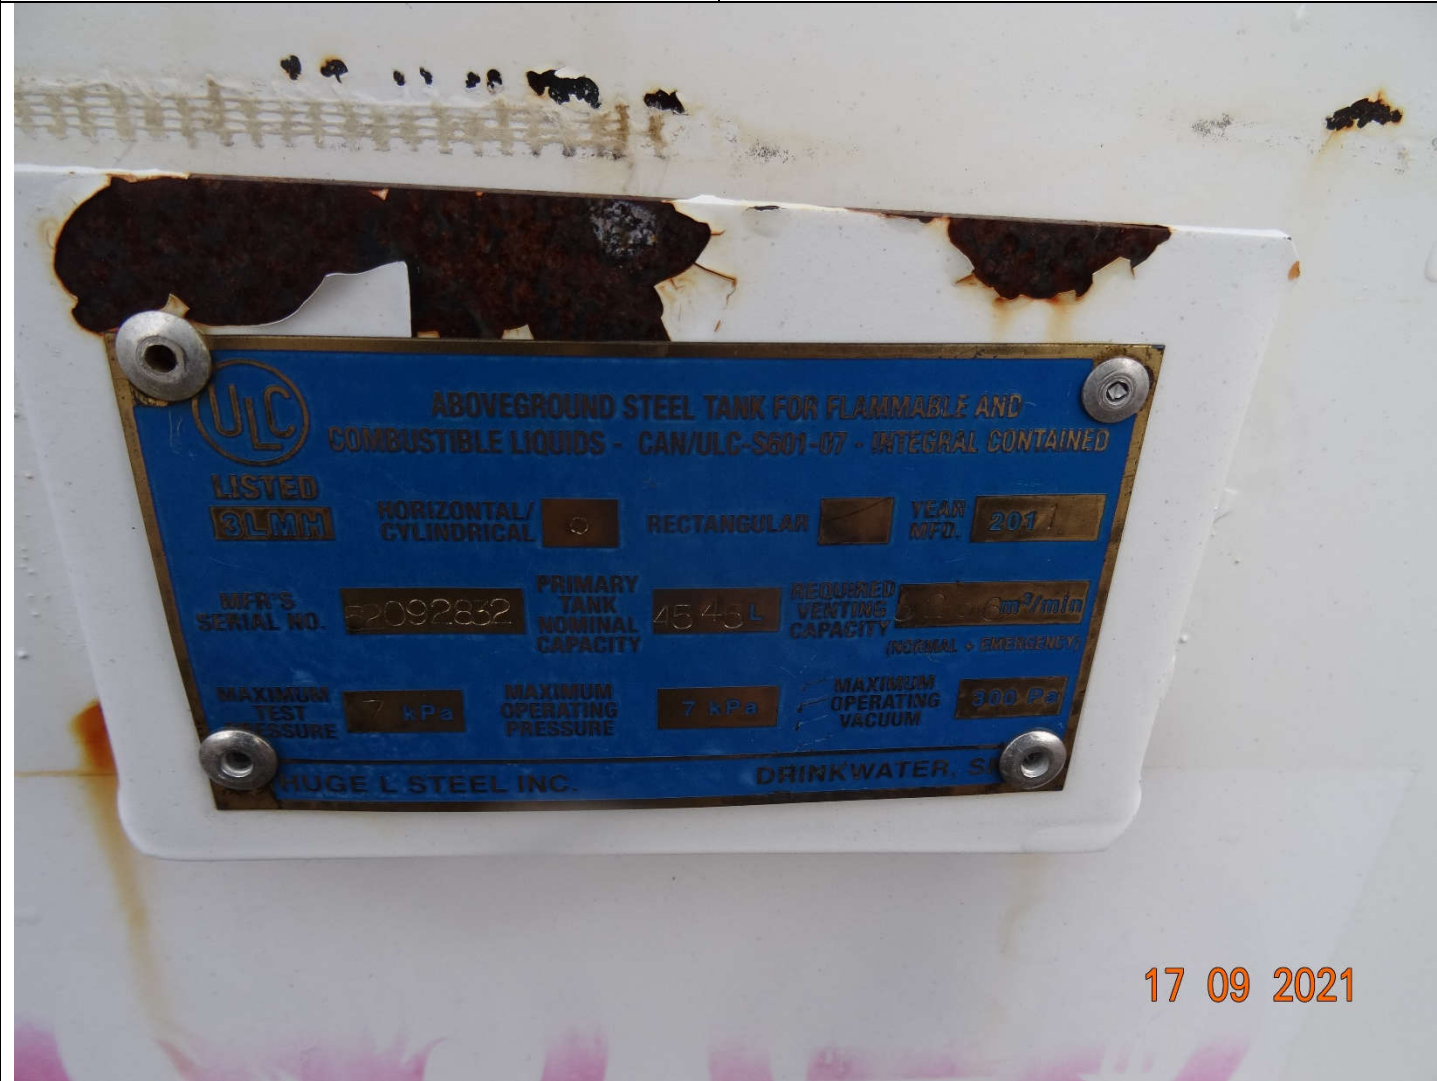
Photo No.	Lat/Long (DD.MM.SS.SS, NAD83)
Photo 6	N60° 27' 48.58", W100° 23' 0.08"

Description:
Tank # 2 placard for diesel partcial
