**WATER LICENCE INSPECTION FORM**☒ Original
☐ Follow-Up Report

Licensee	Licensee Representative
Montego Resources Inc.	Unknown
Permit No. / Expiry	Purpose
2BE-KIY1722, July 21 st , 2022	Exploration
Other Authorizations/ Expiry	Project Name
N2019C0007, March 1 st , 2024	Kiyuk Lake Project
Date of Inspection	Inspector
September 17 th , 2021	RMO Wilson
Activities Inspected	
<input checked="" type="checkbox"/> Camp	<input type="checkbox"/> Drilling
<input type="checkbox"/> Roads/Hauling	<input type="checkbox"/> Mining
<input type="checkbox"/> Other:	<input type="checkbox"/> Construction
	<input type="checkbox"/> Reclamation
	<input type="checkbox"/> Fuel Storage
	<input type="checkbox"/> Other:

On September 17th, 2021 an inspection of Montego Resources Inc., Kiyuk Lake Project was completed by Crown-Indigenous Relations and Northern Affairs Canada (CIRNAC), Resource Management Officer, Christine Wilson (Inspector). The inspection was conducted to ensure compliance with applicable terms and conditions of water licence no. 2BE-KIY1722. This inspection was completed as a follow up to land use permit report no. [2020-KIV18-CW]. A copy of this report is attached in appendix 2.

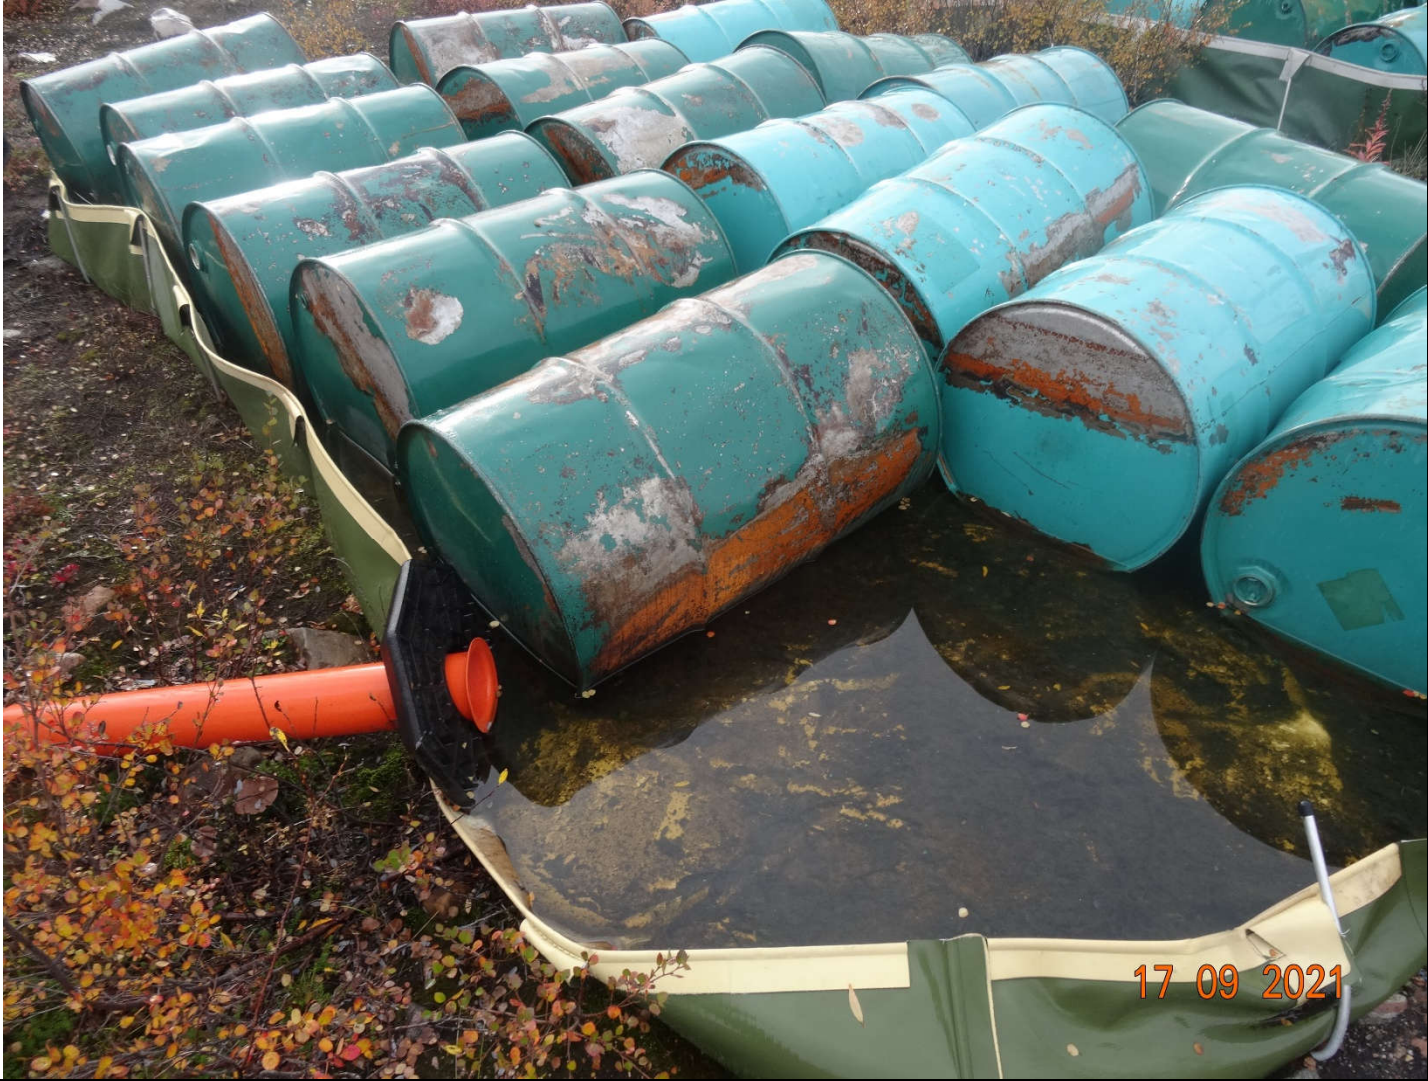
Photo 7

Collapsed berm walls 1

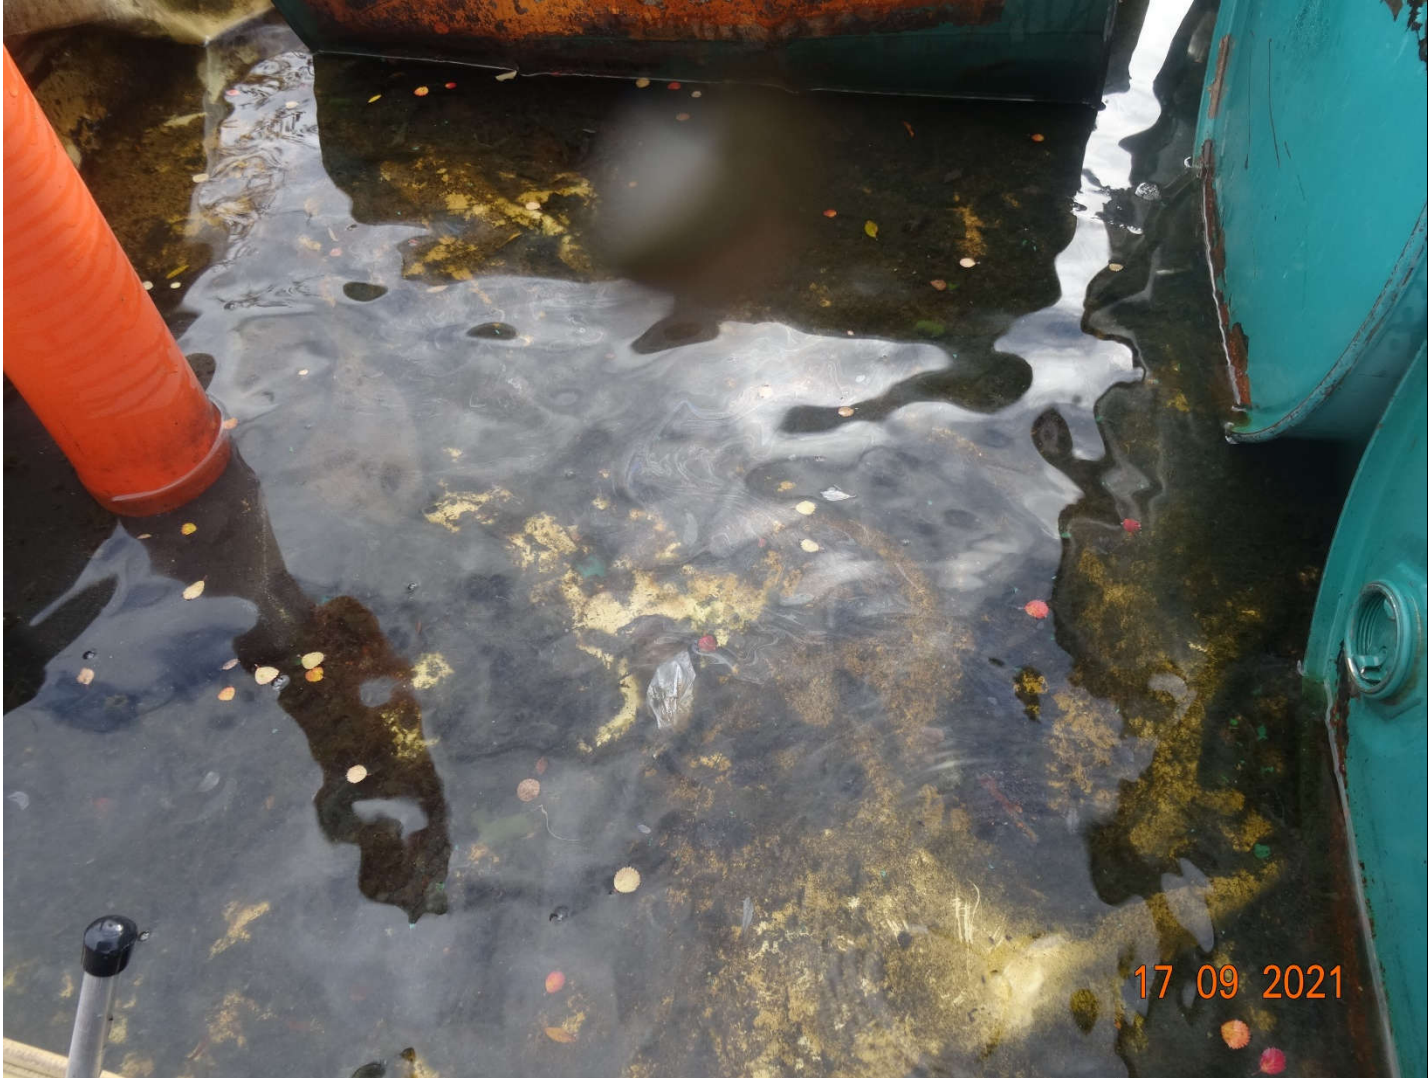
Photo 8

Sheen on the water in the secondary containment berm

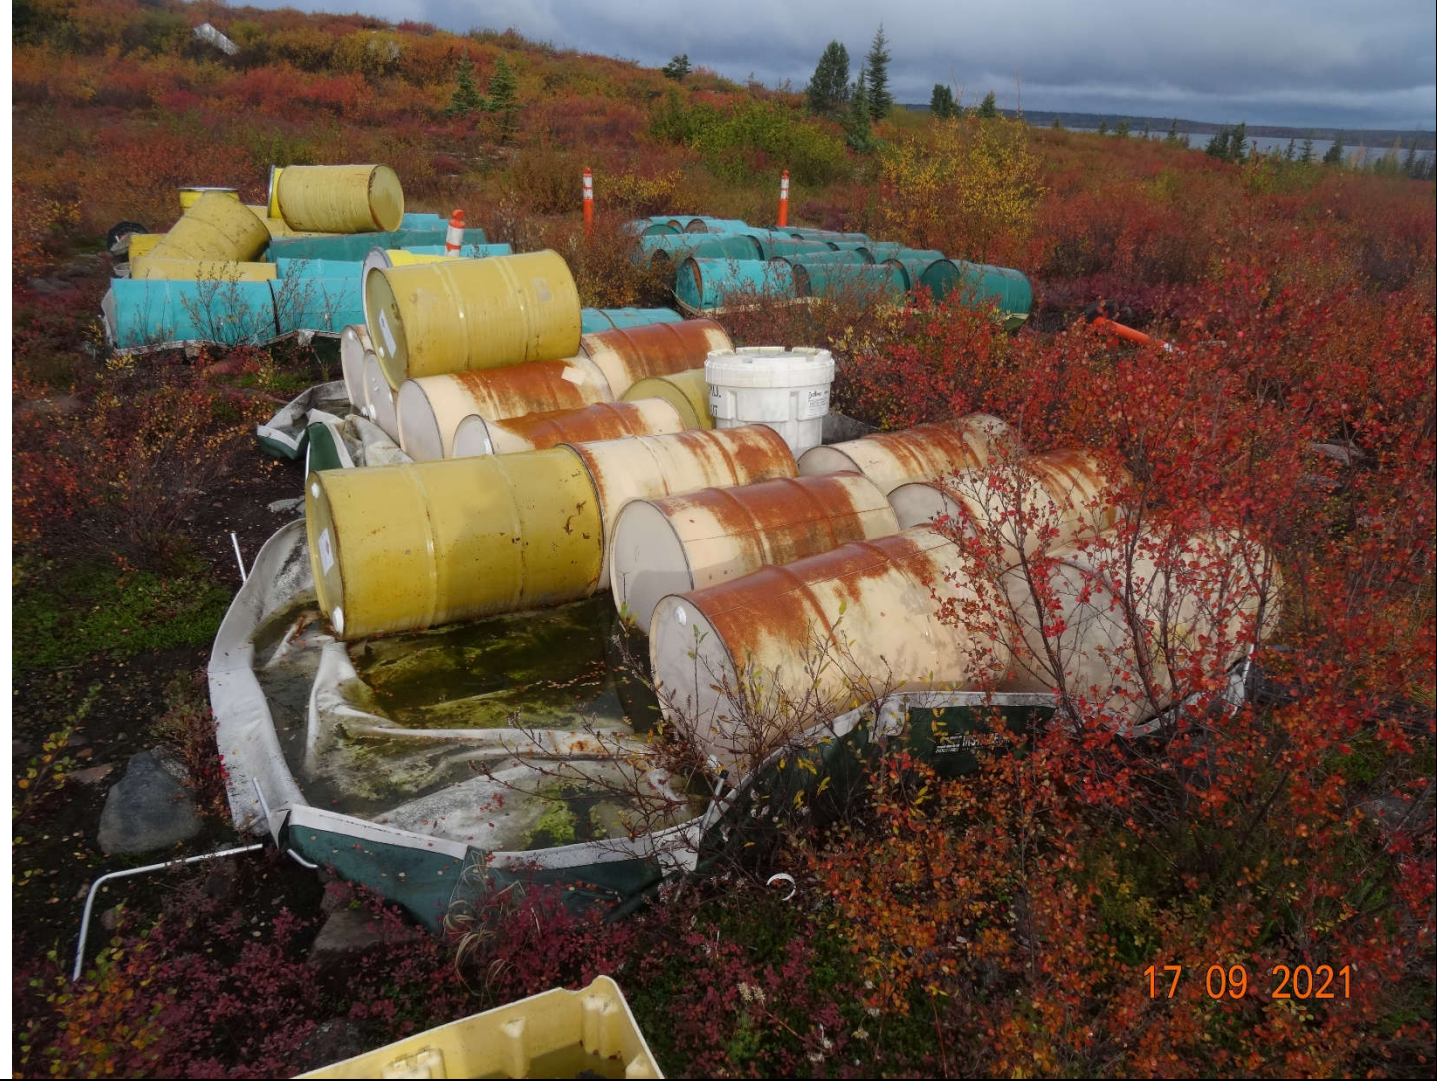
Photo No.	Lat/Long (DD.MM.SS.SS, NAD83)
Photo 9	N60° 27' 50.02", W100° 22' 59.81"

Description:
Collasped berm walls 2

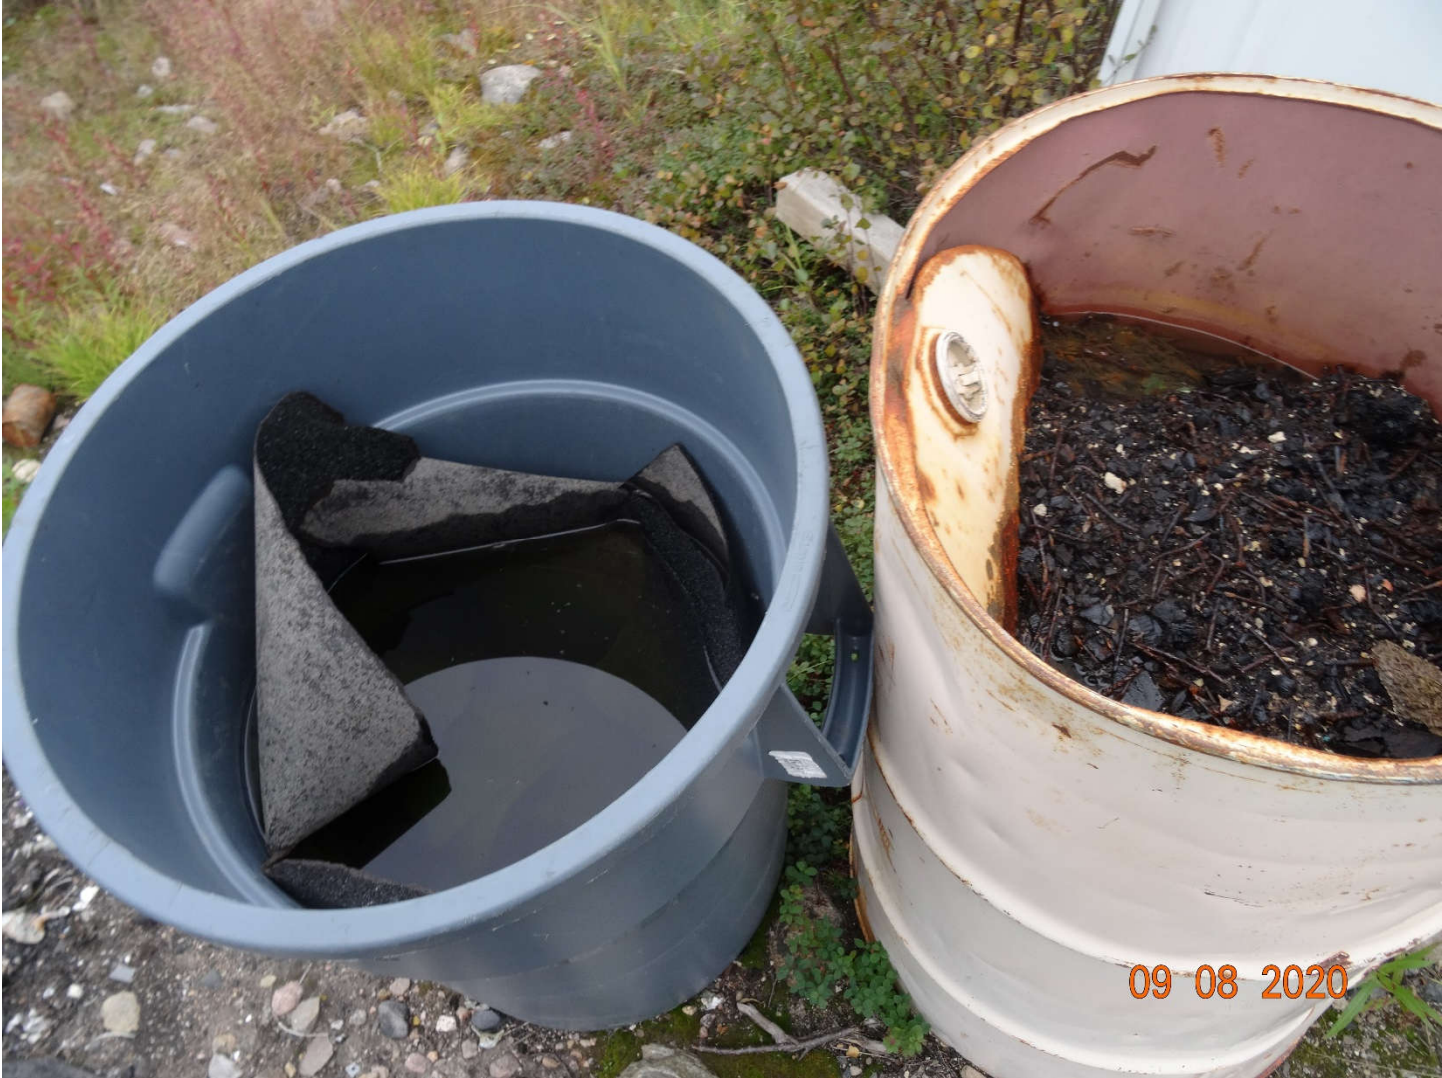
Photo No.	Lat/Long (DD.MM.SS.SS, NAD83)
Photo 3	N60° 27' 48.55", W 100° 22' 59.52"

Description: Garbage and burnt materials stored in a way that is accessible by wildlife.

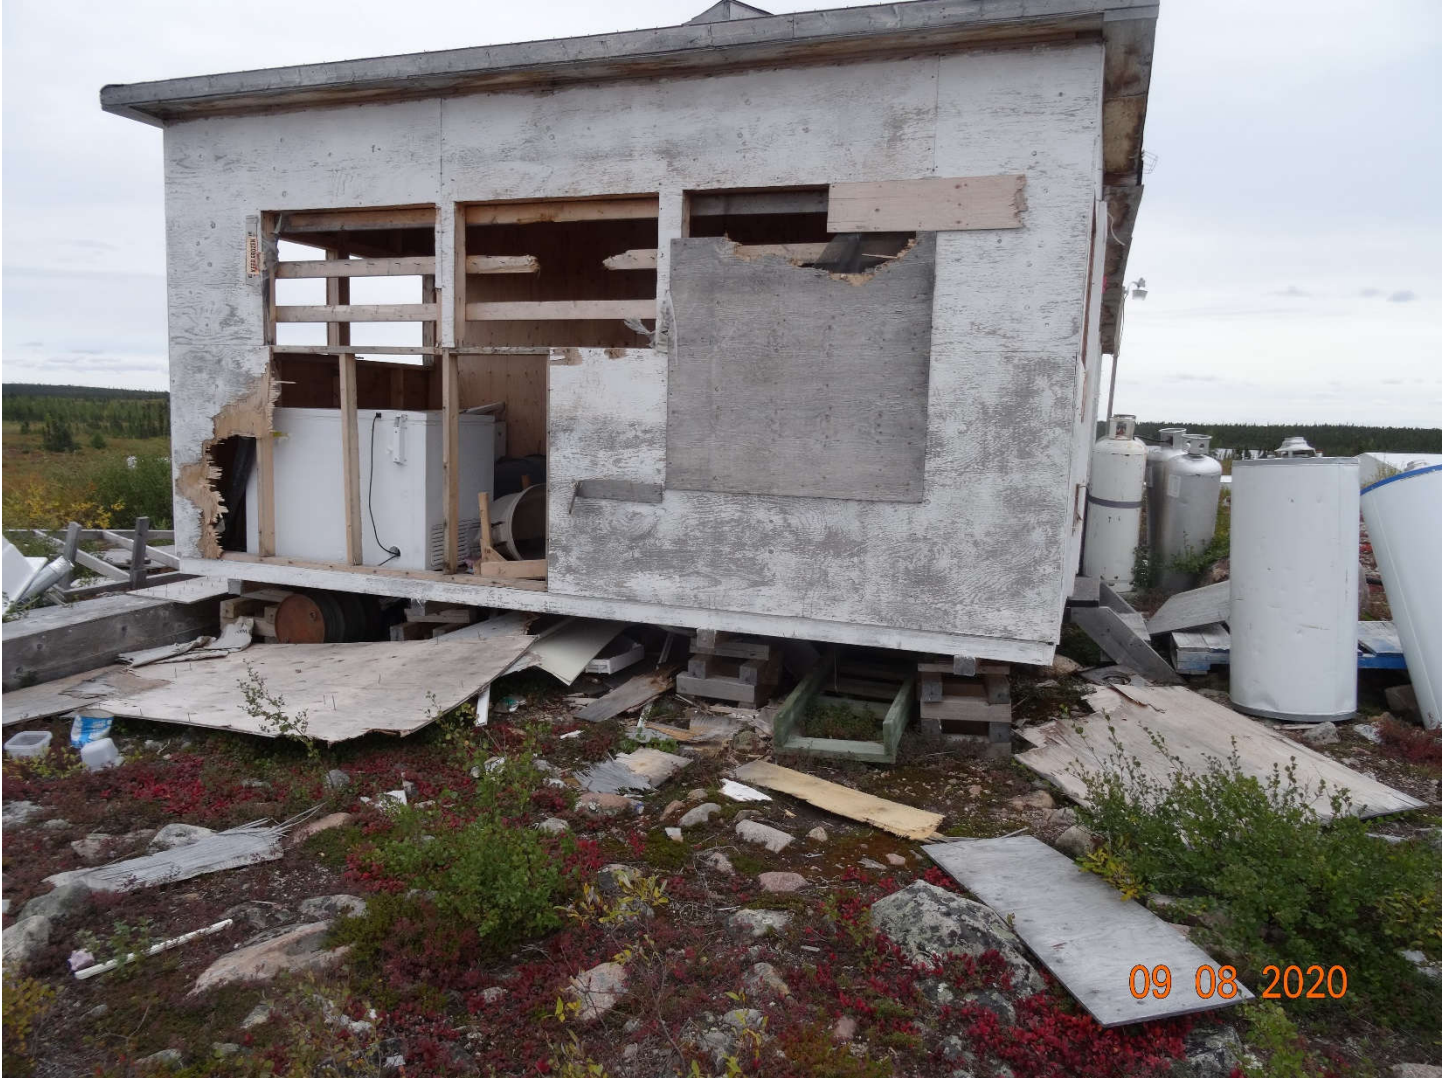
Photo 5

Animal damage to the kitchen cabin.
