WATER LICENCE INSPECTION FORM

Original
 Follow-Up Report

On May 13th, an inspection of Agnico Eagle Mines Ltd.'s Meliadine Gold Project's Exploration Division was completed by Crown-Indigenous Relations and Northern Affairs Canada (CIRNAC)'s, Water Resources Officer, Christine Wilson (Inspector) and Kyle Amsel. The May 13th inspection was conducted as a follow up to the April 19th inspection (report no. 2022-KIV02-CW) to ensure compliance with applicable terms and conditions of water licence no. 2BB-MEL1424.

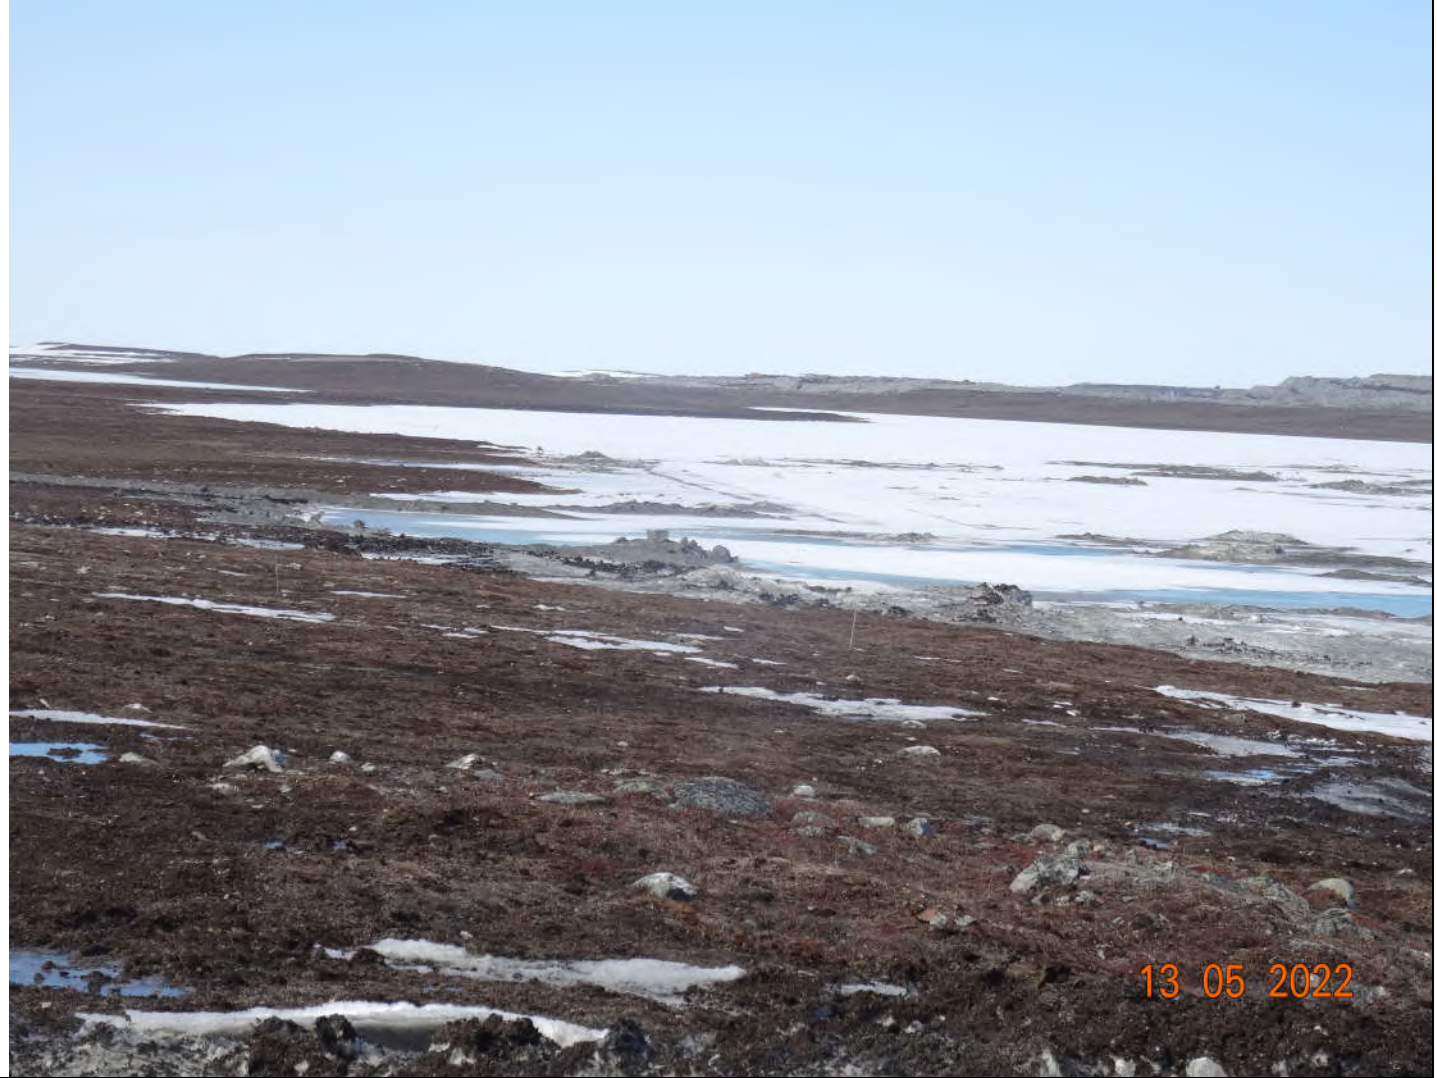
1. All drills and ancillary have been removed from the surface of Lake A8.
2. The overland trail from All Weather Access Road KM27 to Lake A8 is snow free. Water has begun to accumulate around the edges of the Lake (photo 1).

3. The overland trail down to the Lake is rutted and eroded causing surface water to be carried down to the edge of the Lake.
4. On the ice surface of Lake A8 there are piles of grey material. The piles extends over 600m from the south east side of the lake, North west (photo 1).

Description:
Trail going into Lake A8 and piles of grey snow on the surface of the lake.

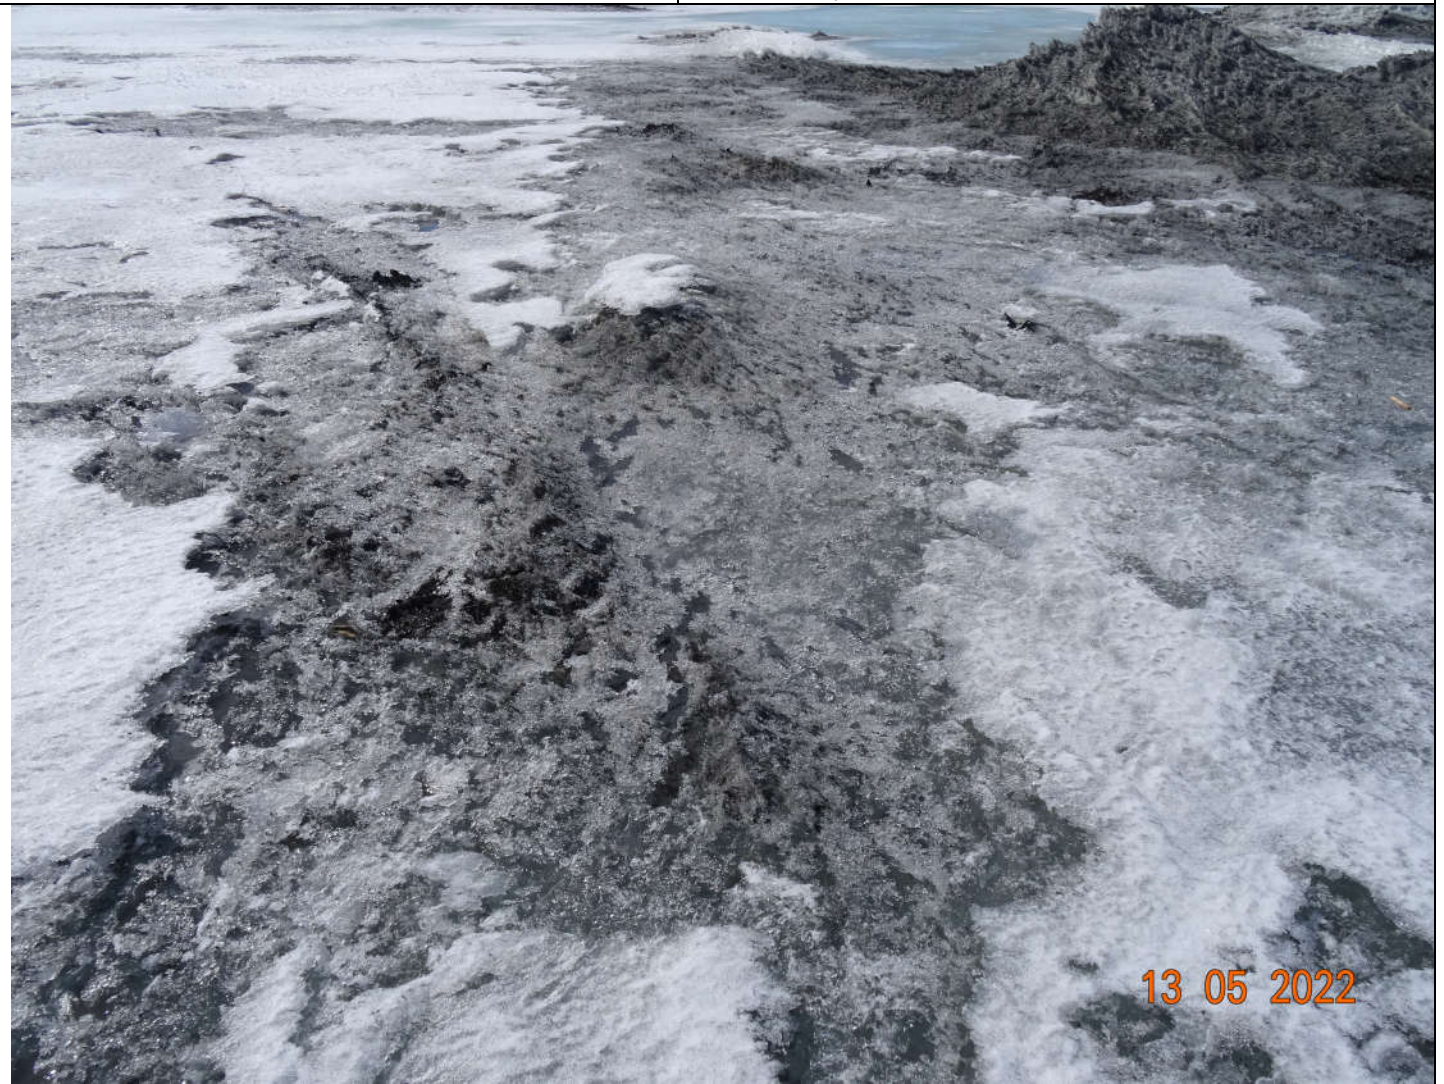
Photo 2

5. Within the piles of snow are pools of water on the surface of the ice that are filled with unknown grey, black, yellow and white materials (photo 2-12 and 17).

Grey material on the surface of the ice of Lake A8.

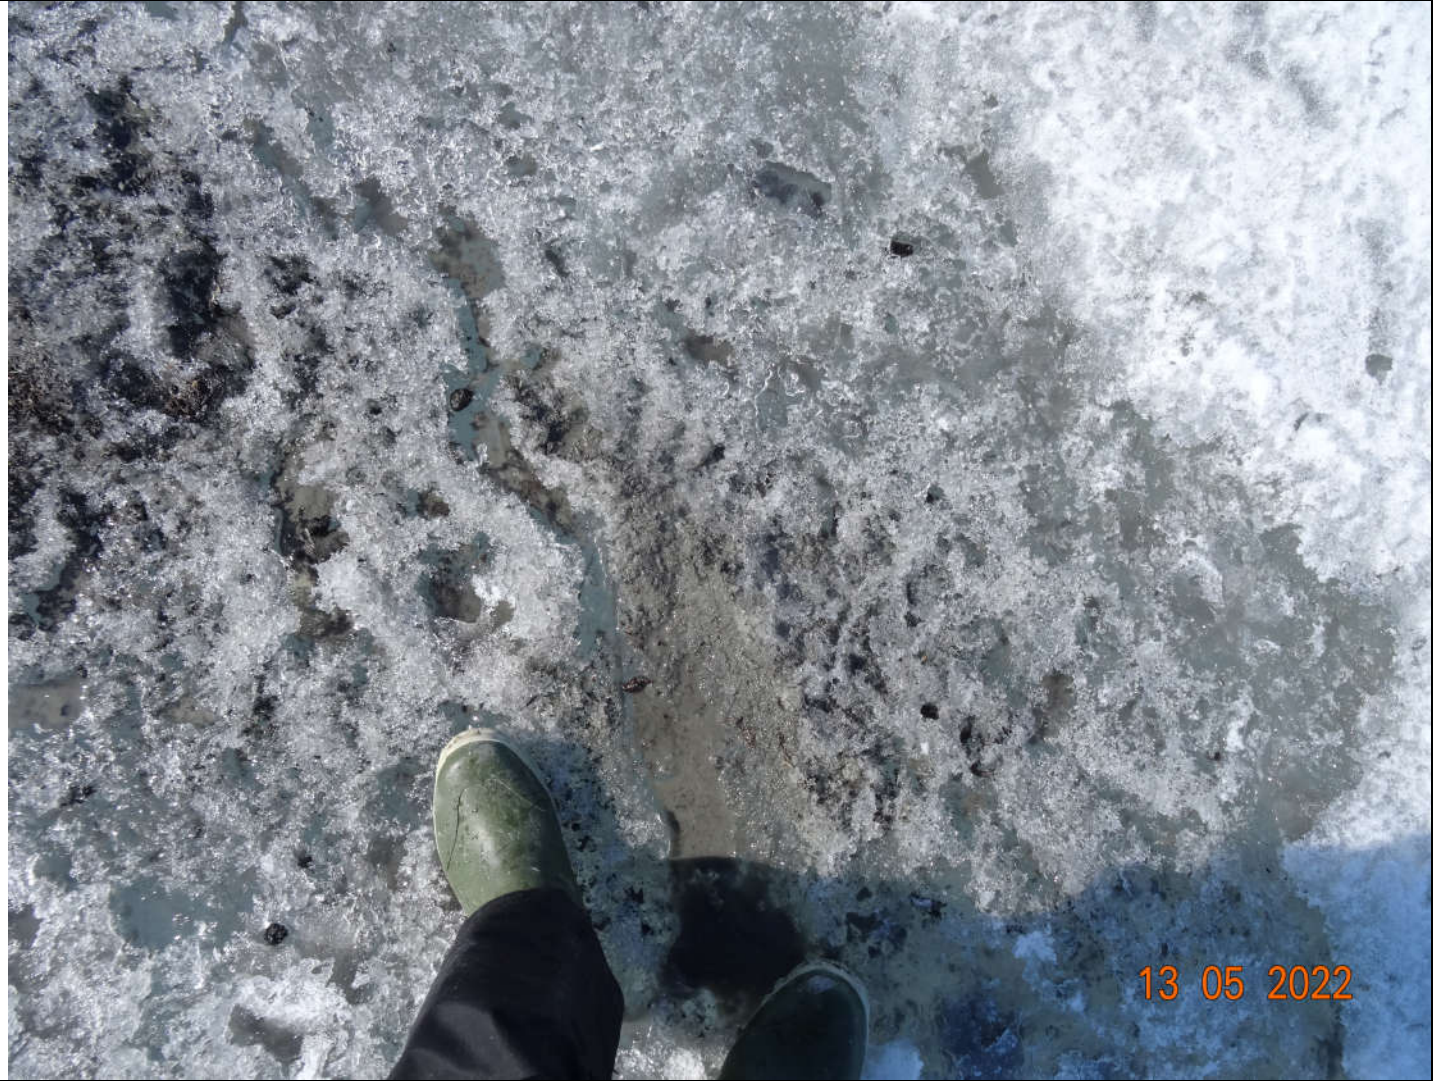
Photo 3

Grey Materials on the surface of the ice.

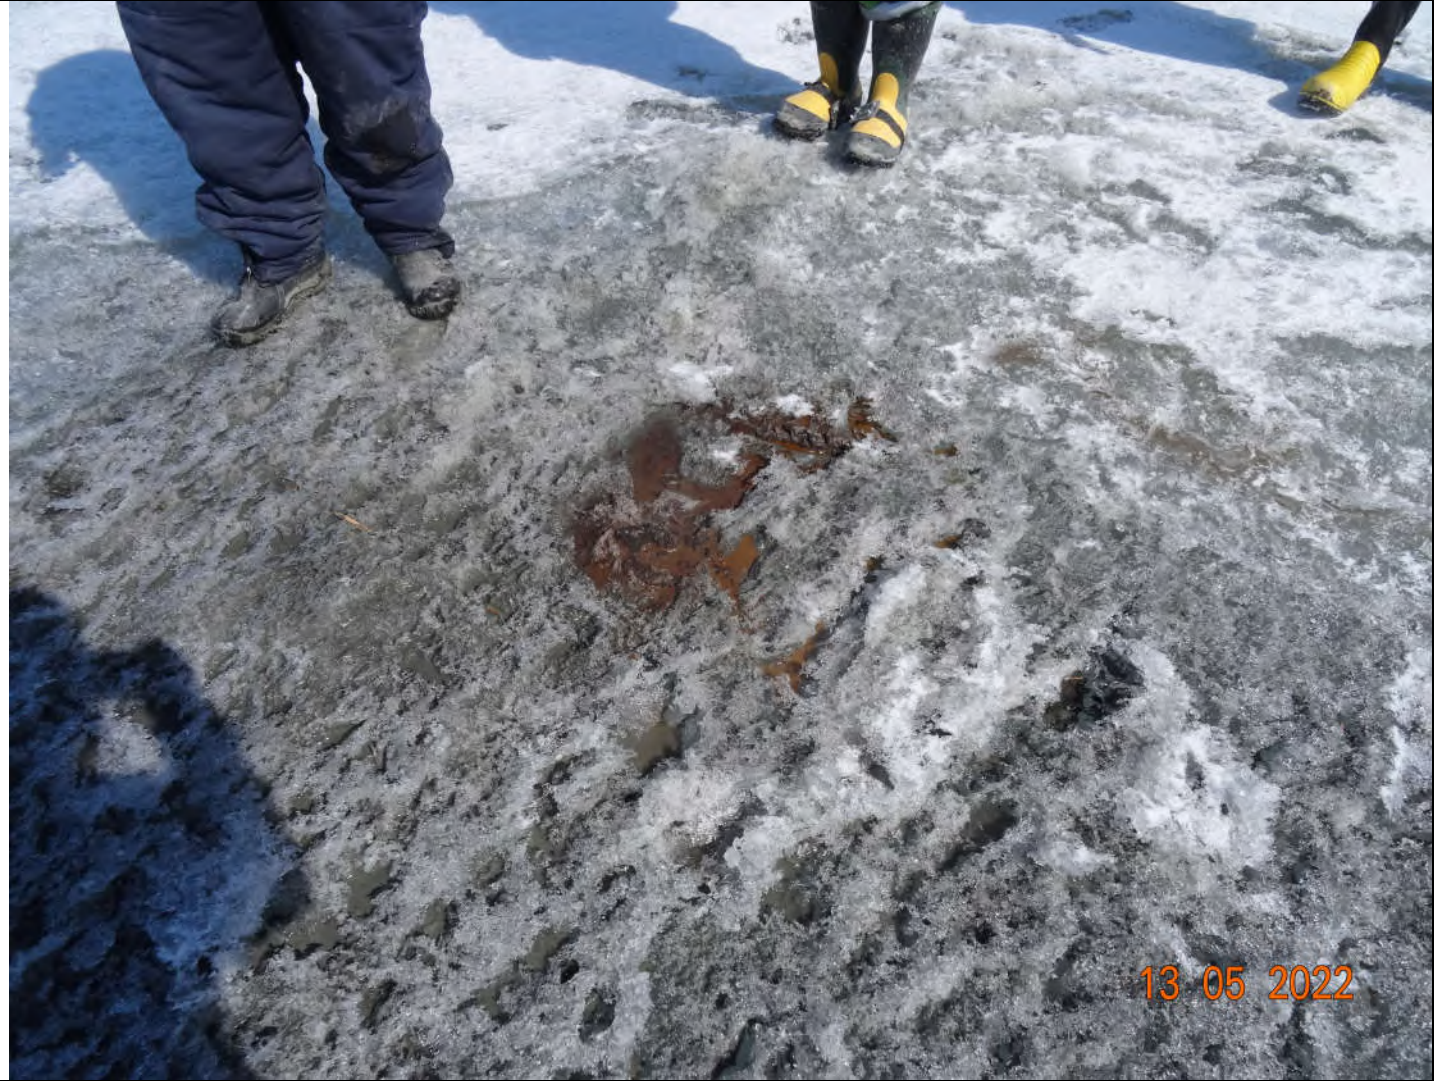
Photo 4

Brown and grey materials on the surface of the ice of A8 Lake.

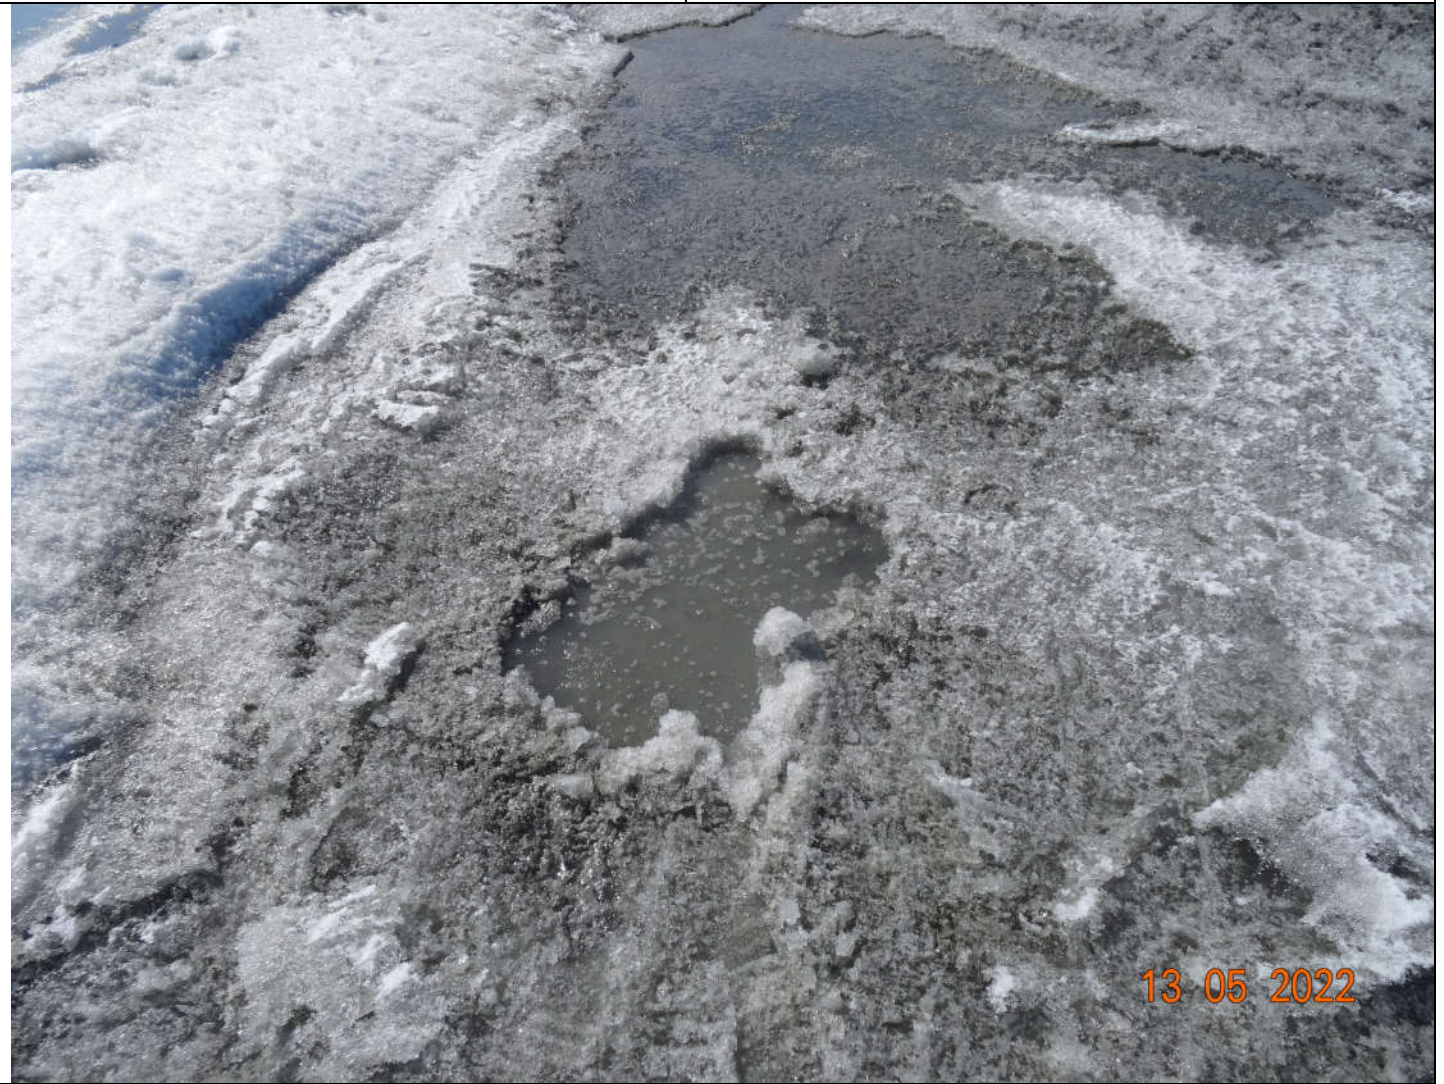
Photo 5

Pools of black and grey material on the surface of the ice of Lake A8.

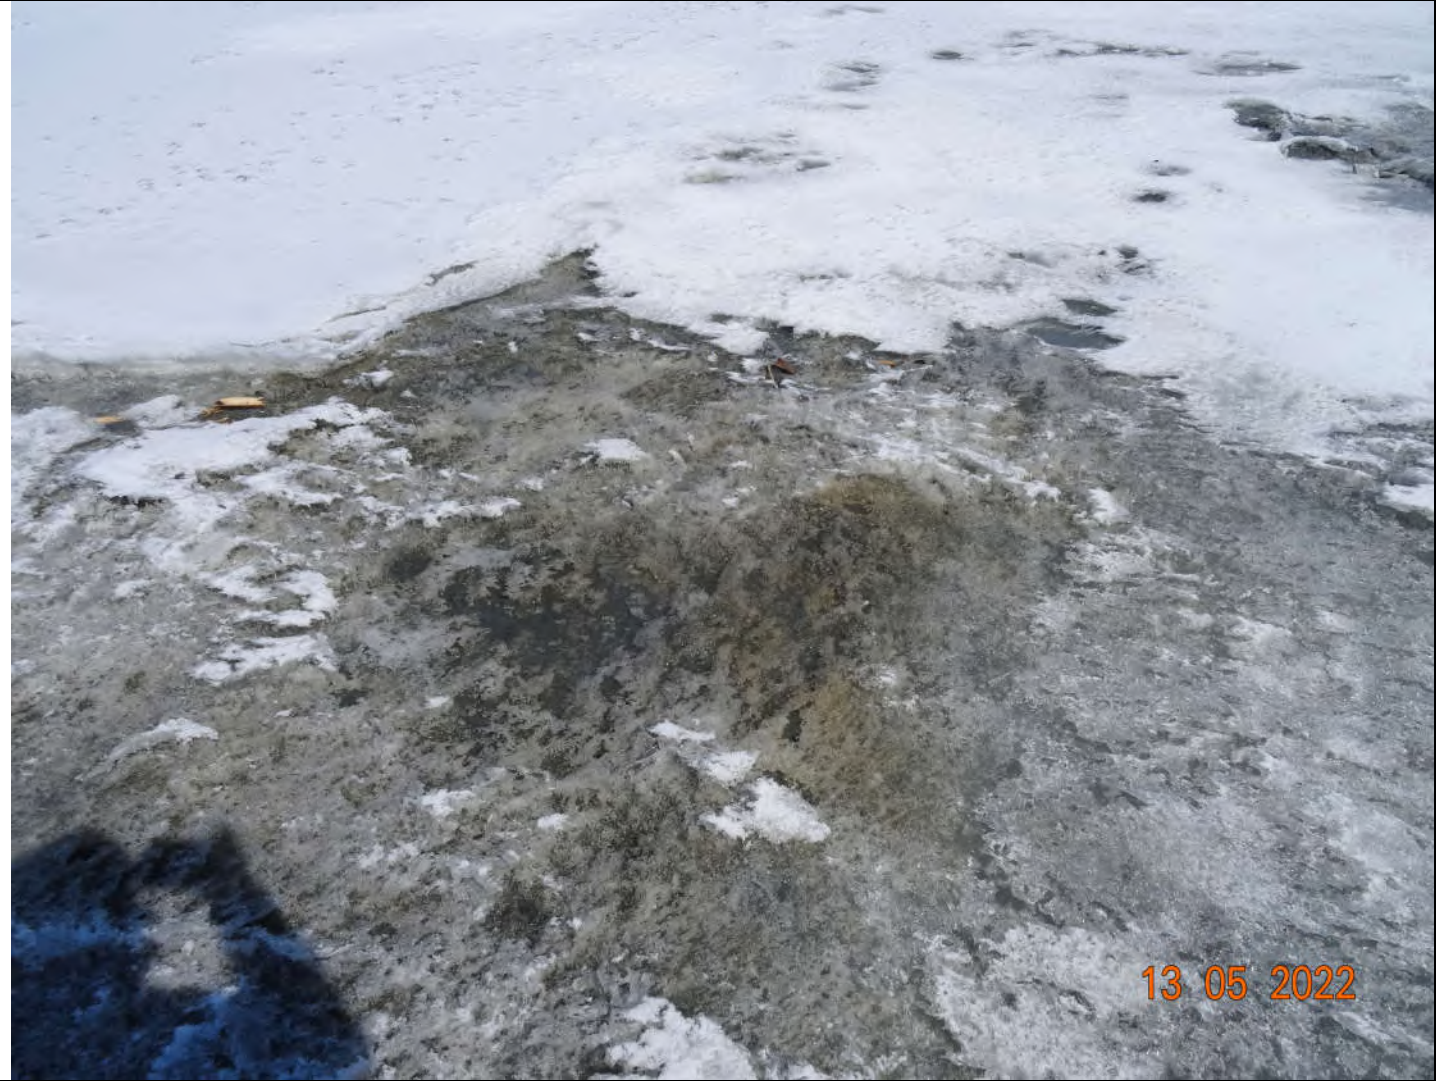
Photo 6

Grey, black, and yellow material on the surface of A8 Lake.

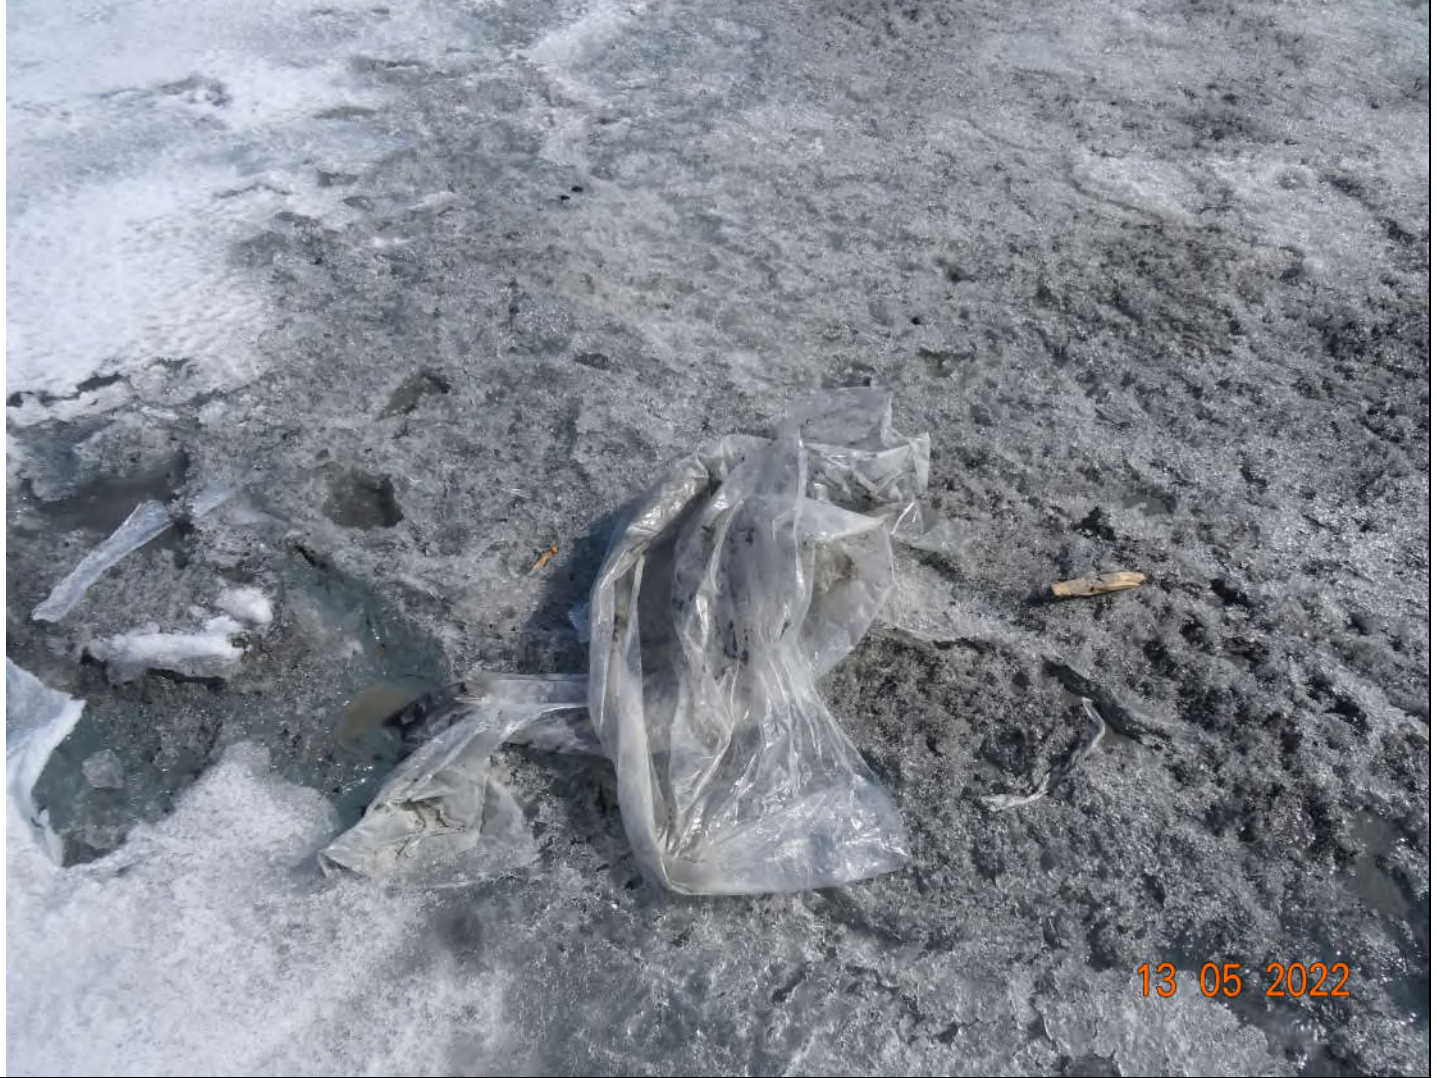
Photo 7

8. Garbage and wood debris is noted in a number of location on the surface of the ice (photo 7, 9, 11, 12, 19 and 18).
9. A drill rod is left sticking out through the surface of the Lake ice at N63° 00' 40.71", W92° 12' 33.42" (photo 20).

Garbage on the surface of A8 Lake.

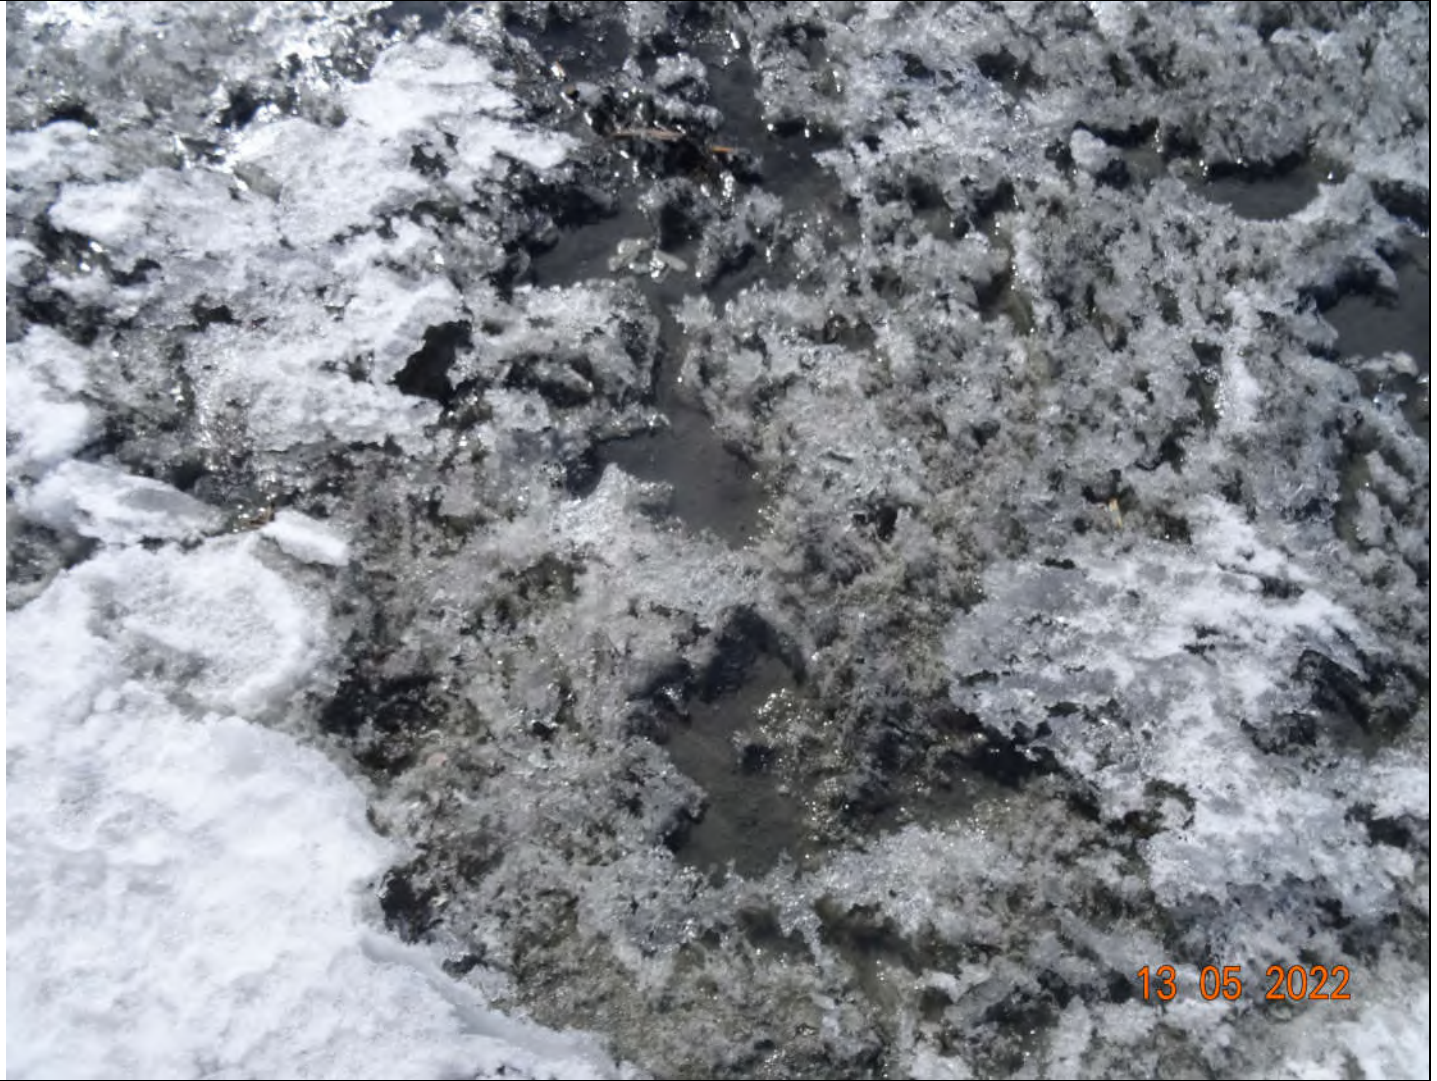
Photo 8

A layer of grey material under the snow which appears to be drill waste on the surface of the ice.

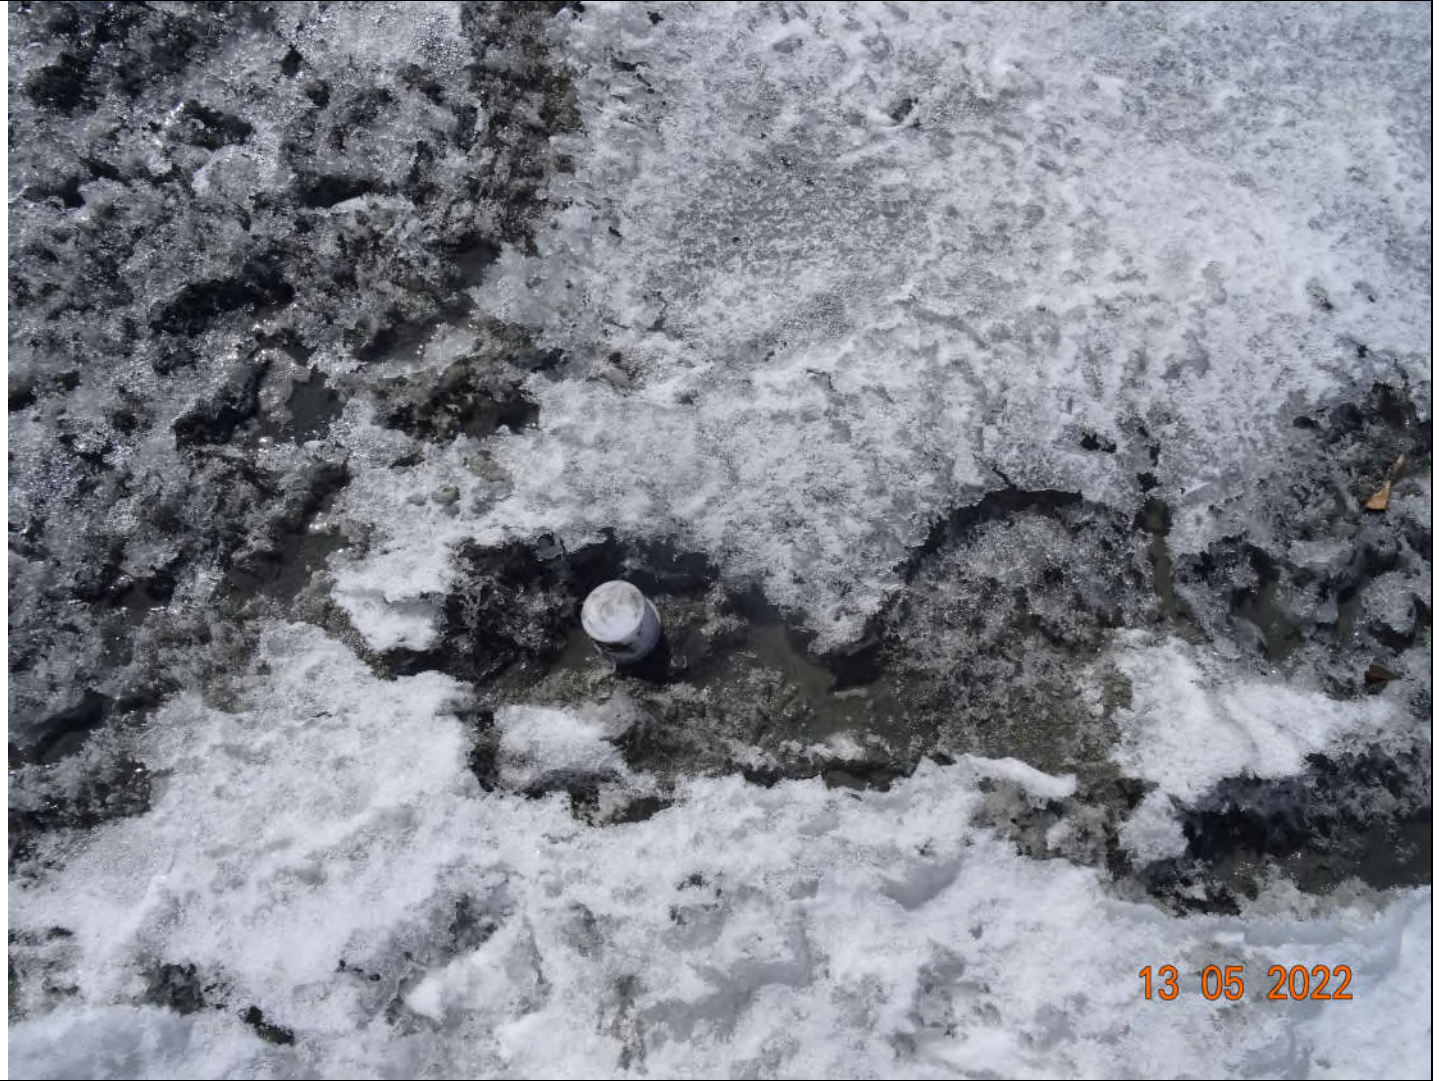
Photo 9

Grey material and garbage on the surface of the ice.

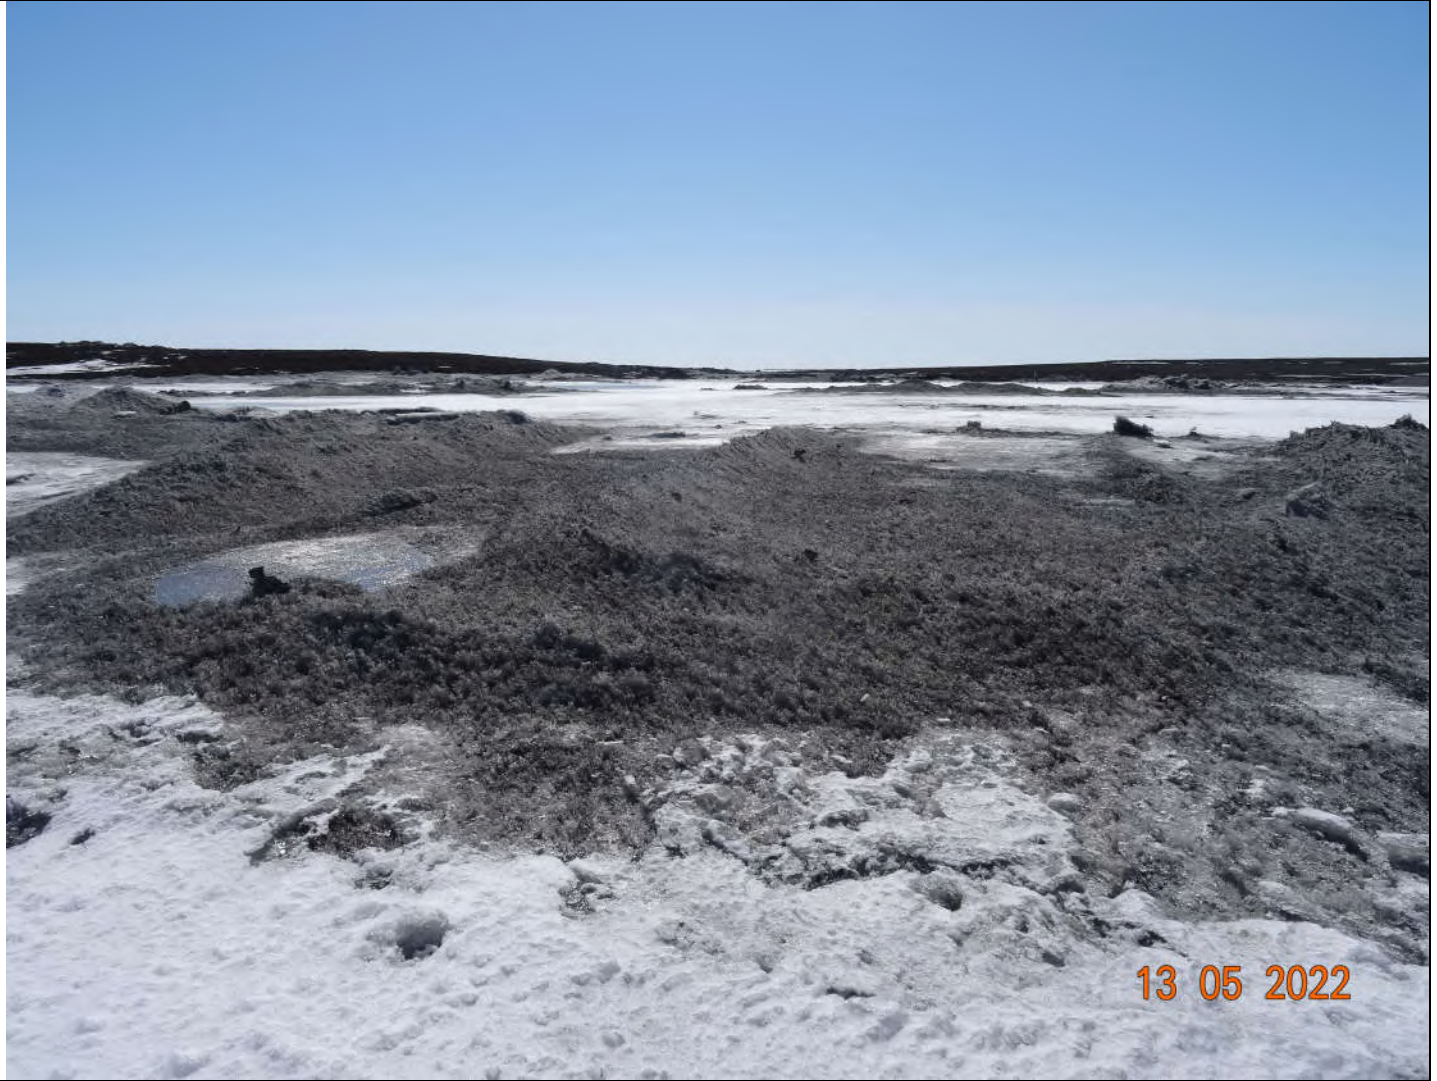
Photo 10

Grey material on the surface of Lake A8.

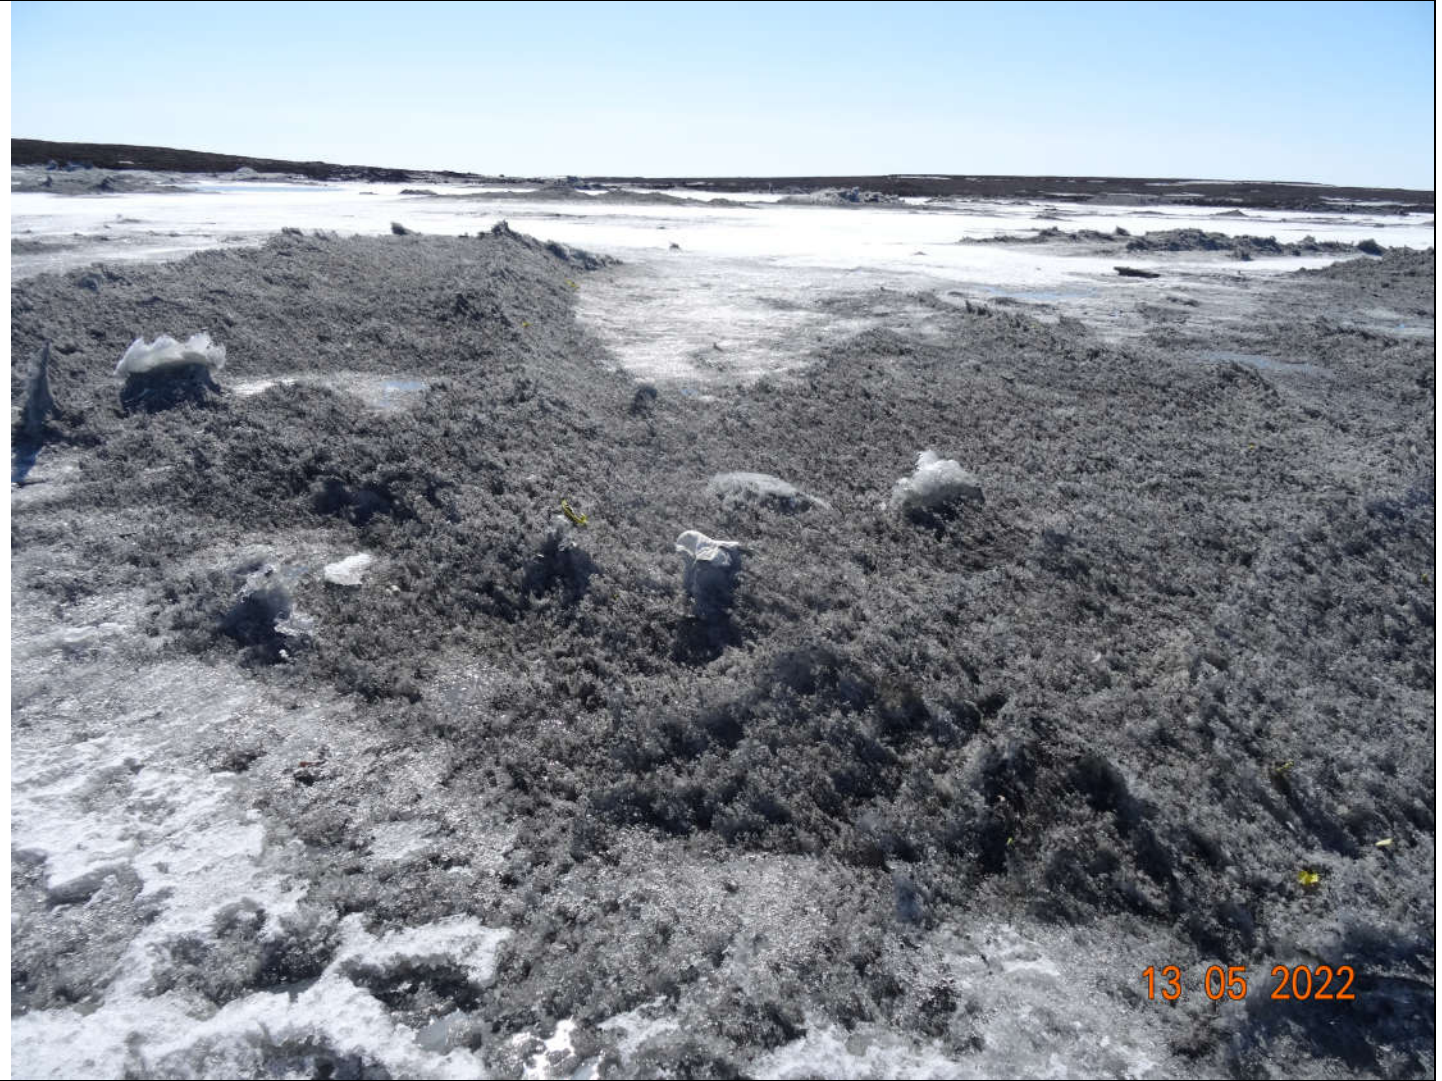
Photo 11

Grey materials and garbage on the surface of the Lake A8.

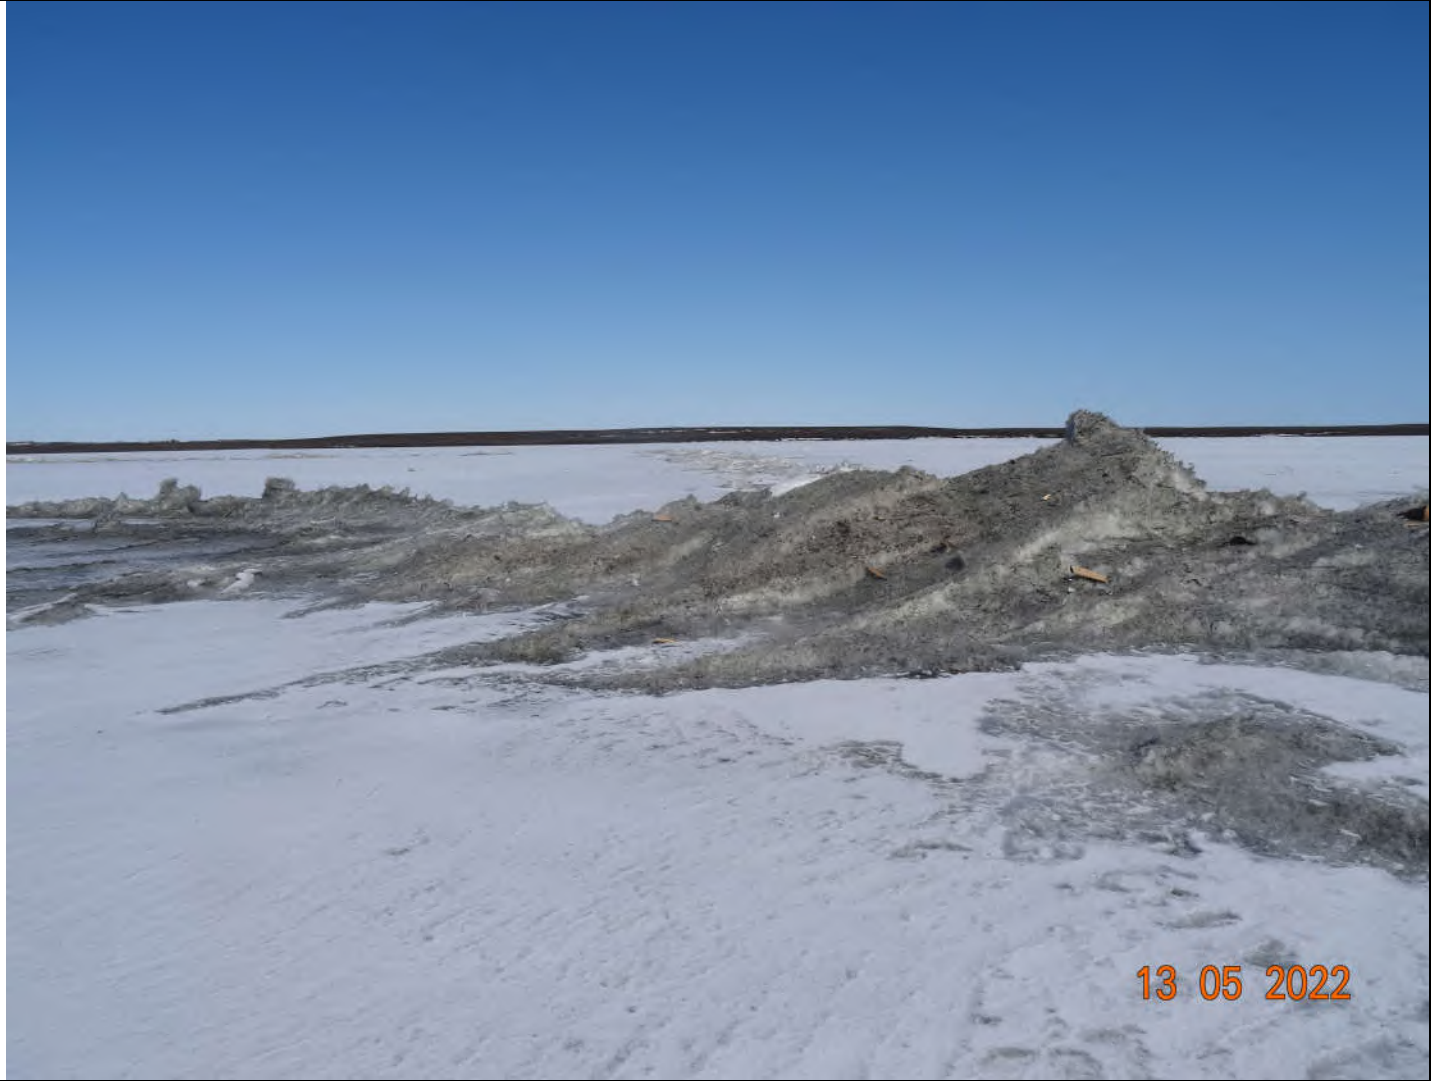
Photo 12

Grey material and garbage on the ice surface of Lake A8.

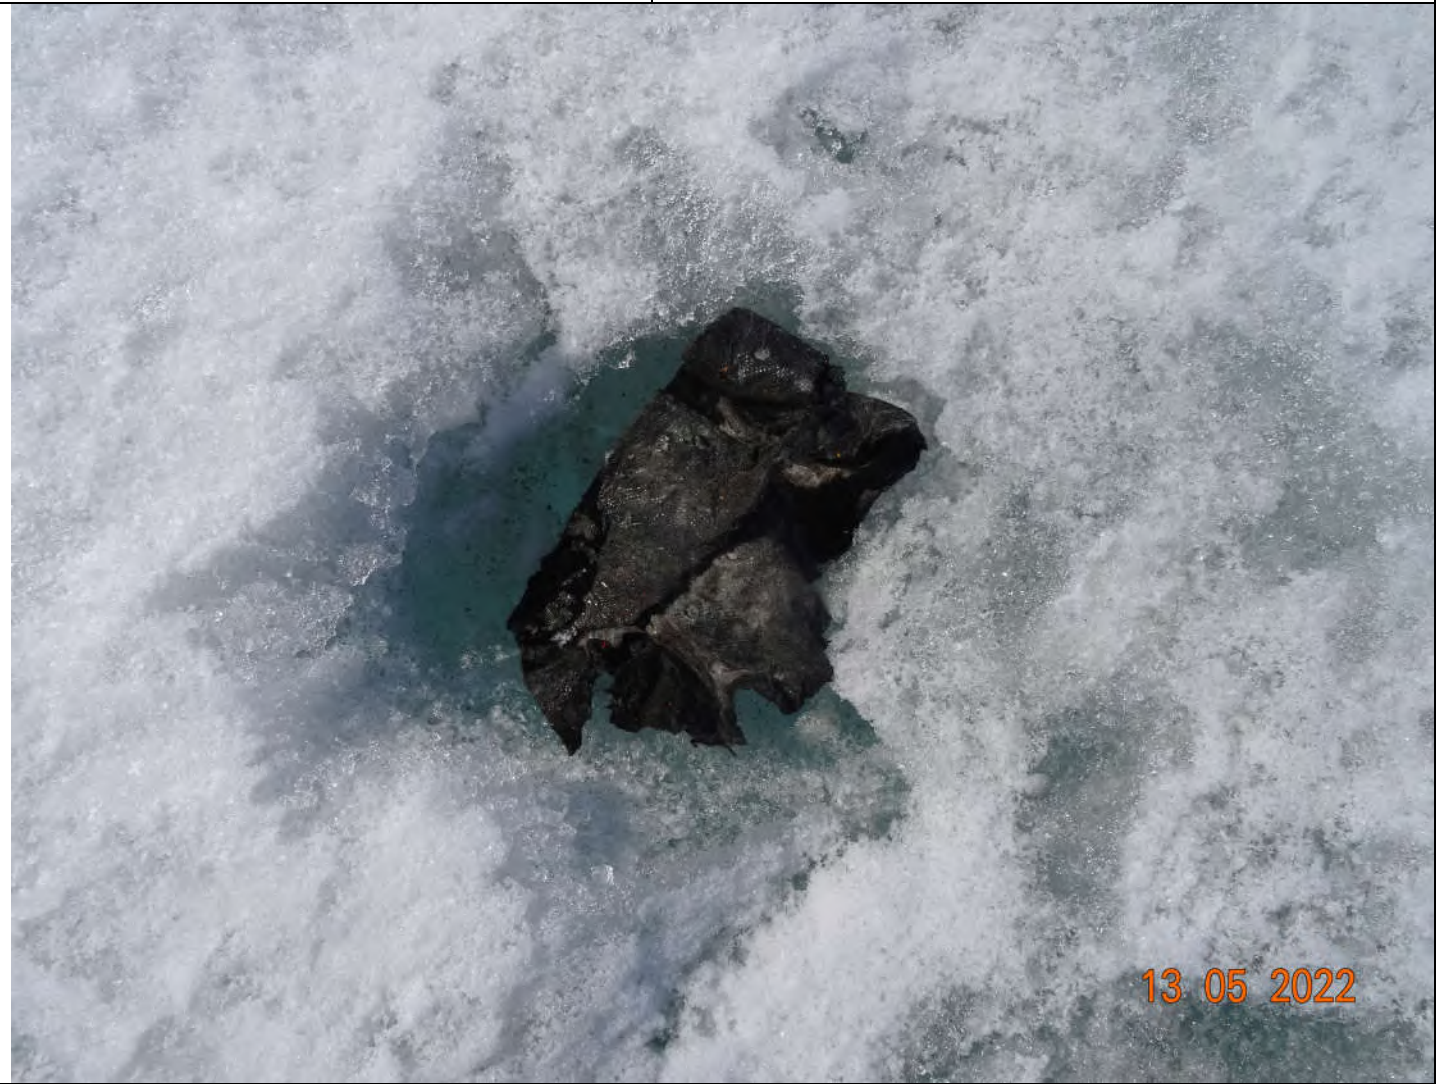
Photo 13

6. In multiple locations the smell of hydrocarbons is present (photo 13-16).
7. Oily rags are found in a number of locations on the surface of the ice (photo 13, 17-19).

Oily rags on the surface of Lake A8.

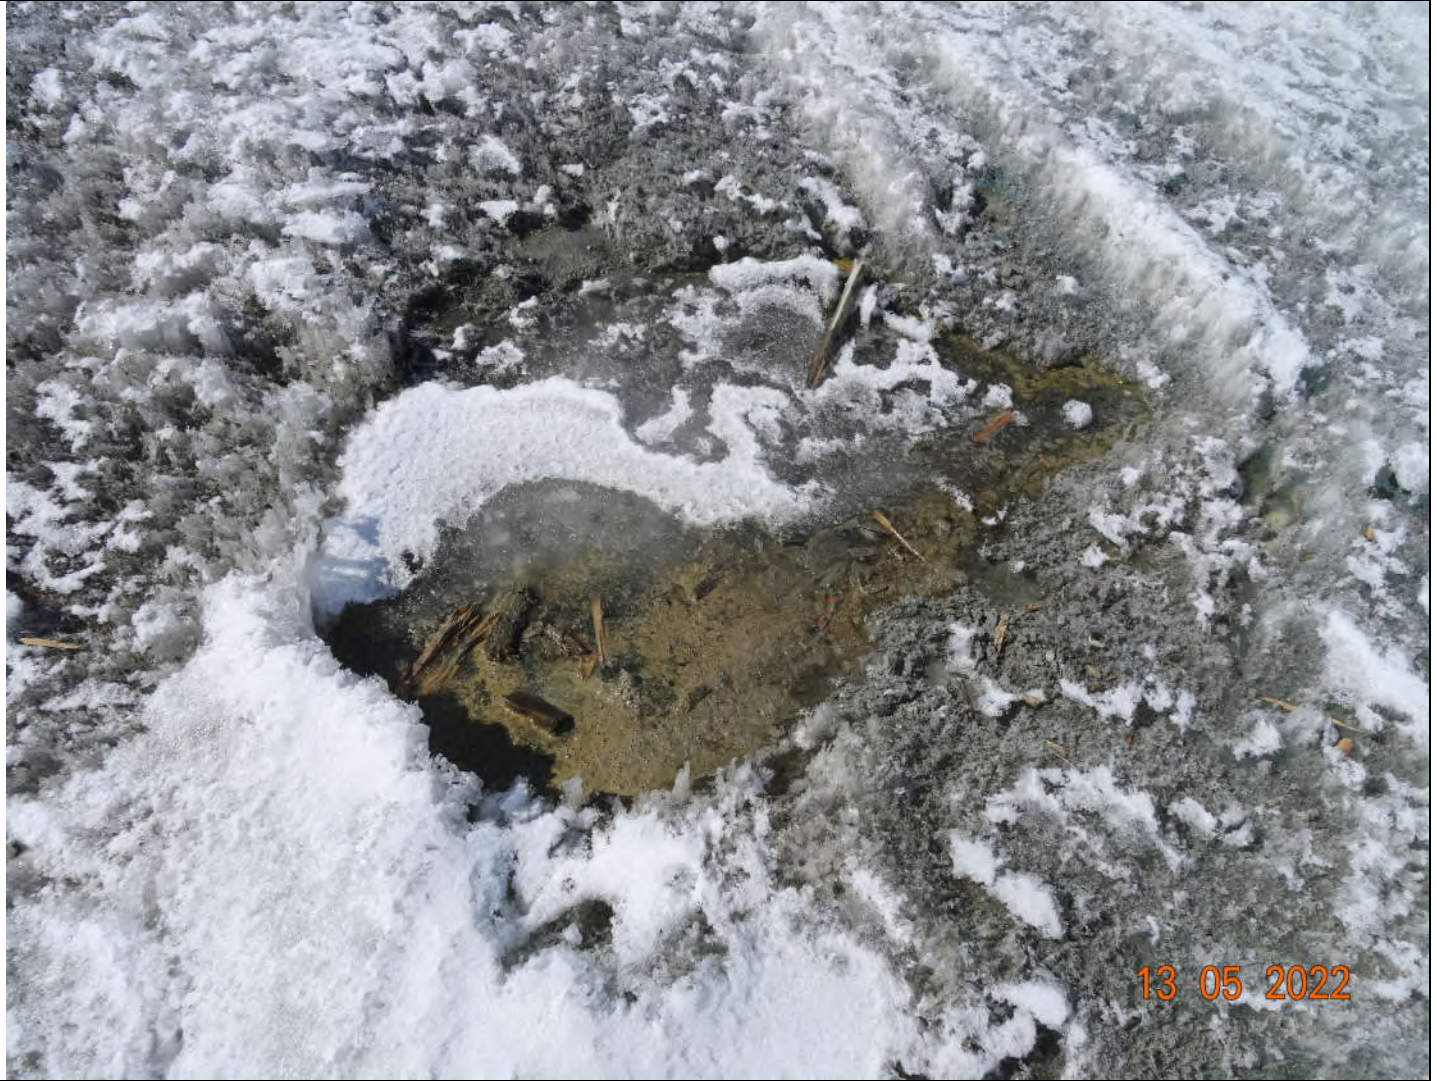
Photo 14

Unknown hydrocarbon on the surface of Lake A8.
