WATER LICENCE INSPECTION FORM

Original
 Follow-Up Report

On May 13th, an inspection of Agnico Eagle Mines Ltd.'s Meliadine Gold Project's Exploration Division was completed by Crown-Indigenous Relations and Northern Affairs Canada (CIRNAC)'s, Water Resources Officer, Christine Wilson (Inspector) and Kyle Amsel. The May 13th inspection was conducted as a follow up to the April 19th inspection (report no. 2022-KIV02-CW) to ensure compliance with applicable terms and conditions of water licence no. 2BB-MEL1424.

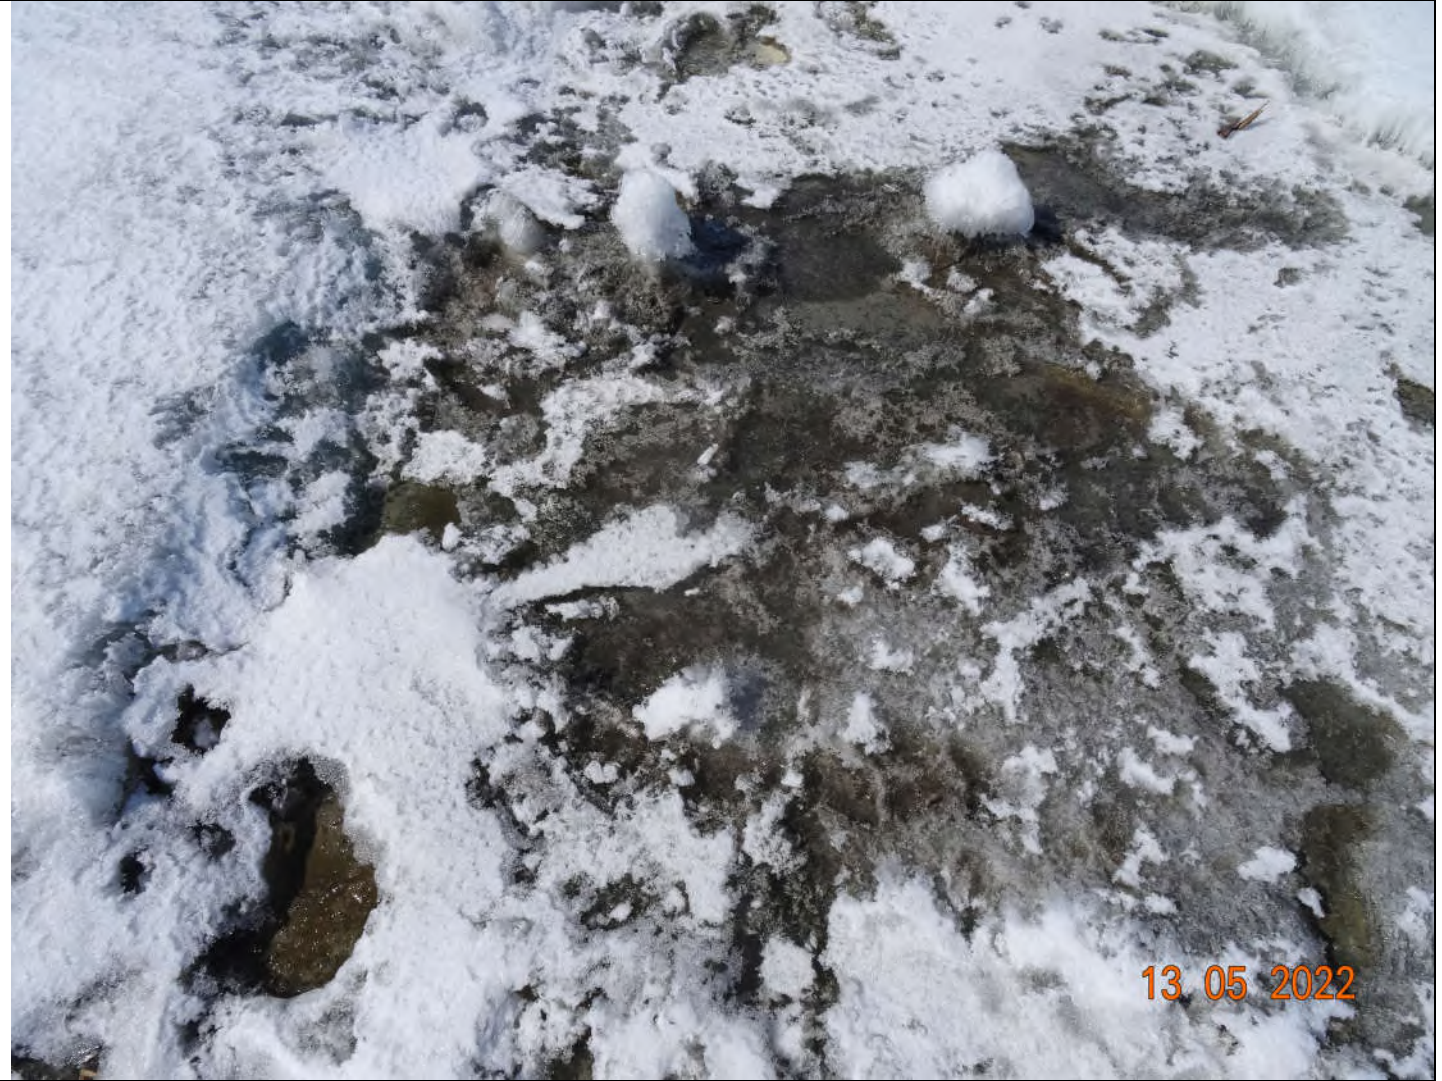
Photo 15

6. In multiple locations the smell of hydrocarbons is present (photo 13-16).
7. Oily rags are found in a number of locations on the surface of the ice (photo 13, 17-19).

Unknown hydrocarbon, smell of diesel fuel, on the surface of A8 Lake.

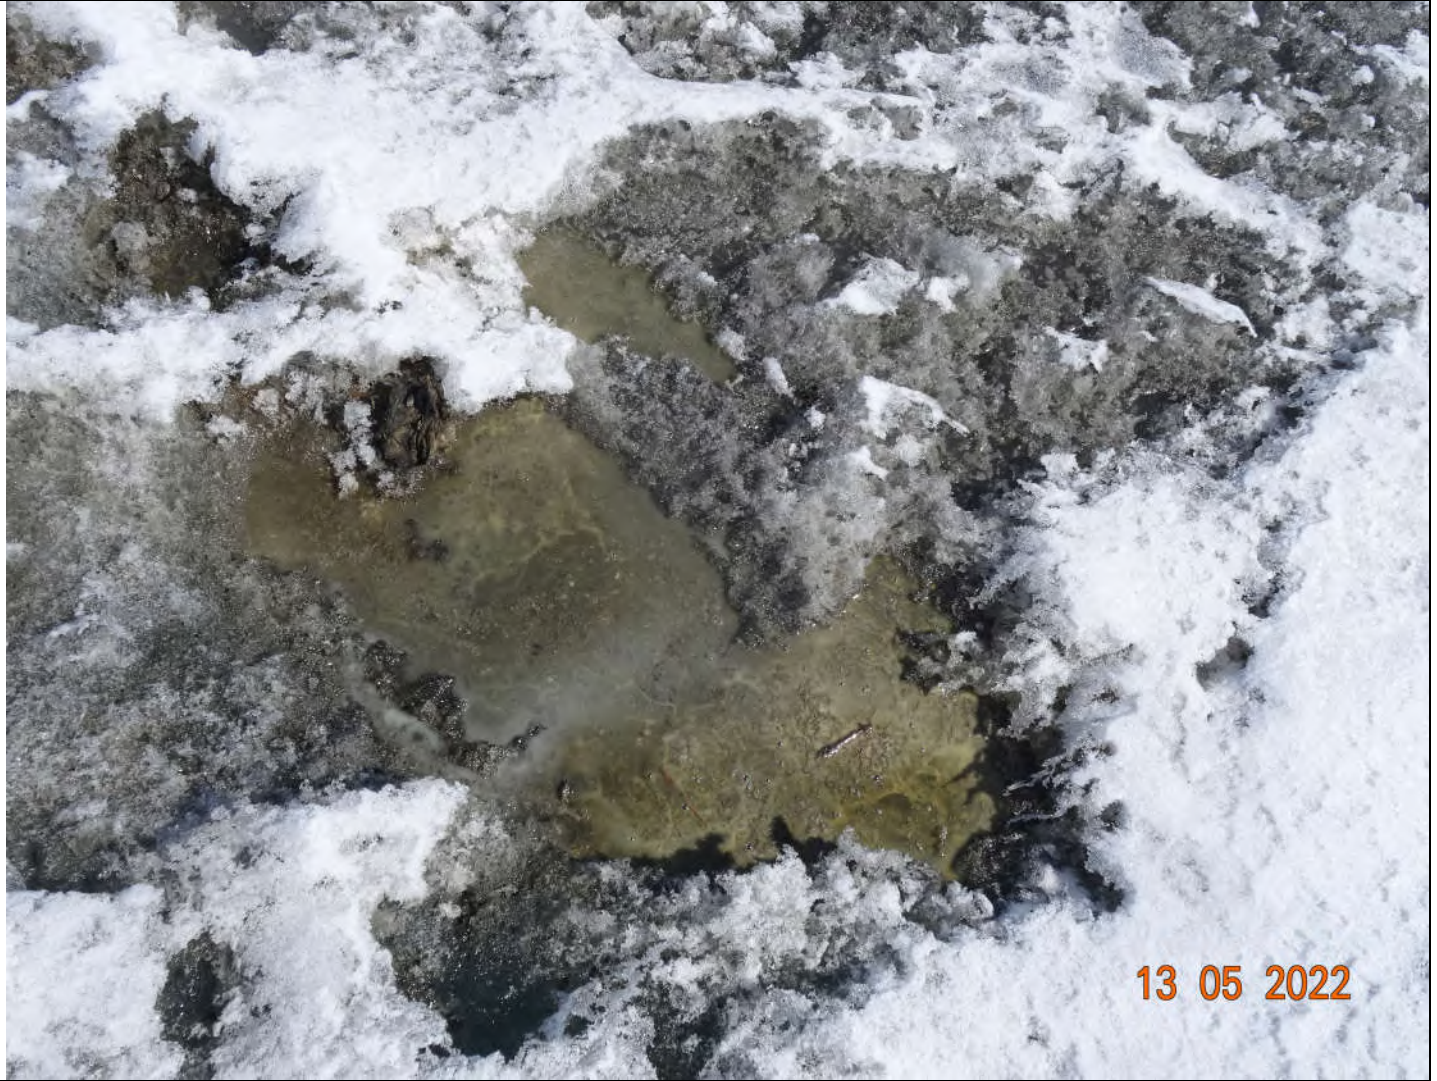
Photo 16

Unknown white material and oily rag in a pool of water on the surface of A8 Lake.

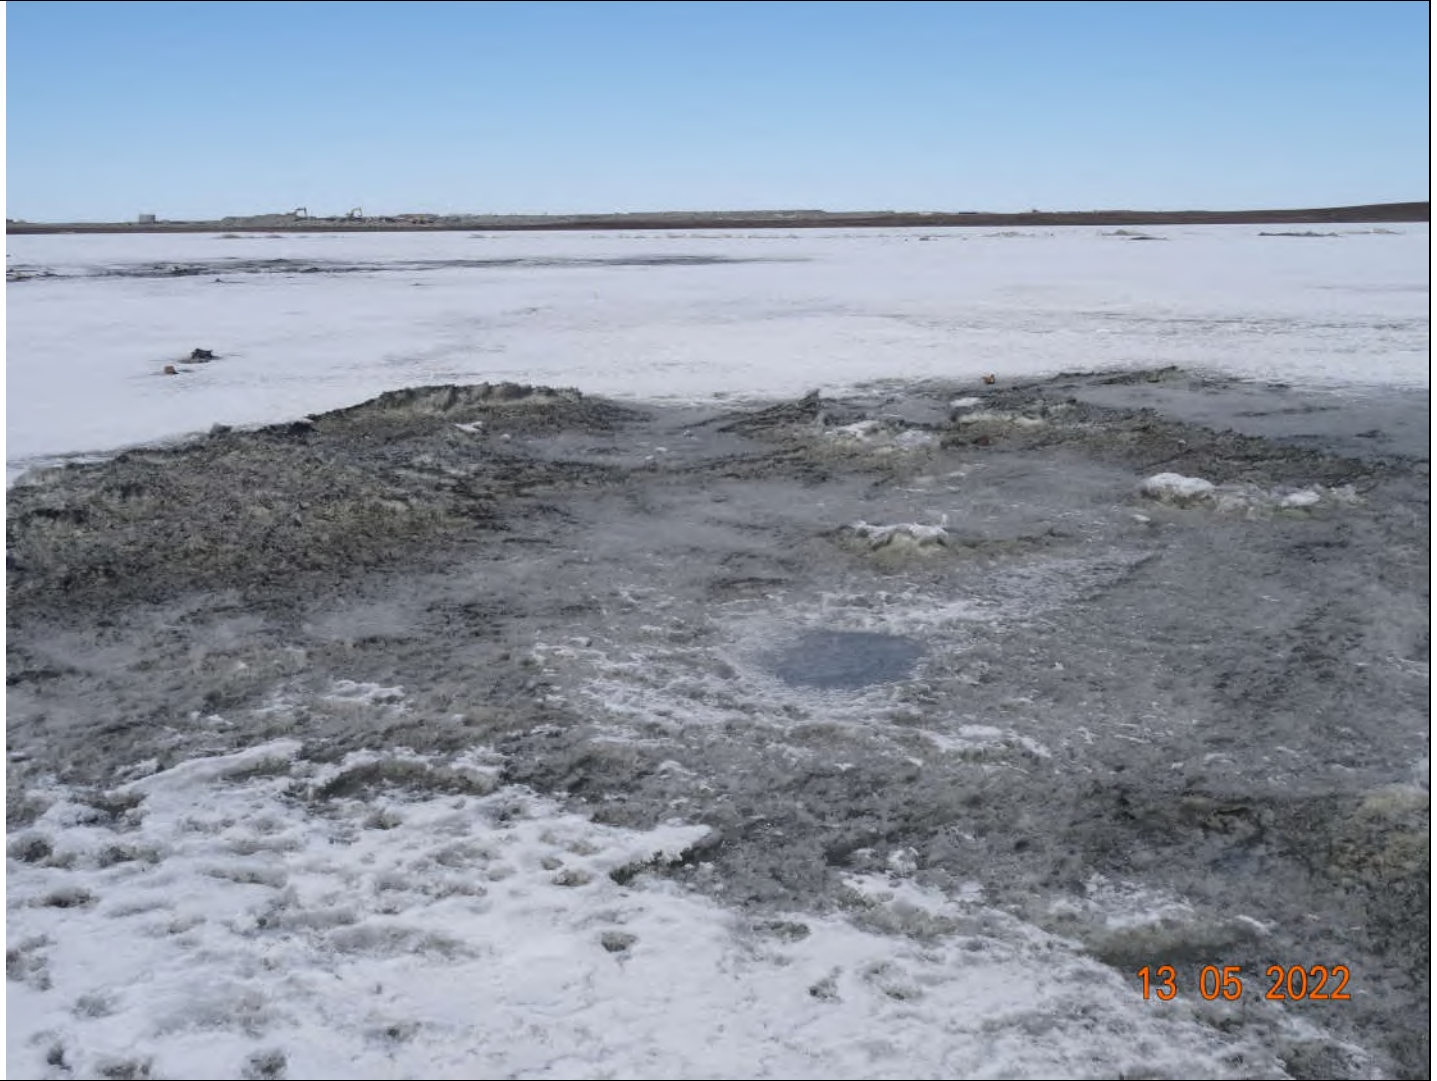
Photo 17

5. Within the piles of snow are pools of water on the surface of the ice that are filled with unknown grey, black, yellow and white materials (photo 2-12 and 17).

Drill site clean up on the surface of A8 Lake.

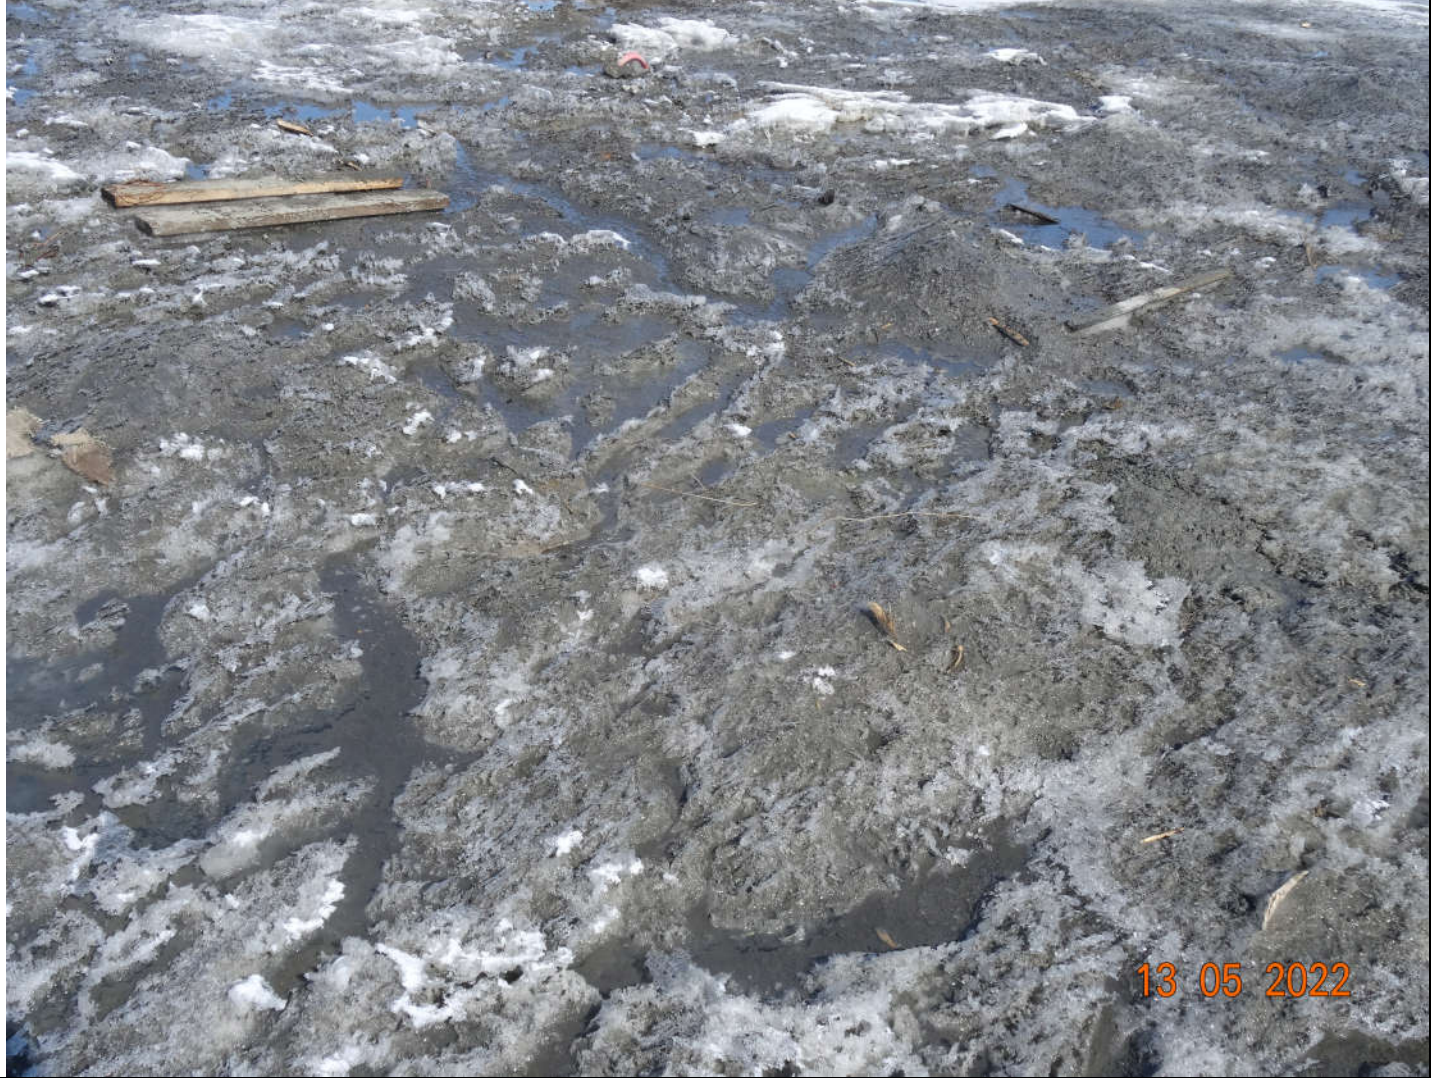
Photo 18

8. Garbage and wood debris is noted in a number of location on the surface of the ice (photo 7, 9, 11, 12, 19 and 18).
9. A drill rod is left sticking out through the surface of the Lake ice at N63° 00' 40.71", W92° 12' 33.42" (photo 20).

Garbage and grey material on the surface of the A8 Lake.

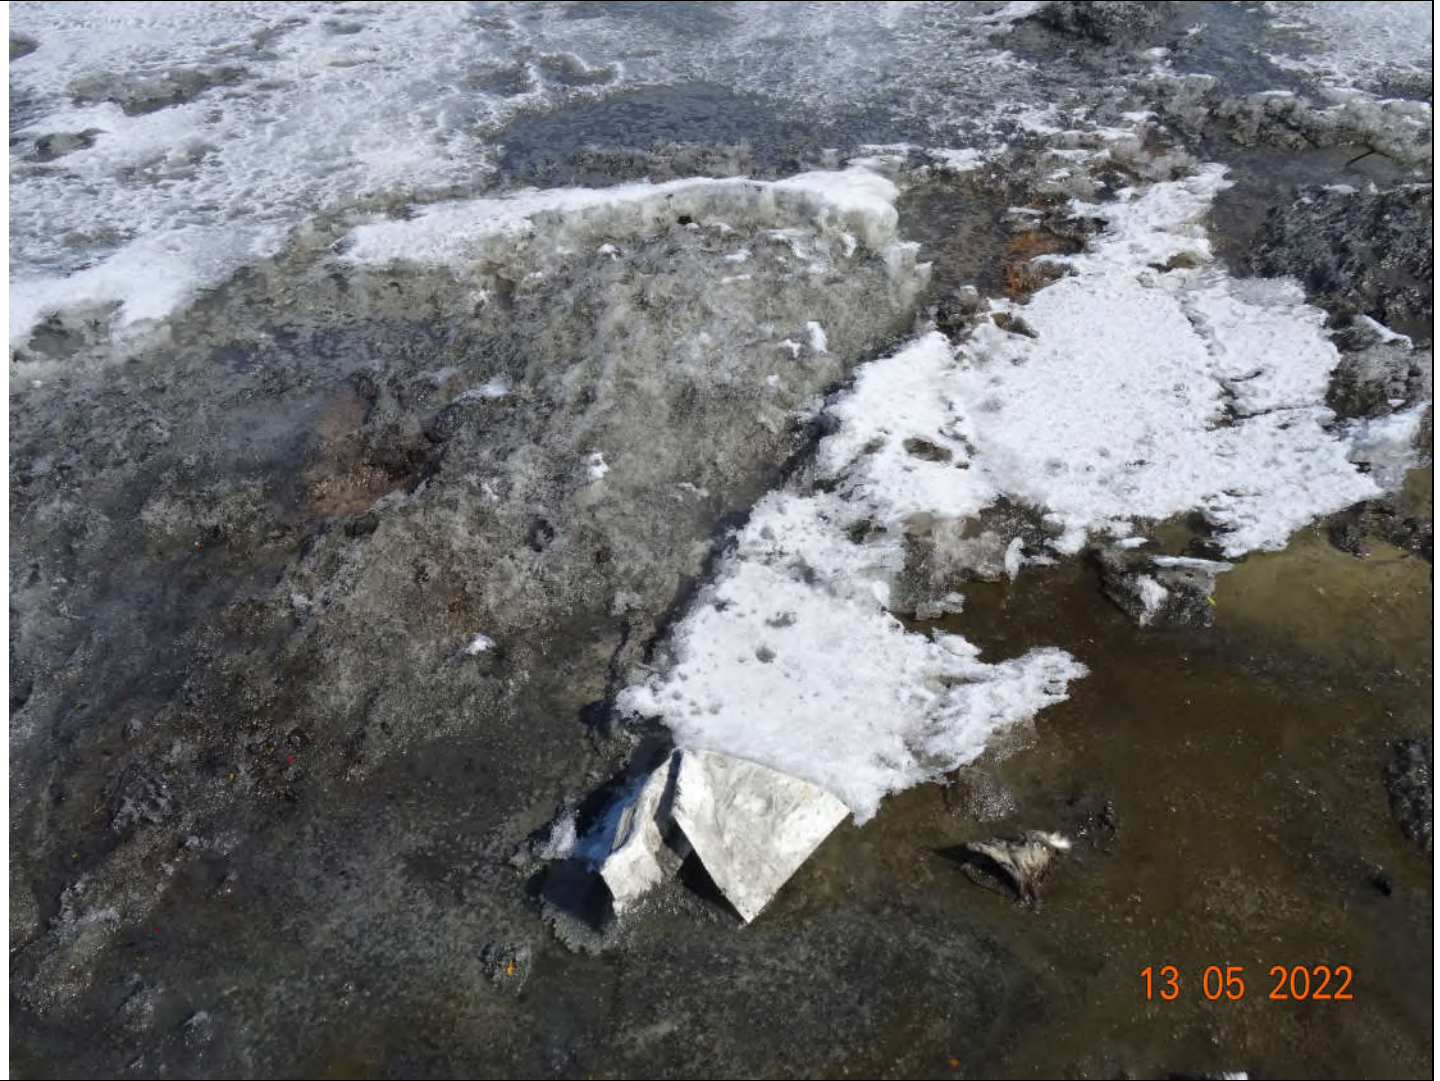
Photo 19

Unknown hydrocarbon, white materials, drilling waste and oily rags on the surface of A8 Lake.

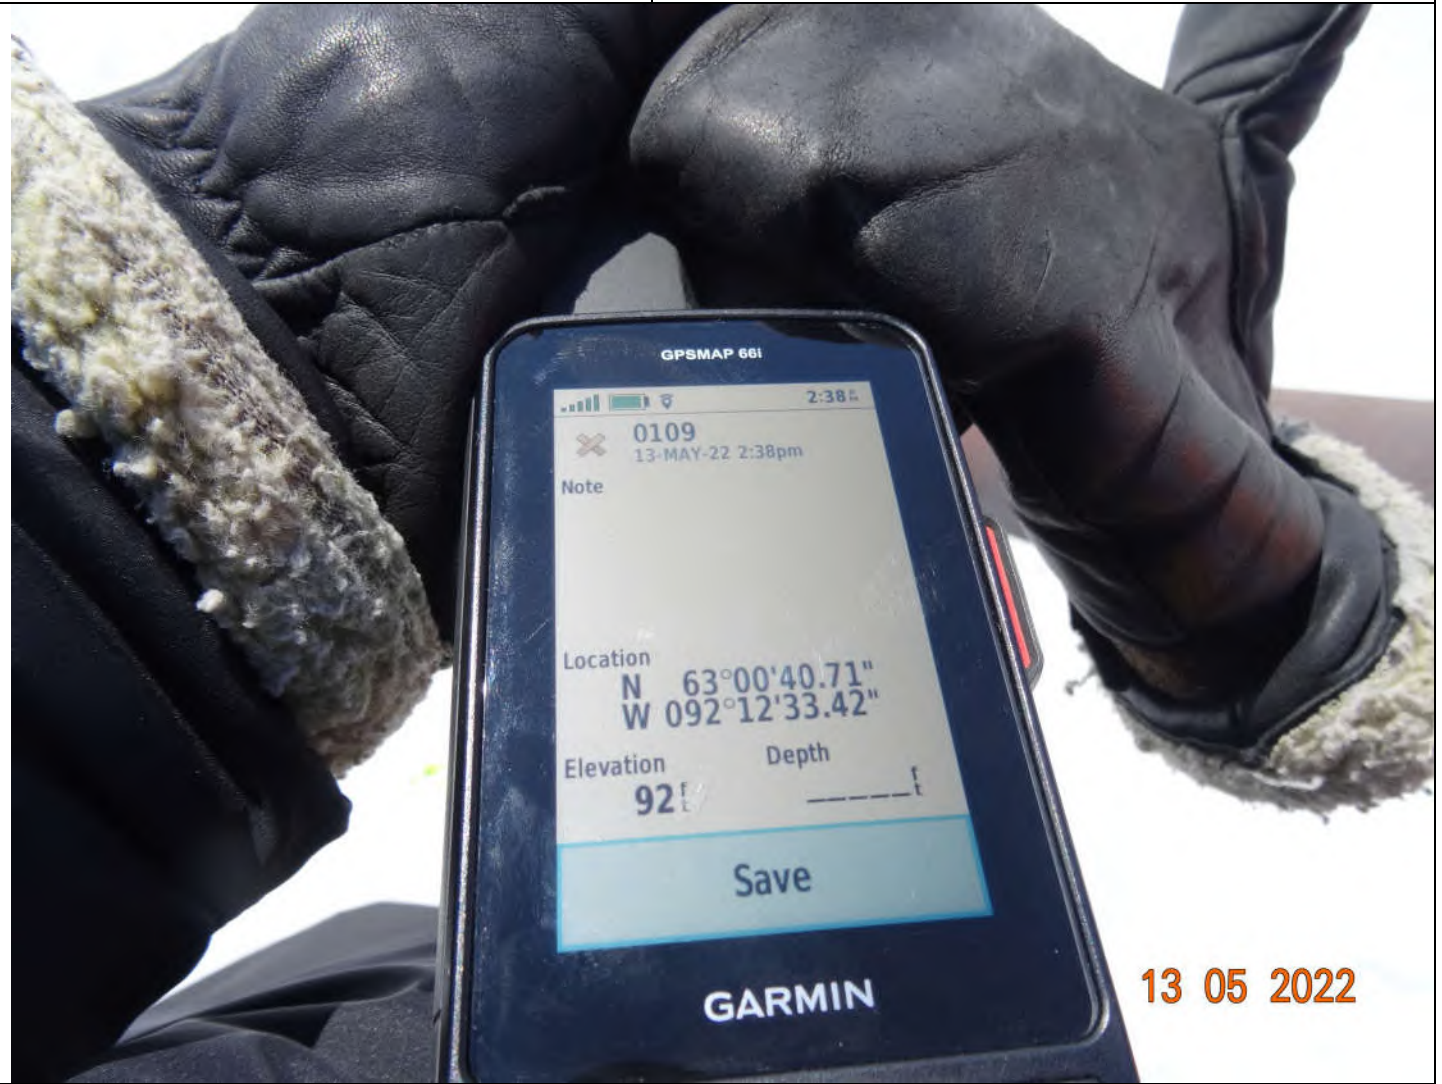
Photo 20

Location of a drill rod and casing exposed through the surface of the ice A8 Lake.

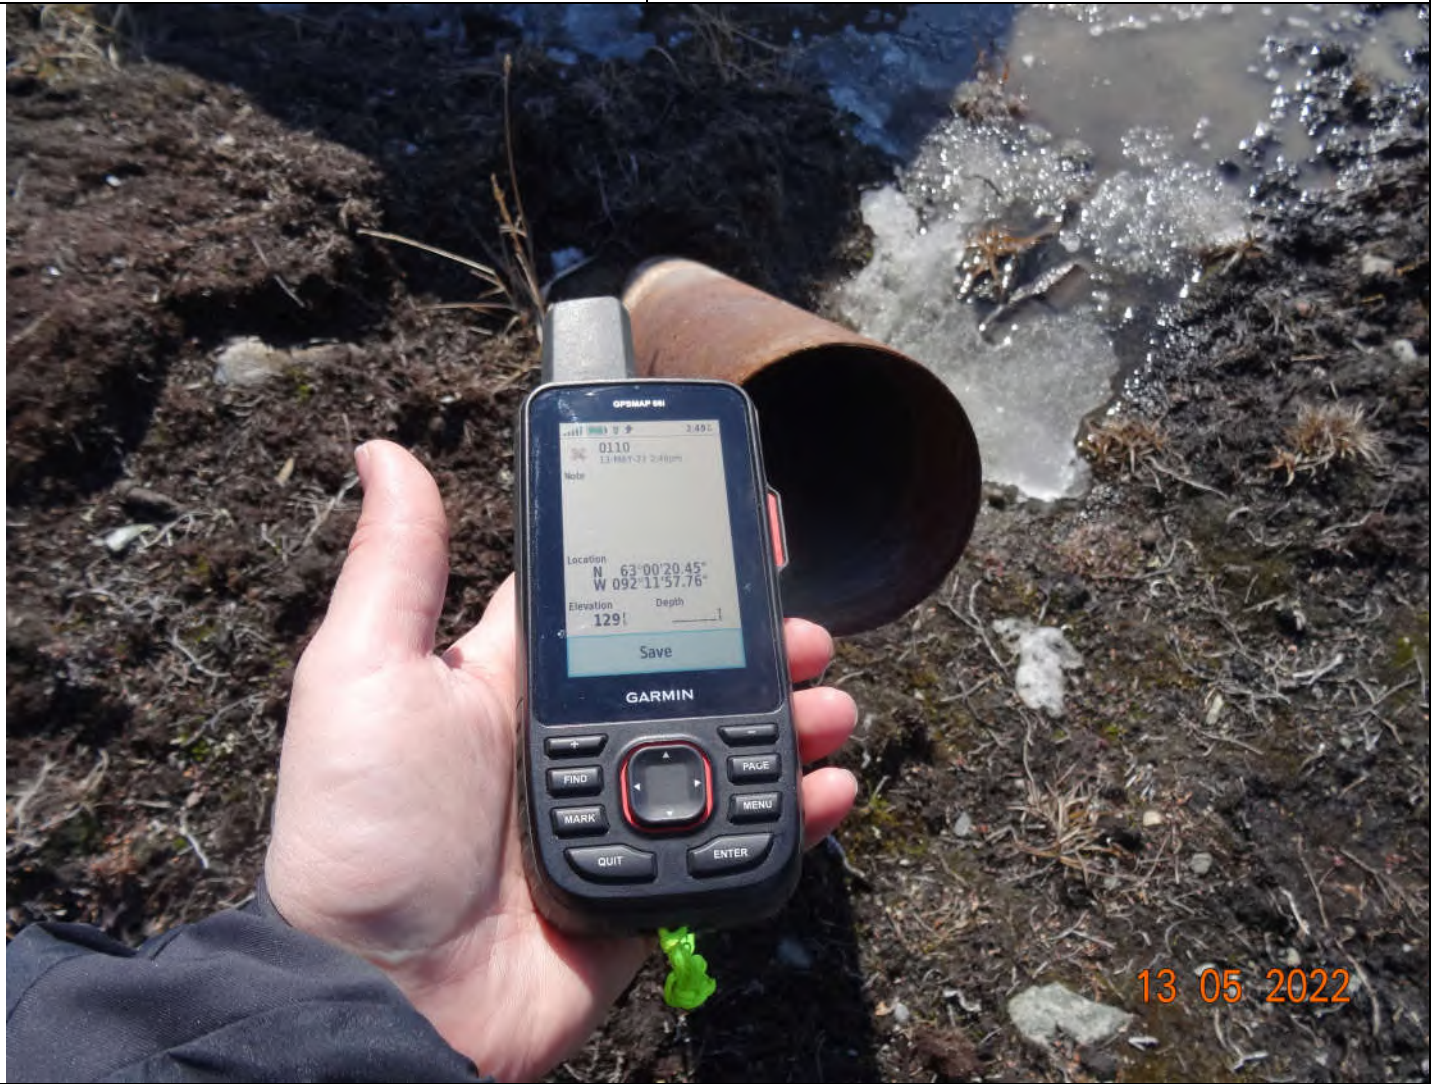
Photo 21

10. A drill collar is left sticking out the ground at N63° 00' 20.45", W92° 11' 57.76"(photo 21).

Location of a drill casing on the shores of A8 Lake.
