WATER LICENCE INSPECTION FORM

Licensee	Licensee Representative
Agnico Eagle Mines Limited	Brett Fairbairn
Licence No. / Expiry	Representative's Title
2BB-MEL1424/ July 21 st , 2024	Environment Coordinator
Date of Inspection	Inspector
May 18 th , 2022	WRO Wilson
Activities Inspected	
<input type="checkbox"/> Camp <input checked="" type="checkbox"/> Drilling <input type="checkbox"/> Mining <input type="checkbox"/> Construction <input type="checkbox"/> Reclamation <input type="checkbox"/> Fuel Storage <input type="checkbox"/> Roads/Hauling <input checked="" type="checkbox"/> Other: Spill <input type="checkbox"/> Other:

The May 18th inspection was conducted as a follow up to the inspections on April 19th (report no. 2022-KIV02-CW) and the May 13th (report no. 2022-KIV03-CW) to ensure compliance with applicable terms and conditions of water licence no. 2BB-MEL1424.

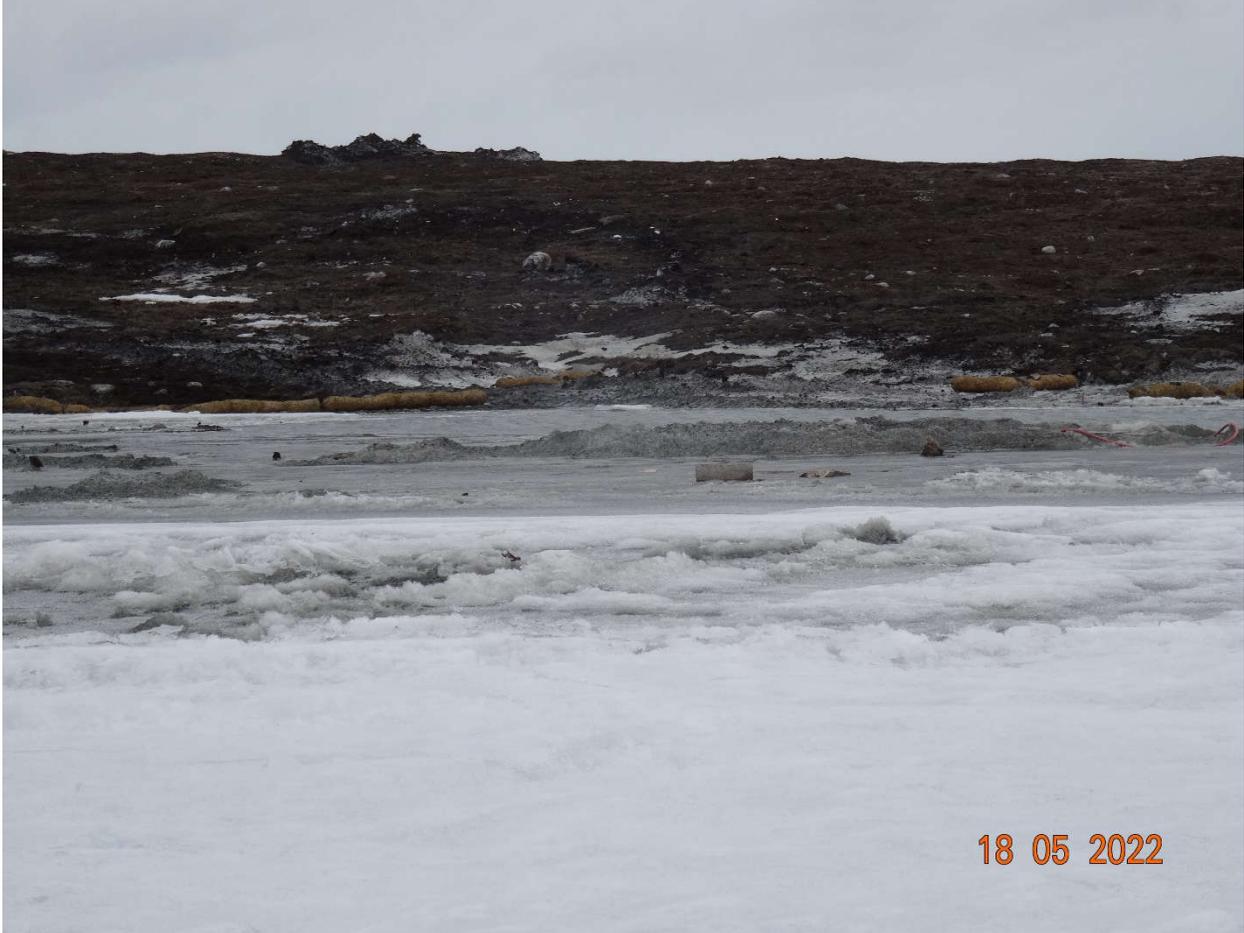
Photo No.	Lat/Long (DD.MM.SS.SS, NAD83)
Photo 1	Not available

Description: Materials on the surface on Lake A8
--

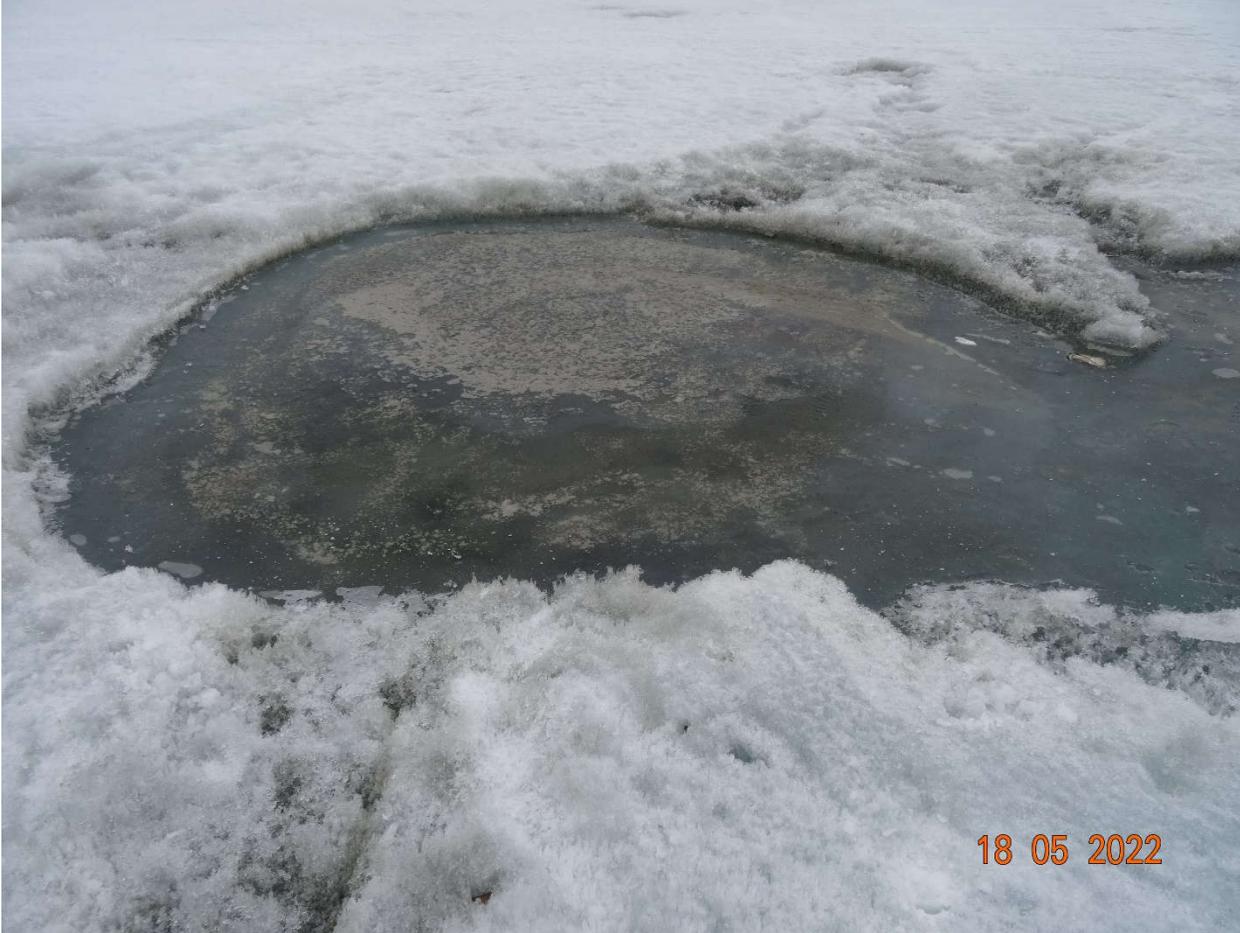
Photo 2

Sampling location A8-02

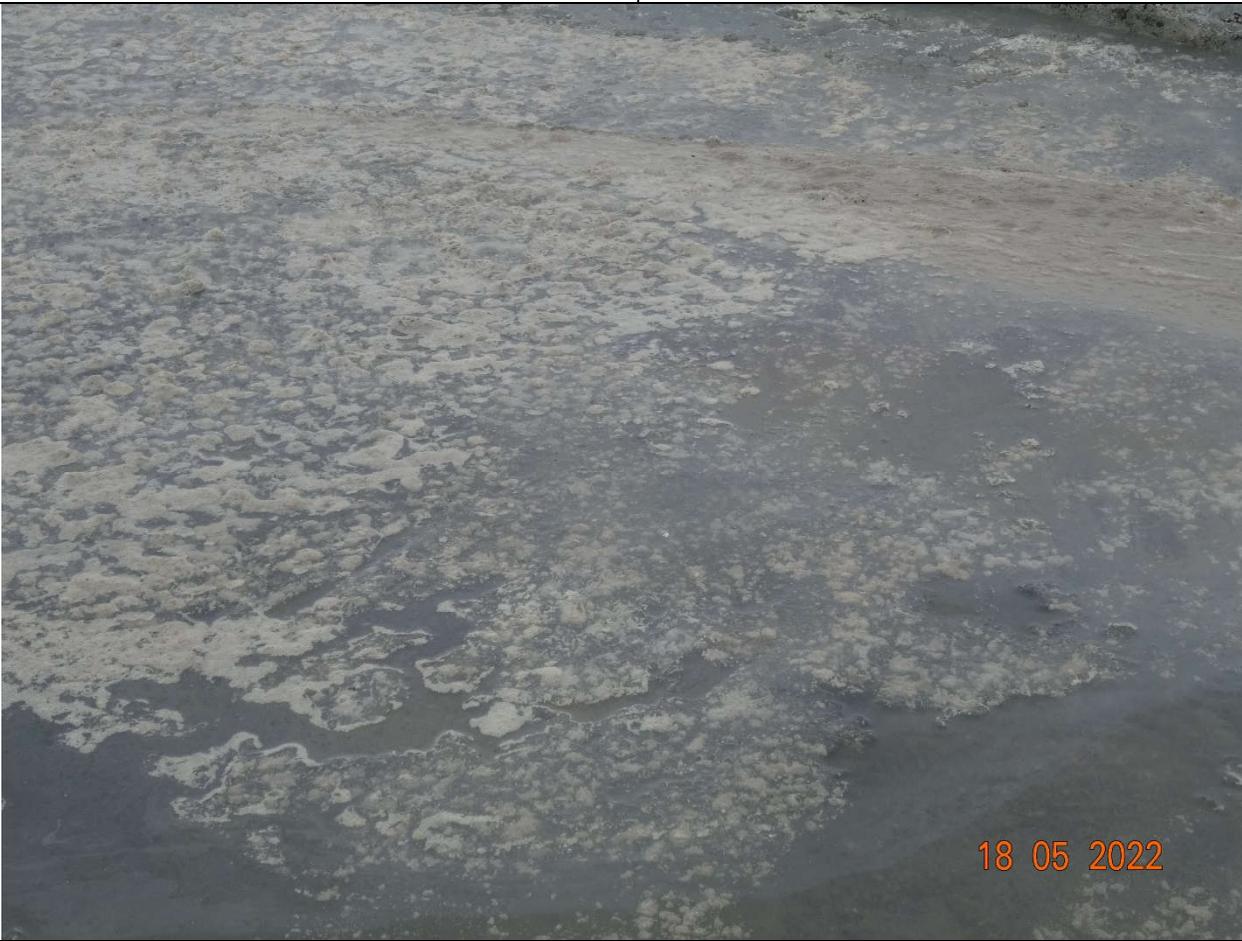
Photo No.	Lat/Long (DD.MM.SS.SS, NAD83)
Photo 3	63° 0' 34"N 92° 12' 11.90"W

Sample Name:	Locations:	Notes:
A8-01	N63° 00' 32.90", W92° 12' 09.65"	Pool of water on surface of the ice, grey material settled on the bottom of the pool, smells of fuel.
A8-02	N63° 00' 33.36", W92° 12' 10.88"	Pool of water on the surface of ice, visible sheen.
A8-03	N63° 00' 42.25", W92° 12' 24.98"	The water appears to be turbid and grey in colour, pooled inside the snow piles on the surface of ice.
A8-04	N63° 00' 42.40", W92° 12' 22.76"	Pool of water on surface of the ice, water appears turbid and is grey in colour.

Description:	
A8-02 visible sheen

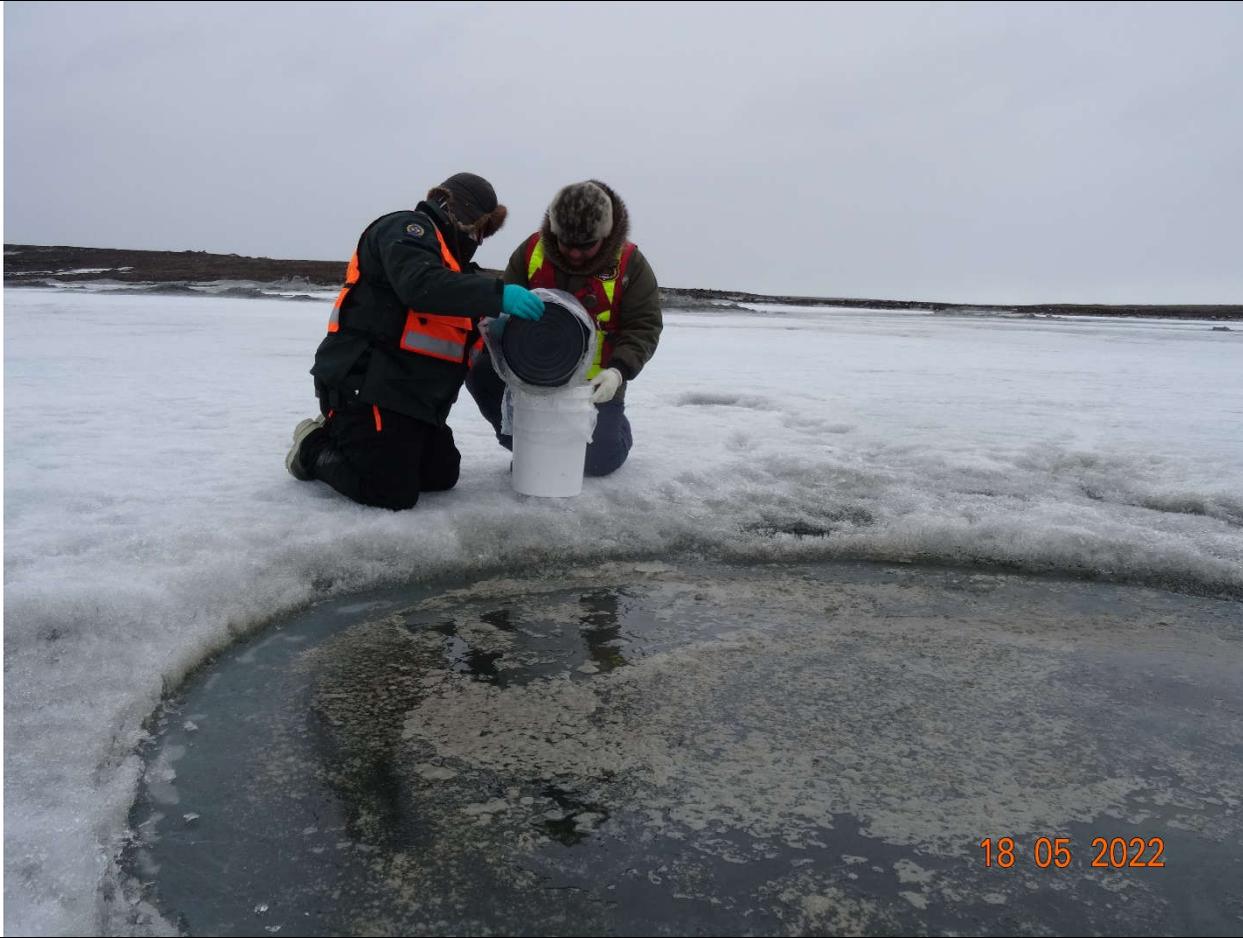
Photo 4

Filling clean lined bucket A8-02

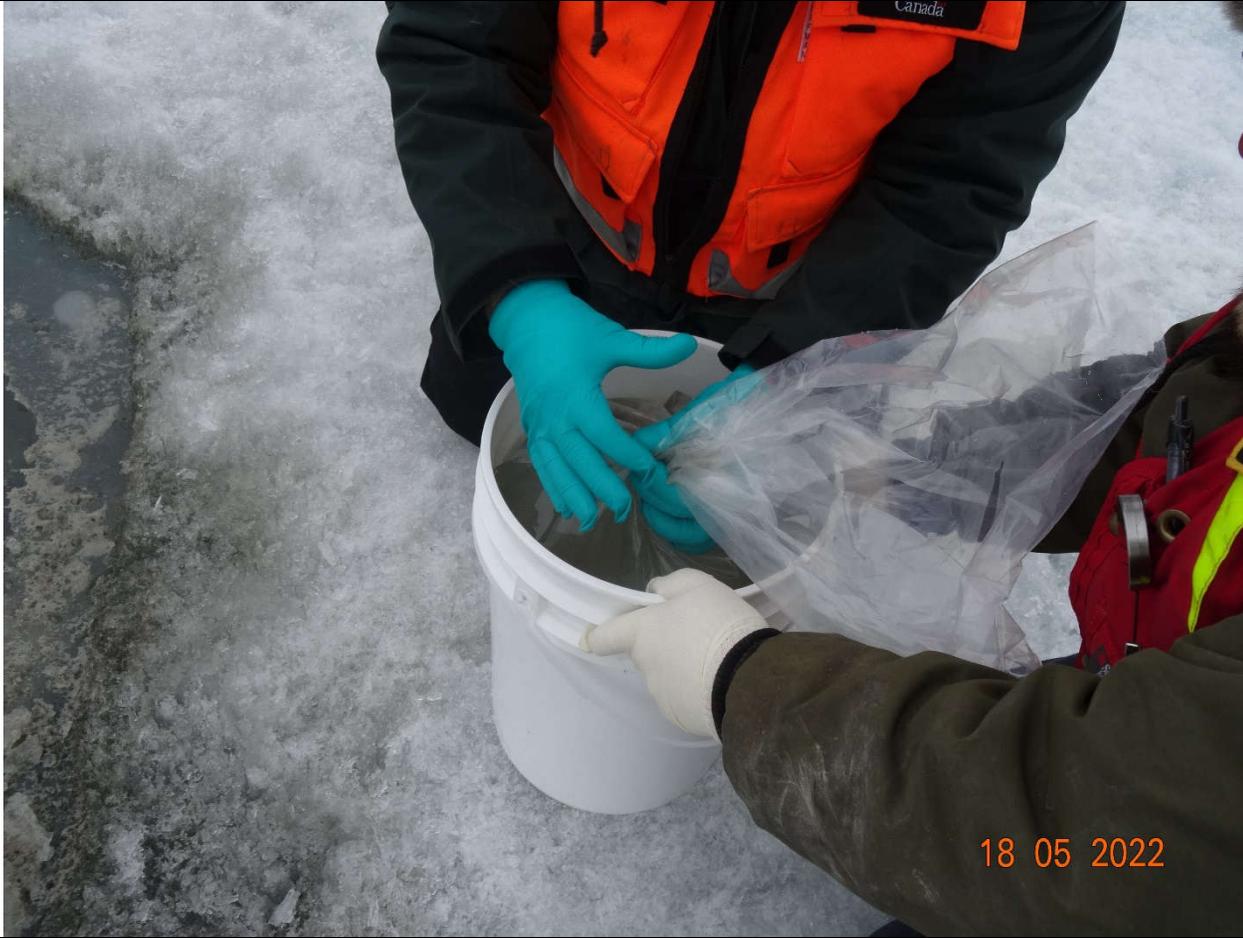
Photo 5

Sealing liner in bucket A8-02

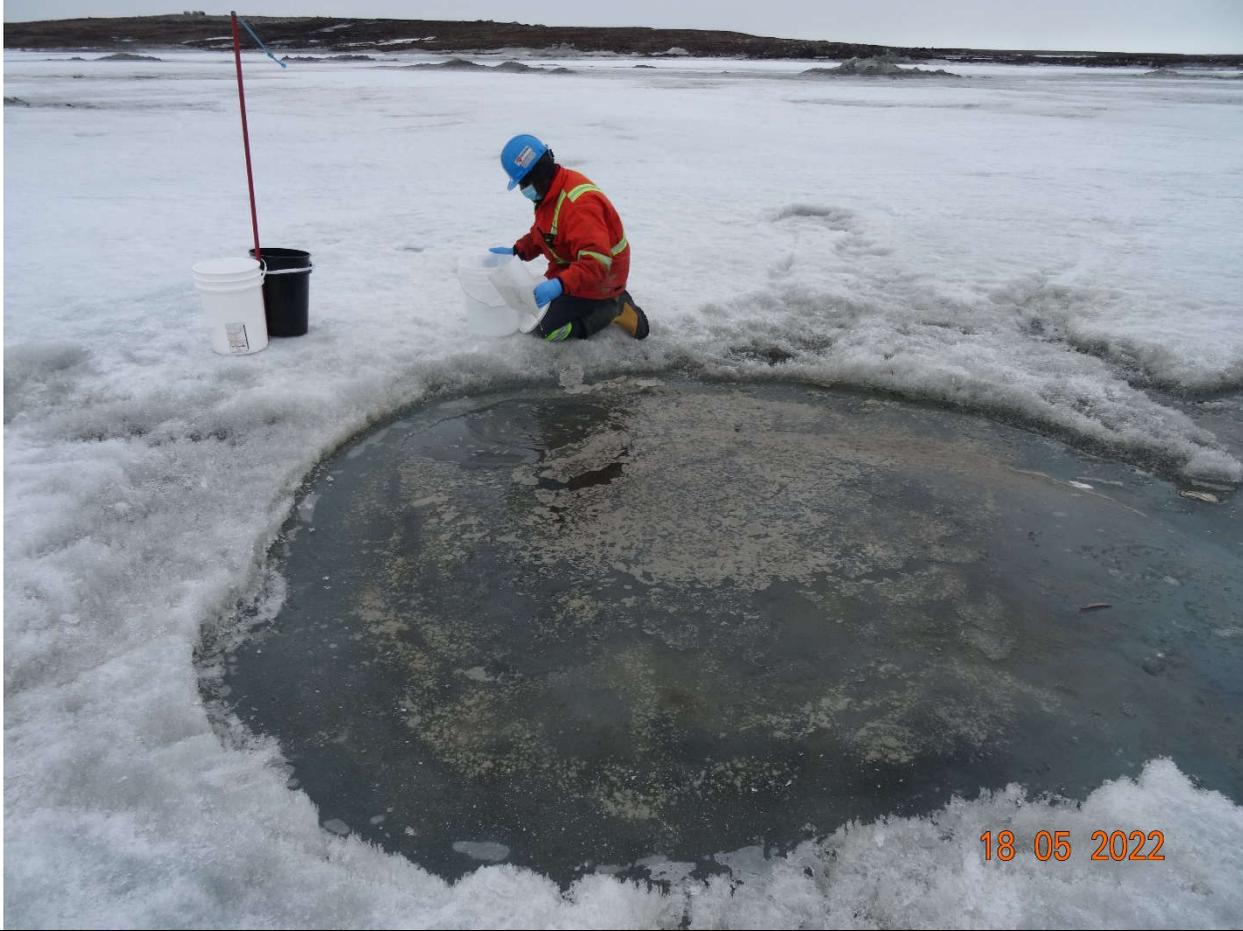
Photo 6

AEM Representative Daphne Morin collecting samples at A8-02

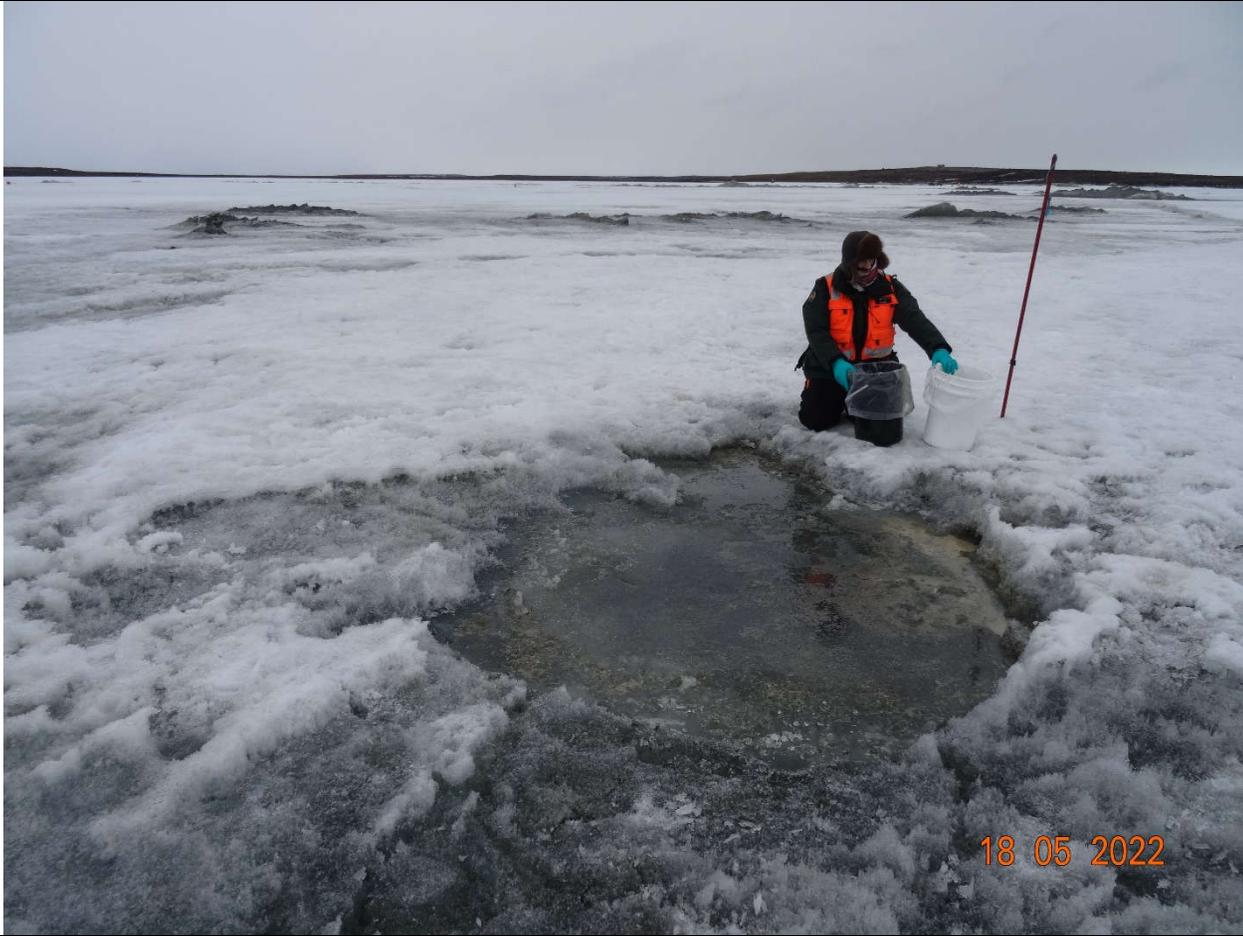
Photo 7

Sampling location A8-04

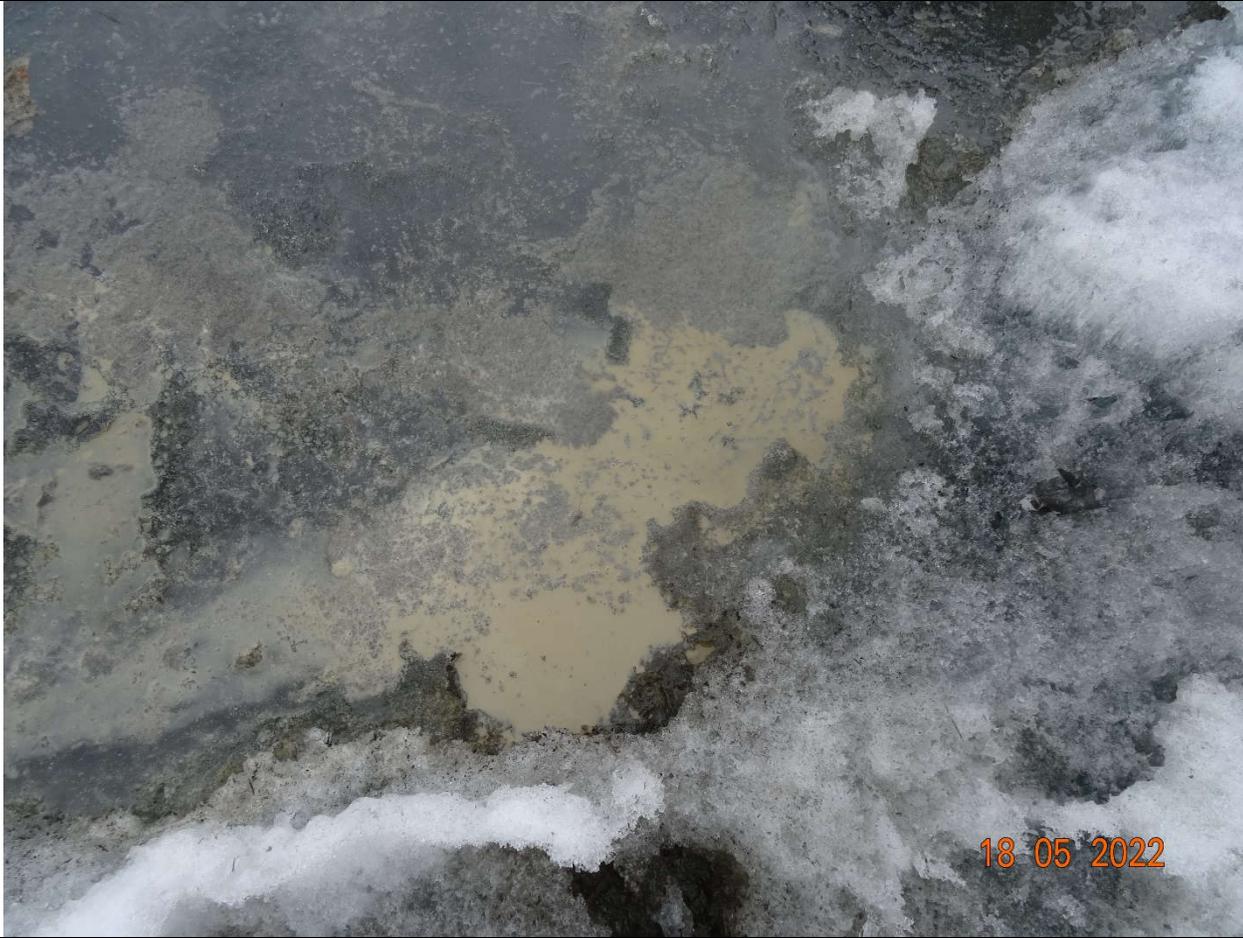
Photo 8

A8-04 unknown substance in pool of water.

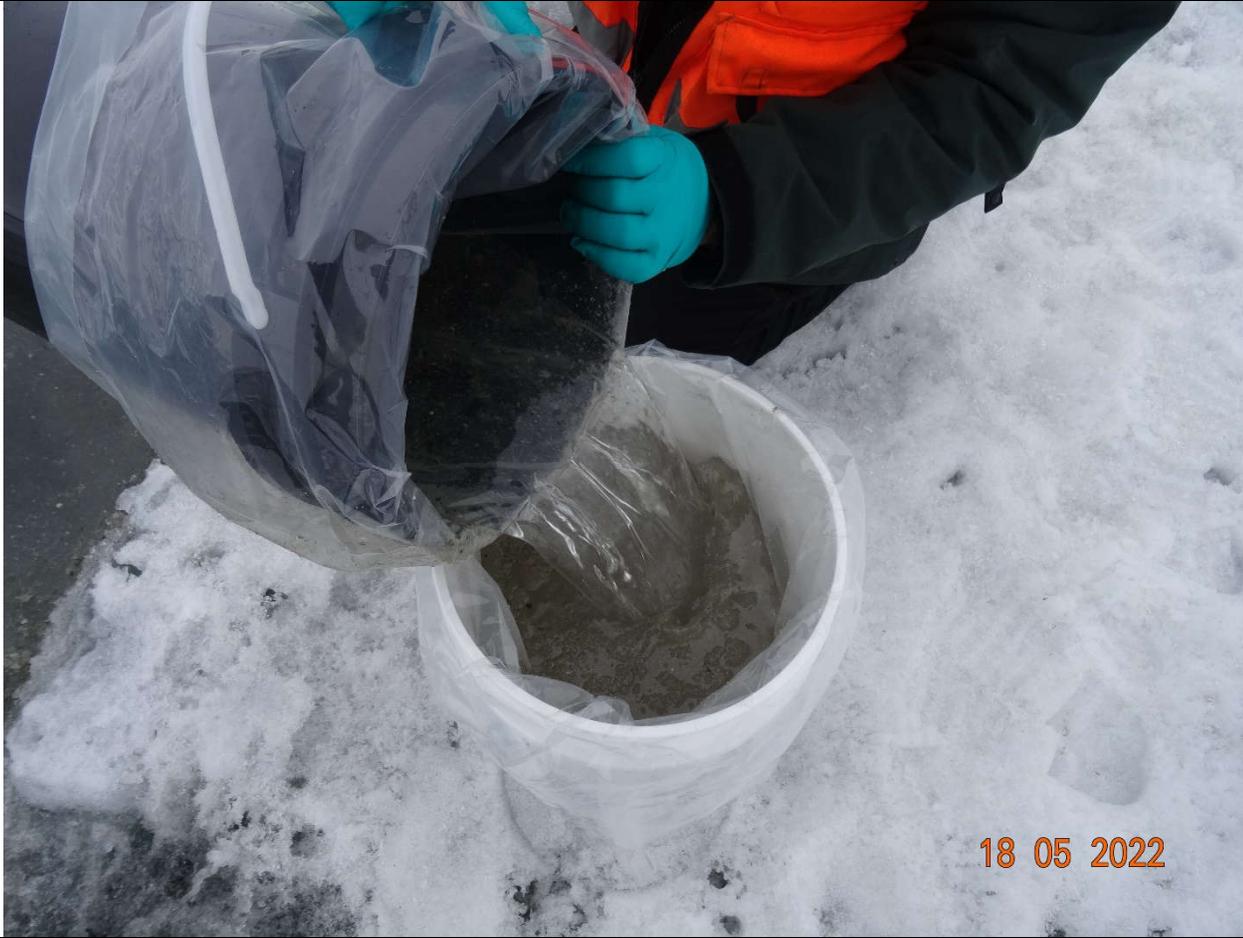
Photo 9

Filling clean lined bucket at sampling location A8-04

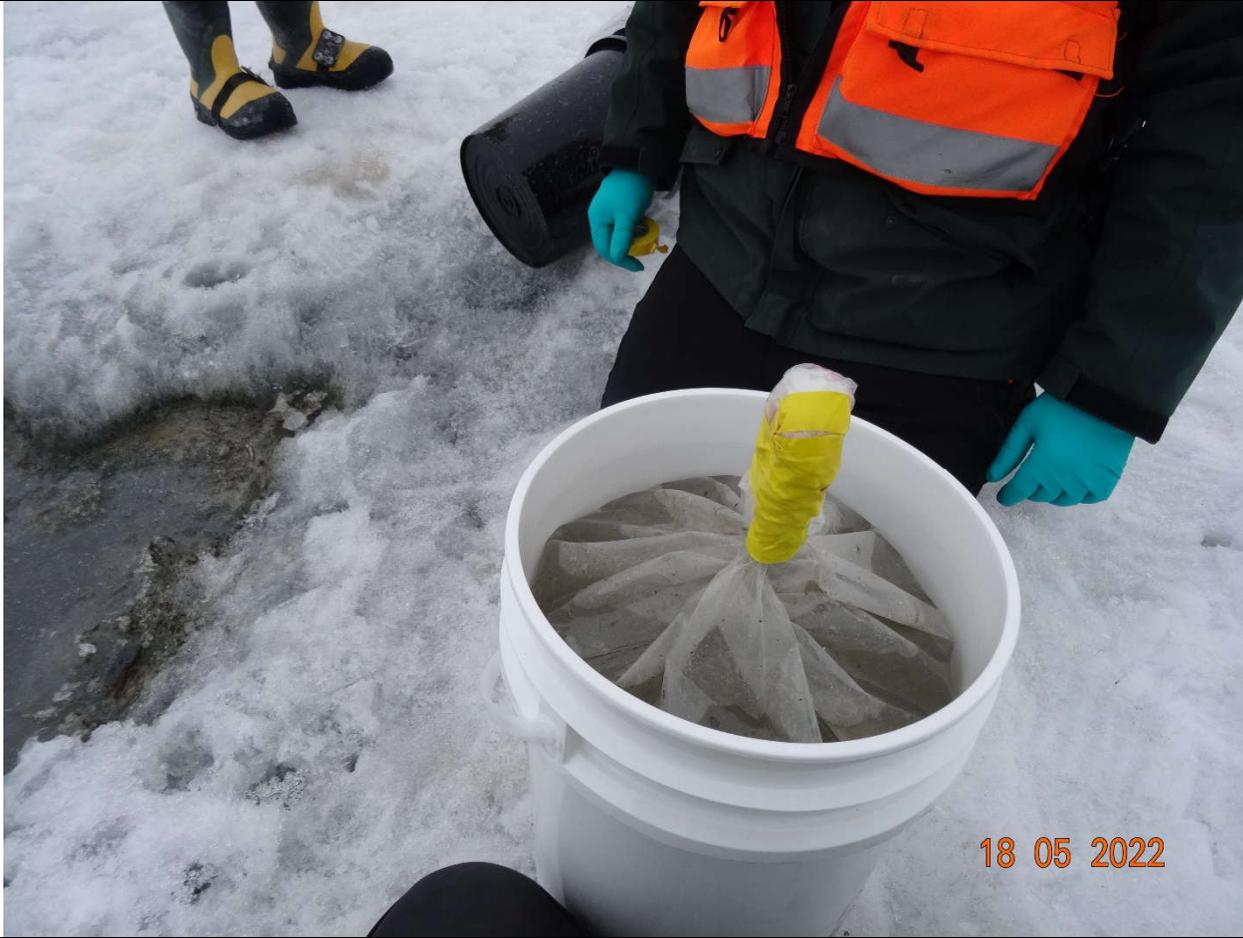
Photo 10

Sealing liner at A8-04

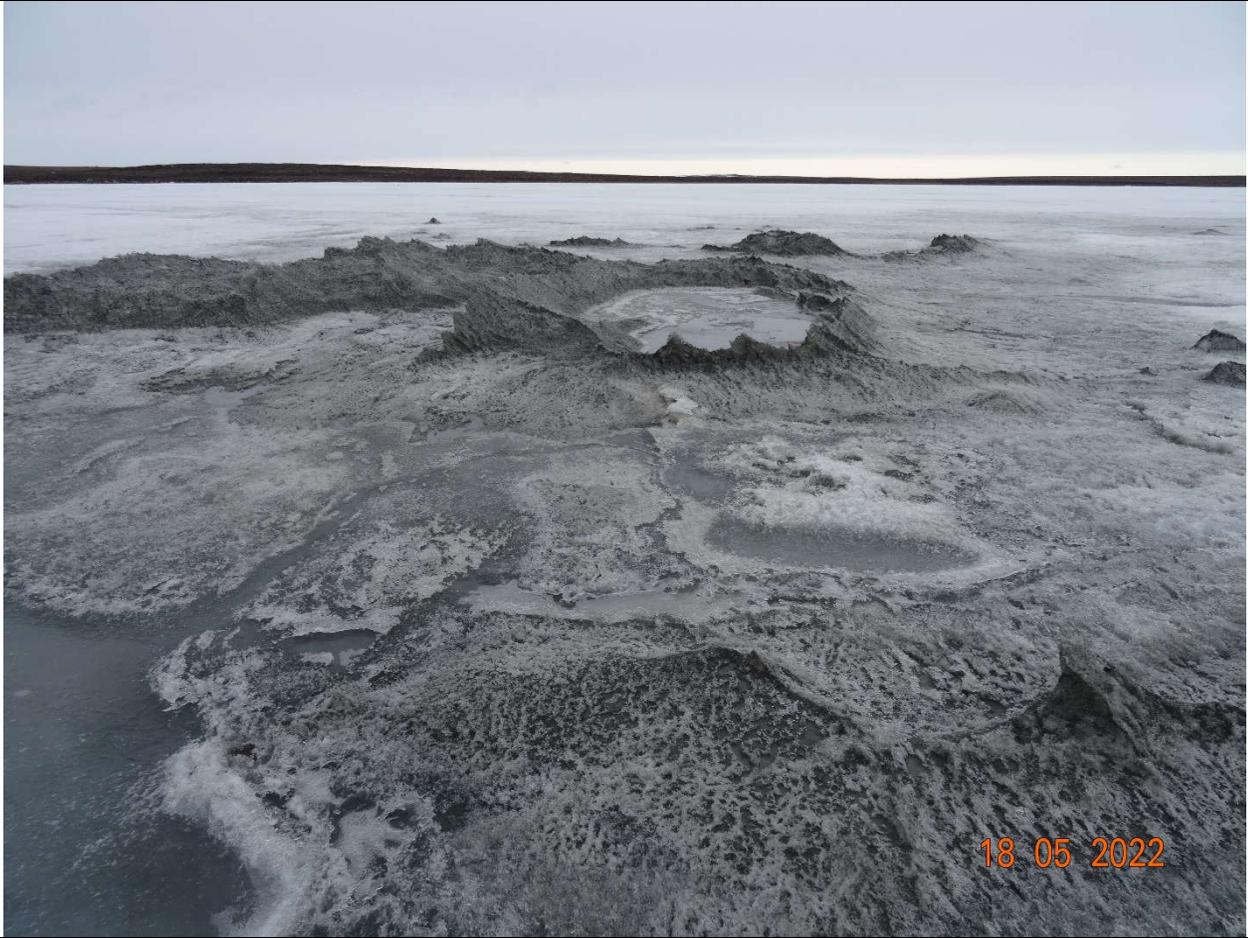
Photo No.	Lat/Long (DD.MM.SS.SS, NAD83)
Photo 11	63° 0' 42.37" N 92° 12' 23.99" W

Description: A8-03 Sampling location.

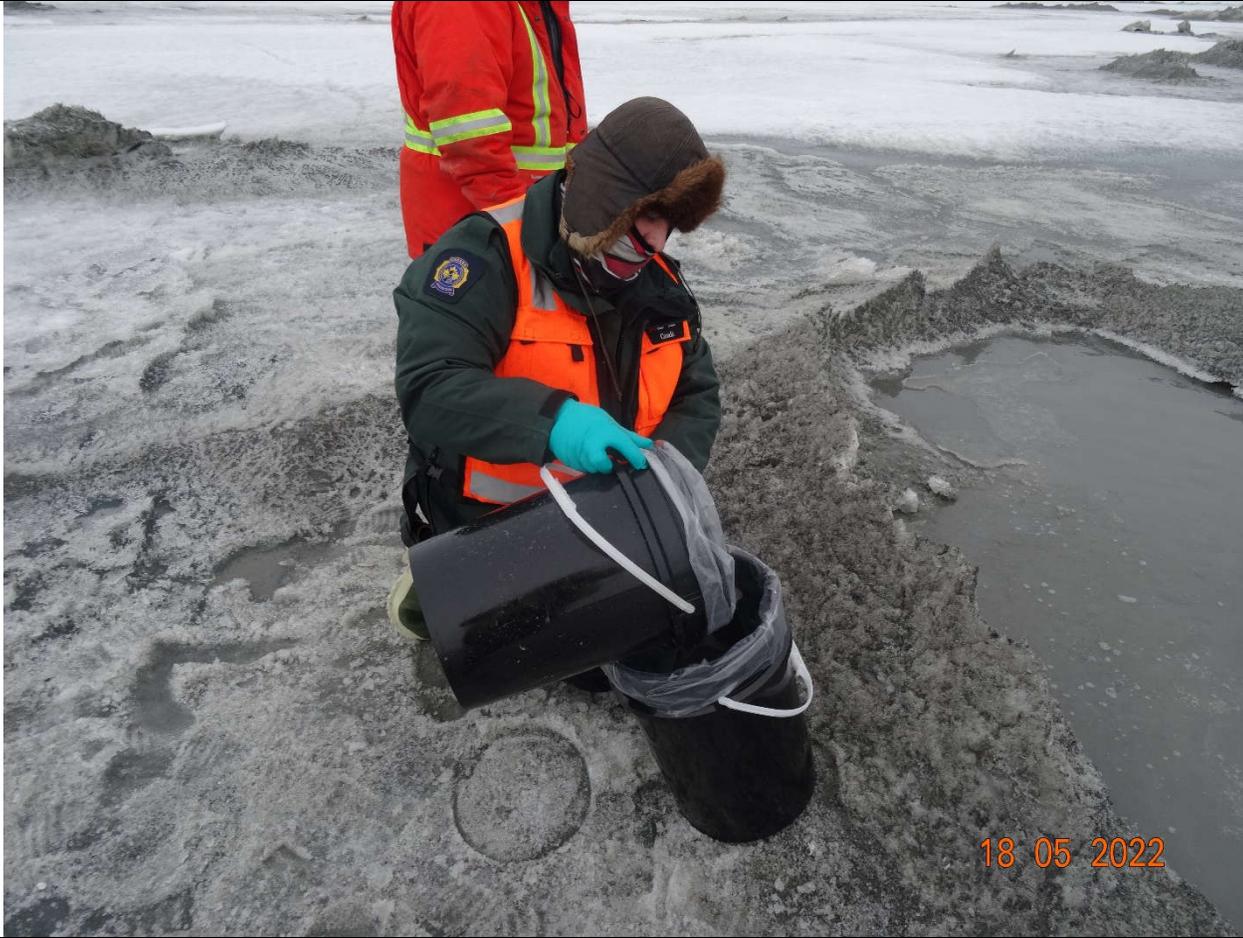
Photo 12

Filling clean lined bucket at A8-03.

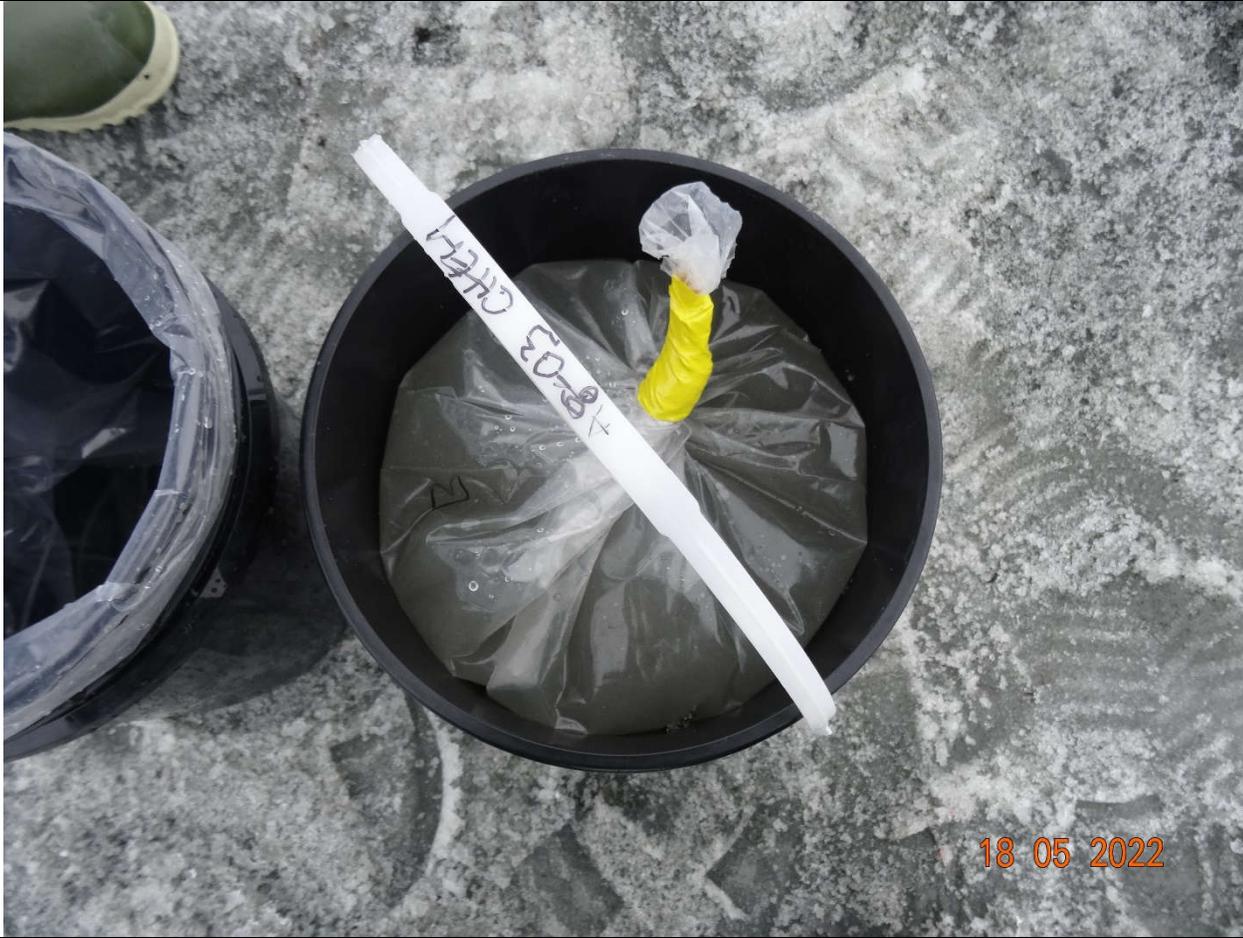
Photo 13

Sealing liner at A8-03

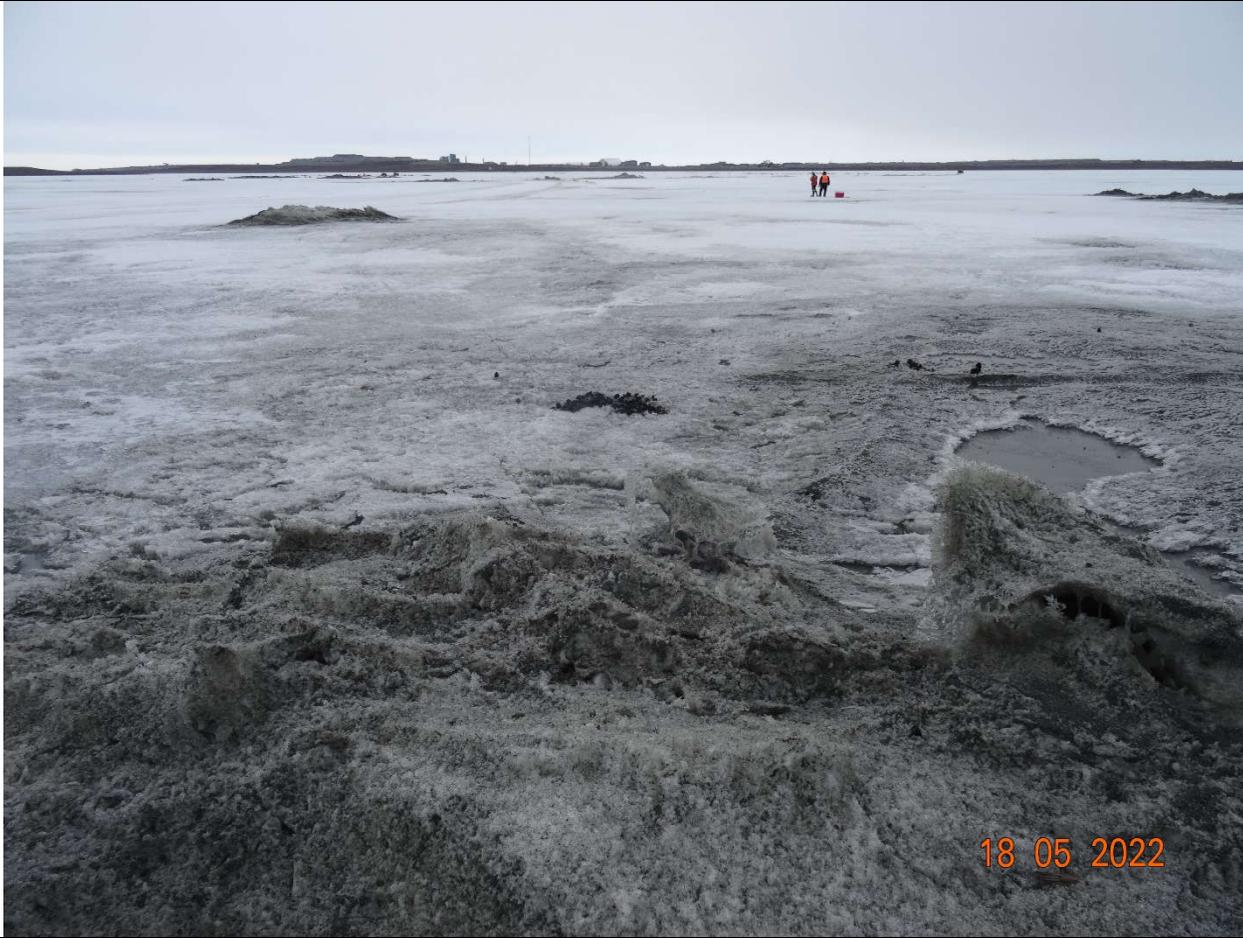
Photo 14

Grey material on ice surface of A8

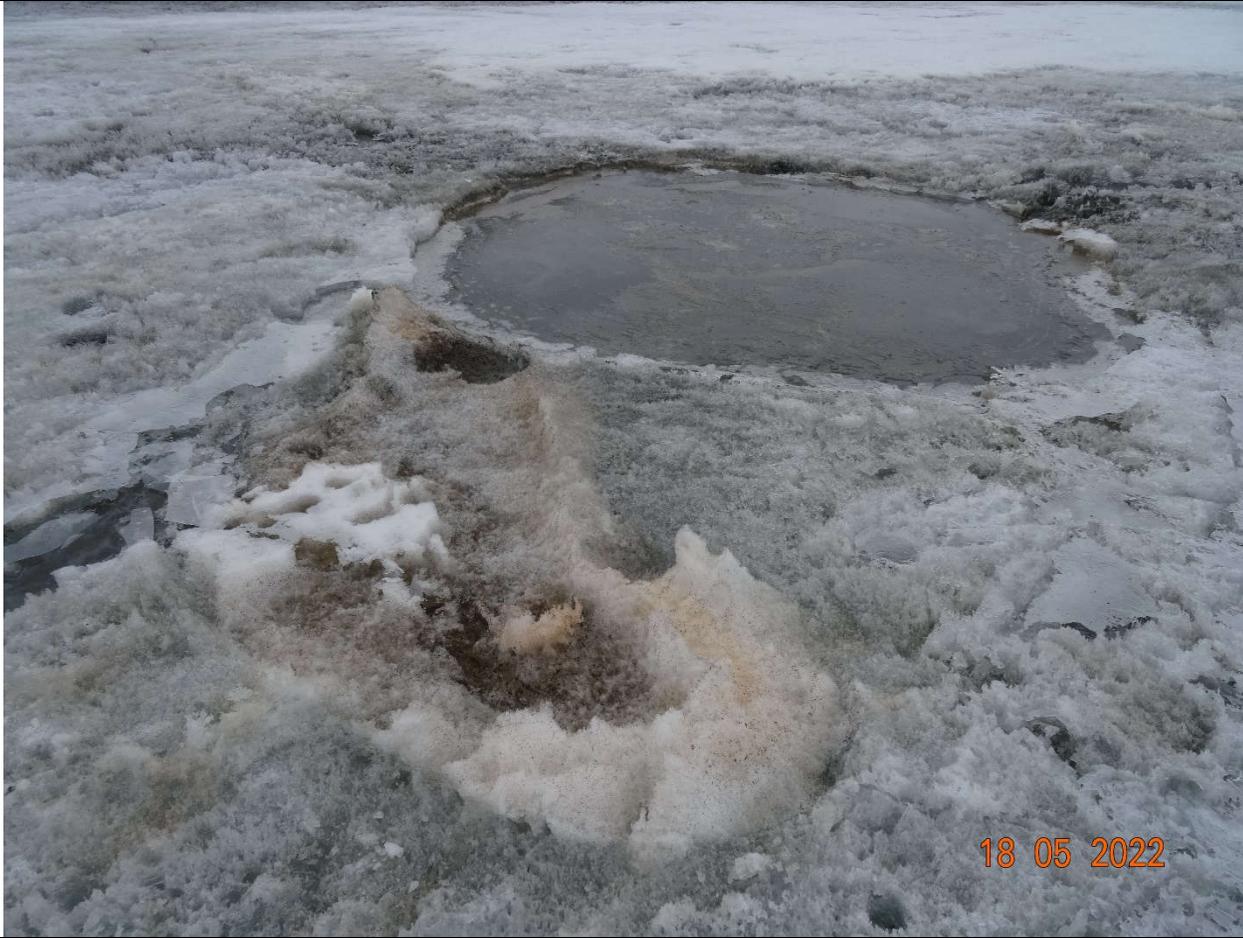
Photo 15

Sampling location A8-01

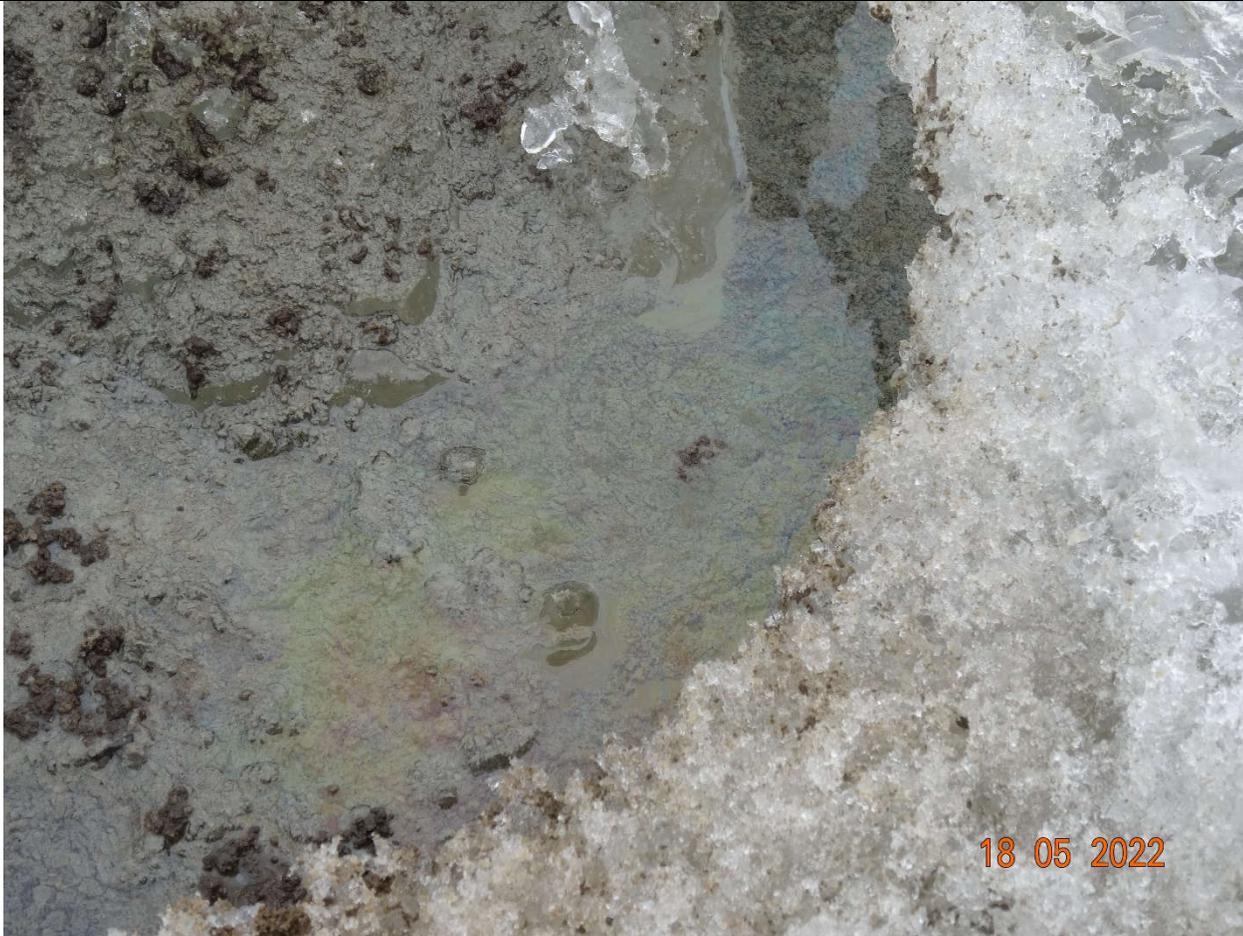
Photo 16

Visible sheen at sampling location A8-01

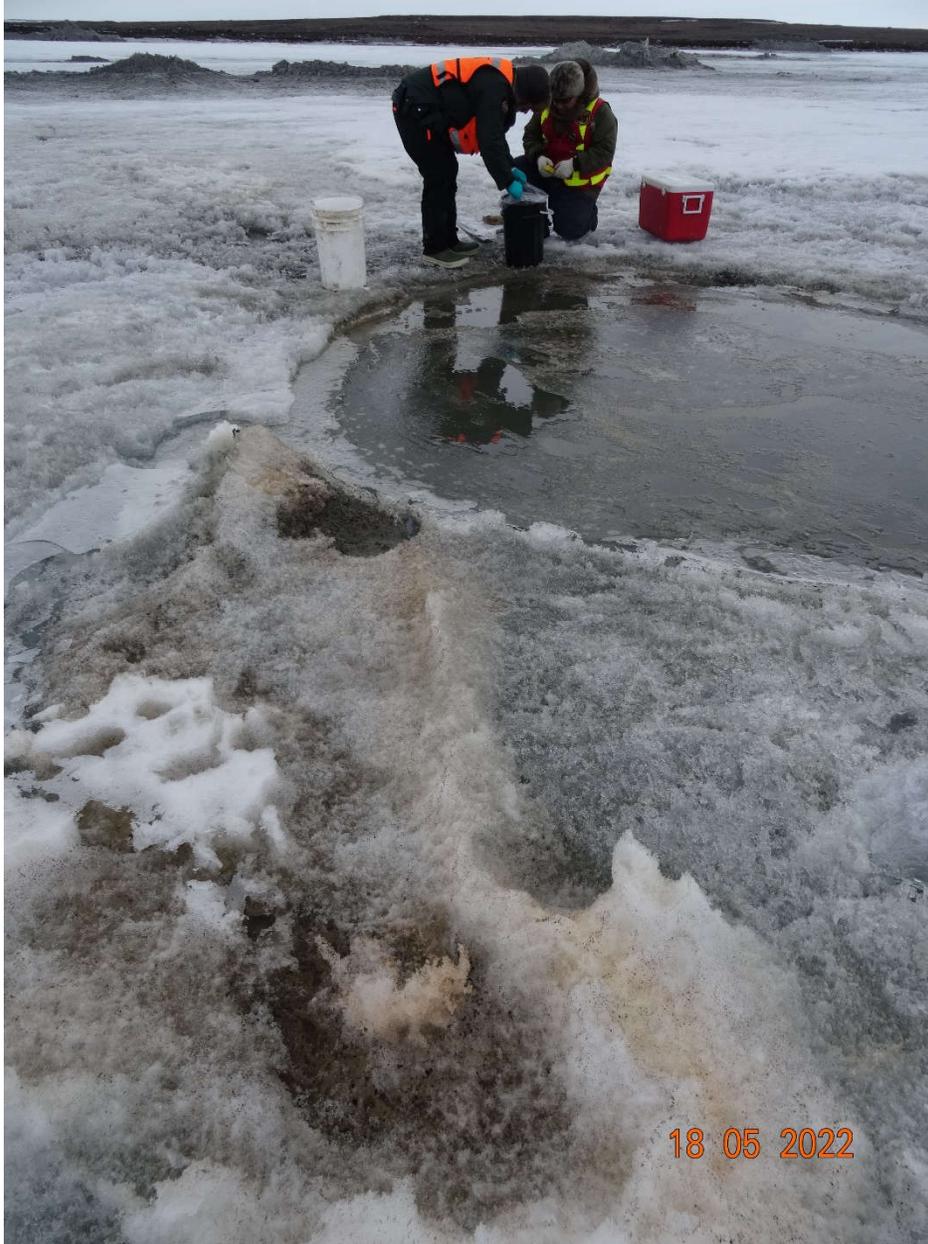
Photo 17

A8-01 sampling location filling clean, lined bucket.

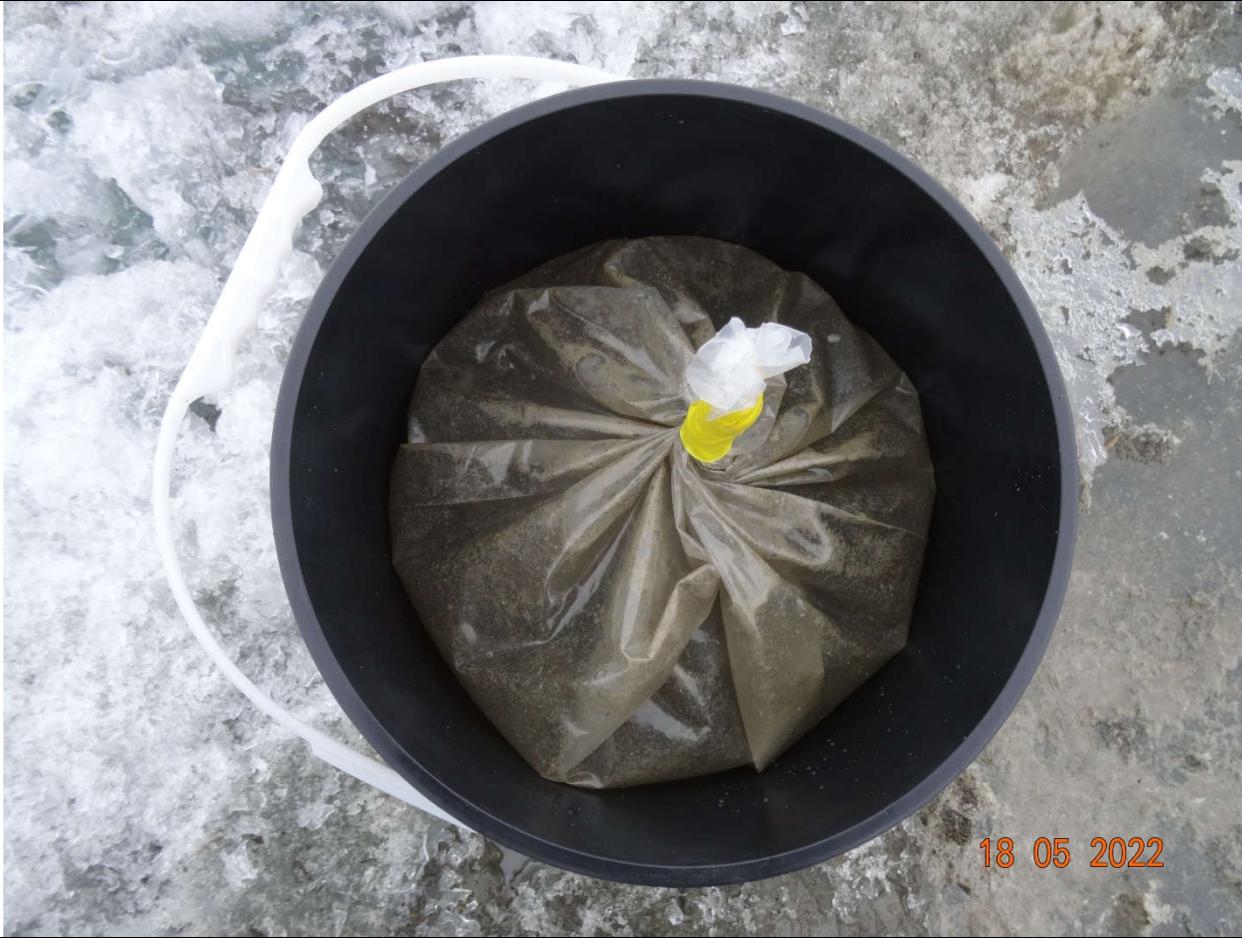
Photo 18

Sealed liner at A8-01 sample location

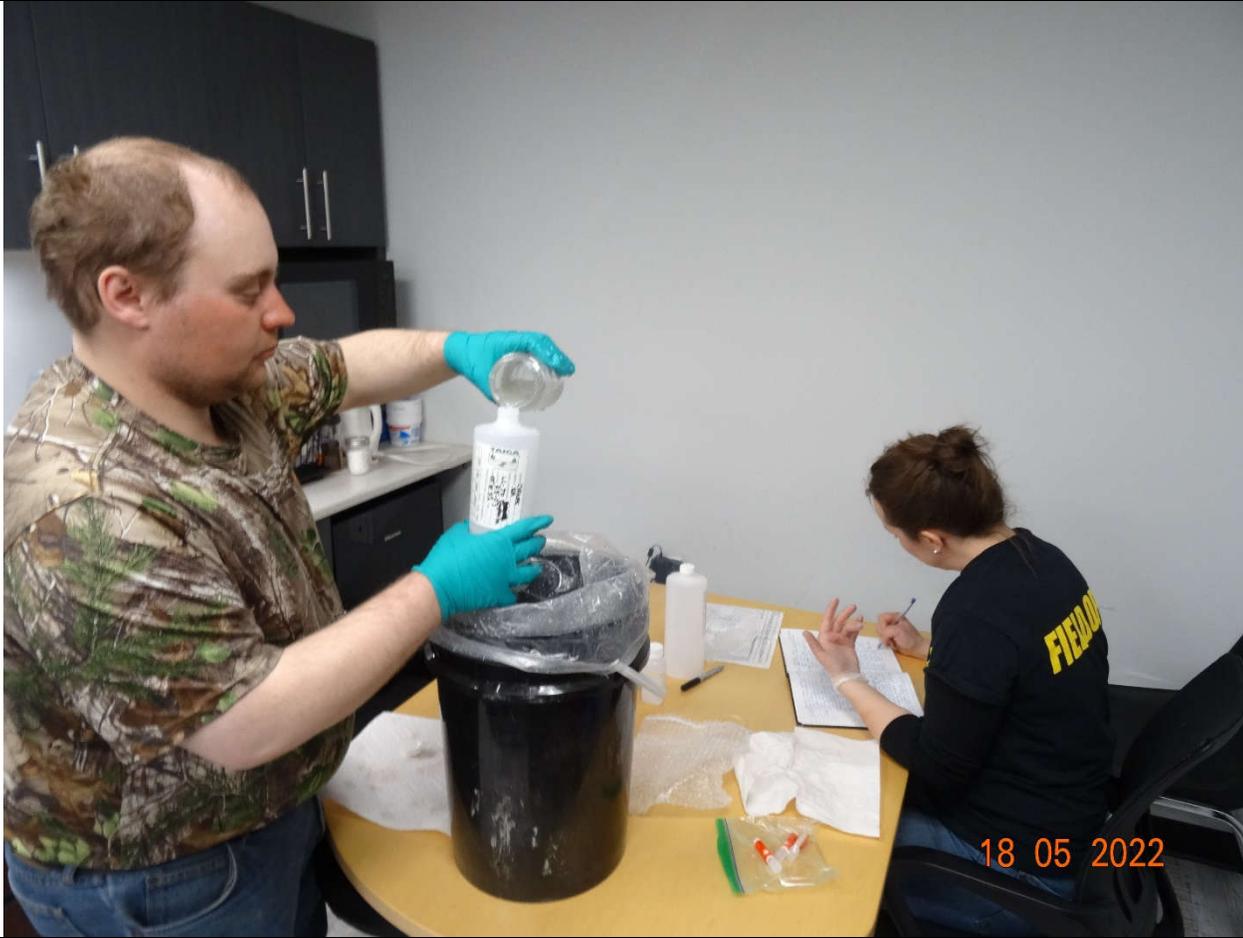
Photo 21

Collecting samples for each bucket for chemical analysis.
