WATER LICENCE INSPECTION FORM

Licensee	Licensee Representative
Agnico Eagle Mines Limited	Brett Fairbairn
Licence No. / Expiry	Representative's Title
2BB-MEL1424/ July 21 st , 2024	Environment Coordinator
Date of Inspection	Inspector
May 18 th , 2022	WRO Wilson
Activities Inspected	
<input type="checkbox"/> Camp <input checked="" type="checkbox"/> Drilling <input type="checkbox"/> Mining <input type="checkbox"/> Construction <input type="checkbox"/> Reclamation <input type="checkbox"/> Fuel Storage <input type="checkbox"/> Roads/Hauling <input checked="" type="checkbox"/> Other: Spill <input type="checkbox"/> Other:

The May 18th inspection was conducted as a follow up to the inspections on April 19th (report no. 2022-KIV02-CW) and the May 13th (report no. 2022-KIV03-CW) to ensure compliance with applicable terms and conditions of water licence no. 2BB-MEL1424.

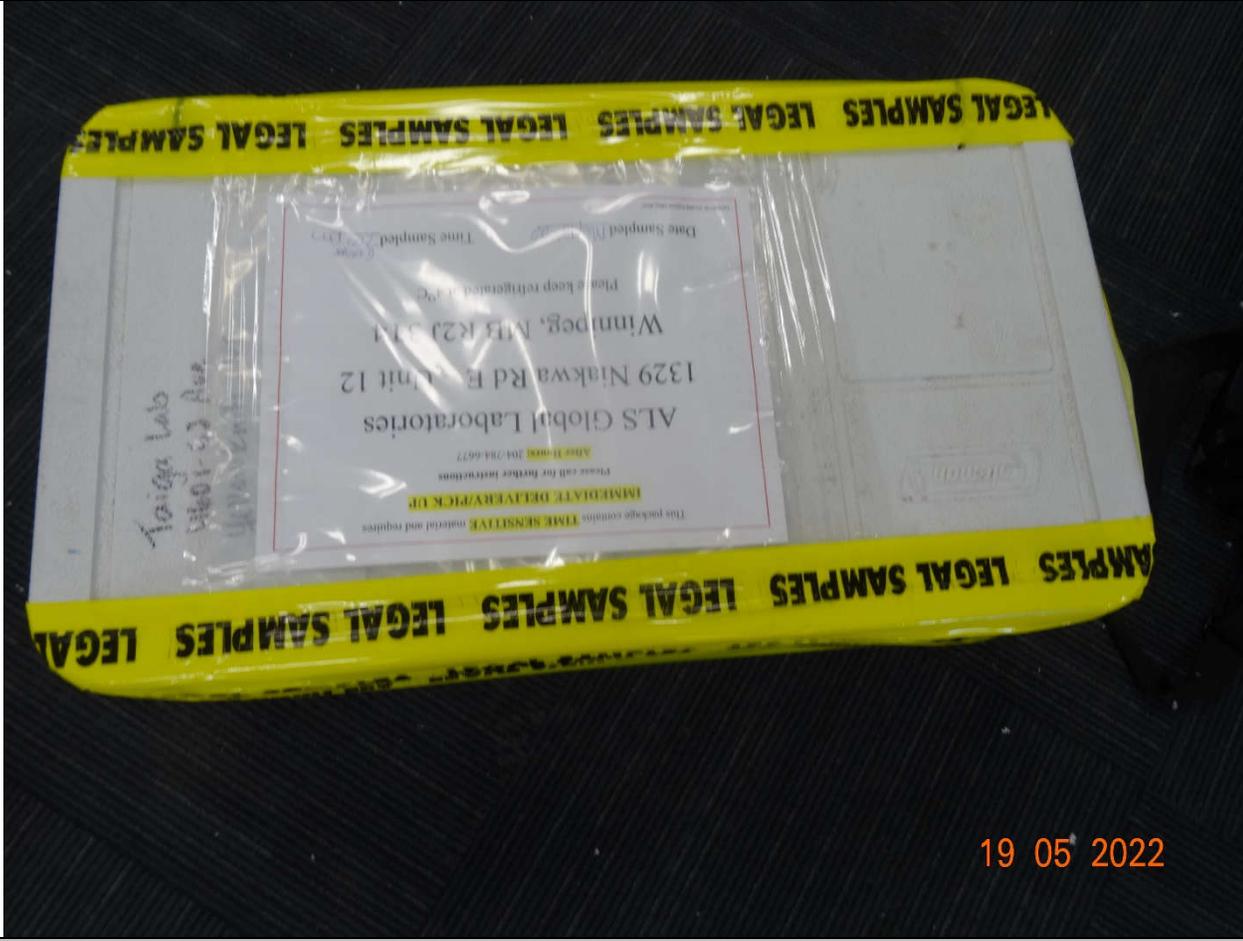
Photo 22

Prepared cooler for shipping to ALS Laboratories.
