WATER LICENCE INSPECTION FORM

On July 31, 2024 Resource Management Officer Kyle Amsel (Inspector) for Crown-Indigenous Relations and Northern Affairs Canada (CIRNAC) conducted an Inspection of Water Licence 2BE-MEL2434 (Licence). The Licence is issued to Agnico Eagle Mines Limited (Licensee) for exploration activities including drilling (Undertaking).

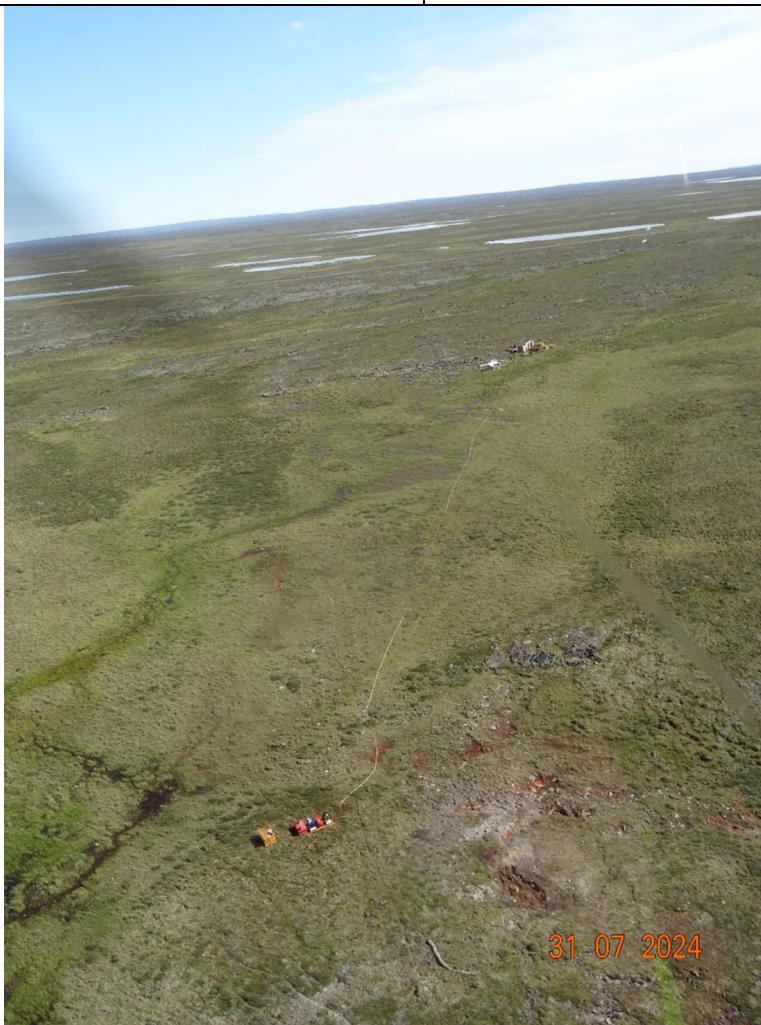
1. Drill 4 at hole M24-3977 located at N62° 58' 22.2" W91° 57' 26.0" (Photo 1)
 - a. The drill was in the process of being prepared for moving during the inspection.

Description:
Drill 4. Note drill is being prepared to be moved.

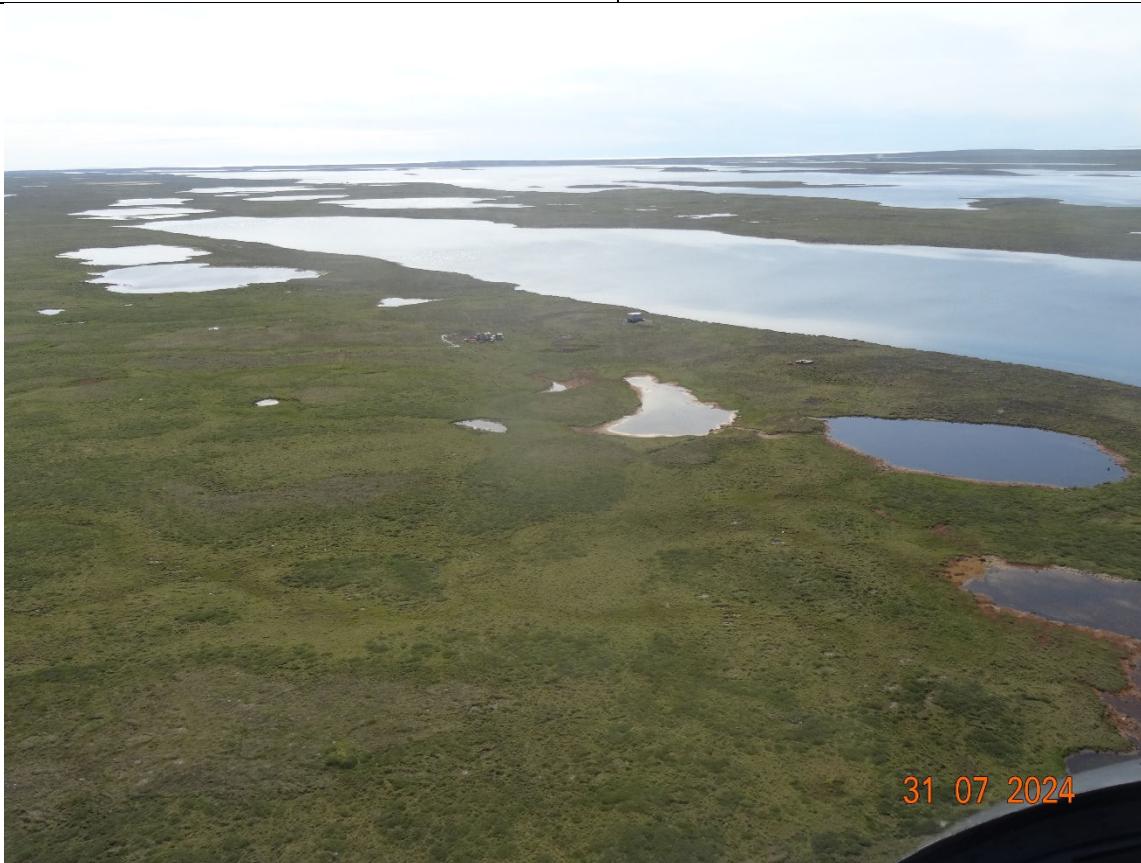
Photo No.	Lat/Long (DD.MM.SS.SS, NAD83)
Photo 2	N62° 57' 9.9" W91° 54' 34.1"

- d. The water intake was in the process of being removed during inspection.
2. Drill 2 at hole SH85 3980 located at N62° 56' 57.6" W91° 54' 15.1" (Photo 2)

Description:
Drill 2 at hole SH 85 3980. Infrastructures from left; drill site, old remnant geophysical survey shed, new drill laydown for future drill move.

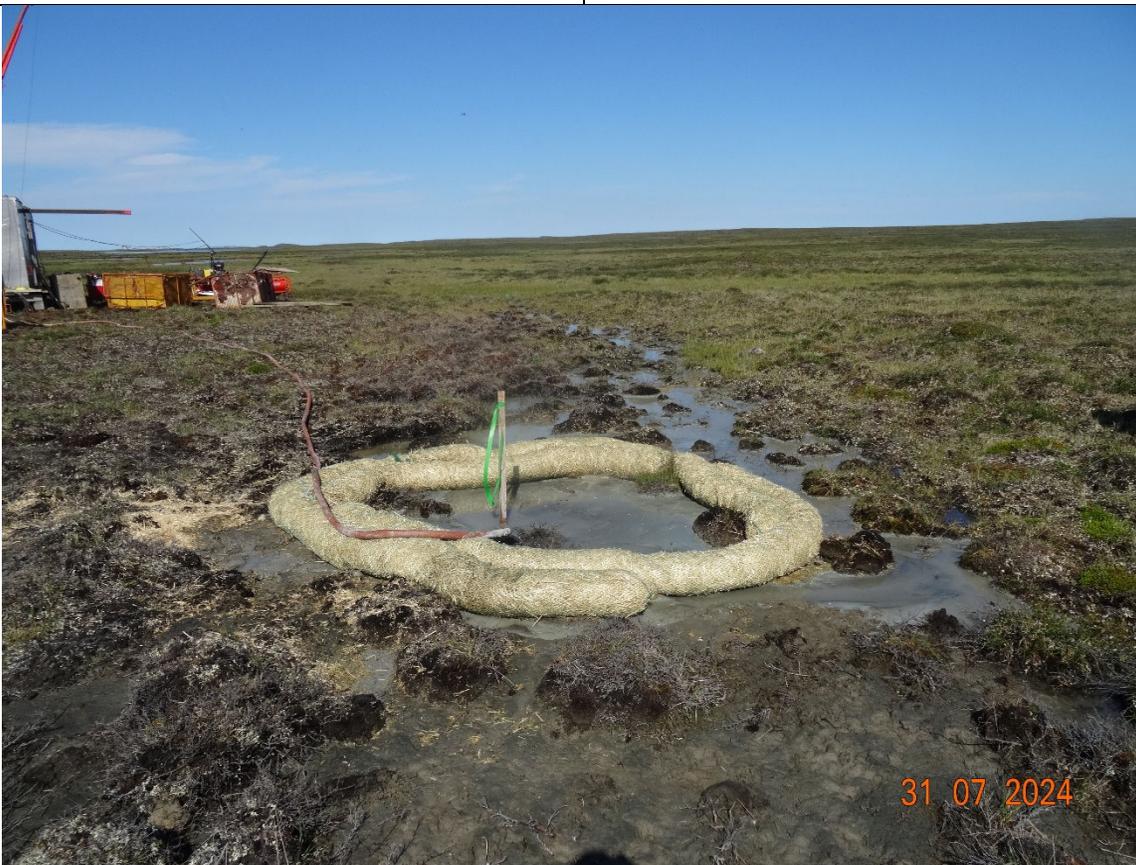
Photo 3

- a. The drill was operating during the inspection.
 - b. Cuttings sump was located at N62° 56' 57.6" W91° 54' 10.0". The Inspector notes that this sump generally meets the requirements of Part F Item 5. Small amounts of flow were noted leaving the sump which was built using straw booms and reporting to another natural depression. This was rectified while on site. (Photo 3)

Sump location for Drill 2. Not some flow of cuttings into distance of photo. Straw booms were weighted prior to departing site preventing offsite impacts.

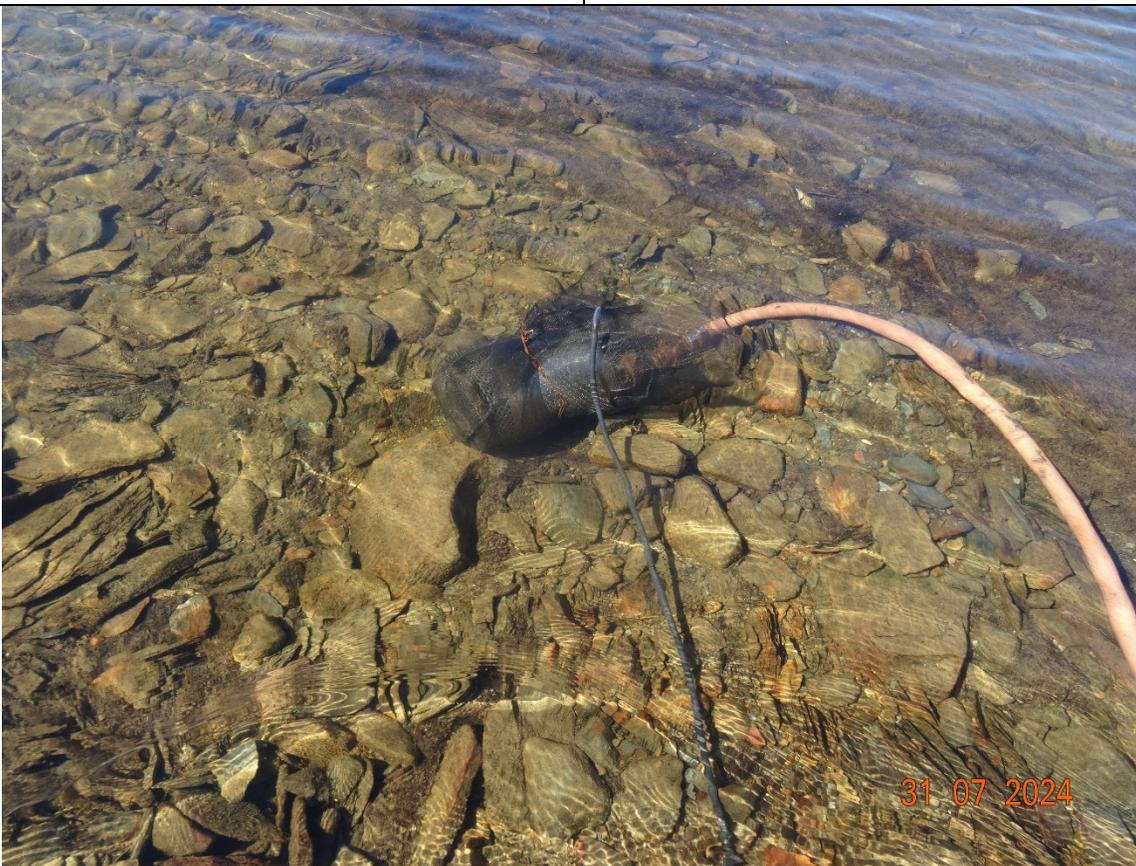
Photo 4

- c. Water intake was at N62° 56' 52.0" W91° 54' 10.0". A screen was present on the water intake as required under Part C Item 5. The diesel generator powering the pump was located 31m from fresh water. (Photo 4)

Water intake for Drill 2.

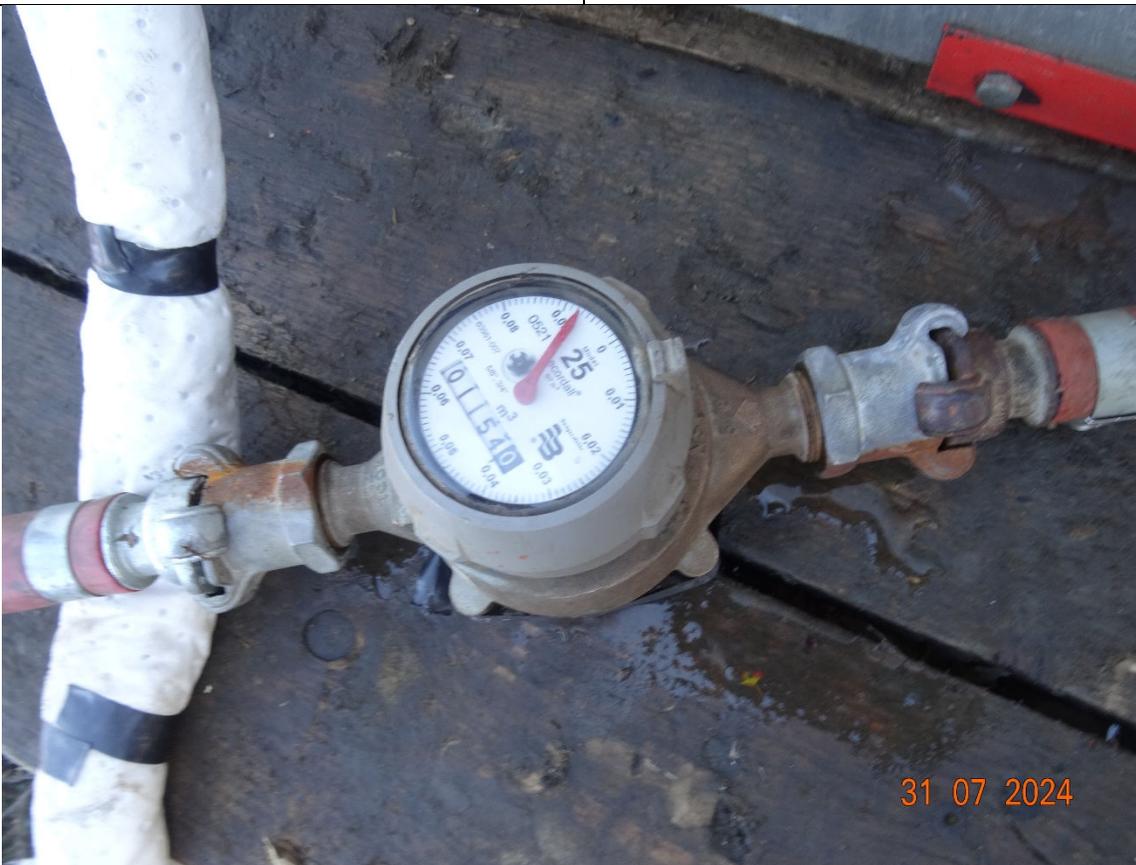
Photo 5

- d. A water meter is present as required under Part B Item 4 of the licence. During the inspection the meter read 1154.0m³. (Photo 5)
3. The Inspector conducted areal inspection of a number of other drill sites noted throughout the area. These are not limited to: UP23-II, T123-005, T123-001, NM23-071, NM23-067, FZ23-169, FZ22-077, FZ22-022.

Water meter for Drill 2.

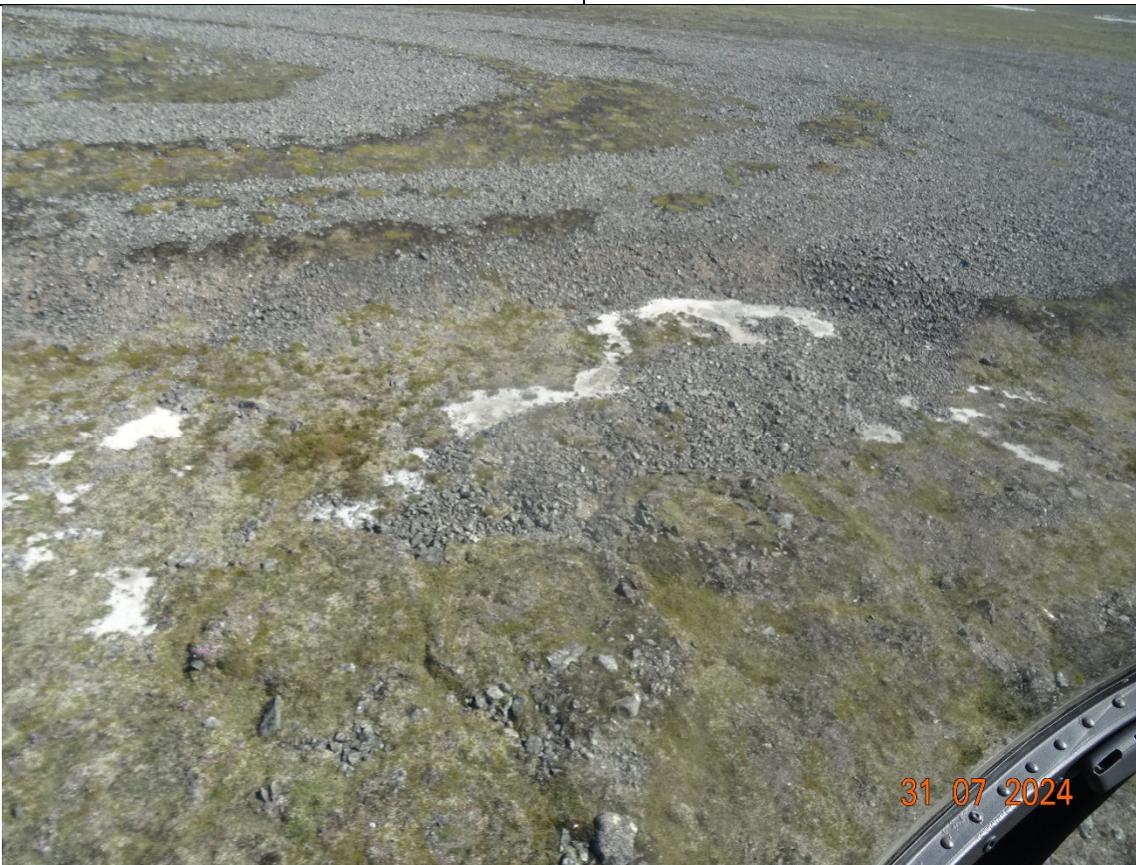
Photo 6

4. Cuttings sumps, Part F Item 5.
 - a. During the Inspection it was noted that multiple older drill locations utilized poor sump locations. An example was the sumps at UP23-II and FZ22-077. (Photo 6 & 7) It is unclear if these sump locations are remnants from historical drilling or from the noted drill sites due to the extensive drilling occurring within these locations. The Licensee is reminded to choose appropriate sump locations compliant with the licence.

Sump location near borehole UP23-II

The Permittee will endeavour to utilize appropriate cuttings disposal locations.

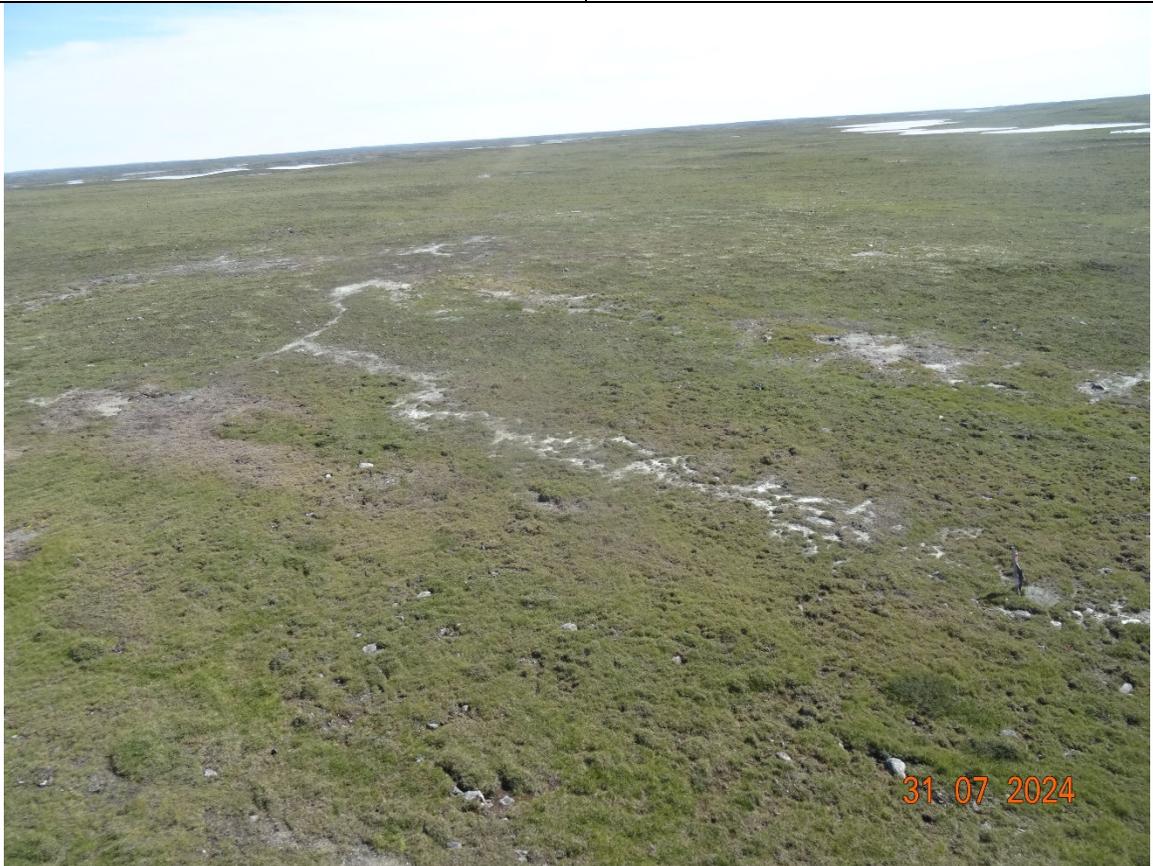
Photo No.	Lat/Long (DD.MM.SS.SS, NAD83)
Photo 7	N62° 54' 23.6" W91° 33' 08.3"

Description: Sump location near borehole FZ22-077.
