Water Licence Inspection Report

Authorization	Representative
2BE-MEL2434	Kyle Conway
Authorization No. / Expiry	Representative's Title
July 21, 2034	Environment General Supervisor
Inspection Date	Inspector
March 13, 2025	RMO Kyle Amsel
Other Authorization/s	
Activities Inspected	
<input type="checkbox"/> Municipal <input type="checkbox"/> Camp, Commercial <input checked="" type="checkbox"/> Drilling <input type="checkbox"/> Mining <input type="checkbox"/> Construction <input type="checkbox"/> Reclamation <input type="checkbox"/> Fuel Storage <input type="checkbox"/> Roads/Hauling <input type="checkbox"/> Winter Hauling <input type="checkbox"/> Camp, Private <input type="checkbox"/> Other Click or tap here to enter text.

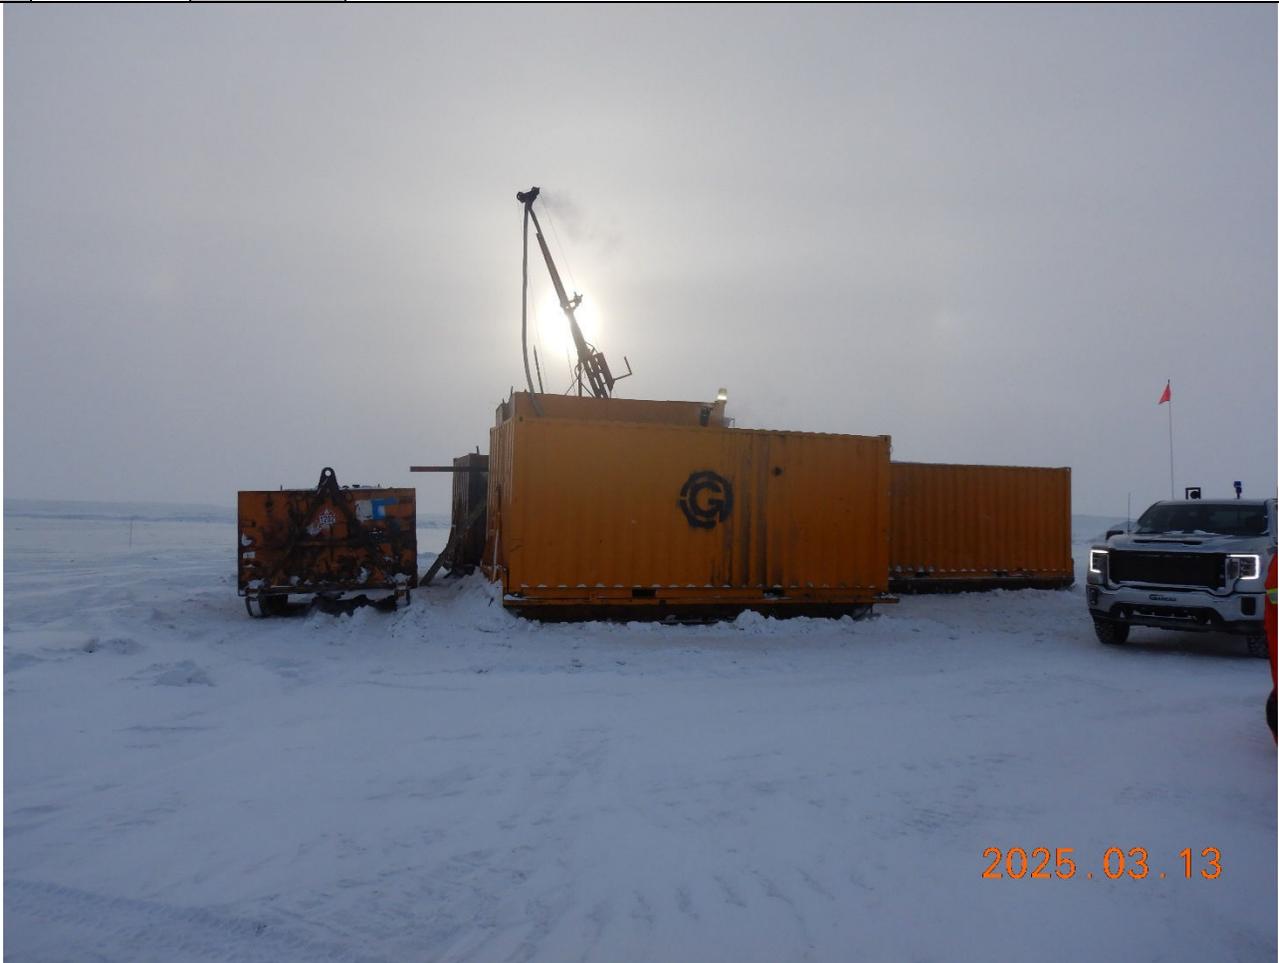
Photo #	Coordinates:
1	NA

Description:
Drill 31 at borehole M25-4207A.

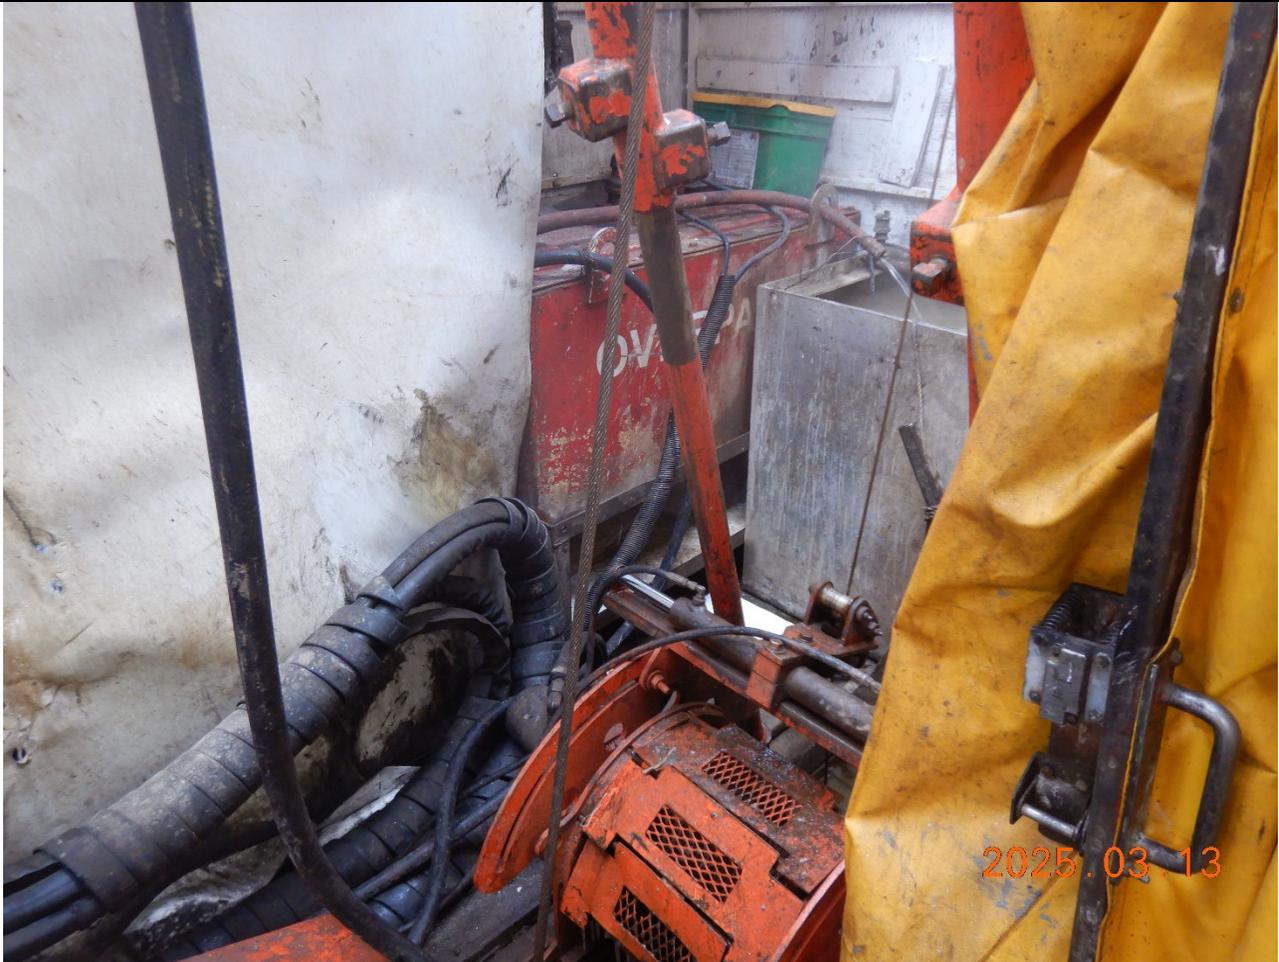
Photo #	Coordinates:
2	NA

Description:
Note spill pads under fuel tank in background.

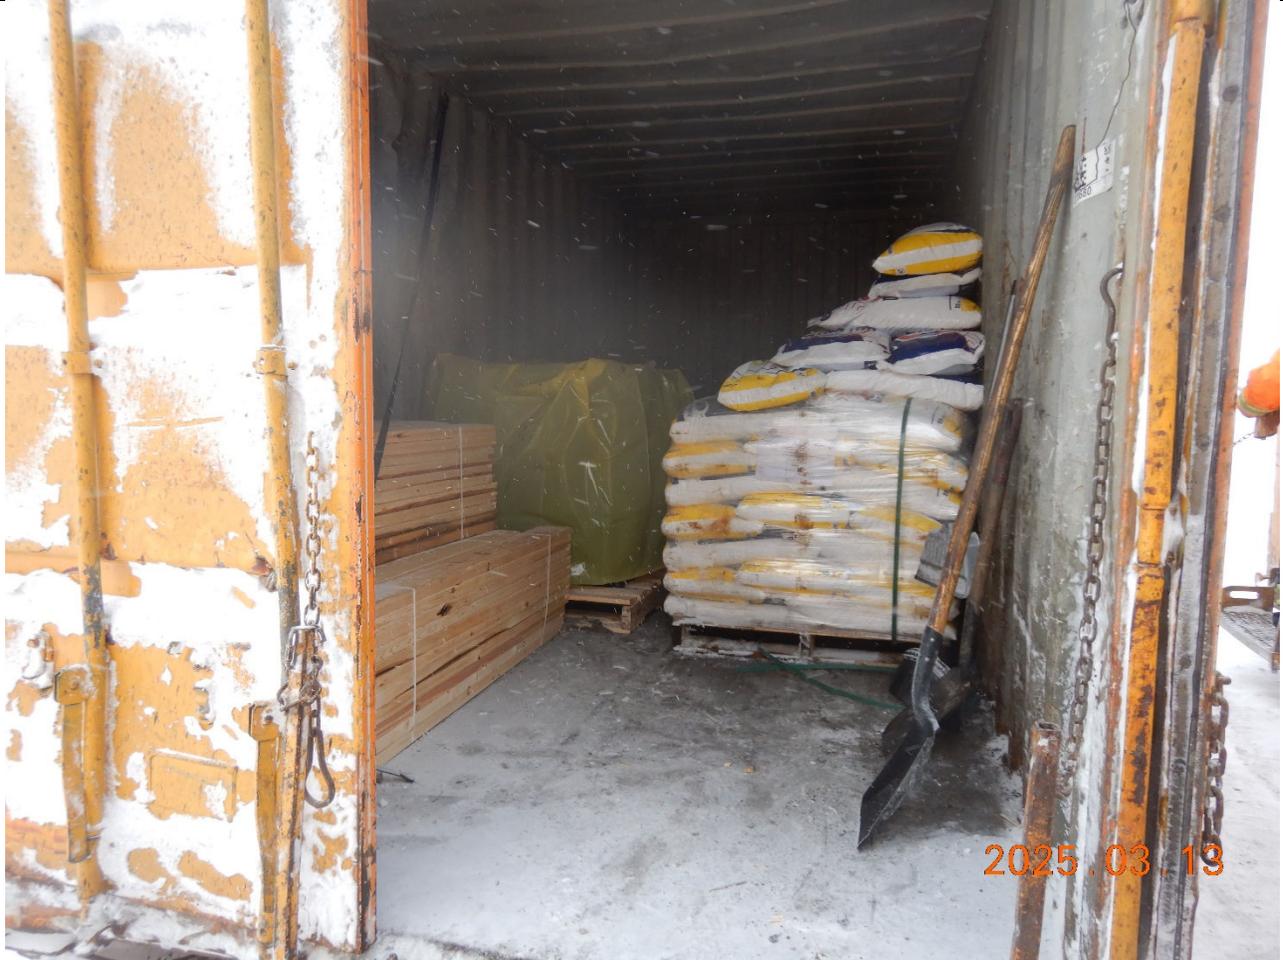
Photo # 3 Coordinates: NA

Description: Salts sea can. Note that dry snow blown in without melting is an indication that no salt has been spilled inside the container.

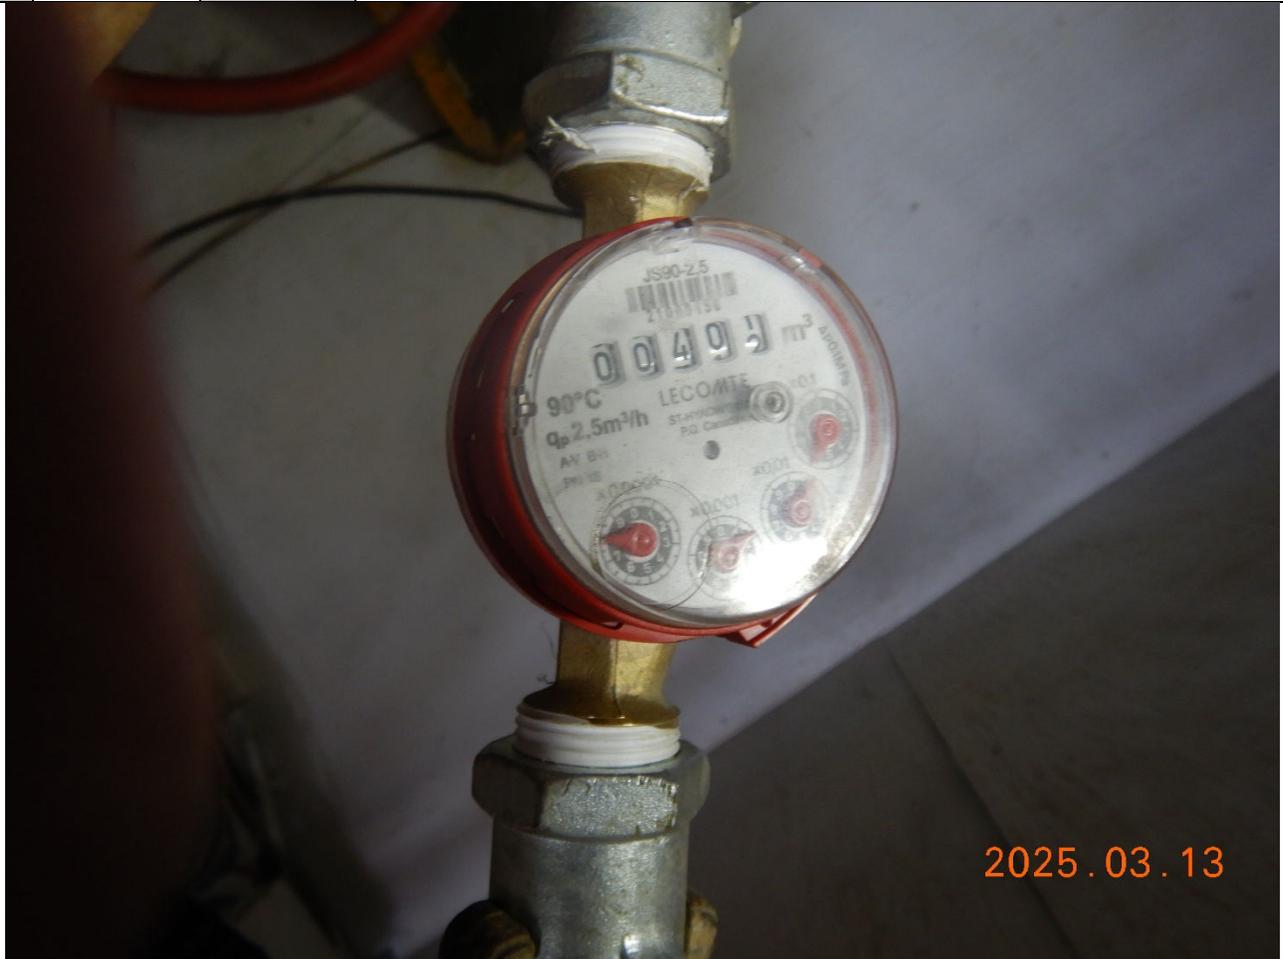
Photo # 4 Coordinates: NA

Description: Fuel meter installed on drill 31.

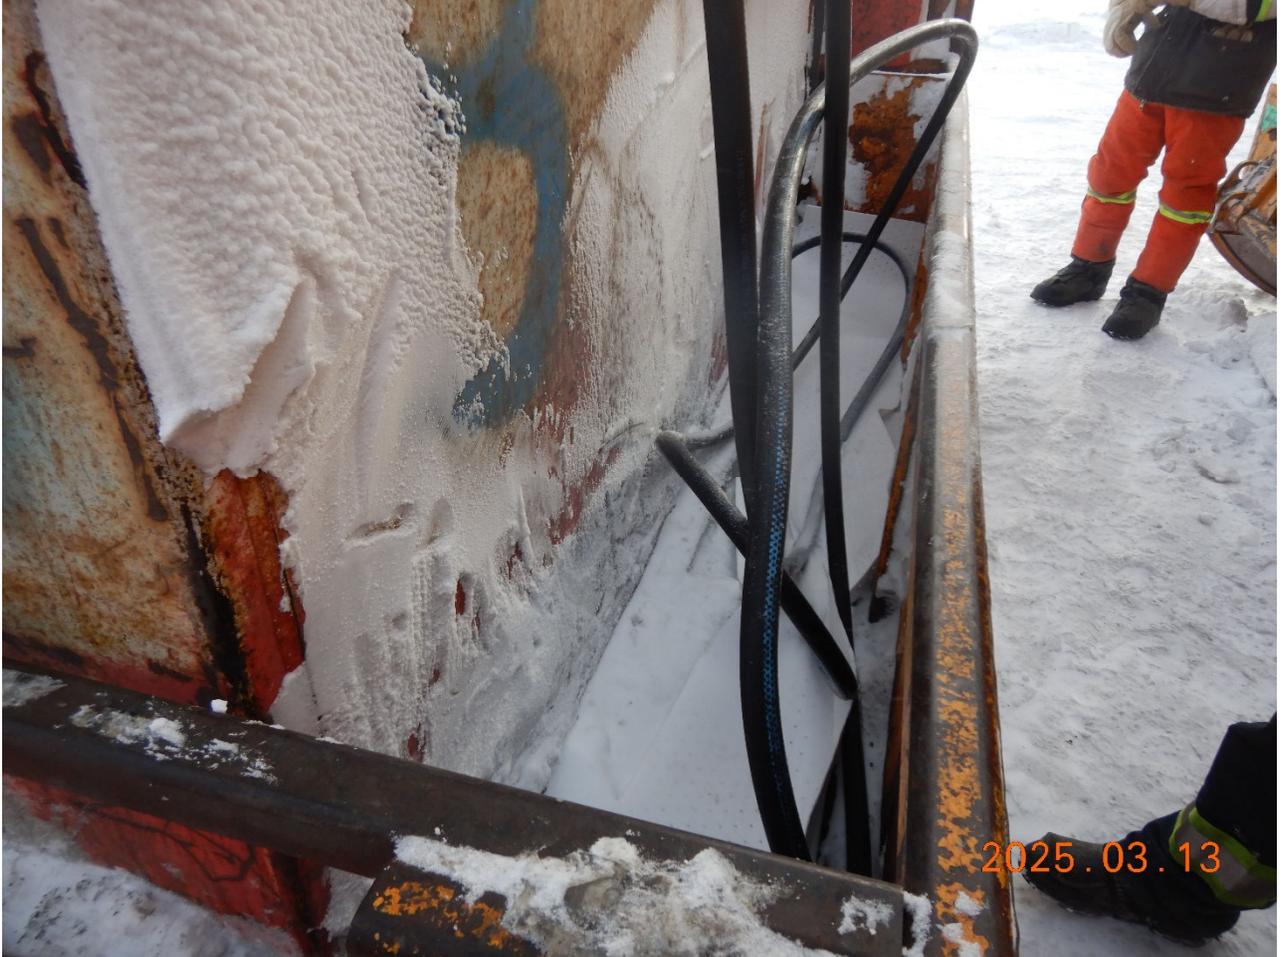
Photo # 5 Coordinates: NA

Description: Fuel spill pads located around double walled tank. Note pads are clean.

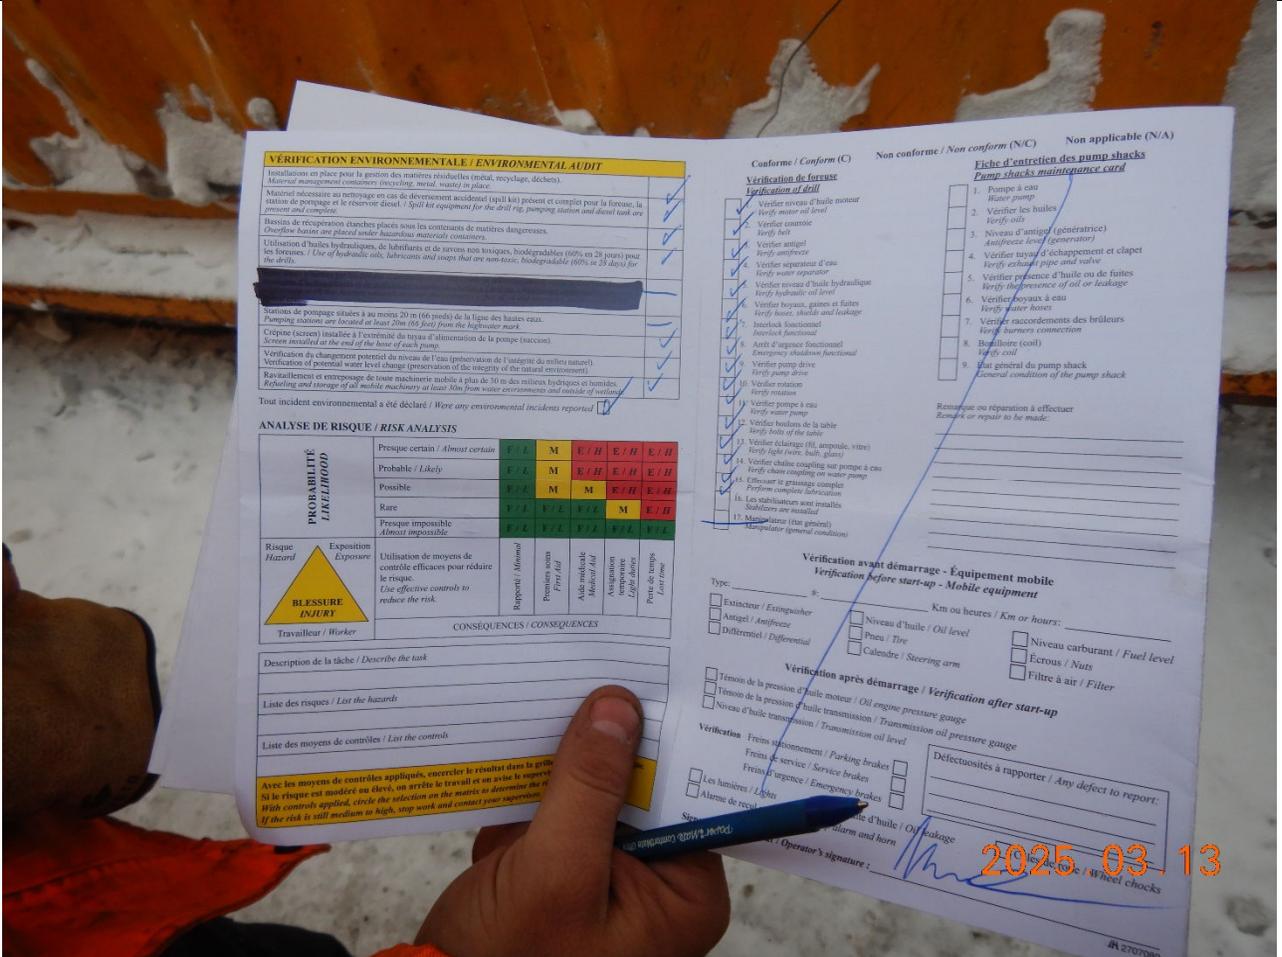
Photo # 6 Coordinates: NA

Description: Environmental inspection sheet used by drillers at each shift.

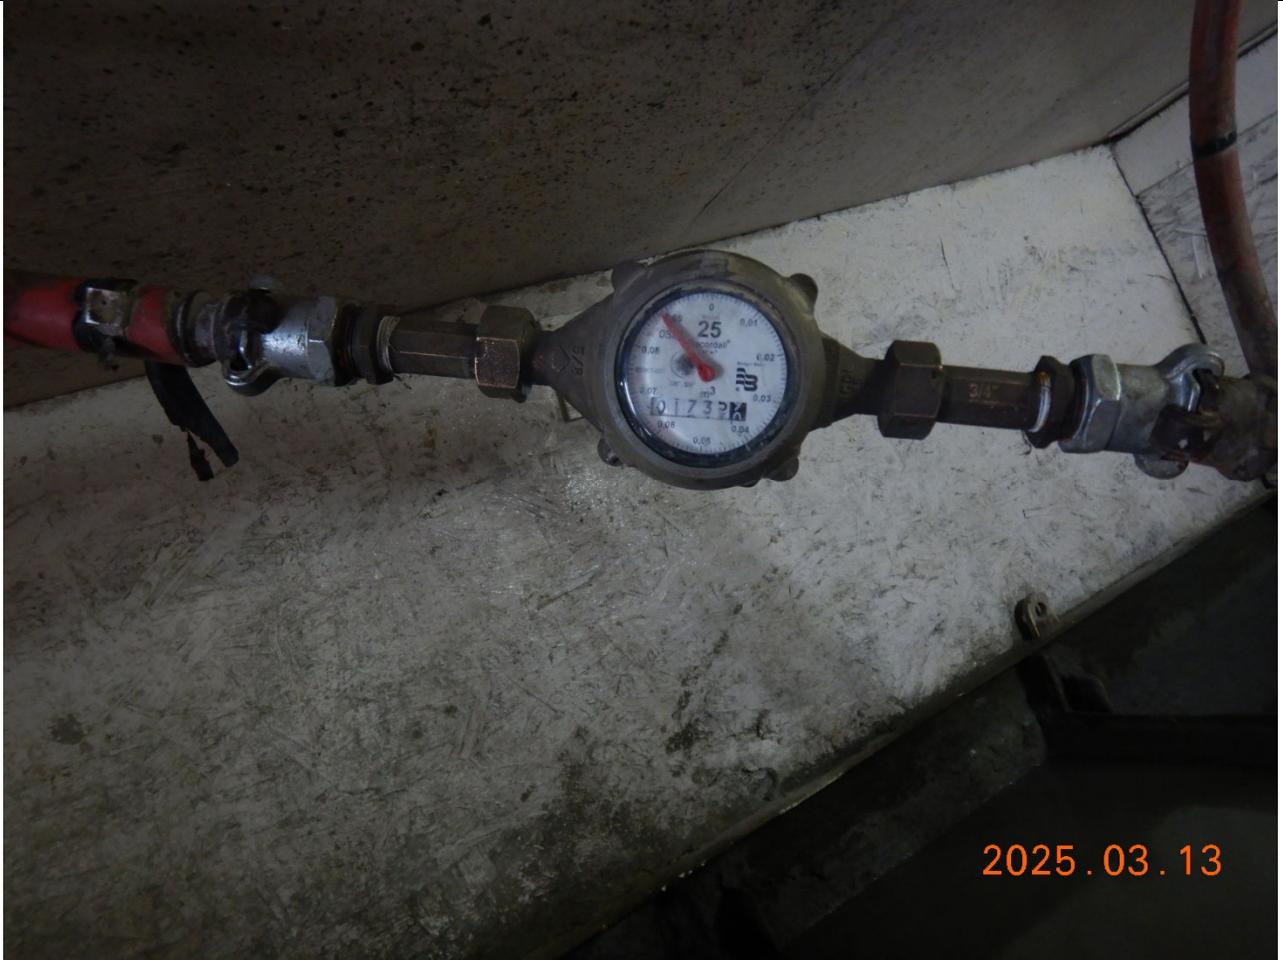
Photo # 7

Water meter at drill 85.
