# Water Licence Inspection Report

<b>Authorization</b>	<b>Representative</b>
<b>2BE-MEL2434</b>	<b>John Baechler</b>
<b>Authorization No. / Expiry</b>	<b>Representative's Title</b>
<b>July 21, 2034</b>	<b>Environment General Supervisor</b>
<b>Inspection Date</b>	<b>Inspector</b>
<b>March 26, 2026</b>	<b>RMO Kyle Amsel</b>
<b>Other Authorization/s</b>	
<b>Activities Inspected</b>	
<input type="checkbox"/> Municipal <input type="checkbox"/> Camp, Commercial <input checked="" type="checkbox"/> Drilling <input type="checkbox"/> Mining <input type="checkbox"/> Construction <input type="checkbox"/> Reclamation <input type="checkbox"/> Fuel Storage <input type="checkbox"/> Roads/Hauling <input type="checkbox"/> Winter Hauling <input type="checkbox"/> Camp, Private <input type="checkbox"/> Other <a href="#">Click or tap here to enter text.</a>

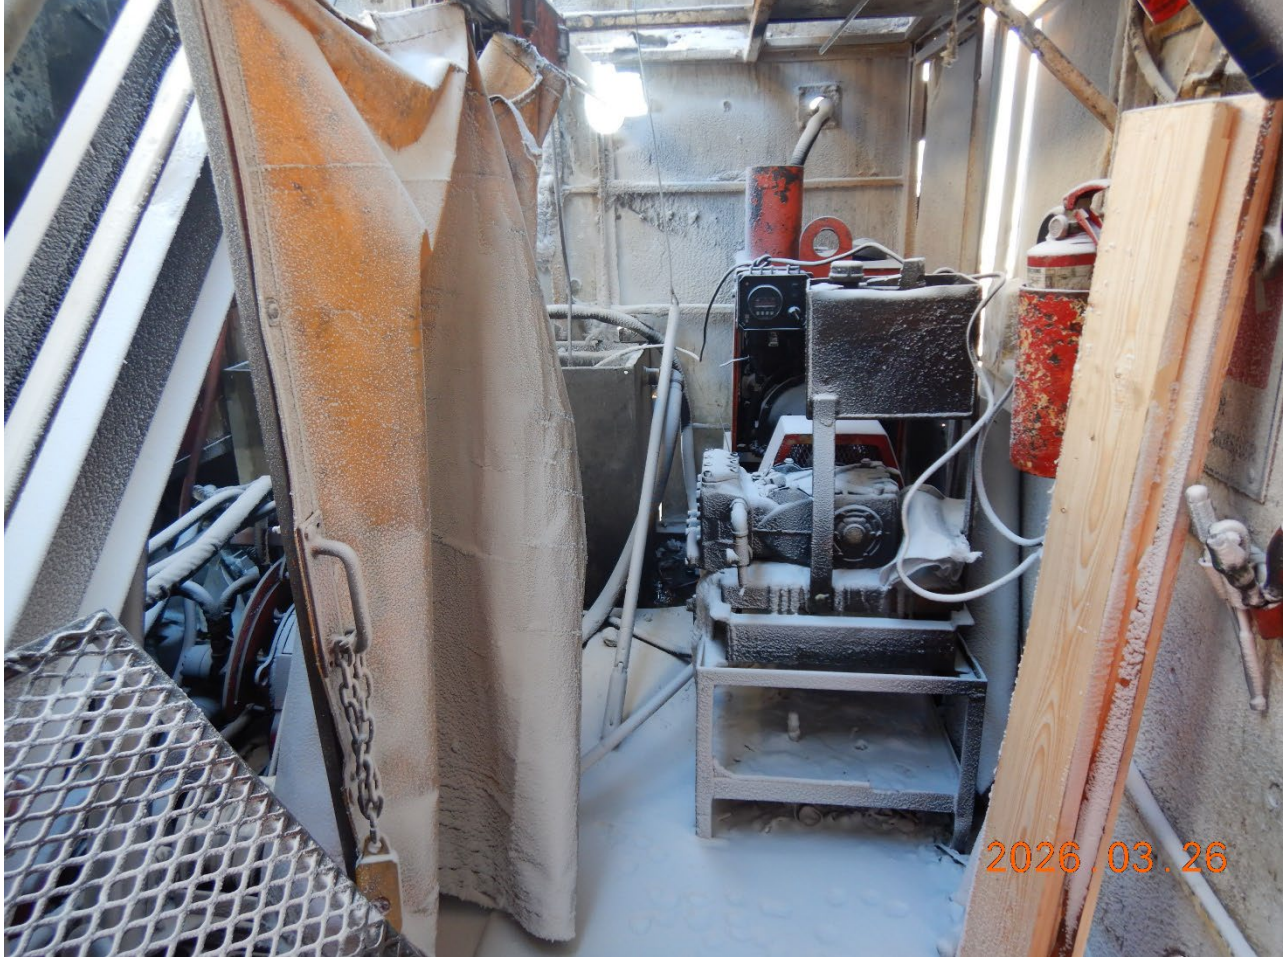
<b>Photo #</b> 1	<b>Coordinates:</b> N63° 0' 11" W92° 9' 44"
------------------	---

**Description:**  
Spill pads under components of laid up drill.

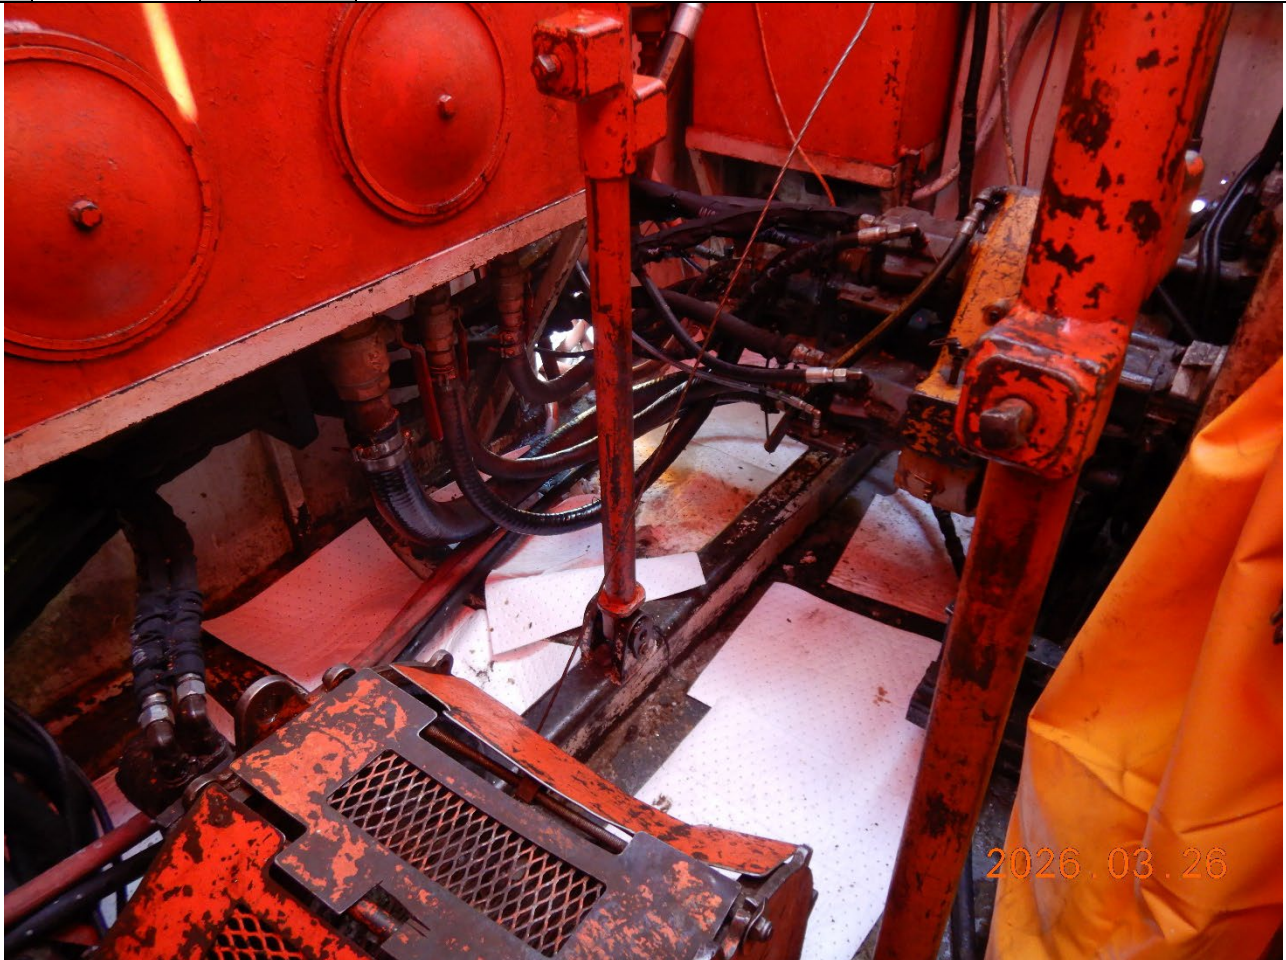
<b>Photo #</b> 2	<b>Coordinates:</b> N62° 59' 27" W92° 13' 51"
------------------	---

**Description:**  
Spill pads under hydraulic components of operating drill.

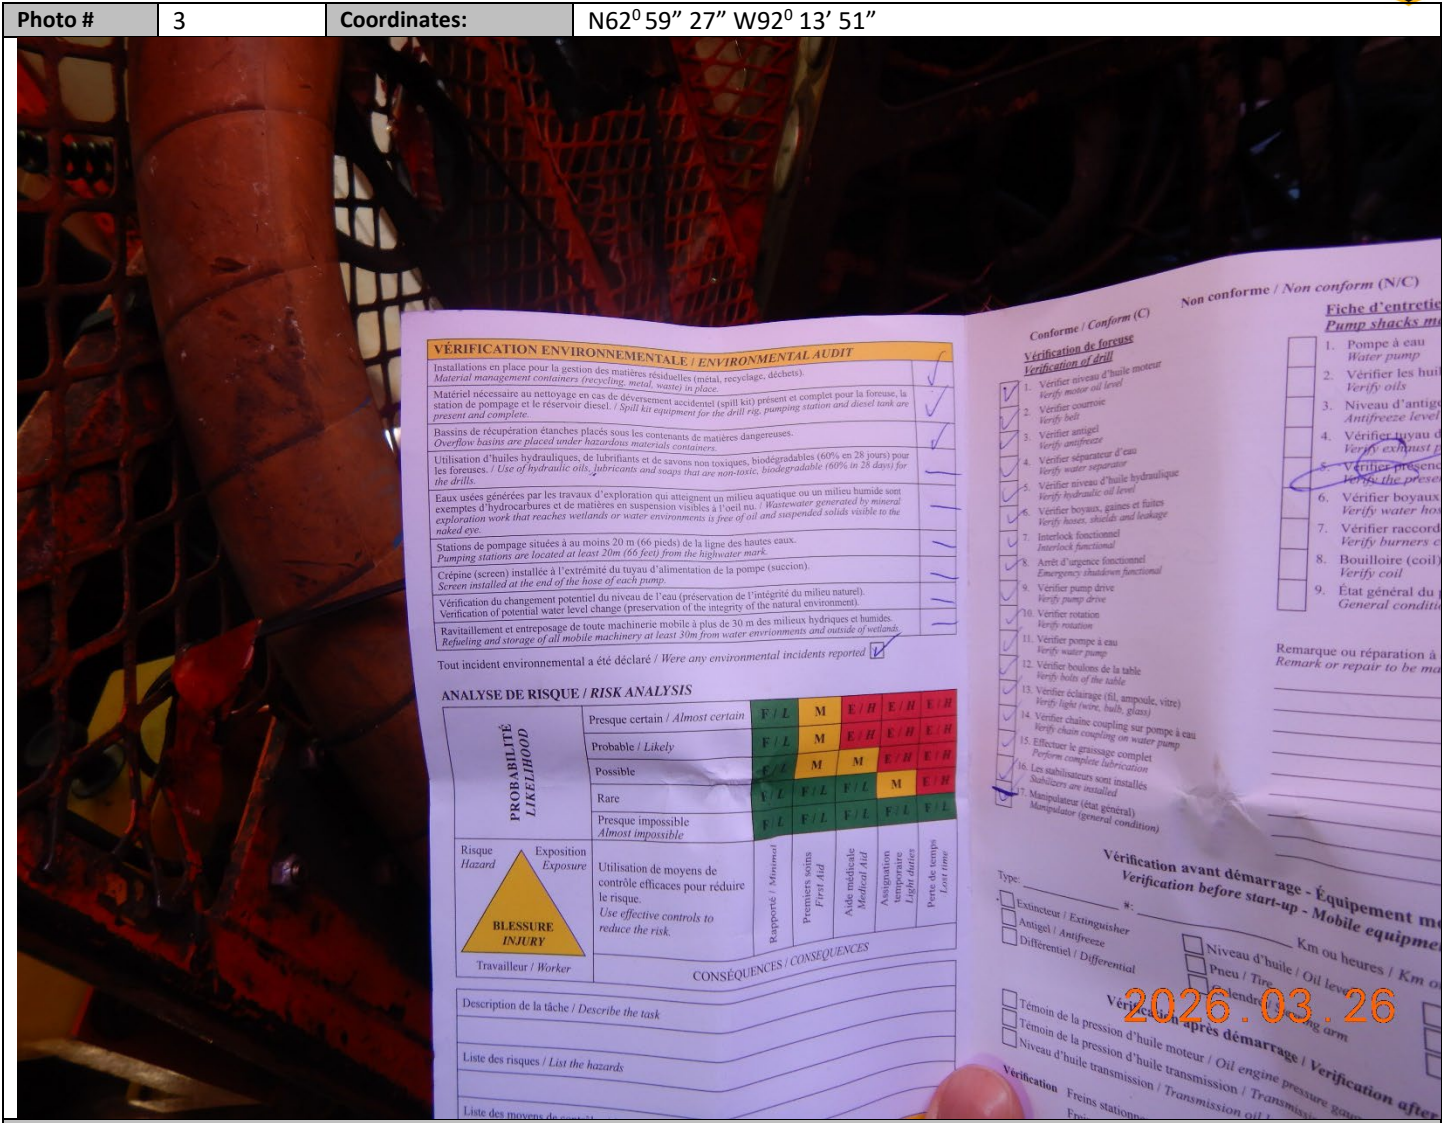
**Description:**  
Drillers inspection sheet. Pictured page is environmental daily inspections.

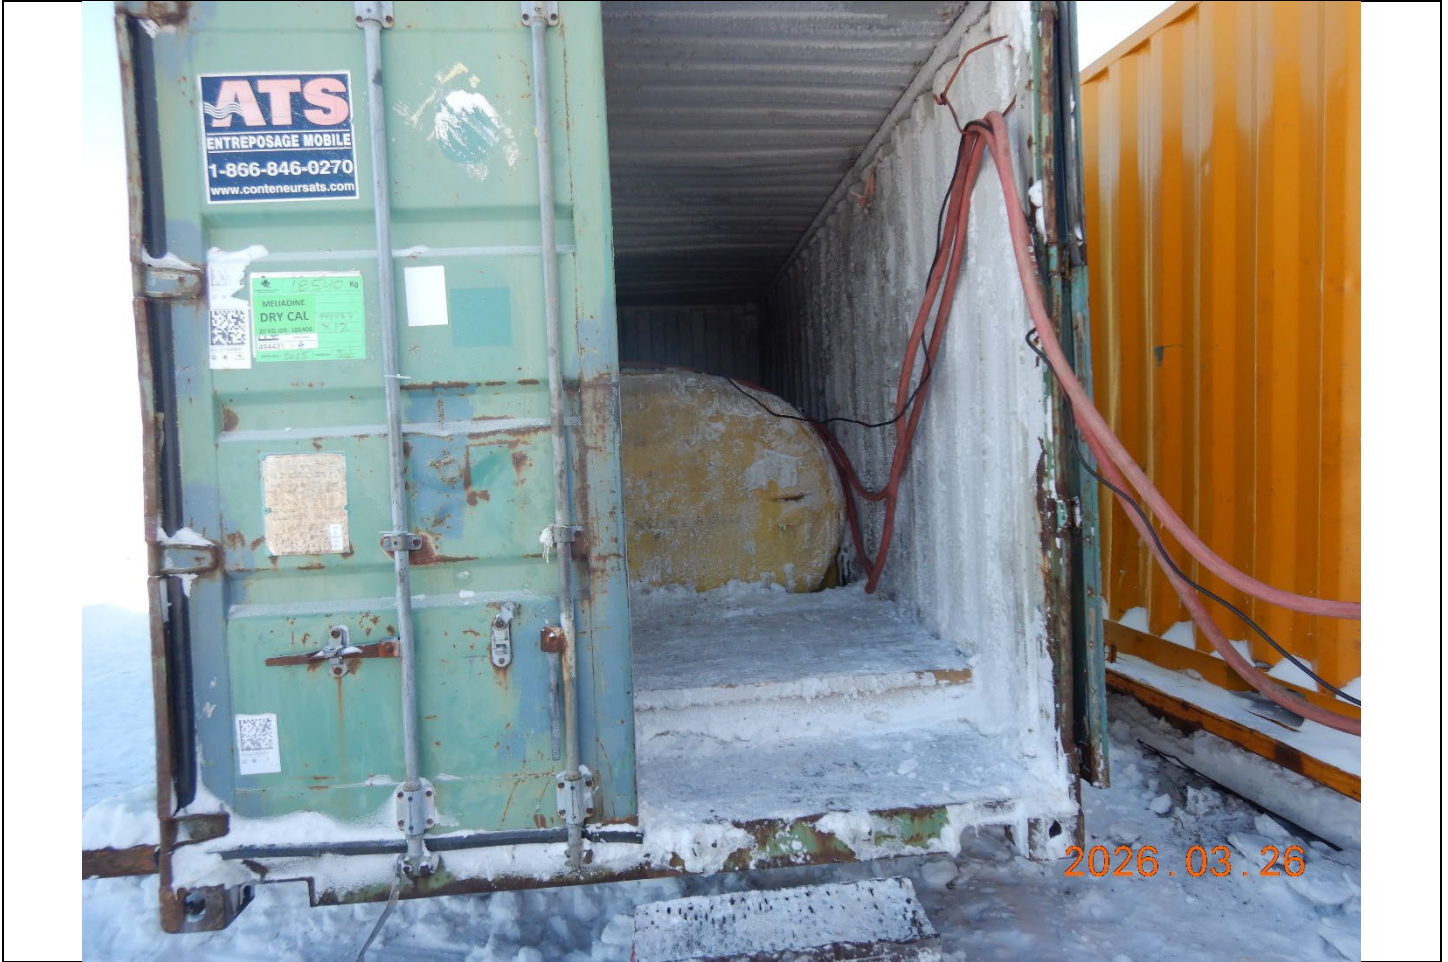
**Photo #** 4      **Coordinates:** N62° 59' 27" W92° 13' 51"

**Description:**  
Water tank used for supplying water to drills.

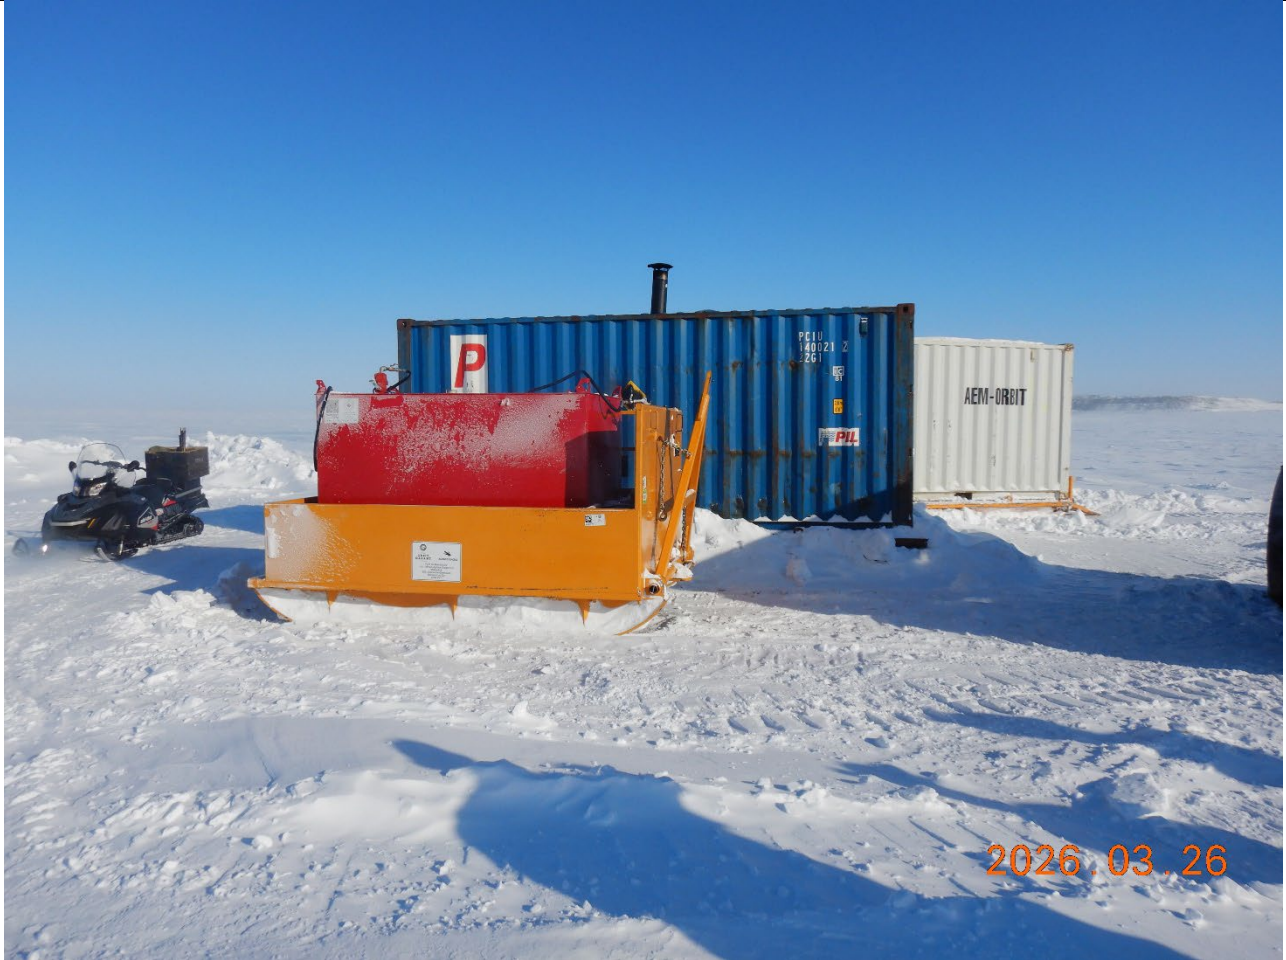
Photo # 5 Coordinates: N62° 59' 50" W92° 13' 45"

Description: Water tank refill area.

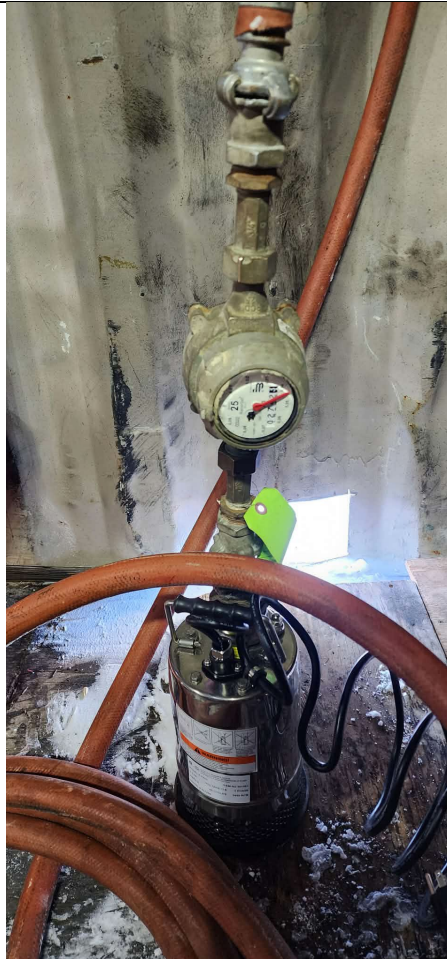
Photo # 6 Coordinates: NA

Description: Newly installed meter on water pump used for filling of water tanks.

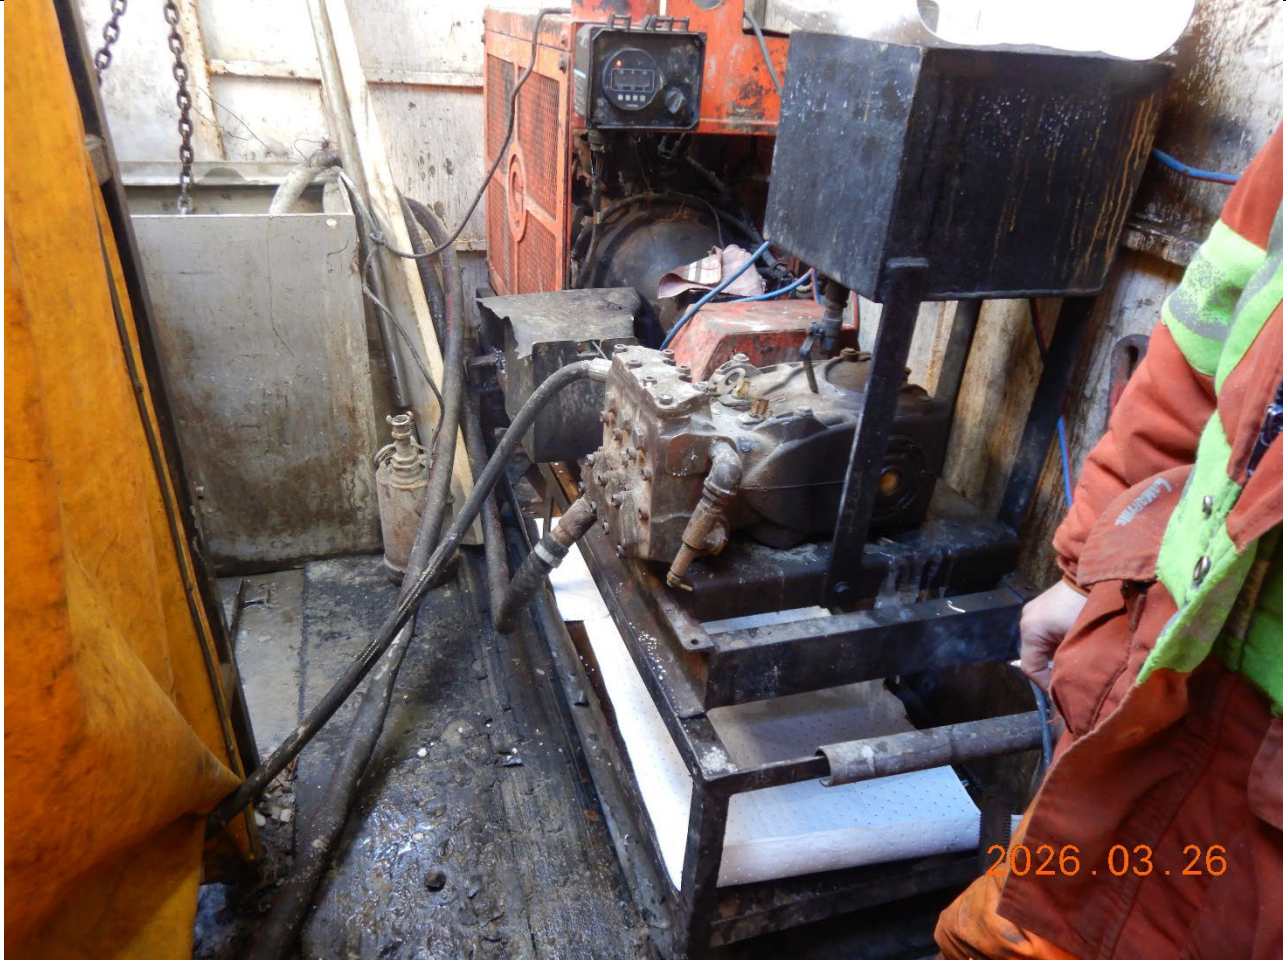
Photo # 7

Spill pads under drill component.
