## WATER LICENCE INSPECTION FORM

On April 19<sup>th</sup>, an inspection of reportable spill number 2022-136 at Agnico Eagle Mines Ltd.'s Meliadine Gold Project, Exploration Division was completed by Crown-Indigenous Relations and Northern Affairs Canada (CIRNAC)'s, Water Resources Officers, Christine Wilson (Inspector) and Kyle Amsel.

**Summary- Lake A8 Spills 2022**

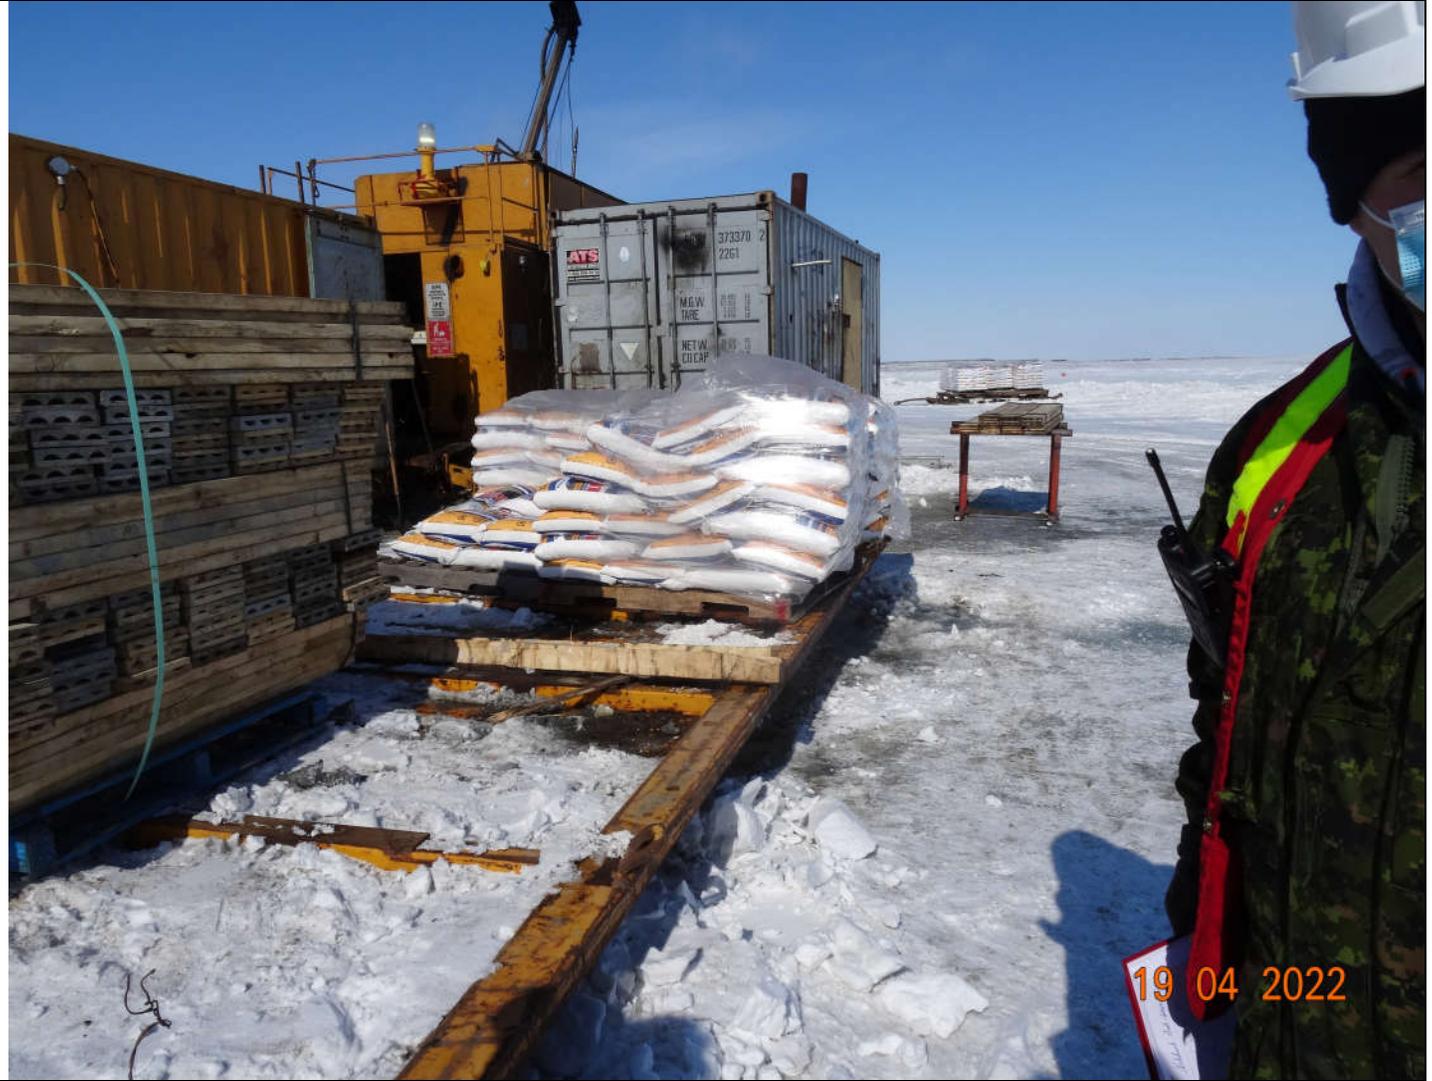
1. Calcium Chloride storage is not adequate. The bags are ripped open and the chemicals are spreading to the surface of the ice (photo 1 and 2).
2. Water is tanked from a hole in the ice of Lake A8 located at N63° 0' 33.17", W92° 12' 9.86" (photo 3) . Currently water usage is calculated by the tank. This method is not acceptable and needs to be improved before the next inspection.

**Description:**  
Improper storage of chemicals at drill rigs 1

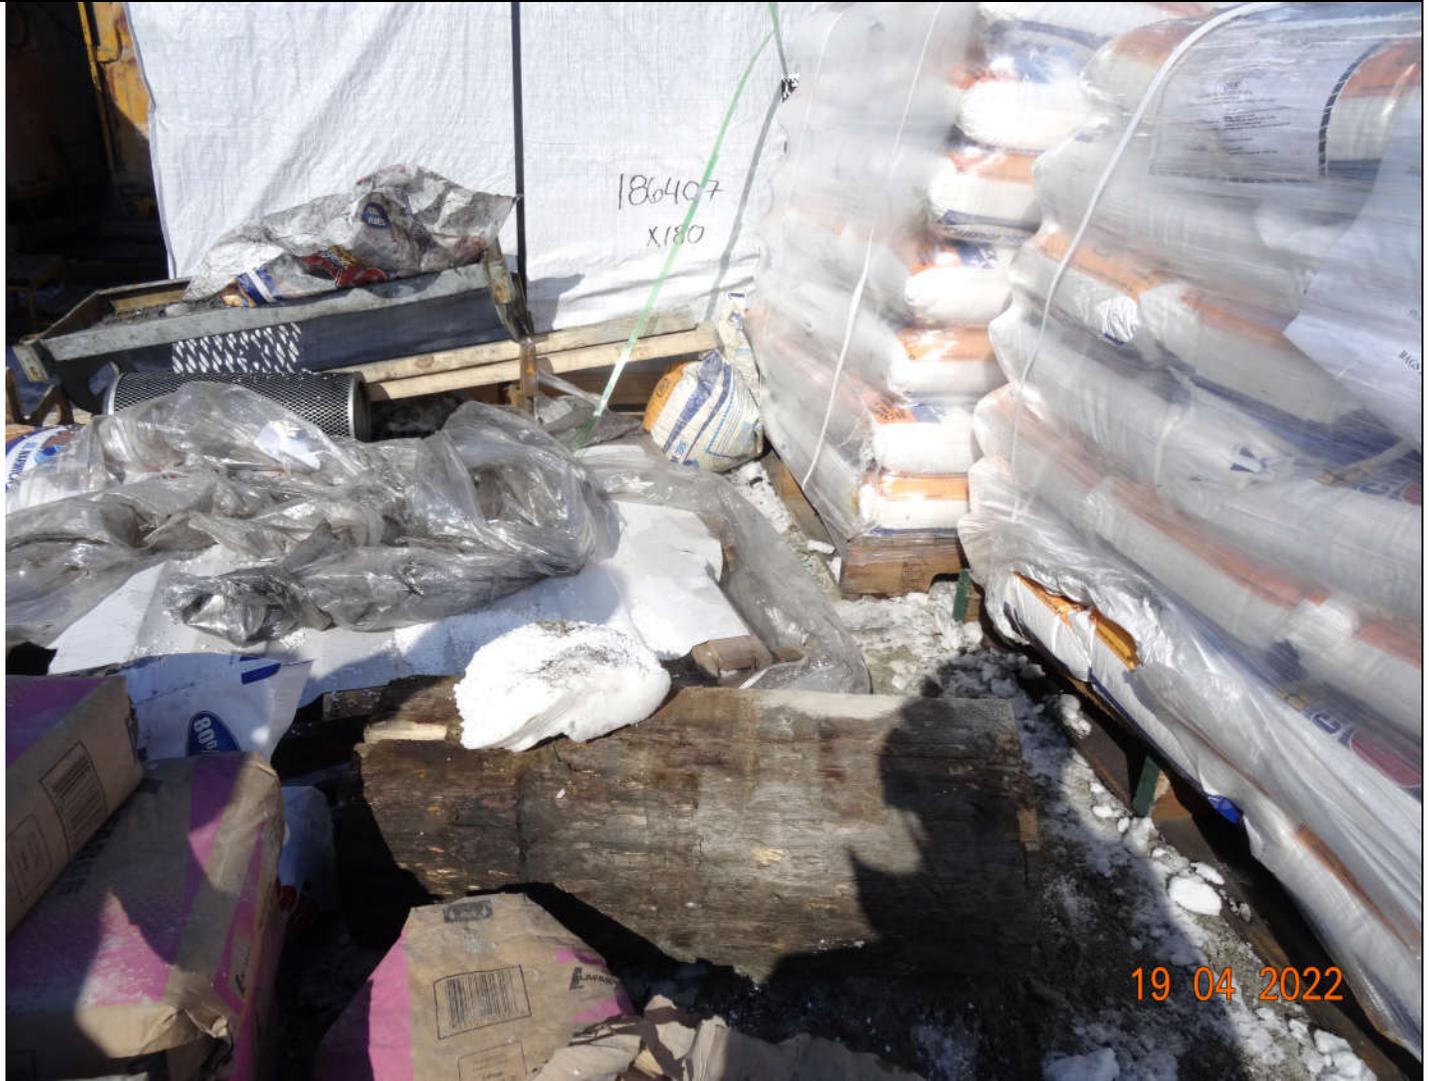
Photo 2

Improper storage of chemicals at drill rig 2.

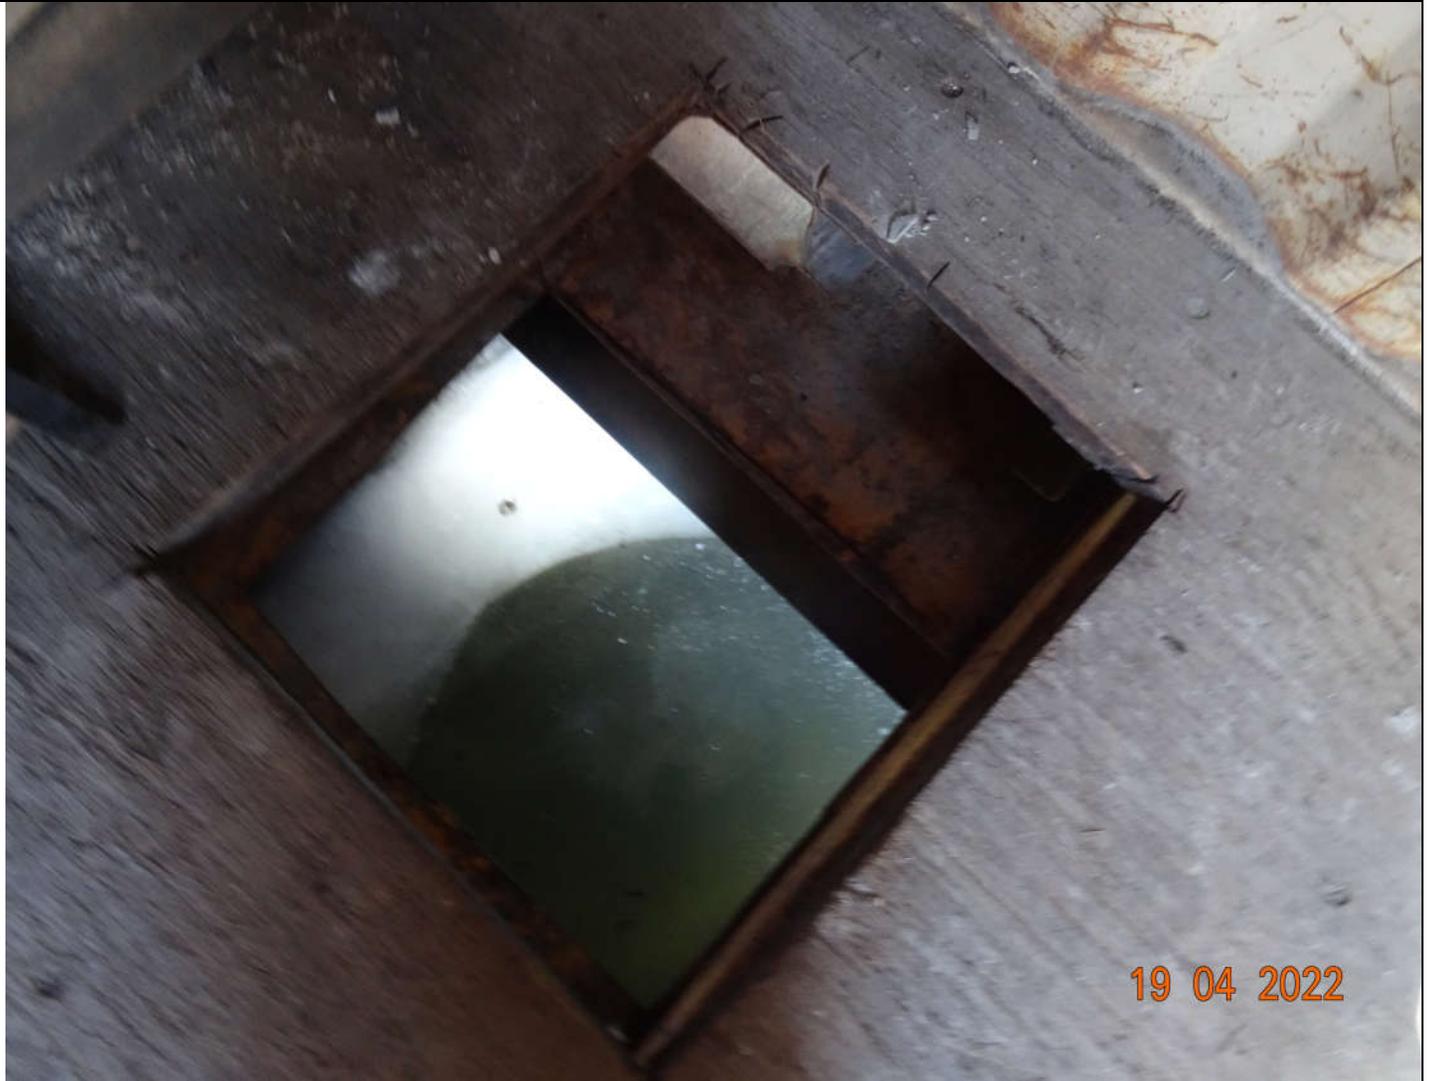
Photo 3

Fresh water hole, Lake A8.

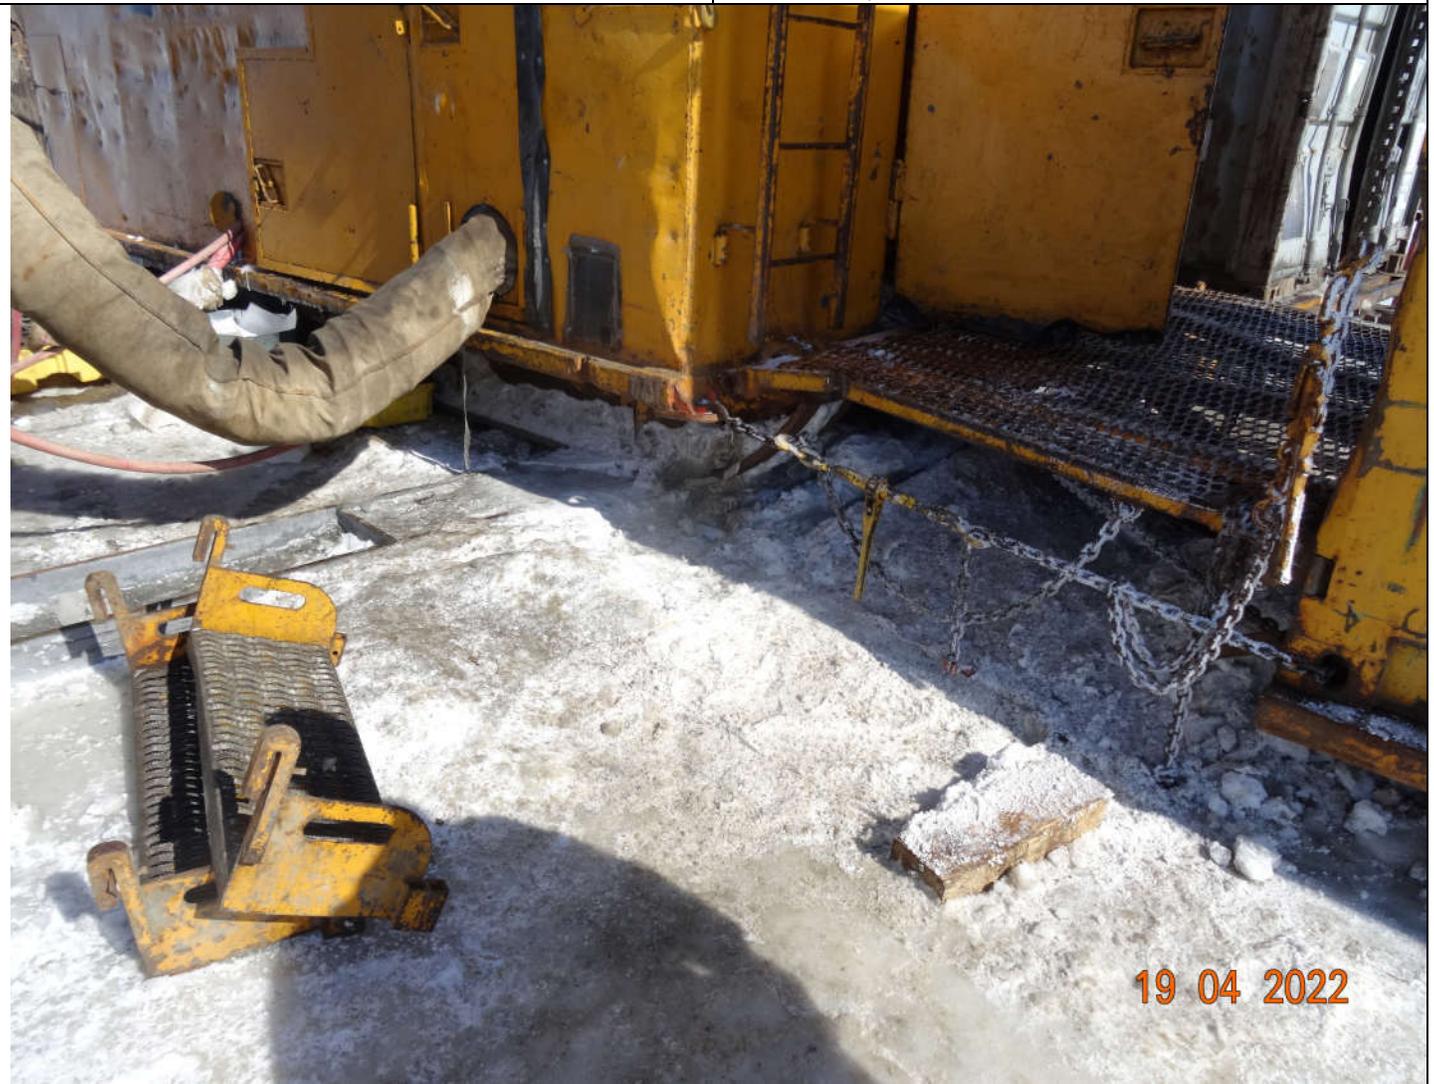
Photo 4

3. The ice surface around the drill are generally stained with a grey material and water which is used in the drilling process (photo 3- 12 ). Orbit indicated the majority of the grey material is dust from drilling.

Ice Surface around the drills 1

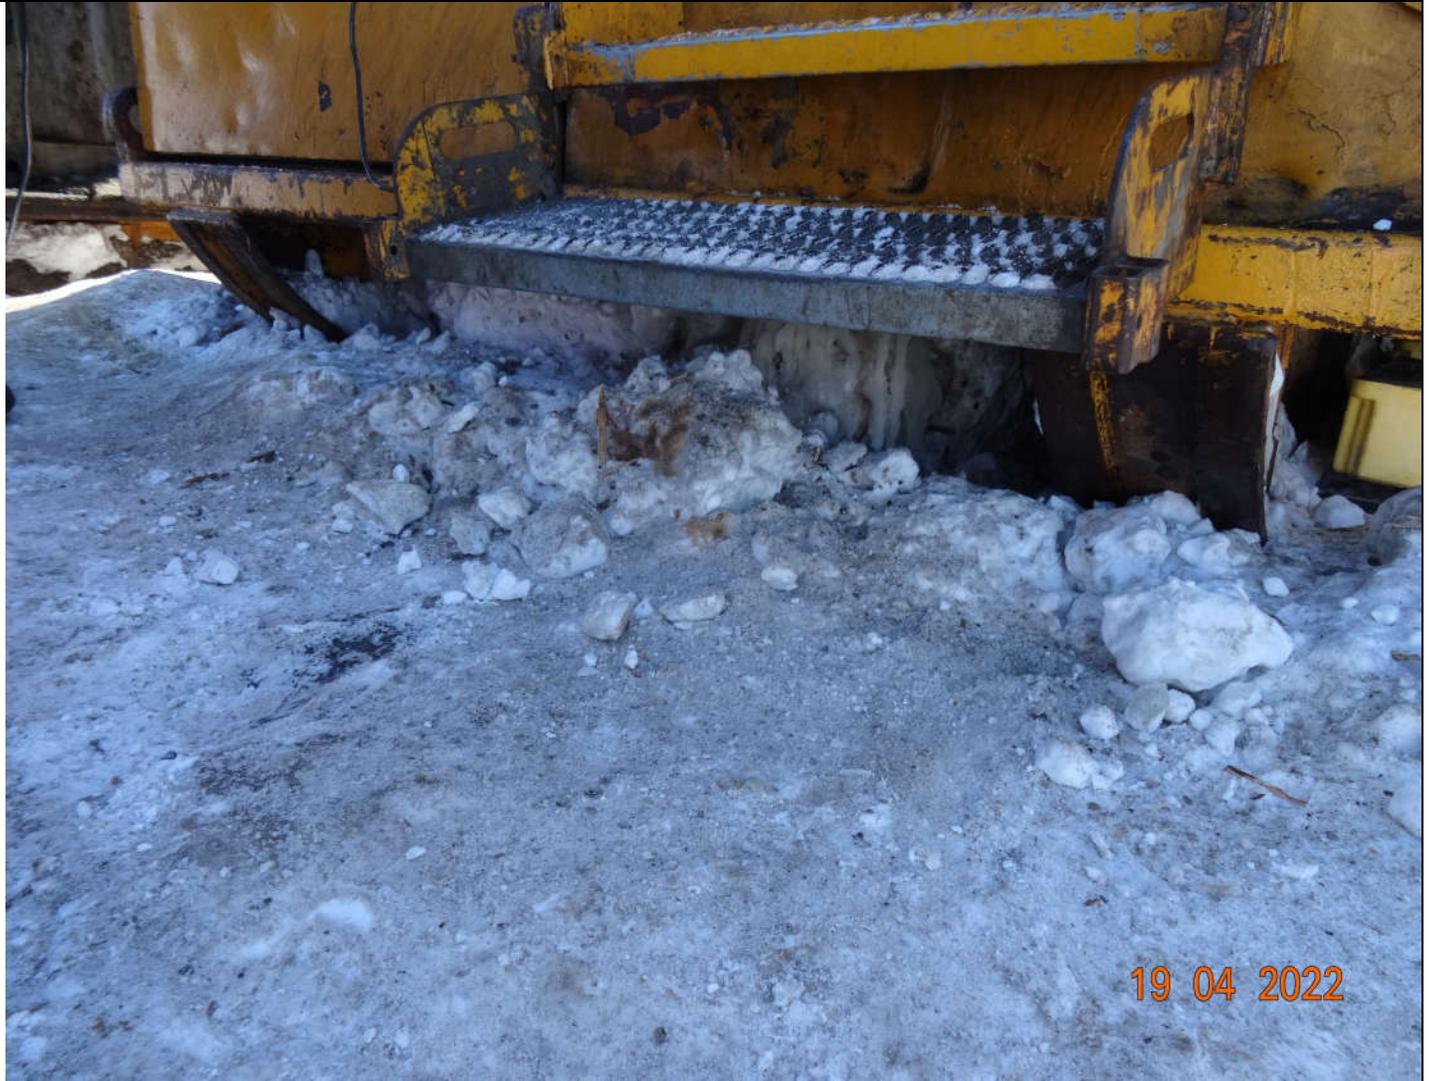
Photo 5

Grey staining to Ice surface around sleds.

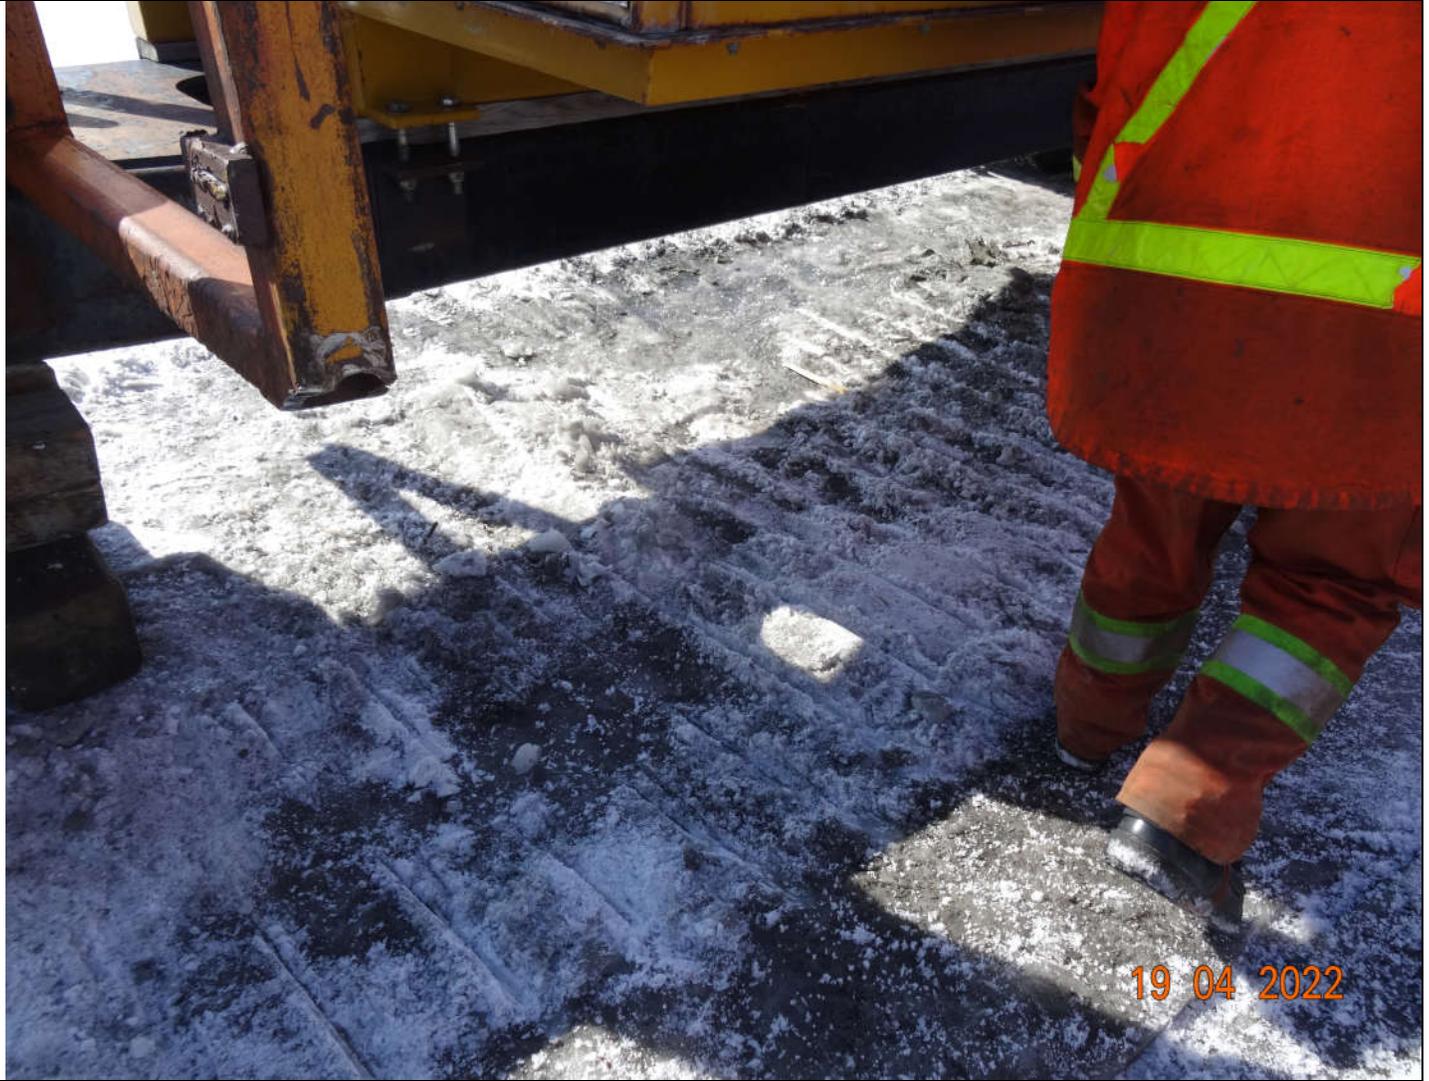
Photo 6

Grey material on the ice surface of A8 Lake.

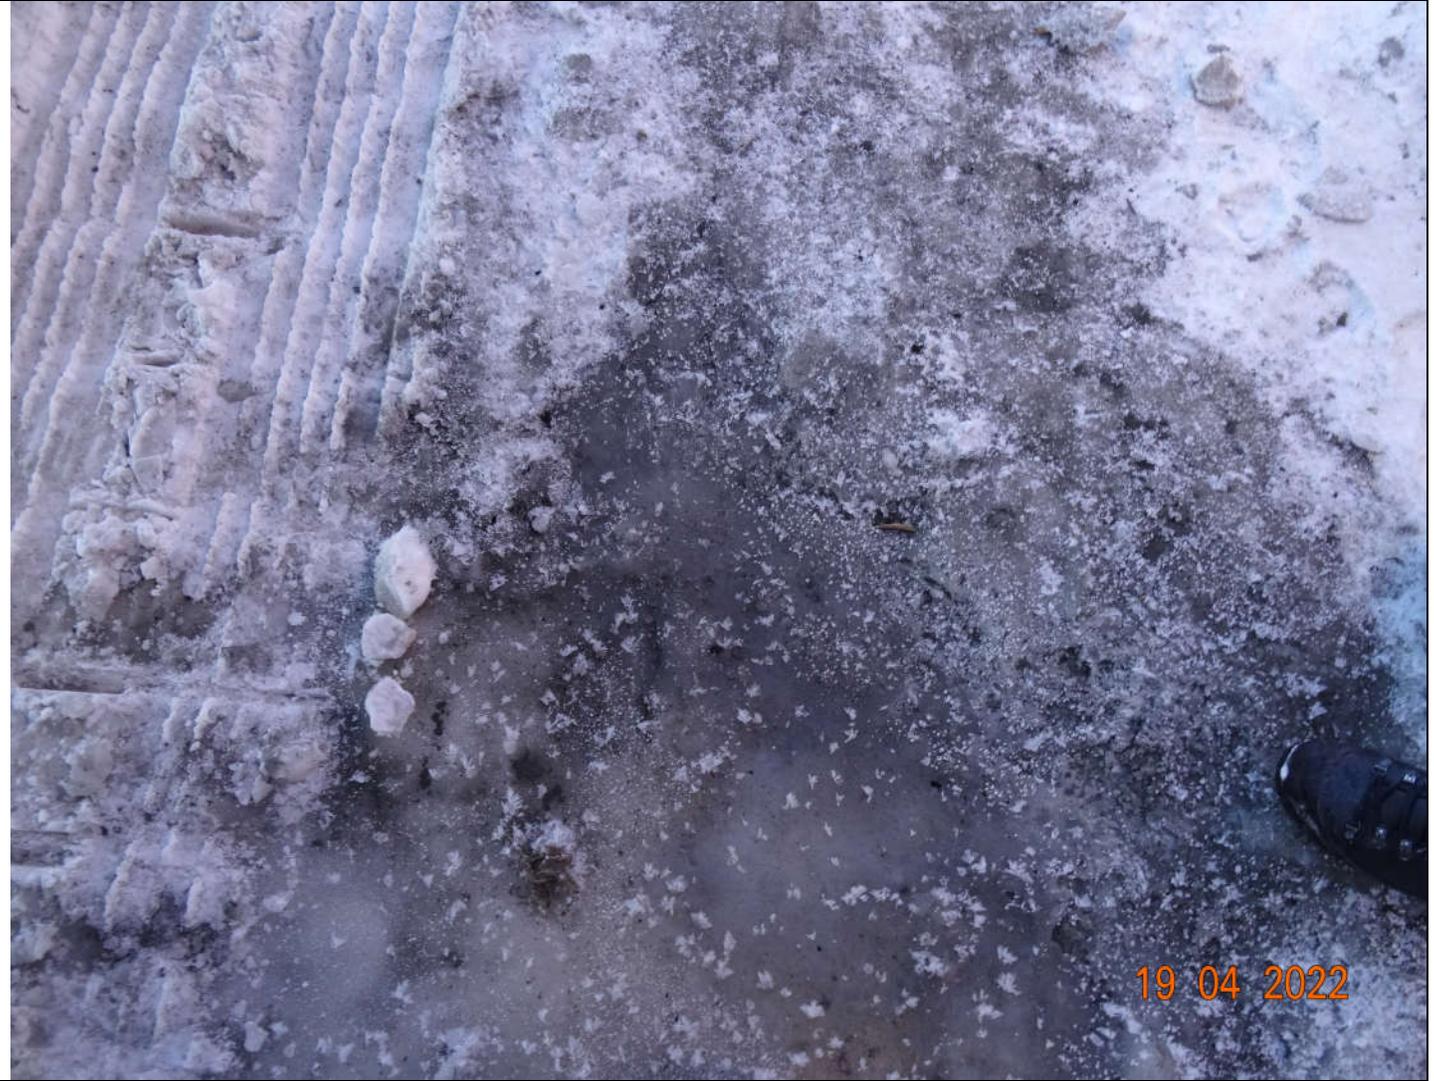
Photo 7

Grey materials of the surface of the ice of Lake A8

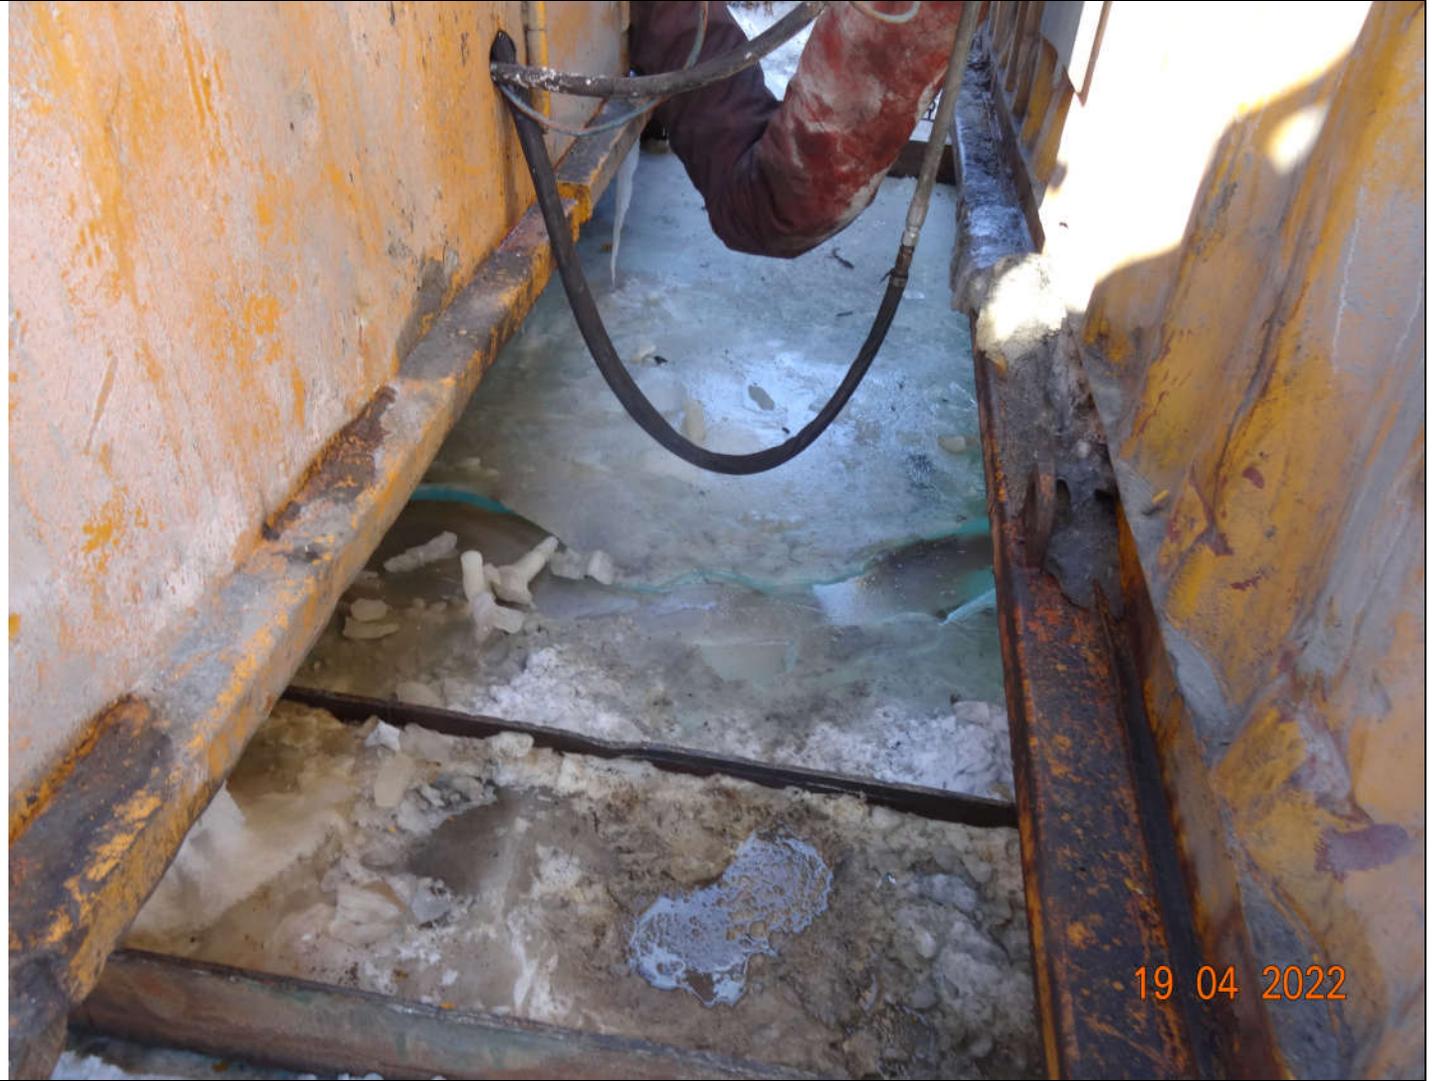
Photo 8

Material on the surface of the ice at Lake A8

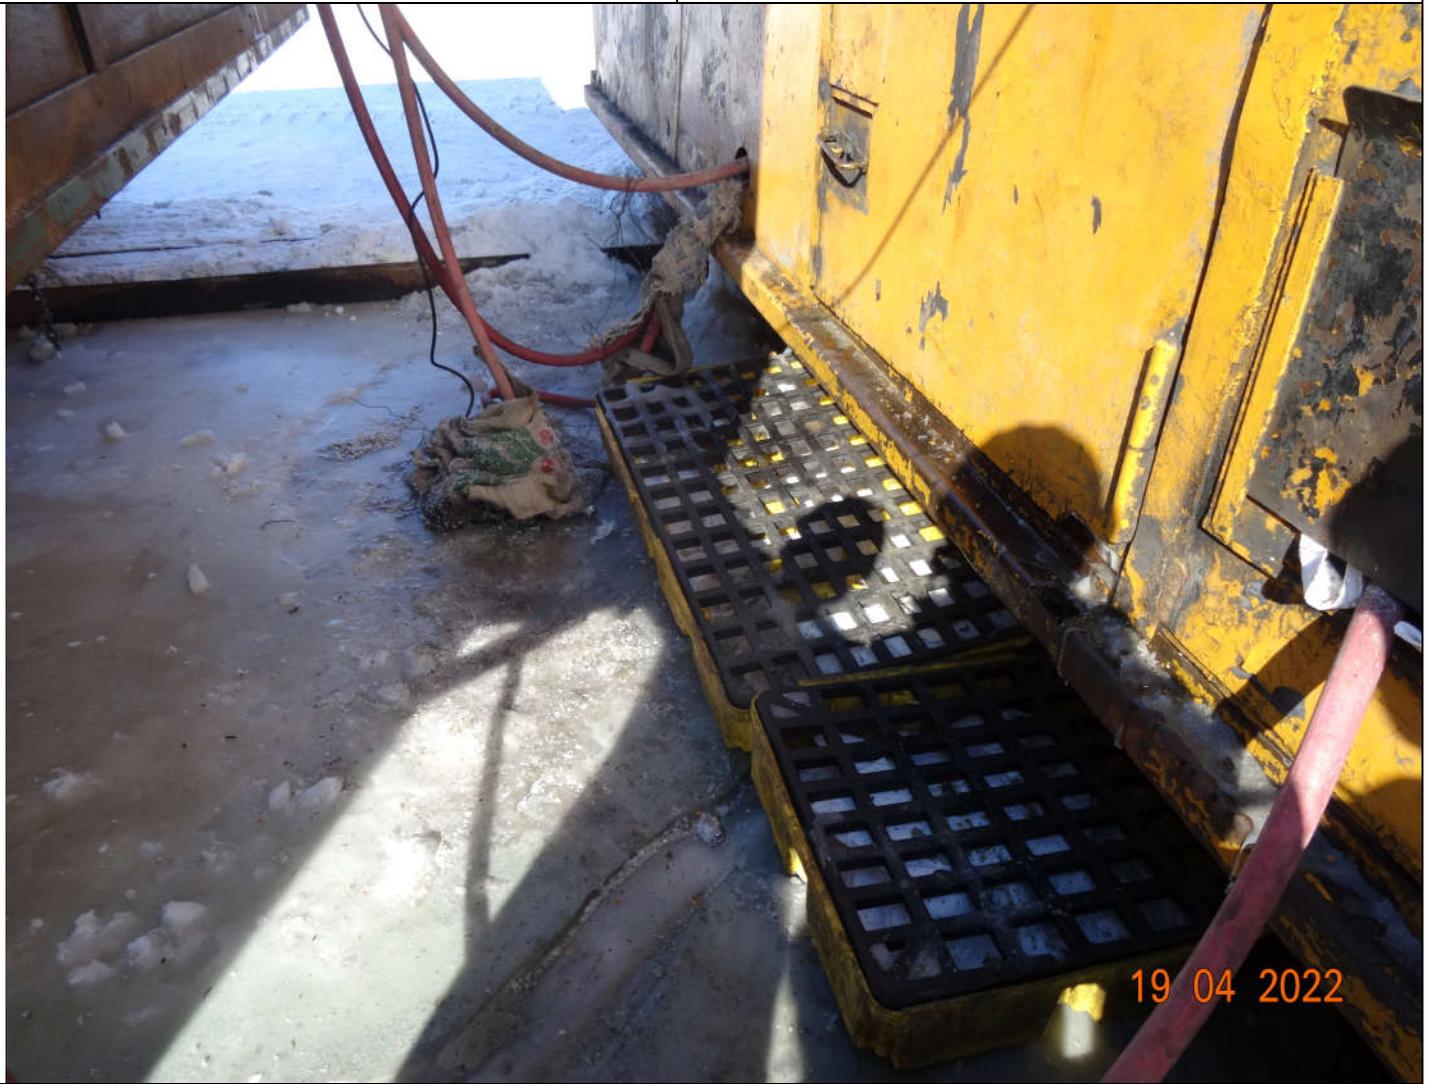
Photo 9

Grey material and drilling water on the surface of the ice.

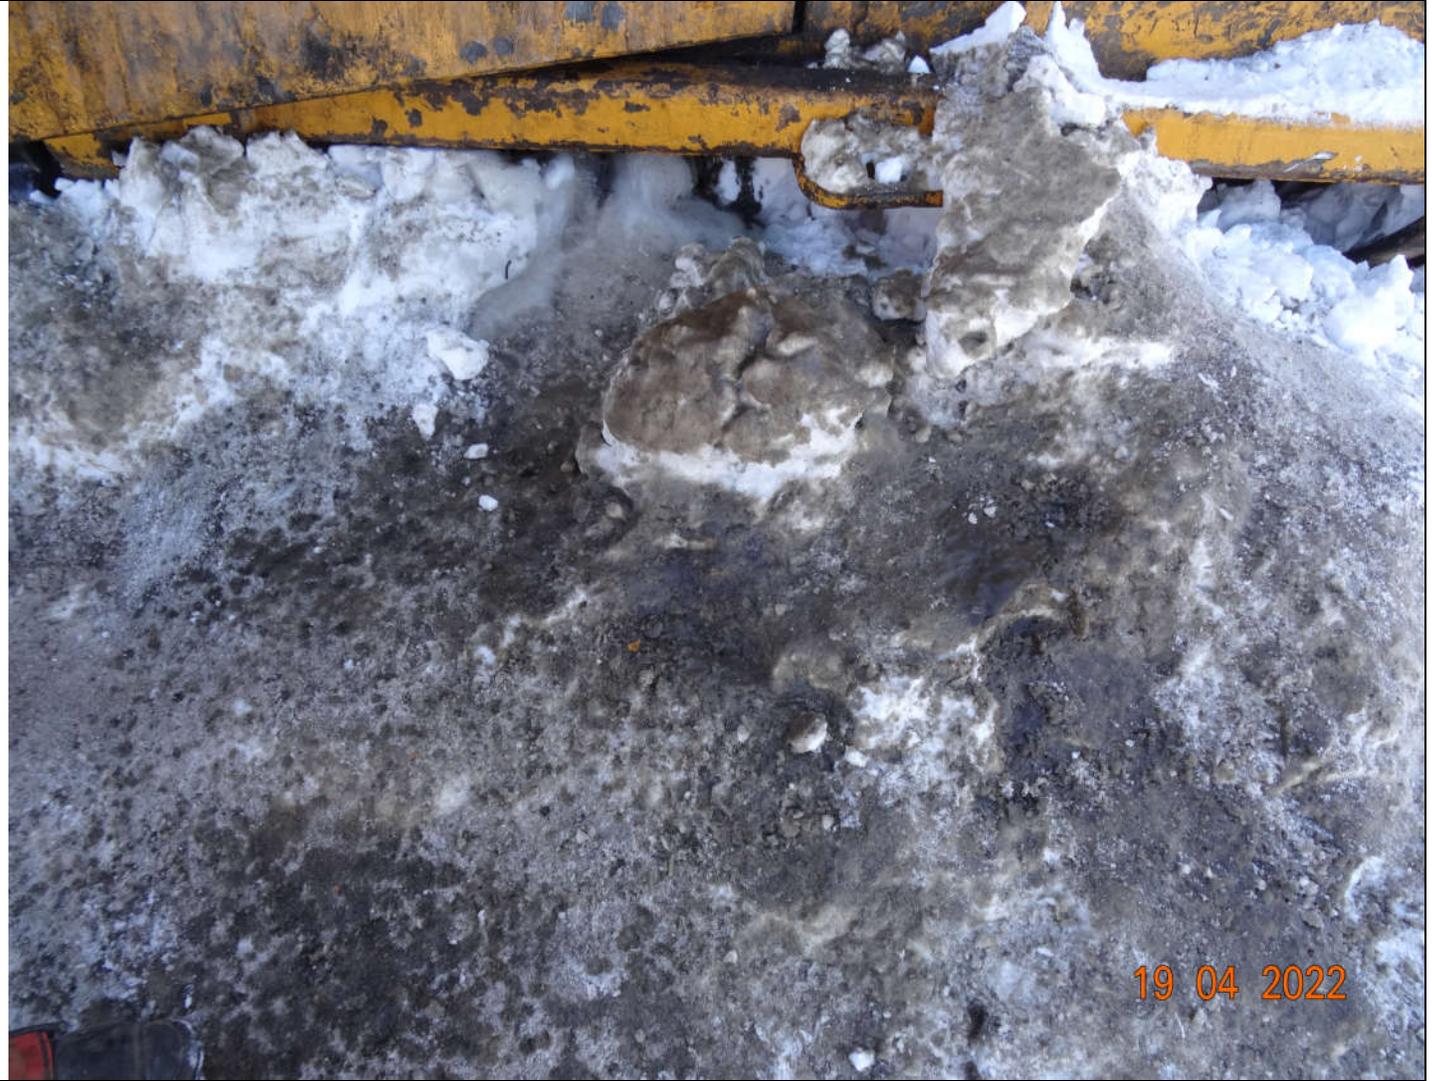
Photo 10

Grey and black material in a pile of snow on the surface of the Lake A8.

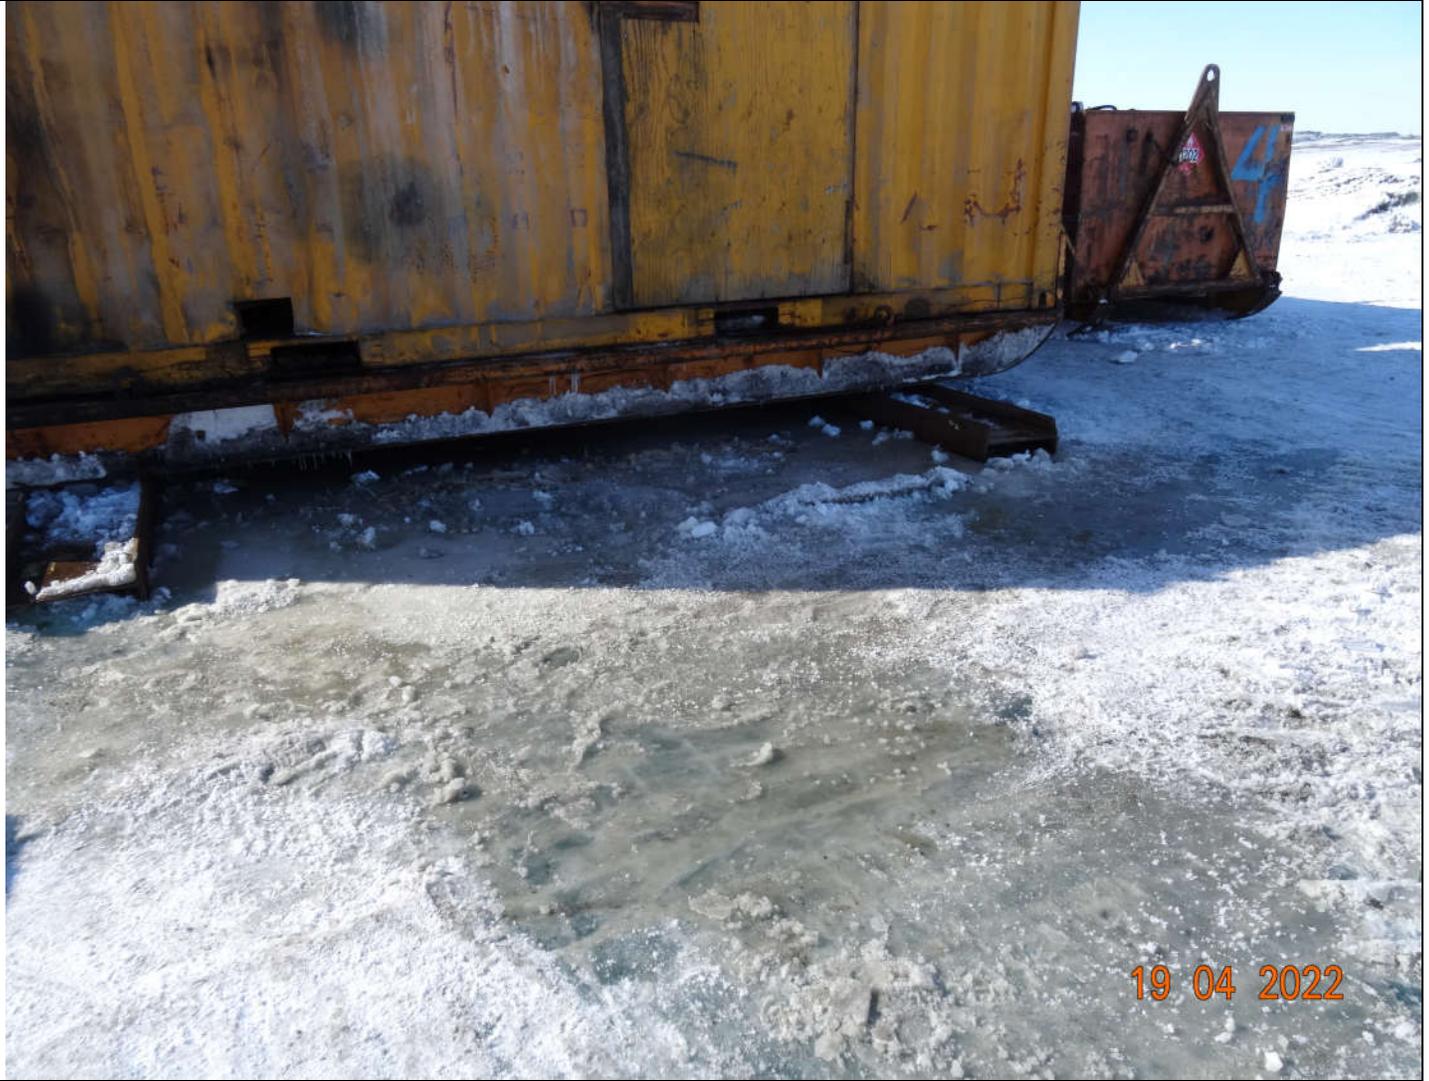
Photo 11

Grey materials on the sides of the sled and the surface of the ice.

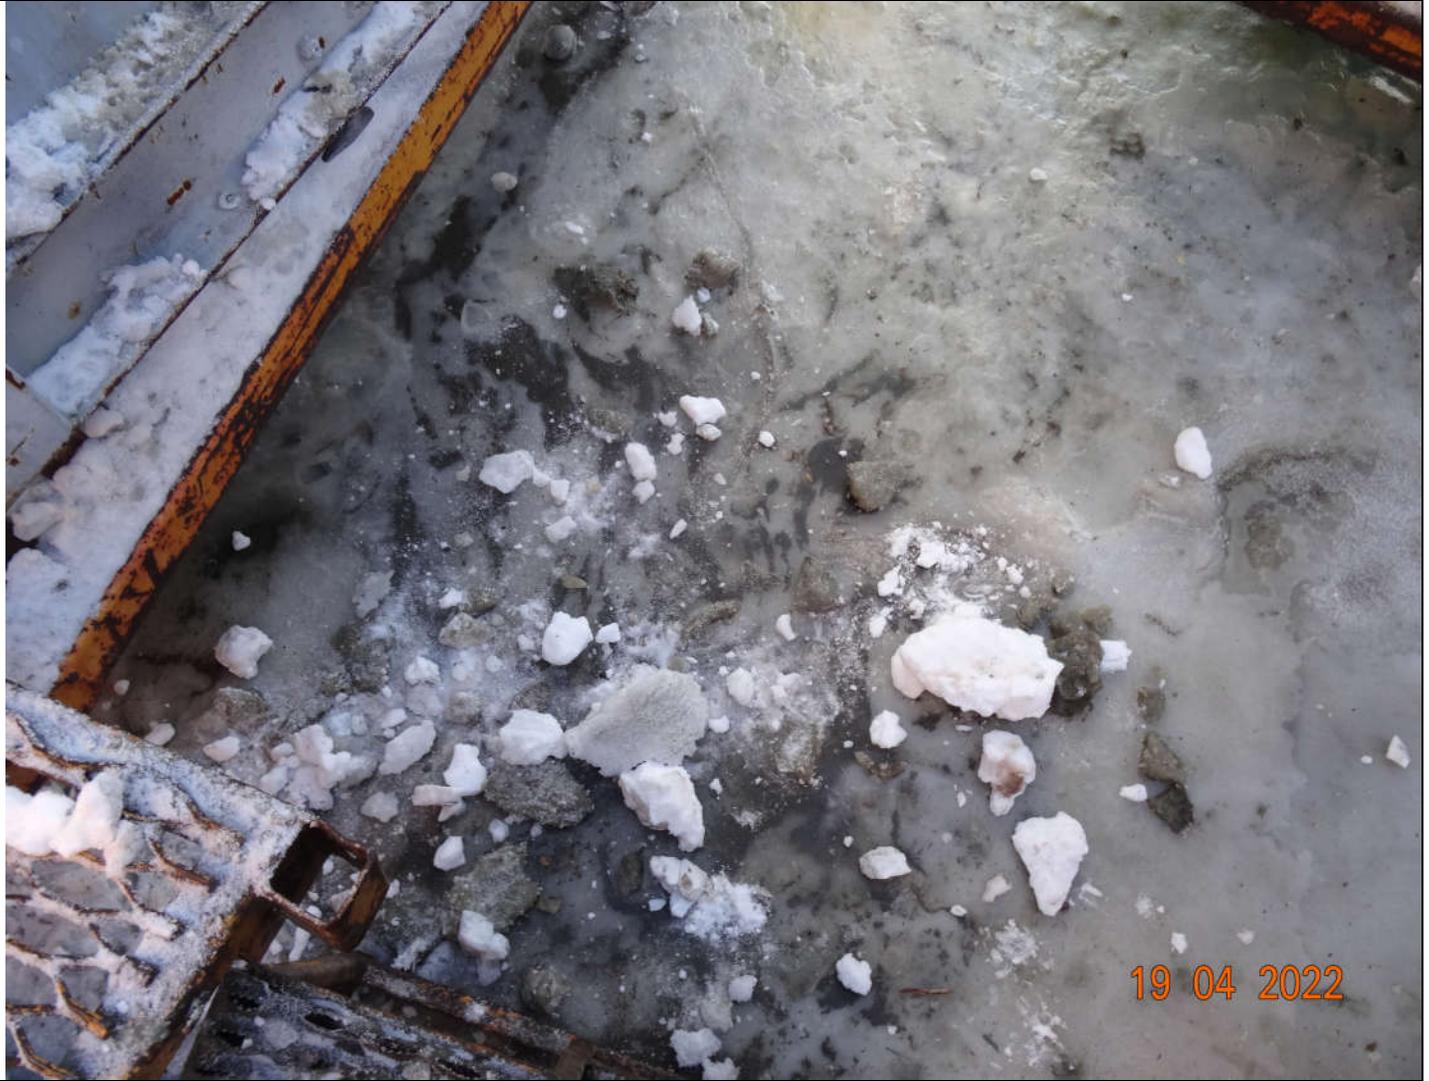
Photo 12

Grey materials on the ice surface of A8 Lake.

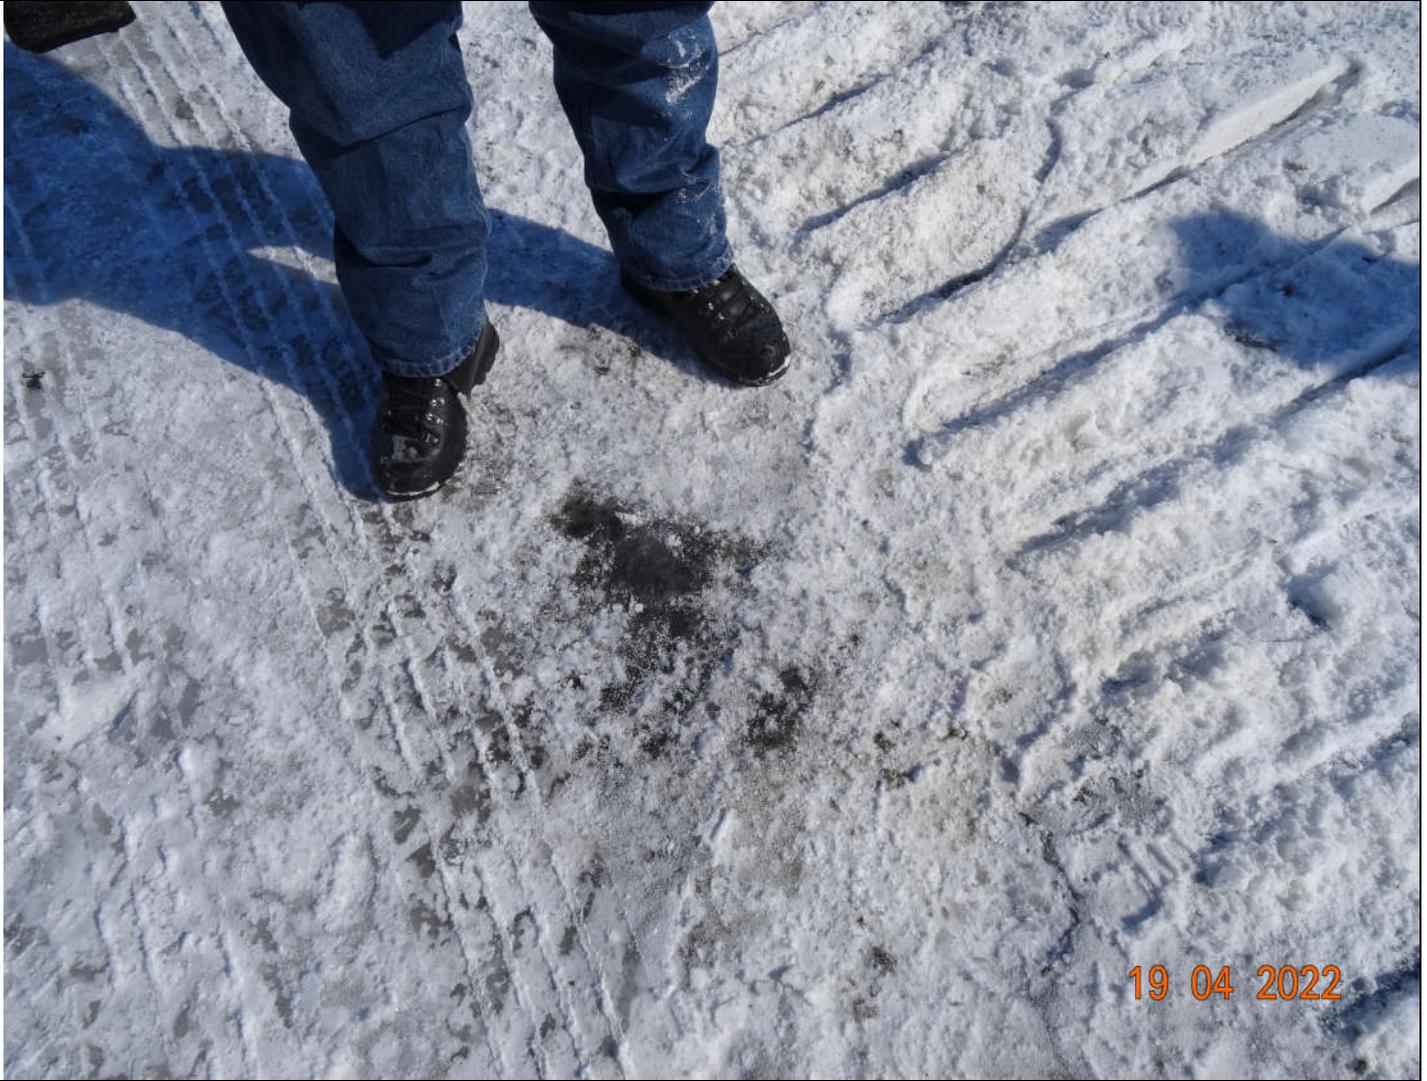
Photo 13

6. Upon completion of drilling the ice surface is scrapped and the material is brought to the snow cell for disposal. A reclaimed drill site approximately located at N63° 0' 31.46", W92° 12' 13.84" has some grey material remaining on the surface of the ice and in the melted hole as well as a small spill of what appears to be hydrocarbons (photo 13).

What appears to be a small spill on the surface of the ice.
