Follow Up Report – February 2nd 2018 MEL-07 Treated Water Discharge

Description of Exceedance:

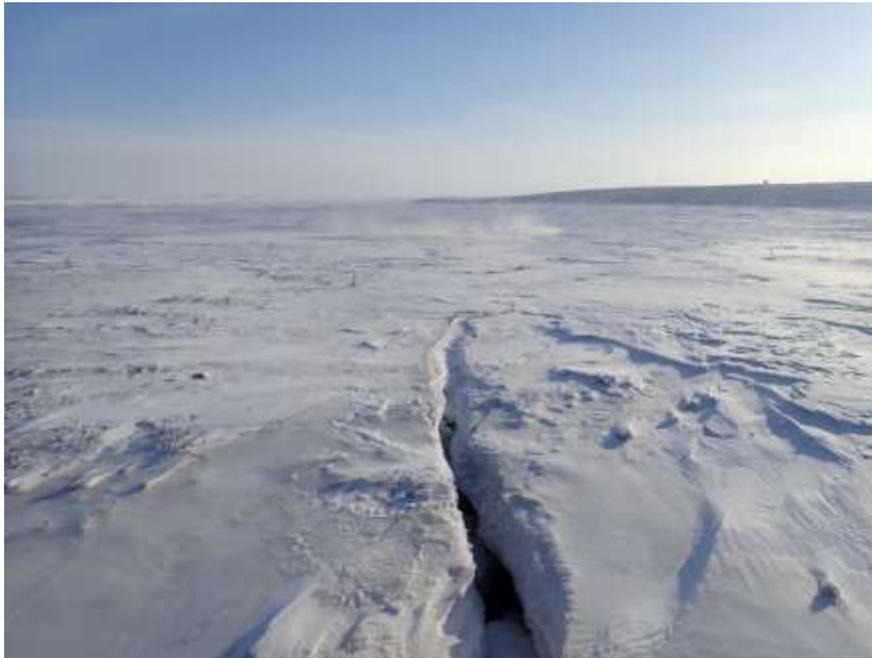
Picture 1: Channel formed by release water flowing through ice into Meliadine Lake.

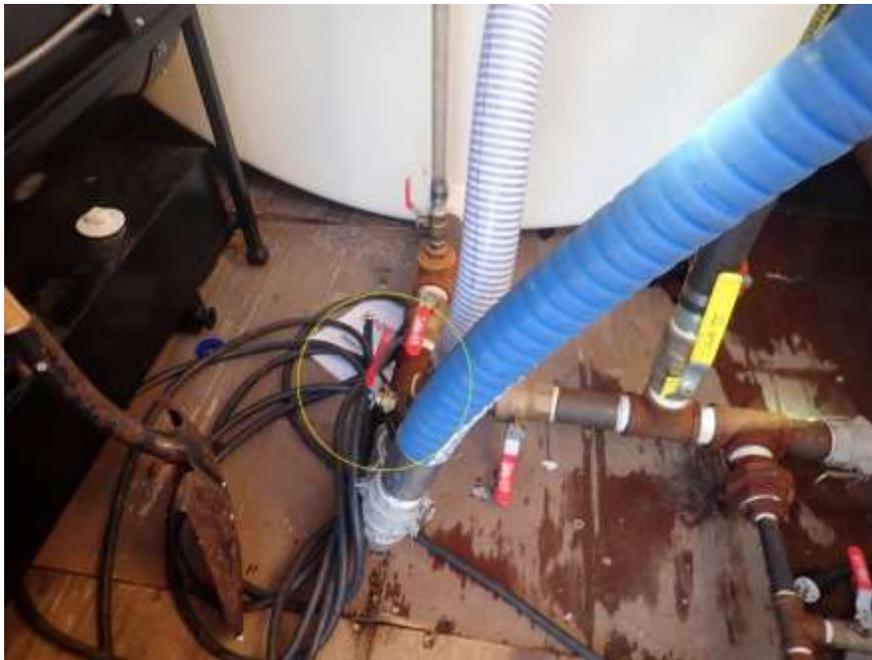
Picture 2: Release valve left open causing the spill.

Investigation into the release was inconclusive. However, it is believed that a water truck operator failed to close the release valve after transferring water to a truck.

The release was deemed to be caused by human error. The release valve is now fitted with a locking mechanism. A supervisor now keeps a register to record which operator is in possession of the key.

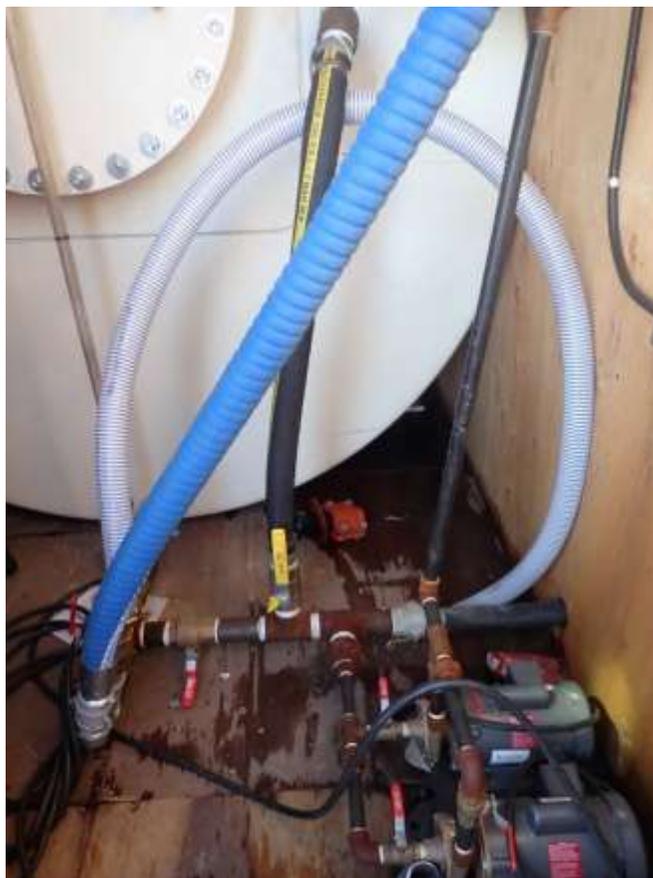
Picture 3: Discharge hose connected to retention tank release valve.

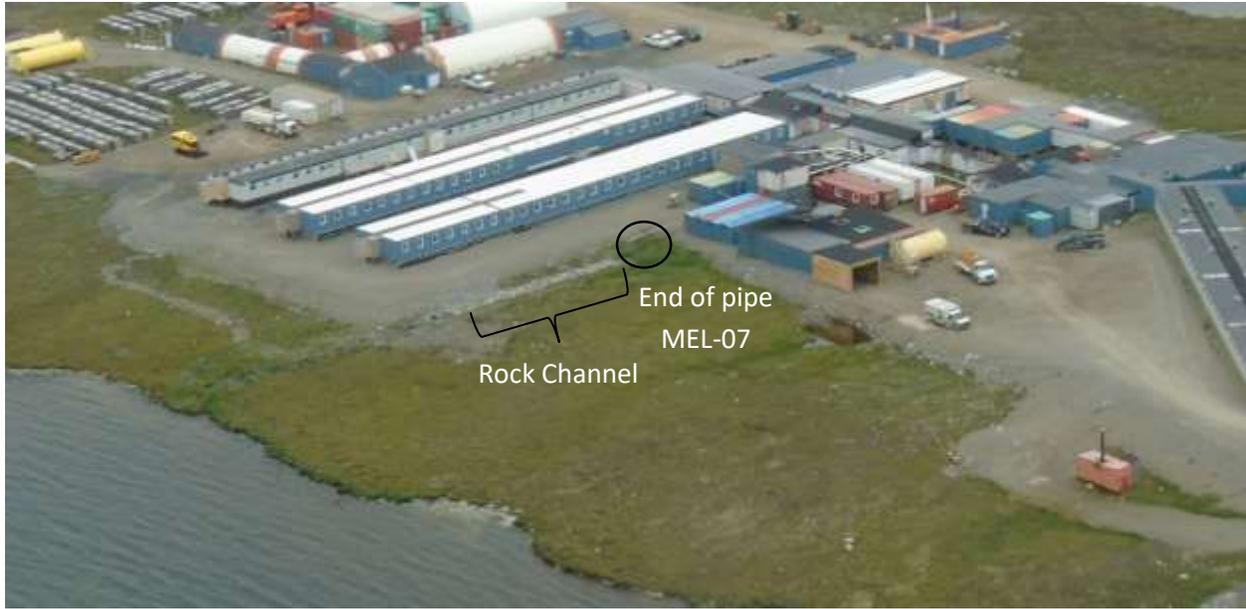
The MEL-07 effluent discharges to land at a location situated approximately 65 m from the ordinary high water mark of Meliadine Lake (see Figure 1). Once the effluent reaches the end of the pipe, it travels along a rock channel intended to reduce the flow and prevent erosion. The effluent will then follow the rock channel to Meliadine Lake. It is expected that with the extreme cold temperatures on February 2nd, and the fact that the effluent discharges to land first, the bacteria would likely not have survived.

Figure 1: View from above - MEL-07 discharge configuration with rock channel and flow path to Meliadine Lake
