# Follow Up Report: #2022136

## April 18<sup>th</sup>, 2022

### 0.5 L Engine Oil on Water Body A8 – Drill Rig#7

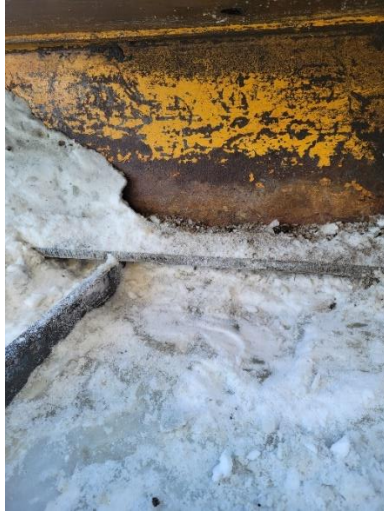
On April 18<sup>th</sup>, 2022 at approximately 11:30, Environment Technicians were conducting an inspection of surface Drill# 7 M22-3396, operated by Orbit Garant. During the inspection, areas with small amounts engine oil coming out of the drill shack and from underneath the drill onto the lake ice were observed. It is estimated approximately 0.5 L of engine oil was released onto the lake ice.

**Figure 2: Spill Location – Post cleanup**

During the inspection, Environment technicians notified the drillers of the issues and the Orbit Garant supervisor was also notified. Absorbent pads were placed to clean the engine oil and a shovel was used to clean up the remaining material. The contaminated snow and ice were disposed in a quatrex bag.

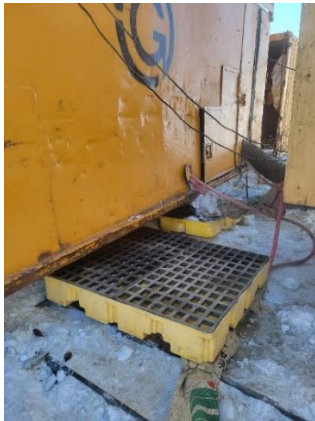
The release was a result of a human error as the worker didn't use a funnel to fill the tank. Some engine oil was spilled inside the drill and released outside the drill through the drain hole.

**Figure 3: Spill tray installed under the drain hole**

Funnels are now used. A spill tray was also installed under the drain hole to collect any other substance that could be released through the drain hole.
