March 18th, 2023

Re: Follow-up Report Spill #2023-068 – Release of 50 L of Drill Cuttings Water Meliadine Gold Project Lake A19

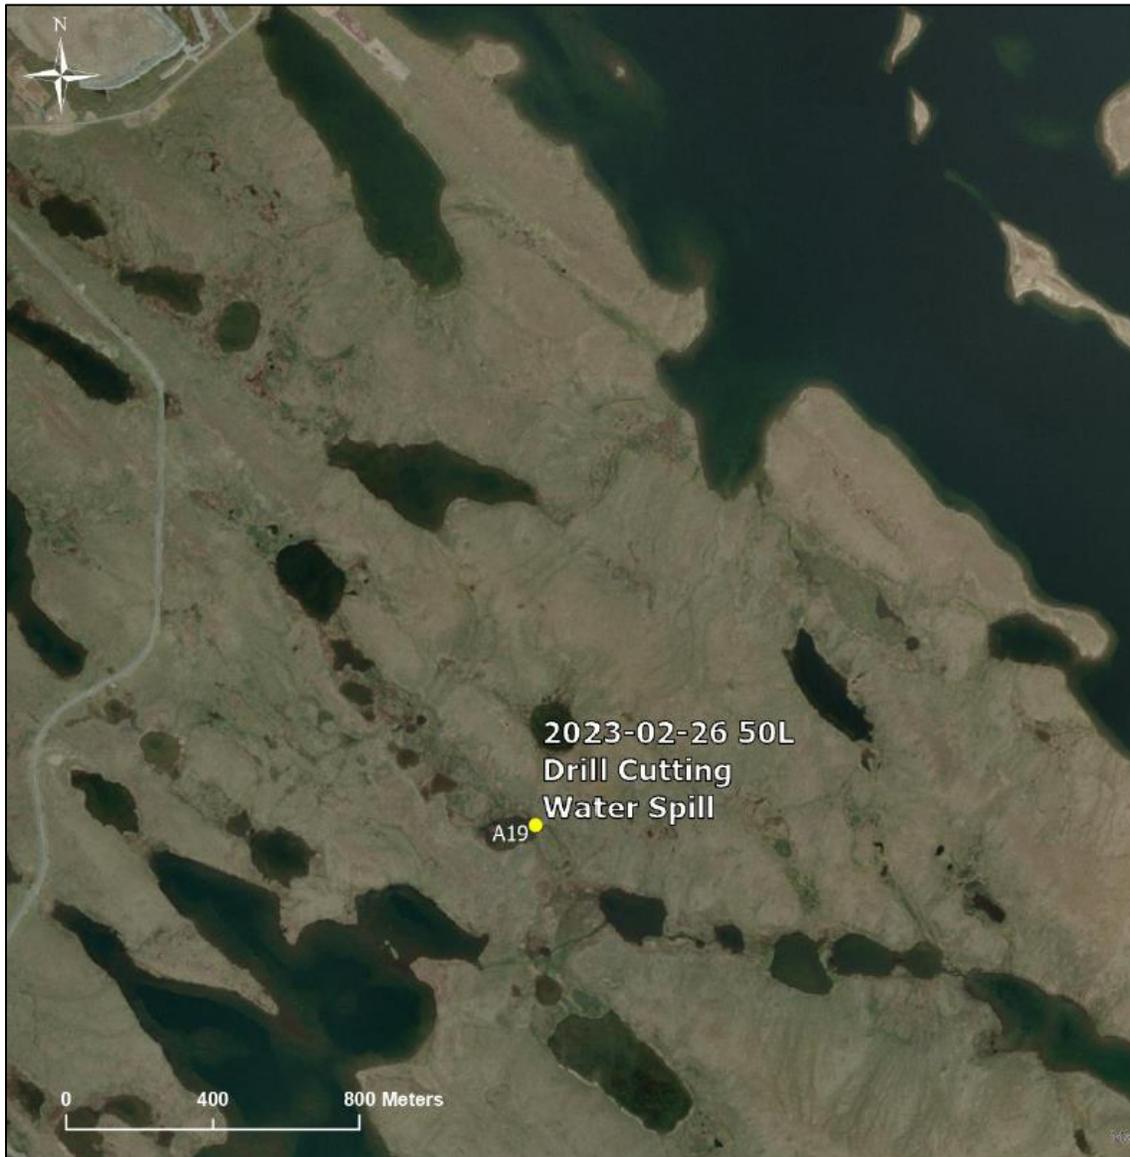
On February 26th, 2023, at approximately 8:00 am, an estimated 50 L of drill cuttings water was spilled onto the ice surface on lake A19. The generator powering the water recovery pan pump failed allowing the water recovery pan to overflow. The spill was located on Lake A19, as seen in Figure 1.

Figure 1: Location of the drill cuttings water spill.

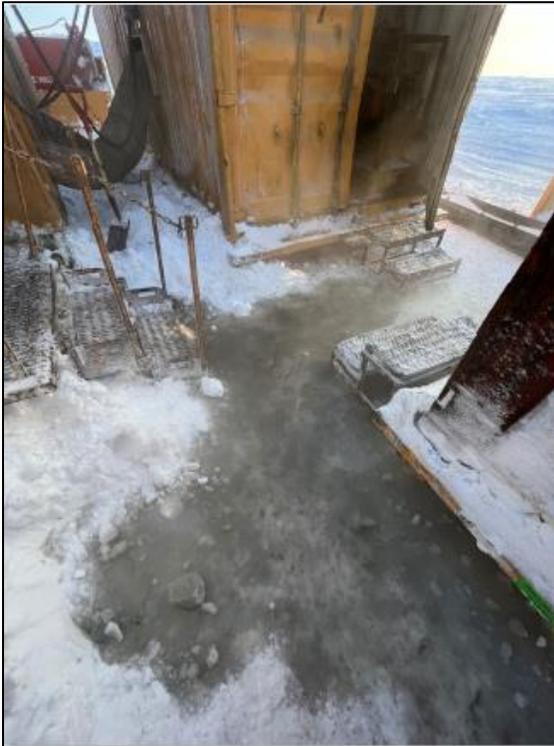
- The failure of the drill site generator resulted in a power loss to the water recovery pan pump allowing it to continue to fill from the water pressure pump.
- Water contaminated fuel was identified in the fuel filter sight glass resulting in a generator failure.

Photo 1: Drill cutting water spill.

- A signal light has been installed in the drills to notify the driller of a generator failure.
- Operating instructions to shut down the water pressure pump during a generator failure has been provided to all drilling employees.
- Direction has been provided to all drilling employees to inspect fuel nozzle to ensure there is no snow inside prior to refueling equipment, therefore preventing equipment failure.

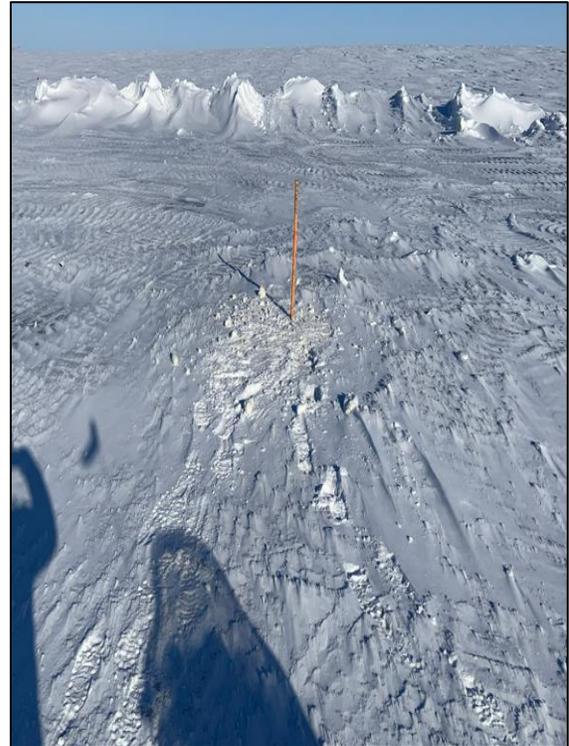
Photo 2: Drill cutting water spill post remediation.

repaired and restarted to lower the volume in the water recovery pan. Clean up of the spilled material occurred on March 14th, 2023, immediately after the drill setup was demobilized from this location. The impacted snow and ice was disposed of on the Waste Rock Storage Facility 3 (WRSF3).
