April 14<sup>th</sup>, 2023

## **Re: Follow-up Report Spill #2023-104 – Release of 1 L of Hydraulic Oil Meliadine Gold Mine Lake A8**

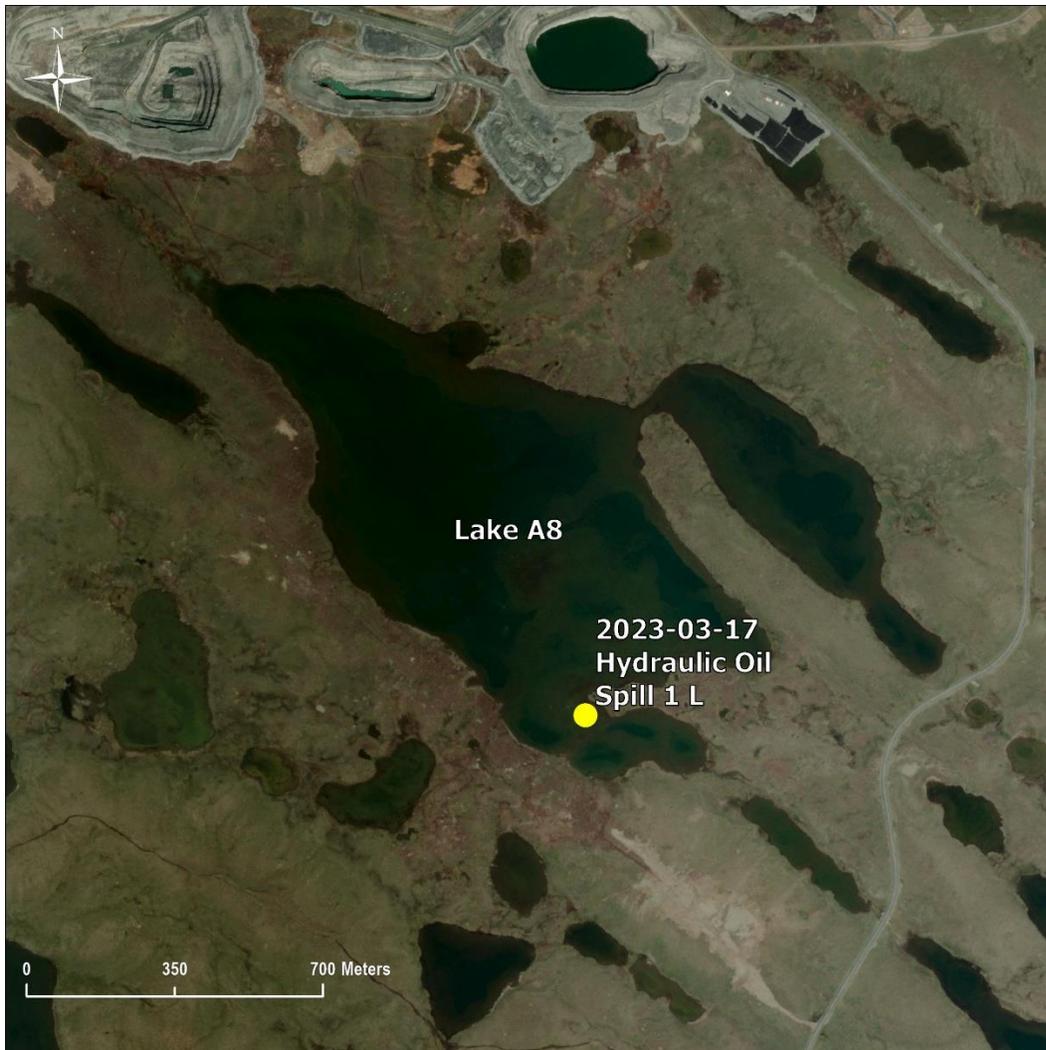
On March 17<sup>th</sup>, 2023, at approximately 14:00, an estimated 1 L of hydraulic oil was spilled onto the ice surface on Lake A8 as seen in Figure 1. While lowering the drill tower to relocate the drill a hydraulic line was pinched spilling hydraulic oil within the drill and into the water recovery pan. After the water recovery pan was removed and the drill relocated, remnant oil from under the drill floor was observed on the snow.

**Figure 1:** Location of the 1 L hydraulic oil spill.

- The length of the hydraulic line was determined to be too long and allowed excess to become pinched when the tower was lowered.

Absorbent pads were deployed to absorb the free oil and disposed of in a Quatrex bag at the Meliadine mine site. The remaining impacted snow and ice was recovered with a shovel and bucket and transferred to the contaminated snow cell at the mine site, to be treated through the Oil Water Separator.

- A hydraulic line of suitable length was installed.
- Direction has been provided to all drilling employees to inspect hydraulic lines before a drill move begins.

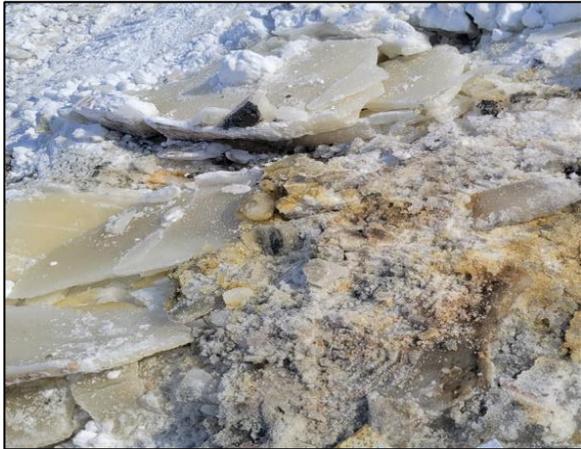
**Photo 1:** 1 L hydraulic oil spill location.

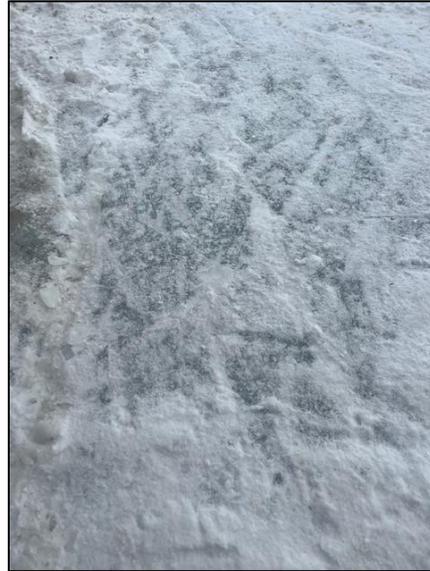
**Photo 2:** 1 L hydraulic oil spill post remediation.
