May 14, 2023

## **Re: Follow-up Report Spill #2023-151 – Release of 40 L of Drill Cuttings Meliadine Gold Mine, Unnamed Waterbody**

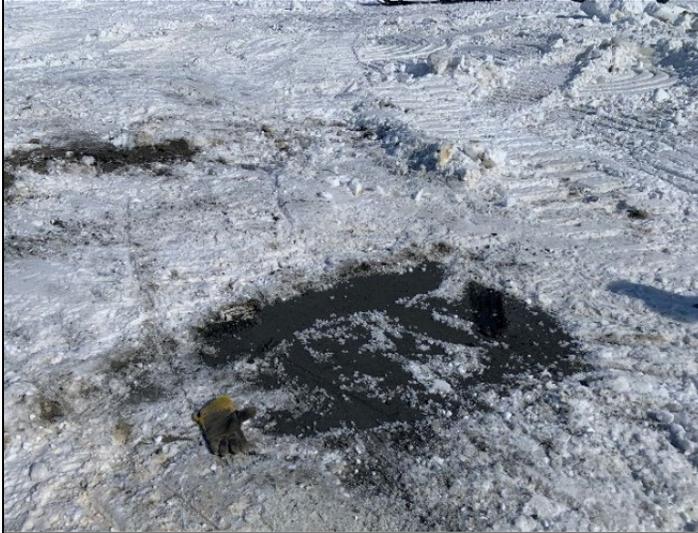
On April 16<sup>th</sup> and 17<sup>th</sup>, 2023, Orbit Garant Drilling was removing their drilling equipment from the ice surface of an unnamed waterbody approximately 7.5 kilometers east of the Meliadine Gold Mine industrial pad. At approximately 3:30 am on April 17<sup>th</sup>, the drill crew prepared to drag two skid-mounted units of drilling equipment, chained in series, behind a tractor. The last unit in the train was the cuttings recirculation unit. Due to the lack of daylight and the cuttings recirculation unit being at the back of the train, the drilling crew did not notice the spill of 40 L of drill cuttings to the ice surface as the equipment left the site. The spill was discovered during the post-drilling inspection on April 17<sup>th</sup>, 2023, at approximately 15:30. The location of the spill is shown in Figure 1.

An incident assessment was conducted soon after the incident occurred to determine the root cause and contributing factors. The assessment concluded with the following:

- Prior to conducting the move, the drill cutting recirculation unit was not cleaned.

**Photos 1:** 40 L Drill cuttings water spill.

The following corrective and preventative actions have been implemented to address the root cause and to reduce the likelihood of reoccurrence:

- The drill transportation procedure will be updated to ensure the cuttings recirculation unit is cleaned prior to transportation.
- The updated drill transportation procedure will be reviewed with the Orbit Garant drilling crews.

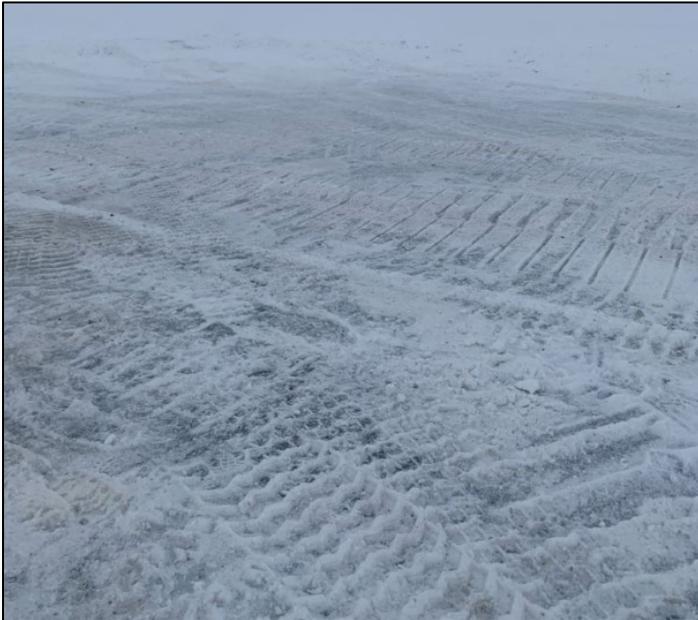
**Photos 2:** 40 L drill cuttings water spill post remediation.

Logistical issues with equipment transportation to the spill site delayed the start of cleanup. Equipment was mobilized on April 20<sup>th</sup>, 2023, with a dozer, skid steer and an equipment sled used to recover the spilled drill cuttings. Final cleanup was complete on April 20<sup>th</sup>, 2023. The frozen material was scraped off the frozen waterbody surface and deposited in a natural depression previously used for drill cuttings disposal which was approved by the Environment Department.
